FILLMORE TERRACE
(Peoples Self Help Housing)

General Plan Amendment, Specific Plan
Amendment, Zone Change, Development
Permit, Density Bonus, and Lot Merger

CEQA INITIAL STUDY & MITIGATED NEGATIVE DECLARATION

November 4, 2020

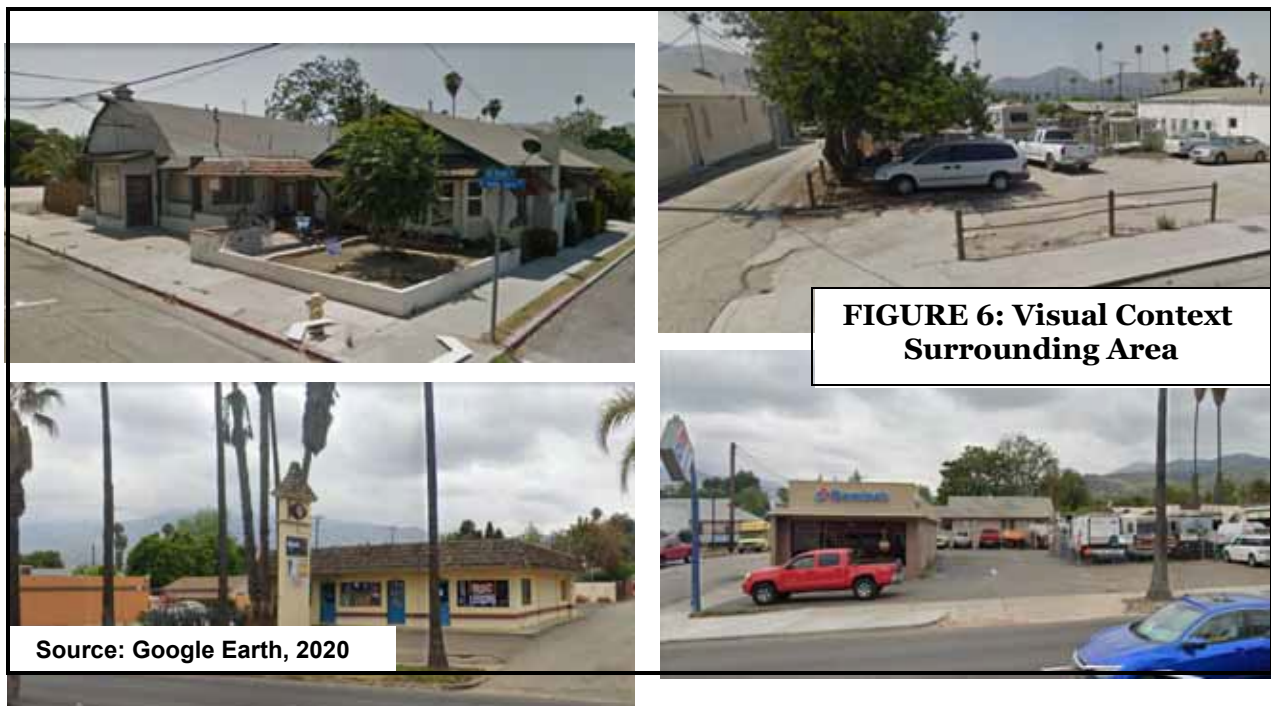
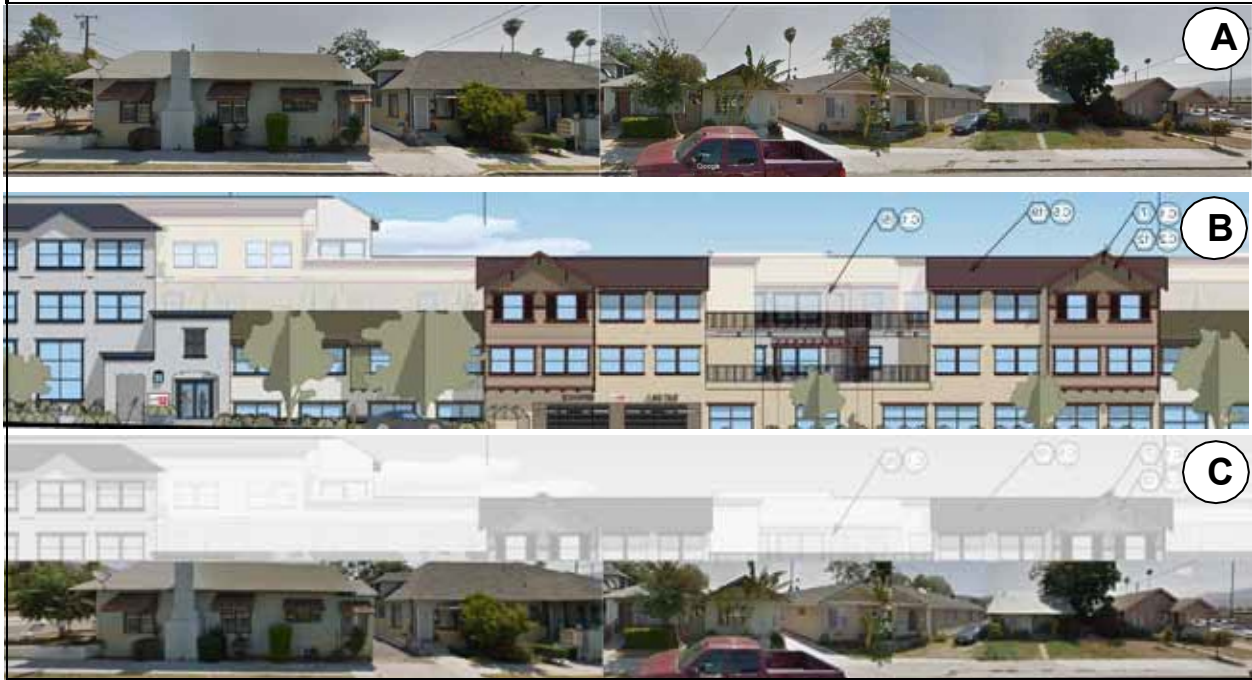
FIGURE 7: Streetscape Comparisons

c (1) Project Scale. As depicted in Figures 4, 5 and 6, the Project Site and its immediate surrounds exhibit an assortment of urbanized uses at varying scales of lot coverage, building configuration and development intensity. In summary: (i) the area’s overall character is best described as eclectic with a predominance of single-story construction and non-descript architectural character; and (ii) the Proposed Project would entail a more intensive use (dwelling unit density) and development scale (lot coverage and building height) than what currently exists both on the site and within the immediate vicinity. The most dramatic changes would involve building size, bulk and height compared to what characterizes the area at present. Figure 7 illustrates this contrast by superimposing the existing neighborhood fronting Palm Street immediately east of the Project Site with the building elevation of the Proposed Project fronting the opposite side of the Street.

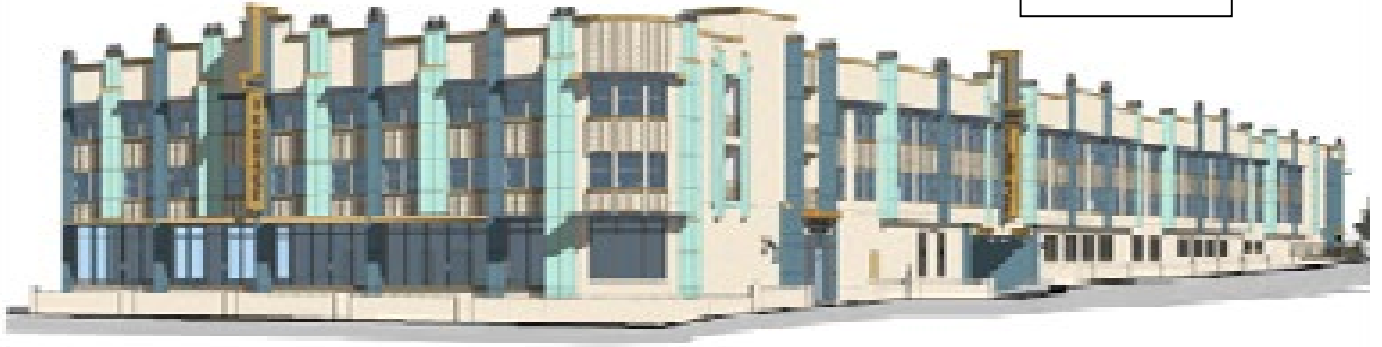
Initial Design

Finding: At present, physical attributes of the Proposed Project are only partially compliant with current existing development standards (Table 6). These potential inconsistencies result from bifurcated land use and zoning designations that apply to the Project Site at present (Figure 8). Although these regulatory inconsistencies could be resolved through the Project's requested General Plan amendment and Zone change to the CBD Transitional land use designation over the portion of the Project Site currently designated Commercial Highway, applicable policies under the DTSP that apply to the CBD designation require that: "building mass and organization...be compatible with the adjacent and nearby neighborhoods...incorporating strong reference to, traditional residential scale, detail and materials." The CBD Transitional designation allows for residential uses, three story structures, and reduced setbacks. Building and site improvements of the Proposed Project are greater in mass and scale than the immediately surrounding properties which consist of single-story residential homes, commercial buildings, and a public service building (Senior Center). Design of the Proposed Project has integrated a number of features to minimize it's impacts relative to the neighborhood character. These features include building increments, varying roof lines between two and three stories, an open second floor area along Palm Street, articulation of the perimeter walls, surrounding planters, and complimentary architectural details.

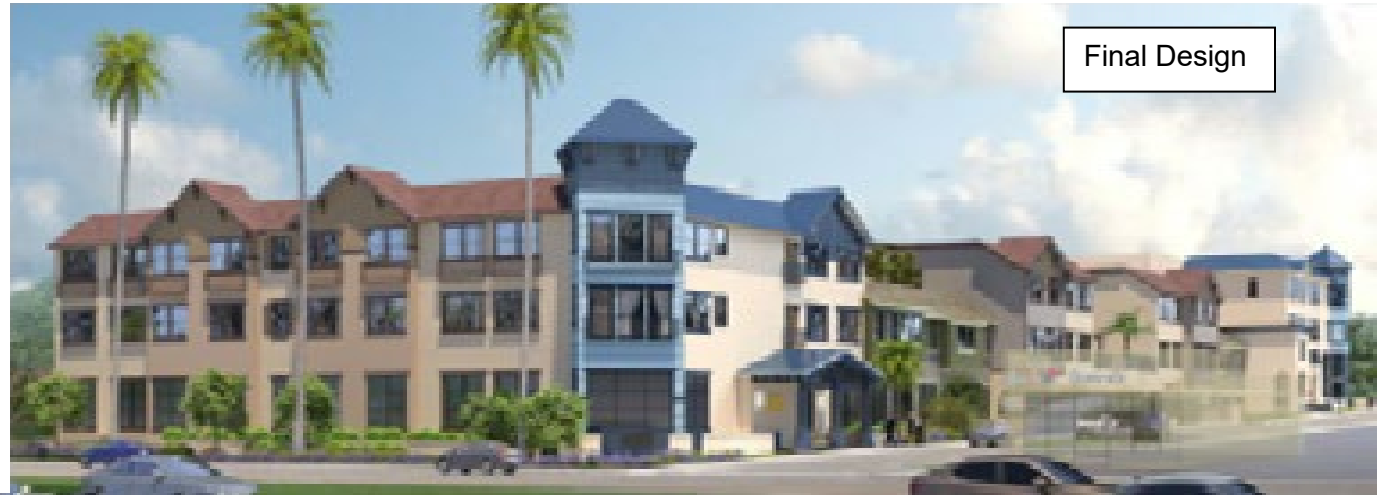
Final Design

With incorporation of these design features, along with the proposed change in zoning from CH to the CBD Transitional land use designation, the Project will be consistent with the development standards for the CBD zone and the DTSP design guidelines and impacts would be less than significant. For light and glare, the potential aesthetic impacts would be potentially significant, but reduced to less than significant with mitigation incorporated.

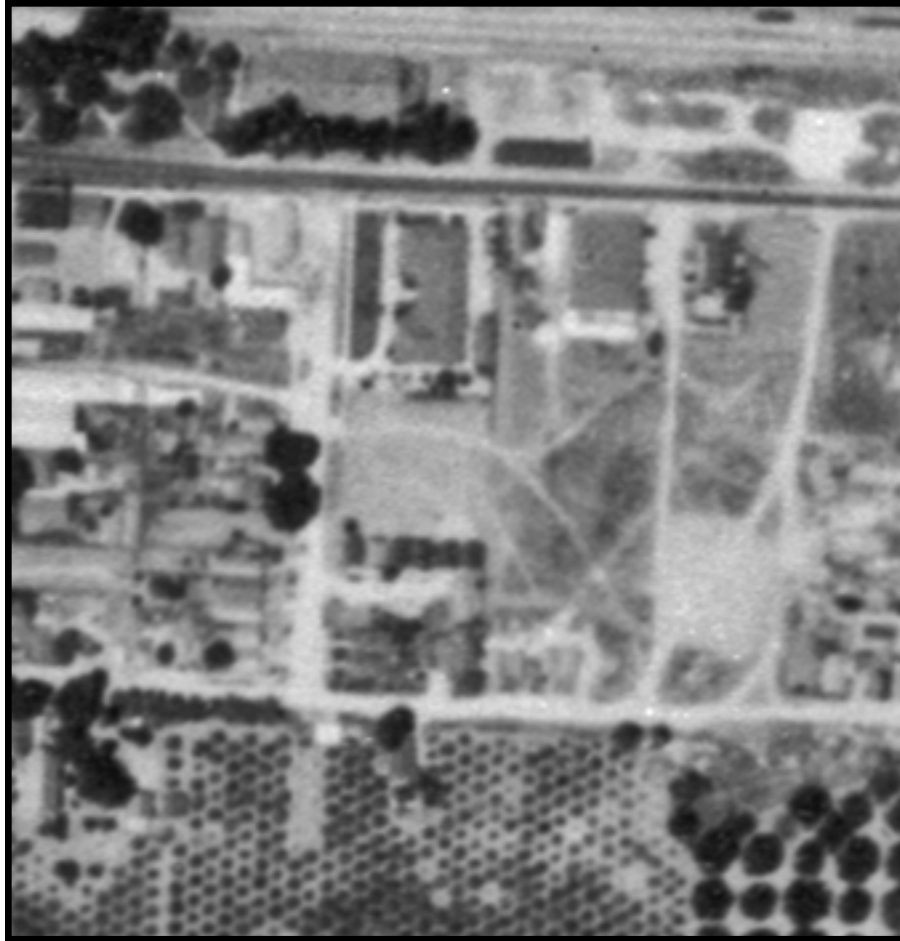
Figure 7: The Project area in 1929 image, showing the Project property (center) (UCSB Historic Aerial Image Database).

The oldest aerial photograph in the UCSB Library historic aerial photography database was from 1929 (**Figure 6**). As was found with the older USGS maps, this photo shows minimal development at the time in the local region, and possible development on the Project property. Examination of historic Google Earth satellite images shows the local area and developed Project site from 1994 to current, with constant in-filling of the local area with residential development, and development of the Project property. The built environment study for the Project identified that at least one standing 1910 residential structure is located on the property, confirming early conclusions from the records search (San Buenaventura Research Associates, 2020). Additional early 20th Century structures were also identified in that document.

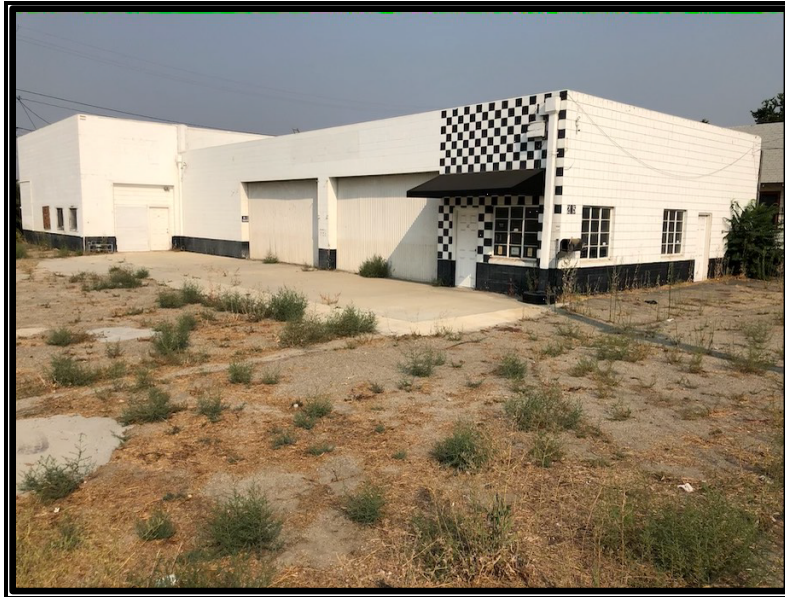
Figure 8: Overview of a commercial building, showing how the landscape around the buildings has been heavily graded and impacted (San Buenaventura Research Associates, 2020)

The built environment study was utilized to provide representative photos of the subject property (**Figure 8, Figure 9, Figure 10, Figure 11, and Figure 12**). The ground is currently covered with either standing structures, concrete pavement, or older concrete pads associated with previous associated support buildings to the existing structures. The subject property appears to be highly impacted by over one hundred years of commercial and residential development, with grading of the terrain, and numerous impacts from utilities, concrete features, pavement, and structural pads.

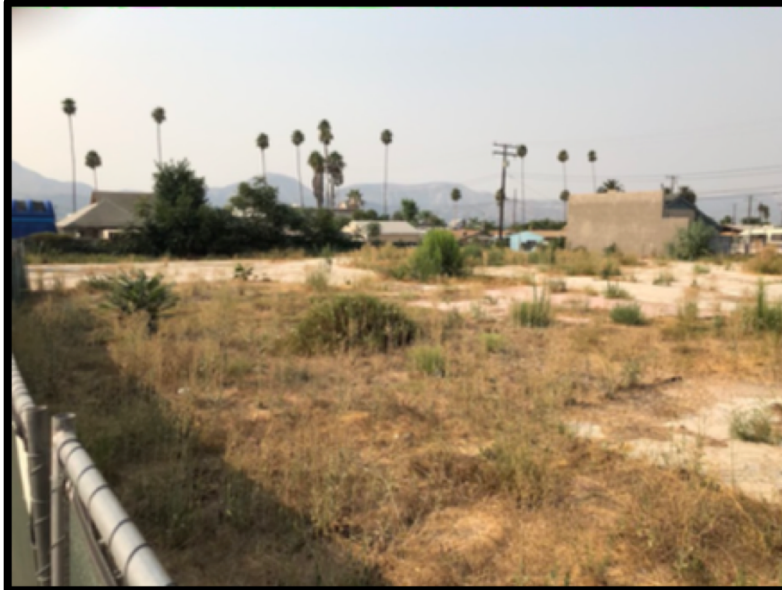
Figure 12: A View of the empty lot, showing older concrete pads and evidence of property grading (San Buenaventura Research Associates, 2020)

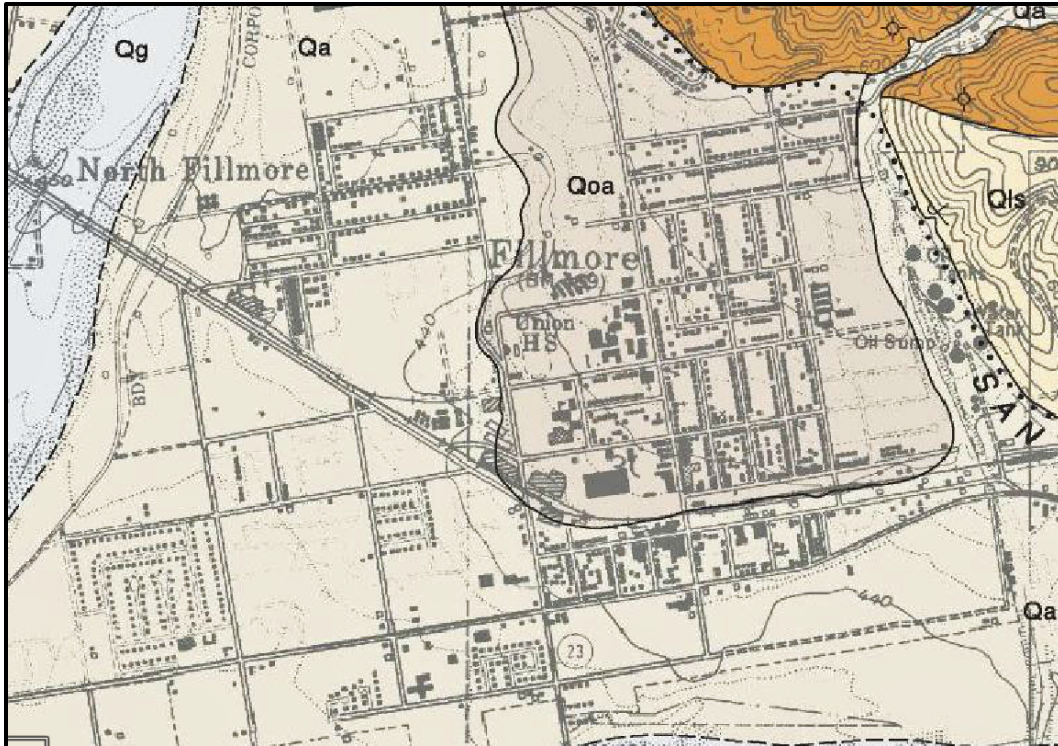
Figure 13: The Project property (located below the railroad tracks in the middle of the image) is located on non-fossil bearing recent alluvial material, however, this material may be over older alluvial material at greater depths (USGS).

The National Geological Map Database of the USGS was examined to assess the paleontological sensitivity of the project for fossil resources. The entire project area is located within recent alluvial fill, which is not sensitive for older fossil resources (**Figure 13**). North of the railroad tracks in Fillmore, older alluvial material is present, which is known to produce significant terrestrial mammal fossils from the Pleistocene era or earlier. Since the Project recent alluvial is probably also over older alluvial layers, a discovery protocol for the project should be in place in the event that unexpected fossil resources are encountered during project grading.

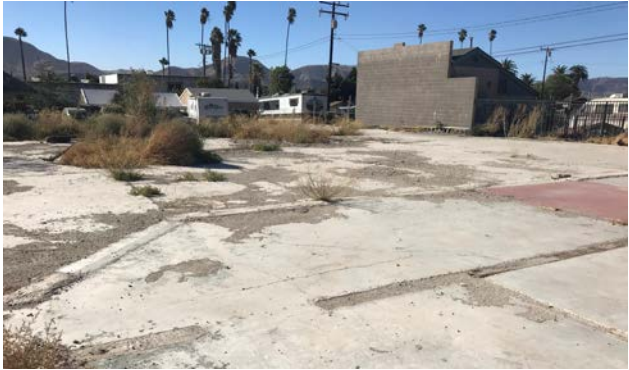
Photograph 1. View of the undeveloped concrete area located on the northern portion of the subject property, facing west.

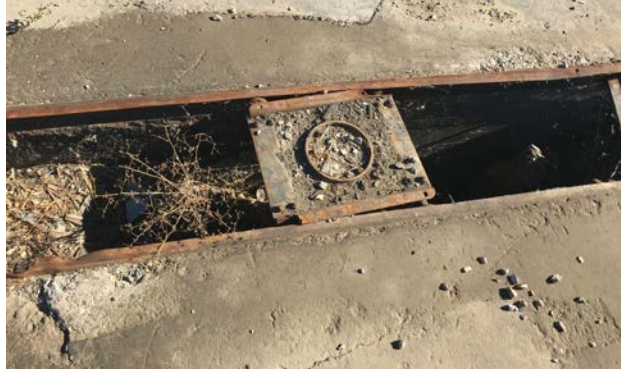
Photograph 2. View of the in-ground hoists present at the undeveloped concrete area on the northern portion of the subject property.

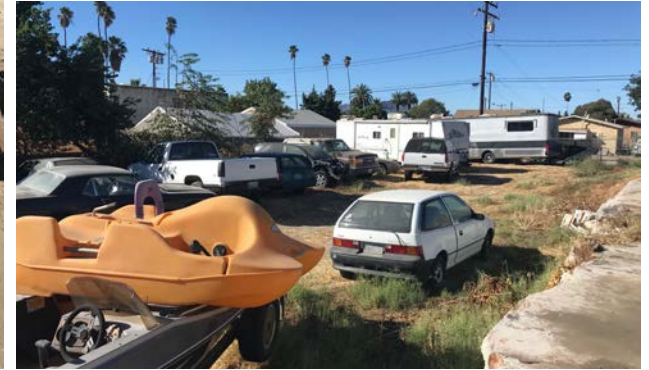
Photograph 3. View of the vehicle storage area on the central portion of the subject property, facing southwest.

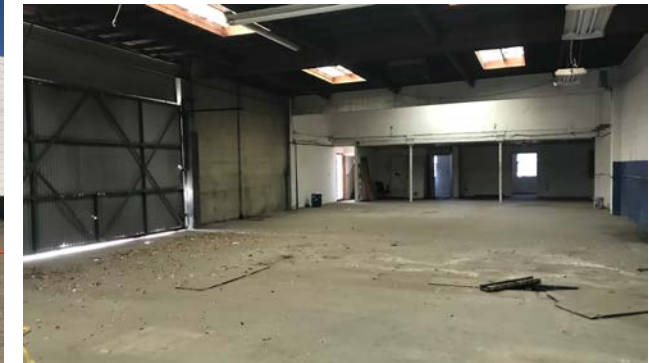
Photograph 6. View inside the former automotive repair building present on the southern portion of the subject property.

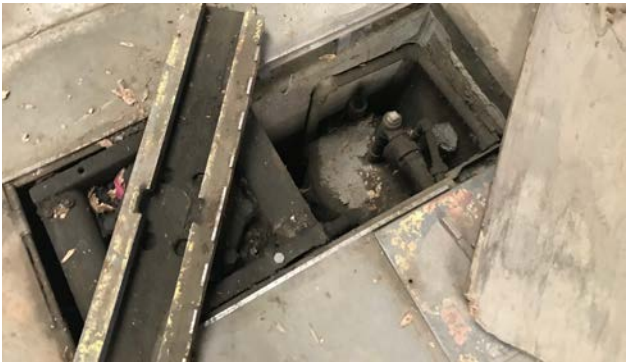
Photograph 7. View of the in-ground hoists present inside the former automotive repair building on the southern portion of the subject property.

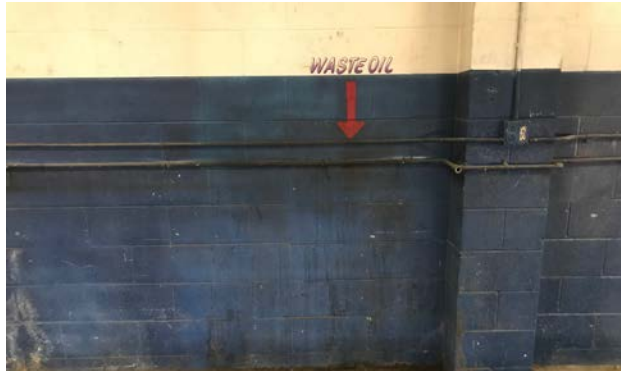
Photograph 8. View of the "waste oil sign" inside the former automotive repair building on the southern portion of the subject property.

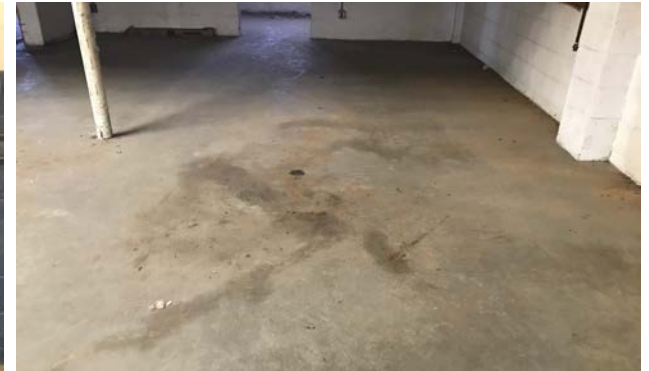
Photograph 9. View of staining inside the former automotive repair building on the southern portion of the subject property.

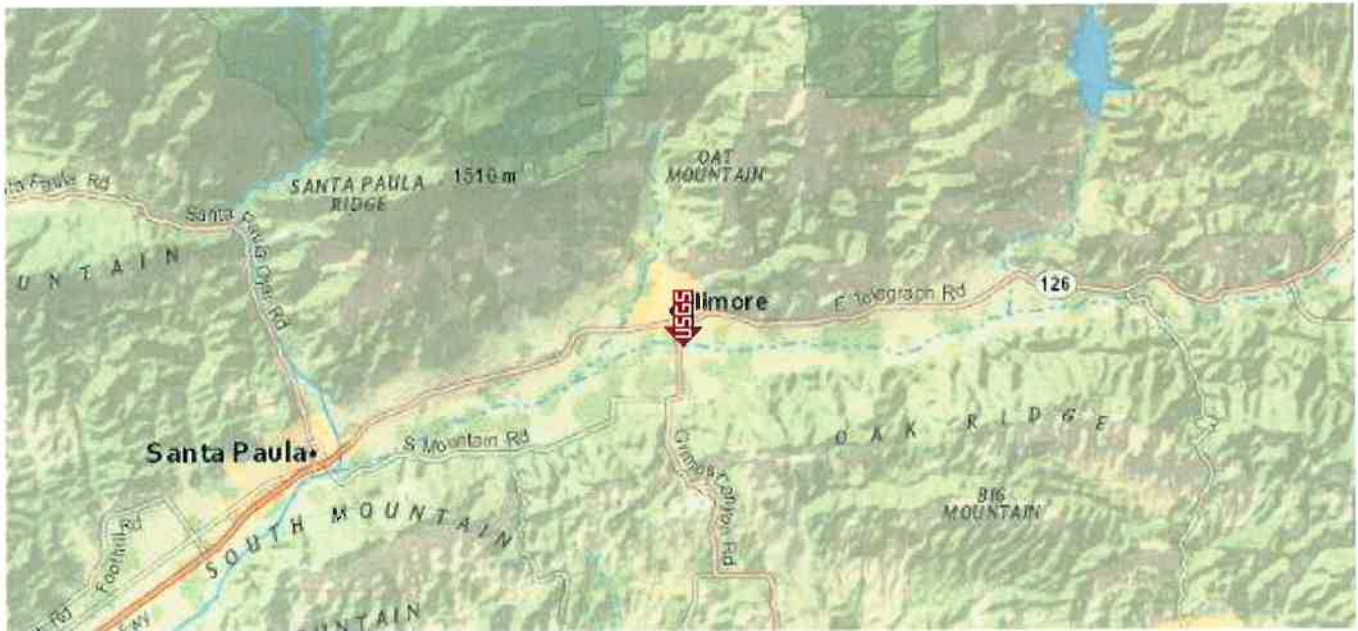
Site Soil Classification Site Class D – “Stiff Soil”

USGS-Provided Output

$S_s = 2.460 \text{ g}$	$S_{MS} = 2.460 \text{ g}$	$S_{DS} = 1.640 \text{ g}$
$S_1 = 0.996 \text{ g}$	$S_{M1} = 1.494 \text{ g}$	$S_{D1} = 0.996 \text{ g}$
