# SAN BERNARDINO MUNICIPAL WATER DEPARTMENT

VINCENT WELL STABILIZATION PROJECT

# General Biological Resources Report And Habitat Assessment For the Vincent Well Flood Protection and Streambed Stabilization Improvement Project

# TECHNICAL MEMORANDUM FIELD OBSERVATIONS AND RECOMMENDATIONS PROPOSED FLOOD PROTECTION AND STREAM STABILIZATION IMPROVEMENTS VINCENT WELL, SAN BERNARDINO COUNTY, CALIFORNIA

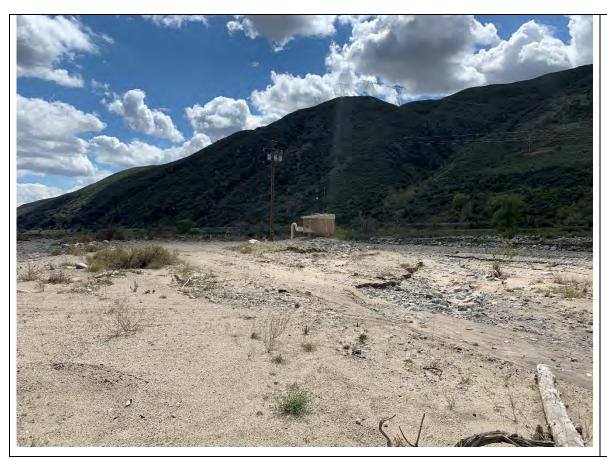
Photo 5 –
Proposed project area. Facing south.
Showing structure to be protected.

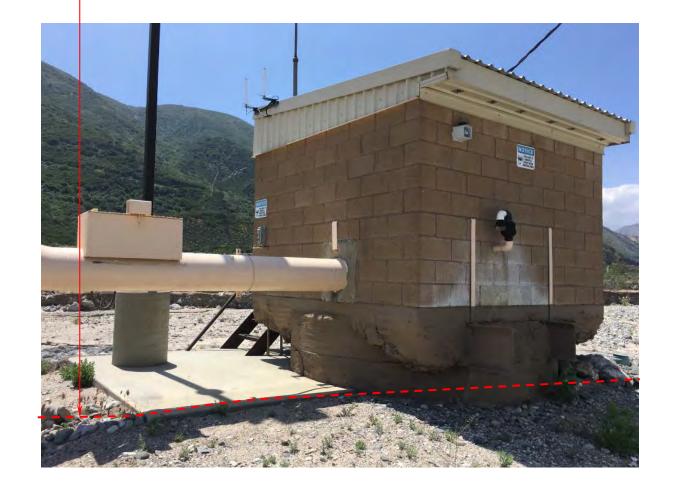
PROJECT NO.	DATE	FIGURE 2
420-CASC-SBC	JUNE 21, 2018	CONCEPTUAL DESIGN-OPTION 1 PLAN VIEW

# Proposed Finished Grade
