Preliminary Delineation of Wetlands and Other Waters Report

Guadalupe River Bridge Replacement Project Preliminary Delineation of Wetlands and Other Waters

August 2020

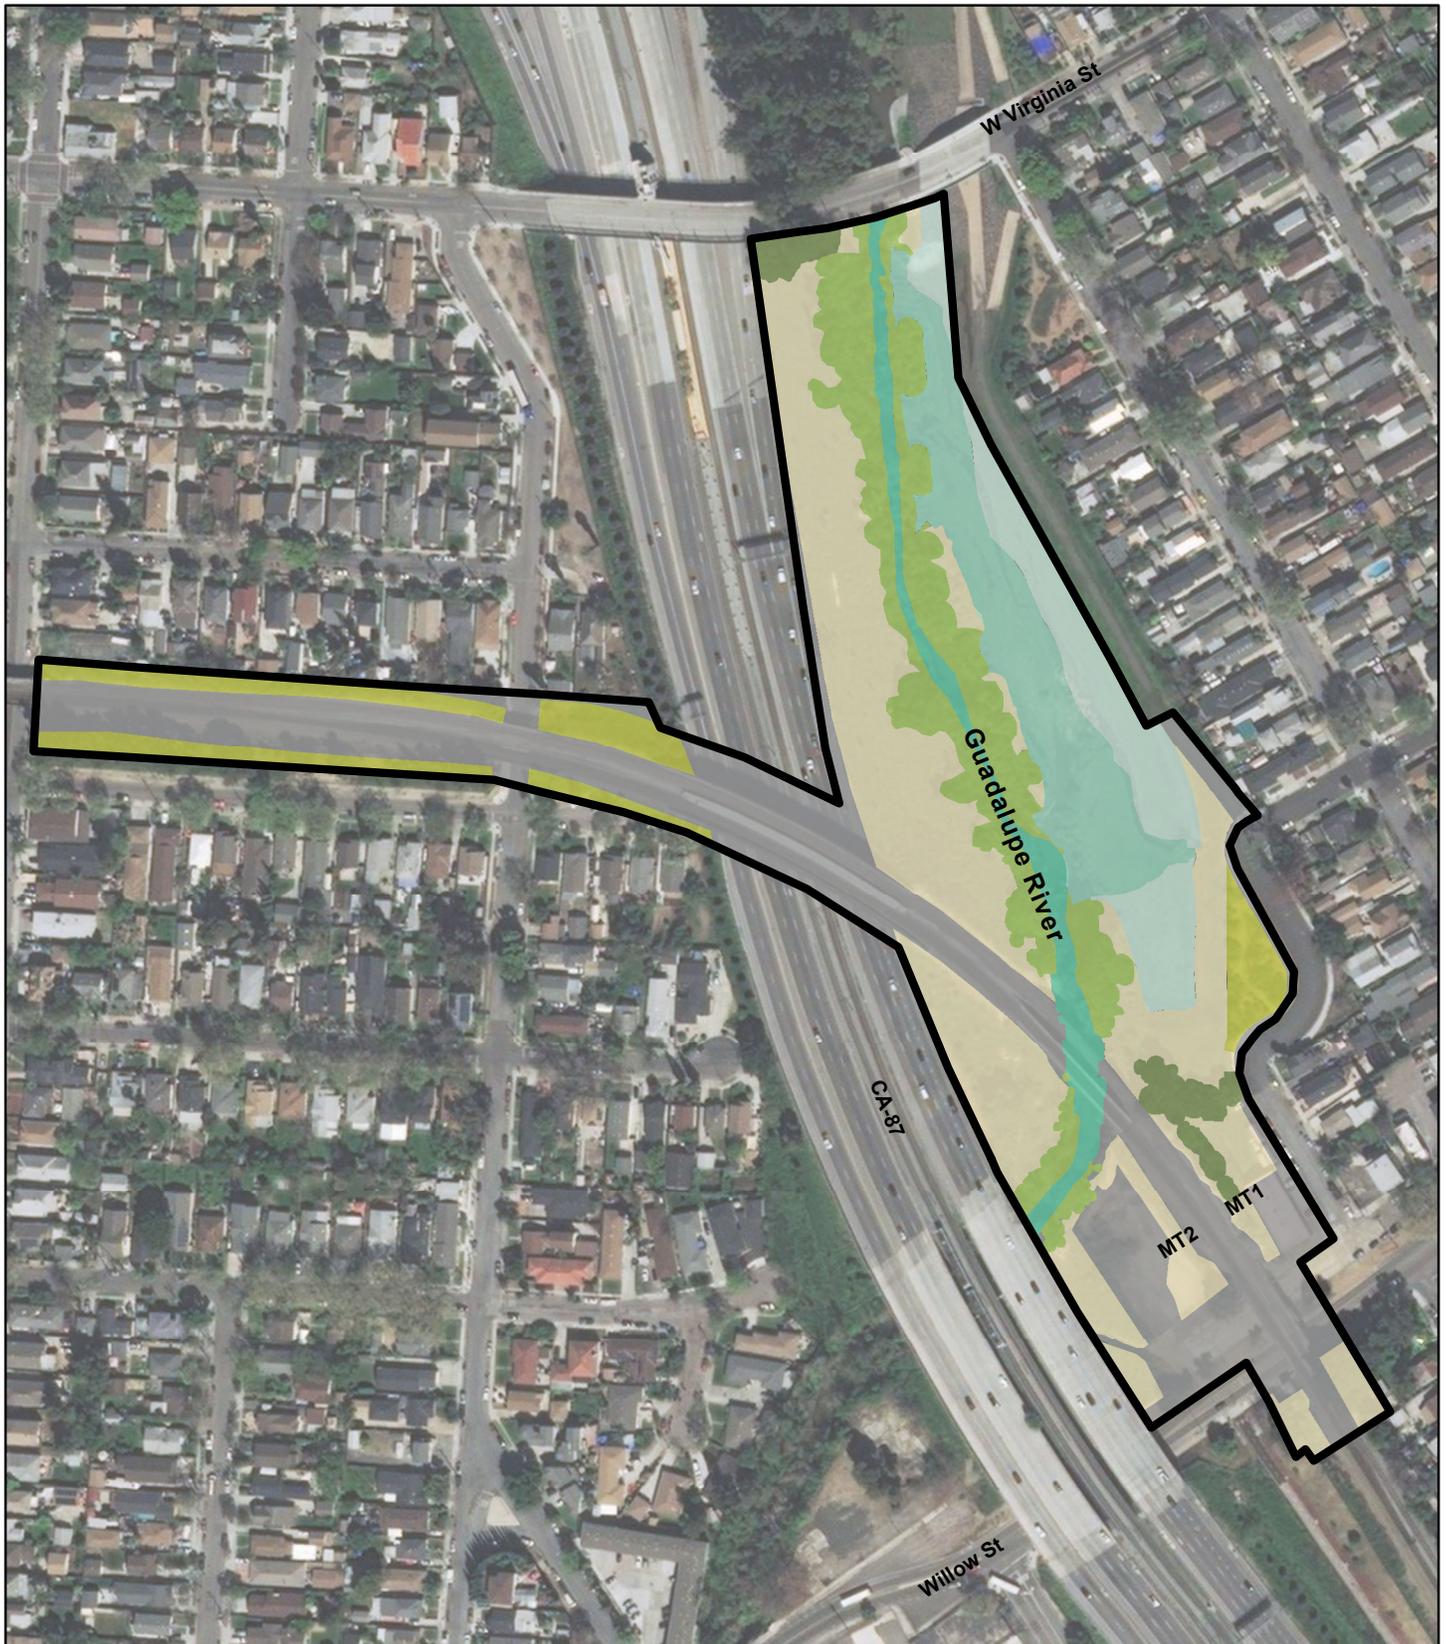
Figure 6 Vegetation Communities Map
Guadalupe River Bridge Replacement Project

- Study Area (17.06 acres)
- Freshwater Perennial Marsh (1.61 acres)
- Seasonal Wetland (1.33 acres)
- Aquatic Habitat (0.73 acres)
- Fremont Cottonwood Forest (2.13 acres)
- Coast Live Oak Woodland (0.38 acres)
- Wild Oats and Annual Brome Grassland (4.59 acres)
- Ornamental Woodland (1.25 acres)
- Developed Land (5.04 acres)

Wild Oats and Annual Brome Grassland. This annual grassland habitat is dominated by non-native grasses, including wild oats (*Avena* sp.), ripgut brome (*Bromus diandrus*), Mediterranean barley (*Hordeum murinum*), and smilo grass. Other species observed included non-native plant species that are characteristic of disturbed areas, including black mustard (*Brassica nigra*), wild radish (*Raphanus sativus*), Canada horseweed (*Erigeron canadensis*), field bindweed, Italian thistle (*Carduus pycnocephalus*), prickly lettuce (*Lactuca serriola*), and Russian thistle (*Salsola tragus*). Annual grassland was mapped within the top of bank of the Guadalupe River and the flood control basin as well as areas outside of the banks of the river and basin.

Developed Land. Developed land within the top of bank included areas that are covered in rip rap or hardpacked soil that does not support vegetation. These areas were mapped under the bridge, adjacent to the abutments, and along the banks adjacent to the bridges. Outside of the banks, developed land includes areas that are paved, graded, hardpack dirt, and gravel access routes. These areas were generally devoid of substantial vegetation cover but contained small patches of non-native vegetation. Species observed includes were the same as observed in the Wild Oats and Annual Brome Grassland (Photo 6, Appendix D).

Ornamental Woodland. Ornamental woodland includes lands that have been planted with landscaping and are maintained on an ongoing basis. Such landscaping may include native and non-native plantings. Within the study area, ornamental woodland is found along both sides of the tracks in the eastern reach of the study area and includes the City of San Jose's Fuller Avenue Park. Trees and shrubs observed included black locust (*Robinia pseudoacacia*), Chinese pistache (*Pistacia chinensis*), Australian pine (*Casuarina equisetifolia*), Canary Island pine (*Pinus canariensis*), and cotoneaster (*Cotoneaster franchetii*). Ornamental woodland is found along the top of bank of the flood control basin and McClellan Avenue in a small landscaped neighborhood park. Trees and shrubs observed included blue elderberry (*Sambucus nigra* ssp. *caerulea*), valley oak (*Quercus lobata*), and California coffeeberry (*Frangula californica*).

Coast Live Oak Woodland. Woodland habitat dominated by coast live oak (*Quercus agrifolia*) occurs in two areas within the study area. A small amount of the oak woodland canopy overhangs the top of bank in the northwest corner of the study area, but the trees are rooted outside of the top of bank; therefore, they were mapped as part of the Coast Live Oak Woodland. Plants observed in the understory were the same as those observed in the Wild Oats and Annual Brome Grassland.

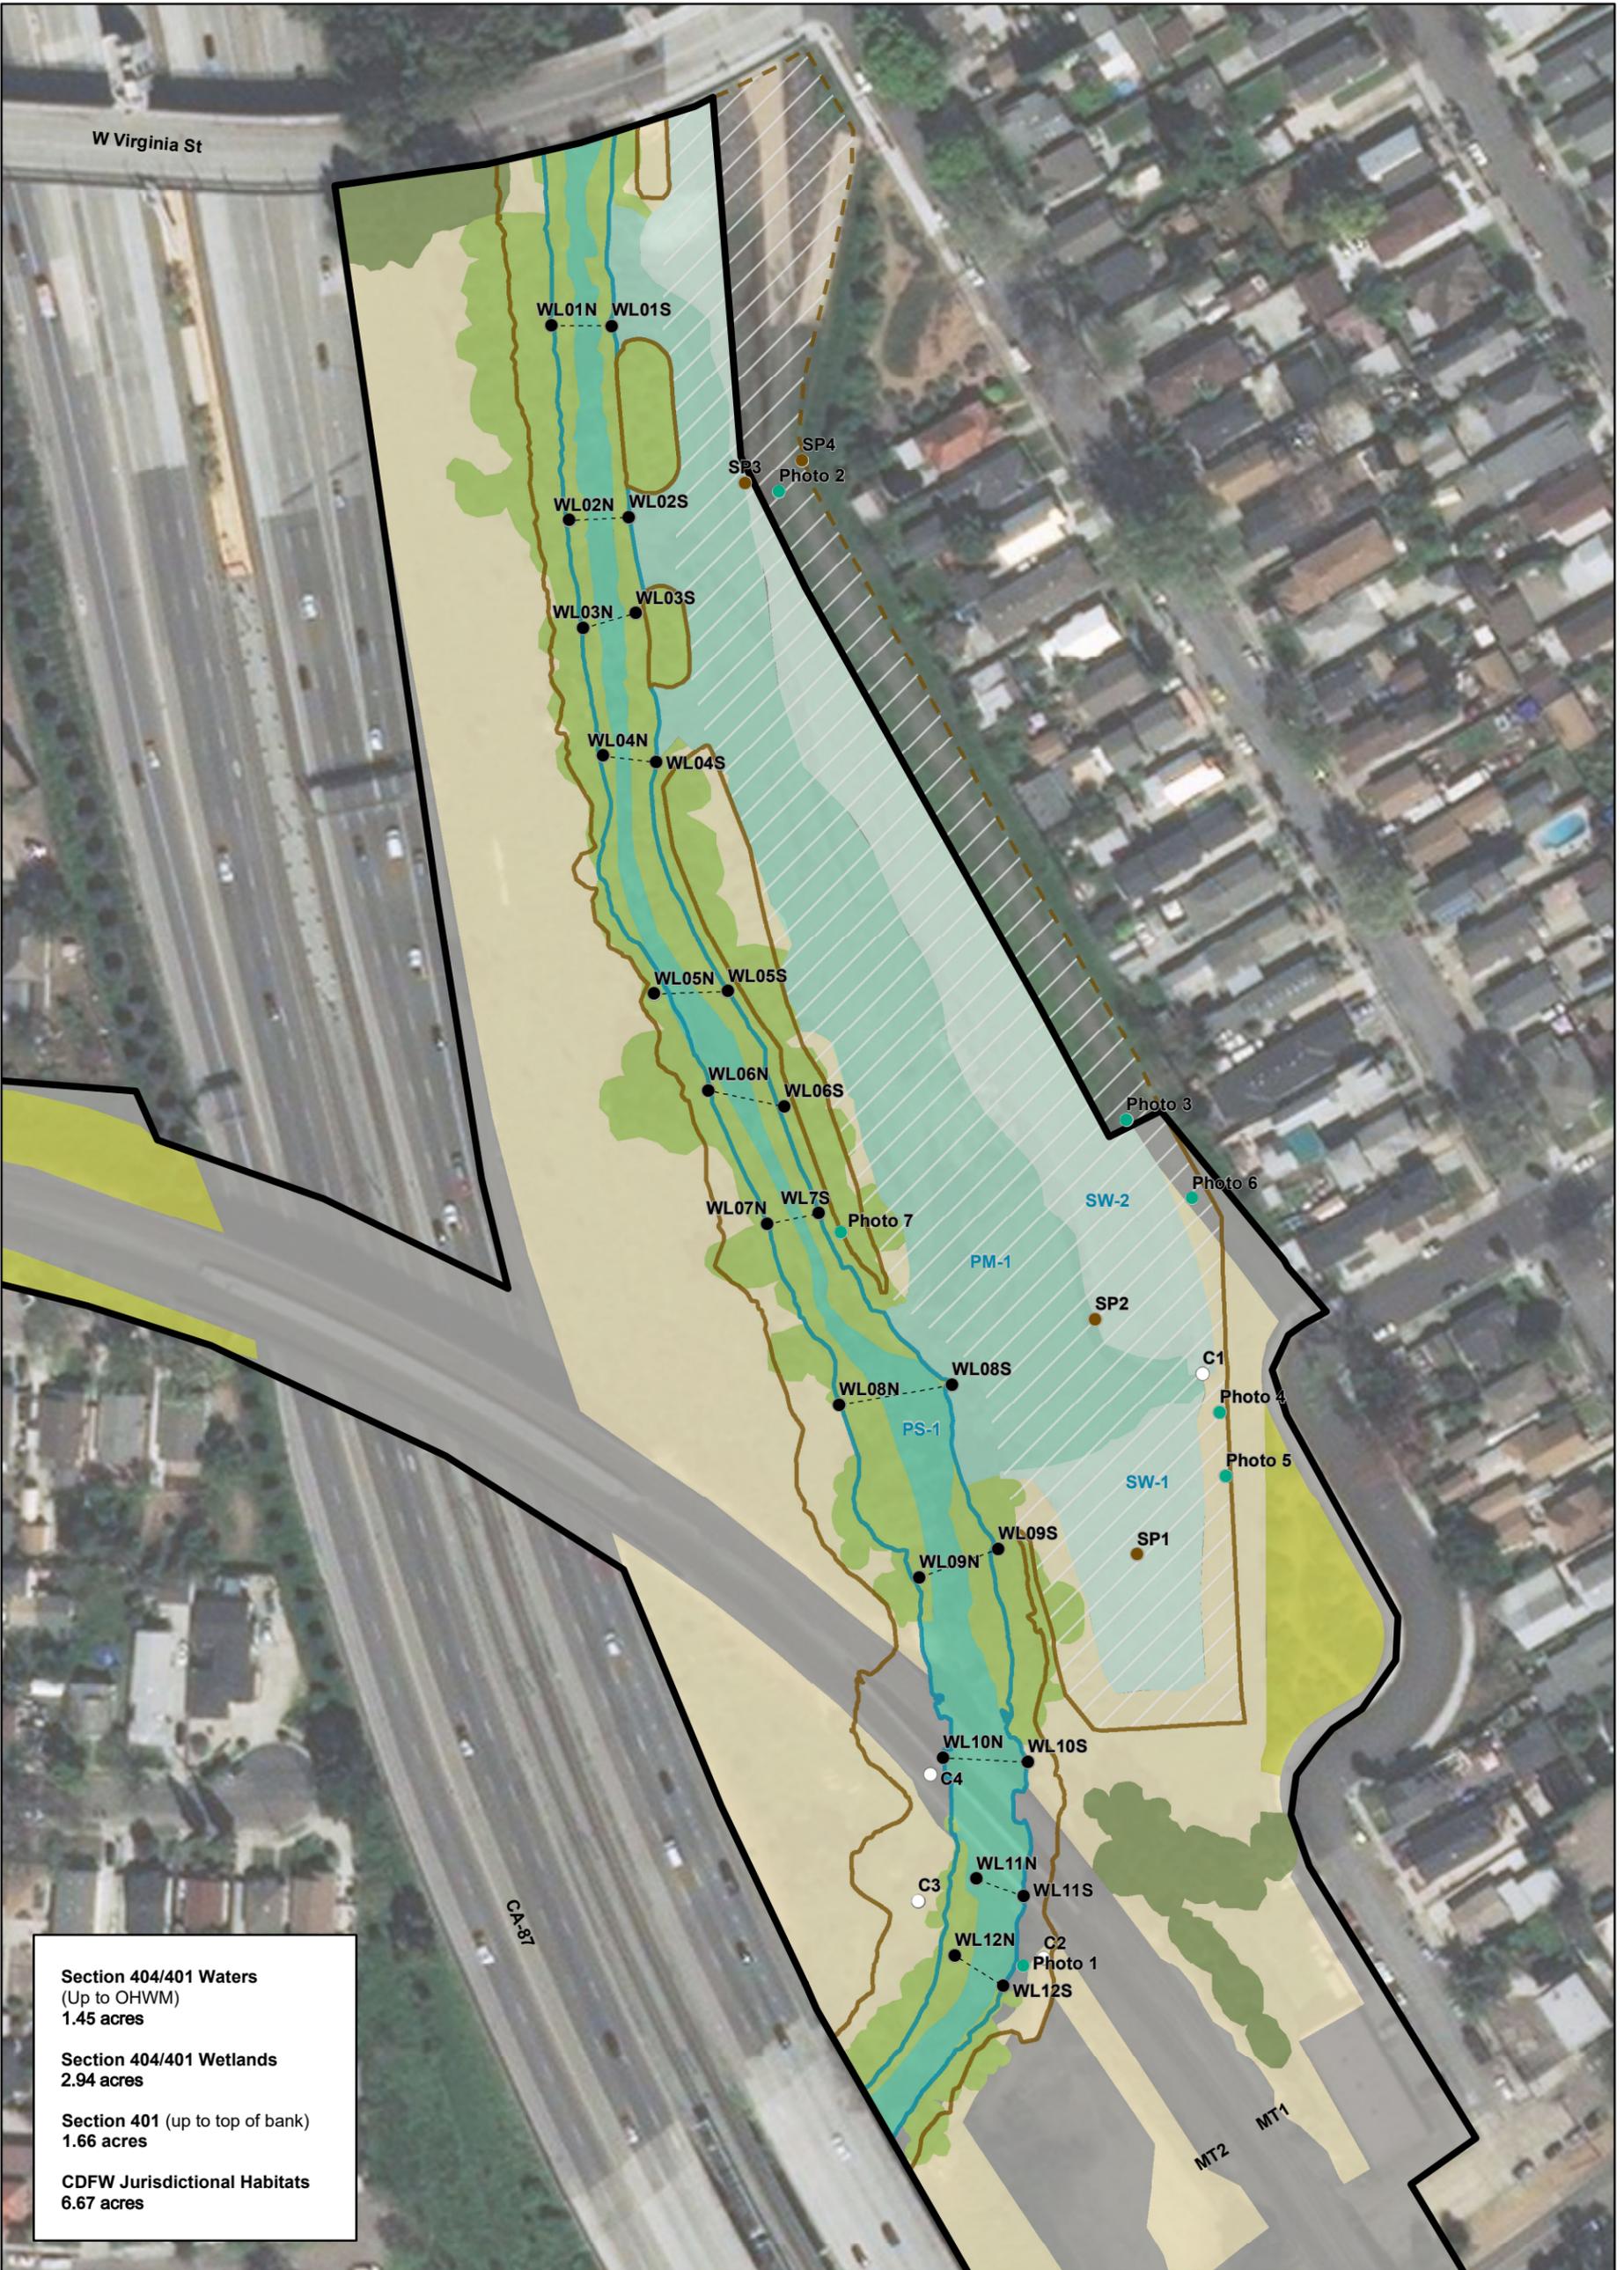
Figure 7 Preliminary Identification of Waters of the U.S./State
Guadalupe River Bridge Replacement Project

Section 404/401 Waters (Up to OHWM)
1.45 acres

Section 404/401 Wetlands
2.94 acres

OHWL transects (WL 01N/S to WL 12N/S) and wetland sample points (SP1 to SP4) were selected to document conditions in representative jurisdictional and non-jurisdictional areas (Figure 7).

SP1 was selected to examine the seasonal wetland in the southern portion of the flood control basin in the study area (Figure 7). Vegetation present was dominated by a single FAC species, bristly ox-tongue (*Helminthotheca echioides*) and the soil exhibited redox depressions. Hydrological indicators, such as saturation visible on aerial imagery and drainage patterns were also observed (Google Inc 2020). The soil was slightly moist. Bristly ox-tongue exhibited increased abundance and plant vigor at SP1, indicating wetland conditions. This is particularly noticeable later in the growing season when adjacent areas are drying out, but moist soils are still present in wetlands, as was the case at SP1

SP2 was chosen to examine the edge of the perennial marsh within the flood control basin near culvert C1 in the study area (Figure 7). Vegetation was dominated by OBL (broadleaf cattail, *Typha latifolia*) and FACW (arroyo willow, *Salix lasiolepis*) species and the soil exhibited a depleted matrix. Hydrological indicators, such as saturation visible on aerial imagery and drainage patterns were also observed (Google Inc 2020). Standing water was observed within 2 feet of SP2 where the perennial marsh continues into a depression. The soil was very moist, but not saturated.

SP3 was selected to investigate the perennial marsh at the northern end of the flood control basin in the study area and was located within a depression (Figure 7.) Vegetation was dominated by a single OBL species, water primrose (*Ludwigia peploides*), and the soil exhibited a depleted matrix. Hydrological indicators, such as saturation visible on aerial imagery and drainage patterns were also observed (Google Inc 2020). The soil was almost saturated, likely indicating the area was recently inundated.

In general, areas that were identified as wetlands included solid stands of hydrophytes and/or areas determined to be ponded and/or saturated for long duration. Approximately 2.94 acres of potential USACE jurisdictional wetlands were identified in the study area (Figure 7). These areas included seasonal wetlands (SW-1 and SW-2) and a perennial freshwater marsh (PM-1). Three parameters identifying Section 404 wetlands were observed at three sample points (Figure 7; SP1 to SP3, Appendix C). The features that were determined to be potentially USACE jurisdictional wetlands are summarized below.

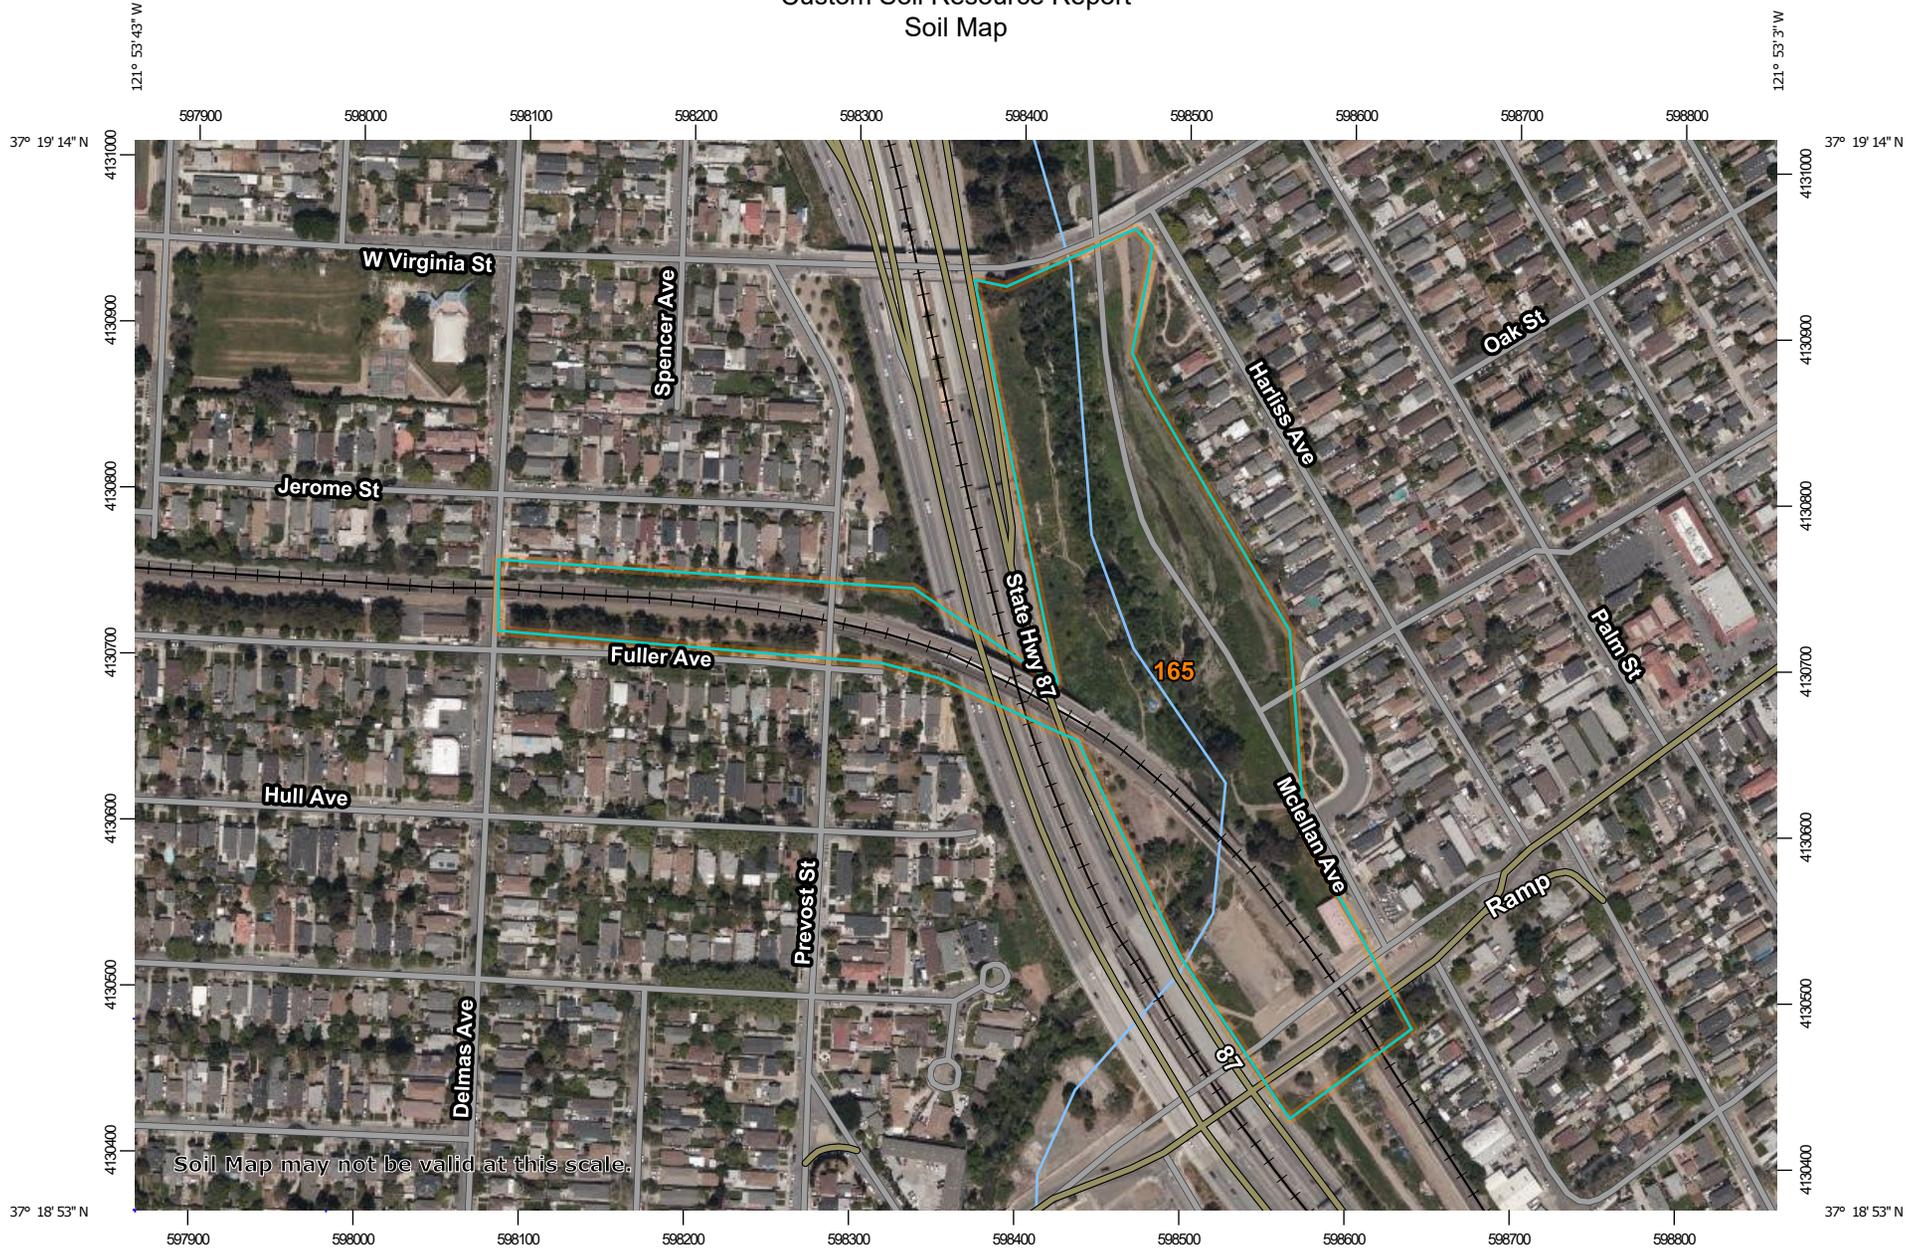
Custom Soil Resource Report Soil Map

Map Scale: 1:4,550 if printed on A landscape (11" x 8.5") sheet.

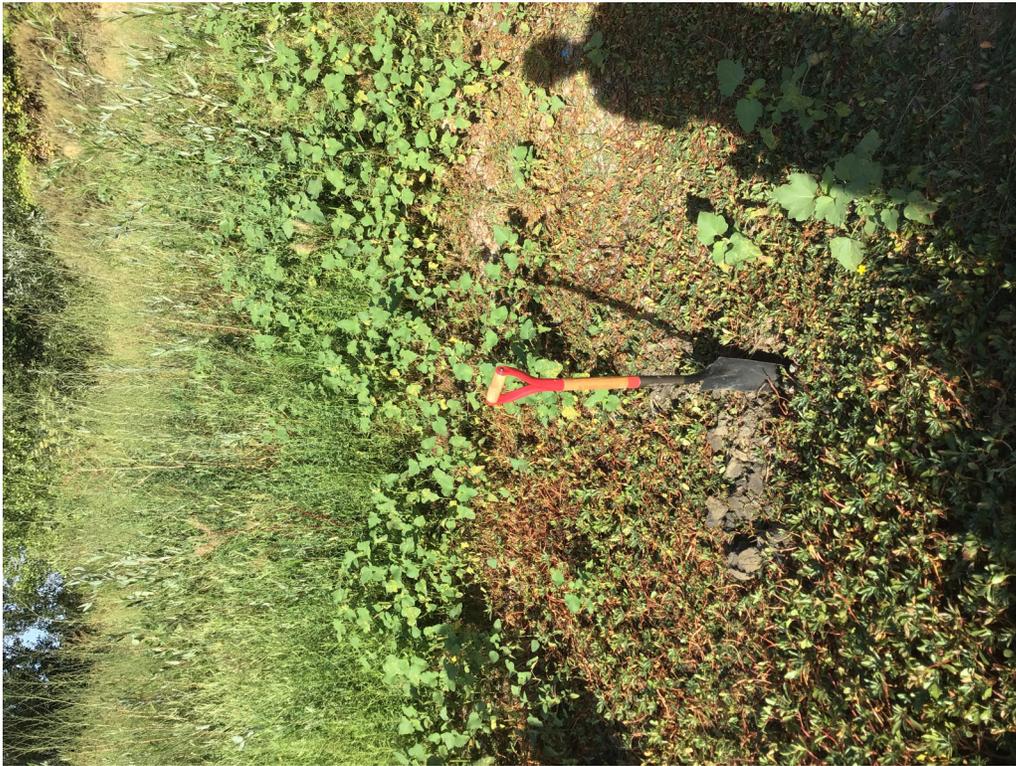
Depth (inches)	Matrix		Redox Features					Texture	Remarks
	Color (moist)	%	Color (moist)	%	Type ¹	Loc ²			
0-16	10YR	5/1	90	5YR	5/8	10	C	PL	Silty Clay

Soil very moist, likley evidence of recent inundation.

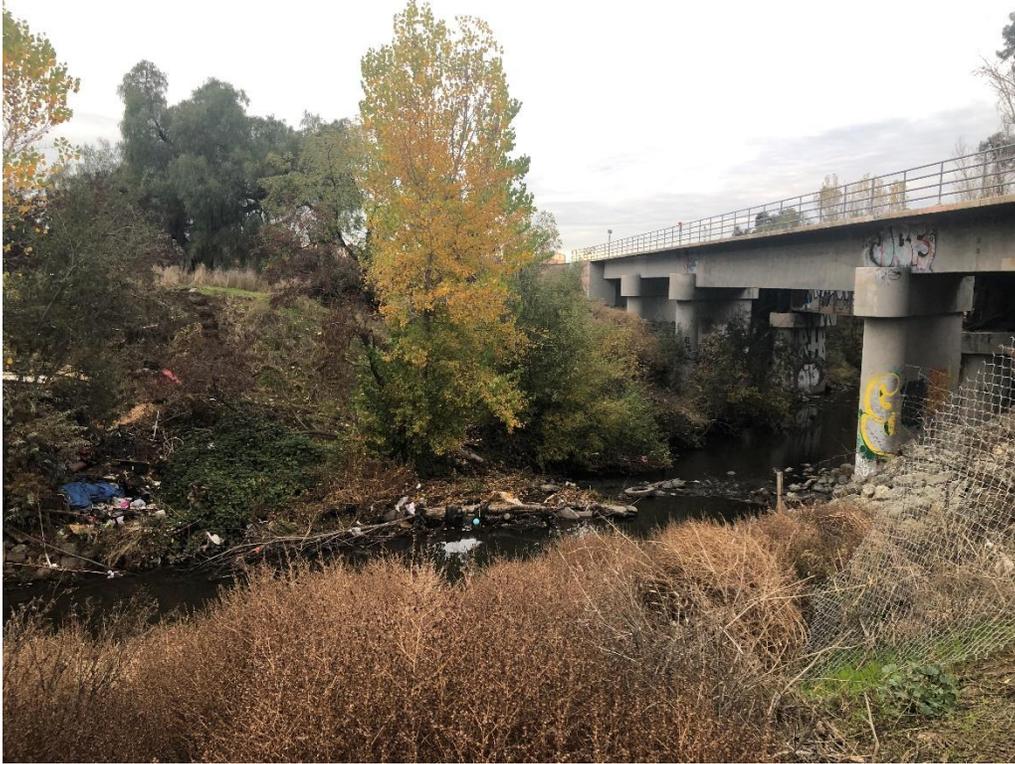
Photo 1. Looking downstream at Guadalupe MT-2 track bridge. Guadalupe River and associated riparian habitat are clearly visible.

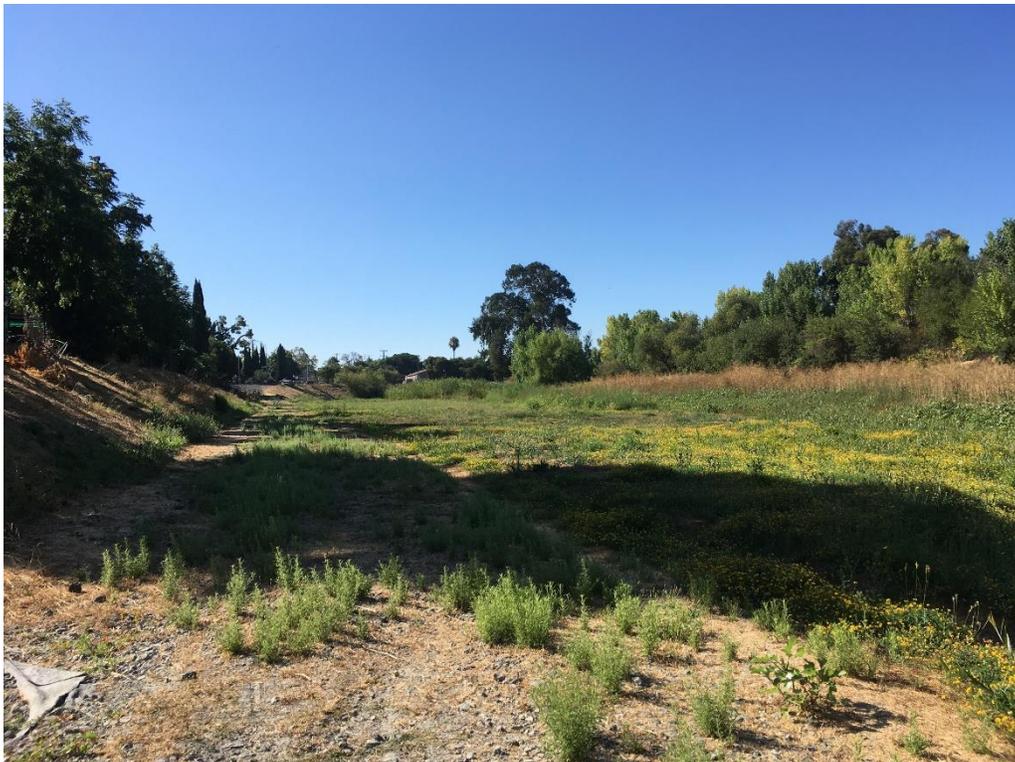
Photo 2. Looking south at the flood control basin. August 2020.

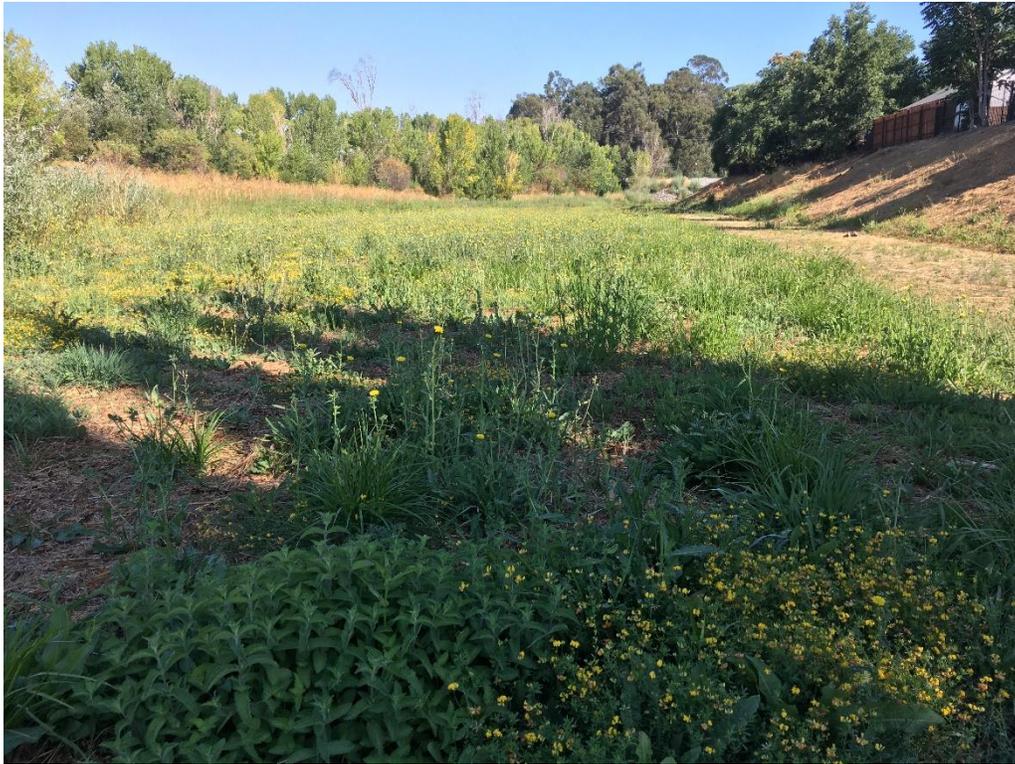
Photo 3. Seasonal wetland within the flood control basin. August 2020.

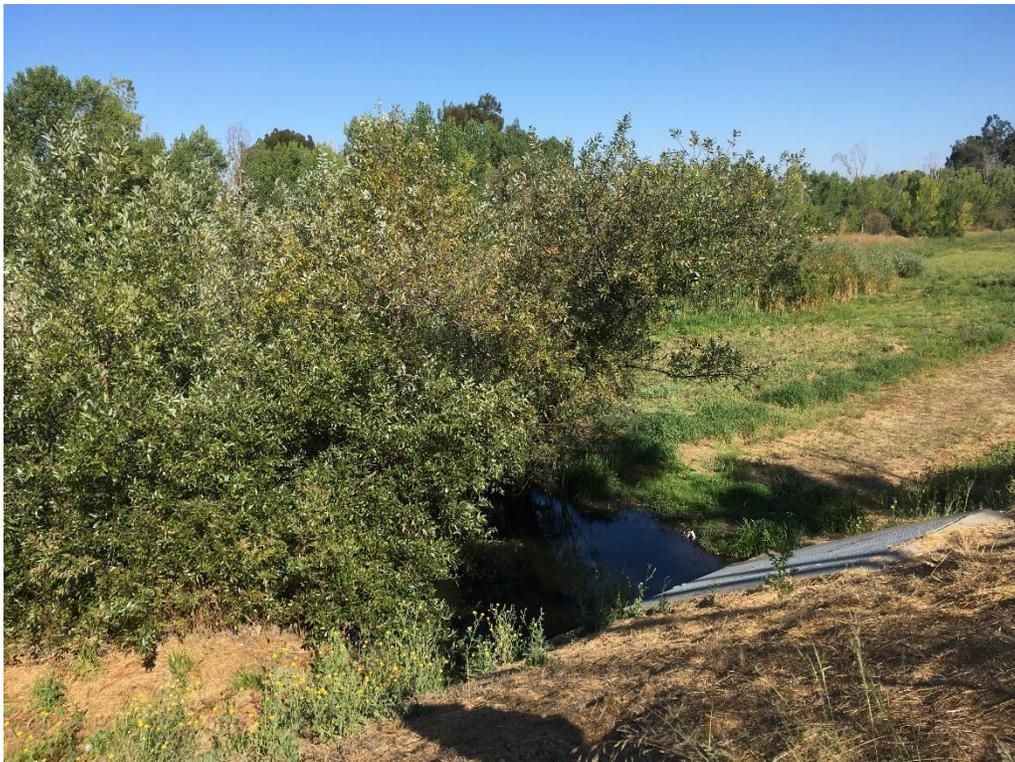
Photo 4. Perennial Wetland within the flood control basin. A large culvert empties into the basin from under Edwards Avenue at McClellan Avenue. August 2020.

Perennial Freshwater Marsh (PM-1). Perennial marshes are generally inundated or have high groundwater levels year-round or for extended periods, but surface water may be lacking during the summer and fall. Approximately 1.61 acres of perennial marsh was mapped within the flood control basin (PM1, Figure 7; SP2, Appendix C; Photo 4, Appendix D). The perennial marsh was mostly confined to a network of depressions within the flood control basin. The source of hydrology is surface flow from culvert C1 and likely from a high groundwater table. Standing water, up to 1 foot deep was observed at C1. Dominant species observed included broadleaf cattail, arroyo willow, water primrose, and rough cocklebur (*Xanthium strumarium*, FACW).

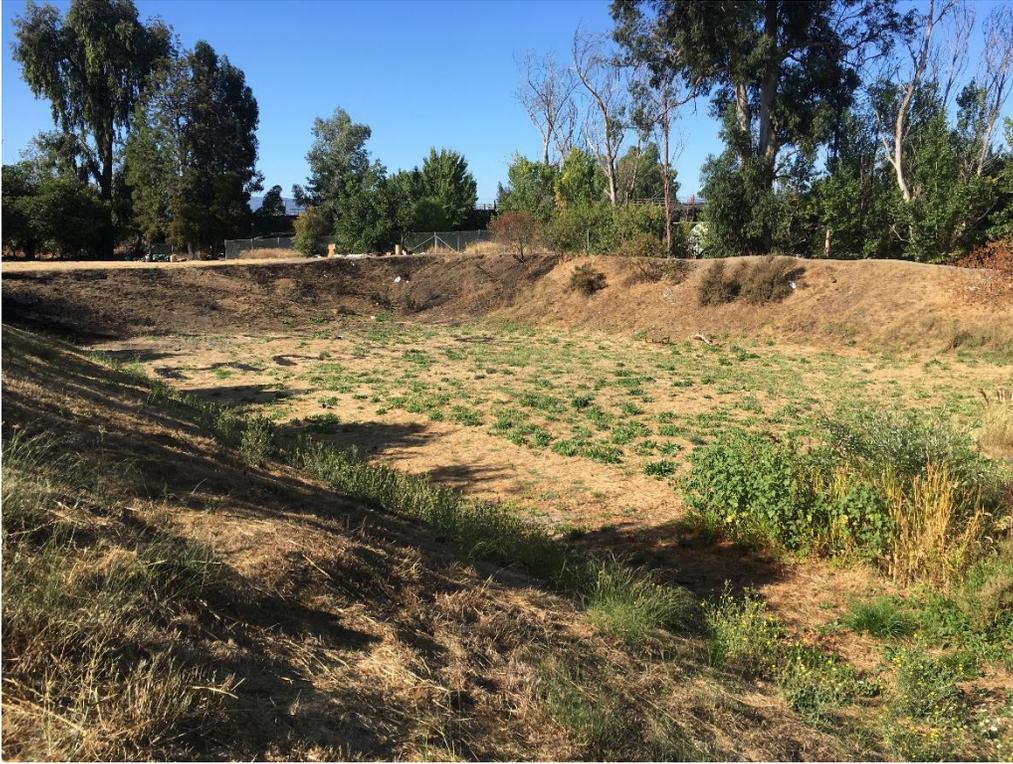
Photo 5. Flood control basin with annual grassland habitat along the banks. The area was recently mowed as indicated by the remaining thatch. The green vegetation in the bottom of the basin is a seasonal wetland. August 2020.

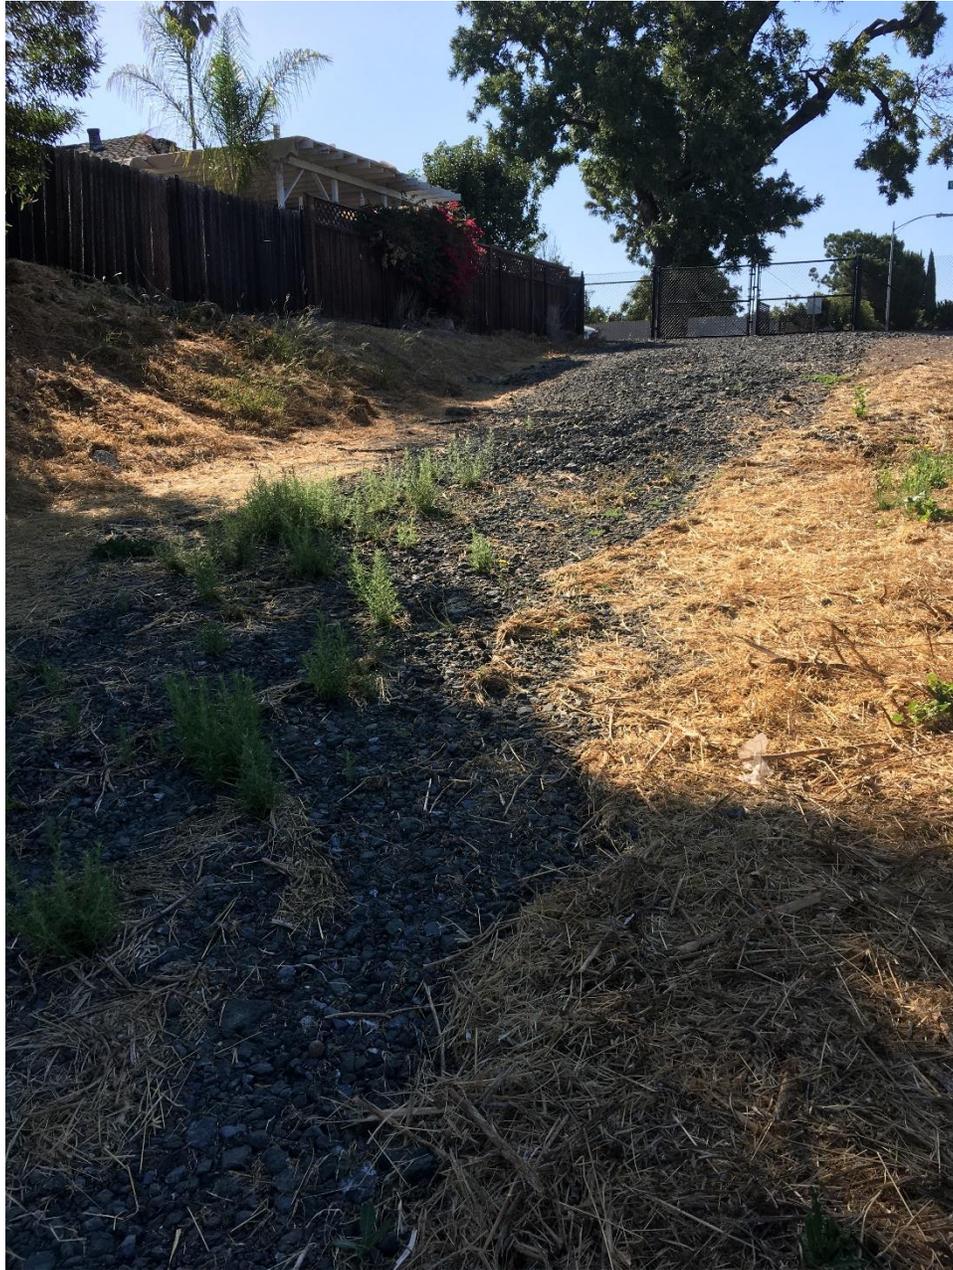
Photo 6. Gravel access road for flood control basin. This area was mapped as developed habitat.

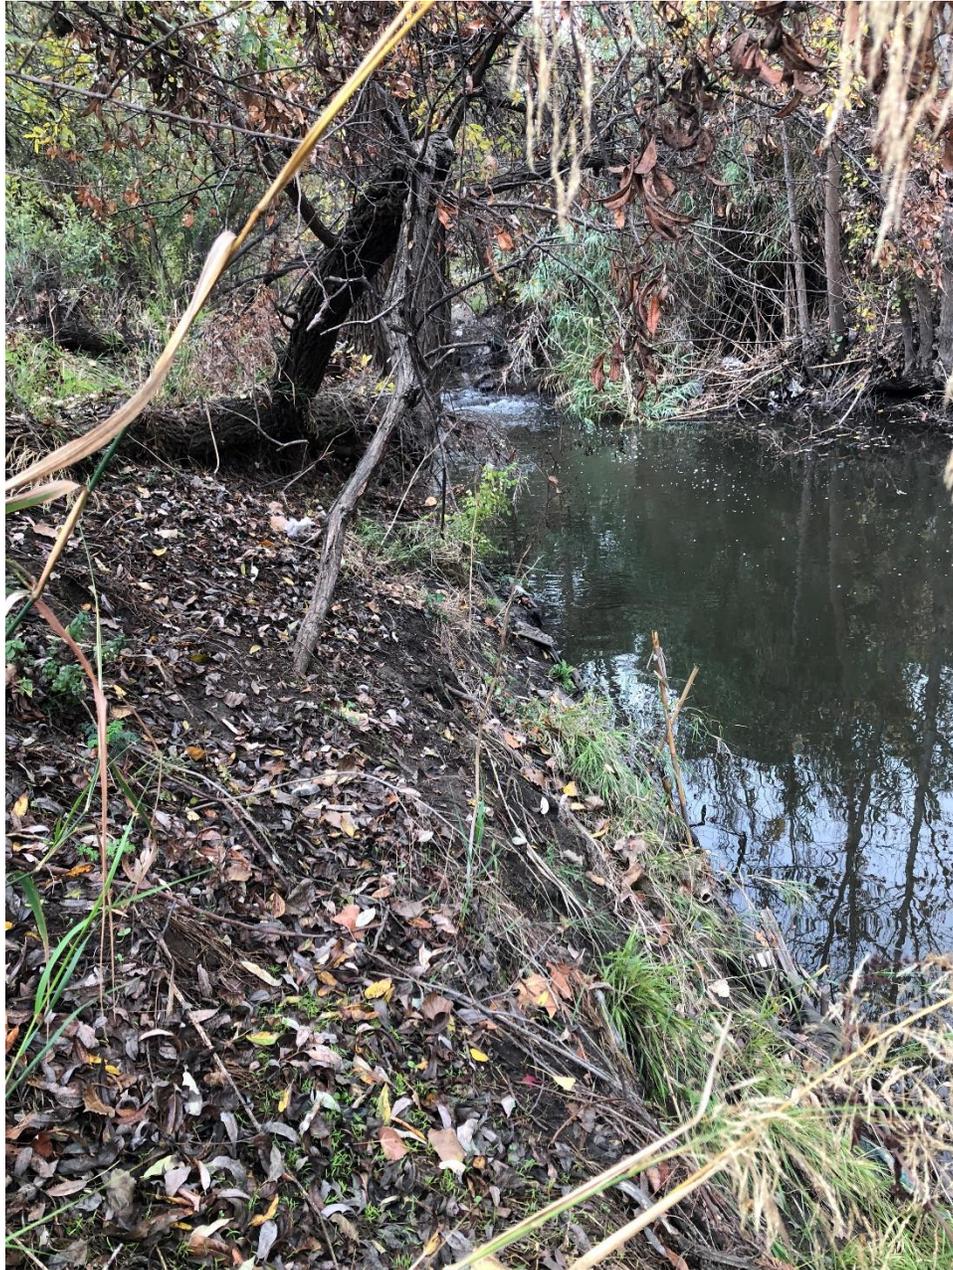
Photo 7. Guadalupe River. Aquatic and riparian habitat are clearly visible.
