Subject: Analysis of Potential Wetland Features in the Vicinity of Proposed Cannabis Cultivation at 11520 Tule Elk Lane, Santa Margarita, San Luis Obispo County, California

Photo Plate

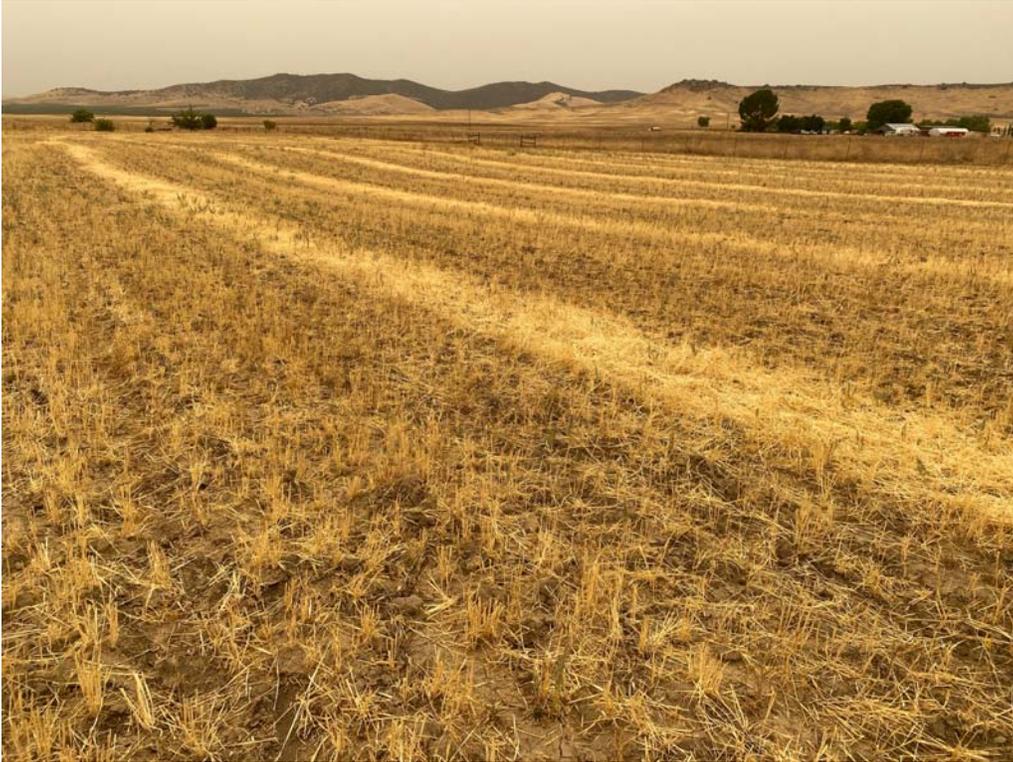
Photo 1. Northerly view of area to west of cultivation site mapped as a depressional wetland by PAX. While a slight topographic depression was still present, no indicators of wetland hydrology or a predominance of wetland plants was observed at this location.

The entire cultivation site and surrounding area was composed of dryland grains that had recently been harvested. The remaining hay crop consisted of topped grasses approximately two to four inches in height. The depressional wetland (circular feature) mapped by PAX to the west of the proposed Cannabis cultivation area was located and no wetland plants or indicators of wetland hydrology (i.e., water stained leaves, biotic or salt crusts, surface soil cracks, or sediment deposits) were observed. The hay crop had grown consistent throughout this area, which indicated saturated soils were not present during the growing season. Typically, where wetlands are farmed in this region, the grain crop performs poorly due to the seasonally saturated soils. In these types of agricultural settings, wetlands or areas of increased soil moisture can be identified based on bare soils, the lack or poor growth of the particular agricultural plant, and presence of agricultural weeds that are tolerant of wetter conditions. Please refer to the attached Photo Plate (Photos 1 and 2) for further information.

The circular topographic depression mapped as a wetland by PAX west of the cultivation site was still faintly evident in the dry farmed grain field, but as stated above, no indicators of saturated soils or wetland plants were present. Historic aerial photographs reviewed on Google Earth show this area appears to have supported saturated soils in the past with the last photo showing an area devoid of the grain crop being from 2016. It appears the ongoing grain farming activities, including regular disking and possibly periodic deep ripping, has increased the permeability of the soil at this location, resulting in a uniform hay crop during the 2020 growing season. Based on field observations from the site visit, this area was not functioning as a wetland, but as a non-wetland topographic depression that has adequate surface drainage to support a homogenous grain crop compared to its historic condition observed on Google Earth.

Field observations from September 2020 of the proposed Cannabis cultivation project on 11520 Tule Elk Lane, confirmed a circular area to the west of the cultivation site is not a wetland but a non-wetland topographic depression. This determination was based on the area not supporting any field indicators for wetland hydrology and absence of wetland plants. The consistent cover of the grain crop throughout this area also indicated no prolonged soil saturation during the growing season. While the Waters Addendum Figures prepared by PAX classified this area as a depressional wetland, it is not currently functioning as a wetland and is more accurately classified as a non-wetland topographic depression. As such, this area should receive a 50 foot setback similar to swales and riverine habitats consistent with County policy.

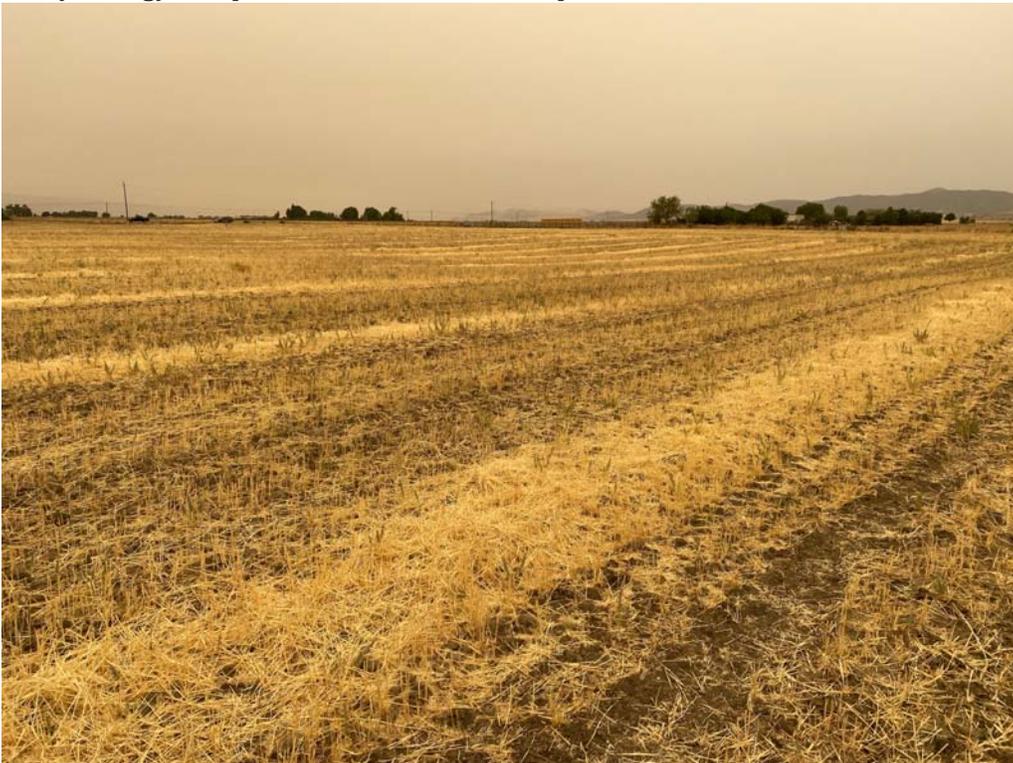
Photo 2. Southerly view of dryland grain crop in the area of the mapped depressional wetland west of the cultivation area showing no indicators of seasonal wetland habitat. Area is more accurately classified as a non-wetland topographic depression.

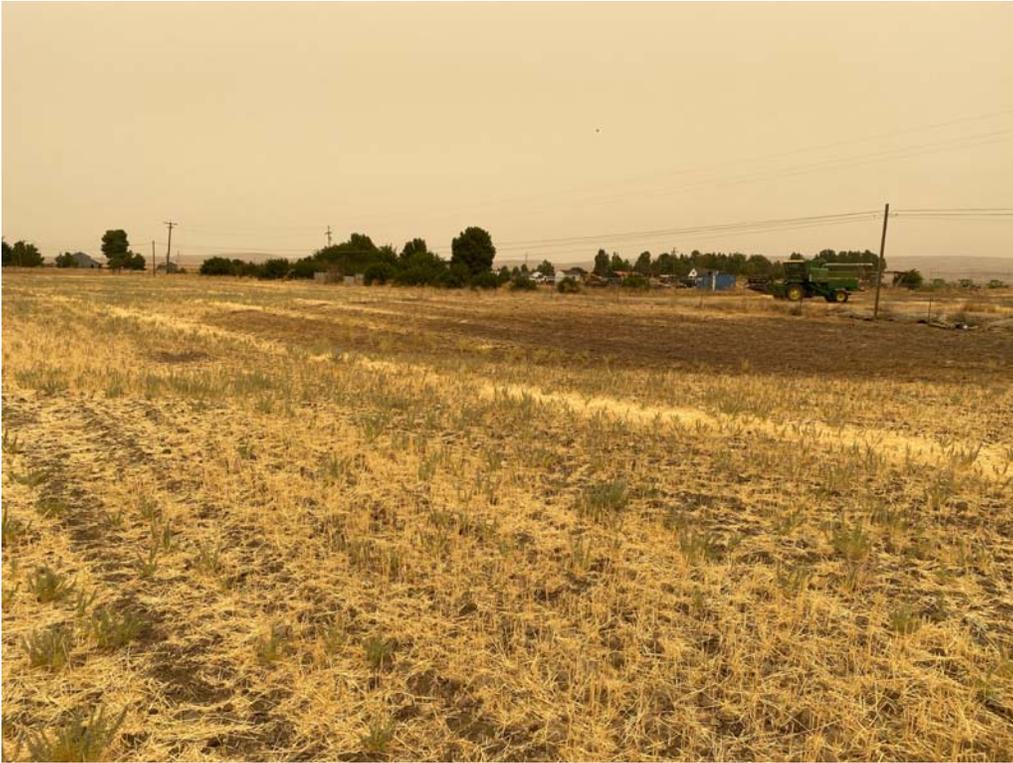
Photo 3. Northerly view of wetland formed from road impoundment of seasonal surface water in a swale complex. Note the bare soils where grain crop was not able to persist due to presence of saturated soils.

The second wetland feature in question is present along the entrance road to the site, which is southeast of the proposed Cannabis cultivation area. It appears to be part of an historic non-wetland swale/depression system that impounds seasonal surface water from construction of the road. The dryland grain crop was not present in this area because it could not grow due to the saturated soils. The entire feature consisted of bare soils with surface cracks and relatively consistent cover of wetland plants such as of toad rush (*Juncus bufonius*), wooly marbles (*Psilocarphus tenellus*) and alkali mallow (*Malvella leprosa*). A culvert is present under the road

and a smaller wetland feature is present on the east side as shown on the project site plans. Please refer to the attached Photo Plate (Photos 3, 4, 5, and 6) for conditions observed during the site visit. The outer limits of the wetland were delineated in the field using a GPS unit, which confirmed the extent of depressional wetland was accurately mapped on the project plans.

The larger depressional wetland along the existing road was confirmed to still be present in the same location and size depicted on the PAX Waters Addendum Figures. Wetland plants and positive indicators of wetland hydrology were observed in this area, thereby supporting it's classification as a depressional wetland. The wetland limits were delineated in the field to verify the extent of wetland habitat shown on the project site plans was accurate, and that project elements avoid impacts to this area. The depressional wetland should receive a 100-foot setback from the cultivation area compared to the 50 foot setback required for swales, non-wetland topographic depressions and riverine habitats.

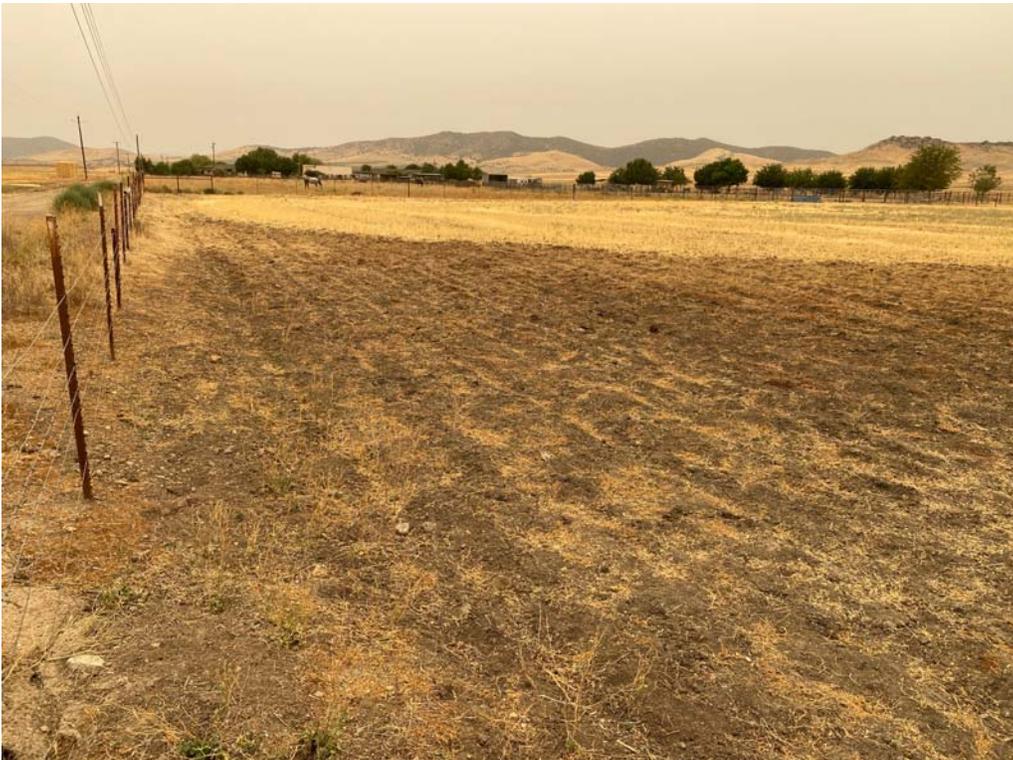
Photo 4. Southerly view of depressional wetland feature along entrance road composed of bare soils with surface cracks and scattered wetland vegetation still evident in September 2020.

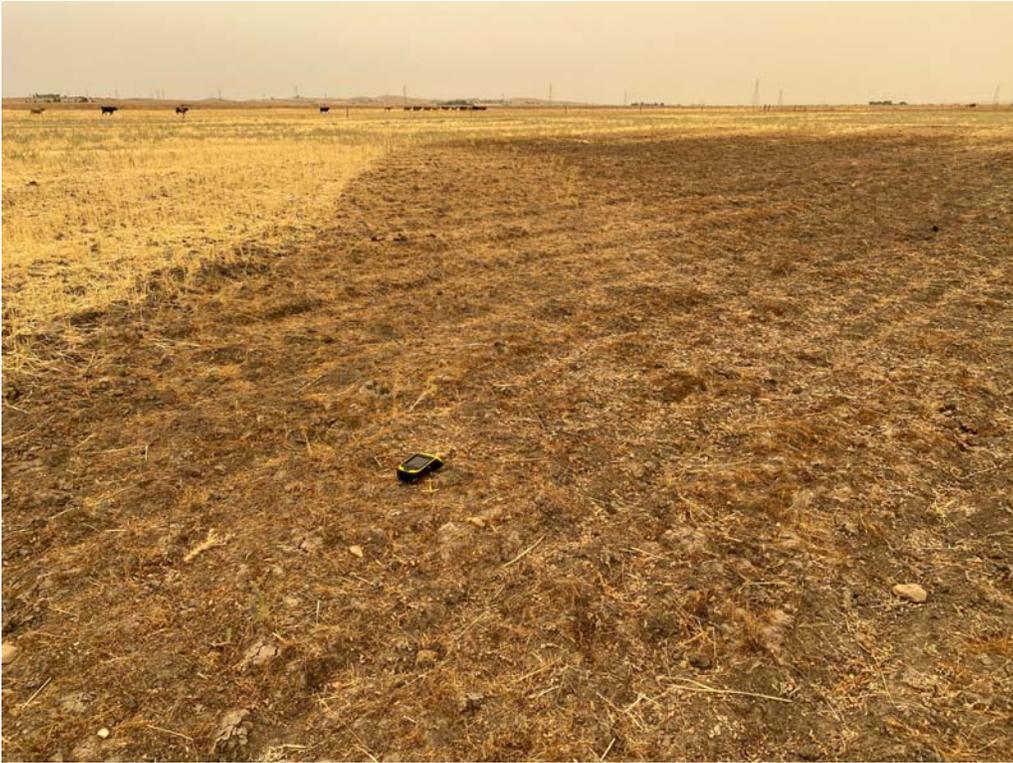
Photo 5. Representative view of depressional wetland feature at existing road showing line of grain crop where soils become saturated and wetland plants become dominant.

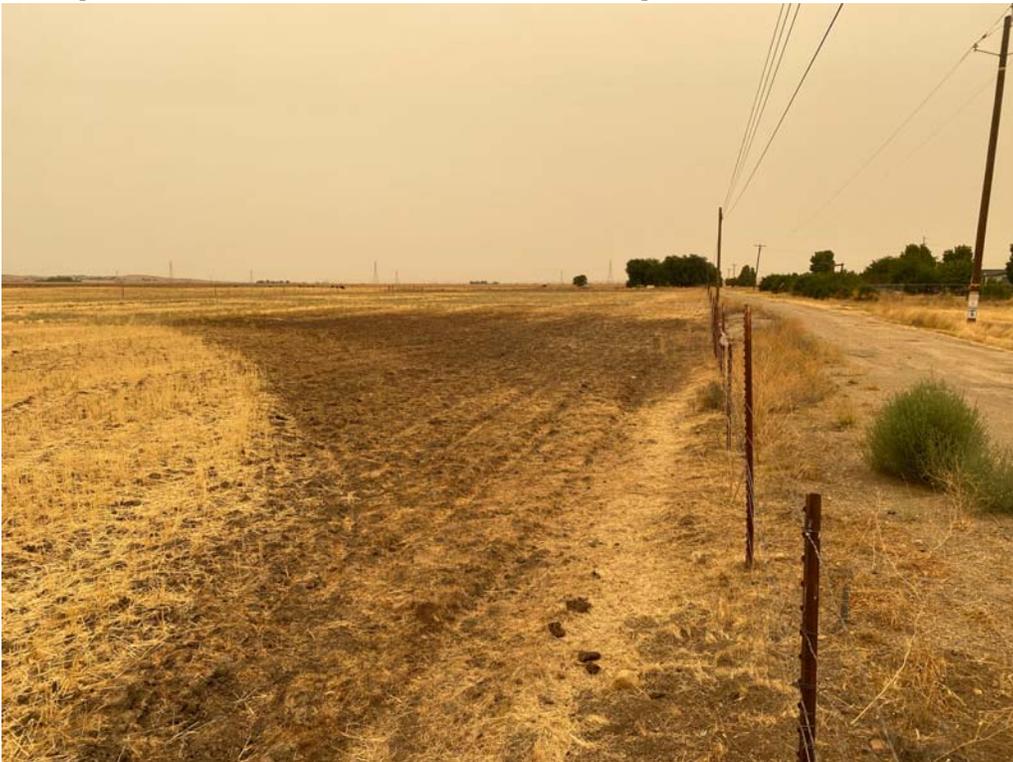
Photo 6. Pulled back view of the depressional wetland in relation to the road and dryland grain crop.
