FINAL Initial Study / Mitigated Negative Declaration

Eucalyptus Pruning

Carmel Area Wastewater District Wastewater Treatment Plant

April 2021

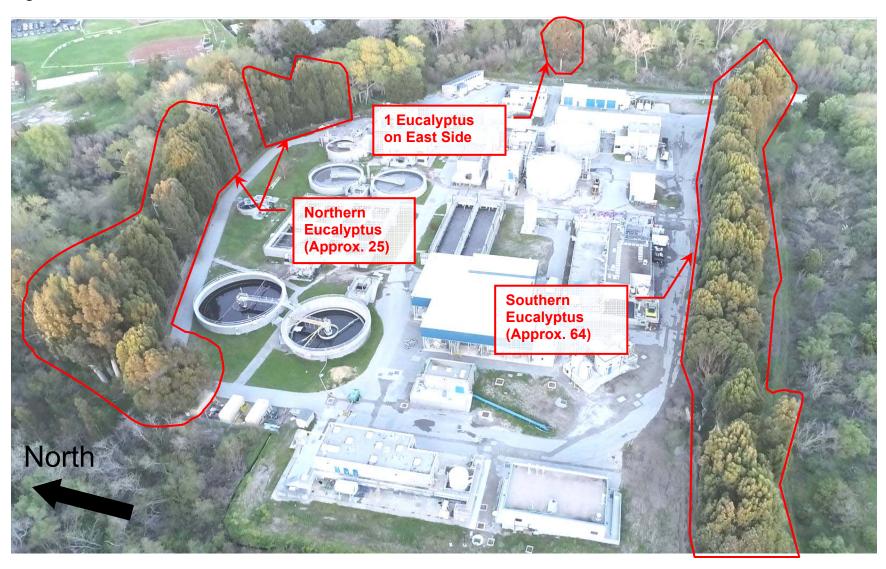
Figure 3: Aerial Photo

Figure 3 is an aerial photograph of the WWTP that shows the eucalyptus trees around the perimeter of the property that are proposed to be pruned. Figures 4, 5 and 6 show photos of the eucalyptus trees viewed from inside the WWTP property and also viewed from outside of the property.

The majority (about 64) of the trees are along the Southern property line as seen in Figure 3.

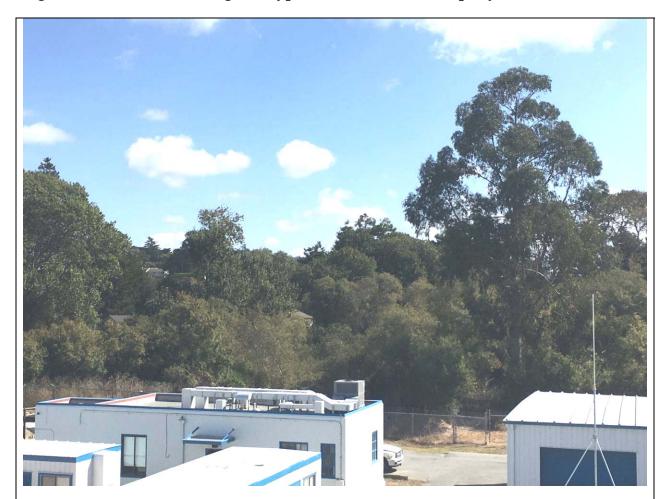
Figure 6: Photo of Existing Eucalyptus Tree at Eastern Property Line

There is one eucalyptus tree just East of the WWTP that would be removed as part of the project as it does not provide any visual screening. There is no development East of the WWTP that is at a high enough elevation to see the WWTP.

Photo 14: Taken from on top of an existing building inside the WWTP looking northeast at eastern property line. One eucalyptus tree is seen on East property line would be removed. Note that buildings can be seen in the distance through gaps in the existing trees.

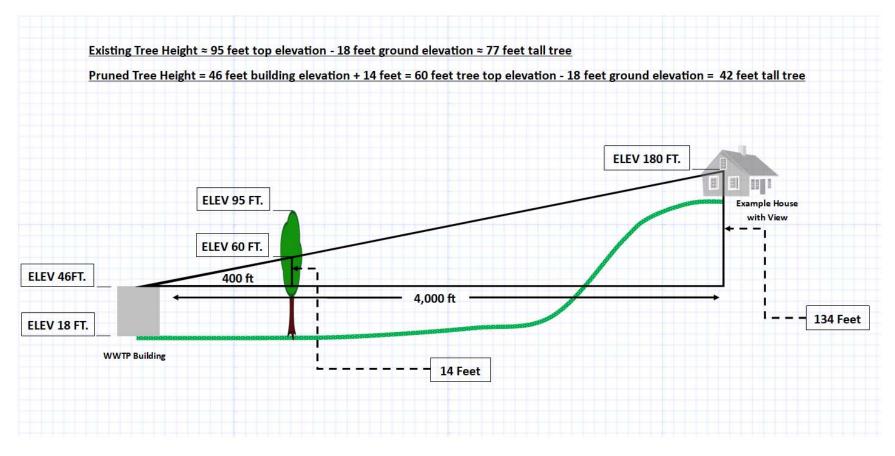
Figure 7: Line of Sight Analysis – From South of WWTP

Figure 7 illustrates the site line analysis looking from the South. A tree height of 42 feet is considered adequate to screen the WWTP from residences with a view from the South of the treatment plant.

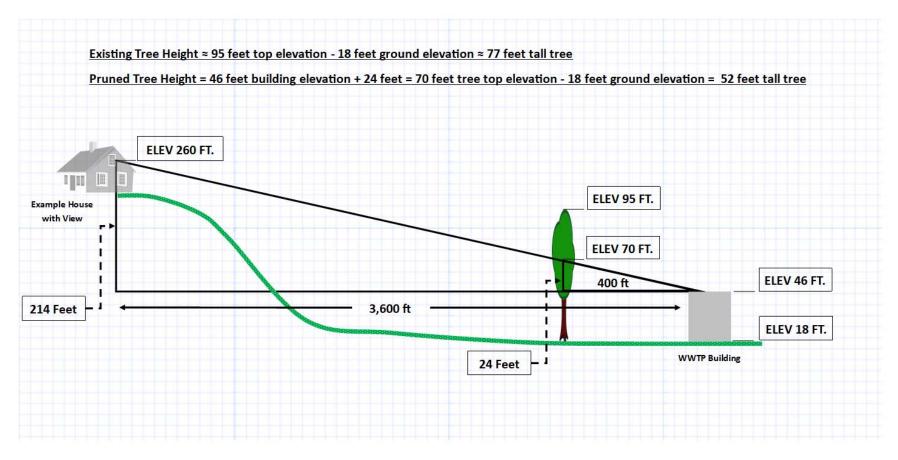
Figure 8: Line of Sight Analysis – From North of WWTP

Figure 8 illustrates the site line analysis looking from the North. A tree height of 52 feet is considered adequate to screen the WWTP from residences with a view from the North of the treatment plant. A significant portion of the North side of the treatment plant is screened by cottonwood trees and these trees will not be modified. There are no eucalyptus trees on the Northeast and East boundaries of the WWTP and there are existing "peekaboo" views of the WWTP through these areas (see Photos 9, 12, and 14).

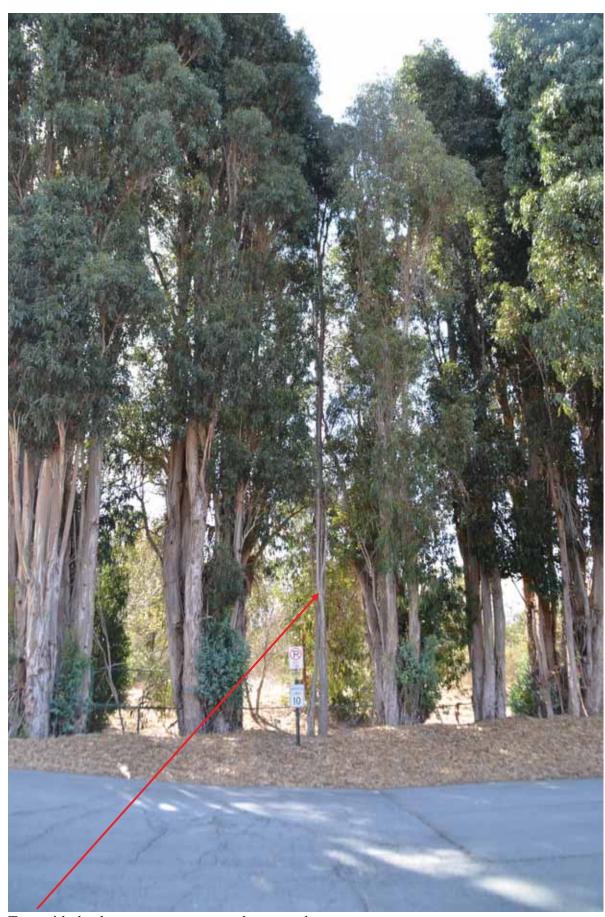
Tree with dead stem at entrance needs removal.

The smaller trees prescribed for removal on the property present significant risk for failure. The trees must be removed to prevent possible injury or property damage. The tree shall be cut down by a licensed insured professional tree service, cut down in smaller manageable pieces consistent with safe arboricultural work practices, and roped down carefully so as not to damage any surrounding trees. The use of specialized equipment can be authorized if it can be shown that no damage to surrounding ecosystem will be sustained. At no time shall the trees be dropped in one piece so as to damage any surrounding trees or property. Tree wood and clippings are to be disposed of consistent with California Department of Forestry guidelines which would include stockpiling of material on site or disposal at an approved refuse site.

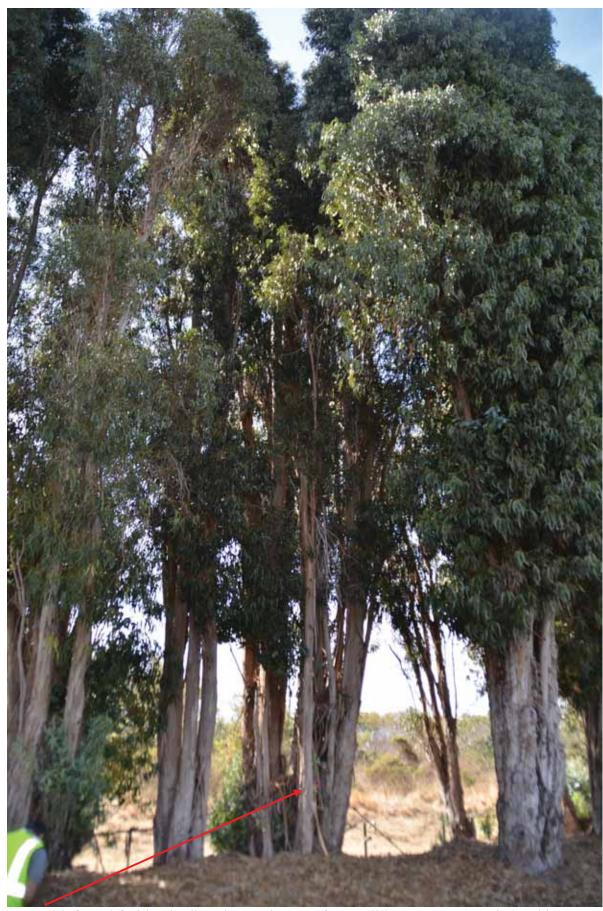
Additionally, several of the trees were also observed with fungal fruiting bodies in their stems. This fungus; Chicken of the woods (*Laetiporus gilbertsonii*) is usually found on dead material and is likely originating from previously cut branches or stems. The pathogen observed on the trees can invade live trees but does not constitute a significant risk in the trees which may be mitigated through pruning and monitoring.

Tree with fungal fruiting bodies observed across from solid waste conveyor belt. This should be monitored

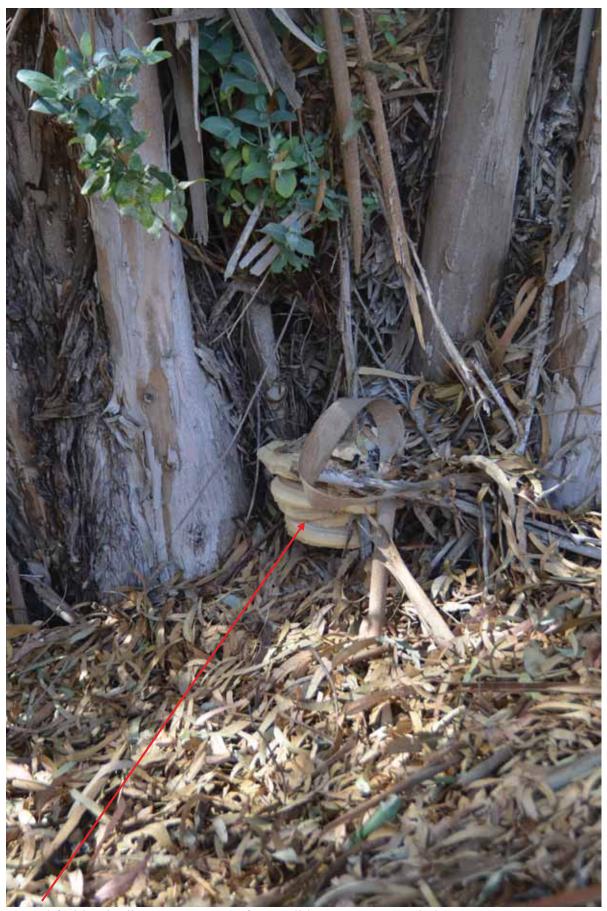
Fungal fruiting bodies on tree across from solid waste conveyor belt.

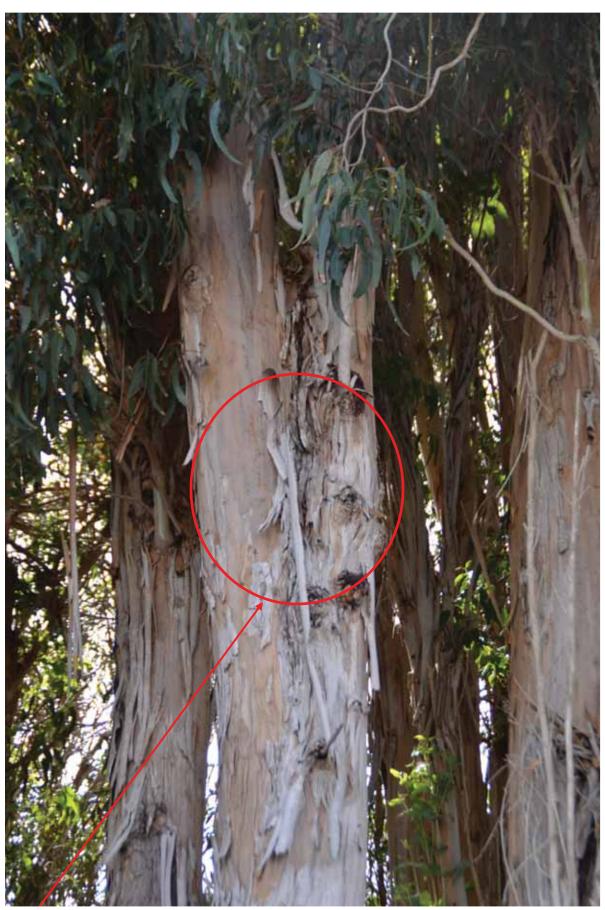
A number of trees have included bark at unions; this one appears to be separating and need attention

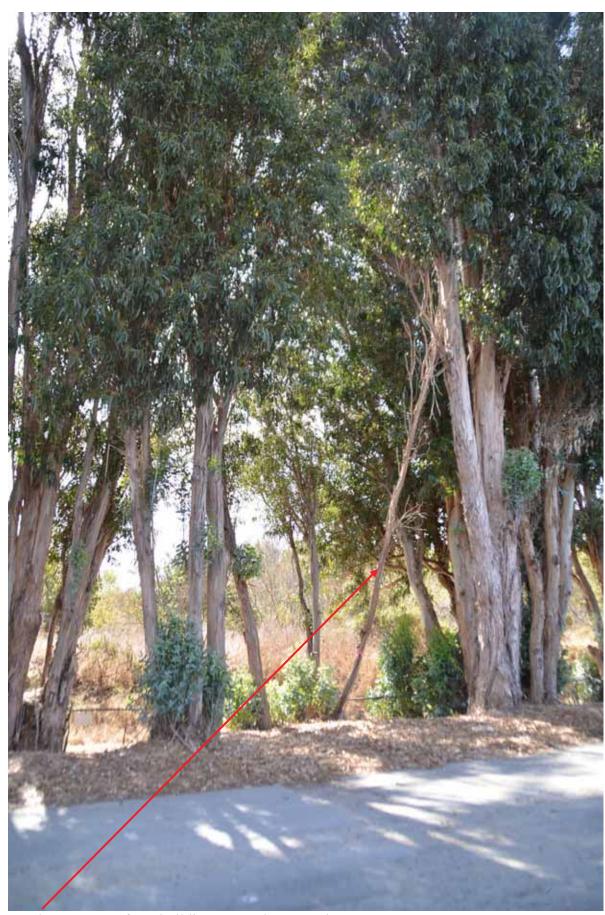
Dead stem across from building 15 needs removal.

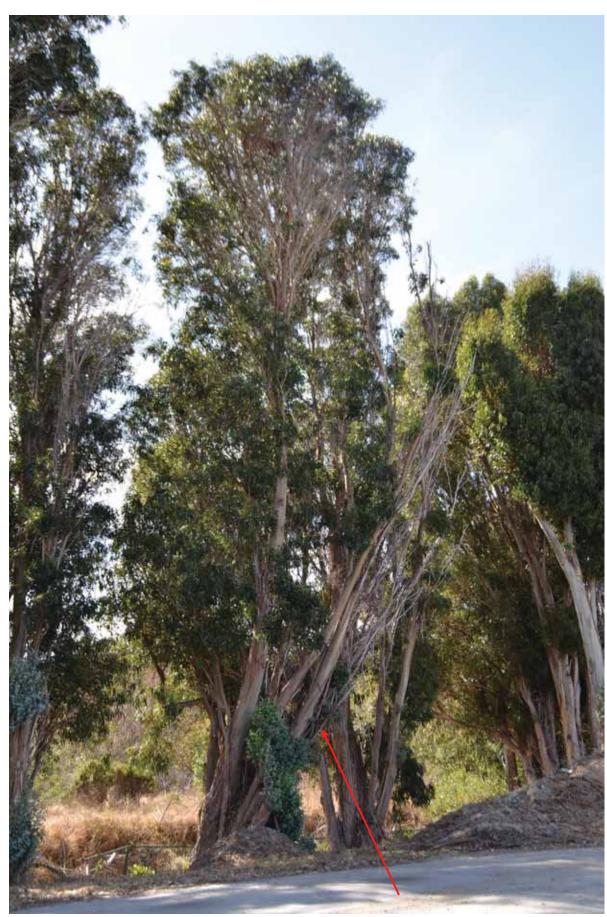
Tree with a corrected lean located across from sodium bisulphate tanks. The tree will need the right side of its crown removed to the base

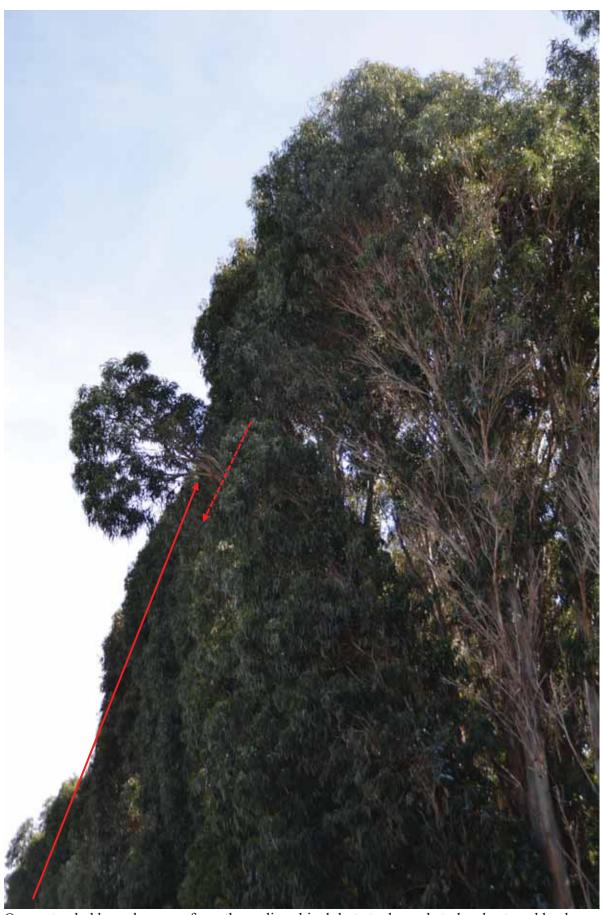
Overextended branch across from the sodium bisulphate tank needs to be shortened back.

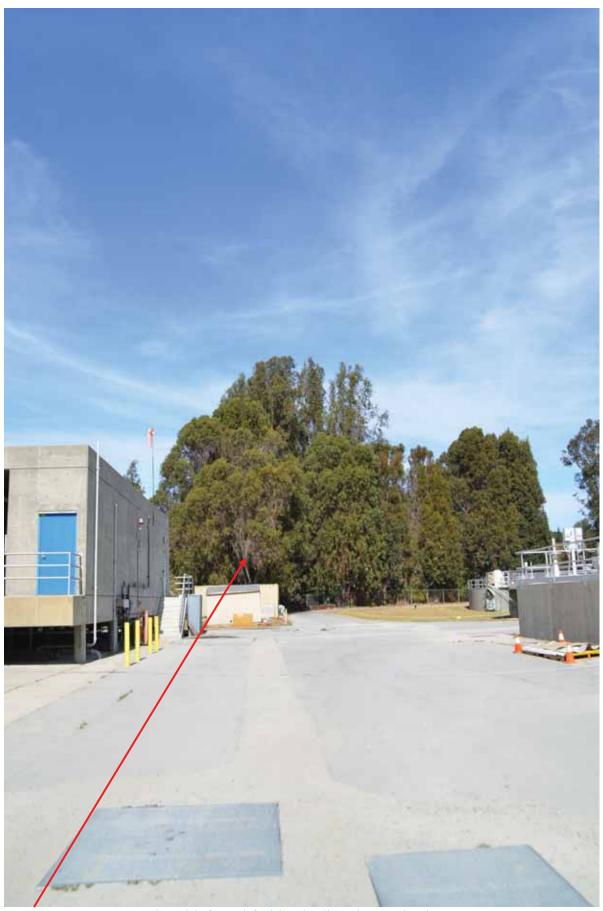
Tree next to storage tanks with fungal fruiting bodies observed at base.

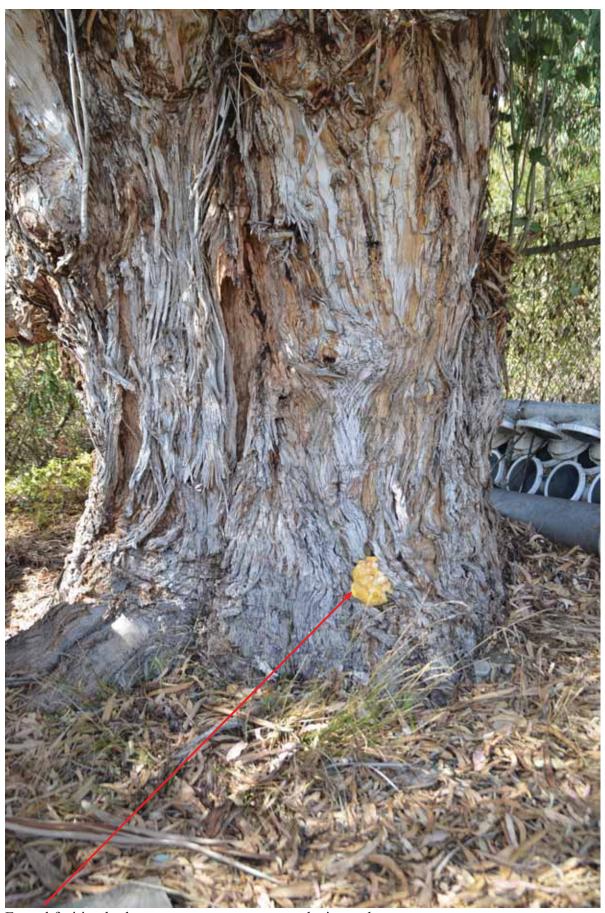
Fungal fruiting body on tree next to storage tanks in northwest corner.

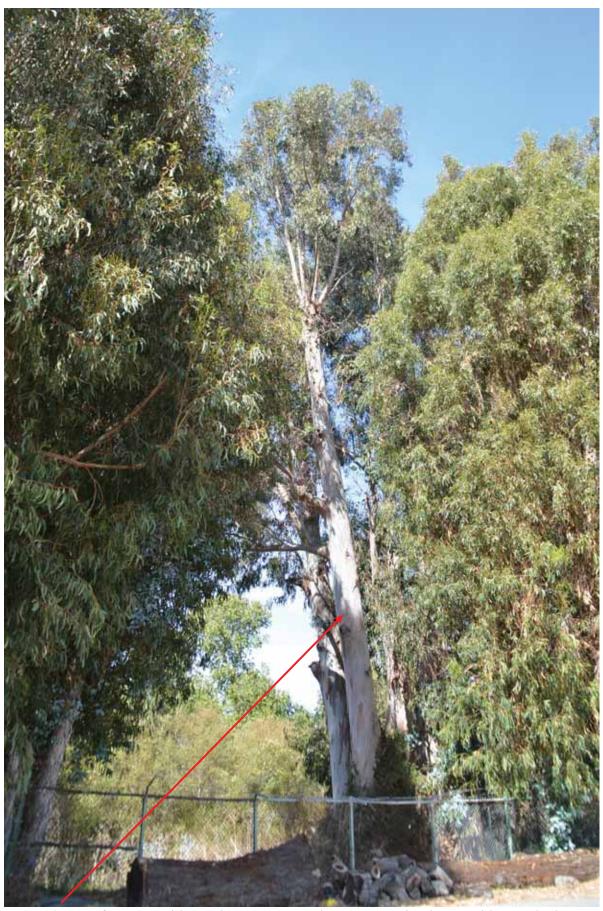
Large cluster of trees outside northwest corner. The upper portion has weakly attached branches prone to breakage

Pruning of the tree will entail crown reduction to one third the tree height and entail deadwood removal down to 1-1/2" in diameter, crossing limbs where practical, clearances for access points and fences where needed, weight reduction on long heavy limbs and selective removal of interior growth. This does not completely remove all interior growth. Re-growth of the limbs of pruned eucalyptus trees will be very high in the first years, however, growth will be mainly vertical, and the new branches should not put on the significant diameter growth necessary for damage until three to five years from old pruning. Inspections of other limbs over the wastewater compound should be made during the pruning. Periodic monitoring and pruning should also occur every three to four years depending on the concerns of the district underneath the trees. All tall trees (both Eucalyptus globulus and Eucalyptus globulus compacta) should also be crown cleaned to allow better movement of wind through the canopy and help decrease breakage during storms. During this pruning event all broken, torn, cracked or weakly attached branches discovered should be removed for safety.

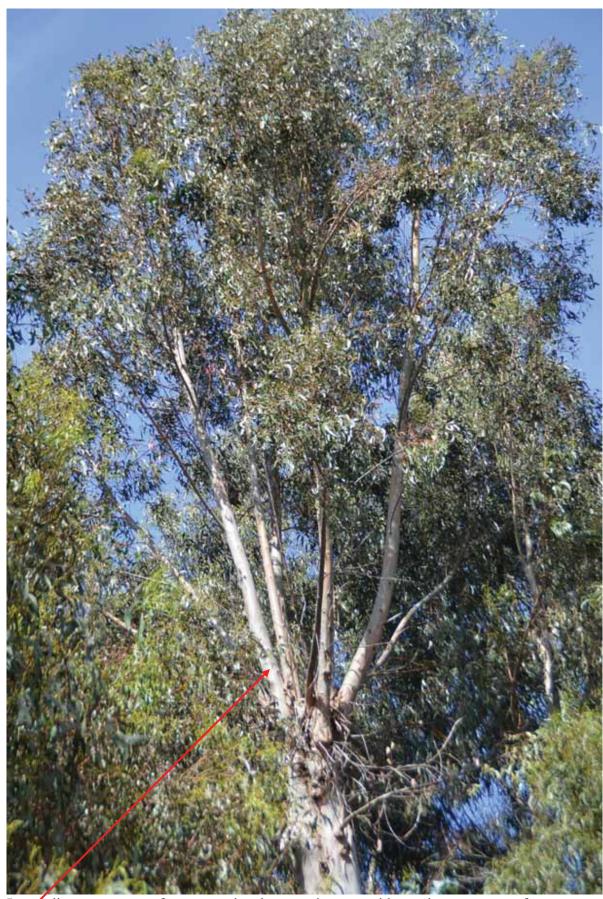
The Eucalyptus trees have been entered into a cycle of heading cuts that will need to be repeated to avoid failure of weakly attached new growth. In the past the trees were reduced to approximately 1/3 or more of their current height. The new sprouts that formed from these heading cuts do not originate from the center of the tree like normal branches but are instead formed in the cambial layer just underneath the bark. This produced new epicormic growth which is much weaker and prone to breaking and failing during windstorm events.

Largé diameter sprouts from a previously topped tree outside northwest corner of property.

The management of the eucalyptus should include a program where trees should be crown reduction pruned back to old heading cuts on a three to five-year cycle. Overall, they may be reduced by one third through the use of a mixture of thinning and some heading cuts. Pruning limb cuts of the eucalyptus should be performed down to the area where the old cuts previously made to minimize the occurrence of weakly attached epicormic sprouts and decrease entry points for decay in old branch stubs. Limb diameters will vary dependent on the parent stem of the limb for reduction.

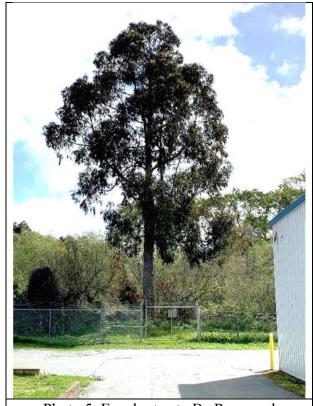
Photo 5: Eucalyptus to Be Removed

In the one location where a tree will be removed, the base of the tree is about 40 feet from the fence. A small walking trail might be used to access the base of the tree from the existing gate, but most of the access will still be by manlift parked on the paved road. Tree material would be lifted by crane to the road for processing prior to removal (See Photo 5).
