## MEMORANDUM

**SUBJECT:** **SUPPLEMENTAL WETLAND DELINEATION STUDY  
685 AVIATION BLVD., SANTA ROSA (APN 059-340-056)**

**DATE:** AUGUST 27, 2020

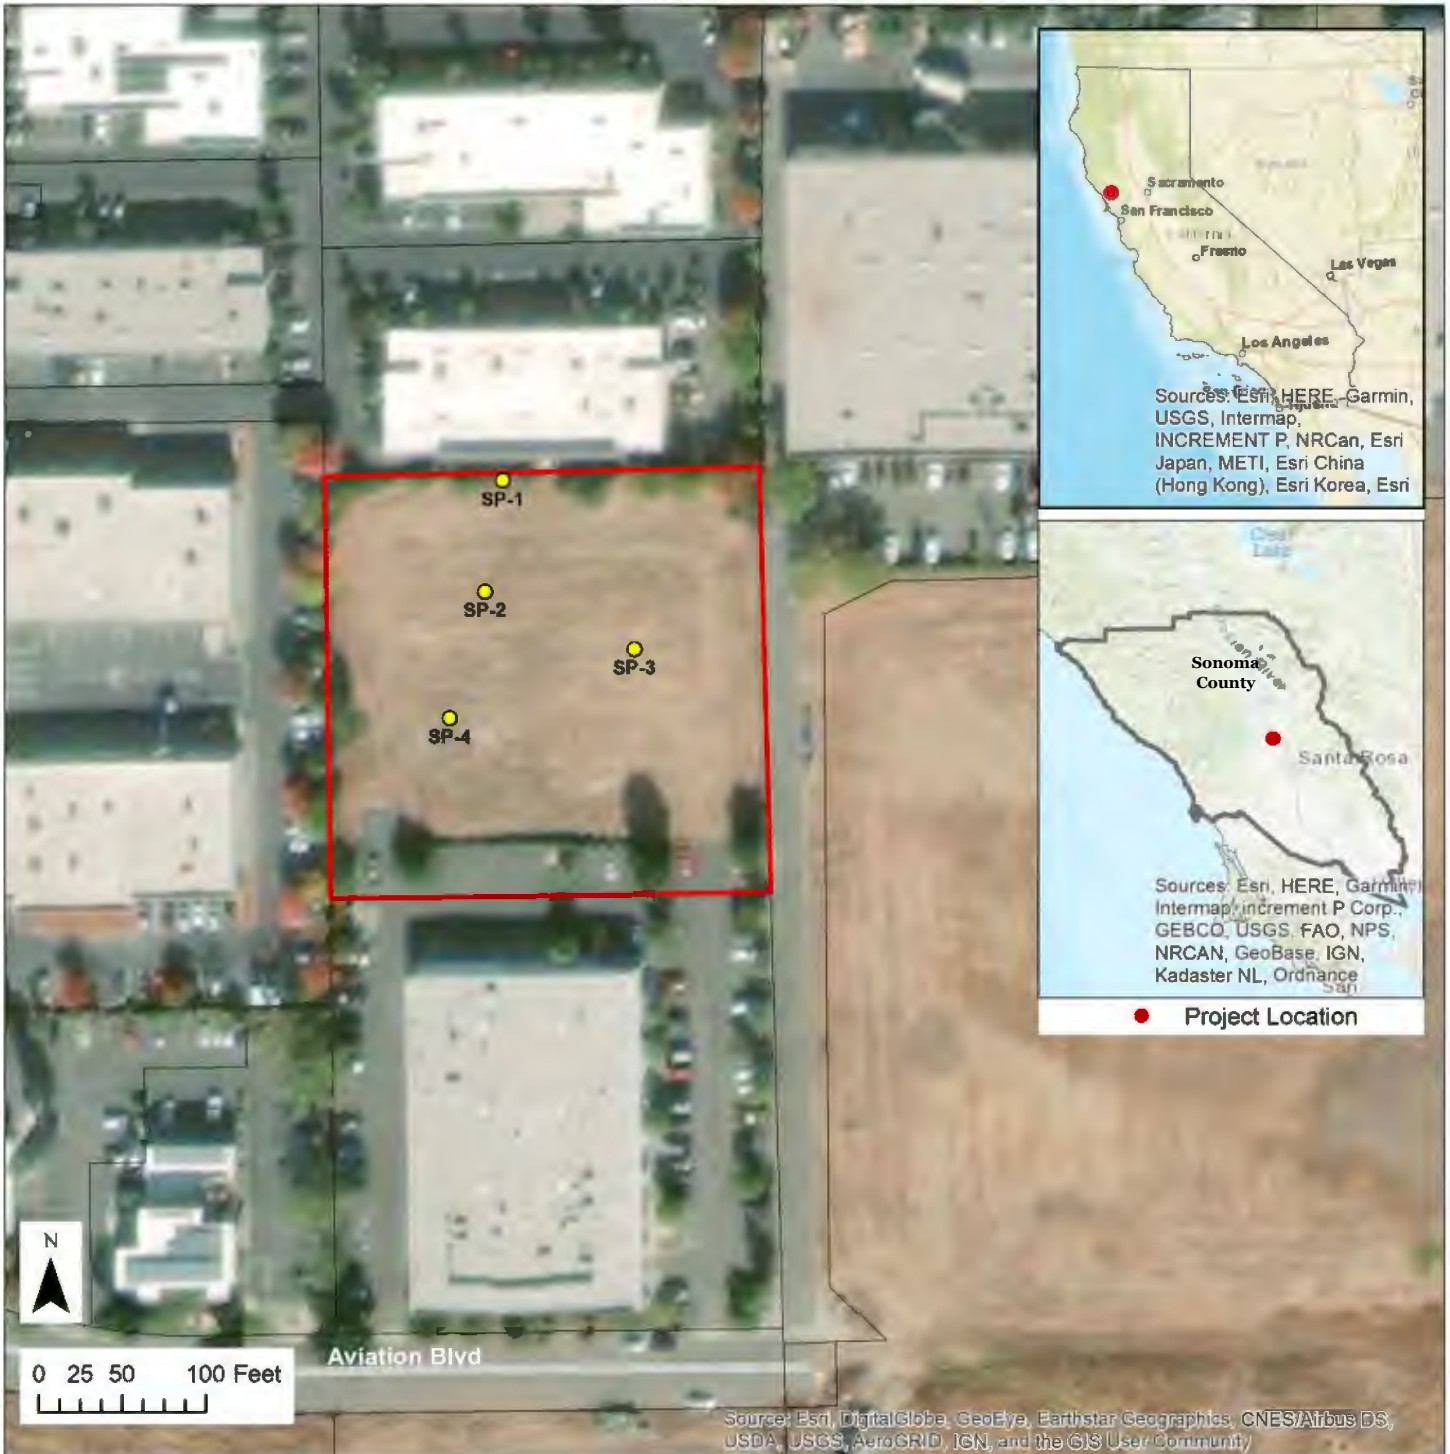
# Figure 1: Location of Project Area

685 Aviation Blvd, Santa Rosa, CA

- Project Study Area
- Parcel Boundaries
- Roads and Streets
- Sample Point

1. Sol Ecology performed plot-based sampling in mapped uplands where County staff determined that wetlands may be present, in areas where very slight topographic depressions exist, or where discernible changes in vegetation were observed during the site inspection. Although the property had been recently mowed, vegetation communities remained visible and were able to be sampled. Plant species were able to be identified and % cover for each species in the sampling plots was able to be determined. It was therefore concluded that normal circumstances were present at the property during the study. No positive indicators of wetlands were found in the sample plots. Vegetation communities were found to include predominantly upland species, including *Phalaris aquatica* (FACU), Harding's grass; *Bromus hordeaceus* (FACU), soft brome; *Acmispon americanus* (UPL), deerweed; *Convolvulus arvensis* (NL), bindweed; *Sonchus oleraceus* (UPL), common sow-thistle; and *Medicago polymorpha* (FACU), toothed medic. Some hydrophyte species were observed in limited distribution in the dark stain area that can be seen in recent aerial imagery near the center of the site; these species included *Centromadia pungens* (FAC), pungent false tarplant; *Plantago lanceolata* (FAC), English plantain; and *Rumex crispus* (FAC), curly dock. However, a predominance of hydrophytic vegetation was not observed (i.e., the Hydrophytic Vegetation Basic Rule was not met) in the sample plot that was located in the dark stain area visible in the aerial imagery.
