Hallmark-Barham Specific Plan EIR
Technical Appendices

Appendix E.4
Jurisdictional Findings

Memorandum

Subject: Jurisdictional Findings for 943 Barham Drive Project Site, San Marcos, CA

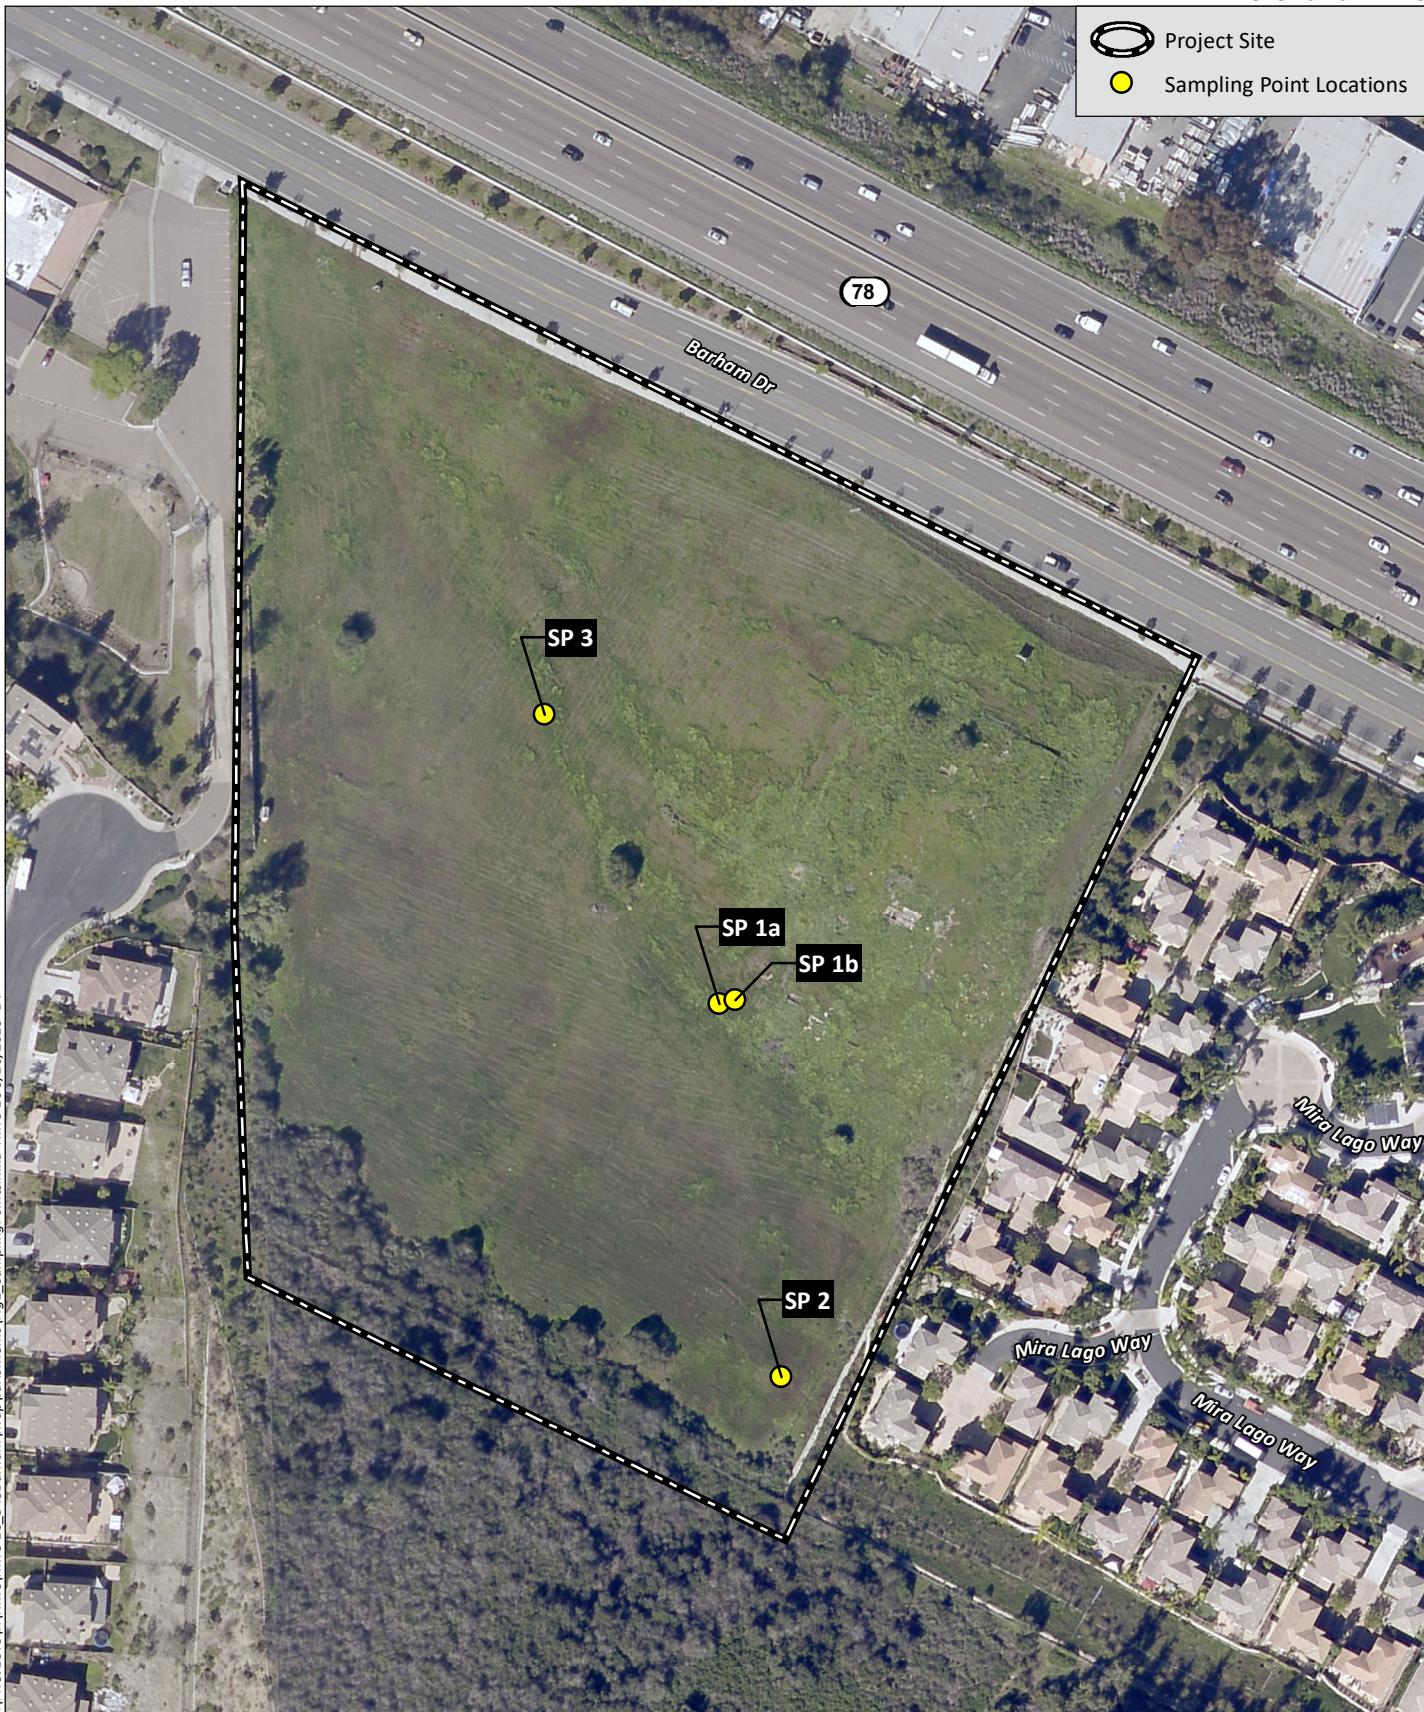
Figure 1 Sampling Point Locations
Attachment A Sampling Point Photos
Attachment B Wetland Determination Data Forms

Four sampling points were studied, and soil pits were excavated at each of these locations. Photographs taken of the sampling points are included in Attachment A. Standard USACE wetland determination data forms were completed for each sampling point in the field, and are included in Attachment B.

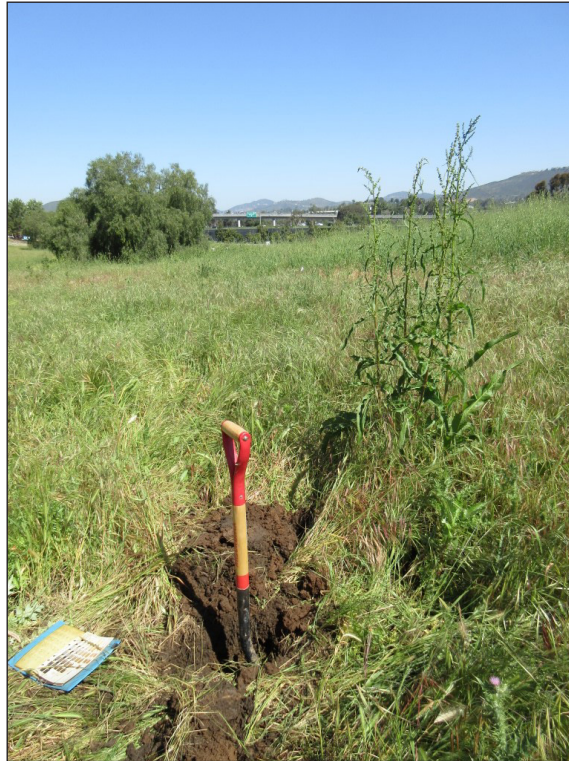
Photo 1. Looking north at Sampling Point (SP-) 1A taken April 24, 2020 in the central portion of the site. SP-1A is in a low area within non-native grassland; it did not meet USACE, RWQCB, or CDFW wetland criteria.

Sampling Point 1A was taken in a low area of non-native grassland in the central portion of the site. Rippgut grass (*Bromus diandrus*), an upland species, was the dominant species present, thus the hydrophytic vegetation criterion was not met. A soil pit excavated to 19 inches did not reveal the presence of hydric soil indicators, thus the hydric soil criterion was not met. No secondary or primary indicators of wetland hydrology were observed; thus, the wetland hydrology criterion was not met. This sampling point did not meet any of the three wetland criteria for the USACE or RWQCB, nor is it a CDFW wetland or riparian habitat.

Remarks:
 Upland vegetation is dominant. Sampling point taken here because it was a low area (landscape position suitable for wetland) supporting a few Rumex crispus (a FAC species). Area is dominated by upland vegetation (= non-native [annual] grassland) and does not support a dominance of hydrophytic vegetation.

No hydric soil indicators present.
 Observed pillbugs and earthworms in excavated soil, and pocket gopher mound 5' from pit.
 Photos 1-7

No primary or secondary hydrology indicators observed. Soil moist with saturation at 14" and water table at 18" during the growing season during a normal rainfall year, but with much higher than average rainfall in the weeks leading up to the site visit (i.e., in March [5.7" while 2.5" is normal] and April [6.8" while 1.0" is normal]). Saturation and water table observations did not satisfy the hydrology indicators as they were deeper than 12" from the surface in the growing season. Saturation and water table observed below 12" likely related to high rainfall in March and April, and location of the pit in the lowest area near convergence of two slopes. FAC-Neutral test: W:U=0:1 (negative).

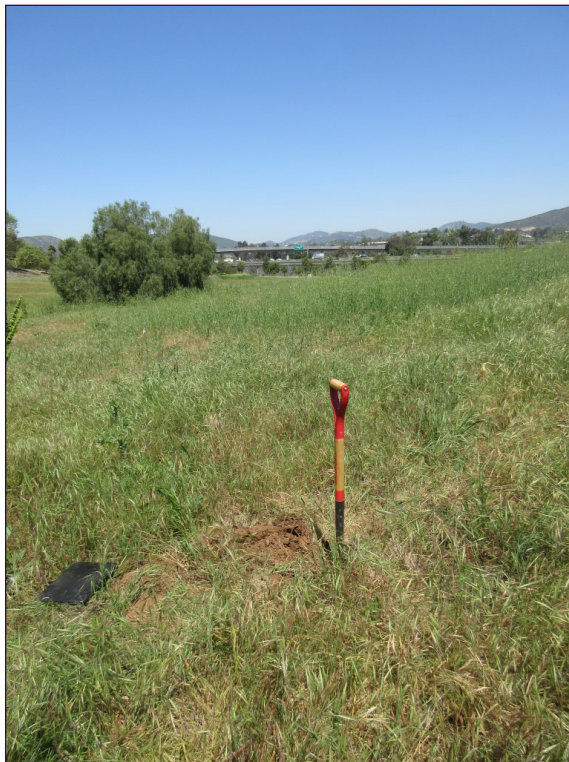
Photo 2. Looking north at SP-1B taken April 24, 2020 in the central portion of the site. SP-1B is near SP-1A but located slightly upslope and to the east. This SP is non-native grassland; it did not meet USACE, RWQCB, or CDFW wetland criteria.

Sampling Point 1B was taken in non-native grassland in the central portion of the site, near to and upslope of Sampling Point 1A. Two upland species: rippgut grass and oats (*Avena* sp.), were the dominant species present, thus the hydrophytic vegetation criterion was not met. A soil pit excavated to 18 inches did not reveal the presence of hydric soil indicators, thus the hydric soil criterion was not met. No secondary or primary indicators of wetland hydrology were observed; thus, the wetland hydrology criterion was not met. This sampling point did not meet any of the three wetland criteria for the USACE or RWQCB, nor is it a CDFW wetland or riparian habitat.

Remarks:
 Area is dominated by upland vegetation (= non-native [annual] grassland).

No hydric soil indicators present. Soil moisture likely due to much higher than average rainfall in March and April, and landscape position near the bottom of two converging slopes. Pocket gopher mounds near pit.
 Photos 12-14

No primary or secondary hydrology indicators observed.
 FAC-Neutral test: W:U=0:2 (negative).

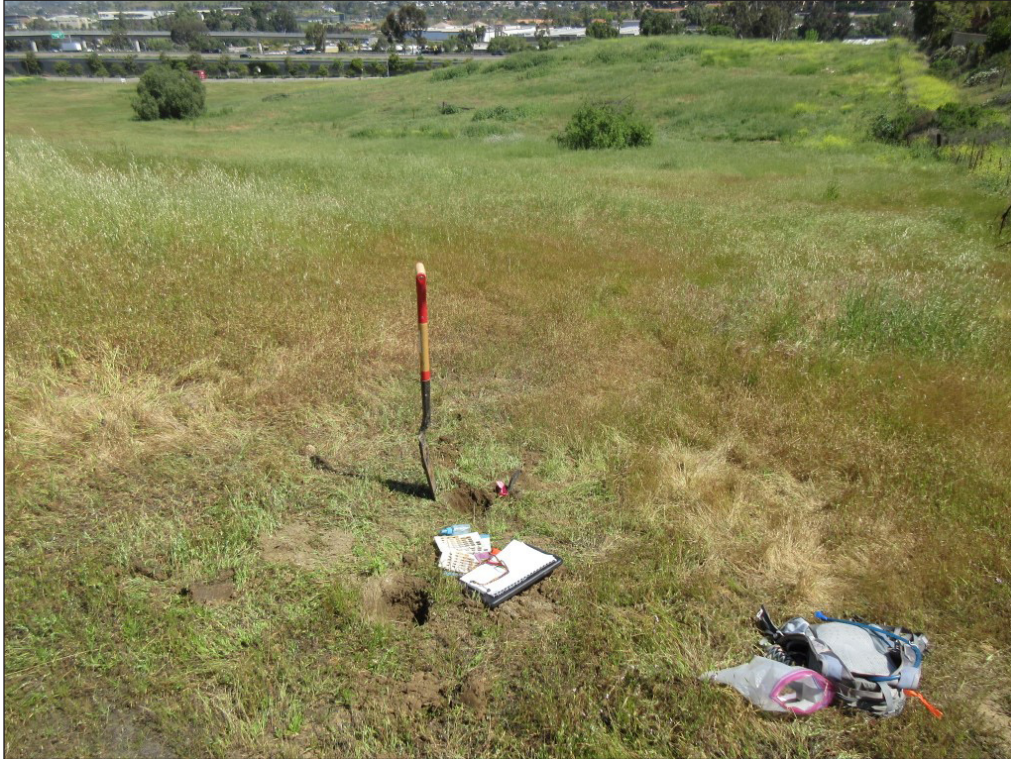
Photo 3. Looking north at SP-2 taken April 24, 2020 in the southern portion of the site. SP-2 is located on a north-facing slope in non-native grassland. This SP did not meet USACE, RWQCB, or CDFW wetland criteria.

Sampling Point 2 was taken in non-native grassland in the southern portion of the site. One upland species: rattail fescue (*Festuca myuros*), was the dominant species present, thus the hydrophytic vegetation criterion was not met. A soil pit excavated to 8 inches did not reveal the presence of hydric soil indicators, thus the hydric soil criterion was not met. Deeper excavation was precluded by the presence of an underlying rock layer. No secondary or primary indicators of wetland hydrology were observed; thus, the wetland hydrology criterion was not met. This sampling point did not meet any of the three wetland criteria for the USACE or RWQCB, nor is it a CDFW wetland or riparian habitat.

Describe Recorded Data (stream gauge, monitoring well, aerial photos, previous inspections), if available:
 Remarks:
 No primary or secondary hydrology indicators observed. Soil completely dry despite much higher than average rainfall in the weeks leading up to the site visit (i.e., in March [5.7" while 2.5" is normal] and April [6.8" while 1.0" is normal]). FAC-Neutral test: W:U=0:1(negative).

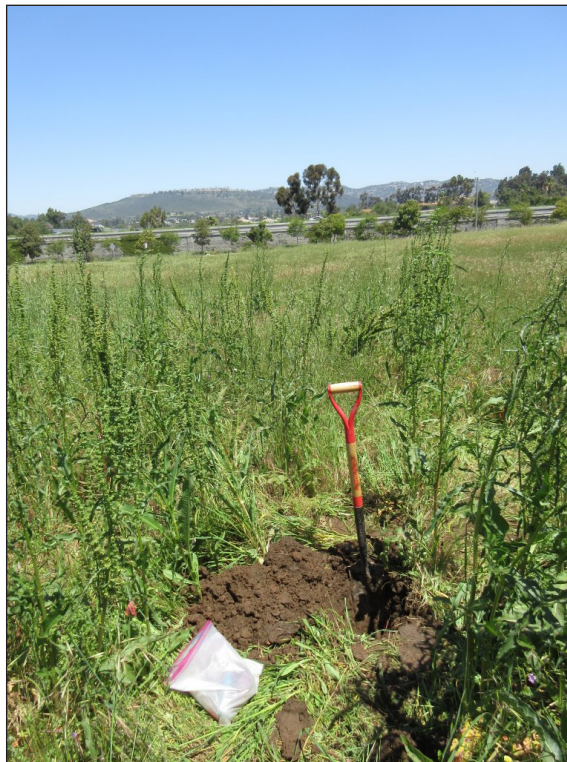
Photo 4. Looking north at SP-3 taken April 24, 2020 in the central portion of the site. SP-3 is in a low area of non-native grassland habitat; it did not meet USACE, RWQCB, or CDFW wetland criteria.

Sampling Point 3 was taken in non-native grassland in the central portion of the site. One upland species (ripgut grass) and one wetland species (curly dock [*Rumex crispus*]) were the dominant species present, thus the hydrophytic vegetation criterion was not met as it failed both the dominance test and the prevalence index. While curly dock can occur in wetland habitat, it also is frequently observed in upland habitat, particularly in grassland. Curly dock is rated as a facultative (FAC) species, which has equal likelihood of occurring in an upland as it does in a wetland; it is not a strongly hydrophytic species. A soil pit excavated to 20 inches did not reveal the presence of hydric soil indicators, thus the hydric soil criterion was not met. No secondary or primary indicators of wetland hydrology were observed; thus, the wetland hydrology criterion was not met. This sampling point did not meet any of the three wetland criteria for the USACE or RWQCB, nor is it a CDFW wetland or riparian habitat.

No hydric soil indicators present. Soil moisture likely due to low and flat landscape position combined with much higher than average rainfall in the weeks leading up to the site visit (i.e., in March [5.7" while 2.5" is normal] and April [6.8" while 1.0" is normal]). Photos 18-22

No primary or secondary hydrology indicators observed. Saturation at 16" depth during the growing season in a higher than average rainfall period does not meet the A3 hydrology indicator, which requires saturation within 12 inches. FAC-Neutral test: W:U=0:1 (negative).
