**Diamond Street Industrial
Technical Appendices**

**Appendix C2
Jurisdictional Delineation**

Melrose and Diamond Industrial Project

Jurisdictional Waters and Wetlands Delineation

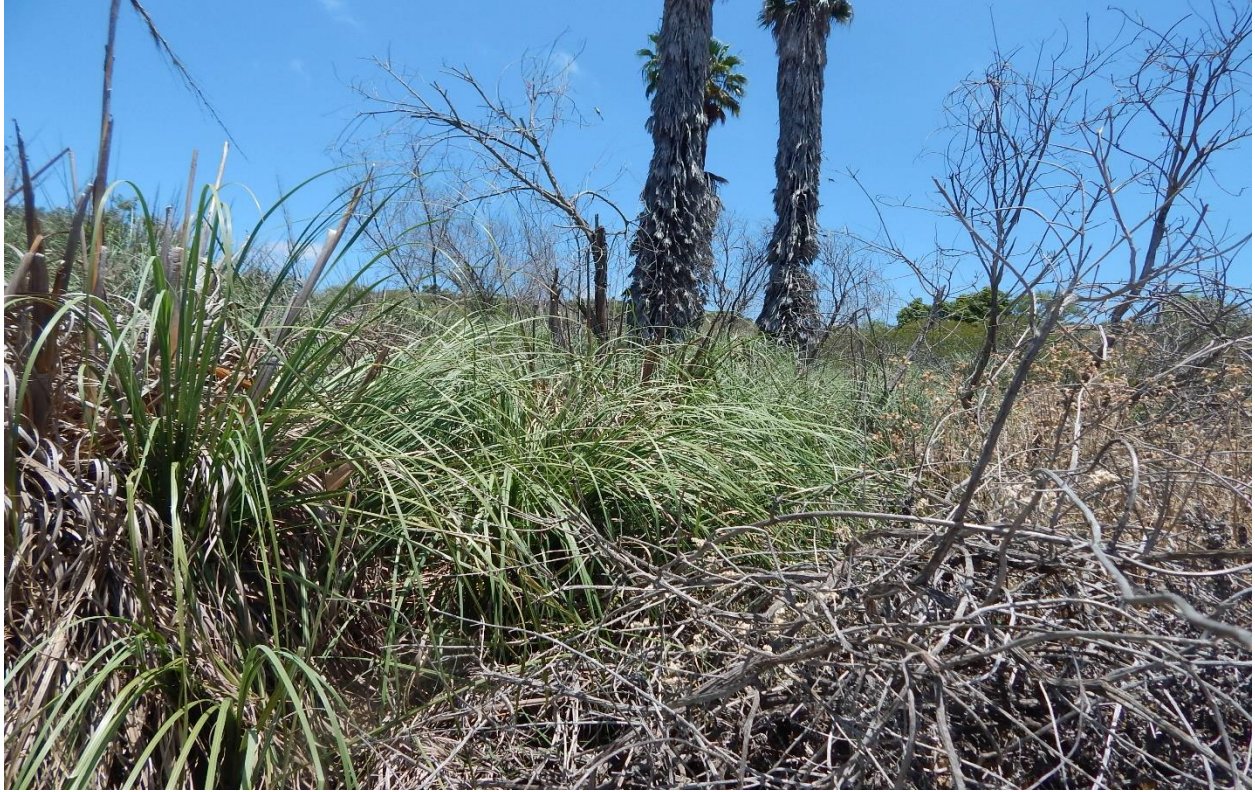
Photograph 1. Upstream view of primary feature, illustrating dense pampas grass and palm trees.

Surface water was observed in a small area in the midstream portion of the streambed. Saturated soils were observed in the upper five inches in the downstream portion of the streambed during the jurisdictional delineation survey. According to the USFWS NWI, this feature is mapped as a freshwater forested/shrub wetland (USFWS 2020). Our field observations led to the conclusion that this feature does not contain wetlands because the drainage only met one (wetland hydrology) of the three parameters needed to determine presence of a wetland. Photographs of this streambed can be found in Appendix 2 Photographs 1 through 4.

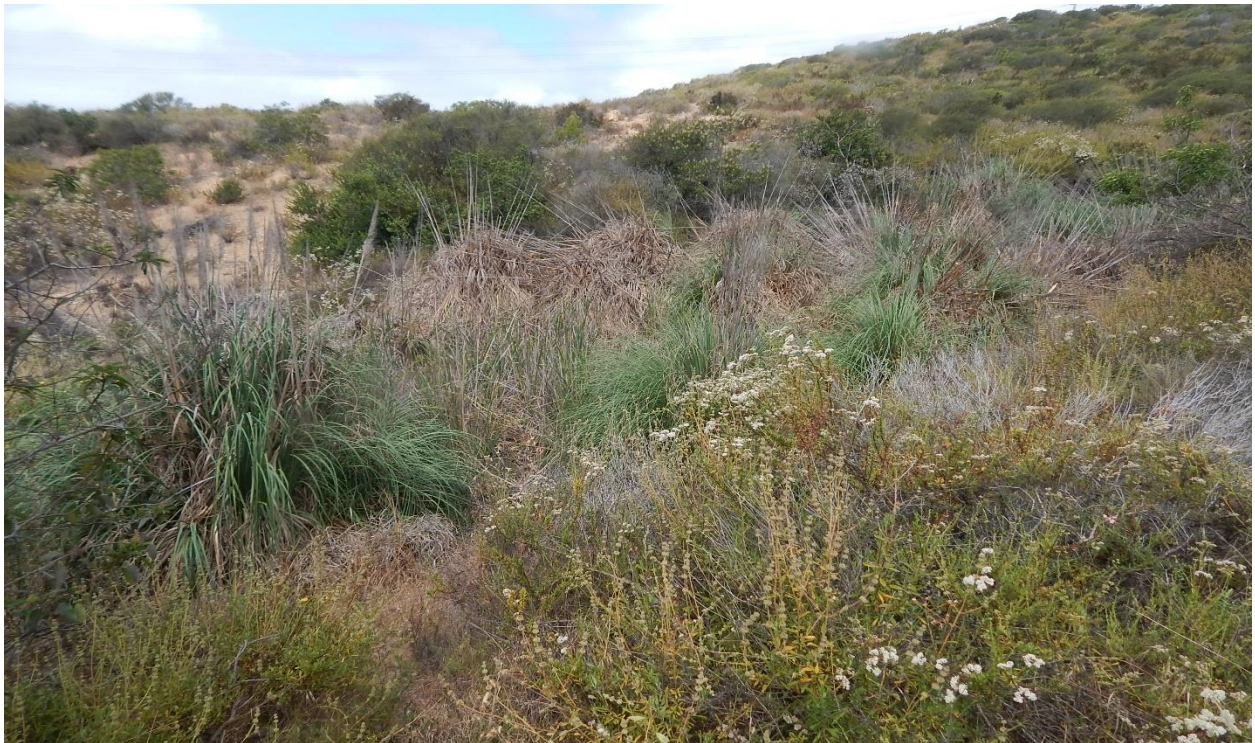
Photograph 2. Side view facing west of the primary feature. The Channel bed is primarily pampas grass.

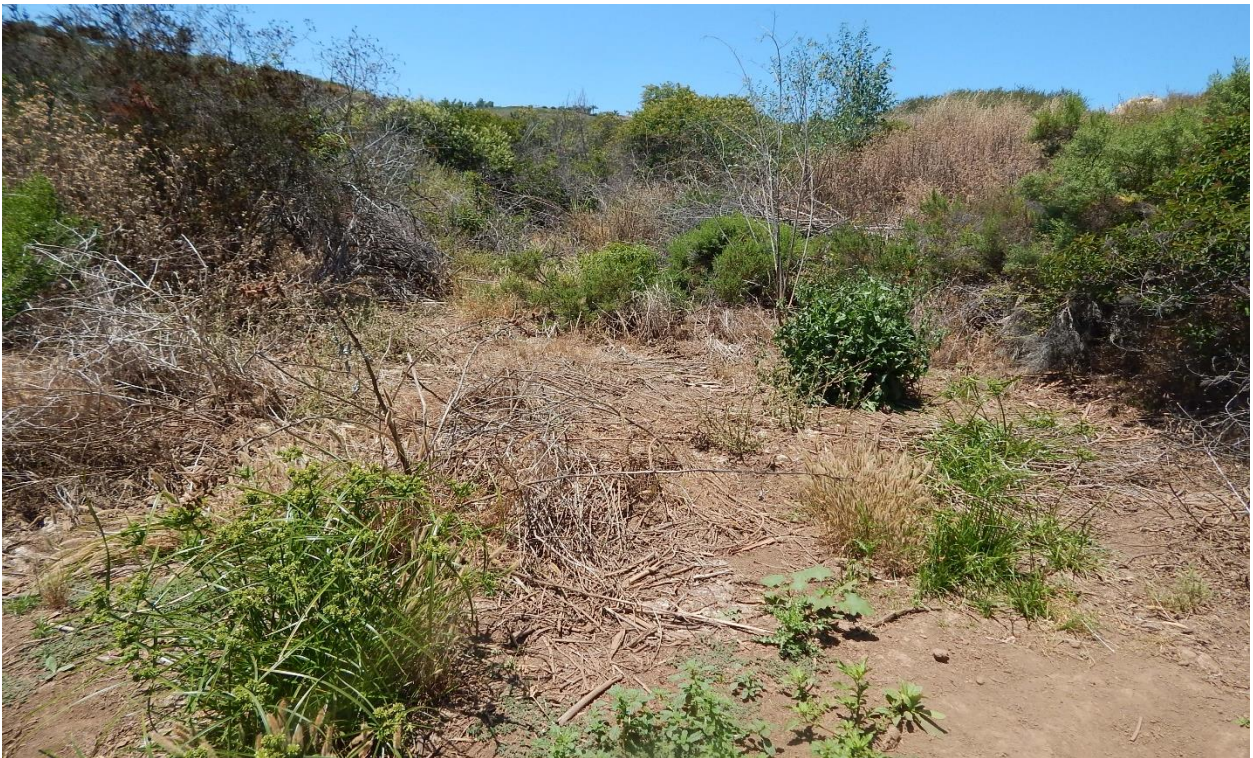
Photograph 4. Upstream view of herbaceous vegetation in the primary feature. View facing north.

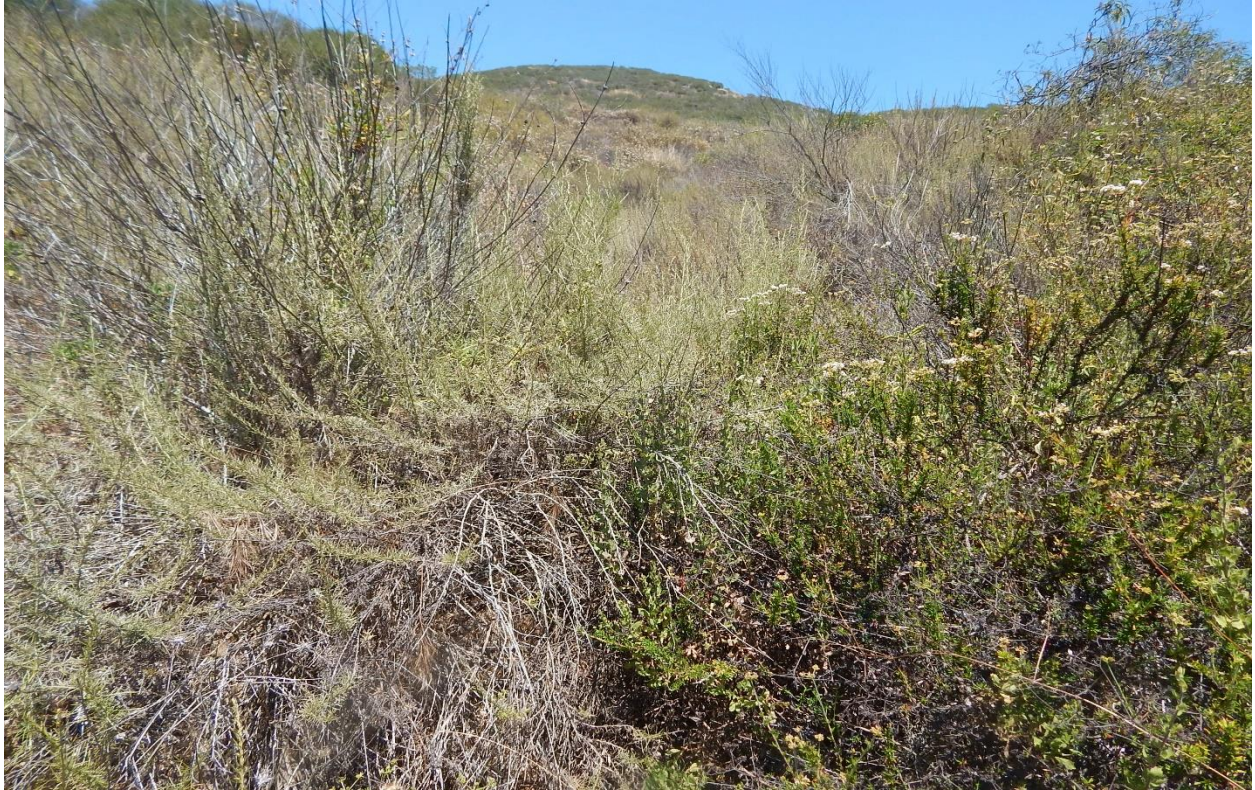
Photograph 5. Upstream view of tributary with dense California sagebrush and California buckwheat.

The tributary, a single-thread channel, joins the main watercourse from the east (Figure 7). Photographs of this tributary can be found in Attachment 2 Photographs 5 and 6. The OHWM limits were defined by presence of a bed and bank and changes in vegetation. This tributary has an average OHWM width of three feet and an average bank to bank width of 4.5 feet. Most of this tributary has dense upland vegetation, including California buckwheat, California sagebrush, black sage, and tocalote (*Centaurea melitensis*). There was no evidence of surface water in the drainage during the jurisdictional delineation survey. No wetland characteristics were observed and as a result, no soil test pits were taken.

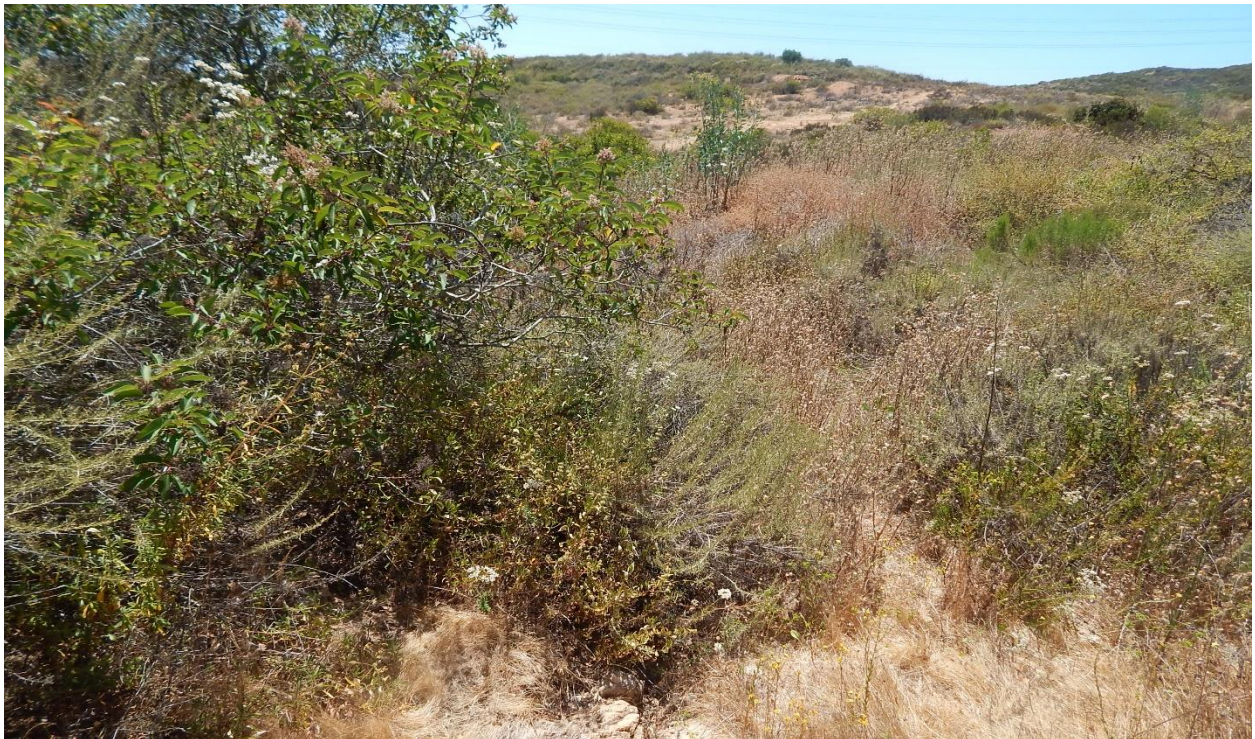
Photograph 6. Downstream view of origination of tributary drainage with dense upland vegetation.
