**Carkel San Marcos Commercial
Technical Appendices**

**Appendix F
Phase 1 Environmental Site Assessment**

Phase I Environmental Site Assessment

SEC of South Bent Avenue and West San Marcos Boulevard
San Marcos, San Diego County, California

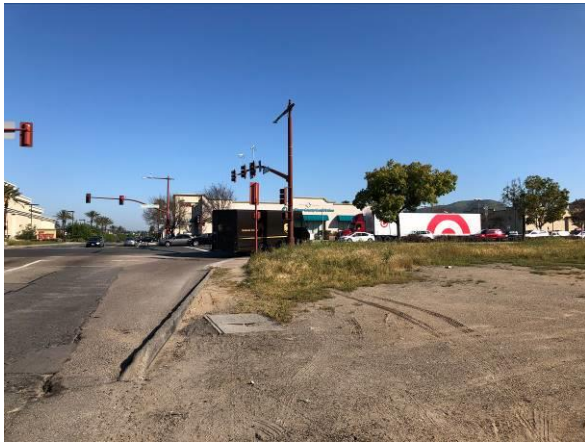
Photo #1 View facing north of the northwestern portion of the site.

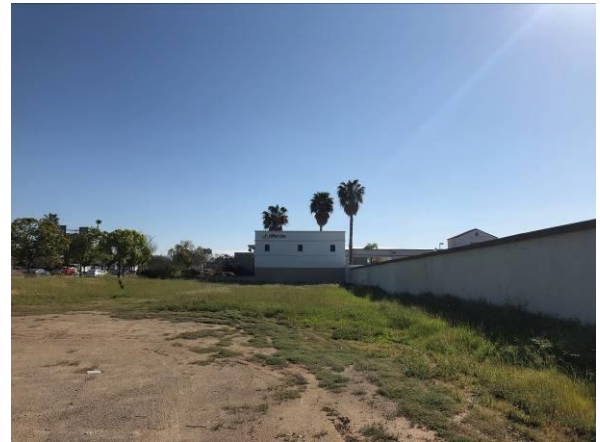
Photo #2 View facing east from the southwestern corner of the site.

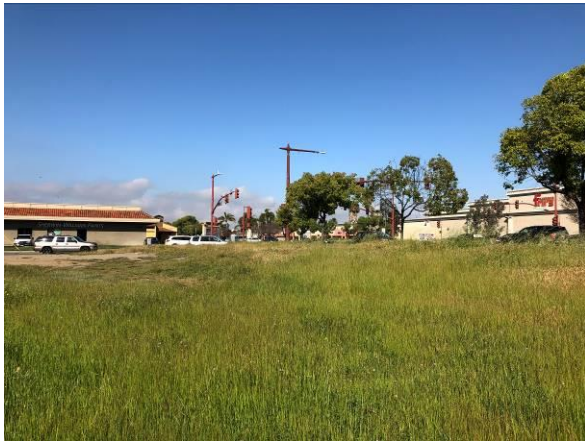
Photo #3 View facing northwest from the southeastern portion of the site.

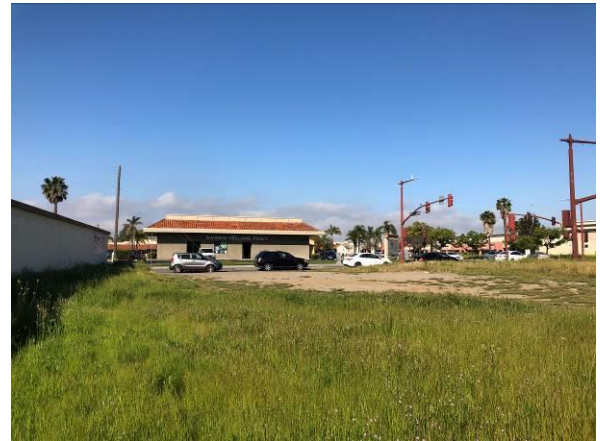
Photo #4 View facing west of the western portion of the site.

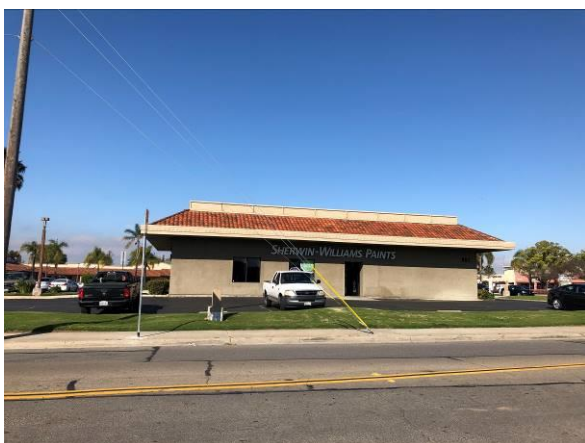
Photo #5 View of South Bent Avenue followed by Sherwin Williams Paint Store (801 West San Marcos Boulevard) located to the adjoining west of the site.

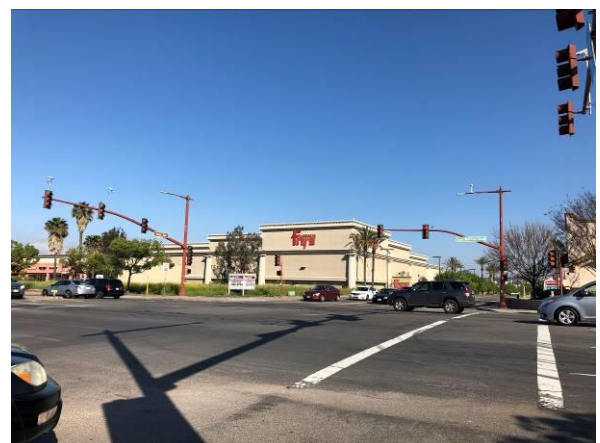
Photo #6 View of the intersection of West San Marcos Boulevard and South Bent Avenue followed by grassy vacant land located to the adjoining northwest of the site.

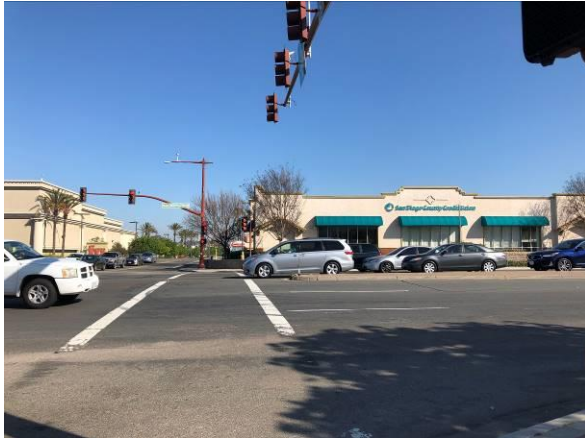
Photo #7 View of West San Marcos Boulevard followed by San Diego County Credit Union (790 West San Marcos Boulevard) located to the adjoining north of the site.

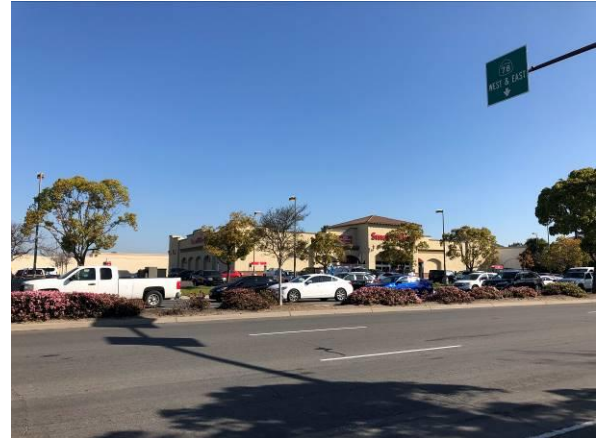
Photo #8 View of West San Marcos Boulevard followed by an asphalt-paved parking lot associated with Smart and Final (770 West San Marcos Boulevard) located to the adjoining northeast of the site.

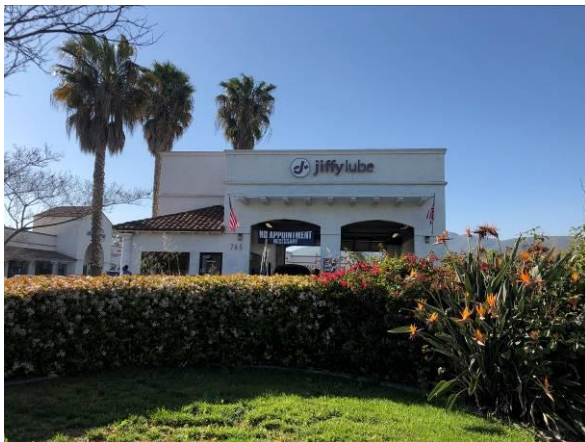
Photo #9 View of Jiffy Lube (765 West San Marcos Boulevard) located to the adjoining east of the site.

Jiffy Lube #1966 and Minit Lube 1568, located to the adjoining east and in a topographic up-gradient position relative to the site, is listed in the Resource Conservation and Recovery Act - Small Quantity Generator (RCRA-SQG), Statewide Environmental Evaluation and Planning System – Underground Storage Tank (SWEEPS UST), Aboveground Petroleum Storage Tank Facilities (AST); and San Diego County Hazardous Materials Division (SAN DIEGO CO.HMMD) regulatory databases. Based on a review of city directories and the records provided by San Diego County Department of Health Services (SDCDHS), the facility operated as an oil-change and repair shop from the late 1980s through the present. Based on a review of the RCRA-SQG listing, the facility was permitted with a SQG in 1991, with no violations found. Based on the AST listing and AST Statement Reports from 2009 and 2010 provided by the SDCDHS, the facility is permitted with the following ASTs: four 120-gallon motor oil, one 240-gallon motor oil, one 200-gallon used antifreeze, one 200-gallon antifreeze, and one 500-gallon used motor oil tank. The four 120-gallon motor oil ASTs were installed in 2008, the remaining ASTs were installed in 1999.

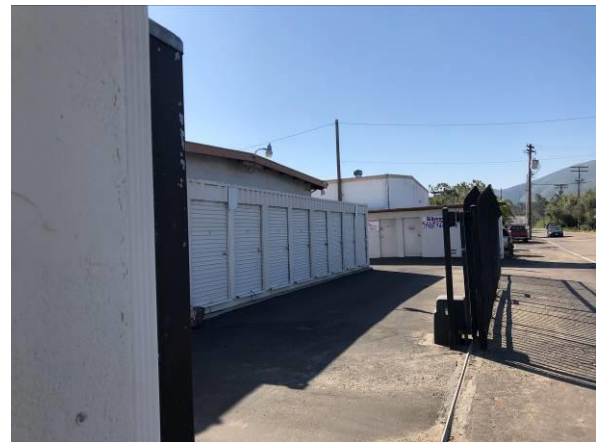
Photo #10 View of Stow-It Self Storage (215 South Bent Street) located to the adjoining south of the site.
