# **Aquatic Resources Delineation**

## **Vega SES 2 and 3 Solar Projects**

Imperial County, California

**February 2021, revised September 2022**

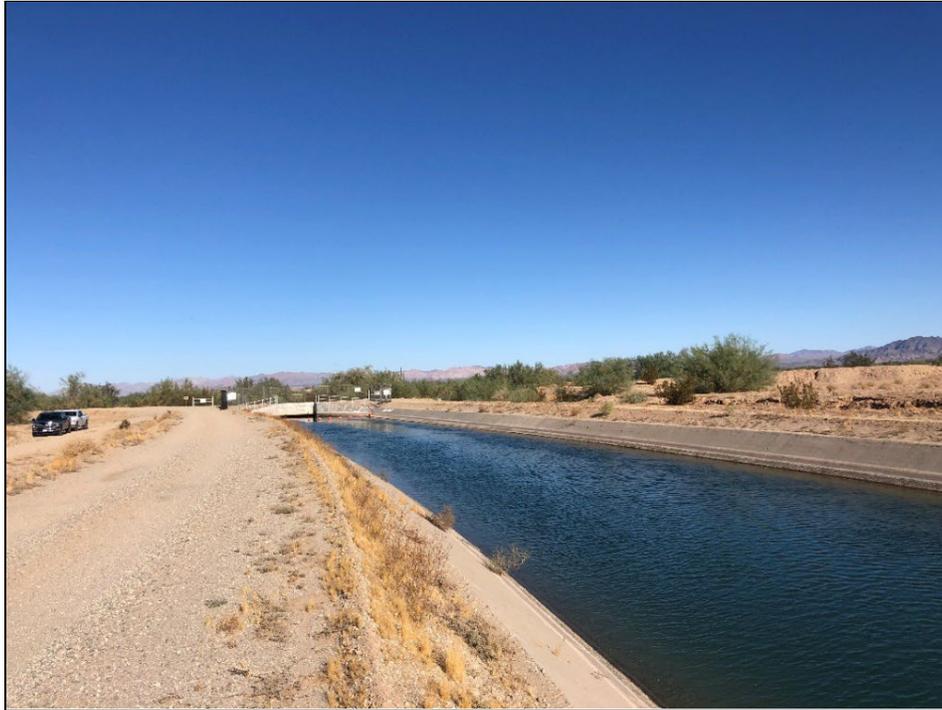
Photo 1. Section of the Coachella Canal adjacent to the Impact Area of Study Area 2; photo facing northwest. November 9, 2020.

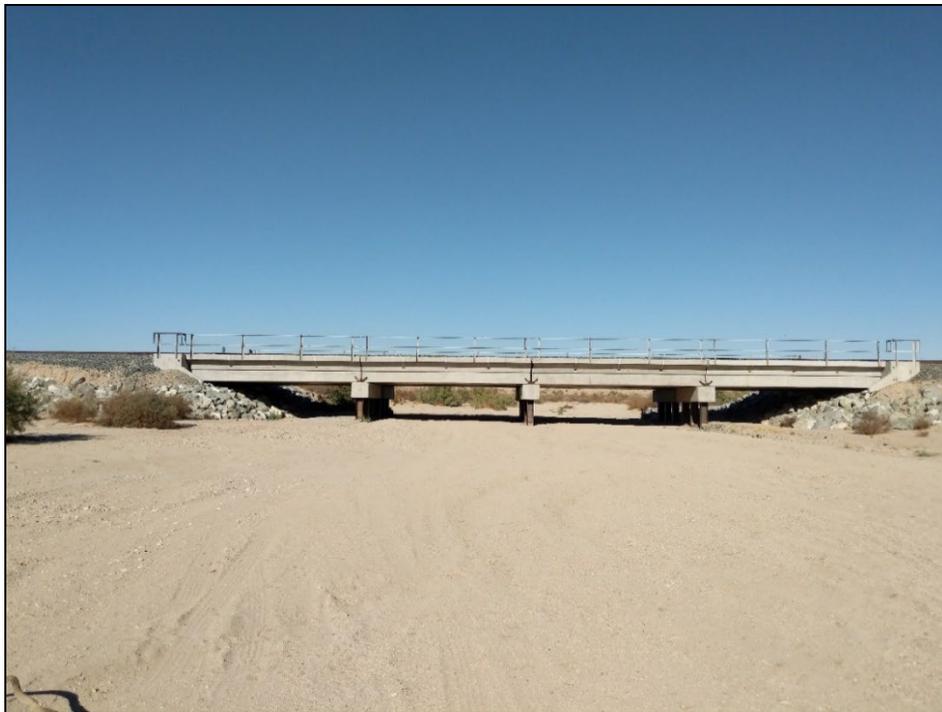
Photo 2. View of the railroad right-of-way bordering the southwest portion of Study Area 1. The ED-3001 drainage crosses the railroad via an underpass; photo facing northeast. November 11, 2020.

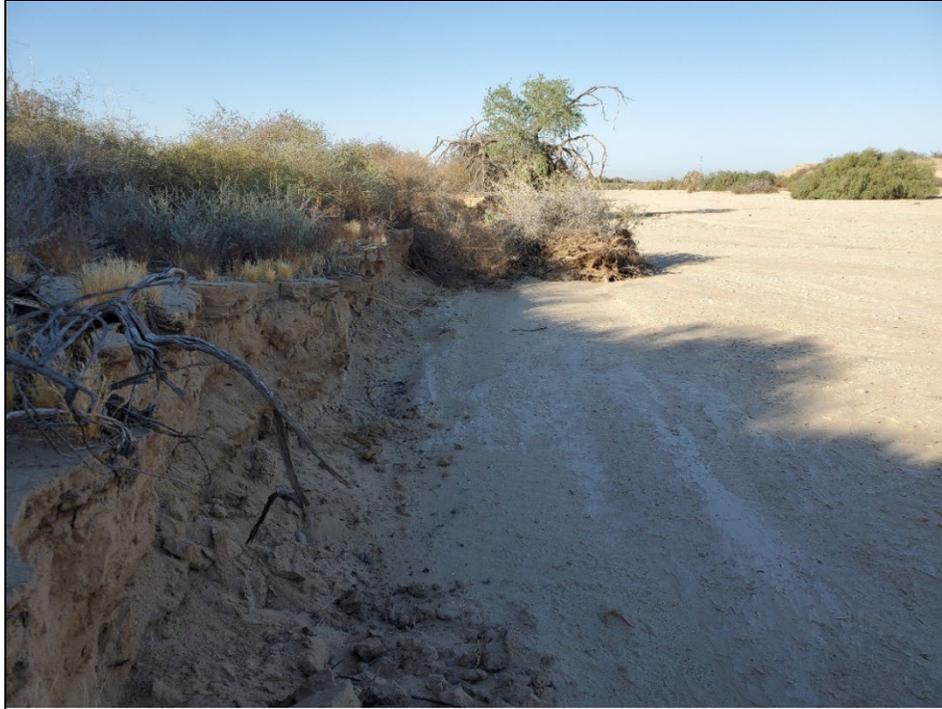
Photo 3. Evidence of defined bed and bank for ED-3001 within the southern portion of Study Area 1; photo facing southwest. September 30, 2020.

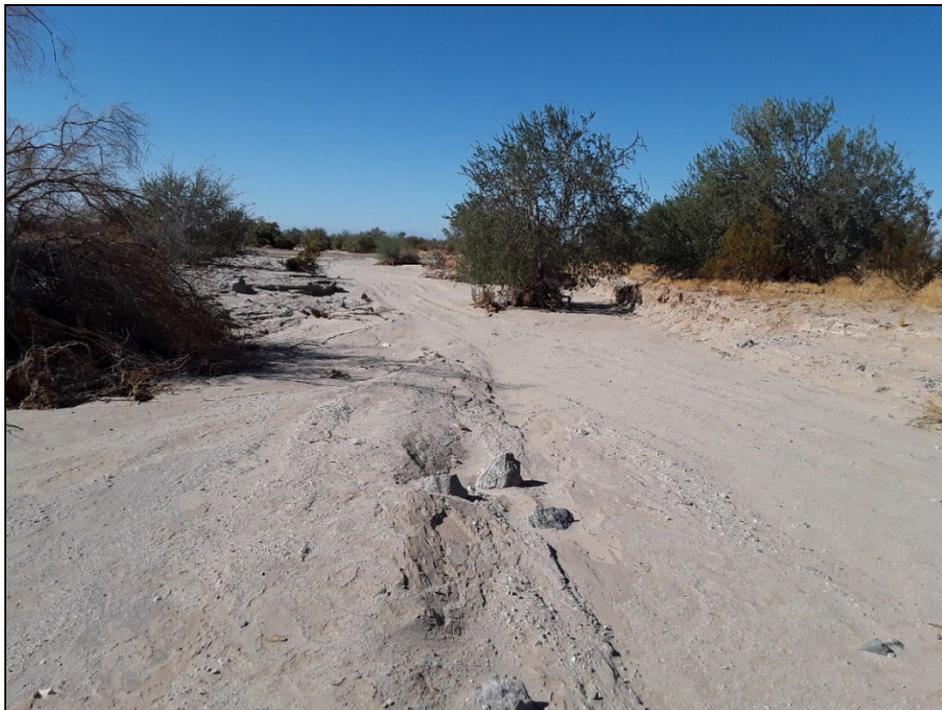
Photo 4. Downstream view of ED-3002 at OHRM Cross Section 102. Drainage associated with Siphon Six within the northwestern portion of Study Area 2; photo facing southwest. November 9, 2020.

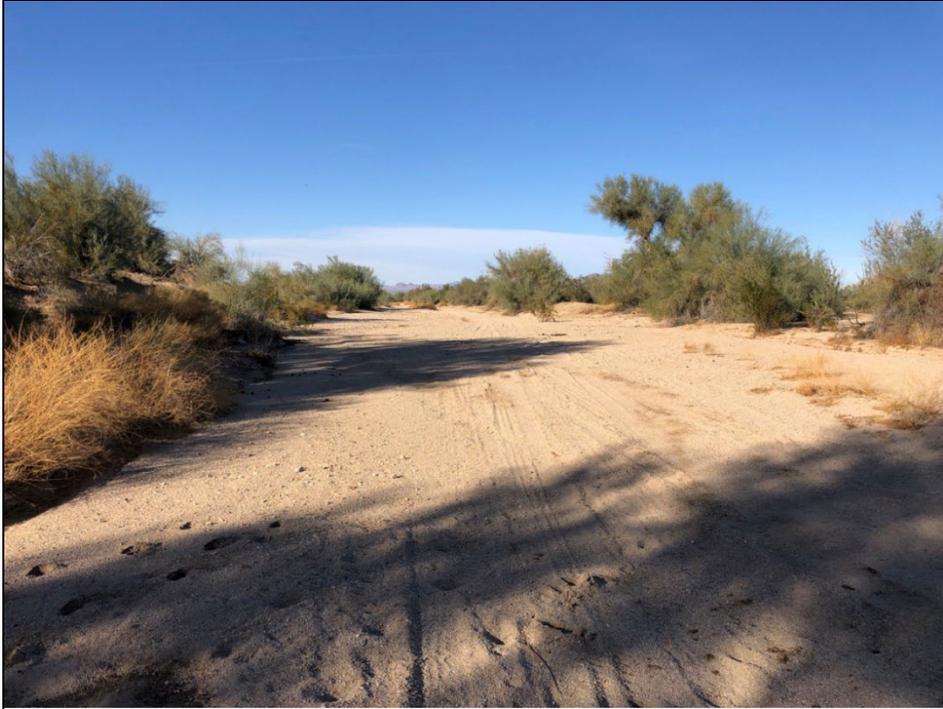
Photo 5. Upstream view of ED-3003. Drainage associated with Siphon Five within the northwestern portion of Study Area 2; photo facing north. January 27, 2021.

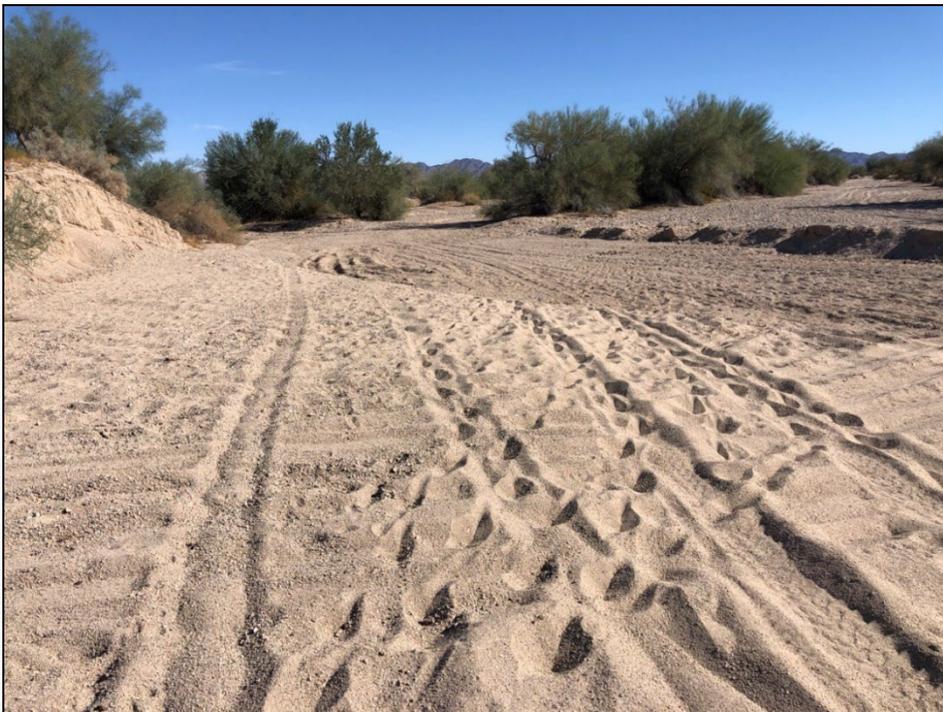
Photo 6. Upstream view of ED-3004 at OHHM Cross Section 101. Drainage associated with Siphon Five within the northwestern portion of Study Area 3; photo facing east. November 11, 2020.

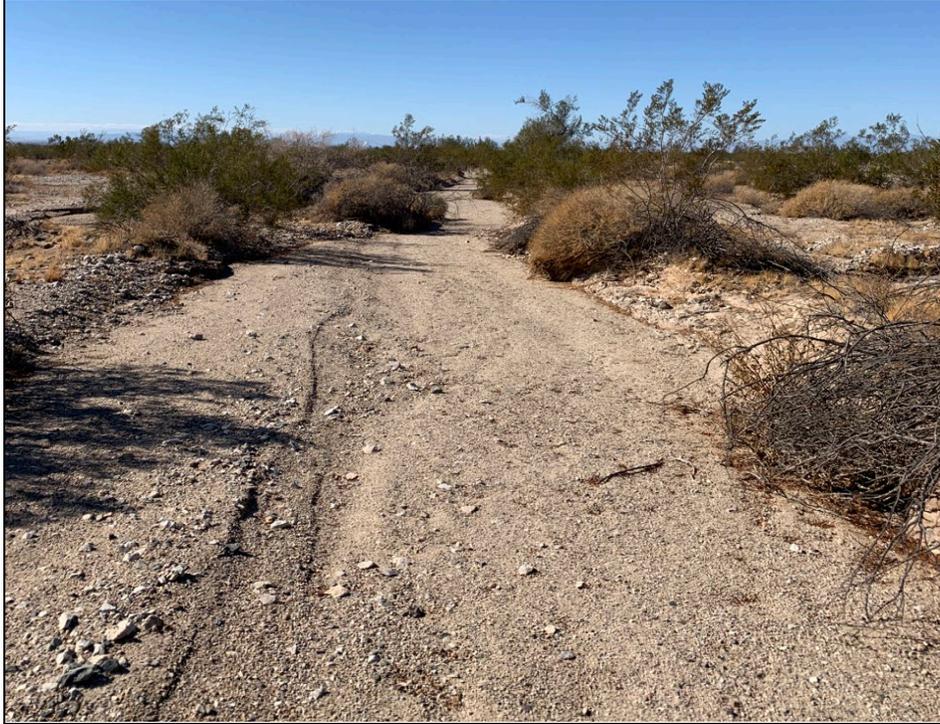
Photo 7. Example of an ephemeral channel determined to be active due to the presence of two or more OHWM indicators within the northwestern portion of Study Area 3; photo facing east. January 26, 2021.

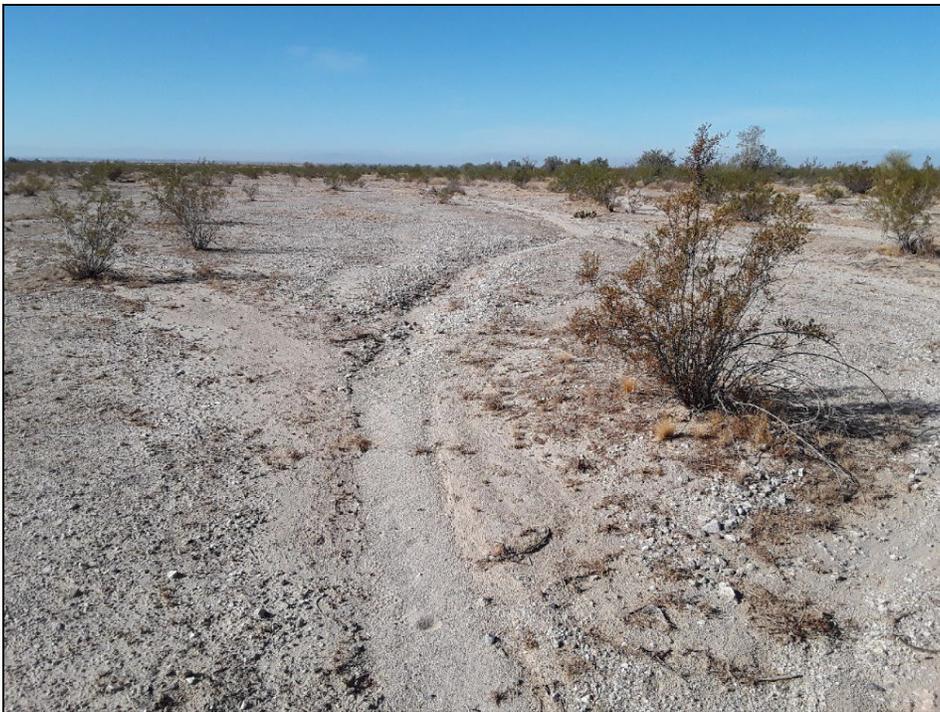
Photo 8. Example of an ephemeral channel determined to be inactive within the southeastern portion of Study Area 3; photo facing west. January 27, 2021.

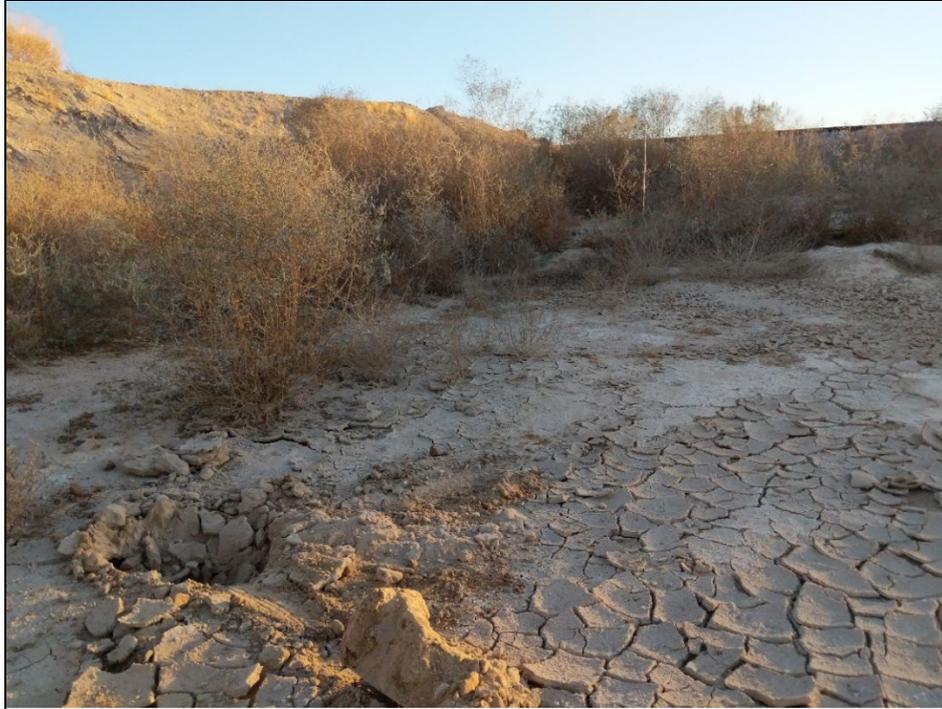
Photo 9. View of Sampling Point 552 taken within alkali sink habitat at the southwest portion of Study Area 1 along the railroad tracks; photo facing southeast. November 11, 2020.

Sampling Point 552 was collected within the alkali sink habitat south of Study Area 1. At the time of the aquatic resource delineation in 2020, this sampling point was inside the Impact Area limits. The Impact Area was revised in 2022 and it now no longer includes the location of Sampling Point 552. However, alkali sink habitat is still present within the revised Impact Area and is subject to direct impacts. Sampling Point 552 is representative of the alkali sink habitat of the Study Area as a whole. Plant species observed included bush seepweed. The soil matrix color at a depth of 0 to 4 inches was 7.5YR 4/4 with no redox features; at a depth of 4 to 7 inches the soil matrix color was 7.5YR 5/4 with no redox features; and at a depth of 7 to 10 inches the soil matrix color was 7.5YR 4/4 with 3 percent redox features colored 5YR 5/8. Hydric soil indicators were determined to be absent at this sampling point. Wetland hydrology indicators observed included the surface soil cracks (B6) primary indicator.

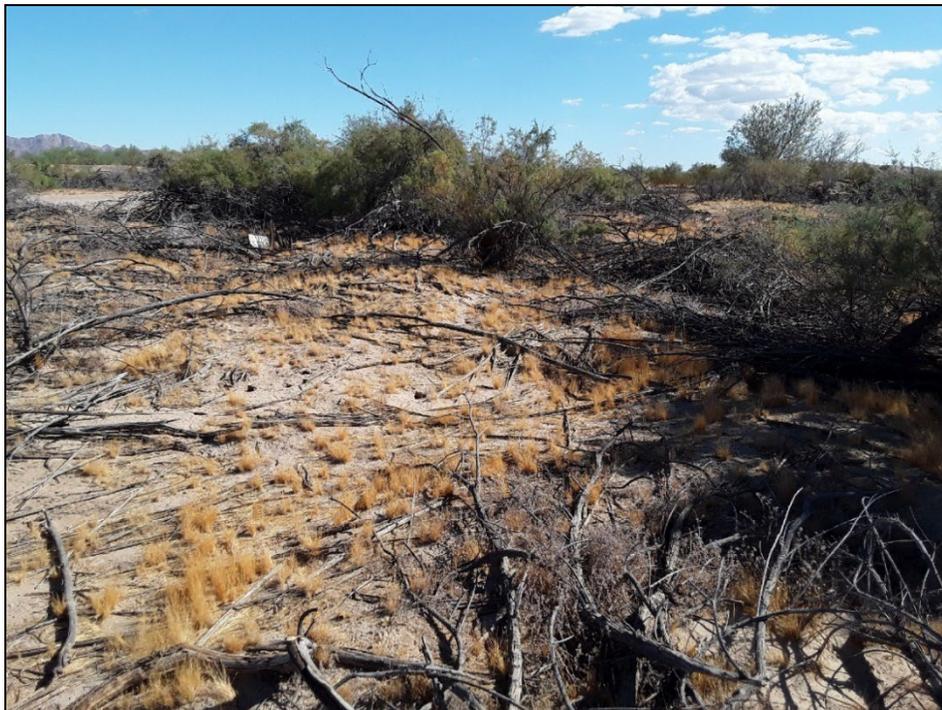
Photo 10. View of the riparian habitat associated with ED-3002 near Sampling Point 2 within the northwest portion of Study Area 2; photo facing southeast. November 11, 2020
