Aquatic Resources Delineation

Vega SES 4 Solar Project

Imperial County, California

ECORP Consulting, Inc. 3838 Camino Del Rio North Suite 370 San Diego, California 92108 (858) 279-4040

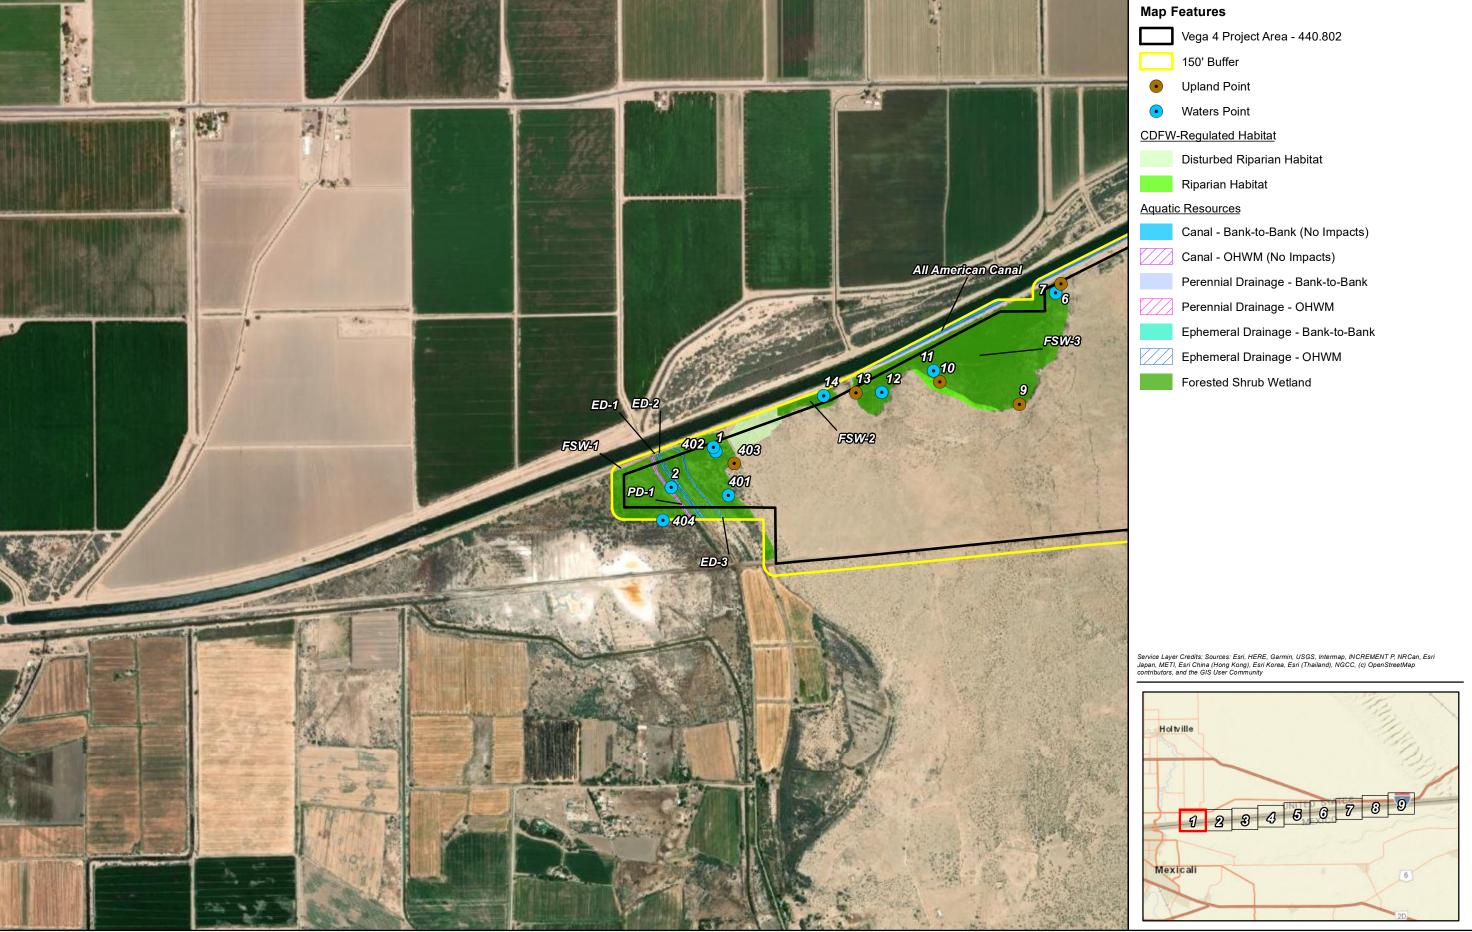
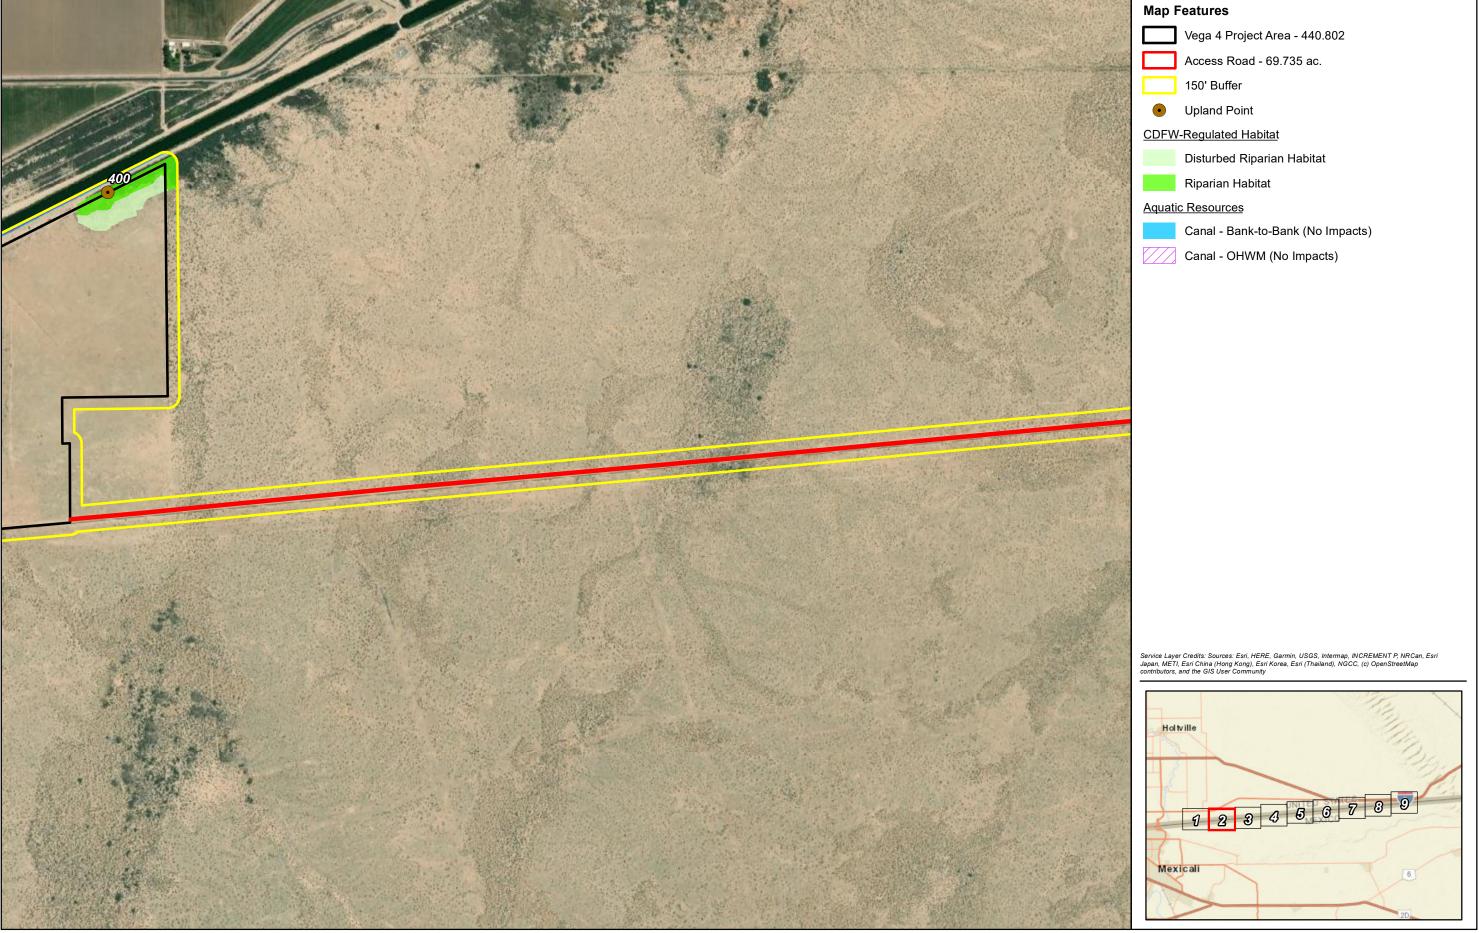
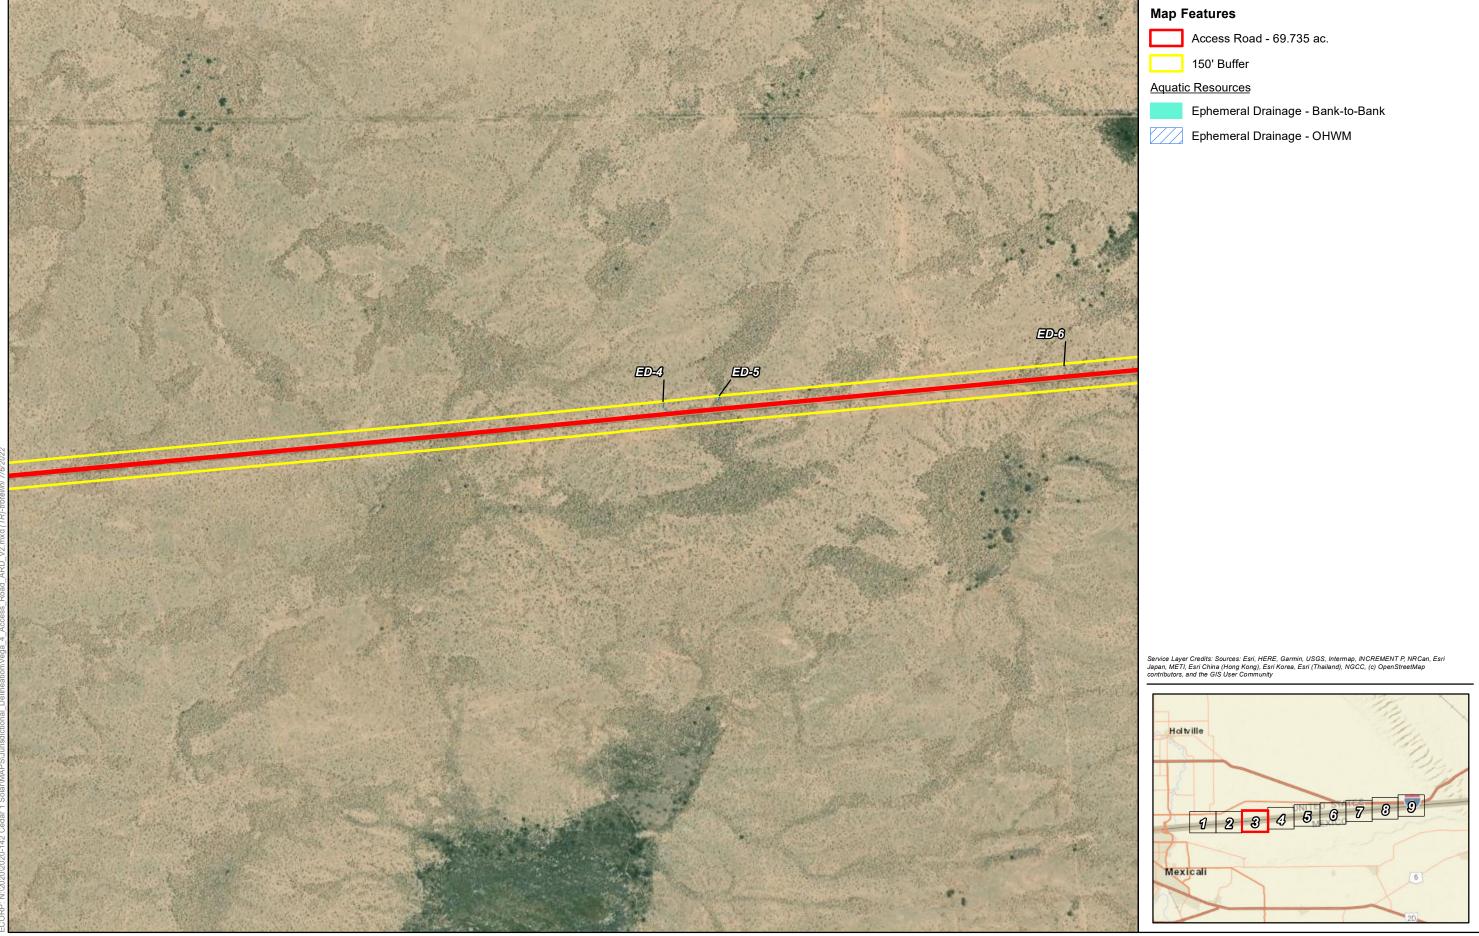
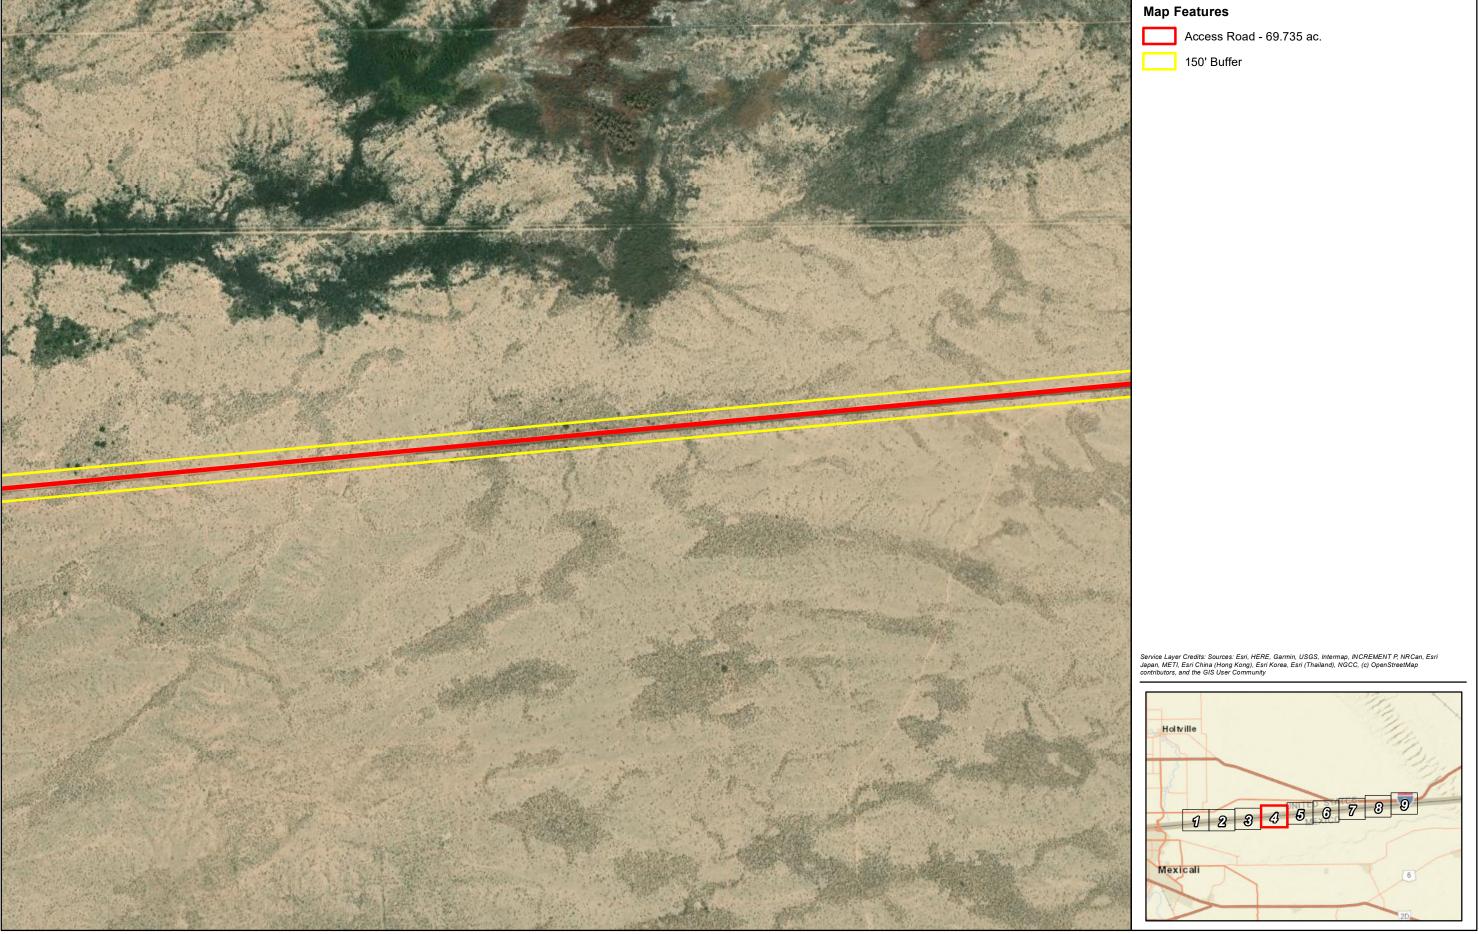
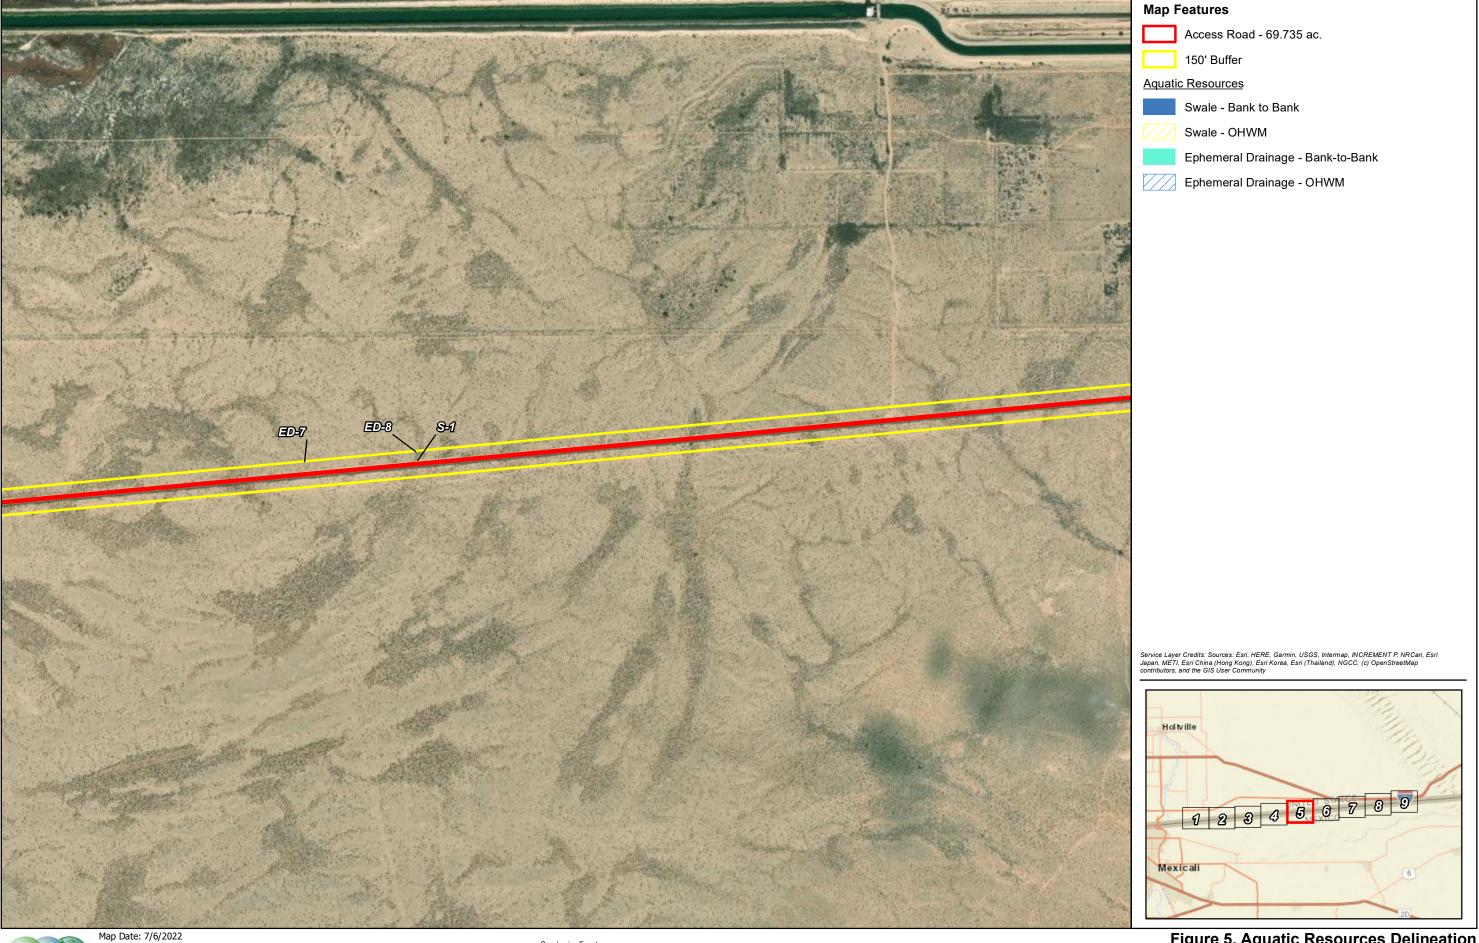
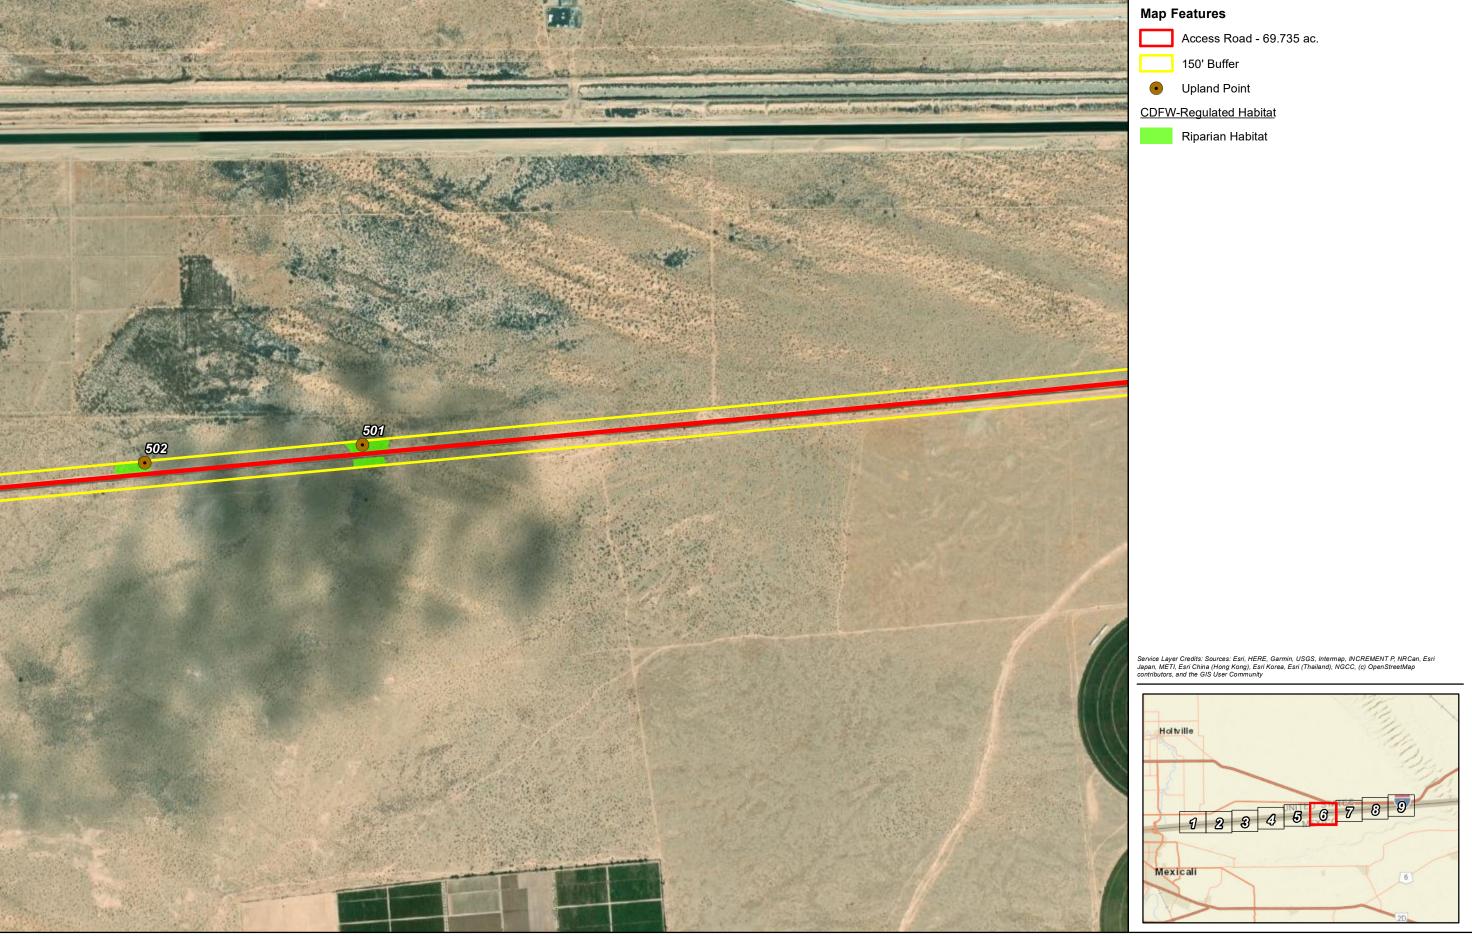
Aquatic resources have been mapped within the Study Area; these results are subject to agency verification. Aquatic resources that fall within the Project boundaries are summarized by feature in Table 5 and depicted on Figure 5.

Features identified as an aquatic resource had wetland indicators present and/or physical evidence of flow including OHWM, defined bed and bank, presence of a clear and natural line impressed on the bank, the presence or absence of sediment deposits, litter/debris, and/or exposed roots indicating active hydrology within the channel. Associated riparian habitat identified within the Study Area consisted of hydrophytic vegetation and hydrological indicators but lacked hydric soil indicators. The OHWM and wetland determination data forms are included as Attachment B, representative site photographs are included as Attachment C, and the USACE Operations and Maintenance Business Information Link Regulatory Module (ORM) aquatic resources table is included as Attachment D.

Freshwater forested/shrub wetlands (FSW) are dominated by woody vegetation such as true shrubs, young trees (saplings), and trees or shrubs that are stunted due to environmental conditions. They are seasonally flooded: therefore, surface water is present for extended periods, particularly in the early growing season, but is absent by the end of the growing season in most years. The water table can be variable after a flooding event, and ranges from saturation at the ground surface to a water table well below the ground surface (USFWS 2022a). There are three FSW within the Study Area (FSW-1, FSW-2, and FSW-3; Figure 5).

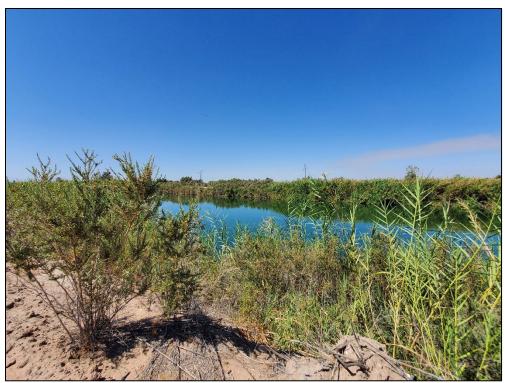
Photo 1. View of the All-American Canal along the northern boundary of the site; photo taken facing west. September 28, 2020.

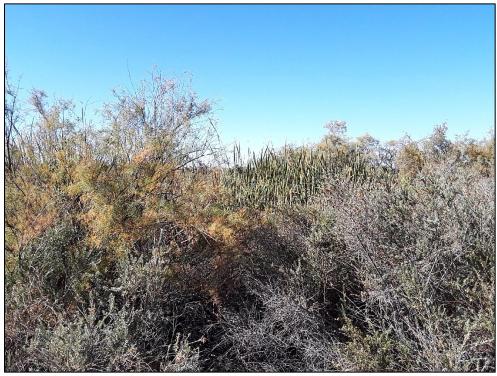
Photo 2. Vegetation lining the bed of PD-1. Photo taken along northern portion of PD-1, facing northwest. November 5, 2020.

Perennial drainages (PD) are linear features that exhibit a bed and bank and an OHWM. These features typically contain surface water flowing continuously year-round. OHWM indicators observed for the perennial drainage (PD-1) that occurs within the western portion of the Study Area included defined bed and bank, change in vegetation species, change in vegetation cover, and natural line impressed in bank. The existing hydrology of PD-1 supports emergent wetland habitat within the channel.

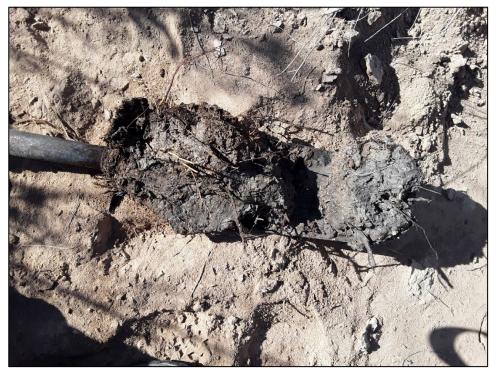
Photo 3. Soil pit sample for Sampling Point 2 taken within the bed of PD-1. November 4, 2020.

Sampling Point 2 was collected within the emergent wetland in the bed of PD-1. At Sampling Point 2, plant species observed within the drainage included tamarisk and cattail. Soils were determined to be hydric based on the presence of hydric soil indicators hydrogen sulfide (A4), loamy gleyed matrix (F2), and

redox depressions (F8). Wetland hydrology indicators observed at Sampling Point 2 included surface water (A1), high water table (A2), saturation (A3), and hydrogen sulfide odor (C1).

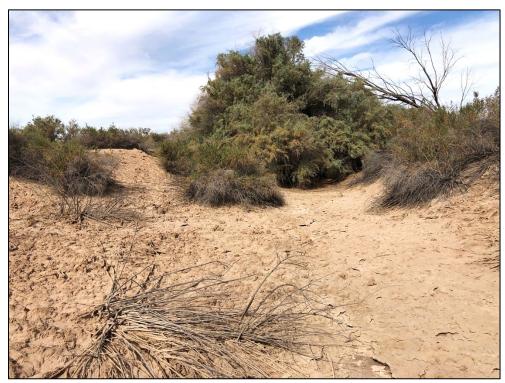
Photo 4. Upstream view of ED-1. Photo taken within northern portion of ED-1, facing northwest. November 5, 2020.

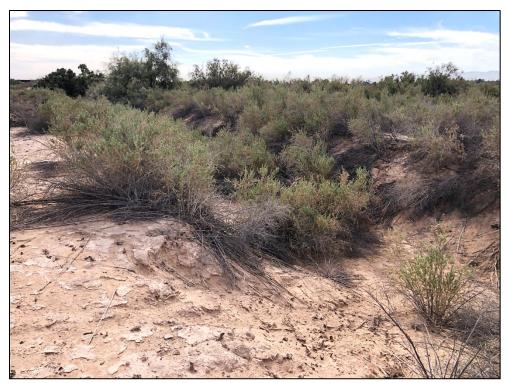
Photo 5. Downstream view of ED-2. Photo taken within northern portion of ED-2, facing south. November 5, 2020.

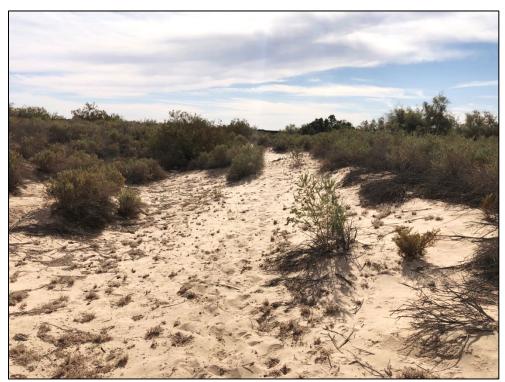
Photo 6. Downstream view of ED-3. Photo taken within northern portion of ED-3, facing southeast. November 5, 2020.

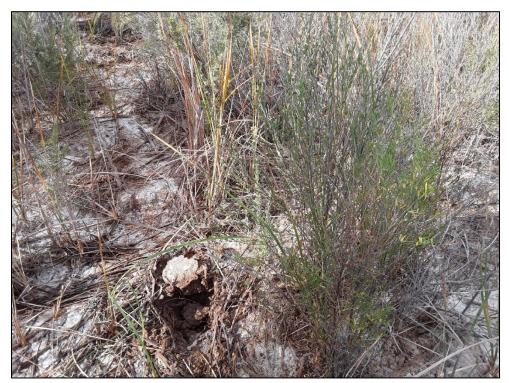
Photo 7. Sample Point 7 taken within the northeastern portion of FSW-3. November 5, 2020.

Sampling Points 7, 11, and 12 were collected in the FSW in the northeastern portion of the solar field Study Area (FSW-3). Sampling Points 6, 9, 10, and 13 were collected outside the limits of FSW-3. At Sampling Point 7, plant species observed within the wetland included willow baccharis, arrow weed, and cattail. Soils were determined to be hydric based on the presence hydric soil indicator redox depressions (F8). Wetland hydrology indicators observed at Sampling Point 7 included saturation (A3) and waterstained leaves (B9).

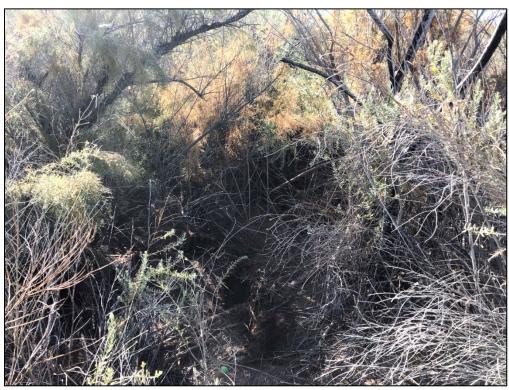
Photo 8. Sample Point 402 taken within the northeastern portion of FSW-1; photo taken facing southwest. November 5, 2020.

Sampling Points 1, 2, 401, 402, and 404 were collected in the freshwater forested/shrub wetland in the western portion of the solar field Study Area (FSW-1). Sampling Point 403 was collected outside the limits of FSW-1. At Sampling Point 402, plant species observed included tamarisk, willow baccharis, and arrow weed. Soils were determined to be hydric based on the presence of hydric soil indicators depleted below dark surface (A11) and redox depressions (F8). Wetland hydrology indicators observed at Sampling Point 402 included saturation (A3), drift deposits (B3), and oxidized rhizospheres along living roots (C3).

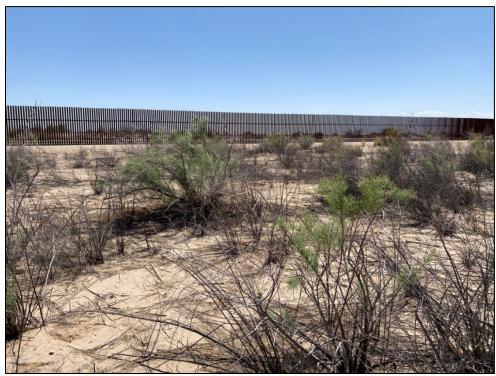
Photo 9. View of riparian habitat within the Study Area buffer and associated with sample point 501. Due to hydrology and vegetation observed, this area is potentially a remnant wetland. Photo taken facing south. April 12, 2022.

Sampling point 501 was collected in riparian habitat located within the northern buffer area of the access road Study Area. Plant species observed included tamarisk, arrow weed, creosote bush, and alkali goldenbush. Hydric soil indicators and wetland hydrology indicators were determined to be absent at this sampling point.

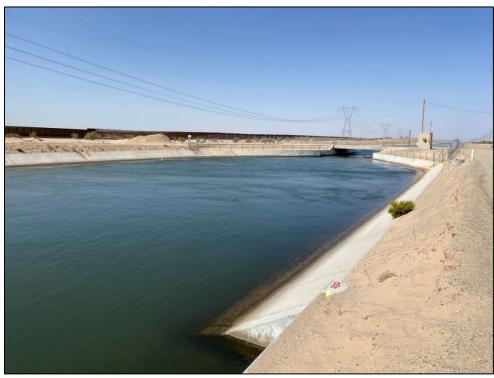
Photo 10. View of the All-American Canal as it flows beneath the access road bridge in the eastern portion of the Study Area. Photo taken facing west. April 12, 2022.

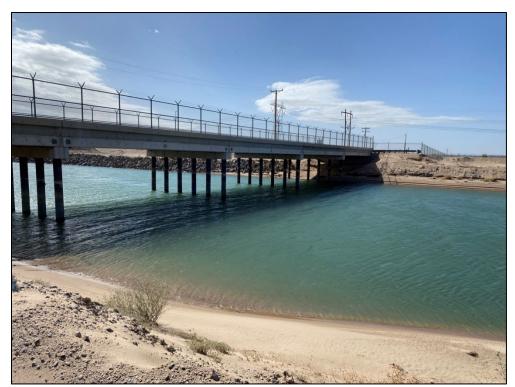
Photo 11. View of the Off-line Storage Canal as it flows beneath the access road bridge in the eastern portion of the Study Area. Photo taken facing southeast. April 12, 2022.

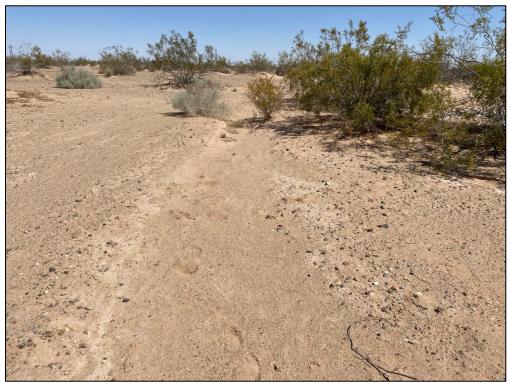
Photo 12. View of ED-8 within the Study Area buffer and north of the access road. Photo taken facing north. April 13, 2022.
