**Delineation of Potentially Jurisdictional
Wetlands and Waters**

Brynildson Residence APN 046-031-033

ALTHOUSE AND MEADE, INC.
BIOLOGICAL AND ENVIRONMENTAL SERVICES
1602 Spring Street
Paso Robles, CA 93446
(805) 237-9626

May 2019

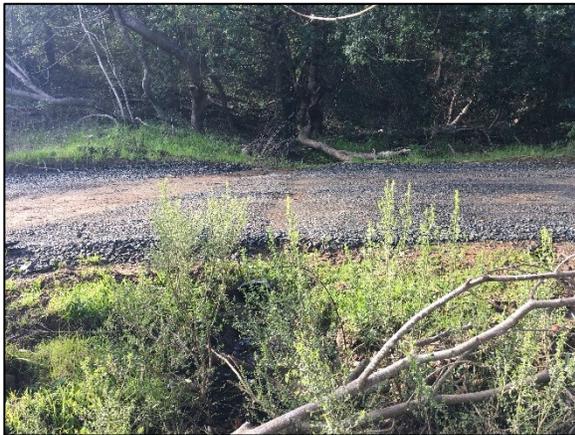
Photo 1. View across road from downstream portion of drainage. Two pathways of water eroded into road base. February 25, 2019

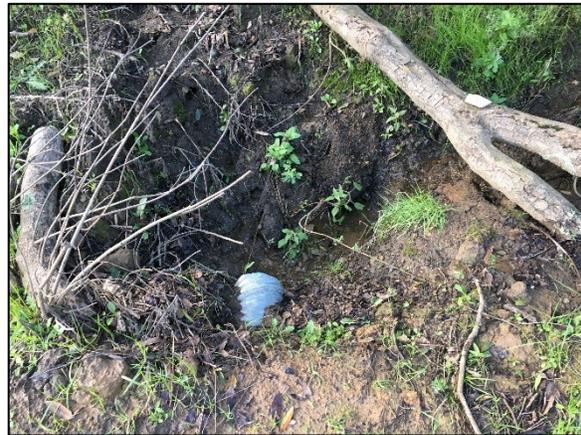
Photo 2. Downstream eight inch culvert outlet. February 25, 2019.

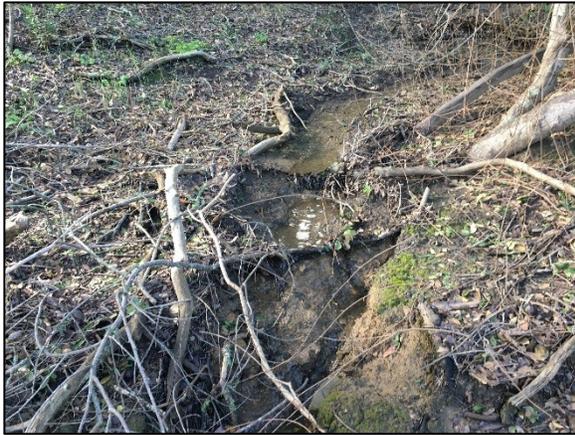
Photo 3. View upstream from upstream cross-section. Riffles and pools created by roots growing across the drainage. Absence of litter is OHWM indicator. February 25, 2019.

The portion of the drainage that is upstream of the road displayed OHWM indicators such as a change in litter and debris presence, bed and bank, change in sediment size, and change in vegetation cover. Roots from bay trees bisect the drainage, creating pools and drift deposition (Photo 3). A gravelly bottom is present in some areas where silt and clay have been washed further downstream (Photo 4). In pools, a thick layer of silt has deposited on top of exposed roots and rocks (Photo 5). The OHWM width is approximately two and a half feet wide and ten inches deep. In February 2019, the flowing water was flowing two feet wide and four inches deep (Chart 2).

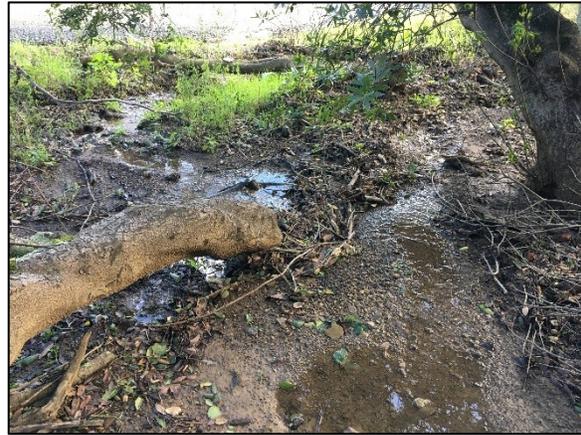
Photo 4. View downstream from upstream cross-section. Channel is less defined but OHWM of change in sediment size is present. Drift and sediment deposits also present. February 25, 2019.

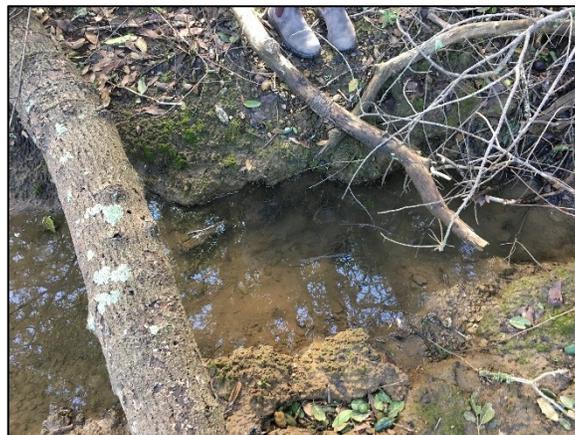
Photo 5. View of substrate where cross-section was completed. Incised channel present with an absence of leaf litter. February 25, 2019.

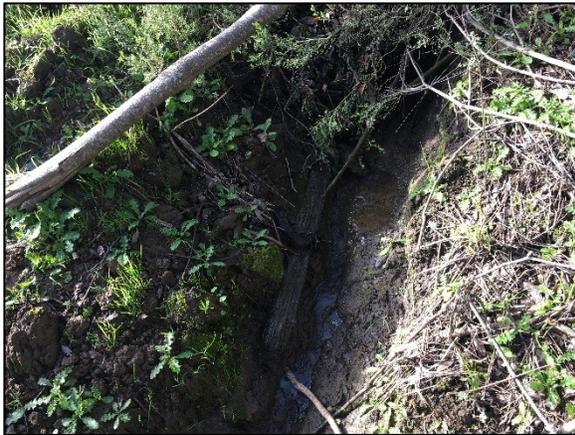
Photo 6. View upstream from downstream cross-section. Channel is incised. OHWM indicators include change in vegetation cover and an absence of leaf litter. February 25, 2019.

Downstream of the road, the drainage is narrower than upstream but has similar OHWM indicators (Photo 6). A presence of bed and bank, change in litter and drift patterns, and a change in vegetation cover were used to determine the OHWM width. A few feet downstream of the cross-section, water slows and pools at the base of a California buckeye and sheet flows through thick California bay and poison oak (Photo 7). Water in the drainage was an inch deep and six inches wide during the February site visit (Photo 8). The OHWM is approximately a foot and a half wide and a foot deep (Chart 3).

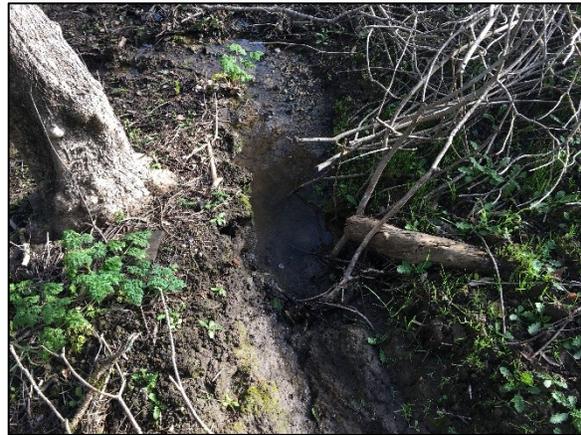
Photo 7. View downstream of downstream cross-section. Channel is incised and then pools where channel becomes less defined. OHWM indicators include change in vegetation cover and absence of litter. February 25, 2019.

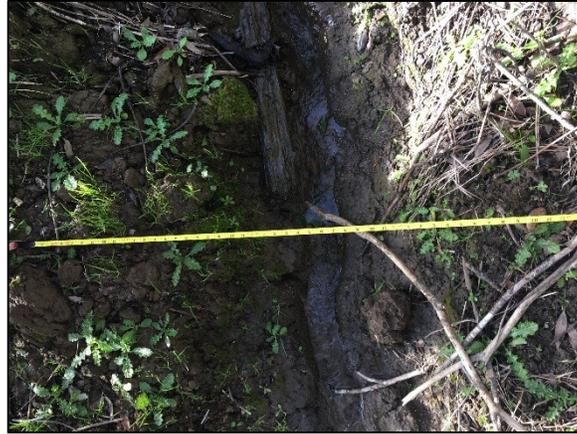
Photo 8. View of substrate at downstream cross-section. Channel is incised. OHWM indicators include change in vegetation cover and an absence of leaf litter. February 25, 2019.

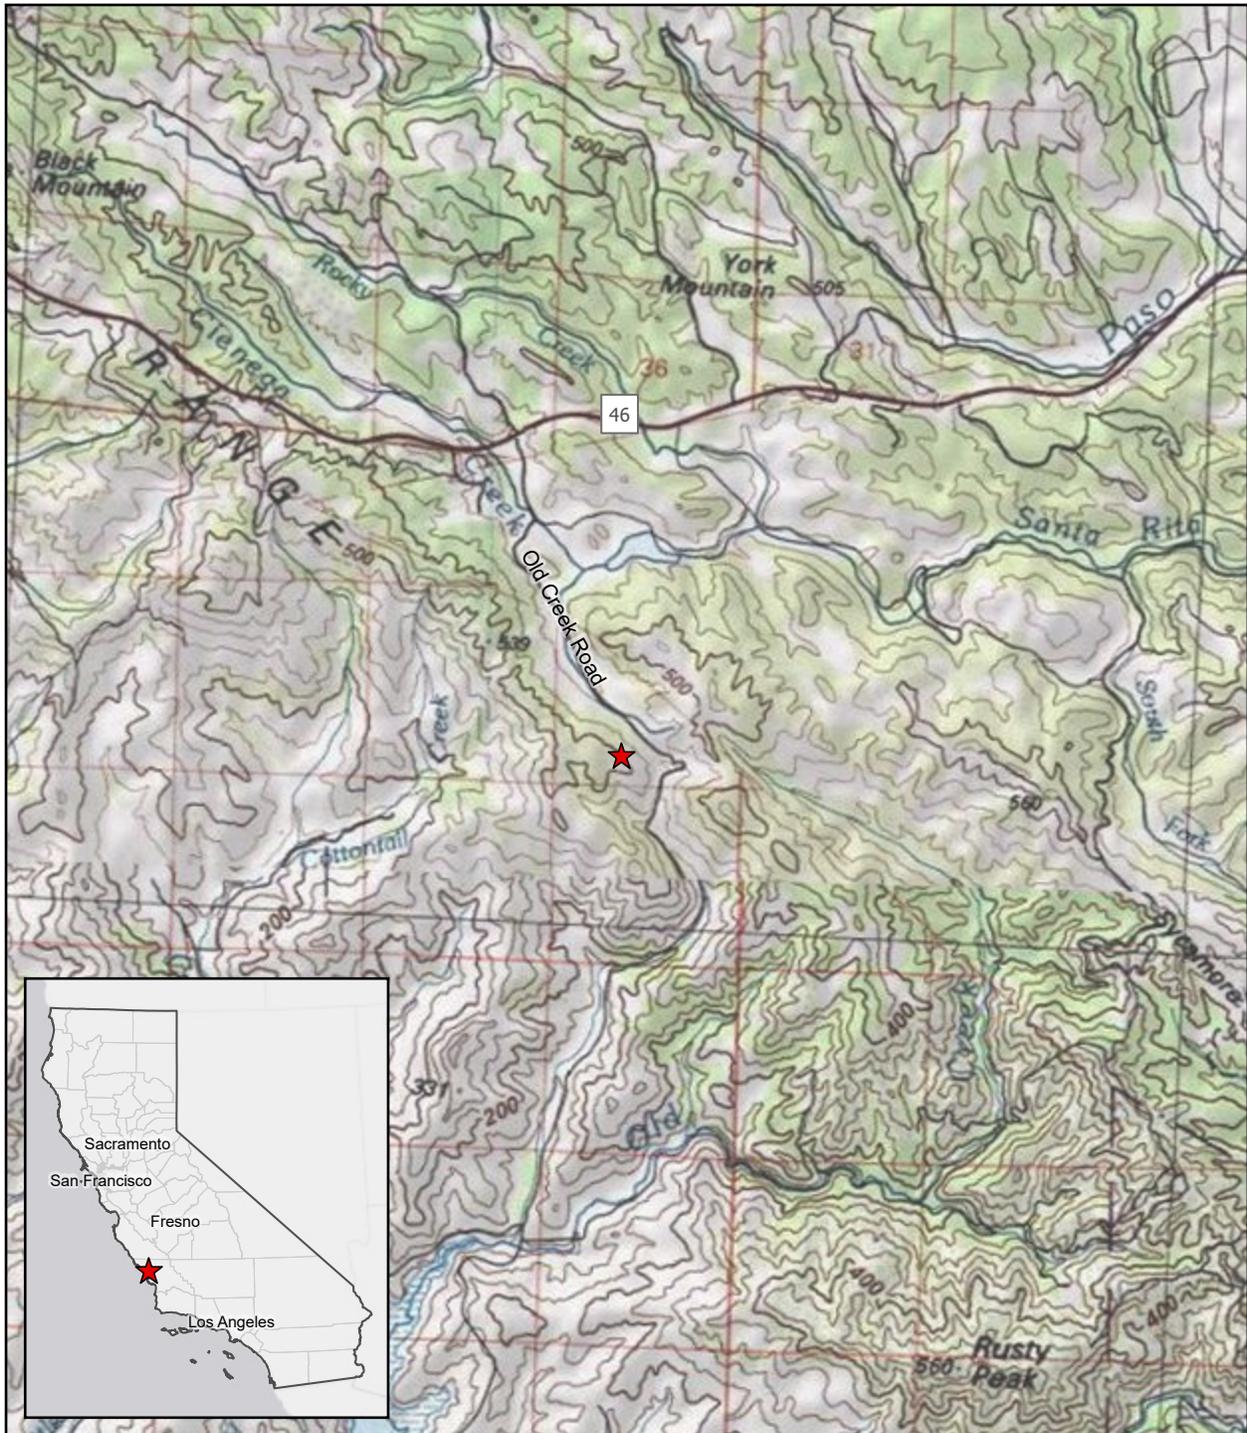
Figure 1. United States Geological Survey Topographic Map

The Study Area is a 12.91-acre portion of an approximately 162-acre parcel (APN 046-031-033) located in western San Luis Obispo County, approximately 1.8 miles south of the intersection of Highway 46 and Old Creek Road. Approximate coordinates for the center of the Study Area are 35.508611, -120.847828 (WGS84) in the York Mountain United States Geological Survey (USGS) 7.5-minute topographic quadrangle (Figure 1). Elevation ranges from approximately 1415 to 1760 feet above mean sea level.

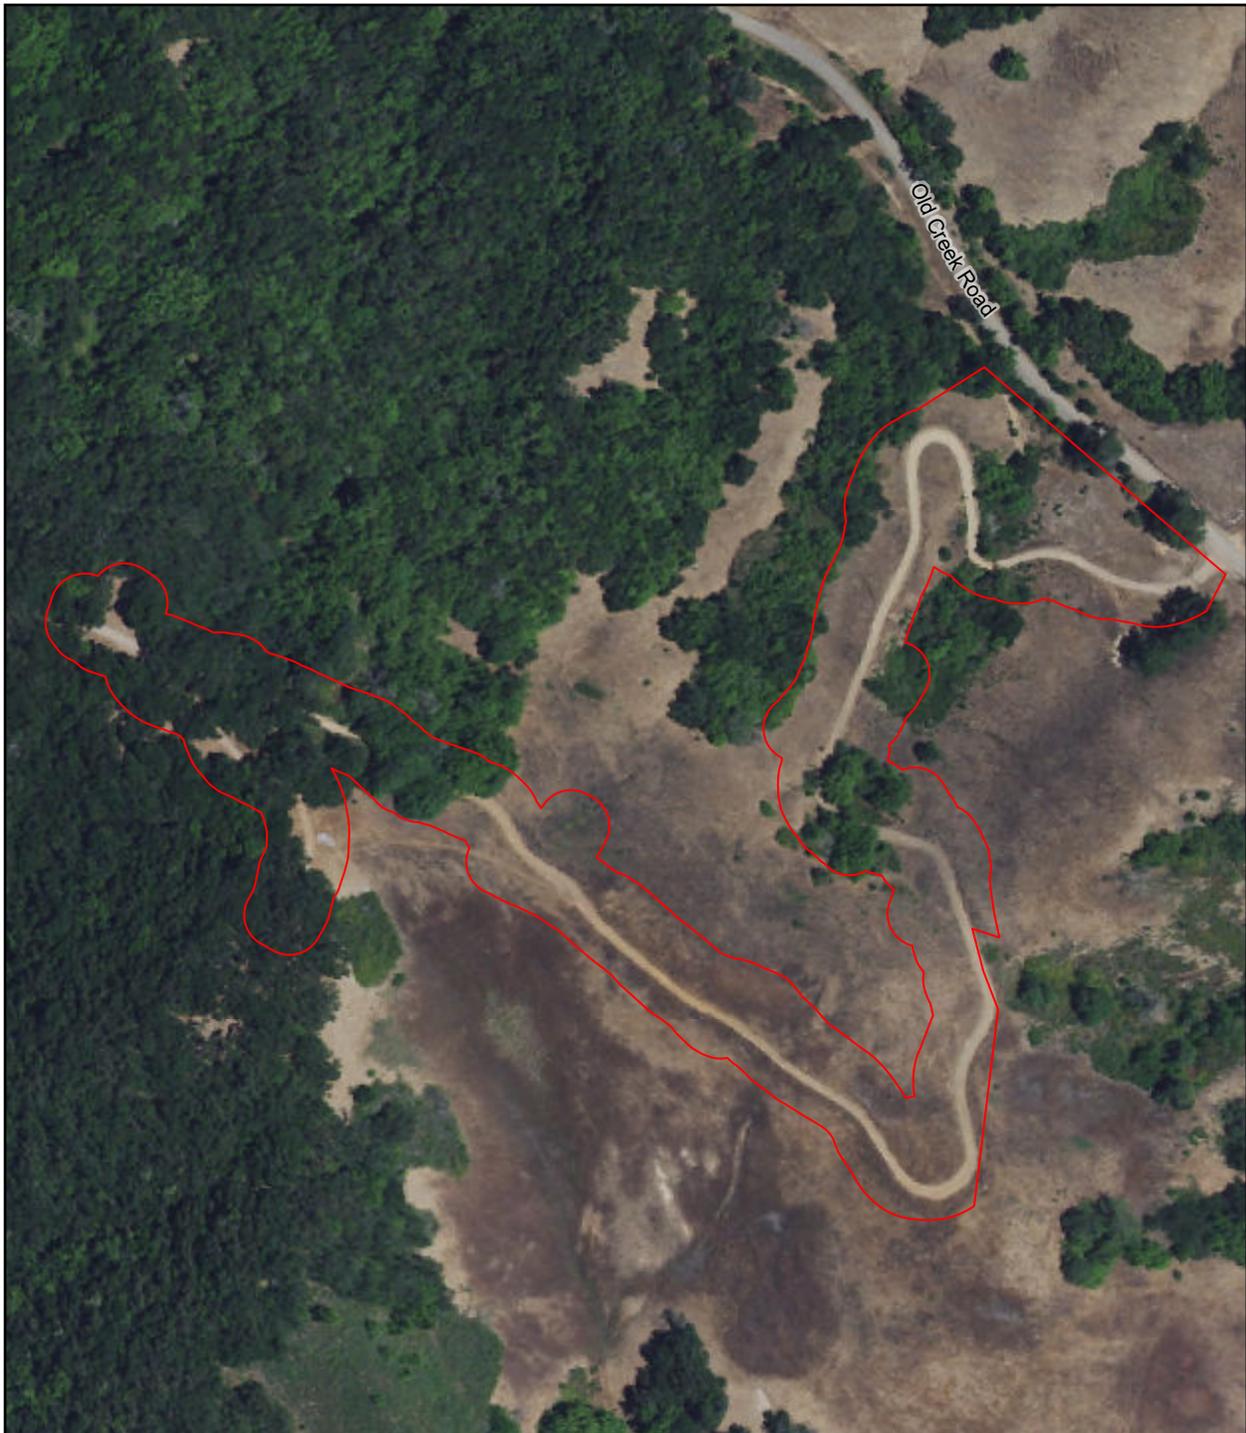
Figure 2. Aerial Photograph

The Study Area is an undeveloped parcel of land dominated by non-native grassland, mixed woodland, and oak woodland habitats (Figure 2). Entrance to the site is from an existing gate and dirt access road on the southwest side of Old Creek Road. The access road is approximately 20 feet wide and winds steeply uphill from east to west through the property. The road is used to access a neighboring property and vineyard to the west.

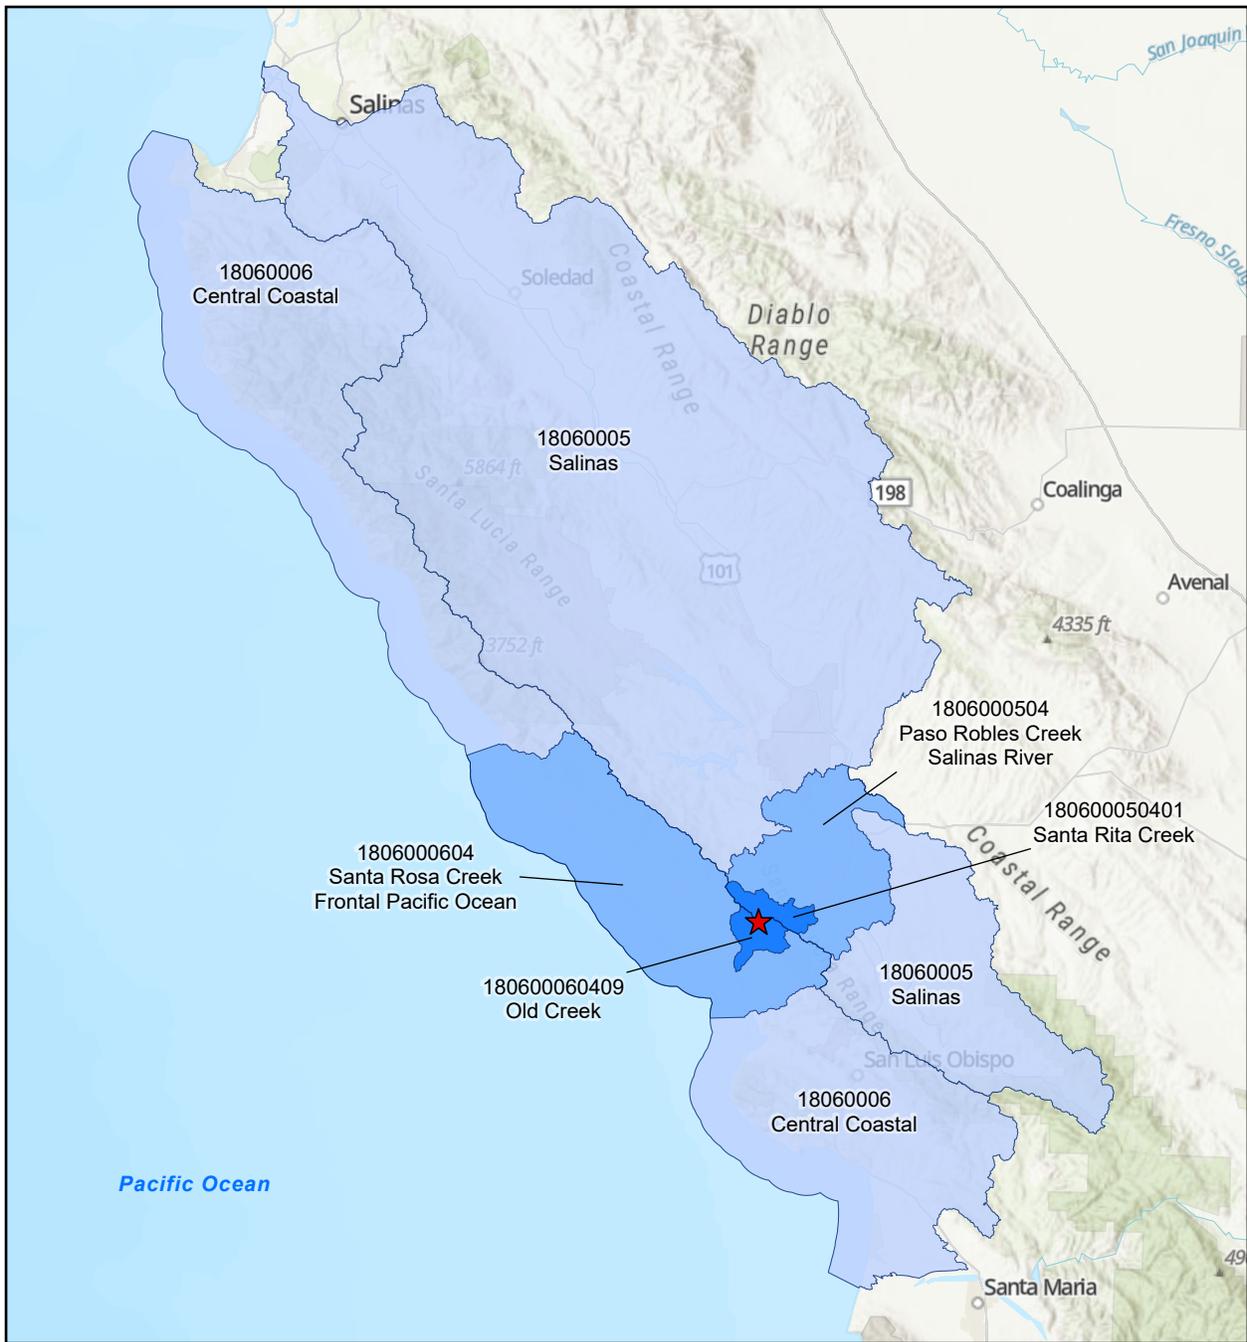
Figure 3. Hydrologic Unit Codes

The USGS and United States Department of Agriculture (USDA)-Natural Resource Conservation Service (NRCS) developed nationally consistent watershed boundaries which range from a two digit code as the first level of classification (Hydrologic Unit Code [HUC] 2) to a 12 digit code for the most detailed watershed delineation (HUC12). The Study Area straddles the Coastal and Salinas watershed (HUC8) with water on the north half of the Study Area flowing north to Santa Rita Creek. Santa Rita Creek flows into Paso Robles Creek and then the Salinas River (Figure 3). A small ephemeral drainage occurs in the northern portion of the Study Area that supports riparian tree species such as California bay (*Umbellularia californica*) and big leaf maple (*Acer macrophyllum*). The drainage conveys water northeast out of the Study Area to a culvert under Old Creek Road, which then flows approximately 120 feet to its confluence with Santa Rita Creek, a riverine and forested shrub wetland, and tributary to the Salinas River (Figures 4 and 5).
