# Jurisdictional Delineation Report

## Federal Boulevard Chollas Creek De-Channelization & Trail Project City of San Diego, San Diego County, California

Prepared June 8, 2020, updated May 5, 2021

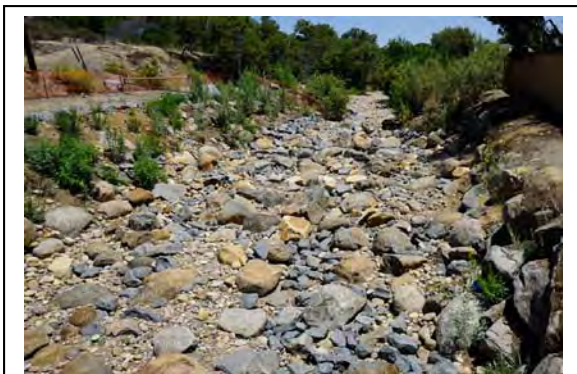
Channel would be similar to this post-restoration condition (Chollas Creek – Lenox Avenue Creek Restoration).

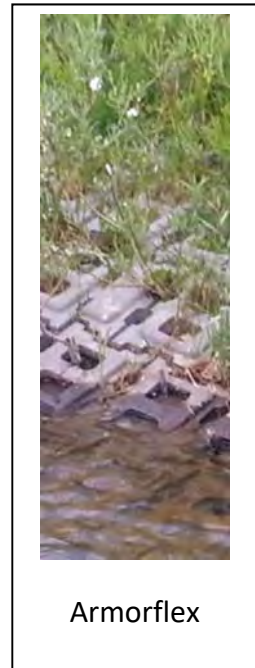
Armorflex

replaced with pipe. Channel access would be maintained through the installation of four access ramps on the north side of the channel, which will be stabilized with armor-flex (or equivalent) and herbaceous vegetation characteristic of Diegan coastal sage scrub. The proposed active channel would have a top width of about 80 feet, with a gentler channel slope to create velocity reduction. Four ungrouted natural-stone drop structures and one concrete drop structure (at the upstream end of the site) would be installed to create the gentle slope between drop structures, and dissipate energy. The largest drop structure at the upstream end of the project would incorporate a concrete spillway. Larger natural stone would be placed intermittently in the channel bottom, combined with the smaller natural stone to create a natural-looking streambed, similar to nearby reaches of Chollas Creek. Natural stone and natural grade control structures would be ungrouted to best mimic the natural streambed function.

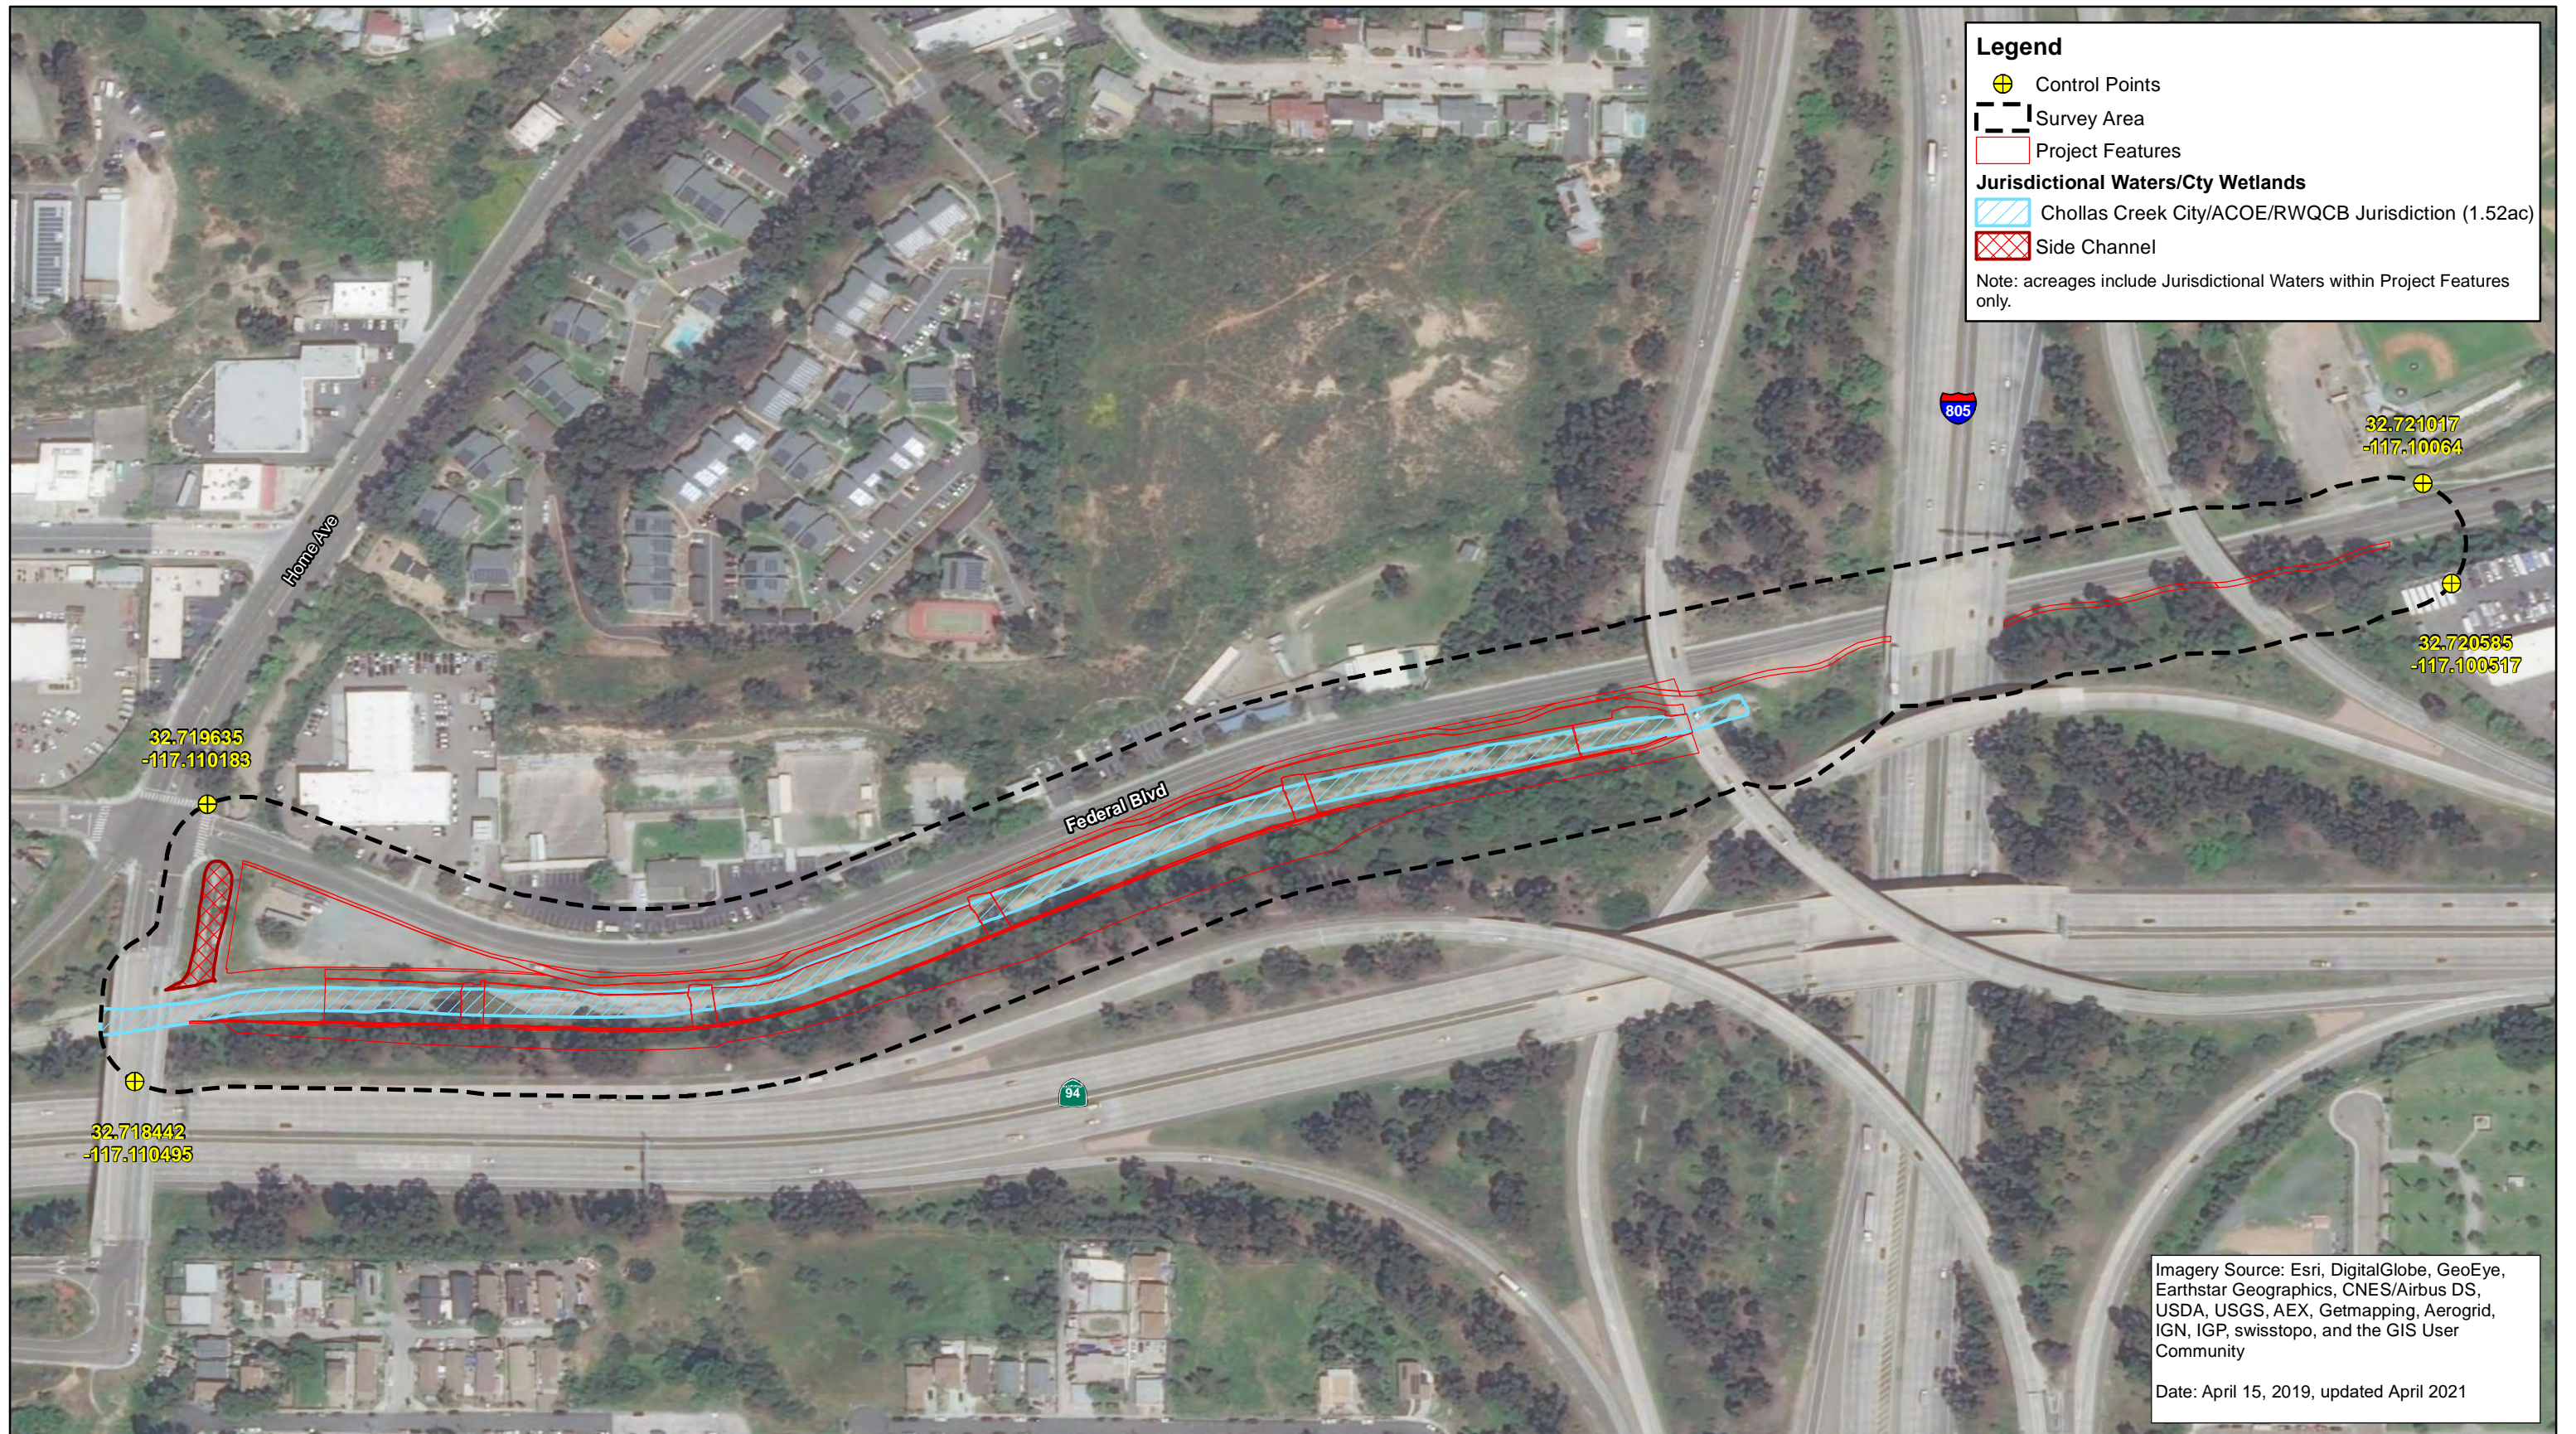
**Existing City/ACOE/RWQCB Jurisdiction**

The project limits contain Chollas Creek and one side drainage subject to the jurisdiction of the ACOE, the RWQCB, the CDFW and the City of San Diego. See Figures 11 and 12 for a map of jurisdiction. Table 2 provides a summary of acreage and linear feet. Site photos locations are depicted in Figure 13 and photos are found in Appendix A. The Arid Land JD Forms are found in Appendix B and Ordinary High Water Mark Forms are found in Appendix C.

The concrete lined channel would be considered a “non-wetland water of the US/State”. The channel bottom is 30 feet wide and the top of the channel is 50 feet wide. Some invasive plants have established within the cracks of the concrete. Under the 2020 ACOE “Navigable Waters Protection Rule” it would be considered a “Category (a)(2) Water of the US”, which is a tributary to a San Diego Bay and the Pacific Ocean (Traditionally Navigable Water) because of its intermittent flow.

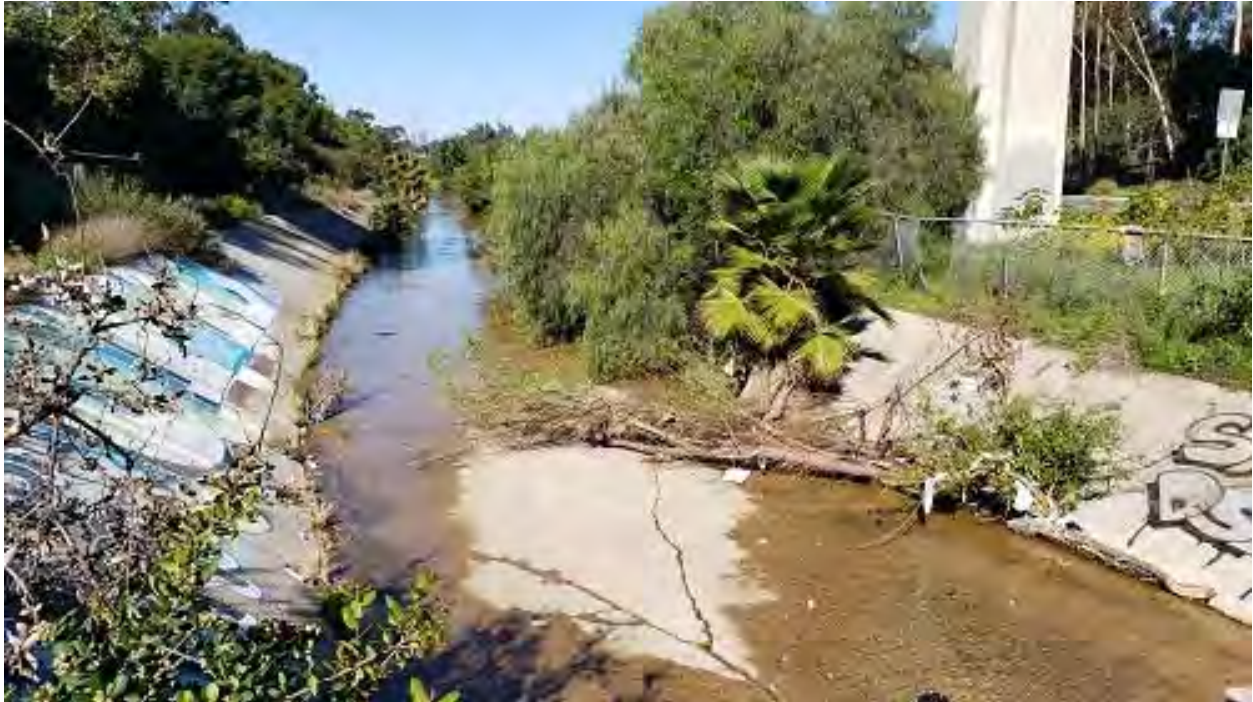
Photo 1: View of Chollas Creek from upper end of Project. Concrete removal will begin downstream of the I-805 Bridge piling, as seen on the right of the photo.

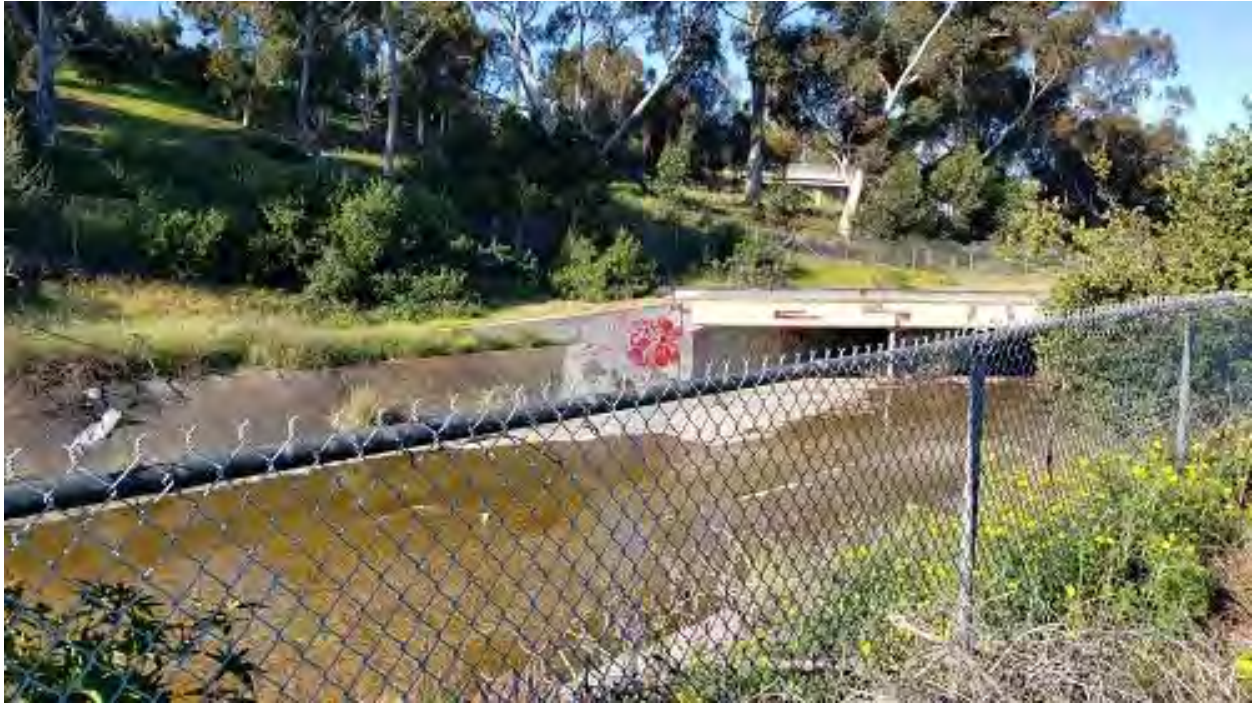
Photo 5. View of bridge structure that will be removed as part of the Project, looking downstream.
