# **BIOLOGICAL ASSESSMENT**

**23180 SHADY GROVE ROAD [APN 014-006-16]  
LAKE COUNTY, CALIFORNIA**

PROJECT № LAK008

FEBRUARY 3, 2020

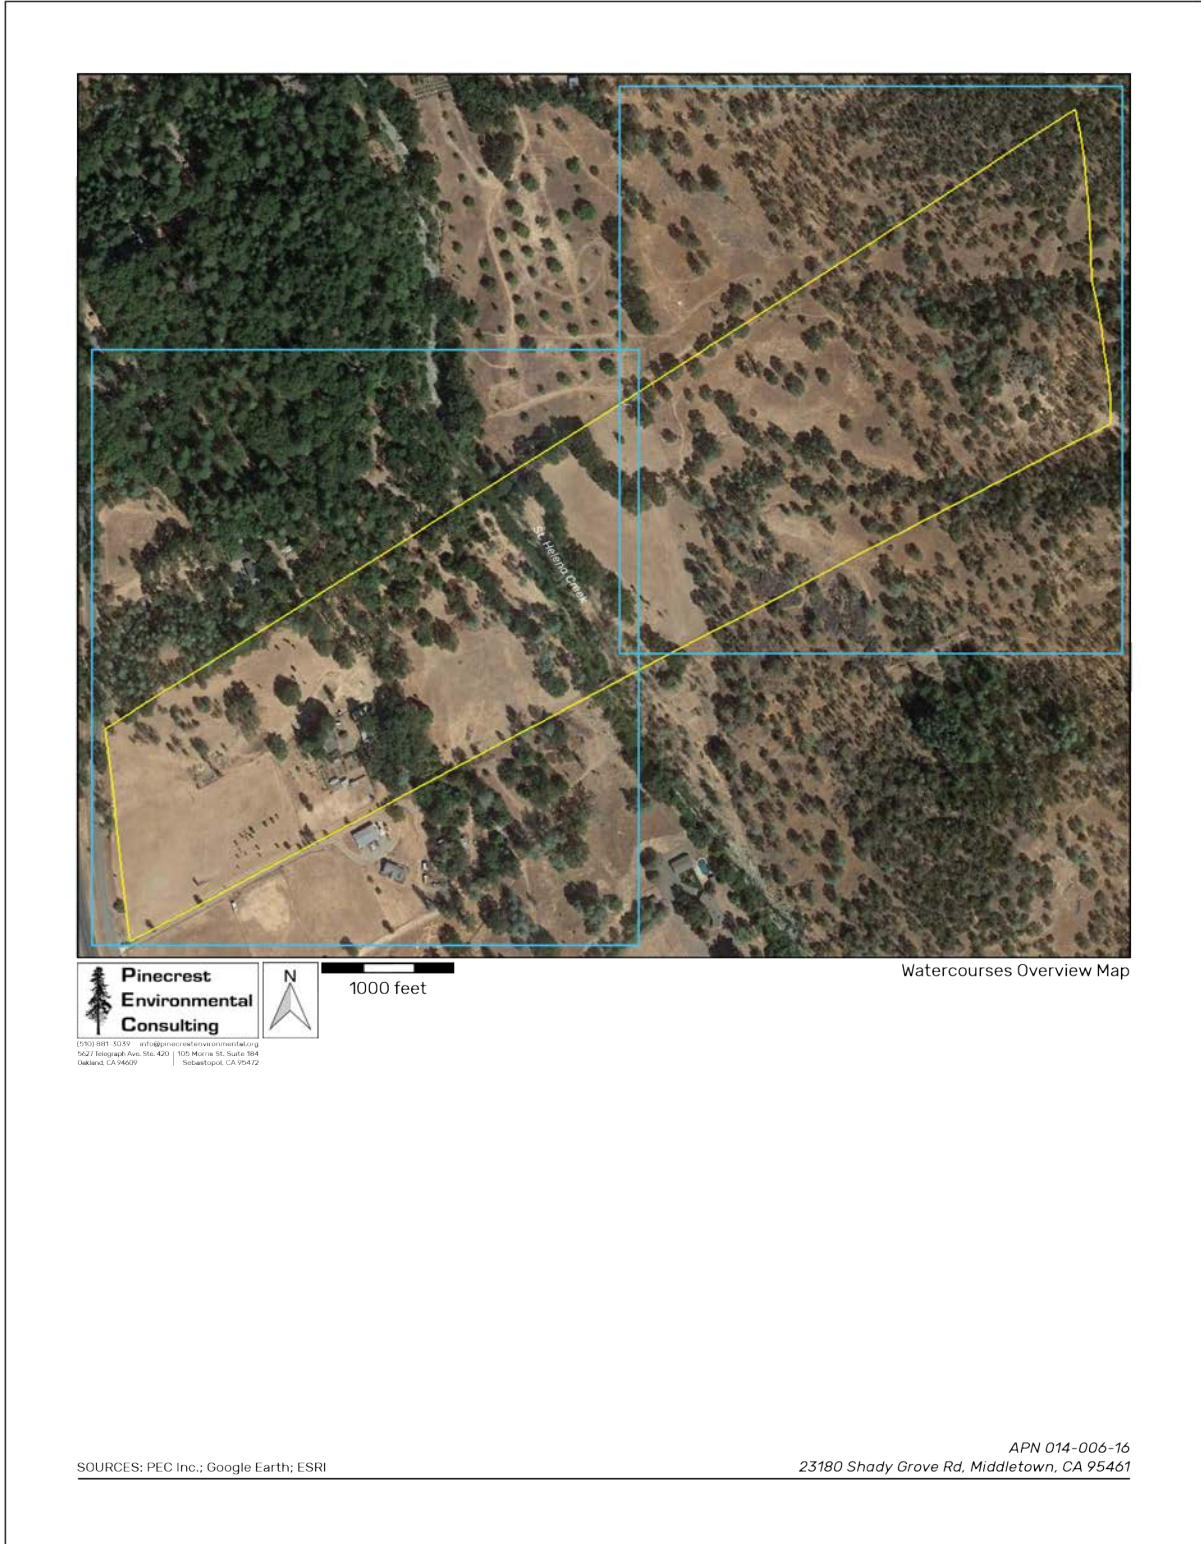
**FIGURE 3: WATER FEATURES OVERVIEW**

There are several unnamed and one named watercourse on site, as well as several potential wetlands (Figures 3-5). A Class I perennial reach of St. Helena Creek divides the parcel in two, flowing north through the middle of the property (Figure 12). St. Helena Creek is crossed by a metal span bridge (Figure 11) that appears to be stable and with footings that are not obviously eroding. The riparian corridor surrounding St. Helena Creek is well developed and stable. There is also an unnamed seasonal Class II watercourse flowing north through the western portion of the parcel (Figure 13) that is crossed via triple-barrel corrugated metal culvert crossing (Figure 10) that is not obviously in danger of failing but likely does not meet current design specifications for withstanding 100-year floods. This Class II watercourse exits the parcel to the north and joins with St. Helena Creek after flowing offsite for approximately 500 feet. There are also several Class III watercourses onsite. In the western portion of the site, two small stock ponds (Figures 15 & 17) are connected with a vegetated swale (Figure 16) that eventually empty into an unnamed ephemeral Class III watercourse (Figure 14) that flows east for approximately 150 feet before the confluence with the aforementioned unnamed Class II watercourse. There is some wetland vegetation surrounding the ponds and swale but not around the Class III watercourse.

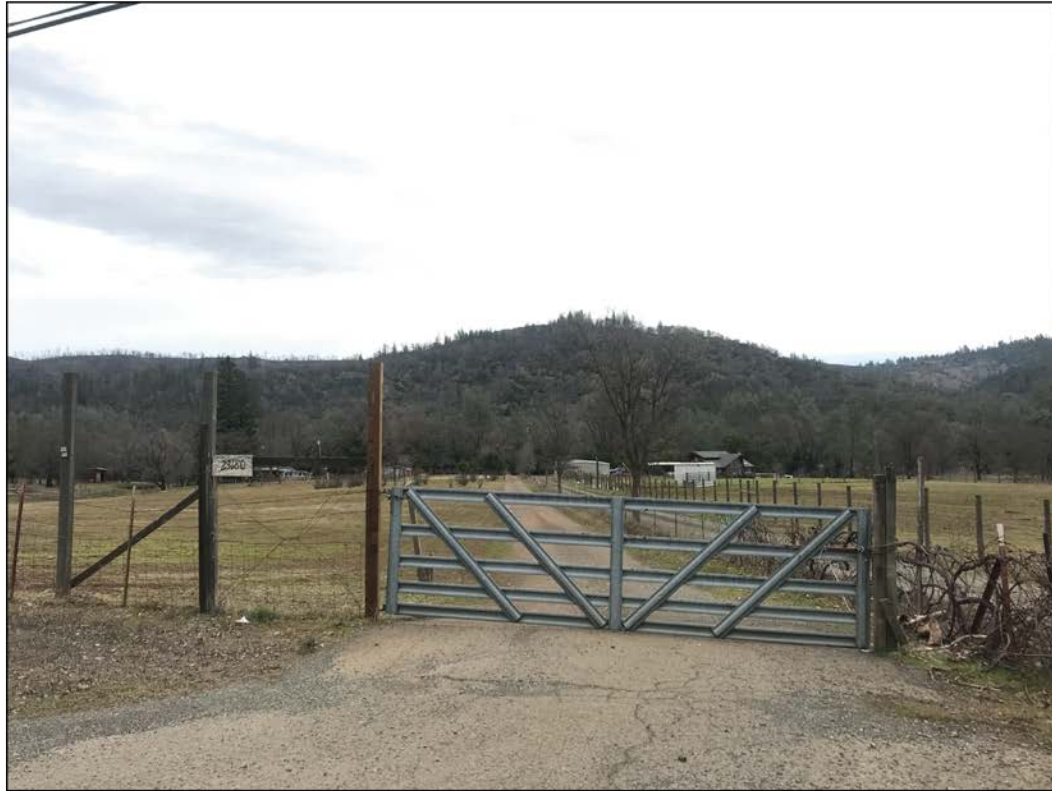
**FIGURE 6: PHOTOGRAPH OF ACCESS GATE**

Access to the parcel is provided off of Shady Grove Road to the south and is controlled via locking manual entry metal gate (Figure 6). The activity area is located at the end of a graded and graveled unpaved driveway (Figure 7) that is in good condition that travels east from the main gate. This driveway also continues past the main residence and follows the southern property line providing access to the remainder of the parcel (Figures 3-5). There are several existing structures onsite associated with the residence and rural agricultural and animal husbandry activities. There is one residence with garage and multiple outbuildings for chickens, tractors, and other farm related activities (Figure 8). After crossing the triple culvert (Figure 10) you reach a groundwater well and several HDPE water storage tanks (Figure 9) adjacent to a large grassland area that would be suitable for cultivation (Figure 18). Further along the road is a metal span bridge (Figure 11) and another potential cultivation area (Figure 19). Most of the parcel is surrounded by barbed wire fence, and there is a utility pole that transmits electricity via aerial lines off of Shady Grove Road. Other than that there are no other built structures onsite.

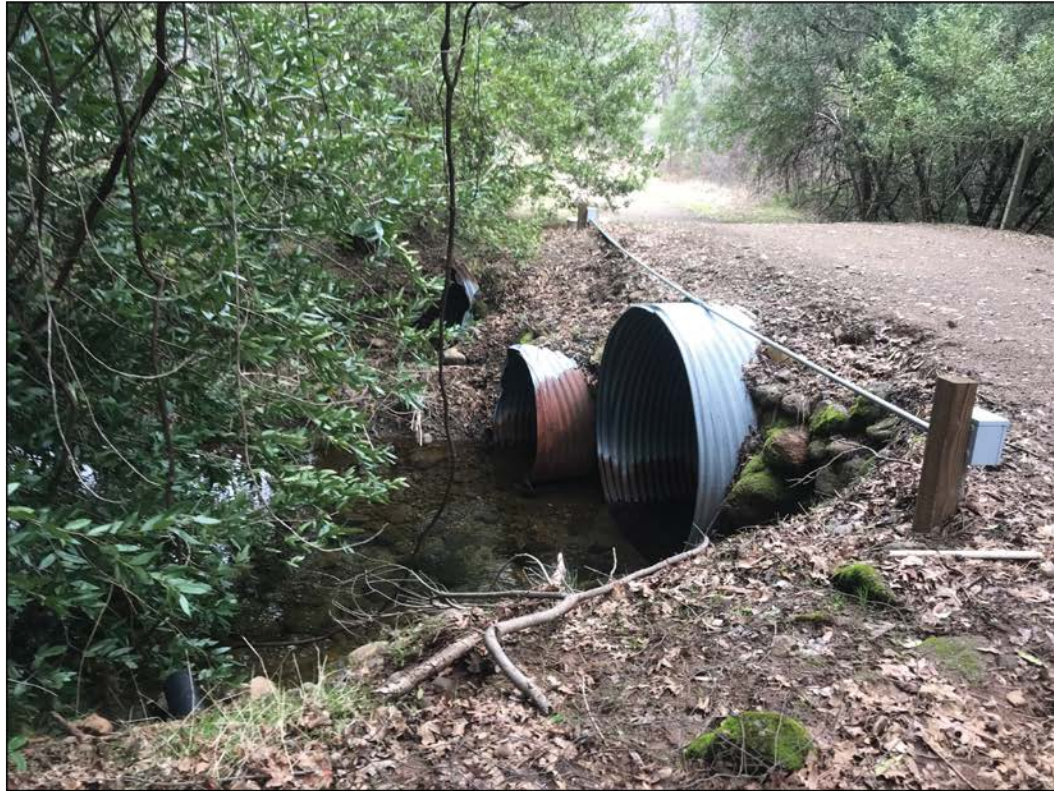
**FIGURE 10: PHOTOGRAPH OF TRIPLE CULVERT**

No impacts are predicted for sediment discharge to watercourses or wetlands due to the location of proposed cultivation areas outside of required setbacks from watercourses and wetlands. The bridge over the Class I watercourse, and the triple culvert over the Class II watercourse, may need to be registered with CDFW, and consultation with a hydrologist is recommended to determine whether these features are properly sized for a 100-year flood. The driveway is not currently eroding however the outlet to the second pond does not have any protection and is in danger of headcutting and thus some emergency erosion prevention measures should be installed here in consultation with a hydrologist. Native woody species should be planted around the perimeter of these ponds and anywhere else there is bare soil there should be native grasses sown. Additional erosion control measures described in Appendix D should be implemented, and we encourage the use of native vegetation along road cuts and anywhere soil stabilization is required in the future.

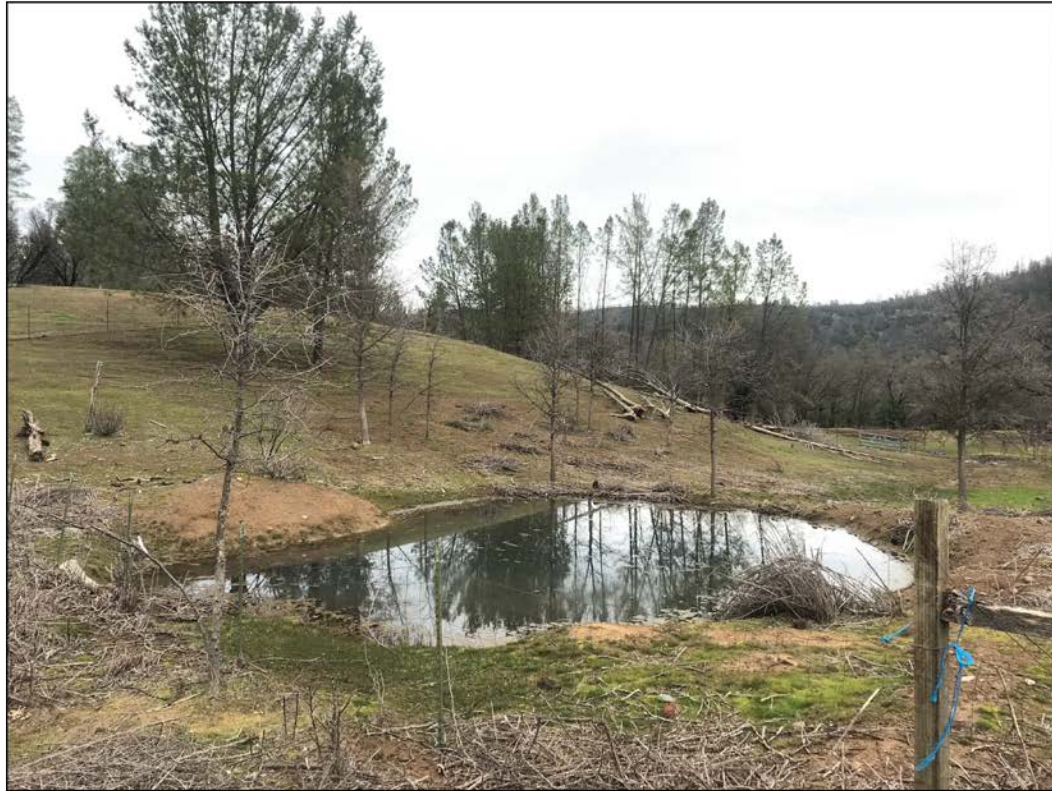
**FIGURE 15: PHOTOGRAPH OF POND A**

Several areas may contain wetlands subject to Army Corps of Engineers (ACOE) jurisdiction, however a protocol-level wetland delineation was not performed. Some wetland vegetation exists around the westernmost pond (Figure 15) however it is not known whether it meets sufficient criteria for jurisdictional wetland. The vegetated swale downstream of this feature (Figure 16) also exhibits some characteristics of wetlands however the vegetation may not have sufficient cover. There may
