MEMORANDUM

To: Simon A. Poulter, Padre Associates, Inc. Date: July 12, 2021
 From: Wenkai Qin, Ph.D., P.E., NV5, Inc.
Project: PRC 421 Decommissioning Project, Goleta, California
Subject: Coastal Impact Assessment for Decommission of PRC 421 Caissons
 CC: Jennifer Leighton, Padre Associates, Inc.

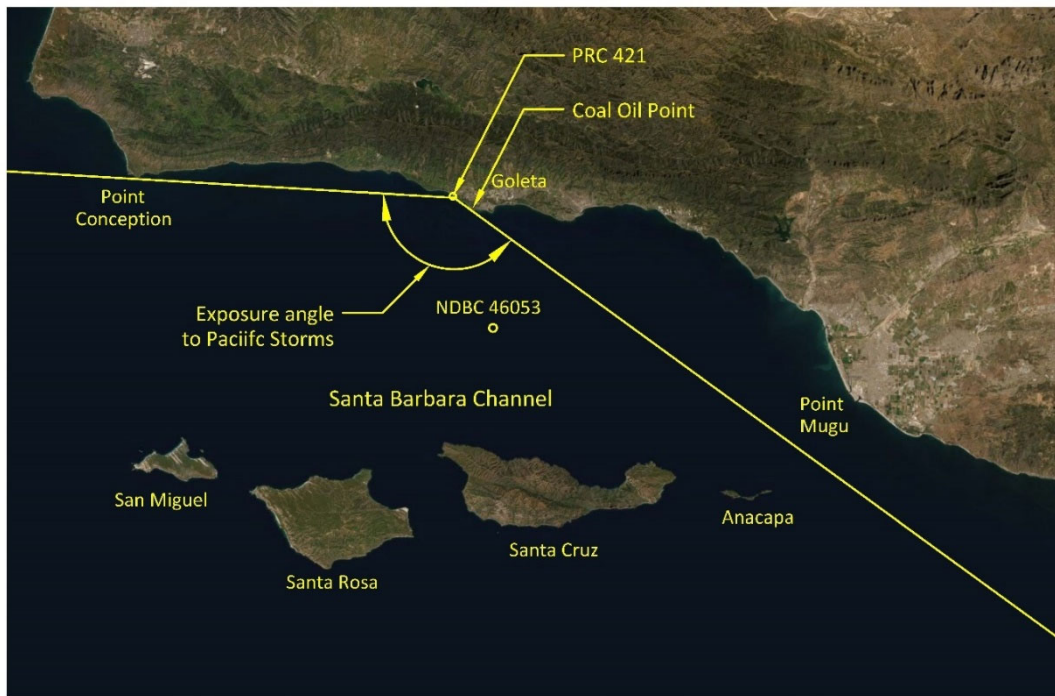
Because of Point Conception and Coal Oil Point, PRC 421 is only exposed to waves coming from the southeast and then clockwise to approximately the west, as shown in Figure 4. Furthermore, the offshore Channel Islands provide some sheltering for waves coming from the Pacific Ocean within this exposure angle and reduce the energy of many ocean swells before they reach Santa Barbara Channel.

Figure 4. PRC 421 Exposure Angle to Pacific Storms

The NOAA National Data Buoy Center (NDBC) maintains a buoy station (NDBC 46053) inside Santa Barbara Channel. The location of this station is shown in Figure 4. Deployed at a water depth of approximately 1,300 feet, this buoy has collected the wave data since 1994. Because this buoy is located within the Channel, the sheltering effect of the offshore Channel Islands is already reflected in the measured data. As waves propagate from the deep water to nearshore coastal areas, they will be further altered by shoaling, refraction, diffraction, and breaking processes because of the variations in local bathymetry. By considering wave shoaling, refraction, and breaking, the hourly wave data measured at the NDBC 46053 buoy was transformed to a nearshore location at approximately -6 feet, NAVD88, which is approximately 300 feet offshore from the PRC 421 caissons. Figure 5 shows the joint distribution of significant wave heights and wave directions at this location. As shown in this figure, the wave direction is from the southwest (SW) direction during approximately 40% of the time and from the west southwest (WSW) direction during approximately 58% of the time. The waves from other directions are negligible. The dominant SW to WSW wave directions is a combined result of the specific wave exposure angle, the sheltering effect of the Channel Islands, and the local nearshore plain/contour orientation that faces SW.

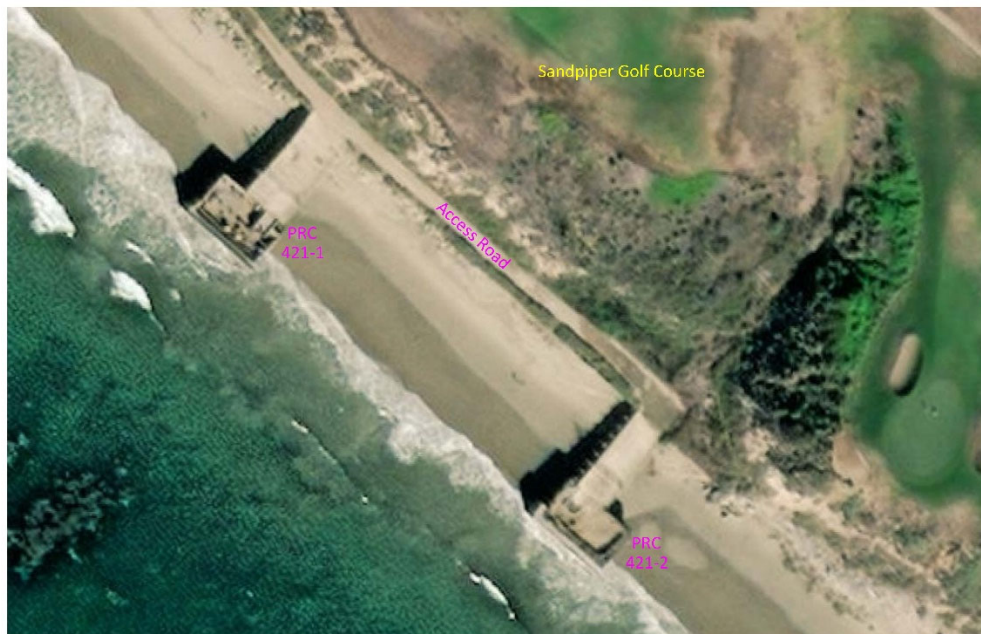
The primary facilities associated with PRC 421 occupy approximately 11,600 square feet of pier space and include two piers on State tide and submerged lands below the bluffs at the southern limit of Sandpiper Golf Course, as shown in Figure 6 and Figure 7. The two piers, Pier 421-1 and Pier 421-2, were built with vertical steel piles with overlying horizontal steel I-beams and wood timber decking and are approximately 325 feet apart. Each caisson is approximately 80 feet in length (in the alongshore direction). The PRC 421-1 caisson is approximately 40 feet wide (in the cross-shore direction), and the PRC 421-2 caisson is approximately 30 feet wide. The piers provide access and support for two wells on separate concrete caissons. Both PRC 421 wells have been plugged to the surface with concrete.

Figure 6. PRC 421 Facilities

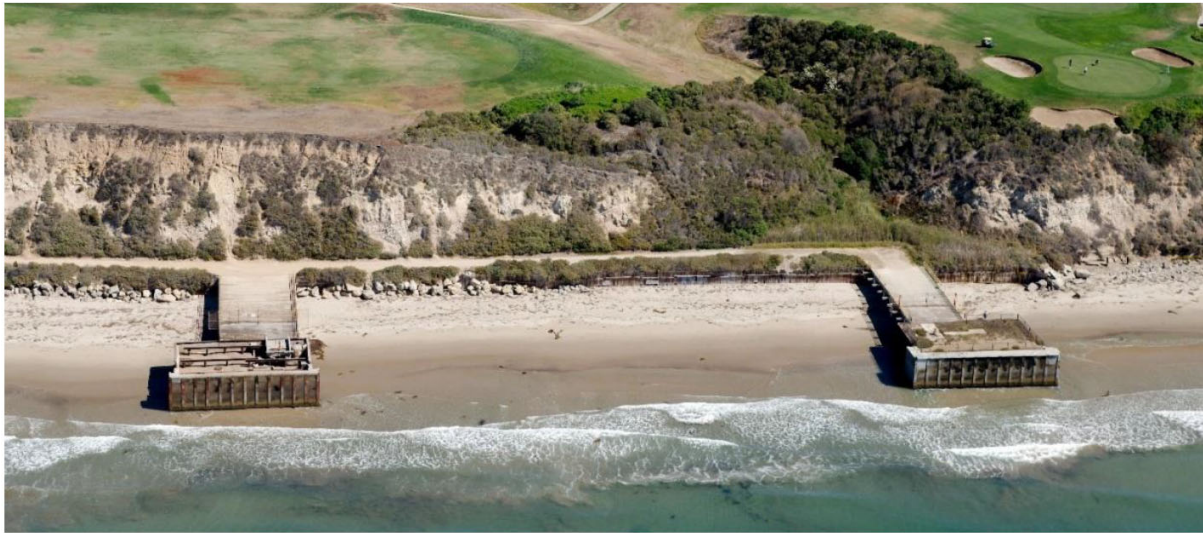
One project alternative consists of a full removal of the piers, pier caissons and well portions above the bedrock, back to the wooden seawall abutments at the intersection of the access road. The caissons, sitting on the beach, and the piles that support the piers have provided a wave sheltering effect for the areas behind (landward of) the caissons during high tides and thus have provided erosion protection for the beach and the shoreline behind these caissons. Removal of pier caissons and piles may impact the local coastal processes in the area adjacent to PRC 421. The sizes of the pier piles are negligible compared to the wavelength and the dimensions of the caissons. Therefore, the impact of pier pile removal on coastal processes is negligible and our coastal impact assessment focuses on the removal of the two pier caissons.

Figure 7. PRC 421 Caissons and Piers

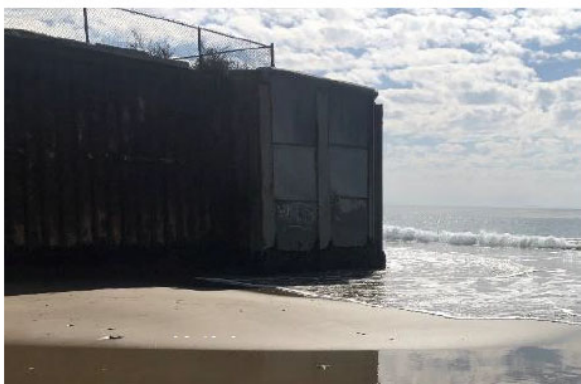
Low sand level – Mar 2020 at 0’ to 3’ tides

High sand level – Sept 2020 at 2’ to 6’ tides

Figure 12. Sand Level at PRC 421

PRC caissons may act as a short sand-retention structure during high tides that will help prevent sand from moving southeast in the beach area and thus help retain more sand on the upcoast. However, because of the limited width (30 to 40 feet) of the caissons and the relative high sand level, this impact is expected to be insignificant.

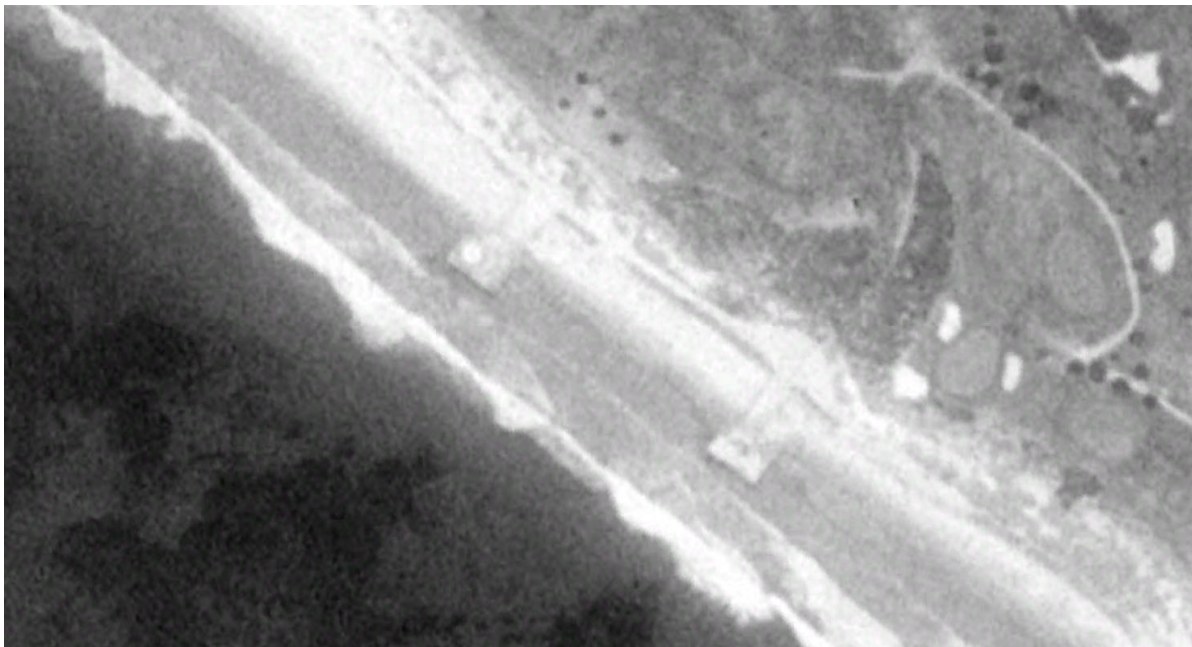
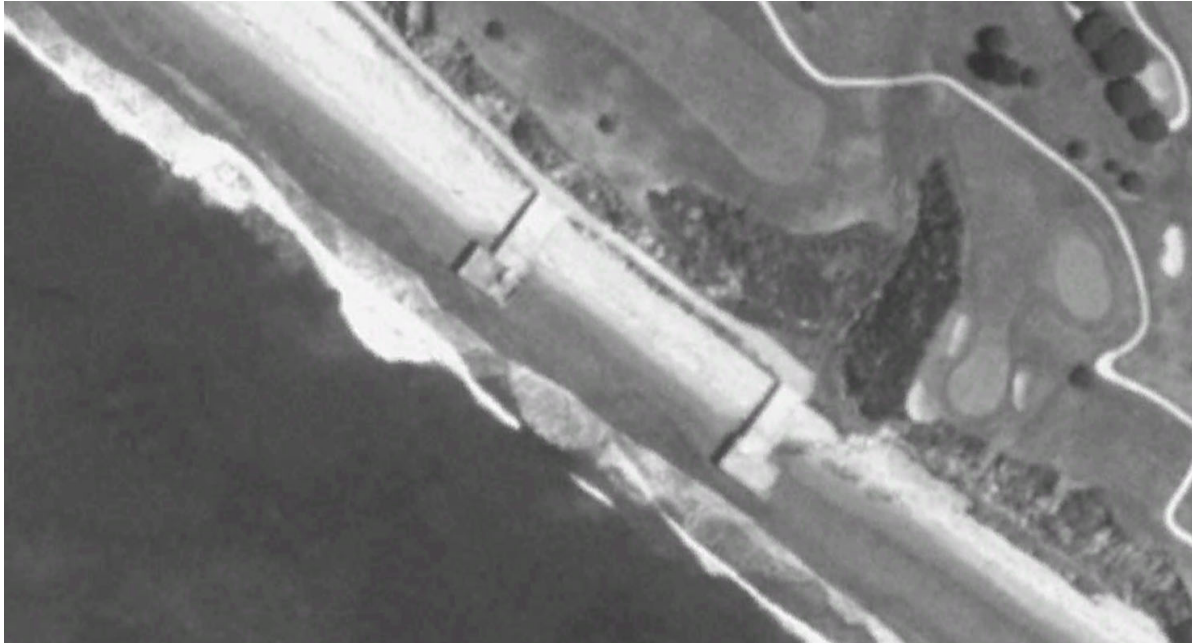
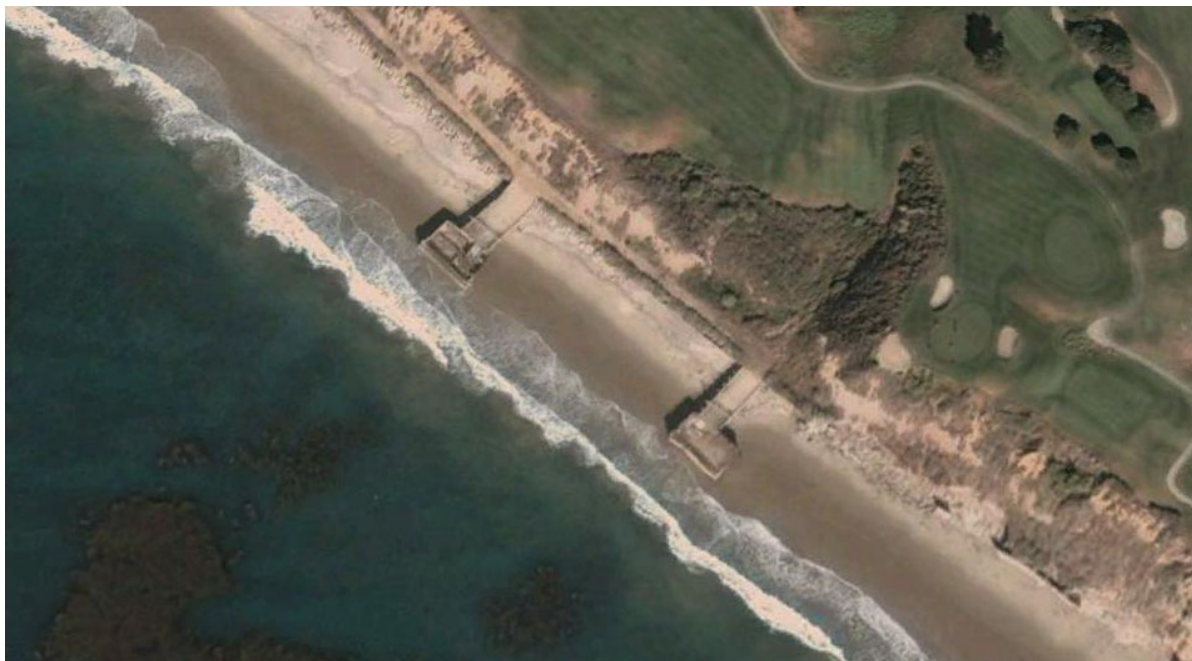
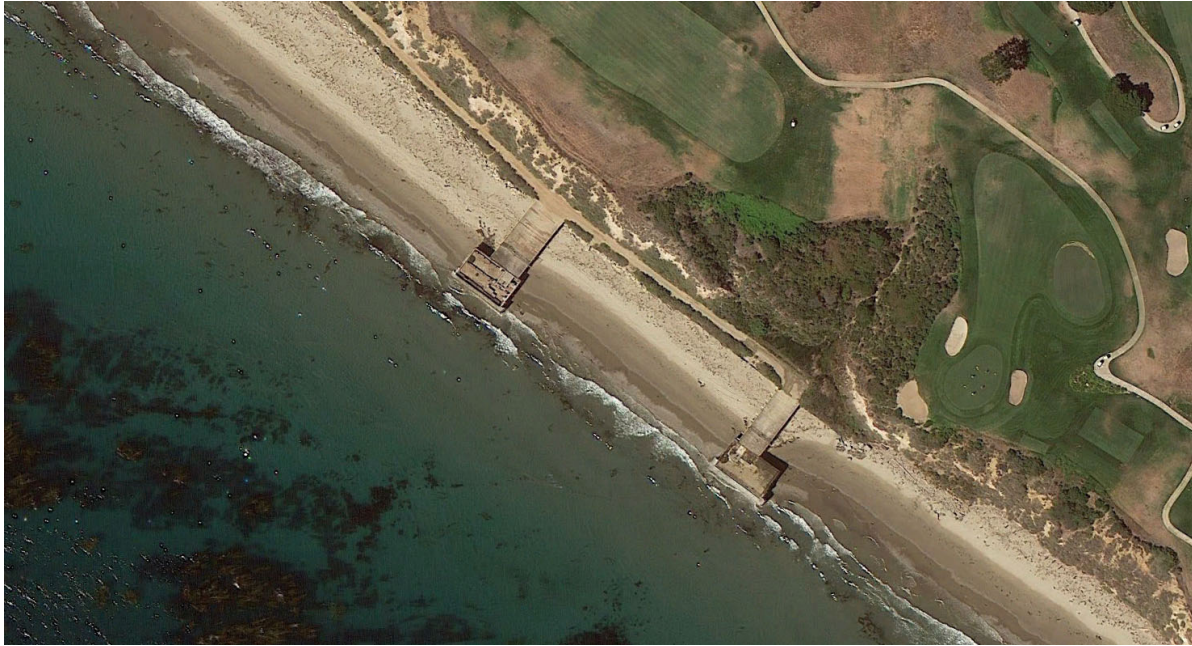
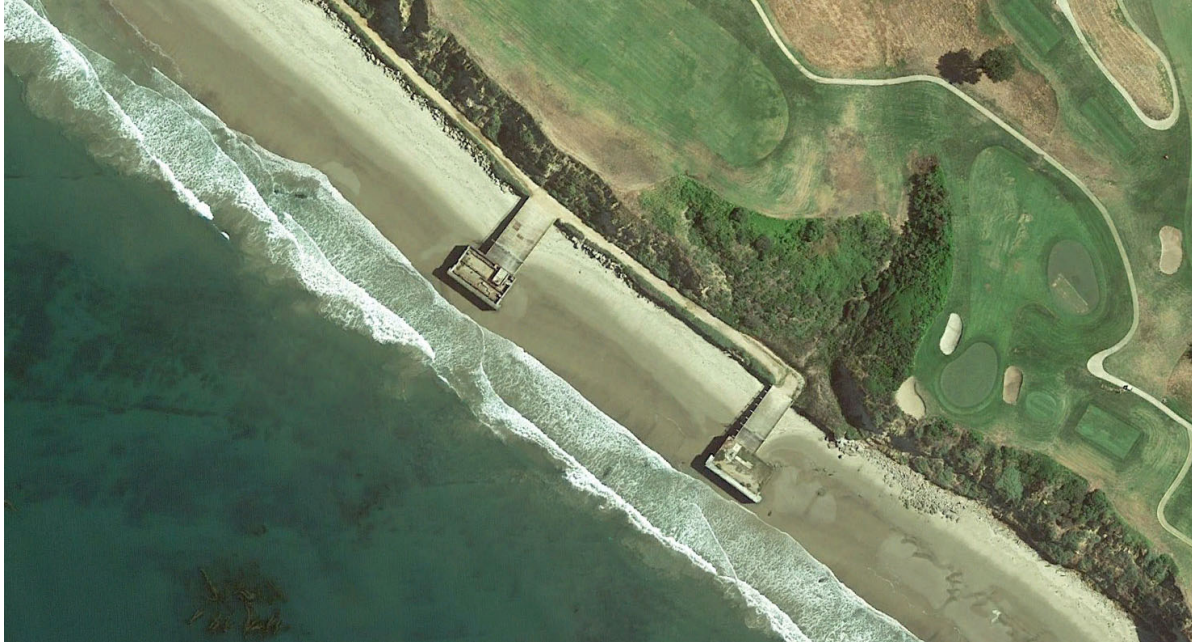
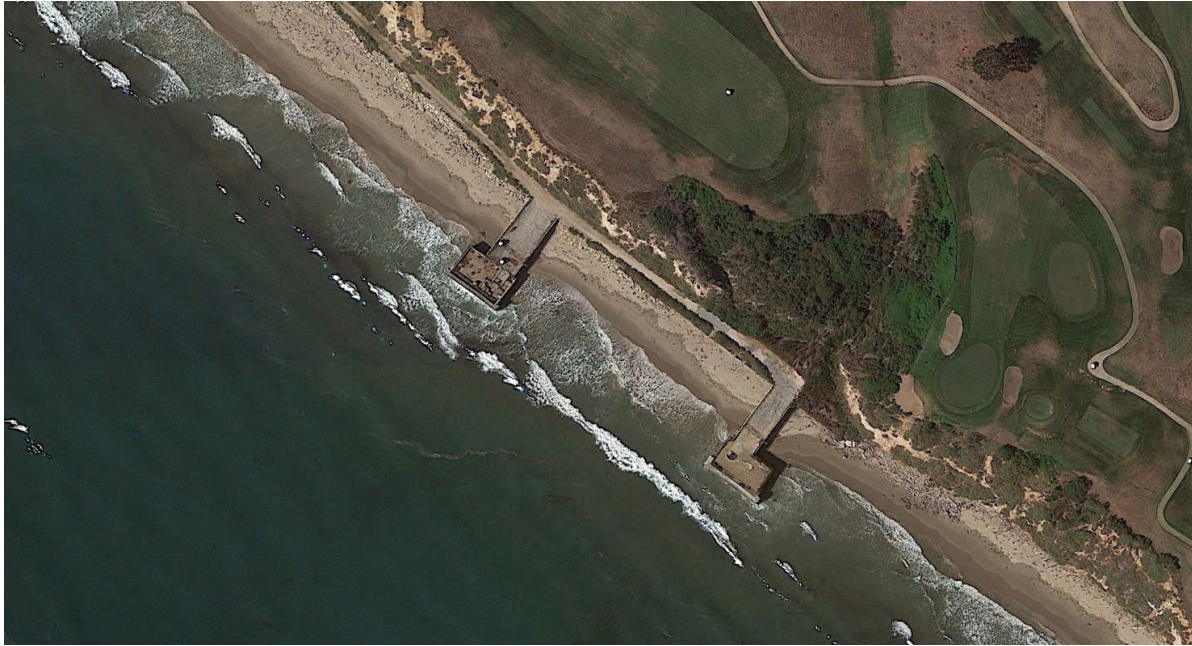
Historical Google Earth images were also analyzed to assist in our long-term shoreline impact assessment. Figure 13 through Figure 18 shows the wide beach condition in the summer or fall season in 1994, 2002, 2007, 2012, 2017, and 2019, respectively. No noticeable beach accretion or erosion trend is observed from these historical images. In other words, the beach or shoreline near PRC 421 is relatively stable without a significant long-term retreat or advance trend. It is also observed that the width of the beach upcoast (northwest) of PRC 421-2 is relatively uniform, except for June 2017 and August 2019 when the beach widths behind the PRC 421 caissons are slightly wider than the adjacent beaches.

Figure 13. Wide Beach Condition in May 1994

Figure 14. Wide Beach Condition in June 2002

Figure 15. Wide Beach Condition in September 2007

Figure 16. Wide Beach Condition in August 2012

Figure 17. Wide Beach Condition in June 2017

Figure 18. Wide Beach Condition in August 2019

The long-term shoreline and beach evolution mainly depends on alongshore sediment transport. It is concluded that the beach and shoreline near PRC 421 is relatively stable without a significant long-term retreat or advance trend. PRC 421 piers and caissons have insignificant impact on the alongshore currents, alongshore sediment transport, or long-term beach and shoreline evolution trend. Removal of PRC 421 is anticipated to have a negligible impact on the long-term beach and shoreline evolution in adjacent beaches. If there is any impact, the impact will be limited to the local areas behind the caissons and the impact is considered insignificant.

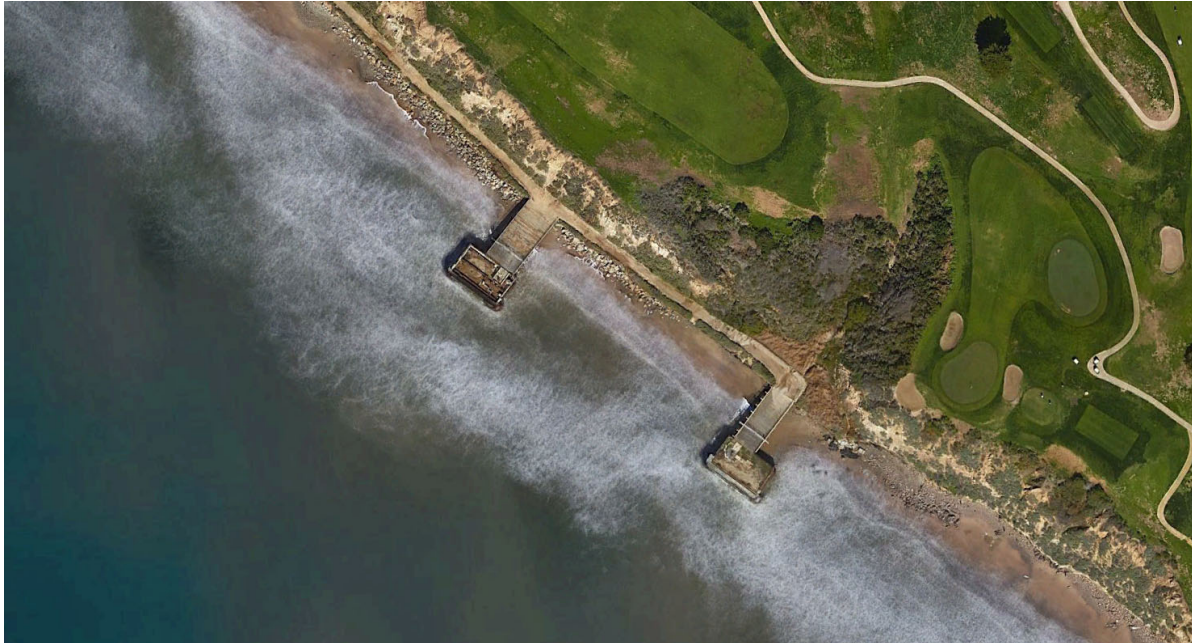
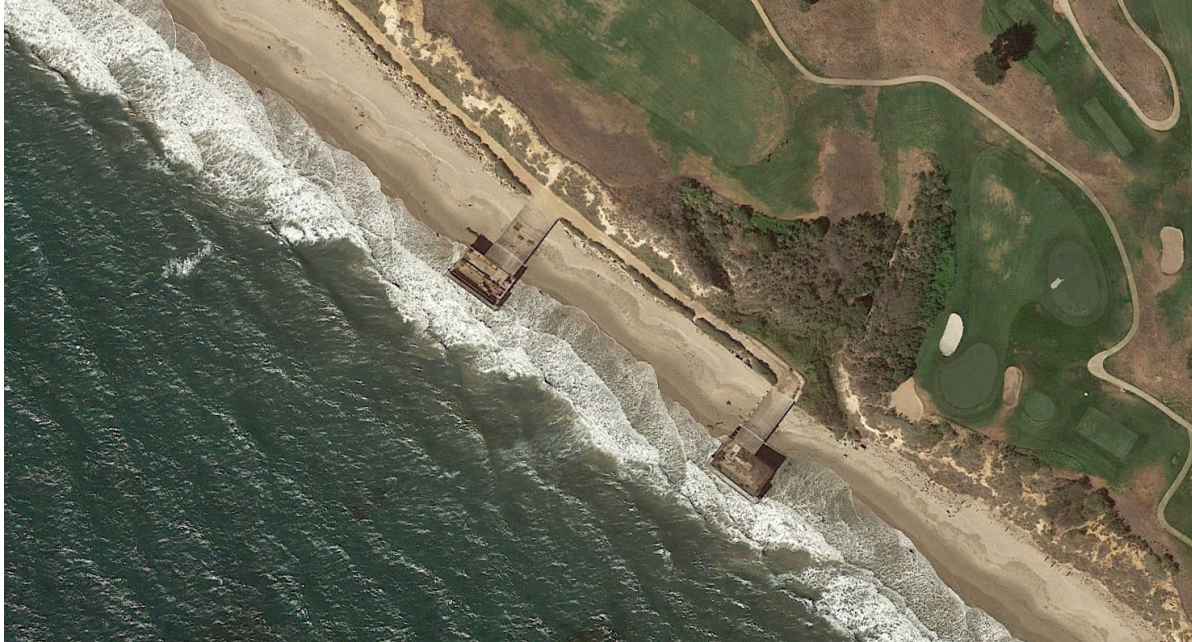
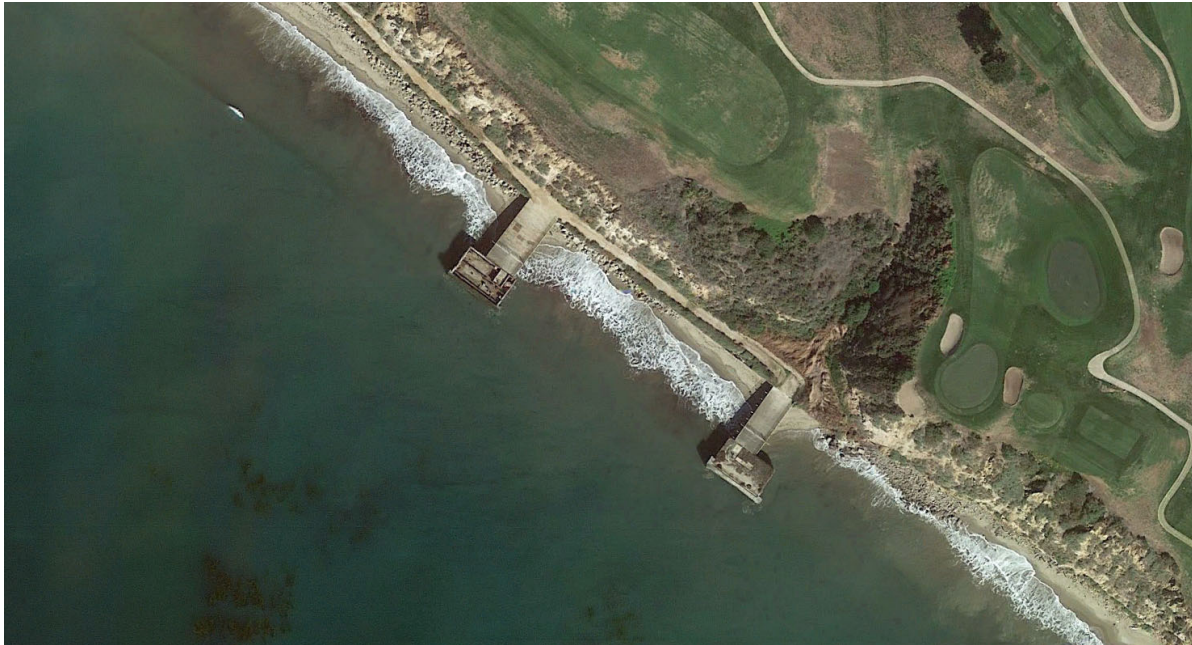
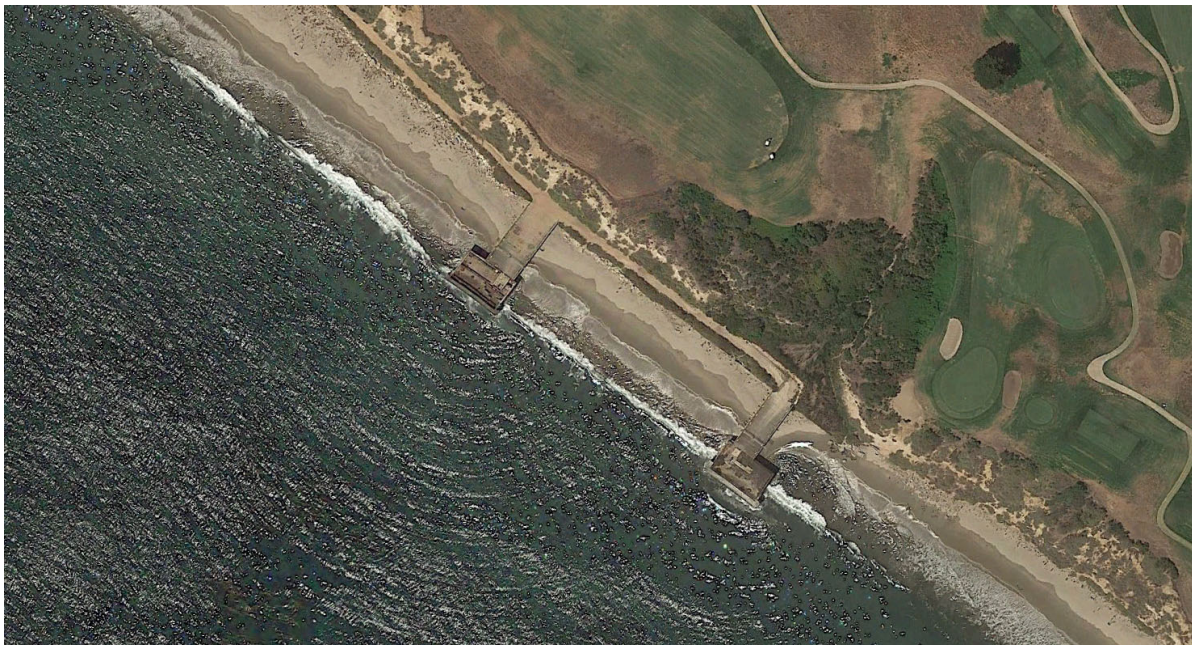
While beaches near the PRC 421 site are relatively stable without a noticeable long-term retreat or advance trend, it undergoes a significant seasonal variation between a wider “summer” beach and a narrower “winter” beach. Figure 19 shows the narrow “winter” beach in February 2016, and Figure 20 shows the wide beach in the subsequent summer/fall season. Figure 21 and Figure 22 show the seasonal variation of beach from a narrow “winter” beach to a wide “summer” beach in 2018. While the beaches near PRC 421 are wider in summer, it is much narrower (Figure 19 and Figure 21) or can be completely depleted, as shown in Figure 23 and Figure 24, in winter.

Figure 19. Narrower “Winter” Beach in February 2016

Figure 20. Wider “Summer” Beach in October 2016

Figure 21. Narrower “Winter” Beach in February 2018

Figure 22. Wider “Summer” Beach in August 2018

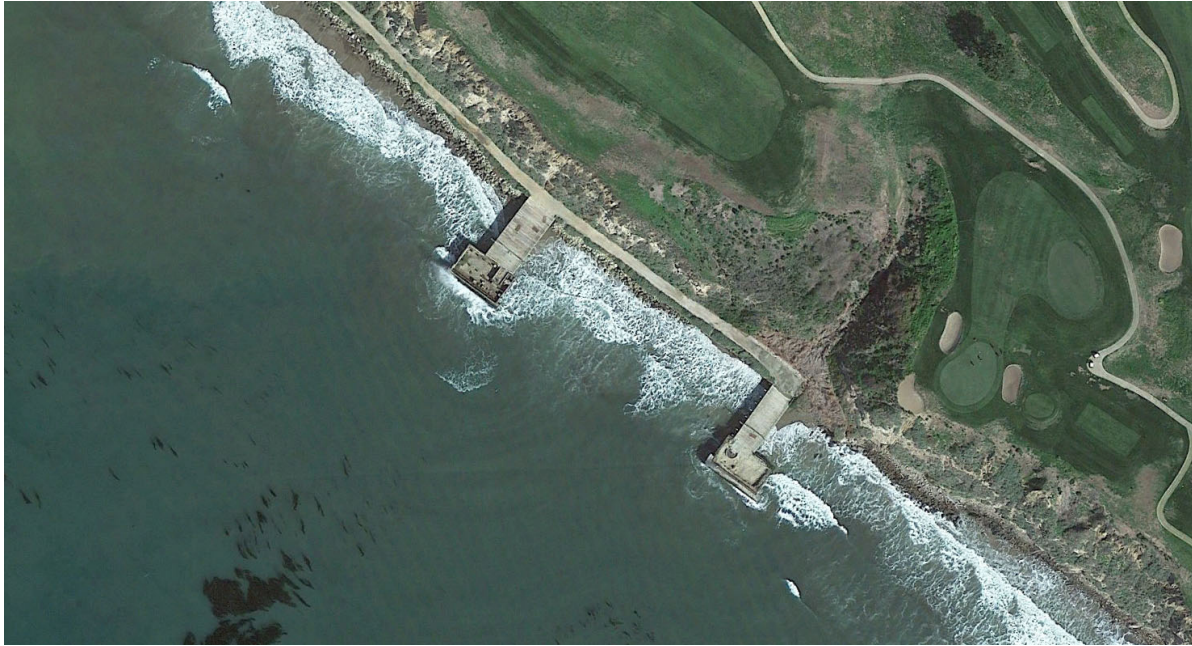
Figure 23. Depleted Beach Condition in February 2021

As discussed in Section 3.4, larger winter storms have caused severe beach erosions near the PRC 421 site. Removal of PRC 421 will expose the areas behind the caissons to storm-induced erosion in winter. The storm-induced erosion can significantly lower the sand level or even completely deplete the beach in front of the access road, as shown in Figure 23 and Figure 24.

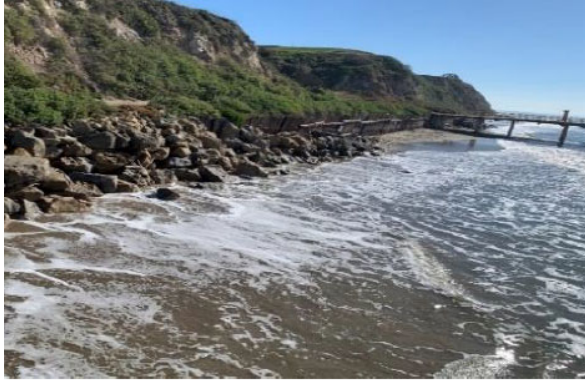
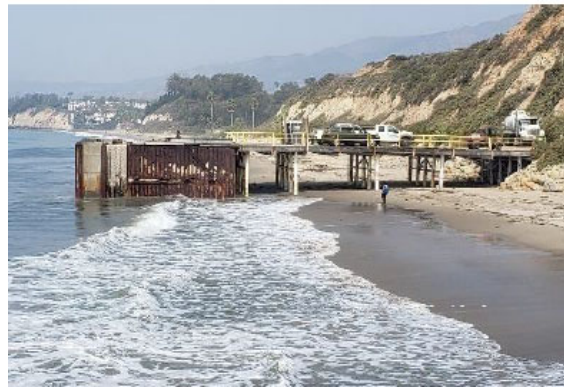
Depleted Beach – Mar 2020 at 0' to 3' Tides

Wider Beach – Sept 2020 at 2' to 6' Tides

Figure 24. Beach Sand Level at PRC 421

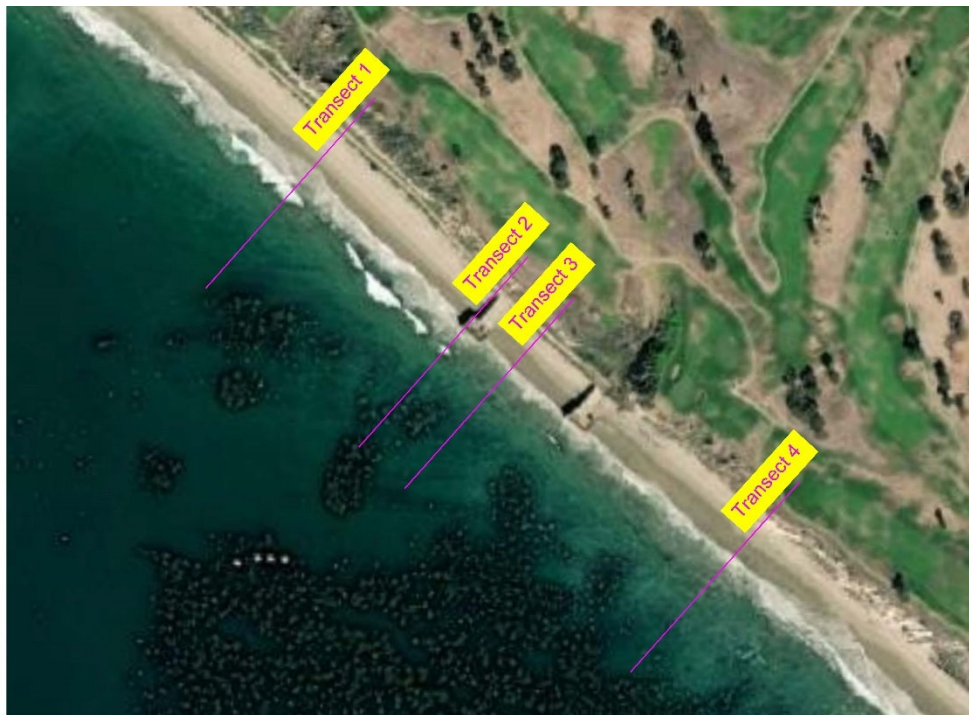
Figure 26 through Figure 29 show beach profiles at four transects near the PRC 421 site. The locations of these four transects are shown in Figure 25. Transect 1 is approximately 600 feet upcoast of PRC 421-1, Transect 2 is along the upcoast face of PRC 421-1, Transect 3 is at the approximately middle point between two caissons, and Transect 4 is approximately 600 feet downcoast of PRC 421-2. The beach profiles were developed based on the USGS 1-meter DEM (collected in summer 2018) and the NOAA nautical chart.

Figure 25. Location of Beach Transects

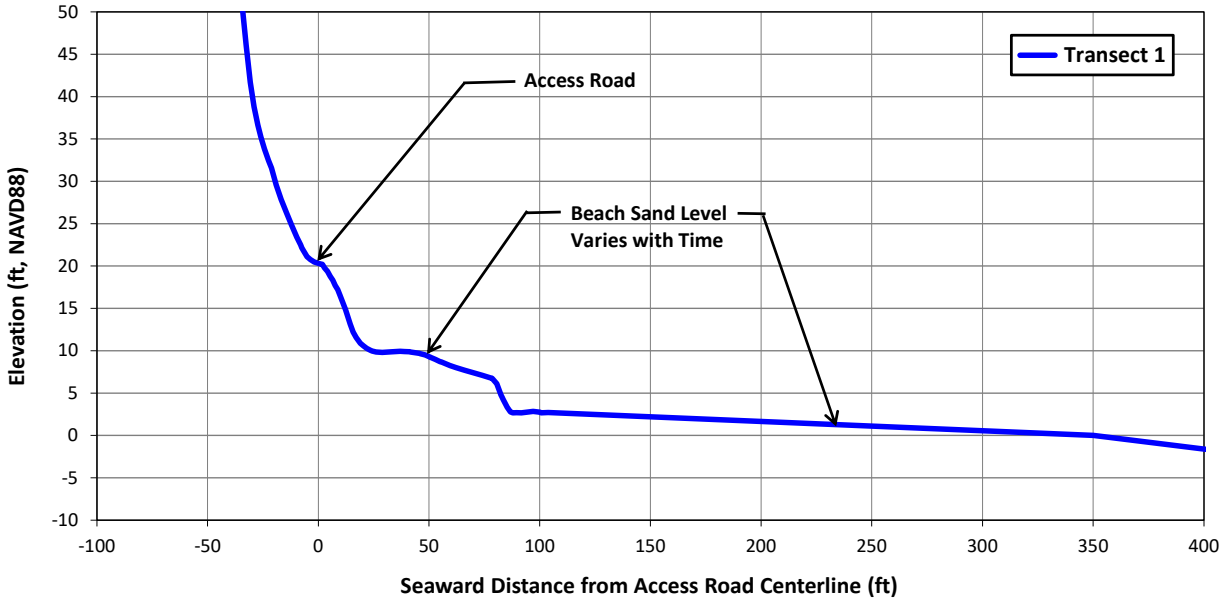
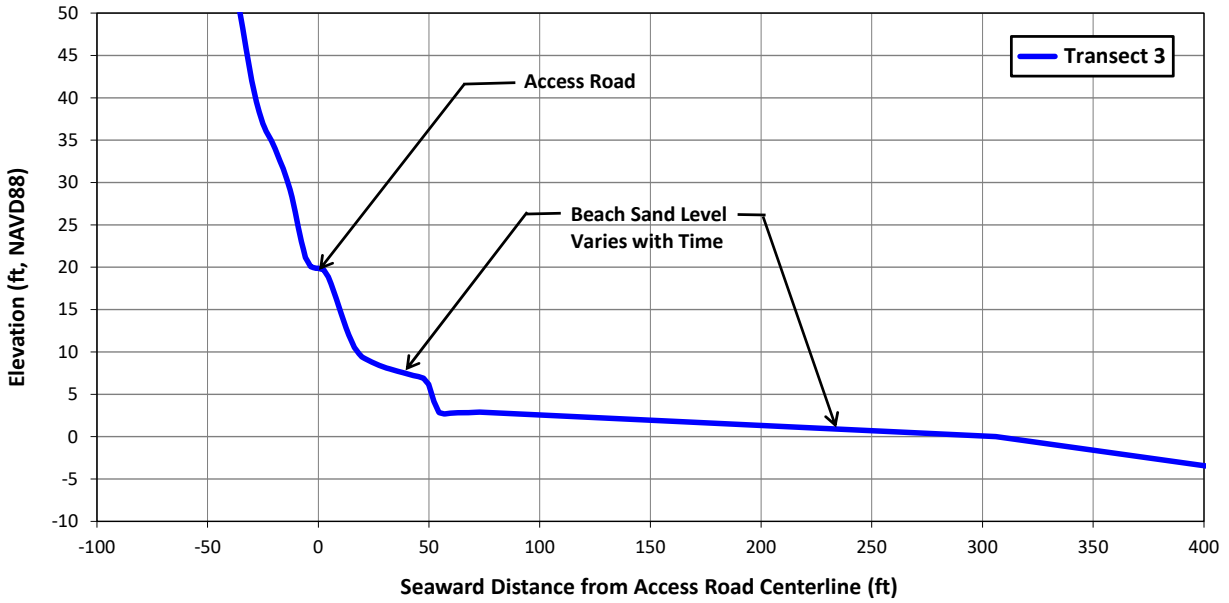
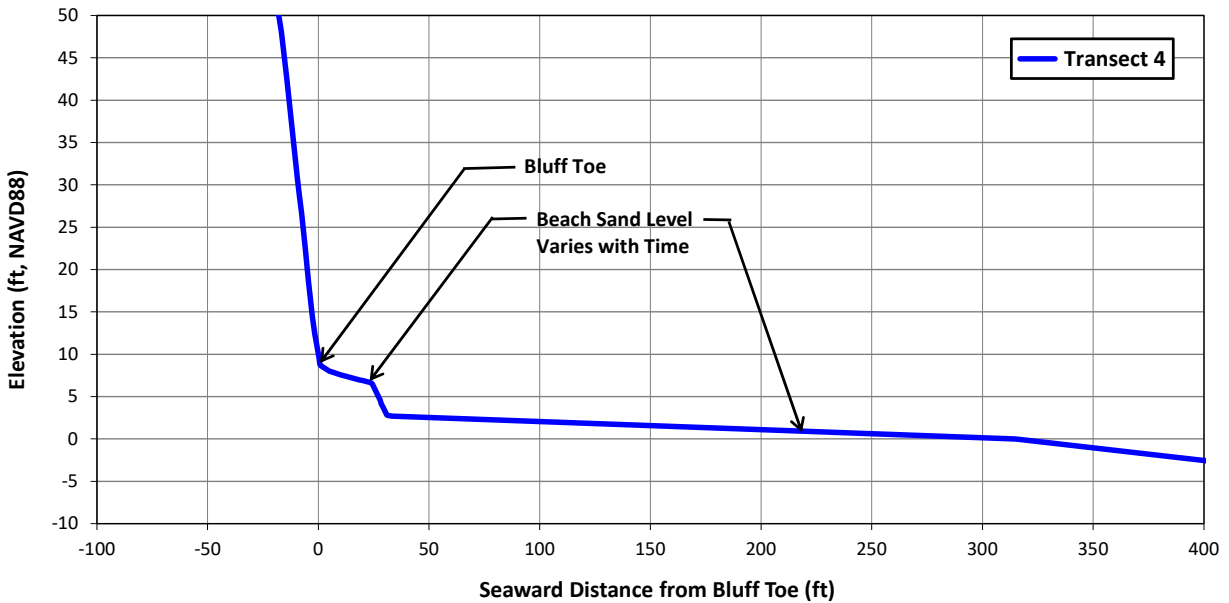
Figure 26. Approximate Beach Profile at Transect 1

Figure 27. Approximate Beach Profile at Transect 2

Figure 28. Approximate Beach Profile at Transect 3

Figure 29. Approximate Beach Profile at Transect 4

The beach sand elevation along the base of the access road is at approximately +10 feet, NAVD88 in the summer. However, this sand level can be eroded down to MLLW or lower during winter storm events (Figure 24). This will expose the earthen bank of the access road to direct wave attacks, leading to a failure of the bank if no erosion protection structure was installed. As an example, the bank of the access road failed during the winter of 2000/2001, and the previously buried pipelines were exposed beneath the access road. While the eroded beach might be restored

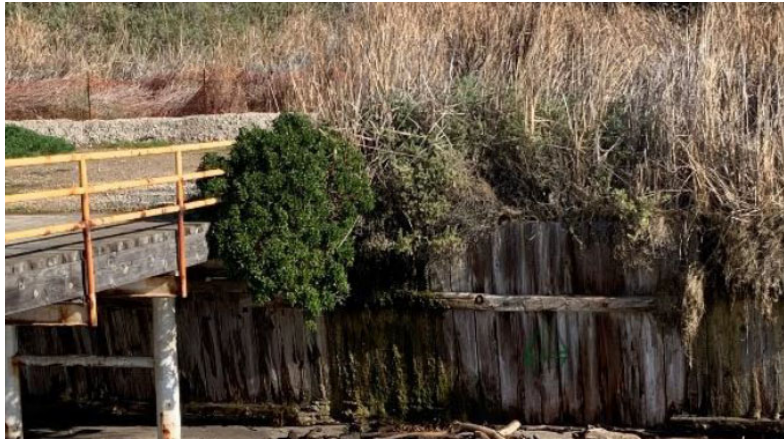
Approximately 1,400 feet long riprap revetment has been placed at the base of the access road starting from the access road gate area to the approximate midpoint between the two PRC 421 pier structures. A wooden seawall runs behind both PRC 421 piers and from the midpoint between the two piers to approximately 75 feet to the east of PRC 421-2, as shown in Figure 7. Much of this wooden seawall has been compromised by storm and wave activity over many decades, as shown in Figure 30. Removal of PRC 421 will expose the beach behind the pier caissons to storm-induced erosion and expose the wooden seawall to direct and more intense wave attacks, further deteriorating or causing a failure of the wooden seawall. If the access road is to remain in place, a riprap revetment is recommended to replace the compromised wooden seawall after removal of PRC 421 structures in order to protect the access road and the land/costal bluff behind the road.

Figure 30. Wooden Seawall Behind PRC 421-2 Pier
