BIOLOGICAL ASSESSMENT

**1496 BELL HILL ROAD [APN 017-002-02]
LAKE COUNTY, CALIFORNIA**

PROJECT № LAK017

JULY 3, 2020

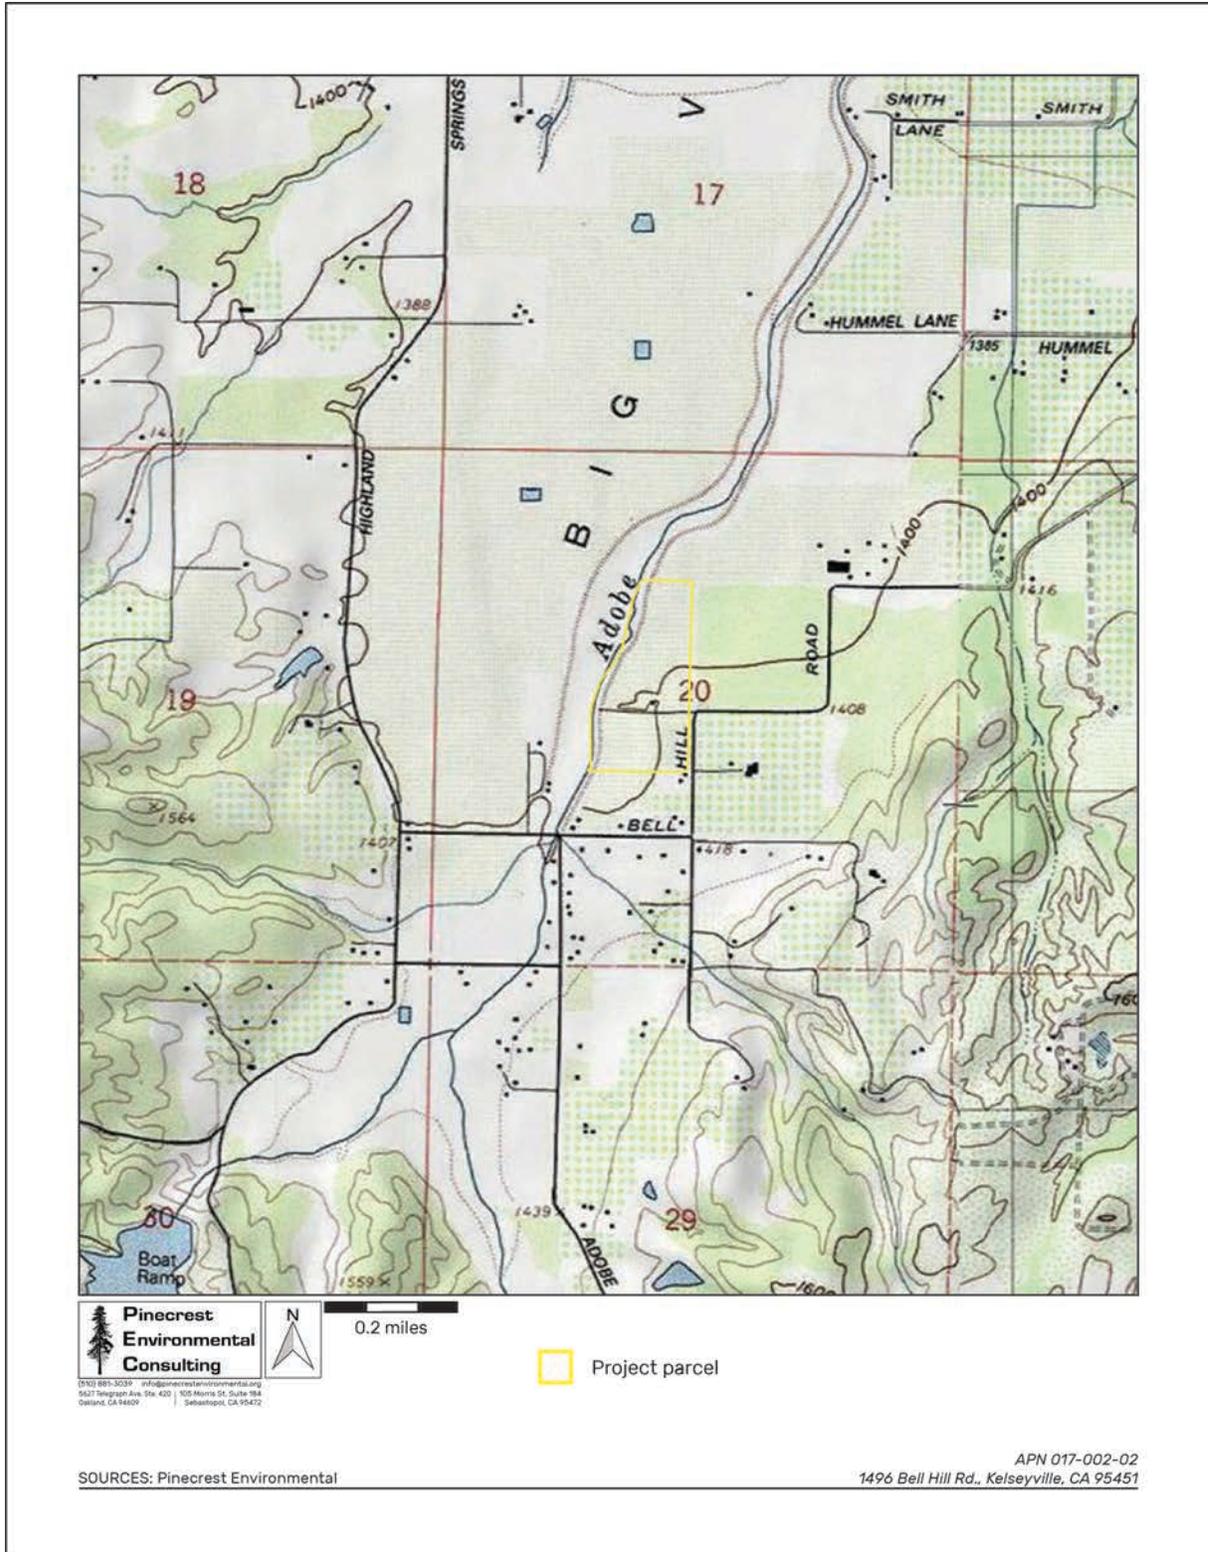
FIGURE 2: 40 FOOT CONTOURS

The parcel encompasses approximately 37 acres entirely planted to active vineyards, with a reservoir and abandoned house in the center of the parcel. Offsite to the east is a Class I reach of Adobe Creek (Figure 3). The maximum elevation of the parcel is 1,414 feet above sea level at the southeast corner of the parcel, and the minimum elevation is 1,401 feet above sea level at the northwest corner of the parcel. All of the parcel is flat with a measured slope of 2%, as measured by Suunto PM5 handheld clinometer.

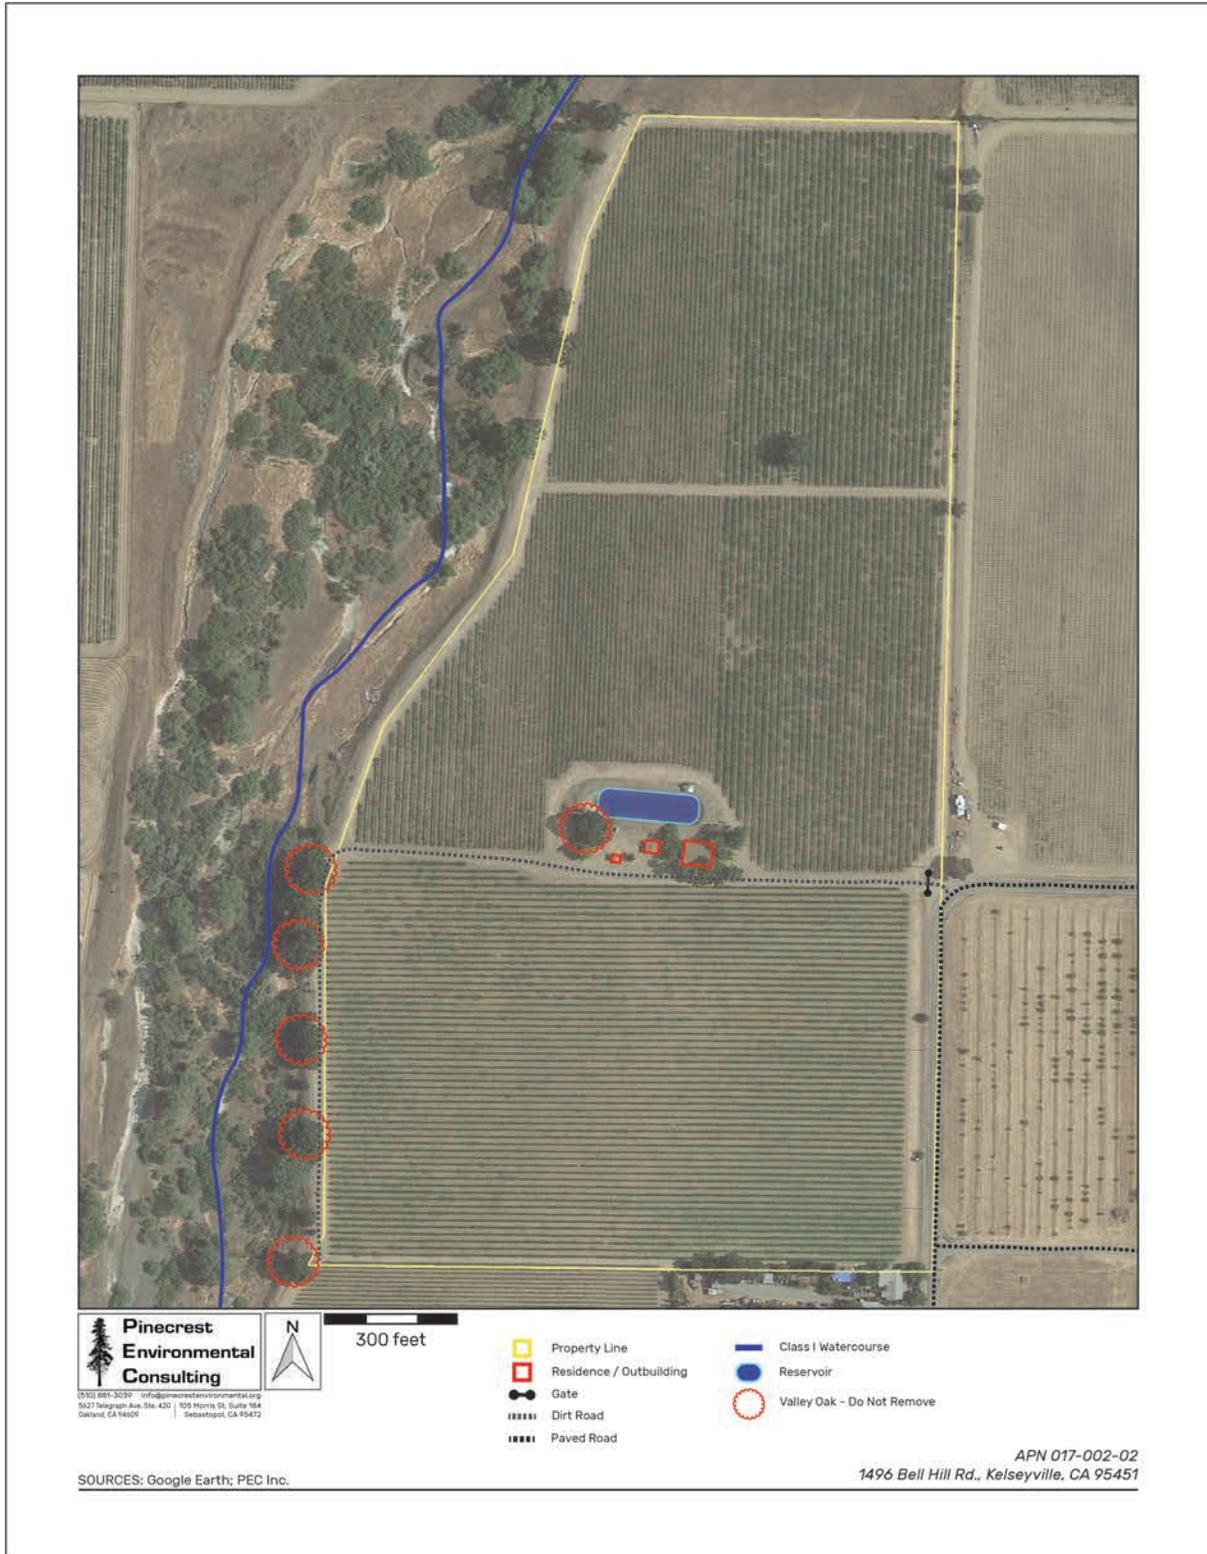
FIGURE 3: WATERCOURSES

There is one artificial pond used as a reservoir for irrigation purposes in the center of the parcel (Figure 6) that is fed by an electric pump (Figure 7). The site is not drained by any classifiable watercourses and all water arriving onsite as precipitation appears to infiltrate locally in the well-drained soils. The Class I reach of Adobe Creek is located offsite and not on the project parcel, however the very edge of the riparian corridor does overhang the project parcel (Figure 9). There are also no potential wetlands identified at the time of the survey. There are no culverts or other watercourse crossings onsite.

Jurisdictional watercourses onsite were classified according to the three-tier method used by the California Department of Forestry & Fire Protection (CALFIRE 2017) and included as a reference in Appendix E. All onsite jurisdictional streamcourses in the vicinity of the project areas are mapped in Figure 3. According to these criteria, there are no classifiable watercourses onsite. The Class I reach of Adobe Creek is offsite to the west (Figure 3). There are also no culverts or other watercourse crossings onsite.

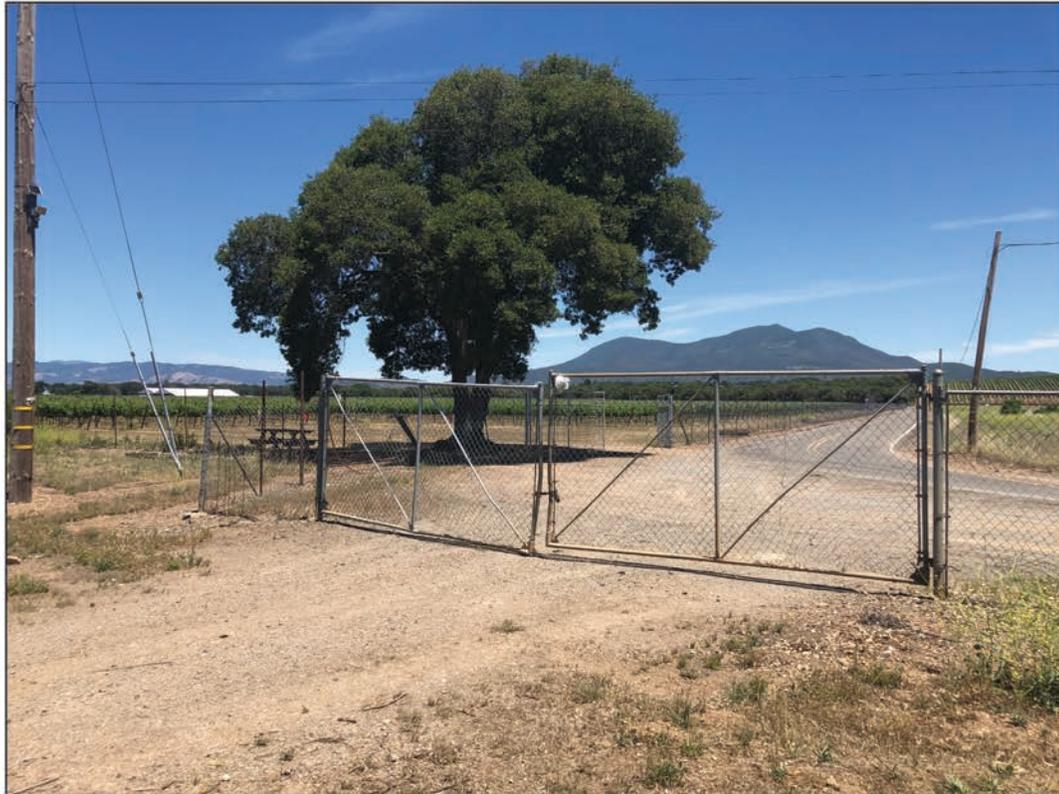
FIGURE 4: PHOTOGRAPH OF ACCESS GATE

The entire parcel is occupied by actively irrigated vineyard blocks (Figure 9). The parcel is accessed via locking manual entry metal gate (Figure 4) and onsite roads are packed earth and in good condition (Figure 5). Access to the parcel is provided to the west off of Hendricks Road, via improved dirt driveway (Figure 7). There are no existing *Cannabis* cultivation facilities onsite. Existing structures are limited to an abandoned residence and several garages (Figure 10).

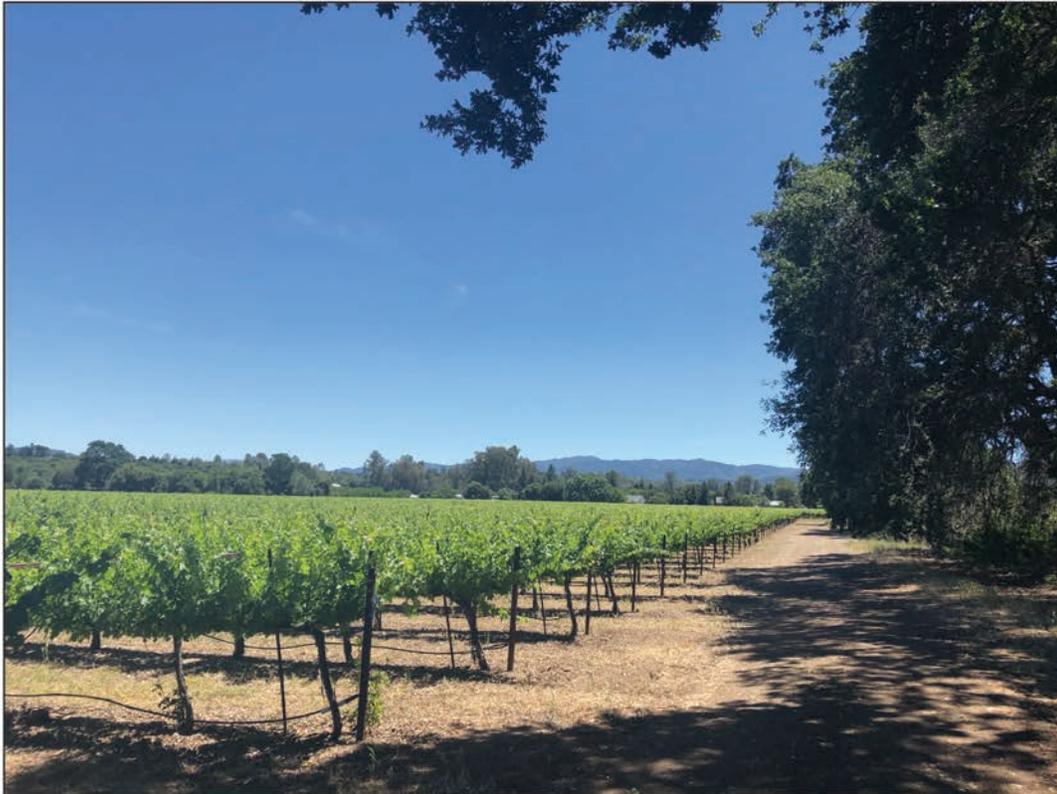
FIGURE 8: PHOTOGRAPH OF VINEYARD & RIPARIAN CORRIDOR

There is a small portion of overhanging riparian canopy in the far western edge of the parcel. While the setback required for Class I watercourses does overlap with the parcel, the actual top of bank and riparian corridor is not on the parcel. Only the overhanging tree vegetation and the shade-tolerant herbaceous species in the understory are on the project parcel. Nonetheless there are species not found in the rest of the parcel and so is treated separately here. The only tree species in this area are Valley oak (*Quercus lobata*) to 40" DBH, and Black walnut (*Juglans hindsii*) to 30" DBH. Both of these tree species provide habitat for wildlife and stability to river banks and should not be removed, even as juveniles. Other species in this section of the parcel include Yerba Santa (*Eriodictyon californicum*), poison oak (*Toxicodendron diversilobium*), coyote brush (*Baccharis pilularis*), mugwort (*Artemisia douglasiana*), farewell-to-spring (*Clarkia amoena*), blue wildrye (*Elymus glaucus*), squirreltail grass (*Elymus elymoides*), slender popcorn flower (*Plagiobothrys tenellus*), common fiddleneck (*Amsinckia intermedia*), farewell-to-spring (*Clarkia amoena*), lowland cudweed (*Gnaphalium palustre*), Western verbena (*Verbena lasiostachys*), common yarrow (*Achillea millefolium*), Western buttercup (*Ranunculus occidentalis*), Klamathweed (*Hypericum perforatum*), and field parsley (*Torilis arvensis*).
