# Notice of Exemption

Project Title: Rasmussen Park Improvements Project

# CATEGORICAL EXEMPTION FINDING

### Biological Resources Analysis

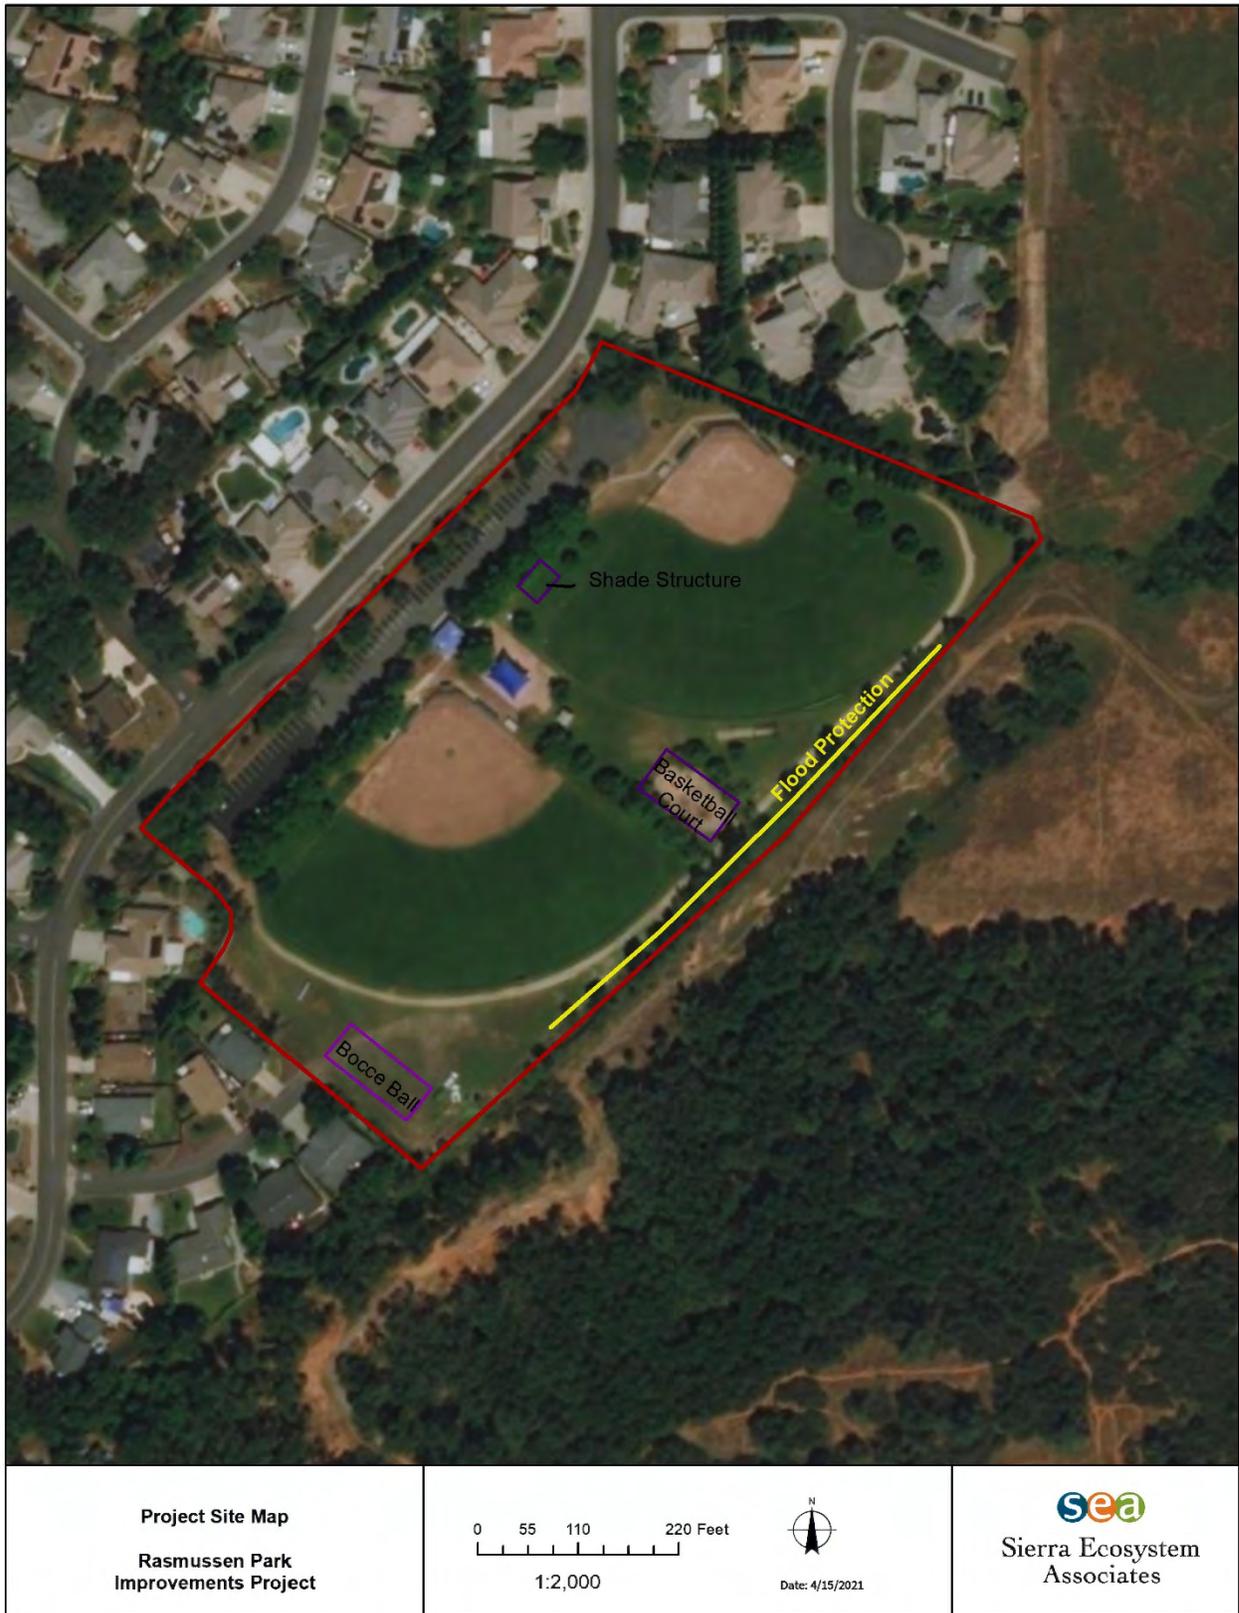
Figure 2: Project Location - Detail

Additional Project features would include adding a basketball court, bocce ball courts, and a 25'x40' open air shelter that would cover 8 picnic tables. These features would be placed on existing improved park grounds that include the turfgrass area and area that has been actively managed for vegetation control such as mowing/trimming.

Figure 1 shows the Project's location. Figure 2 provides a detailed site map of the proposed Project features.

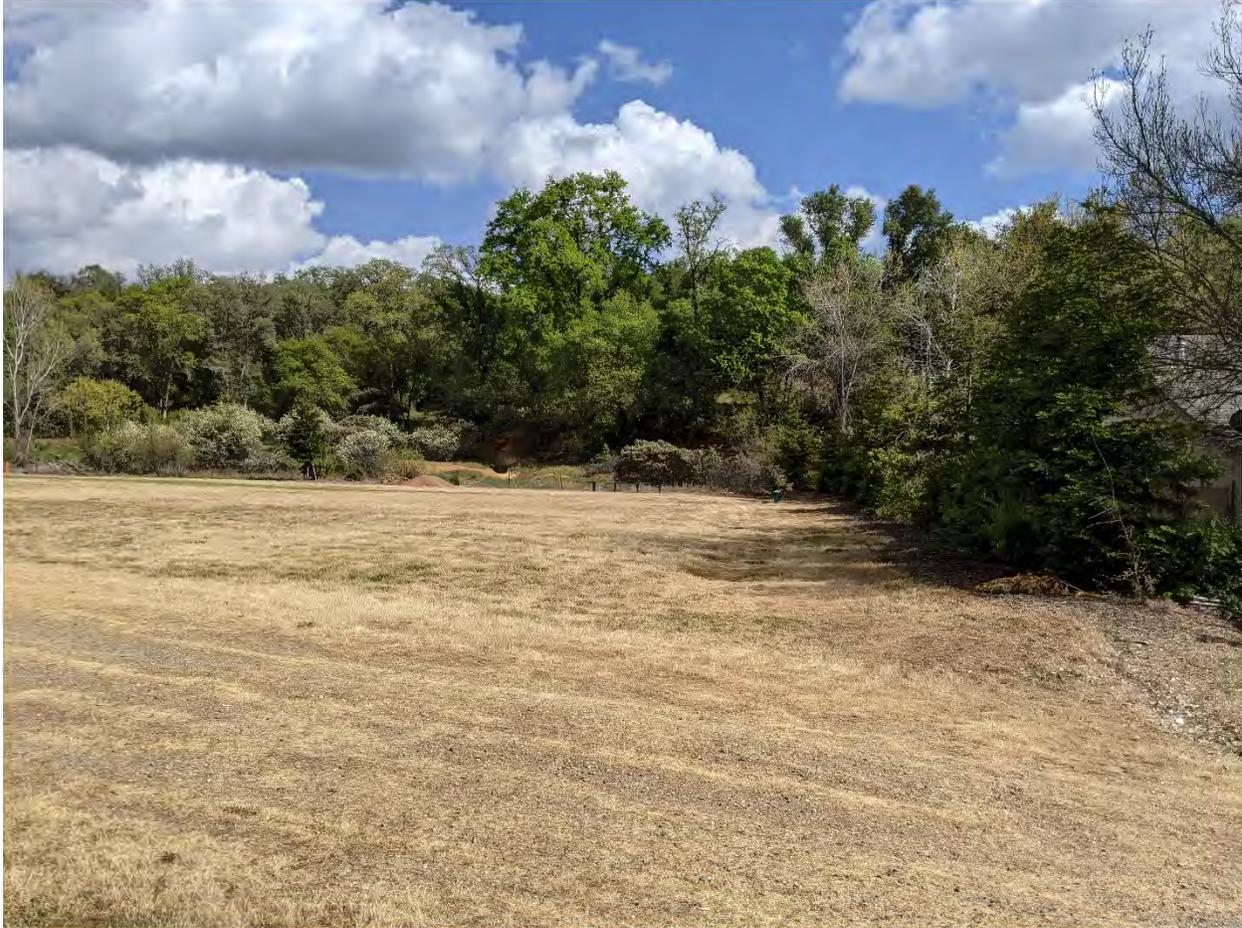
Photograph 1. Proposed bocce ball court placement

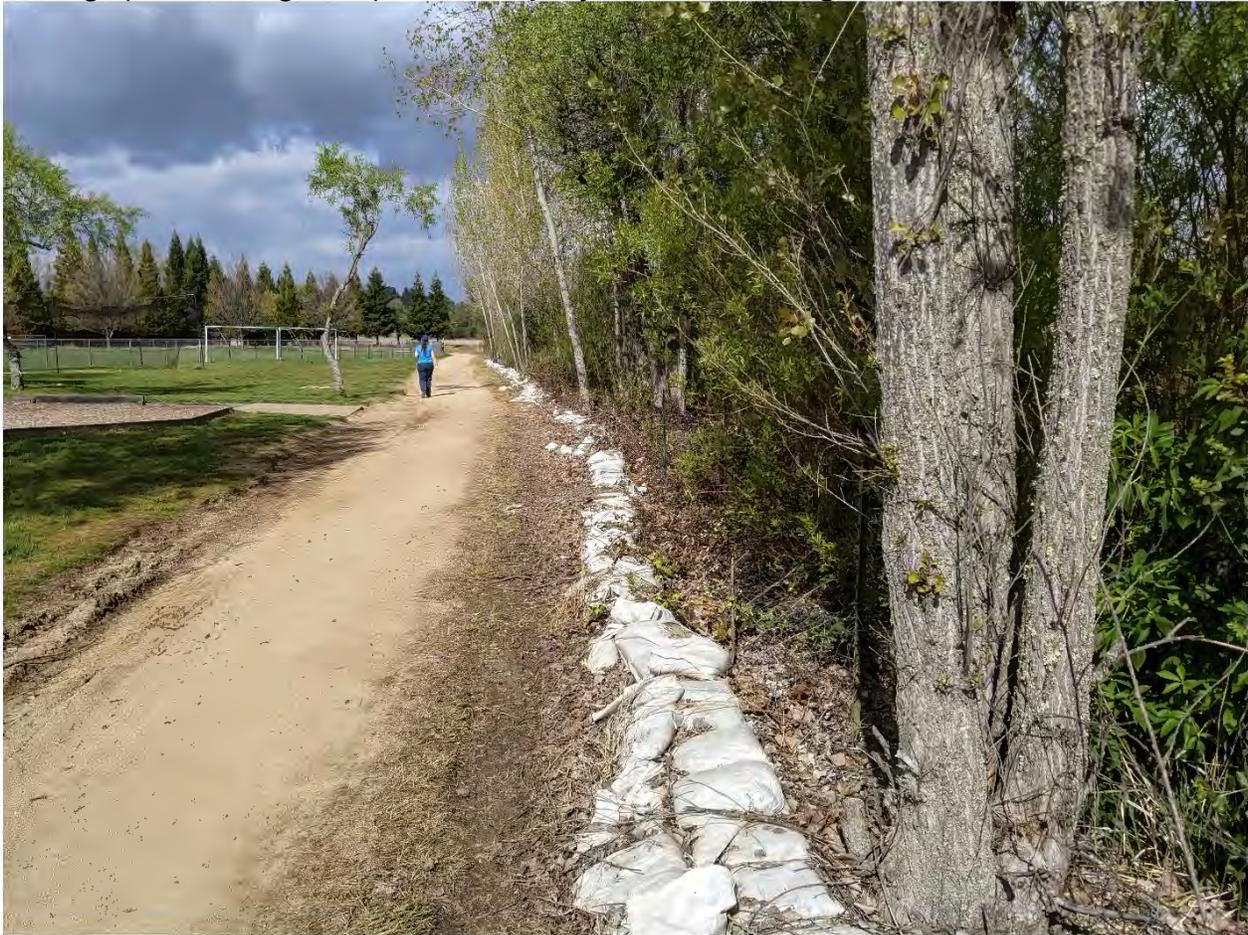
Photograph 2. Existing flood protection by adjacent stream along the southeastern boundary

Measures for flood protection from the adjacent intermittent stream (on the southeast border) would be added that consist of a new 6-inch drain line with catch basins to transport flood water away from the sportsfields. The drain line and catch basins would not be located within the intermittent stream zone and outside the ordinary high water mark. Best management practices will be followed that include exclusionary fencing, and fencing that prevents the transport of sediment into the stream.

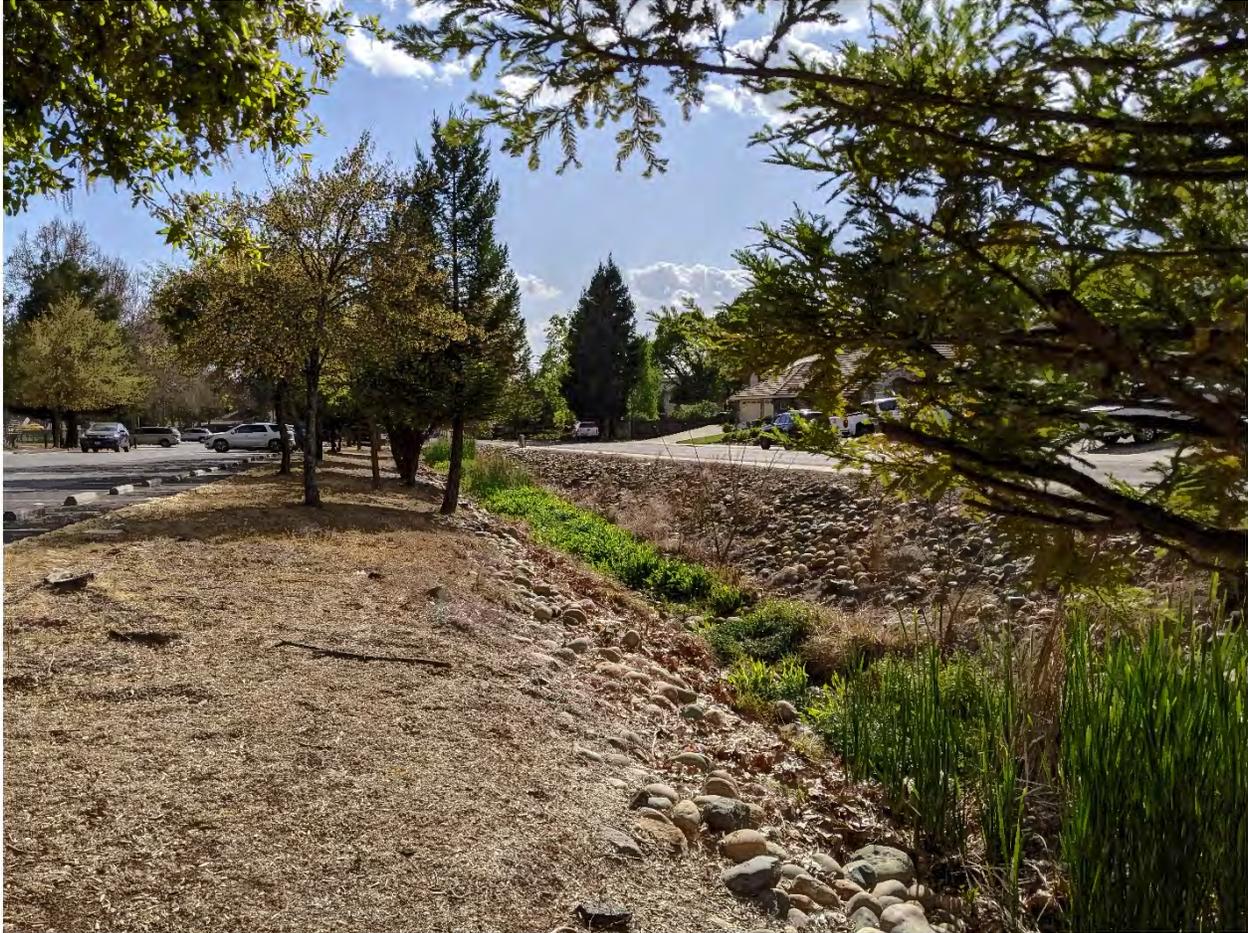
Photograph 4. Drainage on the northwestern side of the park between the parking area and Mira Loma Drive

The park is in a low-lying area in which overland water flow is diverted around the southeast and northwest sides of the park. Both drainages were flowing during the time of the survey. These drainages contained wetland obligate and facultative plants such as willow (*Salix ssp.*), sedges (*Carex ssp.*), and cattail (*Typha ssp.*). Project activities do not include the encroachment or fill of any wetland features.

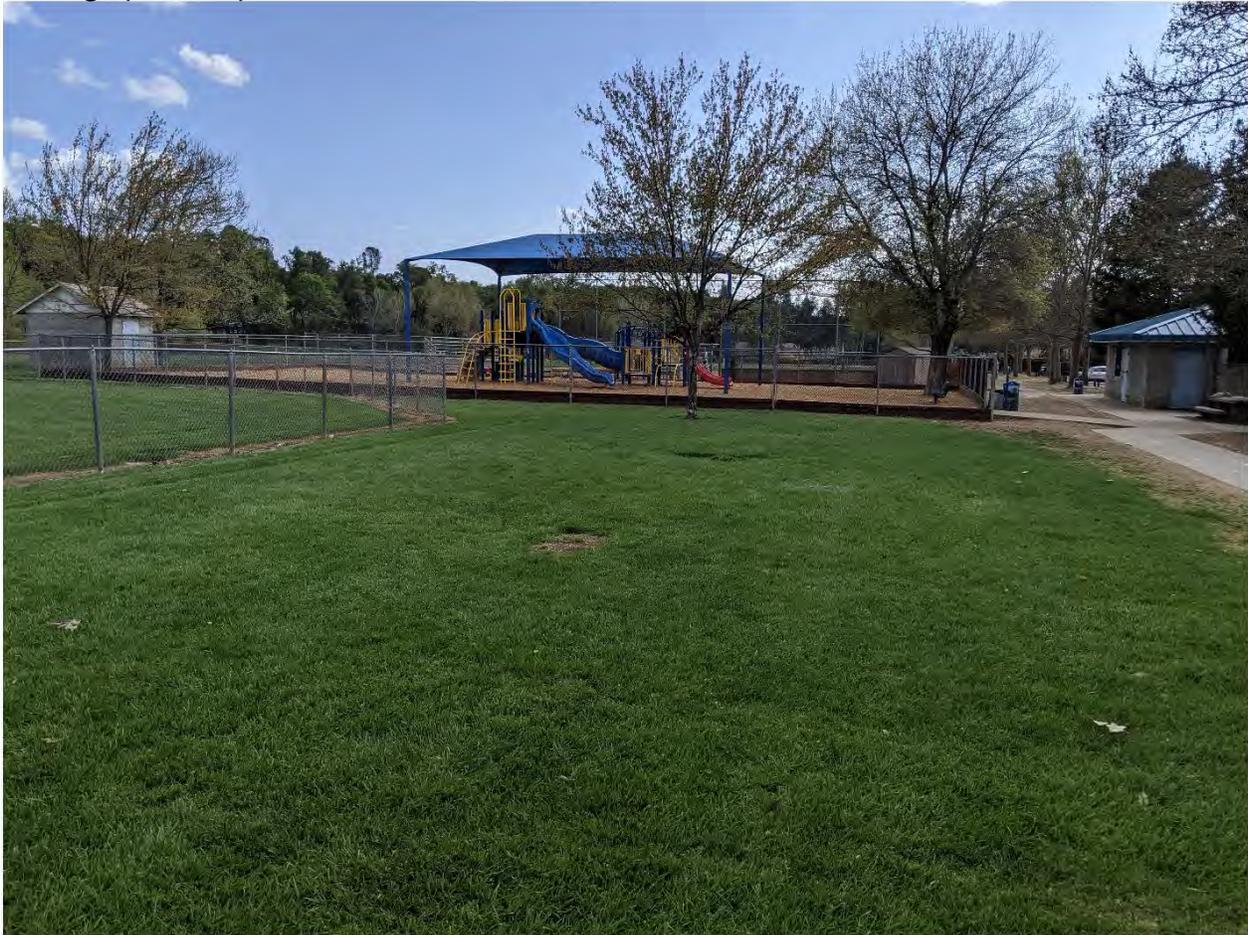
Photograph 5. Proposed area for a shade structure

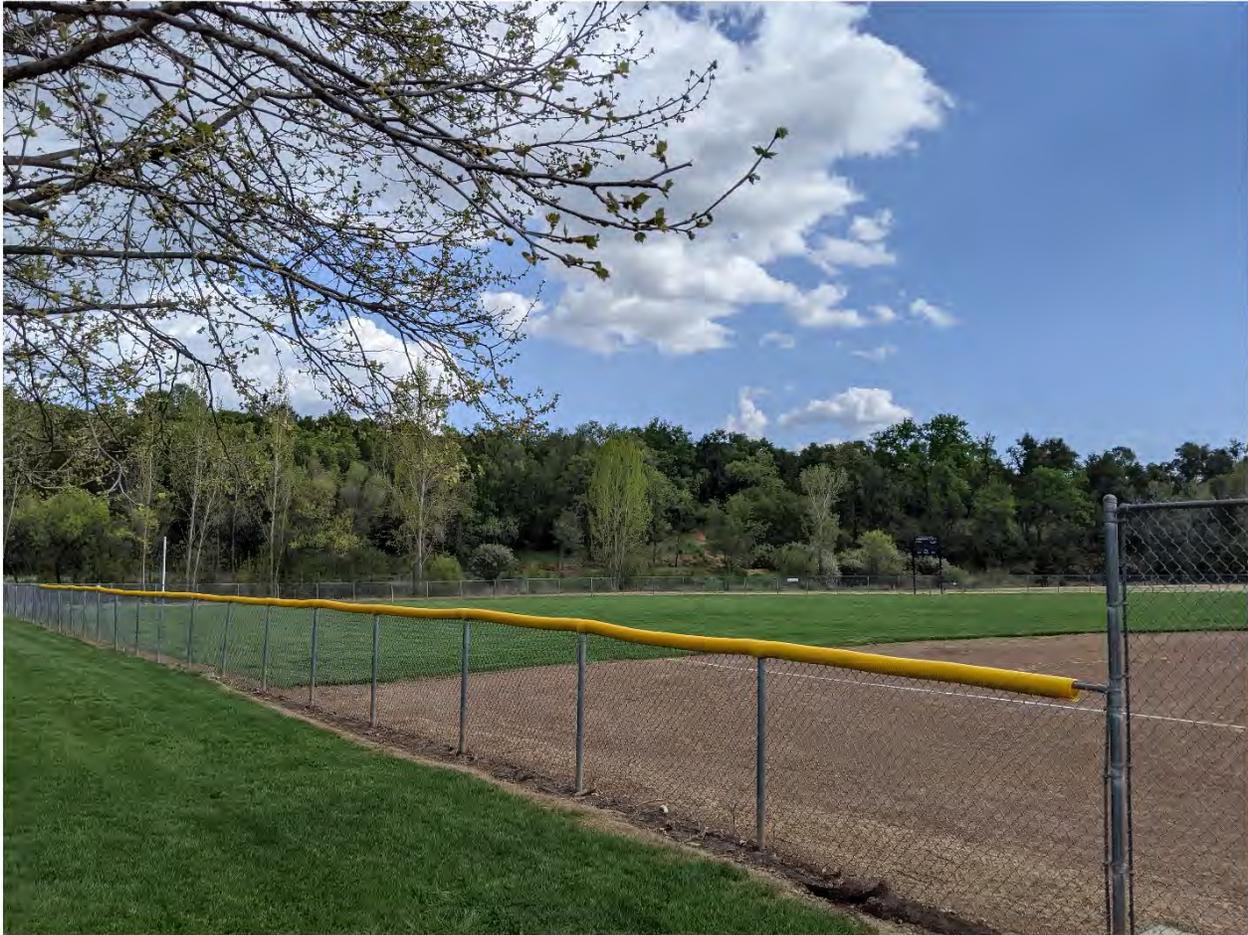
Photograph 6. Existing turfgrass area on sportsfield

The Rasmussen Park Improvements Project (Project) would improve turf quality and durability and field drainage conditions within the limits of the existing two sportsfields. The two baseball fields are a turfgrass area that is approximately 24,500 square feet. The Project would involve removing the existing turfgrass, grading the soil, leveling the surface, hauling excess turfgrass offsite, importing clean fill plus 3 tons of soil conditioners to improve turf health and durability, and then seeding and fertilizing the new turfgrass.
