Phase I Environmental Site Assessment

Estrella Solar

SW of the Intersection of West Avenue A and 90TH Street W

Terracon Project No. 60197493

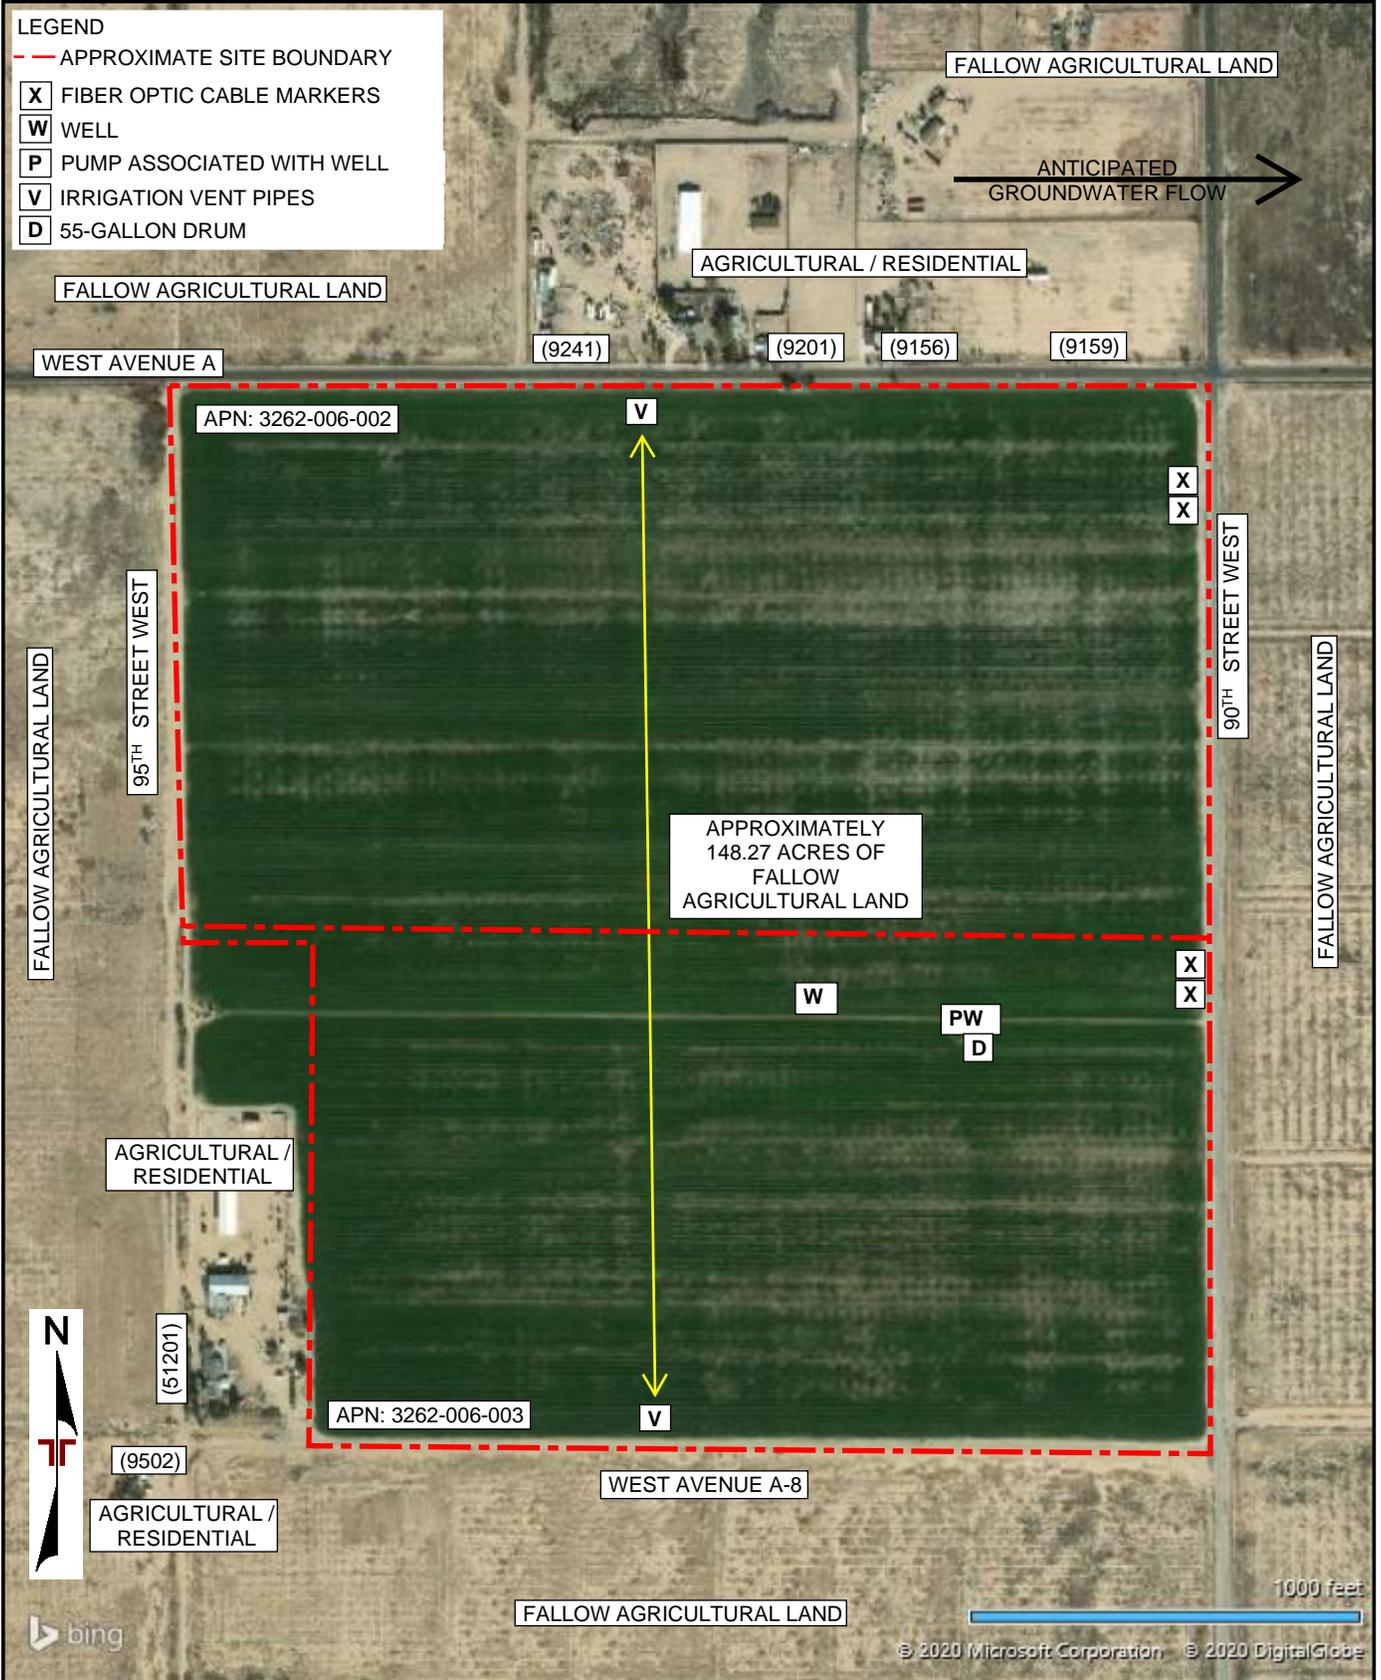
EXHIBIT
2

- APPROXIMATE SITE BOUNDARY
- X FIBER OPTIC CABLE MARKERS
- W WELL
- P PUMP ASSOCIATED WITH WELL
- V IRRIGATION VENT PIPES
- D 55-GALLON DRUM

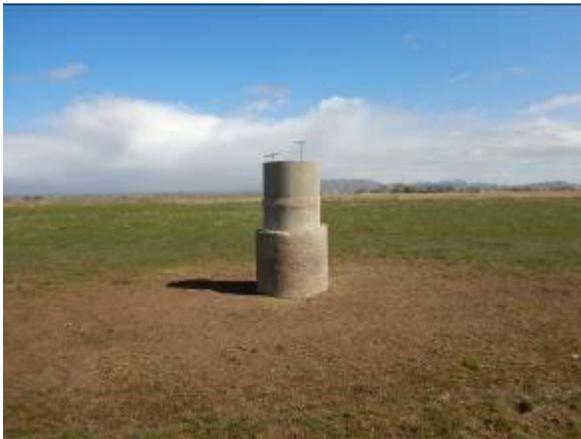
Photo #9 Typical view of cisterns located along the central portion of the site from west to east.

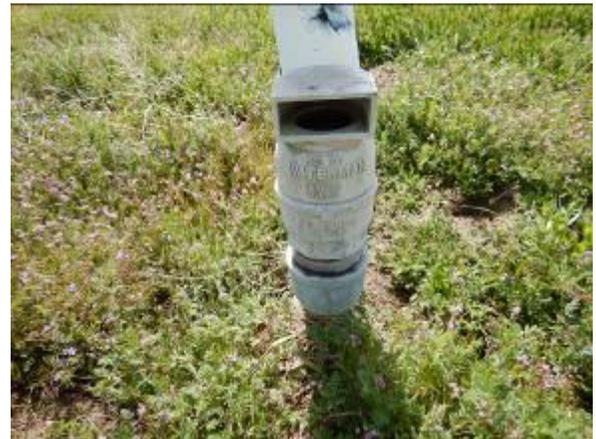
Photo #10 Typical view of vent pipes associated with irrigation system along central portion of the site from north to south.

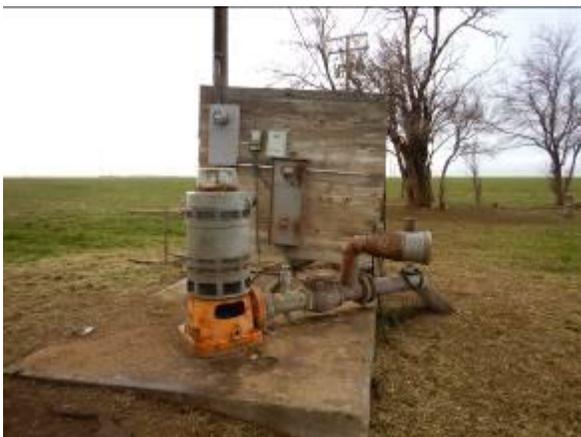
Three wells were identified on site in the Physical Setting Source Map provided by EDR. Depth to groundwater was not reported. The two wells were identified during the site reconnaissance. The third well is located on the southeast portion of the site and was not observed during the site reconnaissance.

During the site reconnaissance, Terracon observed two wells and an associated pump located on the southern portion of the site. The wells observed were greater than 6 feet in height and Terracon was unable to observe the interior of the wells. The concrete wells appear to have been associated with former agricultural operations. Three wells were identified on site in the Physical Setting Source Map provided by EDR. Depth to groundwater was not reported. The two wells were identified during the site reconnaissance. The third well is located on the southeast portion of the site and was not observed during the site reconnaissance.

Photo #11 View of pump associated with the well located on eastern portion of the site.

- Terracon observed a single 55-gallon drum located on the eastern portion of the site, which was observed to be unlabeled at the site reconnaissance, the drum needs to be properly disposed of utilizing a certified hazardous waste transporter.
- Terracon recommends protection of the on-site water wells in place during construction activities and if these wells are to be abandoned, local and state requirements should be followed.

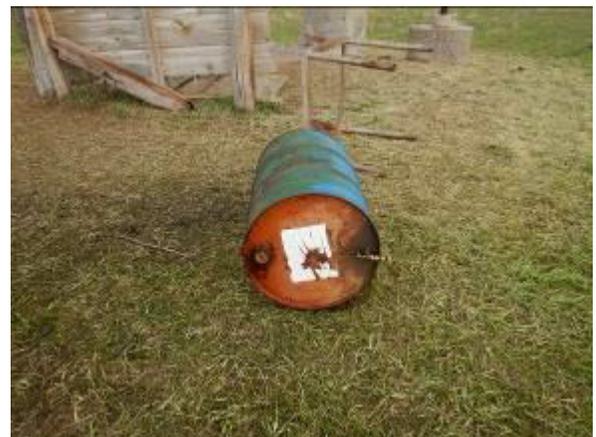
During the site reconnaissance, Terracon observed one 55-gallon drum on the eastern portion of the site. The drum was not labeled and Terracon could not identify its content. Leakage, spills or releases from the drum were not observed. Based on site observations, the 55-gallon drum does not represent a REC to the site.

Photo #12 View of 55-gallon drum located on eastern portion of the site.

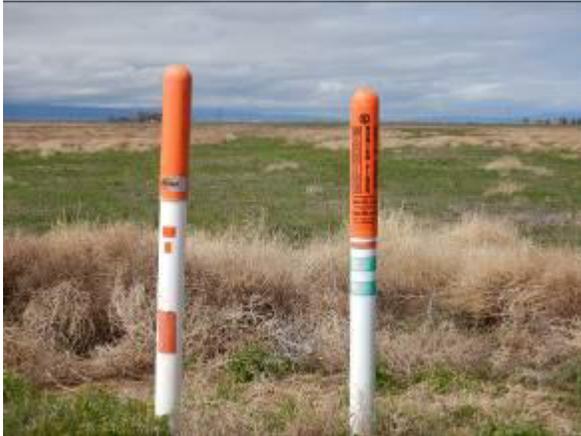
Photo #13 Typical view of fiber optic cable markers located along the eastern boundary of the site.
