California Environmental Quality Act  
Initial Study and Negative Declaration  
for the  
East Weaver Creek Dam Removal  
and Intake Relocation Project

Weaverville, CA  
July 15, 2021

*Prepared for:*  
Weaverville Community Services District  
716 Main Street  
Weaverville, California 96093  
(530) 623-5051

*Prepared by:*  
Northwest California Resource Conservation & Development Council  
Five Counties Salmonid Conservation Program  
40 Horseshoe Lane  
Weaverville, California 96093  
(530) 623-3967

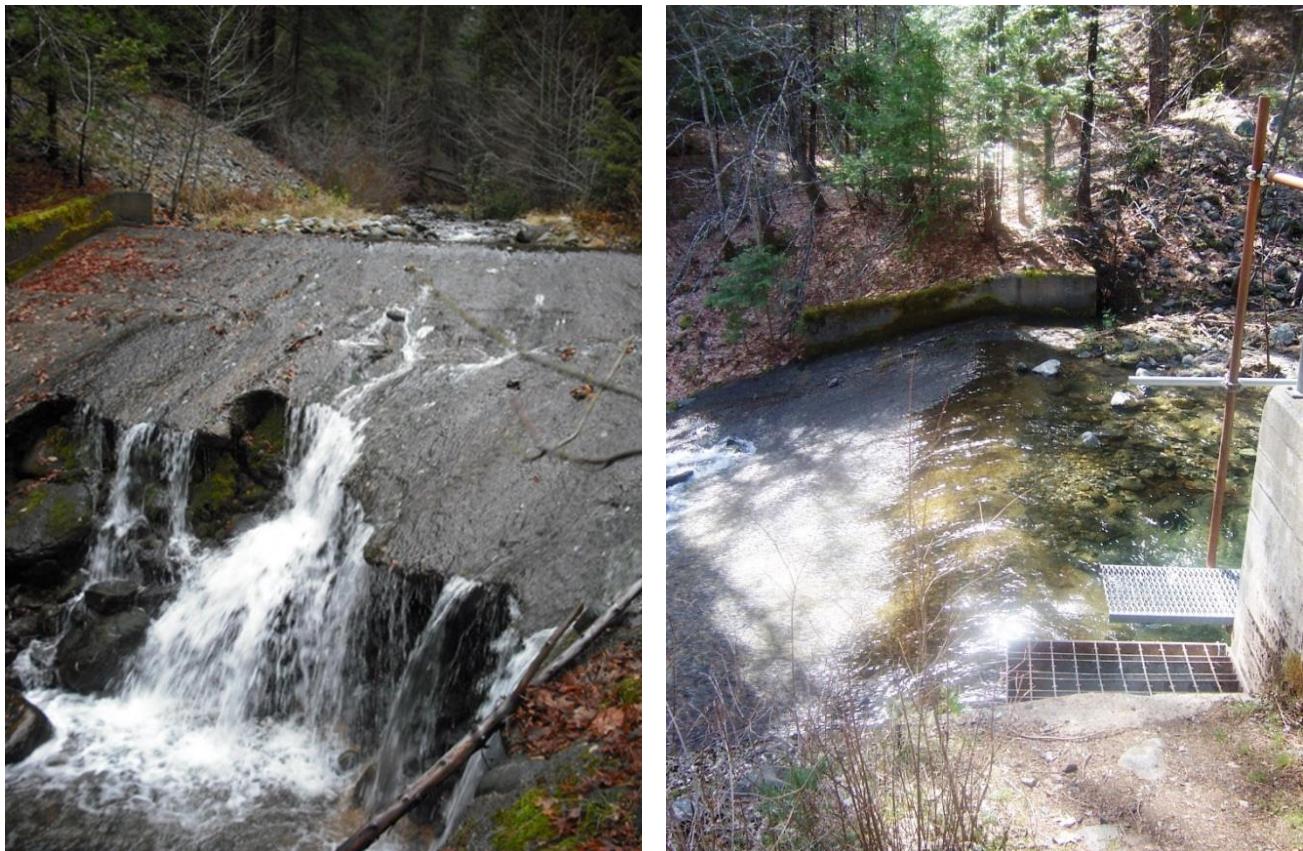
**Figure 2-3.** Dam showing concrete cap (left) and stilling basin to the EWF (right).

A dam condition assessment was completed using the Bureau of Land Management (BLM) Dam Condition Assessment Checklist (BLM, 2006). The EWD is rated in poor condition due to repairs or modifications required to maintain the structure operationally. Deficiencies are evident on visual inspection of the dam including: loss of concrete apron segments, concrete spalling, exposed rebar, water flows interstitially through the dam's rock structure, sediment filling upstream, and bed scour below the base of the dam (Figure 2-3). Major repairs to the dam will be necessary in the reasonably foreseeable future.

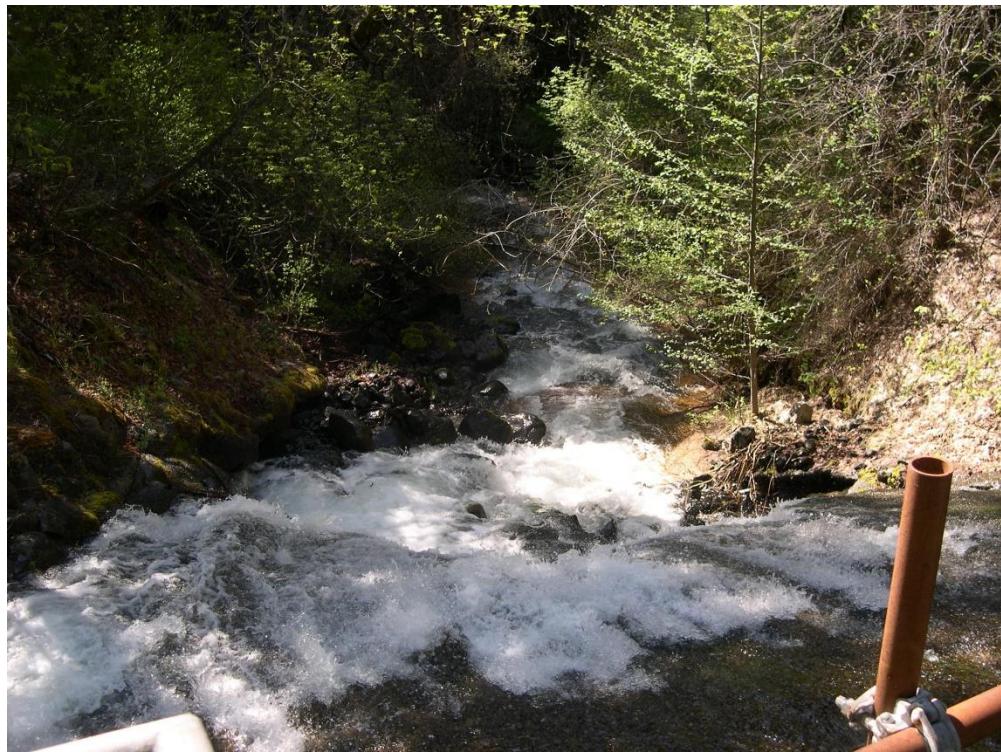
**ii:** East Weaver Dam- photo taken from the intake structure near the crest of the dam, looking downstream.

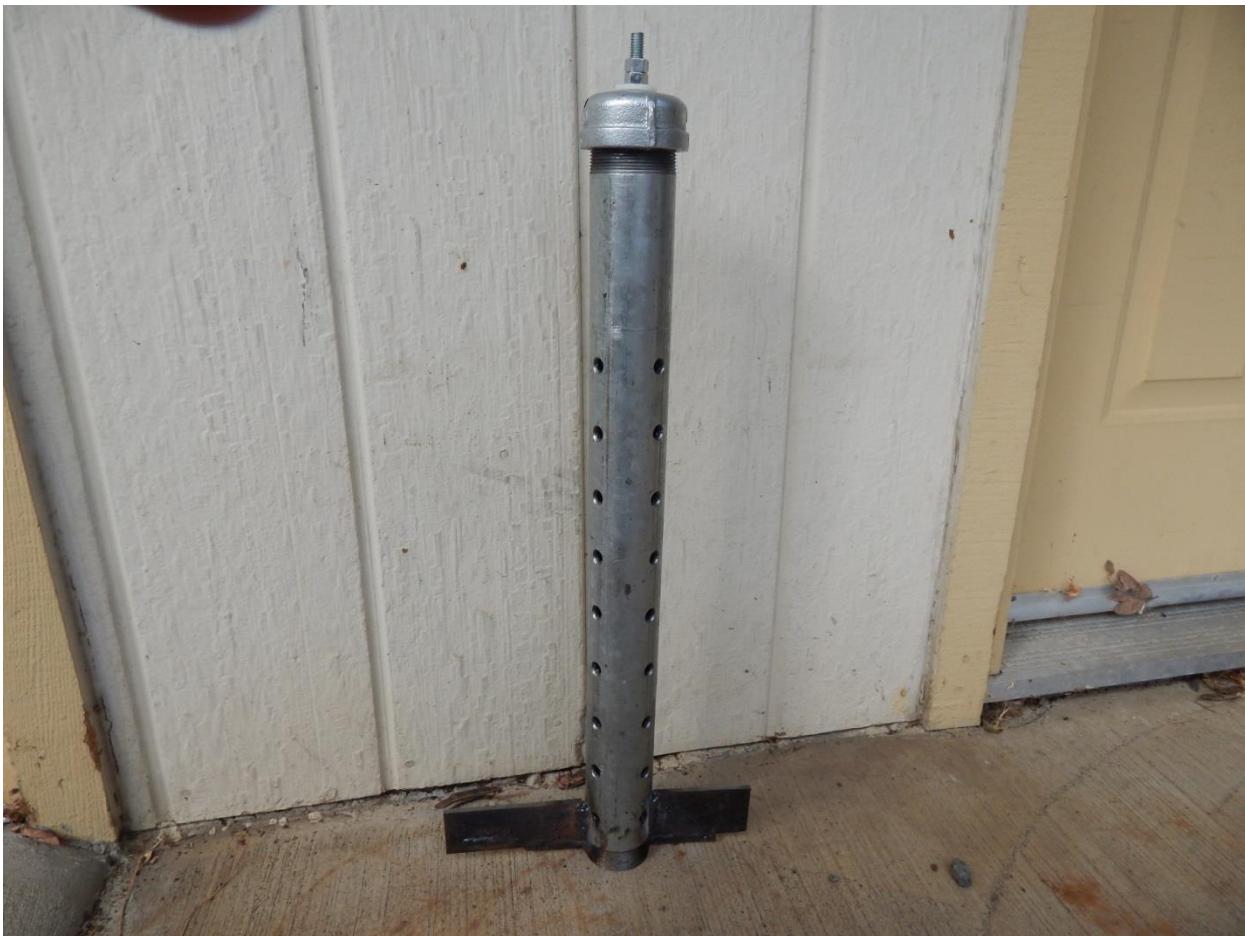
**Figure 4.** HOBO container for Monitoring Sites #2 and #3.
