Appendix C1 - Biological Resources Assessment and MSHCP

BEAUMONT SUMMIT STATION BIOLOGICAL RESOURCES AND MSHCP CONSISTENCY REPORT

Beaumont, California

February 4, 2022

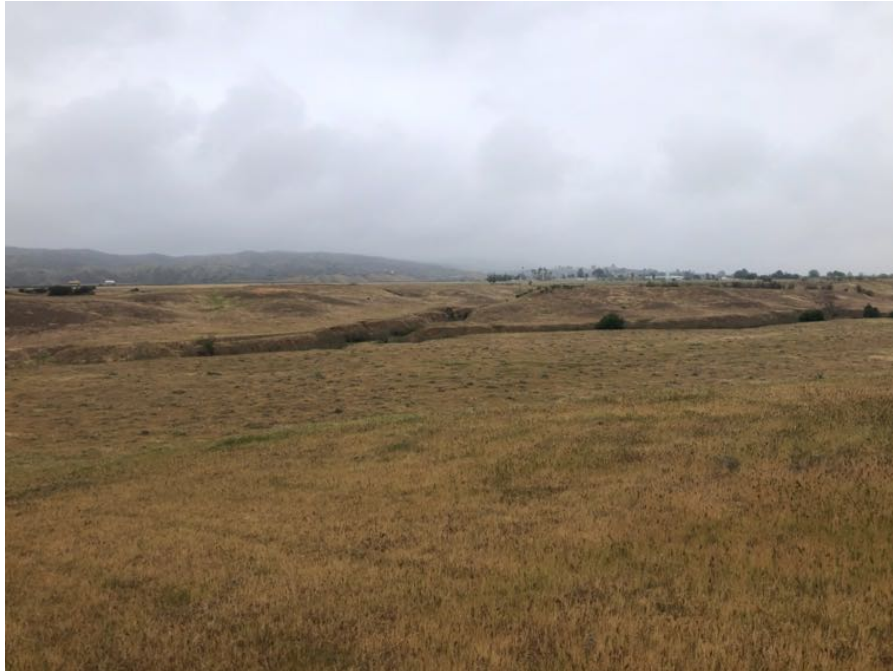
Photo 1. Overview of project site from the western site boundary, showing drainages running through non-native grassland, facing northeast.

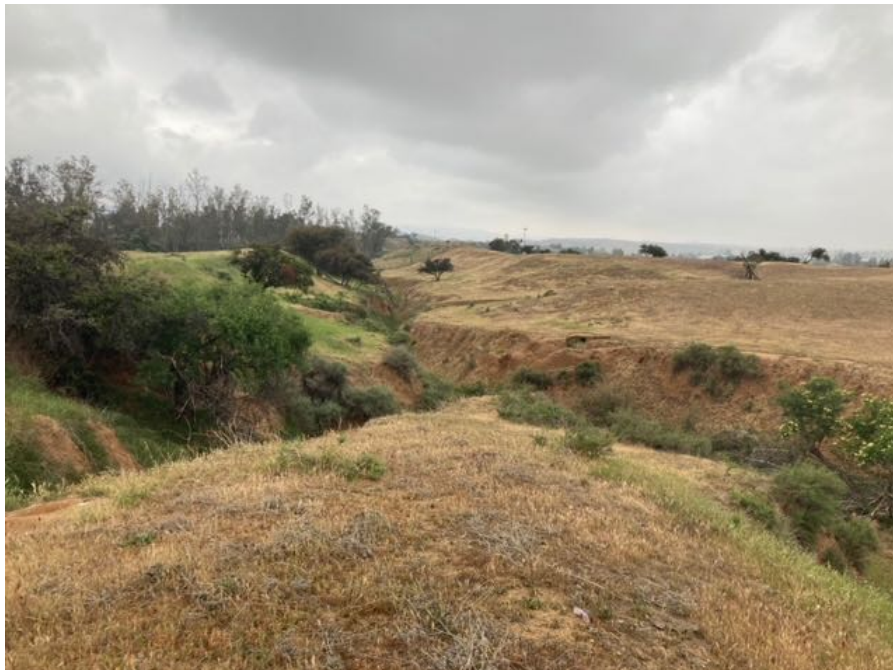
Photo 2. View of non-native grassland in the western portion of the project site, showing oaks and drainages containing mulefat, facing west.

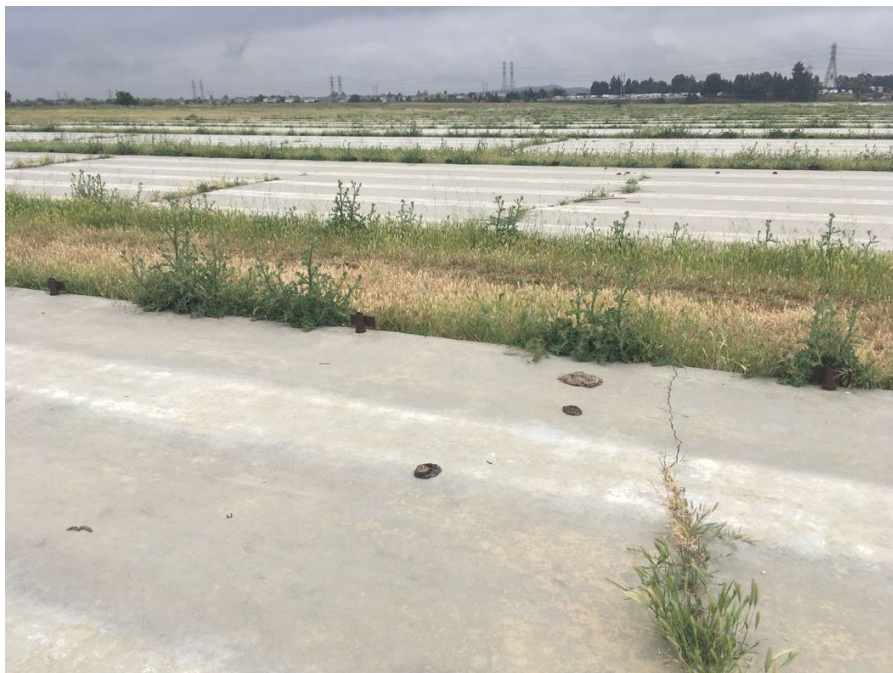
Photo 4. Picture of concrete pads within the central portion of the project, facing south.

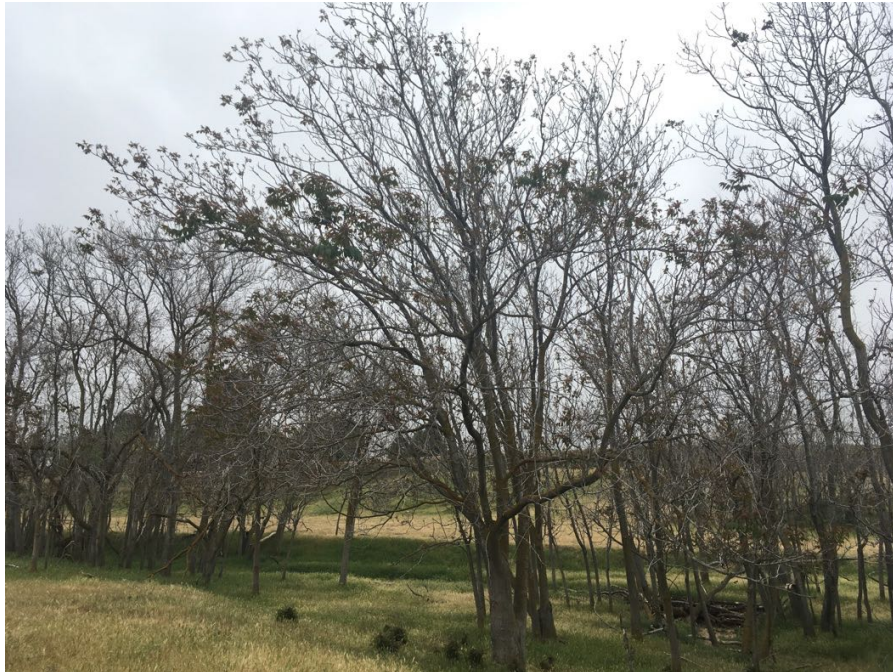
Picture 5. Representative photos of the non-native riparian (*Ailanthus altissima*) within the drainages in the southwestern portion of the site; stands have a height of up to approximately 25 feet.

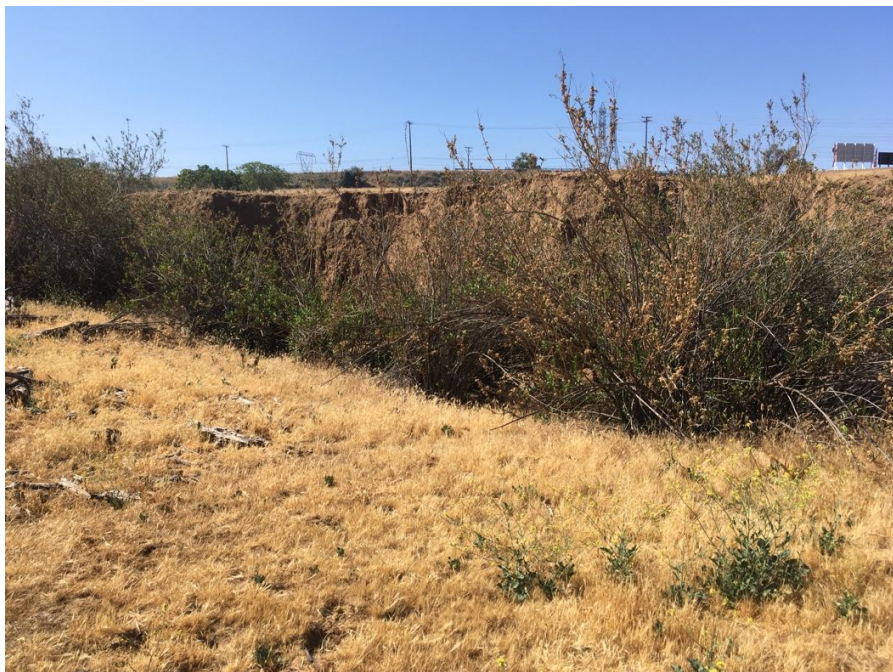
Photo 6. South-facing view of mulefat scrub within the drainages in the southwestern portion of the site, facing west.

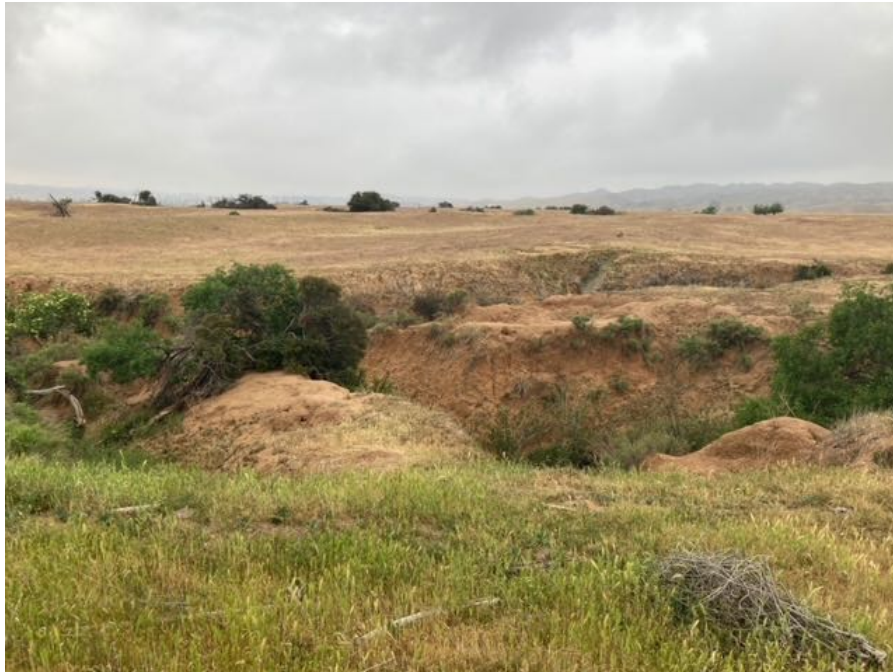
Photo 7. Representative picture of the drainages within the southwestern portion of the project site, facing east.

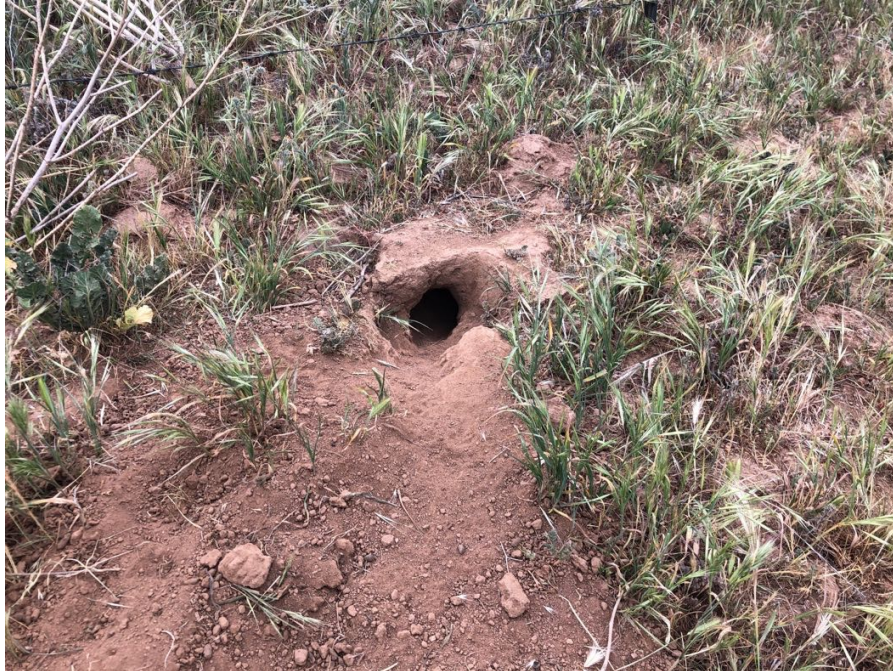
Photo 9. Representative photo of the small-mammal burrows throughout the non-native grassland within the project site.

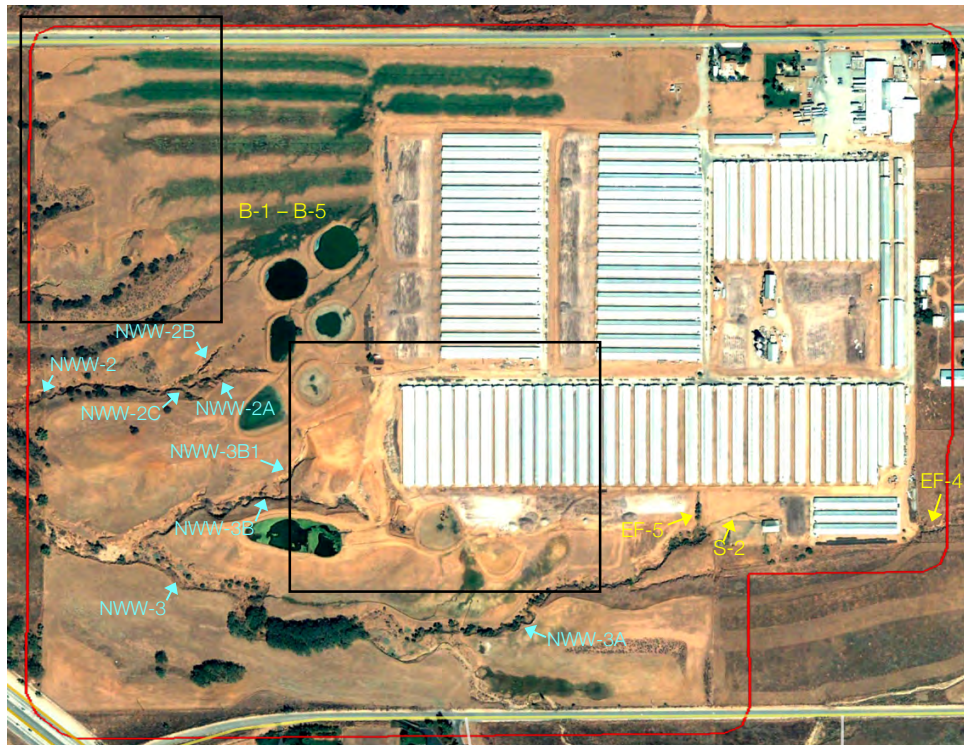
October 2003 – Farming operations within the review area continue to expand between September 1996 and October 2003 with the construction of more poultry sheds in the center of the review area. Additionally, more ponding basins (i.e., B-3 through B-5 and various other unnamed basins) were developed during this time. Remains of these developments and site modifications exist to this day. B-1 and B-2 are still present; however, no longer appear to drain runoff into NWW-2 and NWW-2B. Furthermore, NWW-3B no longer appears to receive flows from the unnamed basin in the center of the review area. NWW-1, NWW-1A, NWW-2, NWW-2B, NWW-2C, NWW-3, and NWW-3A are visible on the aerial in their current locations. The expanding farming operations continue to contribute to further reductions of NWW-3B and NWW-3B1. By October 2003, NWW-3B and NWW-3B1 were reduced to their current extents. NWW-2A is primarily only visible near its convergence with NWW-2.

EF-1 through EF-3 are visible and appear to receive runoff from a new irrigation system within the review area. EF-4 is evident, and EF-5 still appears to receive runoff from the poultry sheds. S-1 is further indistinguishable and appears to likely contain the same characteristics as those observed present-day (i.e., no break in slope or a defined bed and bank between the swale and adjacent uplands). S-2 has reemerged and appears to receive runoff from farming operation buildings. The expansion of the poultry sheds appears to result in S-4 and EF-6 becoming slightly apparent and S-5, EF-7, and EF-8 being visible in their current locations and extents. S-3 and D-1 are not yet apparent.

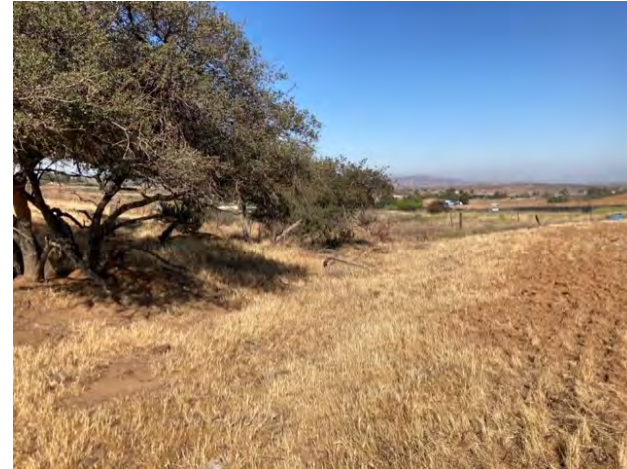
Photo 2. View of OHWM Datasheet Point (ODP) 1, facing west, within the lower topographic area between two gentle slopes just west of EF-1. The lower topographic area did not exhibit any bed and bank indicators, there was no break in slope, and the sediment texture and vegetation did not differ from the lower topographic area to the adjacent slopes (33.968296, -117.024925). June 3, 2021.

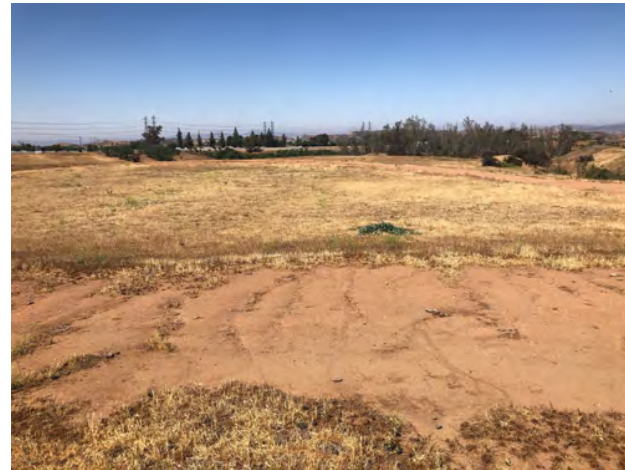
Photo 16. View of area mapped by U.S. Geological Survey (USGS) National Hydrography Dataset (NHD) as a "Reservoir," facing west. No evidence of hydrology was observed (33.965010, -117.021979). June 3, 2021.

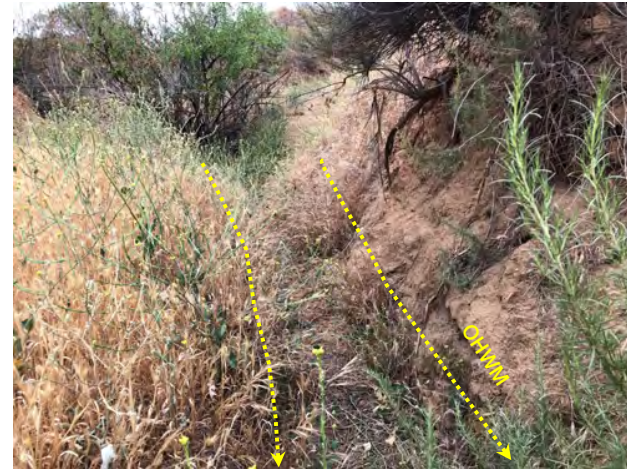
Photo 18. Upstream view of ODP 4, facing east, within NWW-2. The OHWM was defined by a faint break in bank slope and a change in vegetation cover (33.964853, -117.023670). June 7, 2021.

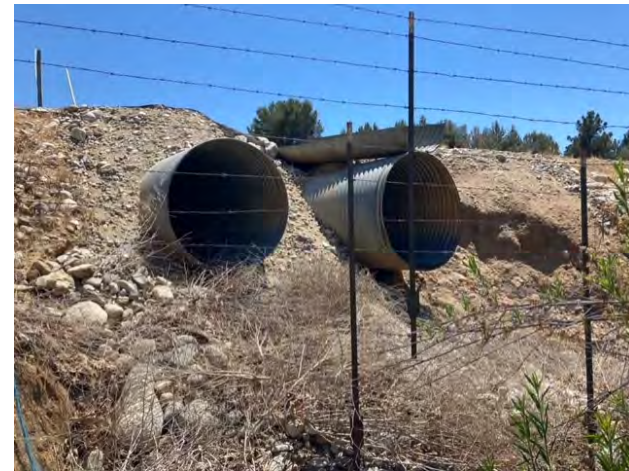
Photo 22. View of culvert outlets located along the southern extent of the review area under Brookside Avenue, facing south. Flows from the culvert outlets continue into NWW-3 (33.961603, -117.018517). June 3, 2021.

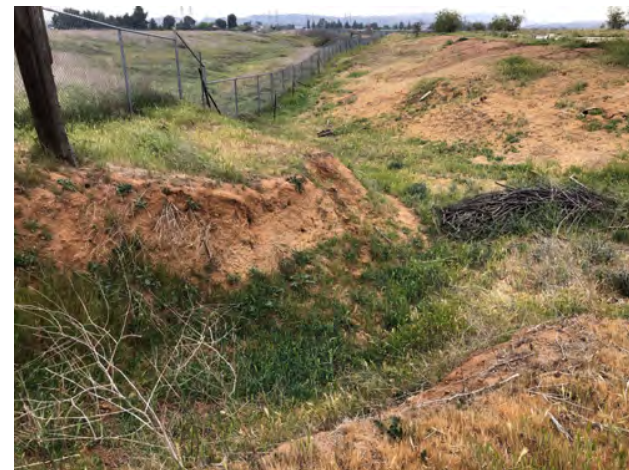
Photo 24. View of EF-4 within the review area, facing west. EF-4 continues west into Swale (S)-1, which ultimately converges with NWW-3A (33.963245, -117.013837). April 22, 2021.

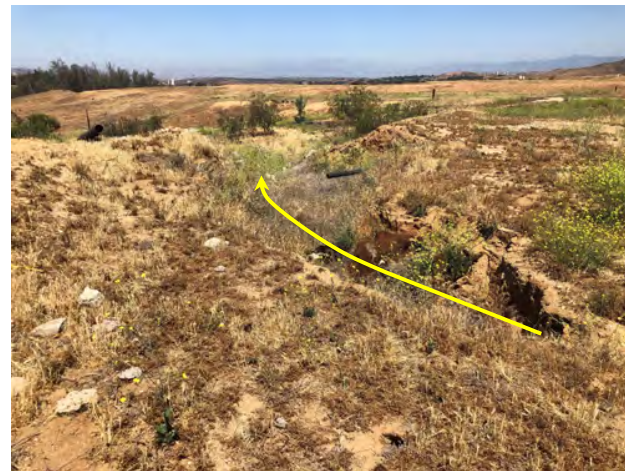
Photo 36. View of EF-6 (yellow line), facing northwest, which travels into area with some mulefat and tree tobacco, just east of NWW-3B. EF-6 did not appear to contribute flows to NWW-3B (33.963667, -117.020341). June 3, 2021.

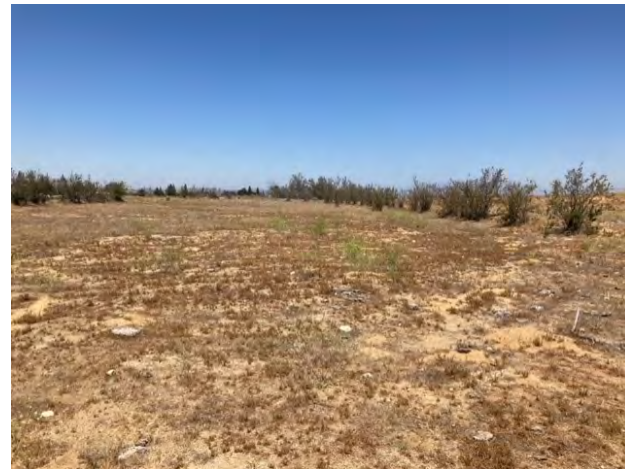
Photo 44. View of slight depressional area surrounded by mulefat scrub, located south of NWW-3B, facing west. No evidence of hydrology was observed (33.963283, -117.021269). June 3, 2021.

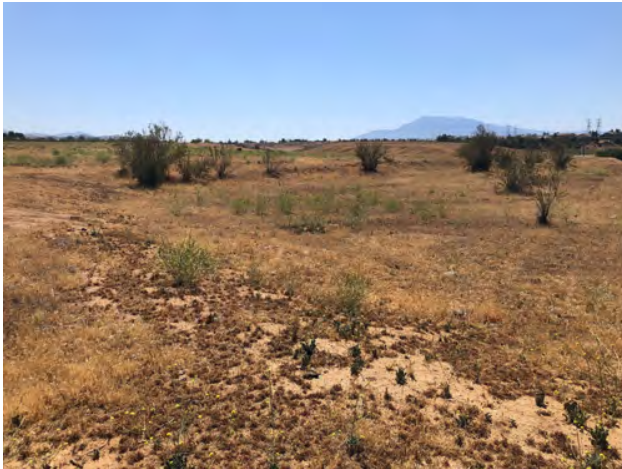
Photo 45. East facing view of area mapped by USGS NHD as a "Reservoir" and where a basin was previously located east of EF-8. No evidence of hydrology was observed (33.963493, -117.020227). June 3, 2021.

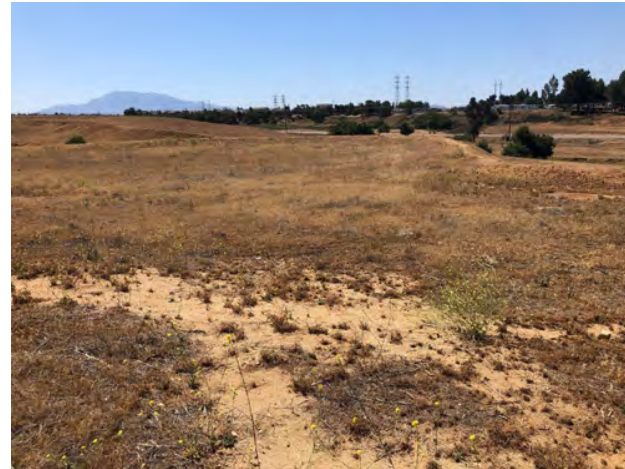
Photo 46. Southeast facing view of area where a basin was previously located west of S-3. No evidence of hydrology was observed (33.963274, -117.019648). June 3, 2021.
