Aquatic Resource Delineation Report

**Quincy Skilled Nursing Facility Project
Plumas County, California**

Prepared for:
Plumas District Hospital

July 2021
655-01

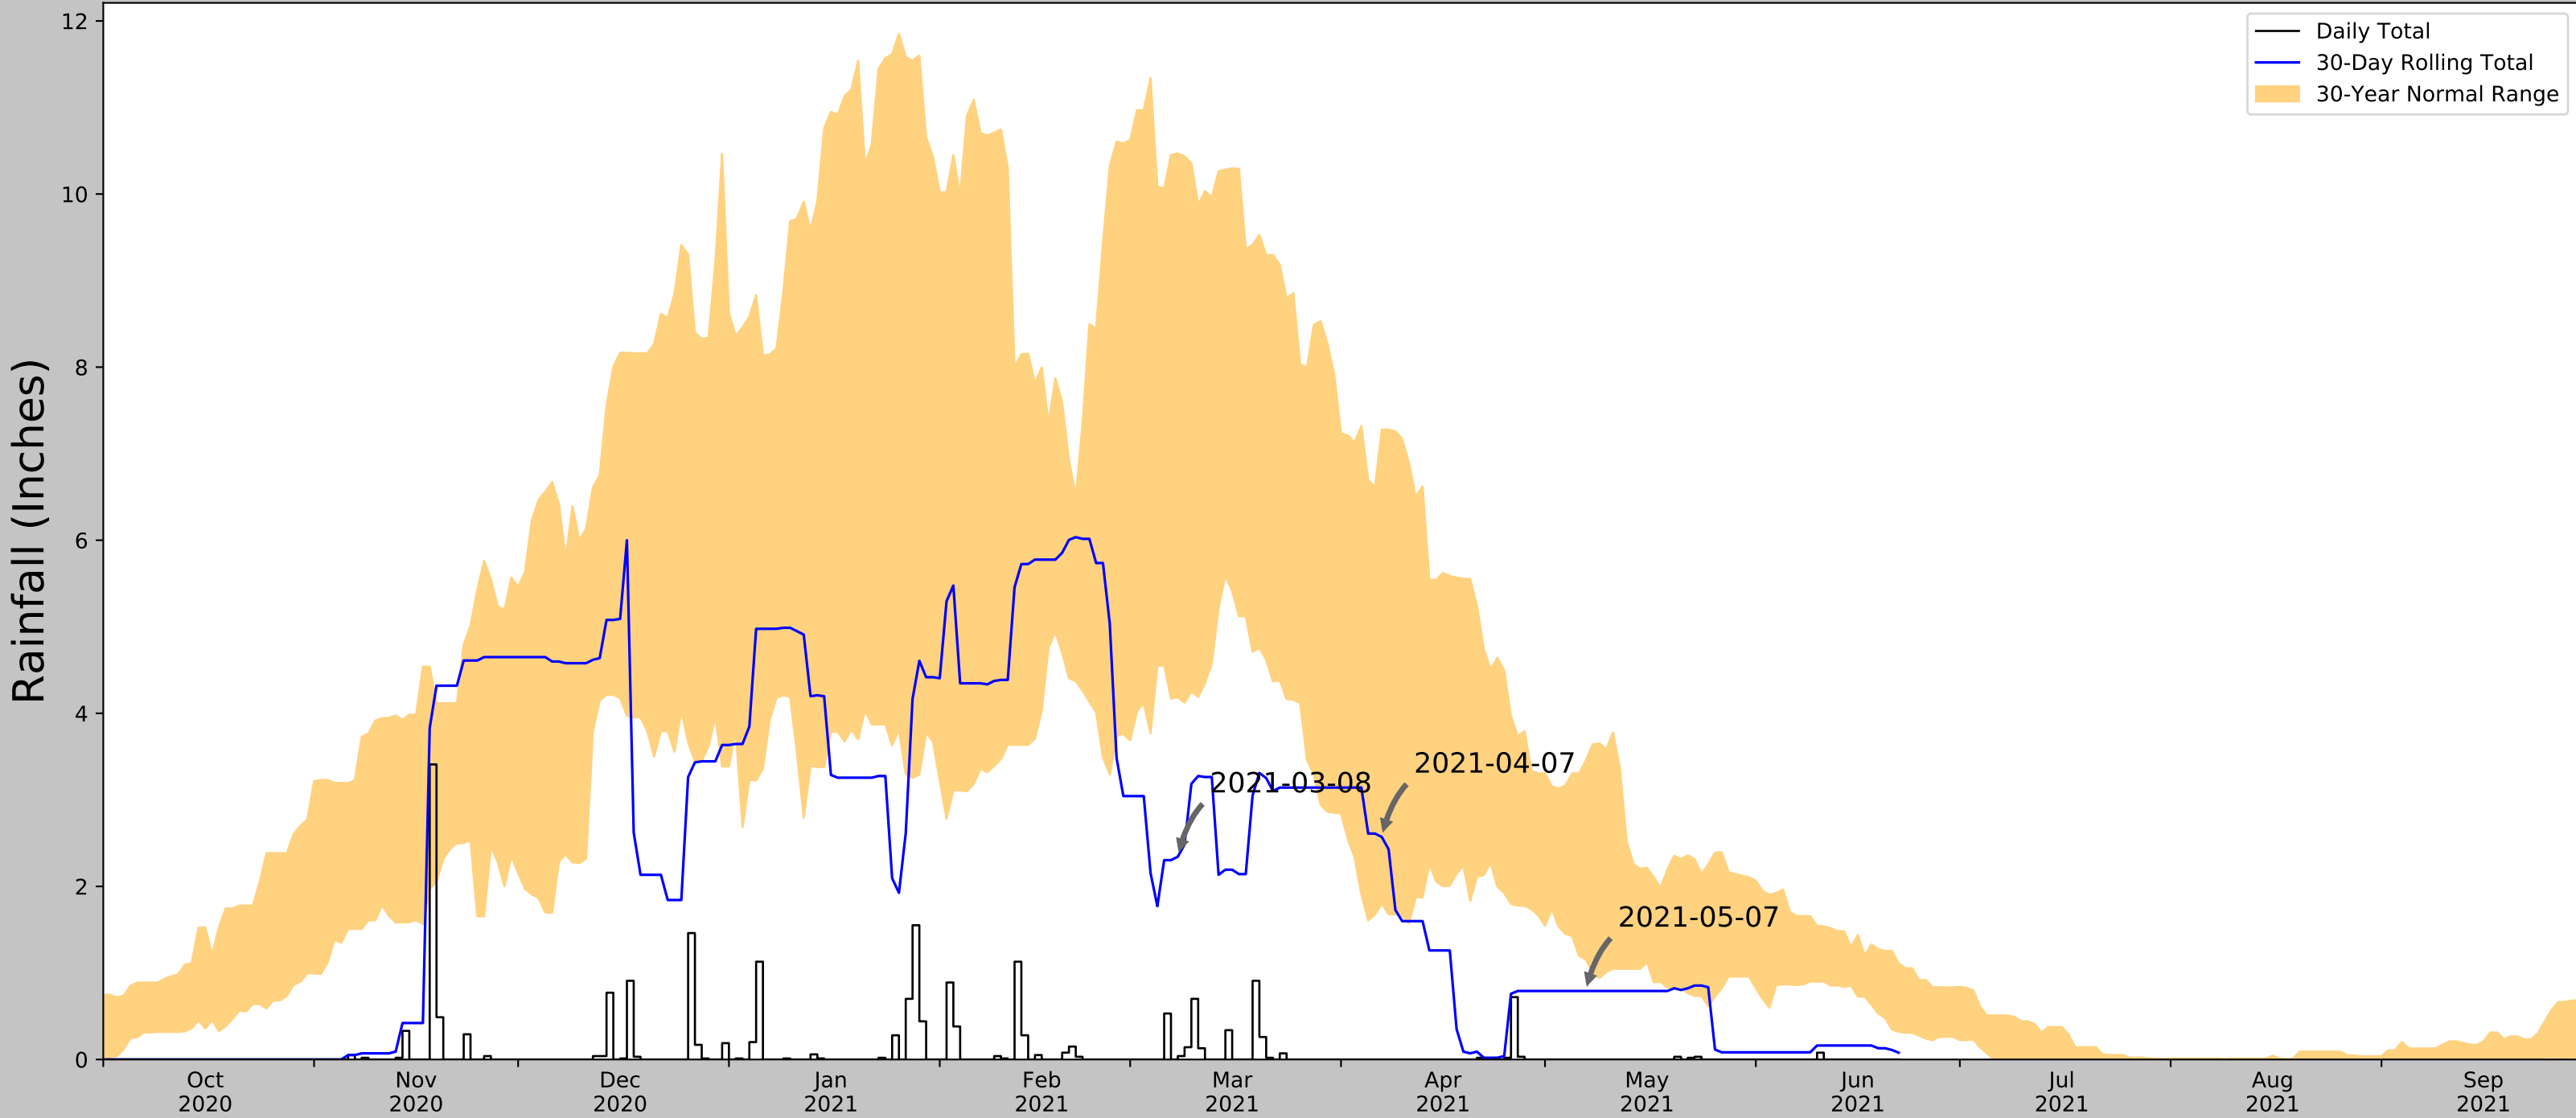
Antecedent Precipitation vs Normal Range based on NOAA's Daily Global Historical Climatology Network

Coordinates	39.93898358, -120.96281749
Observation Date	2021-05-07
Elevation (ft)	3448.02
Drought Index (PDSI)	Extreme drought
WebWIMP H ₂ O Balance	Wet Season

30 Days Ending	30 th %ile (in)	70 th %ile (in)	Observed (in)	Wetness Condition	Condition Value	Month Weight	Product
2021-05-07	1.155512	3.451969	0.791339	Dry	1	3	3
2021-04-07	1.801575	7.277953	2.570866	Normal	2	2	4
2021-03-08	4.183465	10.469292	2.34252	Dry	1	1	1
Result							Drier than Normal - 8

The U.S. Army Corps of Engineers' Antecedent Precipitation Tool (APT) was used as an indicator of climatic circumstances at the time of the field delineation. Rainfall conditions for the three months prior to the field date were calculated and compared to rainfall quantities during typical years. According to the APT, the field delineation was conducted during dryer than normal conditions (Deters, 2020). It is unlikely however, that these conditions were extreme enough to conflict with an accurate wetland delineation. The wetlands specialist is experienced with identifying wetland indicators (i.e., hydrology, soils, and vegetation) during diverse environmental conditions. Results produced by the APT are provided in **Appendix B**.

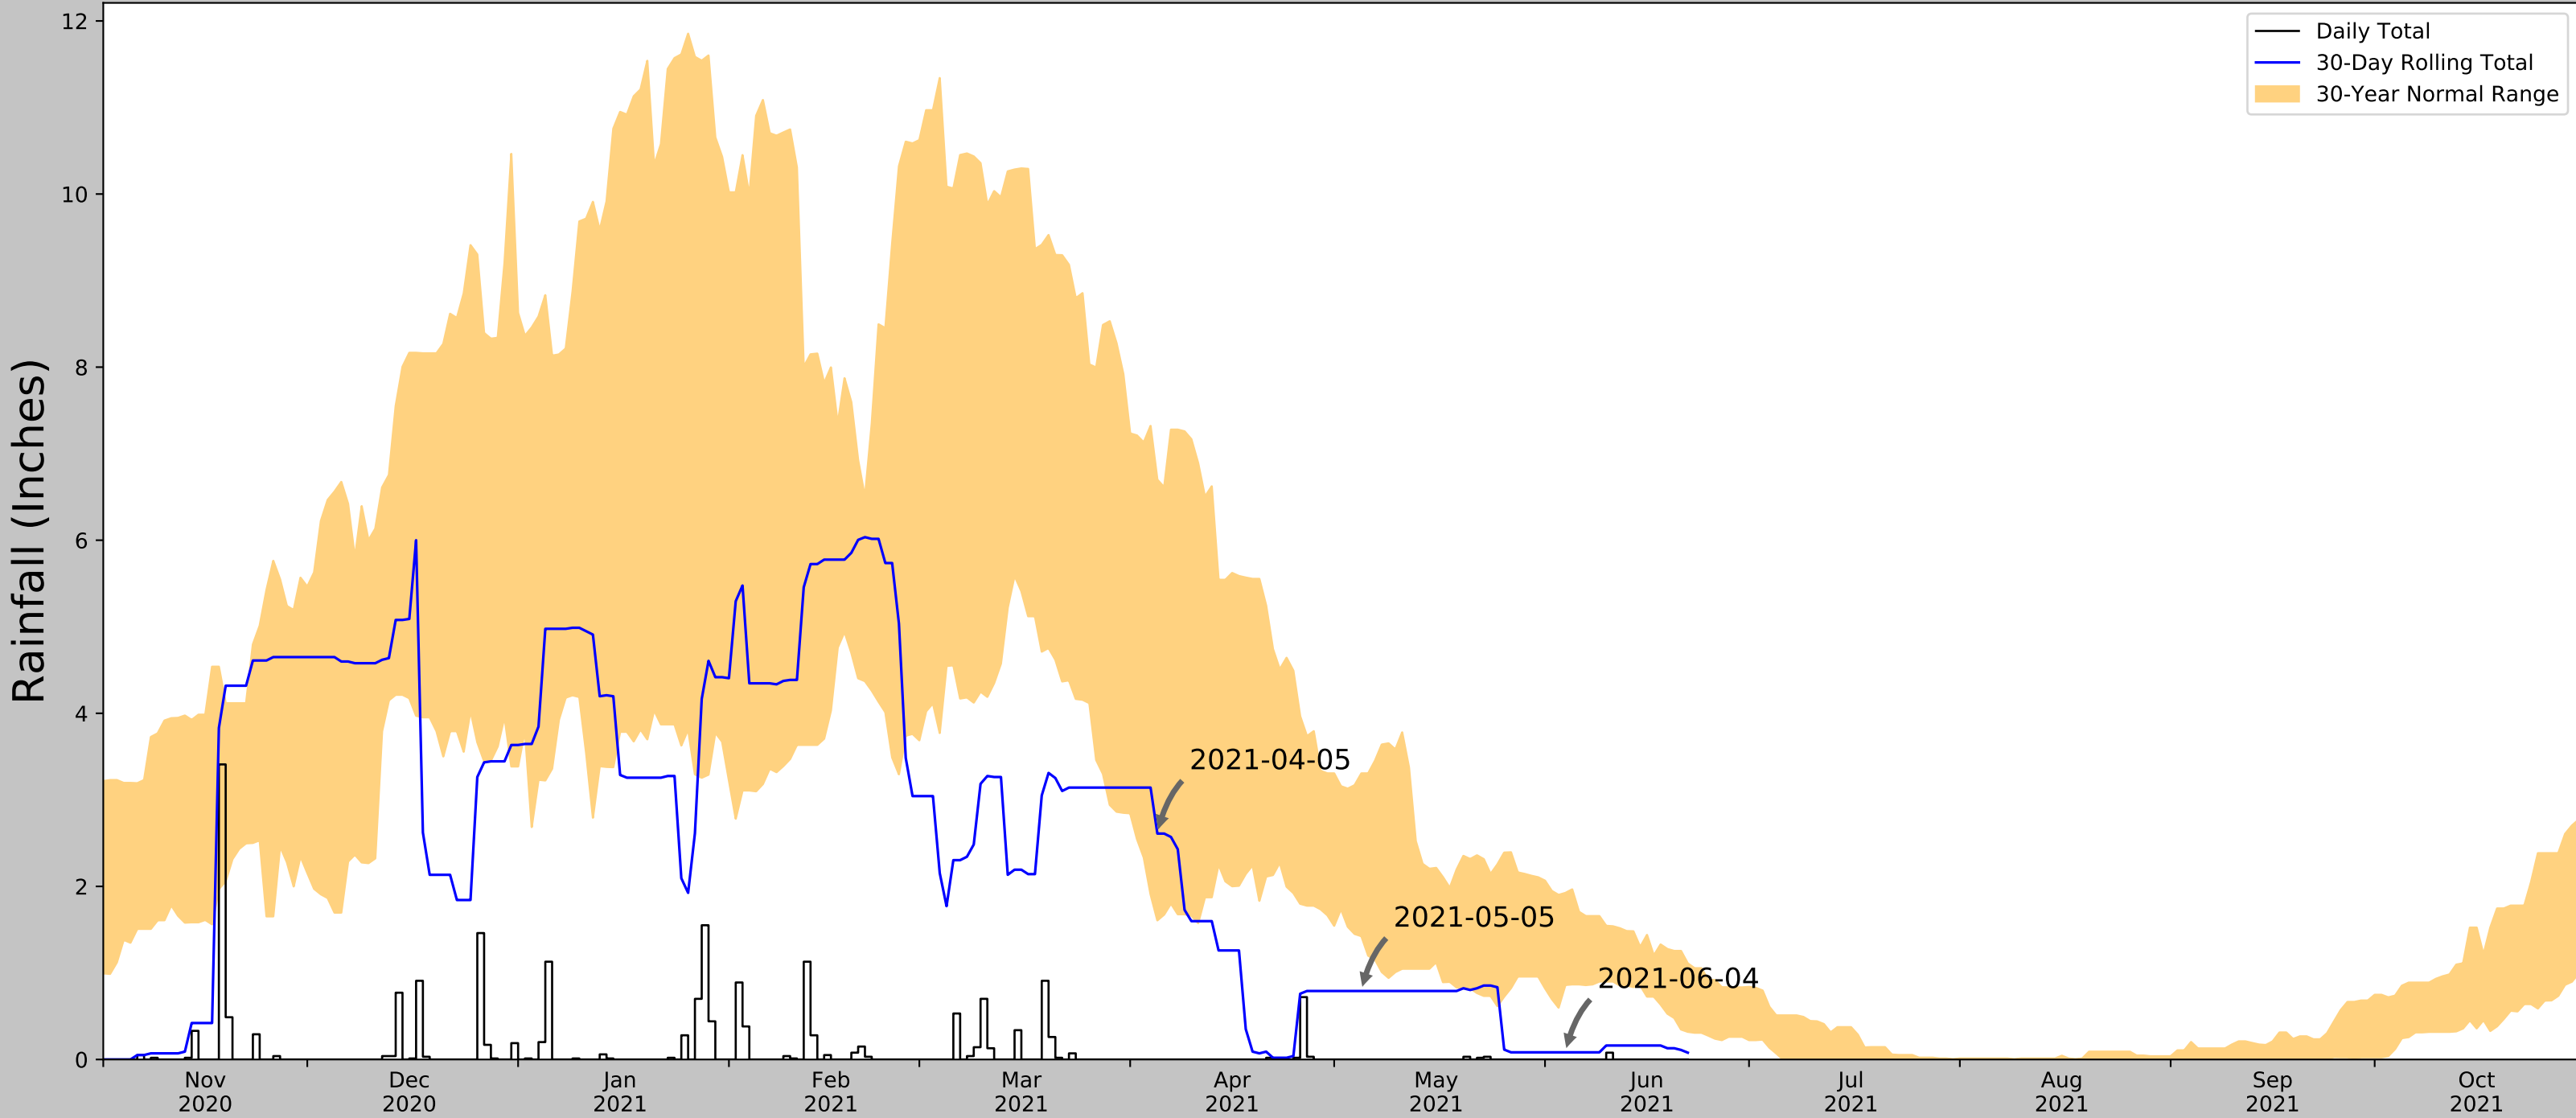
Antecedent Precipitation vs Normal Range based on NOAA's Daily Global Historical Climatology Network

Coordinates	39.93898358, -120.96281749
Observation Date	2021-06-04
Elevation (ft)	3448.02
Drought Index (PDSI)	Extreme drought (2021-05)
WebWIMP H ₂ O Balance	Dry Season

30 Days Ending	30 th %ile (in)	70 th %ile (in)	Observed (in)	Wetness Condition	Condition Value	Month Weight	Product
2021-06-04	0.861024	1.92441	0.082677	Dry	1	3	3
2021-05-05	1.425197	3.305906	0.791339	Dry	1	2	2
2021-04-05	1.60748	6.699213	2.610236	Normal	2	1	2
Result							Drier than Normal - 7

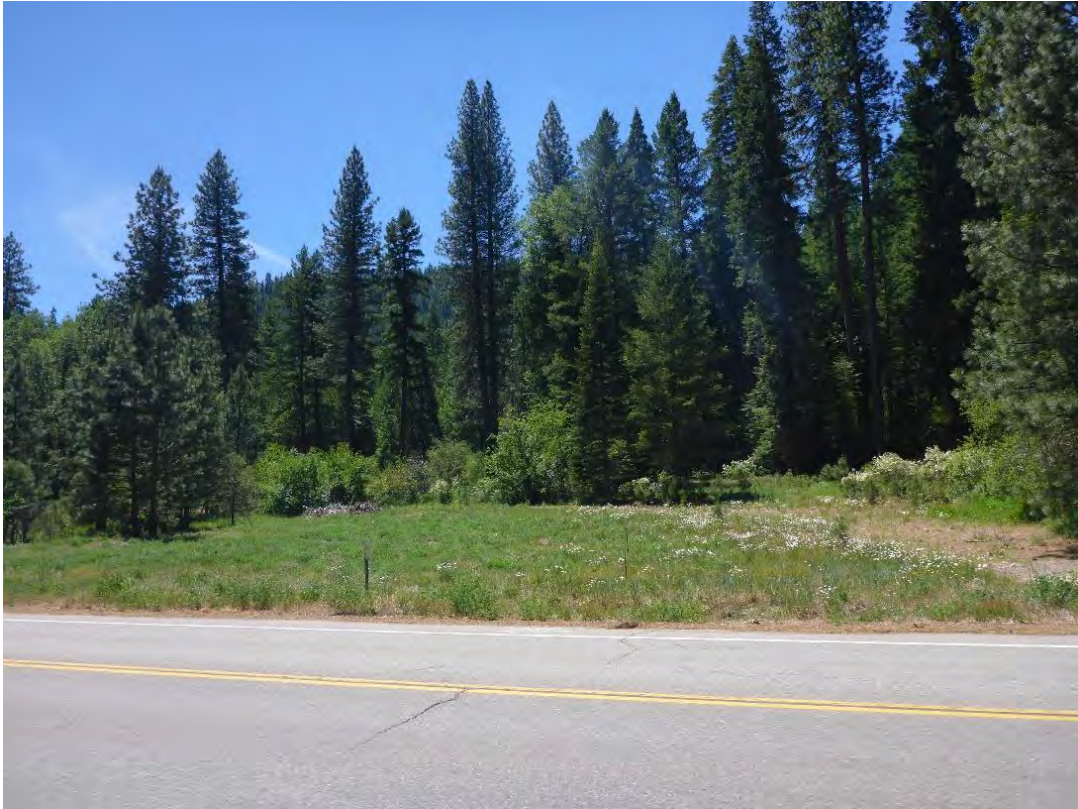
Project site from north of Bucks Lake Road, view to southeast.

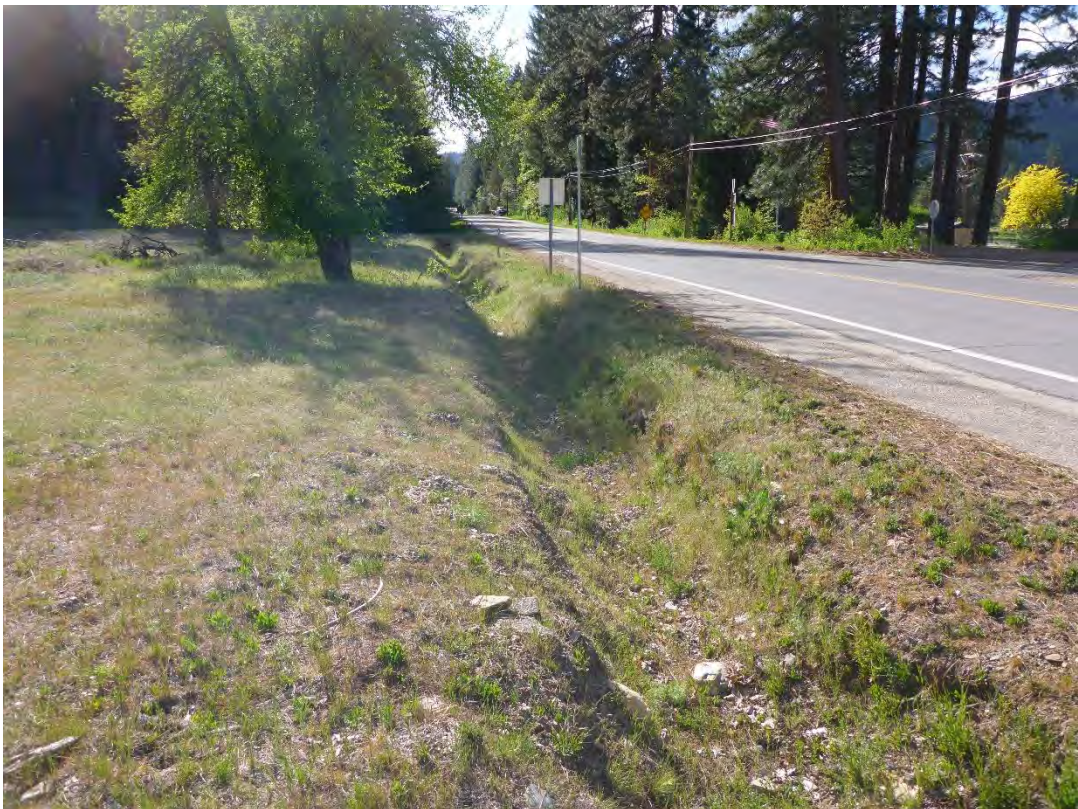
The 0.03-acre roadside ditch is a constructed feature that intercepts sheet-flow runoff from abutting uplands to the south of the ditch. The ditch flows to the west-northwest along Bucks Lake Road. About 30 feet west of the project site, flow enters a culvert under Bucks Lake Road and enters another constructed ditch on the opposite side of the road. This ditch directs flow west and north around the Church of Jesus Christ of Latter-Day Saints and then dissipates into uplands. Under flood conditions, Gansner Creek overflows its banks, and the excess flow enters the roadside ditch. Due to limited culvert capacity at the dental clinic driveway, some of the flood water crosses Bucks Lake Road near the main entrance to the hospital.

Roadside ditch from dental clinic driveway, view to west-northwest

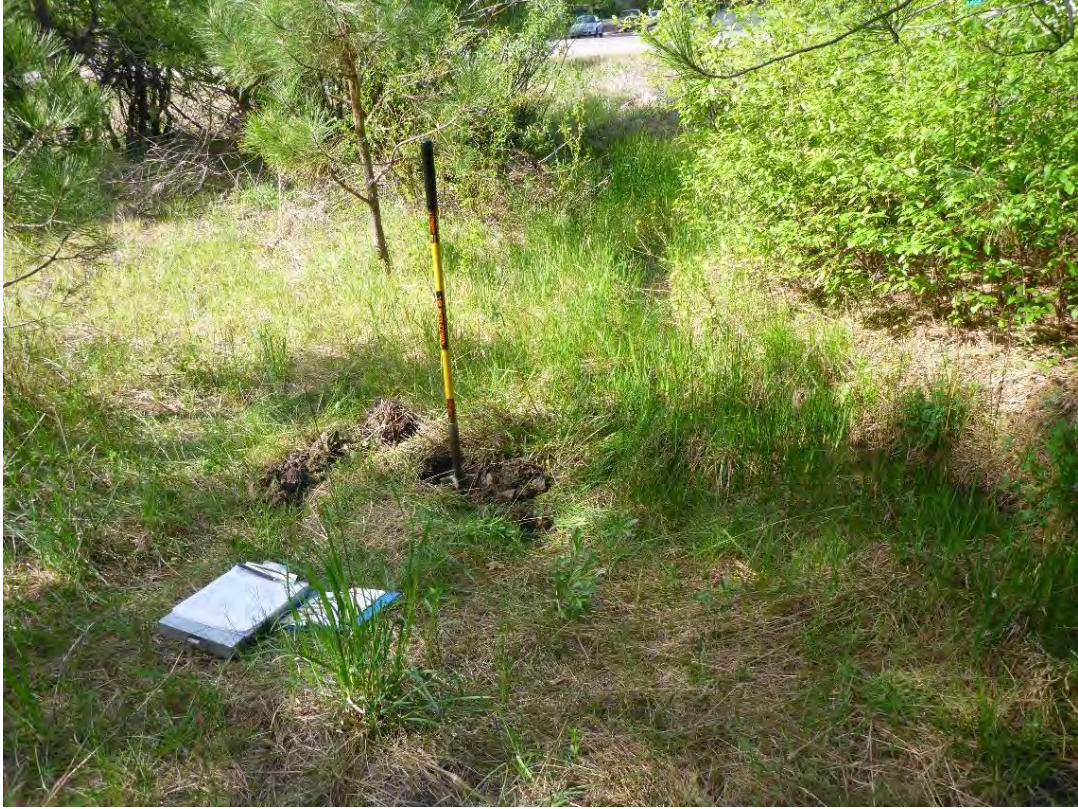
As a result of the field delineation effort, two features were identified: a riparian scrub wetland and a roadside ditch (**Figure 3, Appendix A**). The 0.22-acre riparian wetland is a perennial, or near perennial, spring-fed feature. The spring originates just south of the study area boundary and flows to the north. During the 2021 field visits, surface water was observed in the approximate upper 75 percent of the 290-foot-long feature. All water appears to percolate back into the ground. A low berm is present at the northern end of the feature; moist soil and evidence of ponding was observed upslope of the berm, but there was no evidence of a surface connection (or subsurface connection) to the roadside ditch about 50 feet north of the wetland. The wetland supports both herbaceous and shrubby plant species, including big-leaved sedge (OBL), green-sheath sedge (FACW), fragile-sheath sedge (FAC), Baltic rush (FACW),

Riparian wetland; DP1

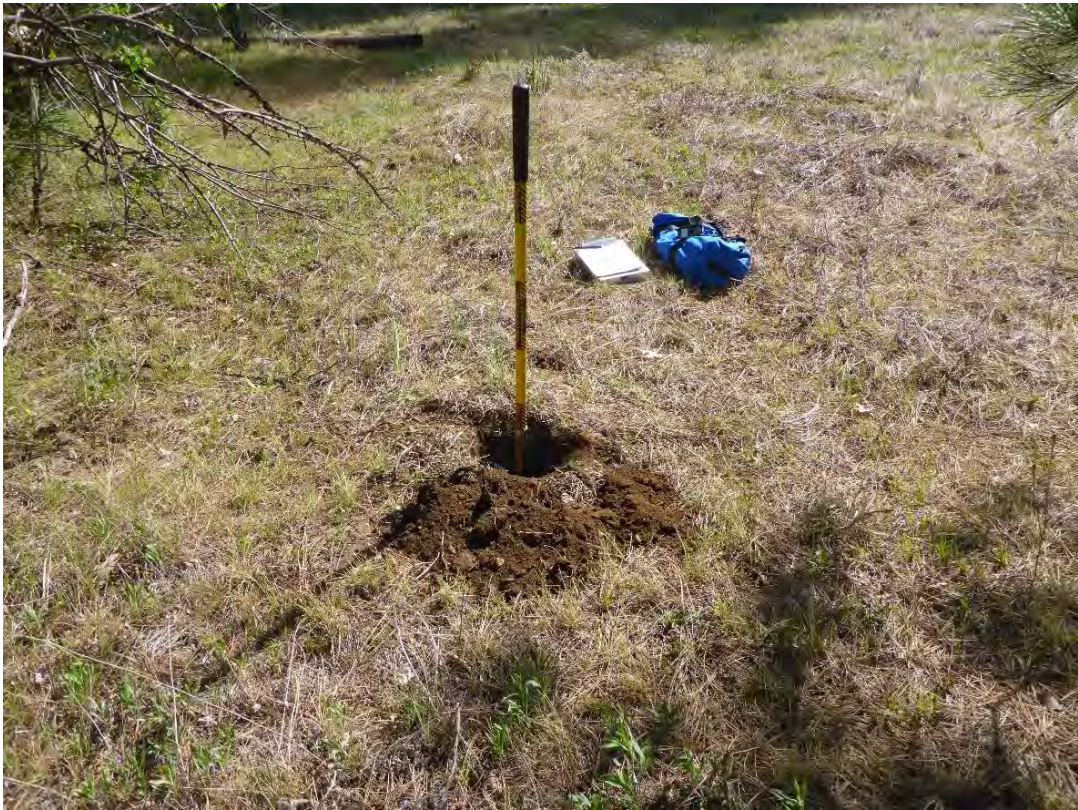
Hydrophytic Vegetation Present? Yes _____ No <u>X</u> Hydric Soil Present? Yes _____ No <u>X</u> Wetland Hydrology Present? Yes _____ No <u>X</u>	Is the Sampled Area within a Wetland? Yes _____ No <u>X</u>
Remarks: <u>The soil is disturbed by past land uses; there is much fill present.</u>

DP2; upland pair point
