13th Street Bridge, Ramona, California Aquatic Resource Delineation Report

County of San Diego, Department of Public Works

AECOM

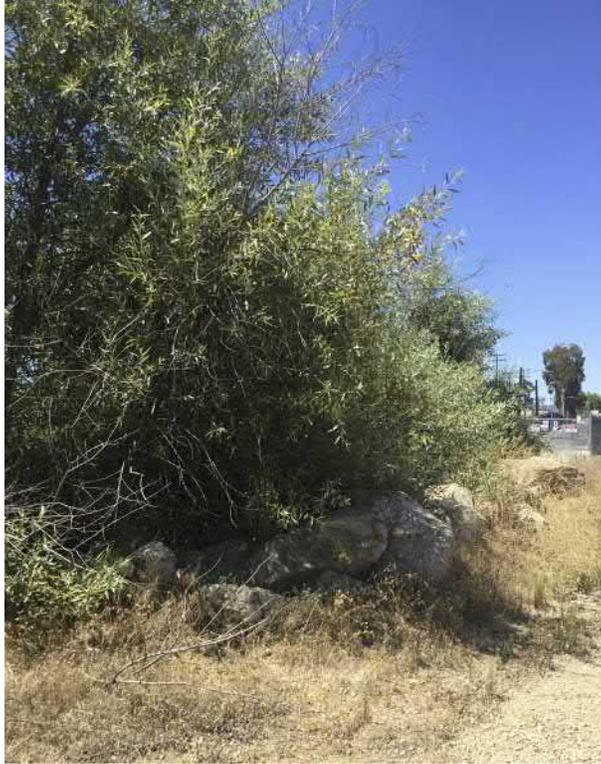
15. View of the arroyo willows that were planted around the outlet (and north) of Basin 1.

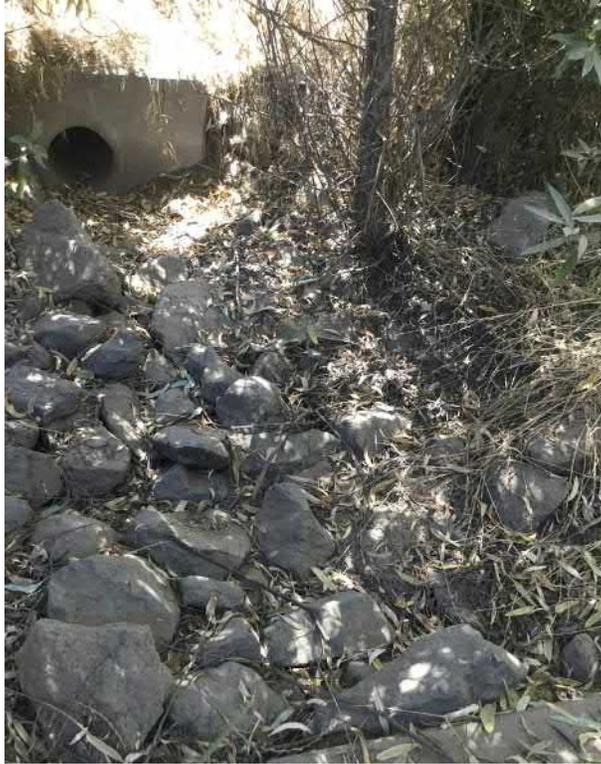
20. View of stormwater detention swale between 13th street road and Basin 1. This receives water from the paved 13th street to the south.

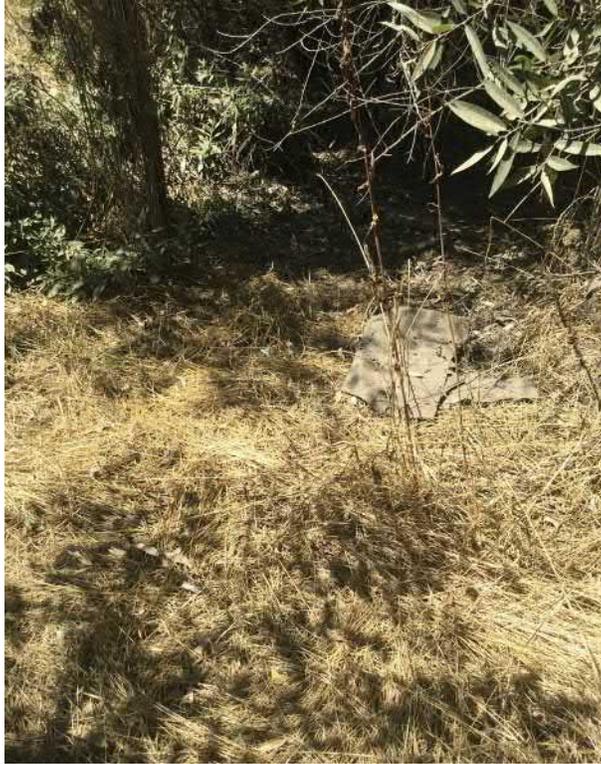
24. View of stormwater culvert and basin that drains Basin 1. This receives water from the library parking lot and the stormwater detention swale/13th street.

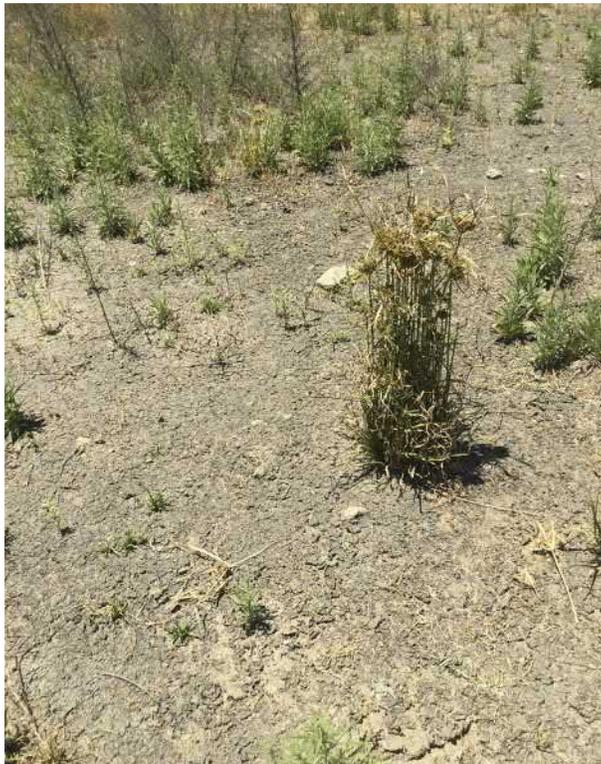
25. View of stormwater detention basin where the water from Basin 1 drains. Debris surrounding basin.

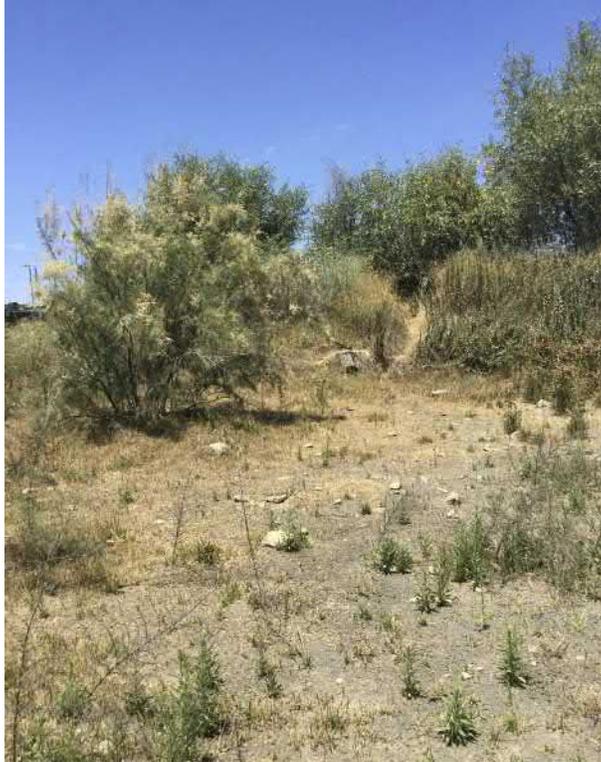
26. View of biotic crusting and soil cracking within Basin 1.
