Natural Environment Study

Unincorporated Community of Ramona

San Diego County, California

October 2020

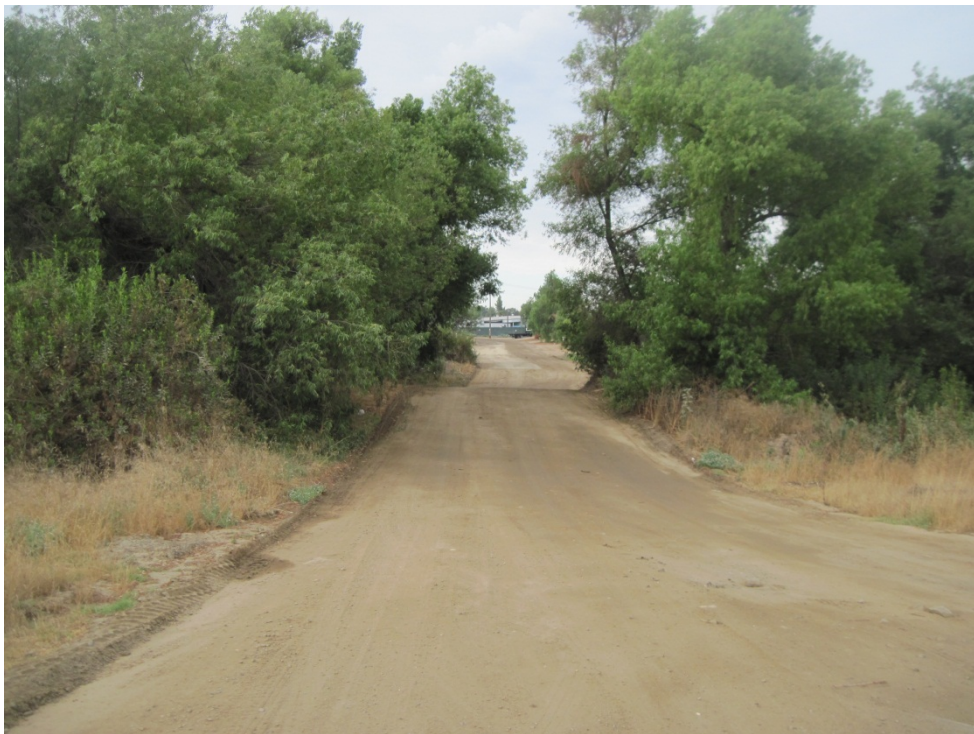
Photo 4 – View of the 13th Street crossing of Santa Maria Creek, facing south.

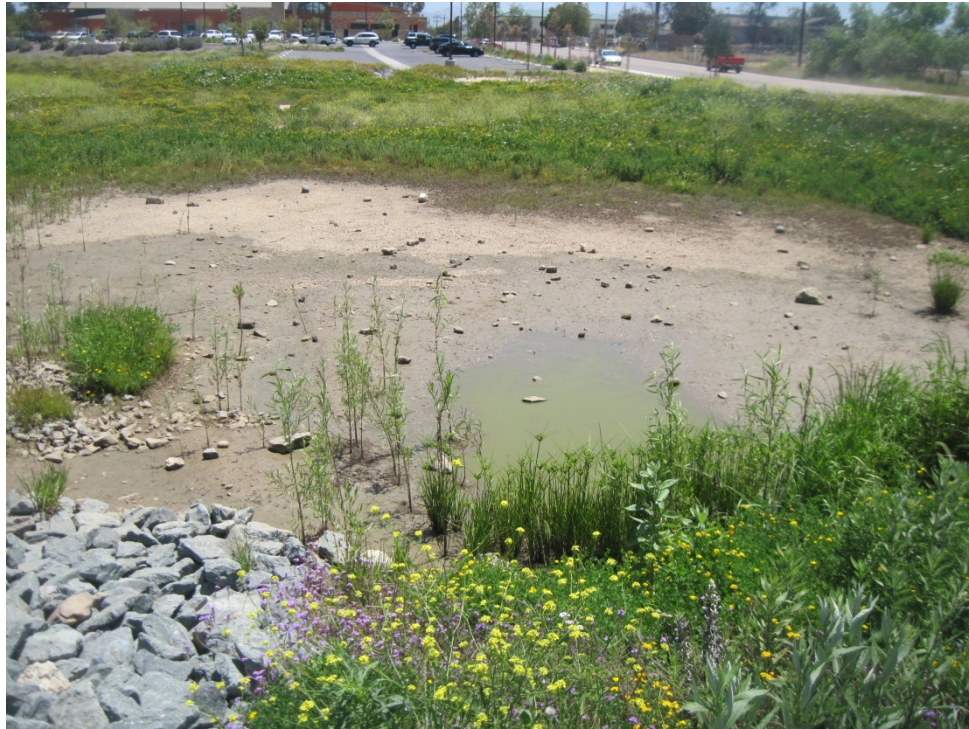
Photo 7 – View of the settling basin adjacent to the library parking lot, facing south.

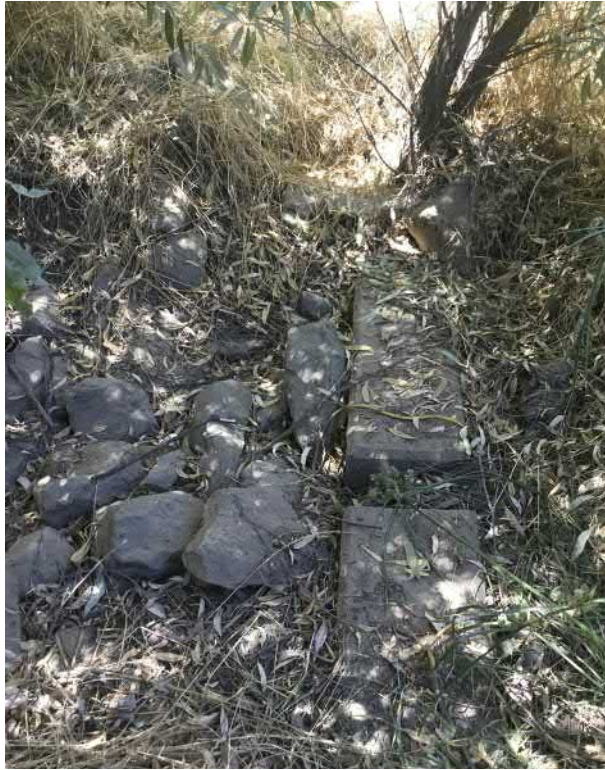
23. View of stormwater culvert and basin that drains Basin 1. This receives water from the library parking lot and the stormwater detention swale/13th street.

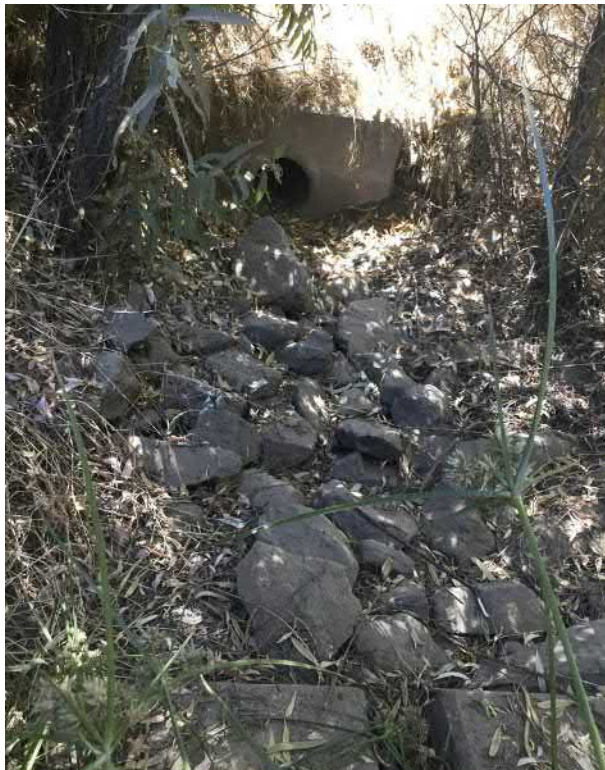
24. View of stormwater culvert and basin that drains Basin 1. This receives water from the library parking lot and the stormwater detention swale/13th street.

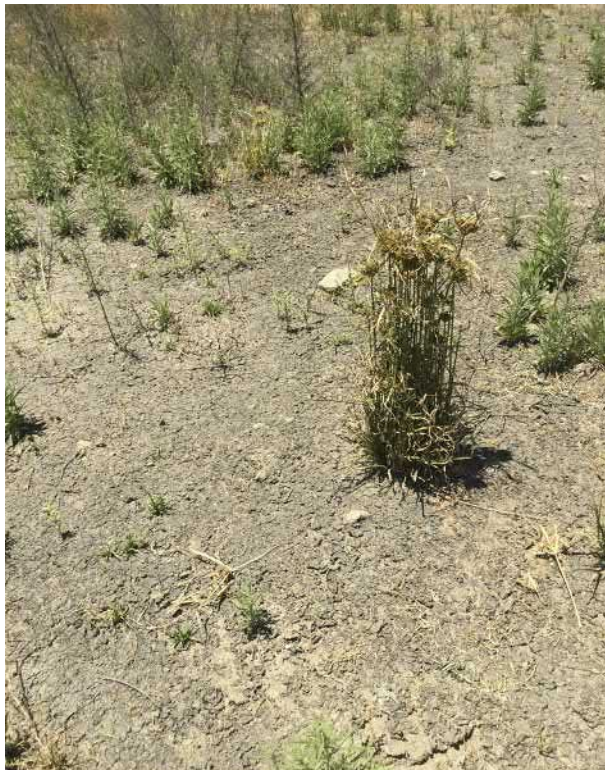
26. View of biotic crusting and soil cracking within Basin 1.

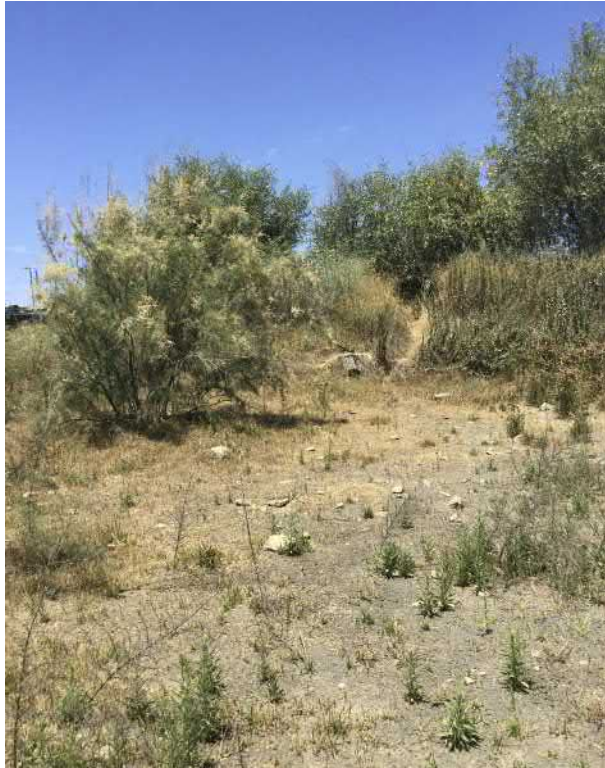
27. View of culvert in Basin 1 taken from within Basin 1.

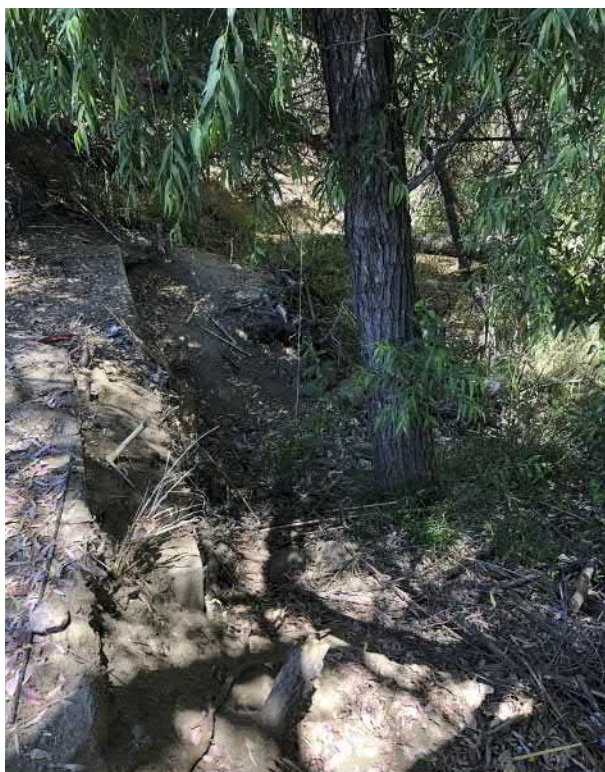
80. View of culvert outlet in Santa Maria Creek.
