Biological Resources Assessment (BRA) Report

# Robles Diversion and Fish Passage Facility Annual Maintenance and Repair Program

## Biological Resources Assessment

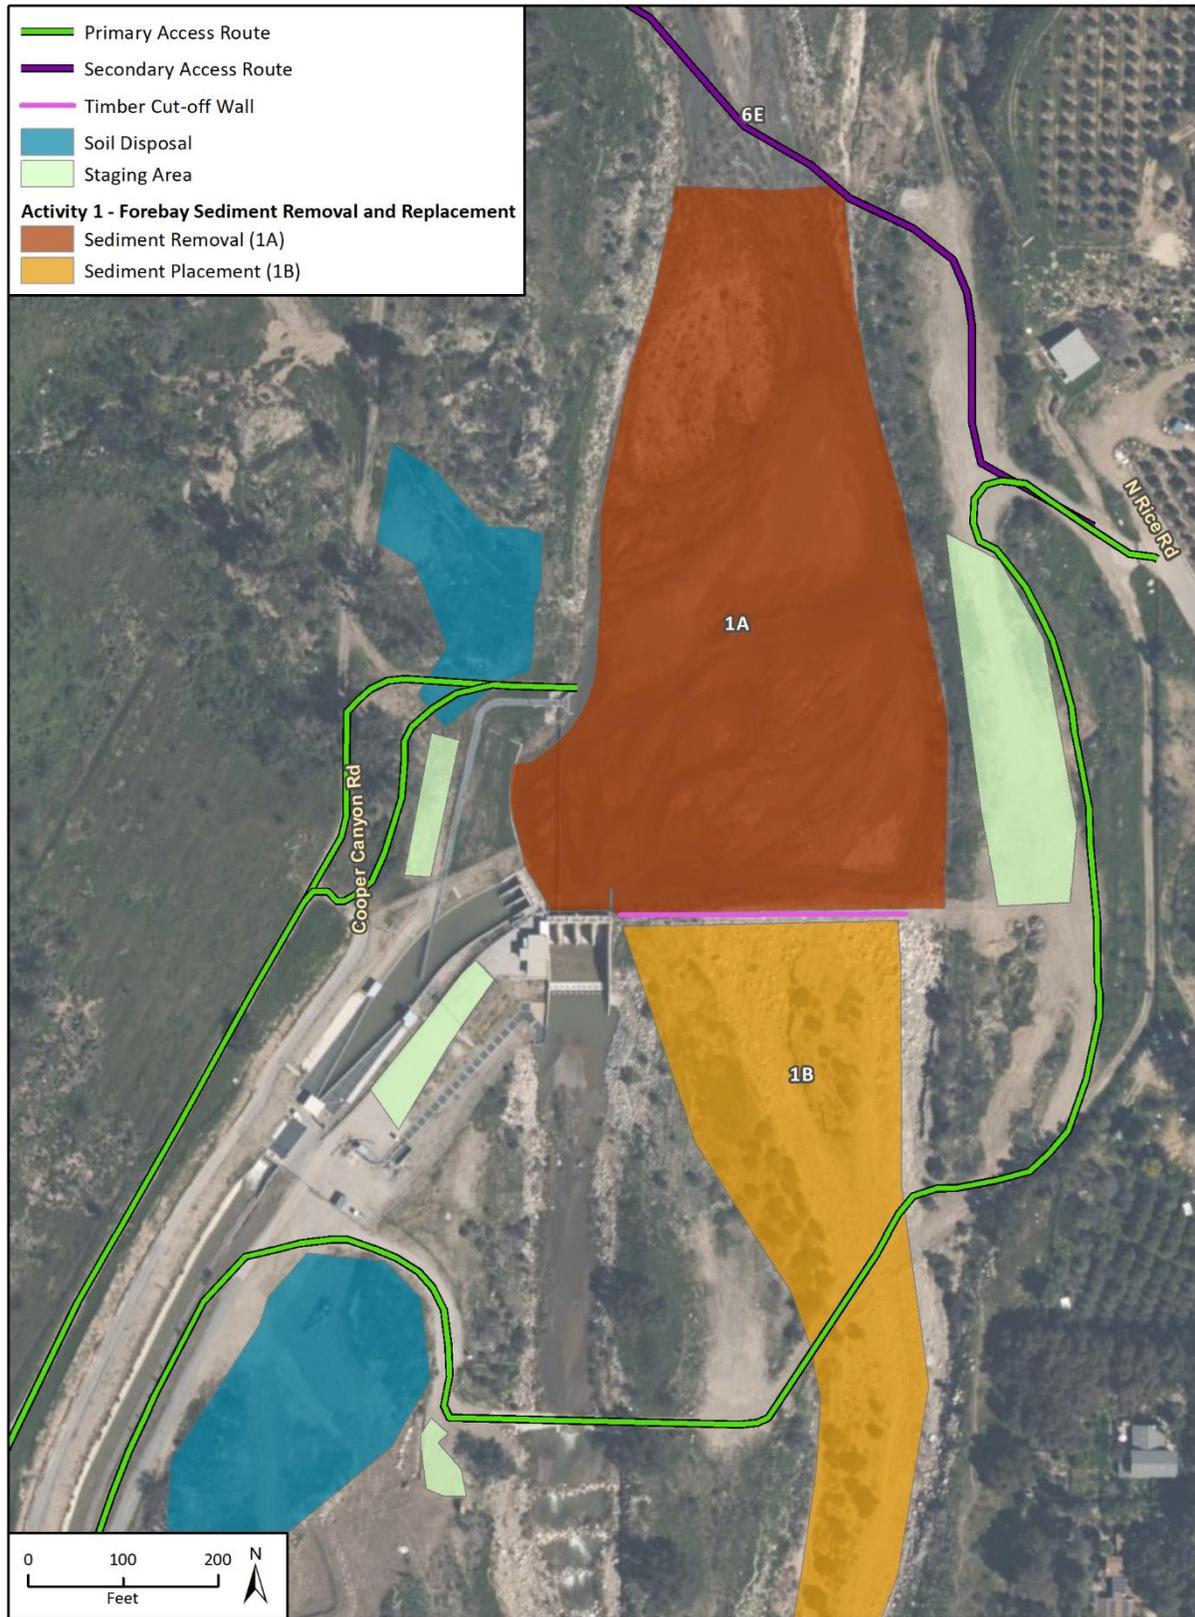
**Figure 3 Activity 1 Forebay Sediment**

Fig 3 Activity 1 Forebay Sediment Removal and Placement 20200401

This maintenance and repair activity may occur annually to restore the forebay's operational volume. The maintenance will return the forebay closer to its historic operational grade (Appendix D) by removing accumulated sediment, and relocating it downstream (1B; Figure 3), or to a stockpile area above the mean high water mark. Remaining sediment excavated may be exported offsite. The quantity of sediment/debris to be removed depends greatly on storm load deposition, which is highly dynamic. In some years no removal would be needed, in other years moderate amounts would be required to be removed and at such times it is generally anticipated that it will not exceed approximately 56,500 cubic yards per year. When annual accumulation is unusually great, as has

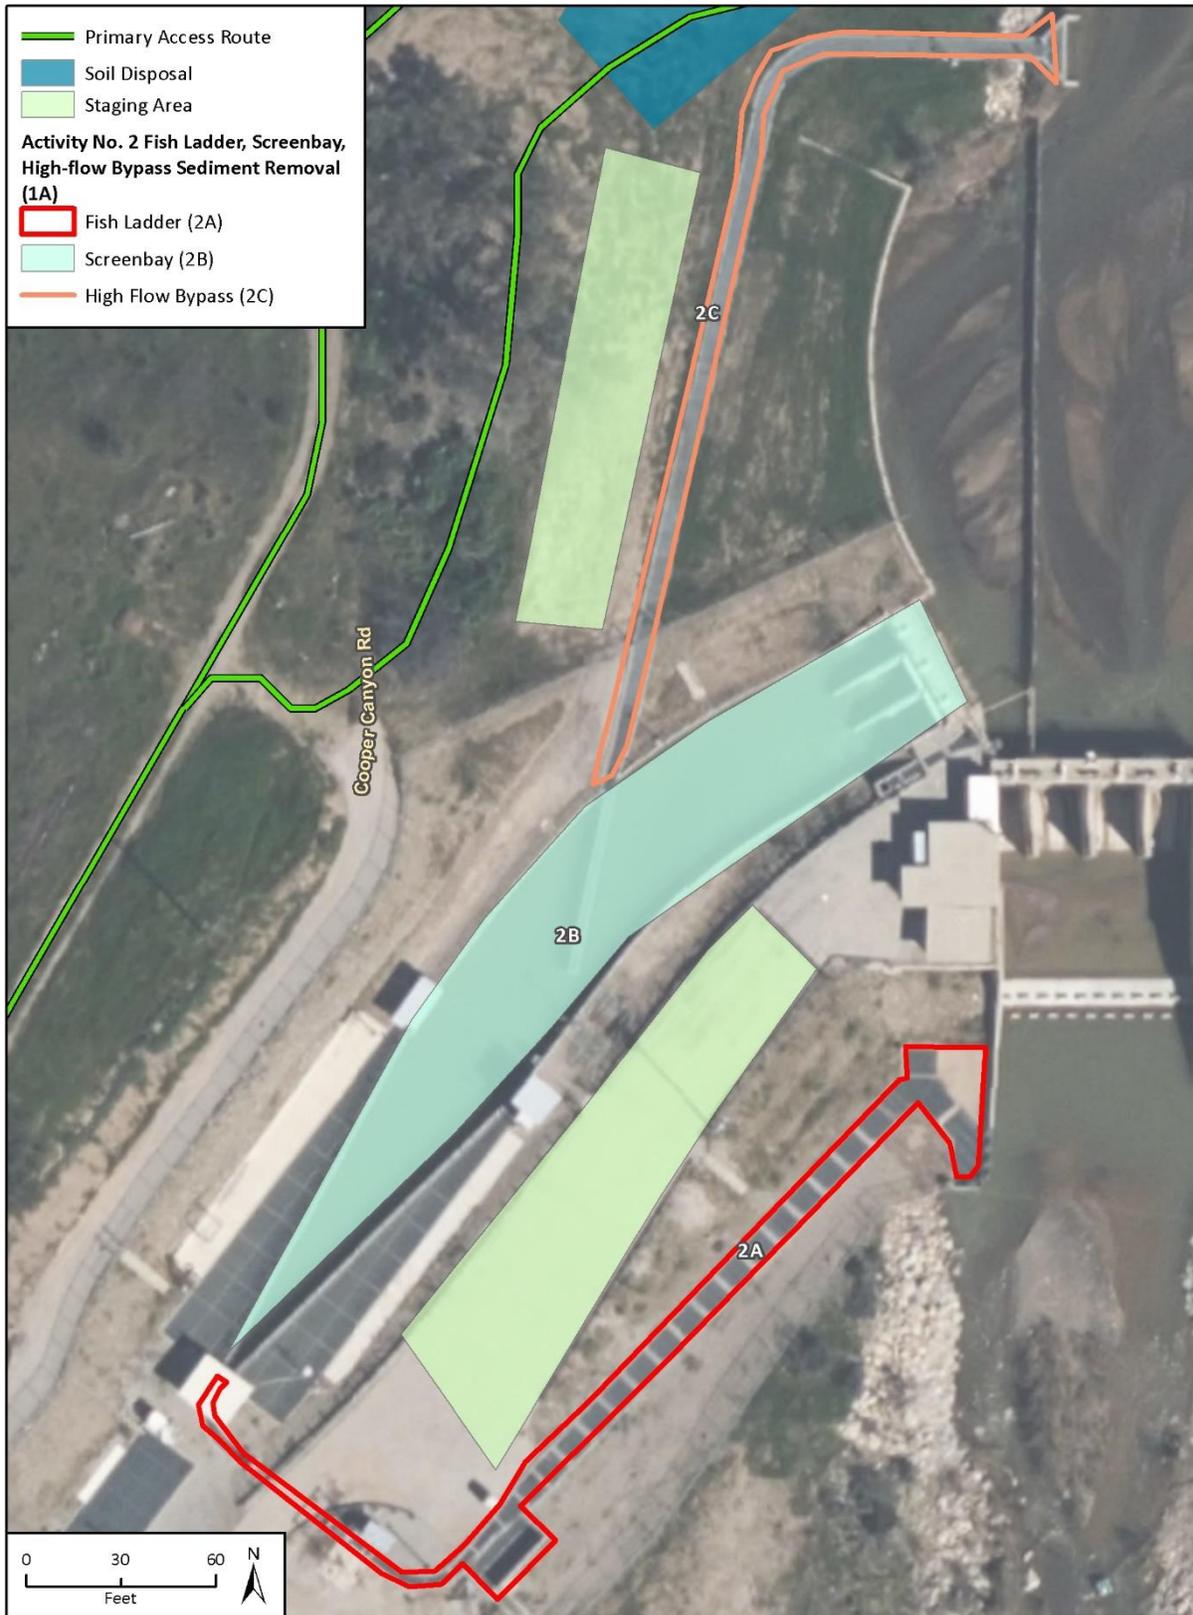
**Figure 4 Activity 2 Fish Ladder, Screenbay, High-flow Bypass**

Fig. 4 Activity 2 Fish Ladder Screenbay High Flow Bypass

It is anticipated the Facility can operate throughout a single fish passage season without the need for any extensive repairs or maintenance. Whenever possible, extensive maintenance or repairs are performed during dry periods or when the fishway is not in operation. The potential exists, however, for substantial damage to result from debris accumulation during the fish passage season. For example, debris or sediment accumulation in the fish ladder, screenbay, and high-flow bypass could impede the function of the baffles, flow meter, entrance gates, and sill blocks. Should this happen during the fish flow operations season (January 1 through June 30), Casitas will evaluate

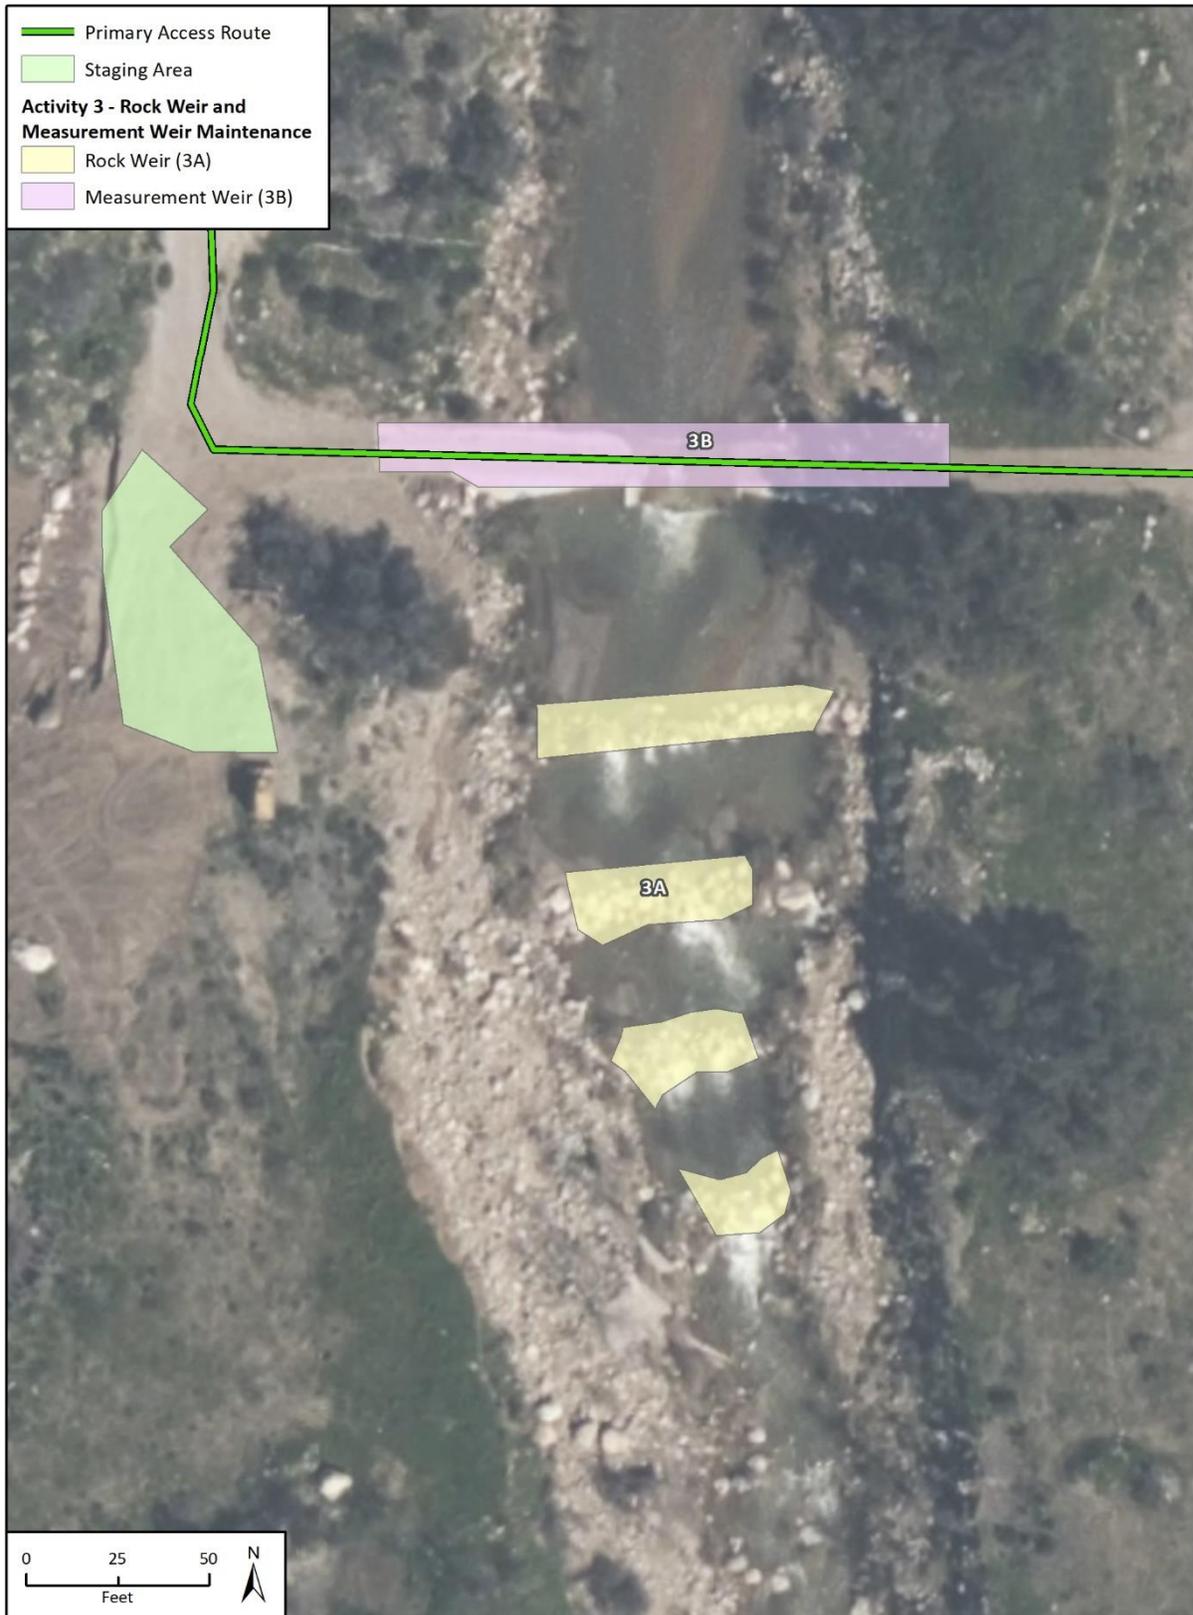
**Figure 5 Activity 3 Rock Weir and Measurement Weir**

Fig. 5 Activity 3 Rock and Measurement Weir

The proposed maintenance activity would occur during the dry season when surface water is absent. It is anticipated maintenance and repair activities associated with the weirs would require 1 to 2 weeks to complete, depending on level of activities. Staging of heavy equipment will occur in upland areas on bare ground above the ordinary high water mark and west of the channel where the weirs are located (Figure 5). Access to the weirs will be from Rice Road located east of the forebay across the Ventura River via the southern access road.

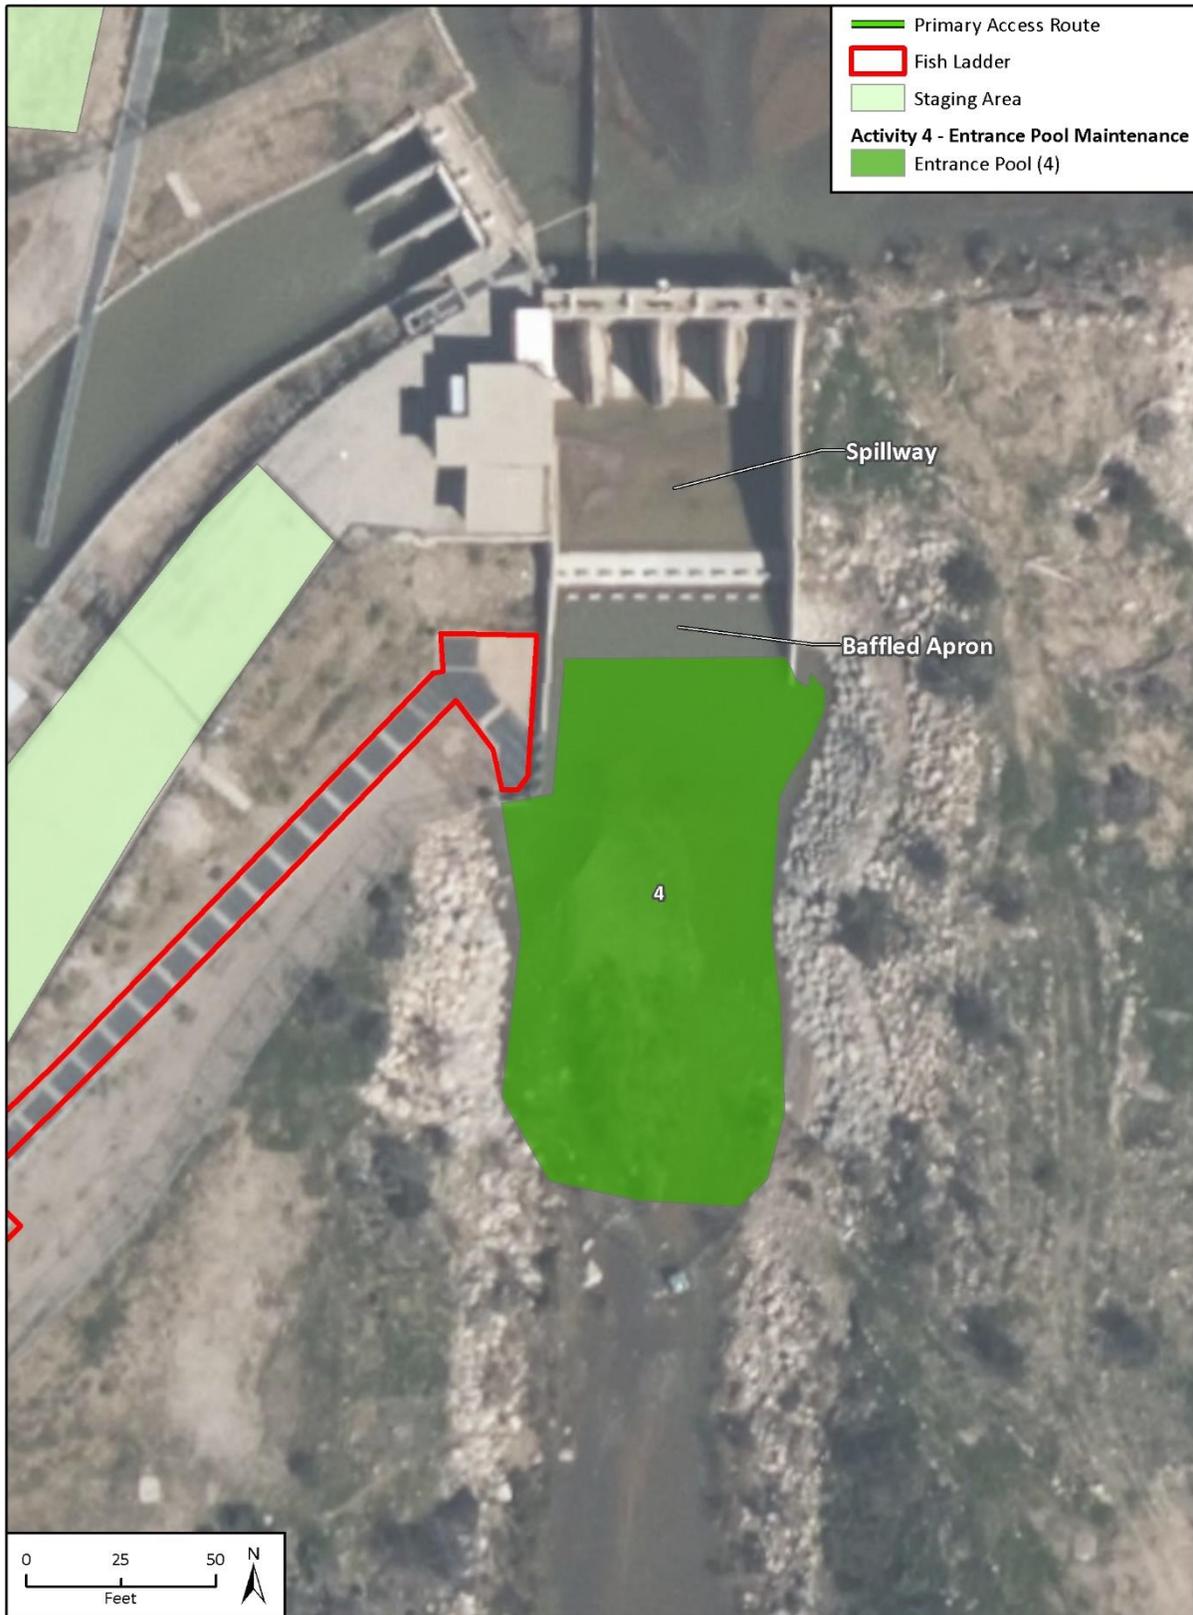
**Figure 6 Activity 4 Entrance Pool**

Fig. 6 Activity 4 Entrance Pool Maintenance

The sediment/debris and vegetation would be removed from the entrance pool with equipment including a bulldozer, excavator or other loader and supporting vehicles (e.g., one dump truck, etc.) to transport and spread the sediment/debris in designated soil disposal areas (Figure 6). It is anticipated maintenance of the pool would require up to 3 to 4 weeks to complete. Staging of heavy equipment will occur in upland areas on bare ground west and east of the channel adjacent to the entrance pool. Access to the entrance pool will be from Rice Road located east of the forebay across the Ventura River via the southern access road.

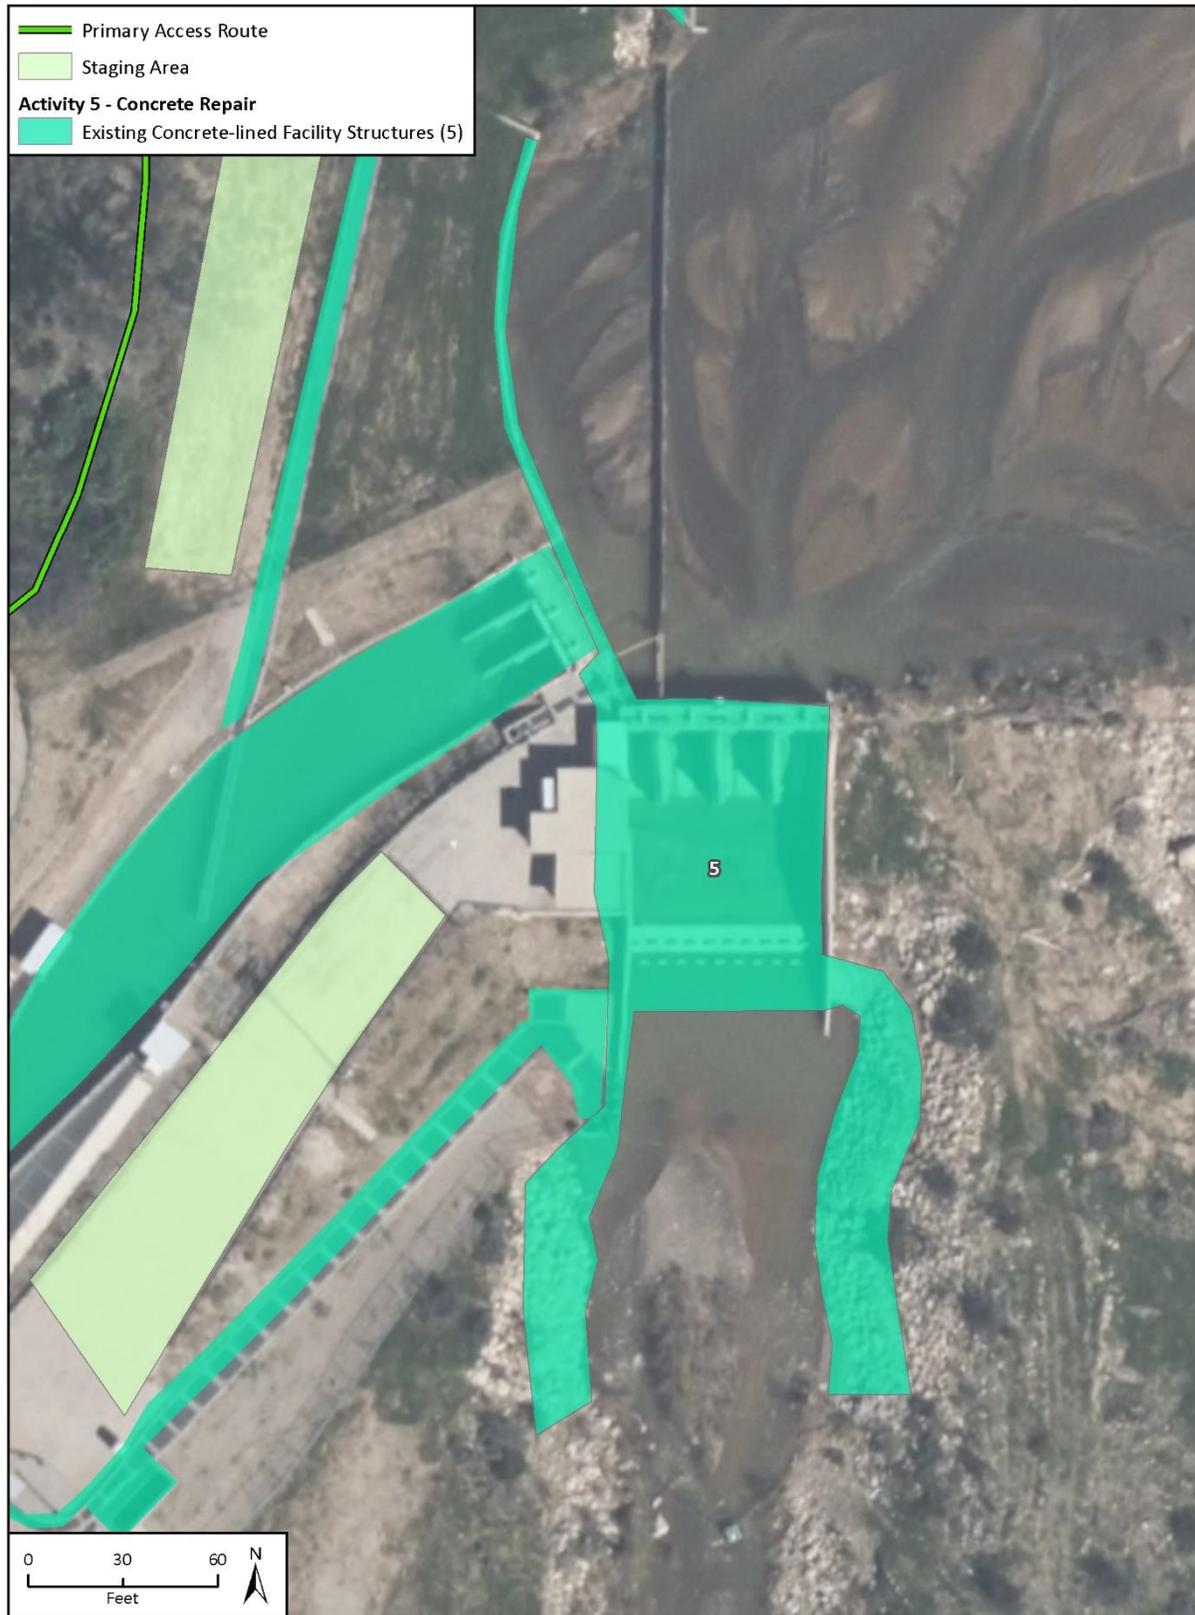
**Figure 7 Activity 5 Concrete Structures**

Fig. 7. Activity 5 Concrete Repair

Work on the concrete structures would not expand the existing footprint of the facility, and no permanent or temporary impacts to jurisdictional areas requiring compensatory mitigation are anticipated.

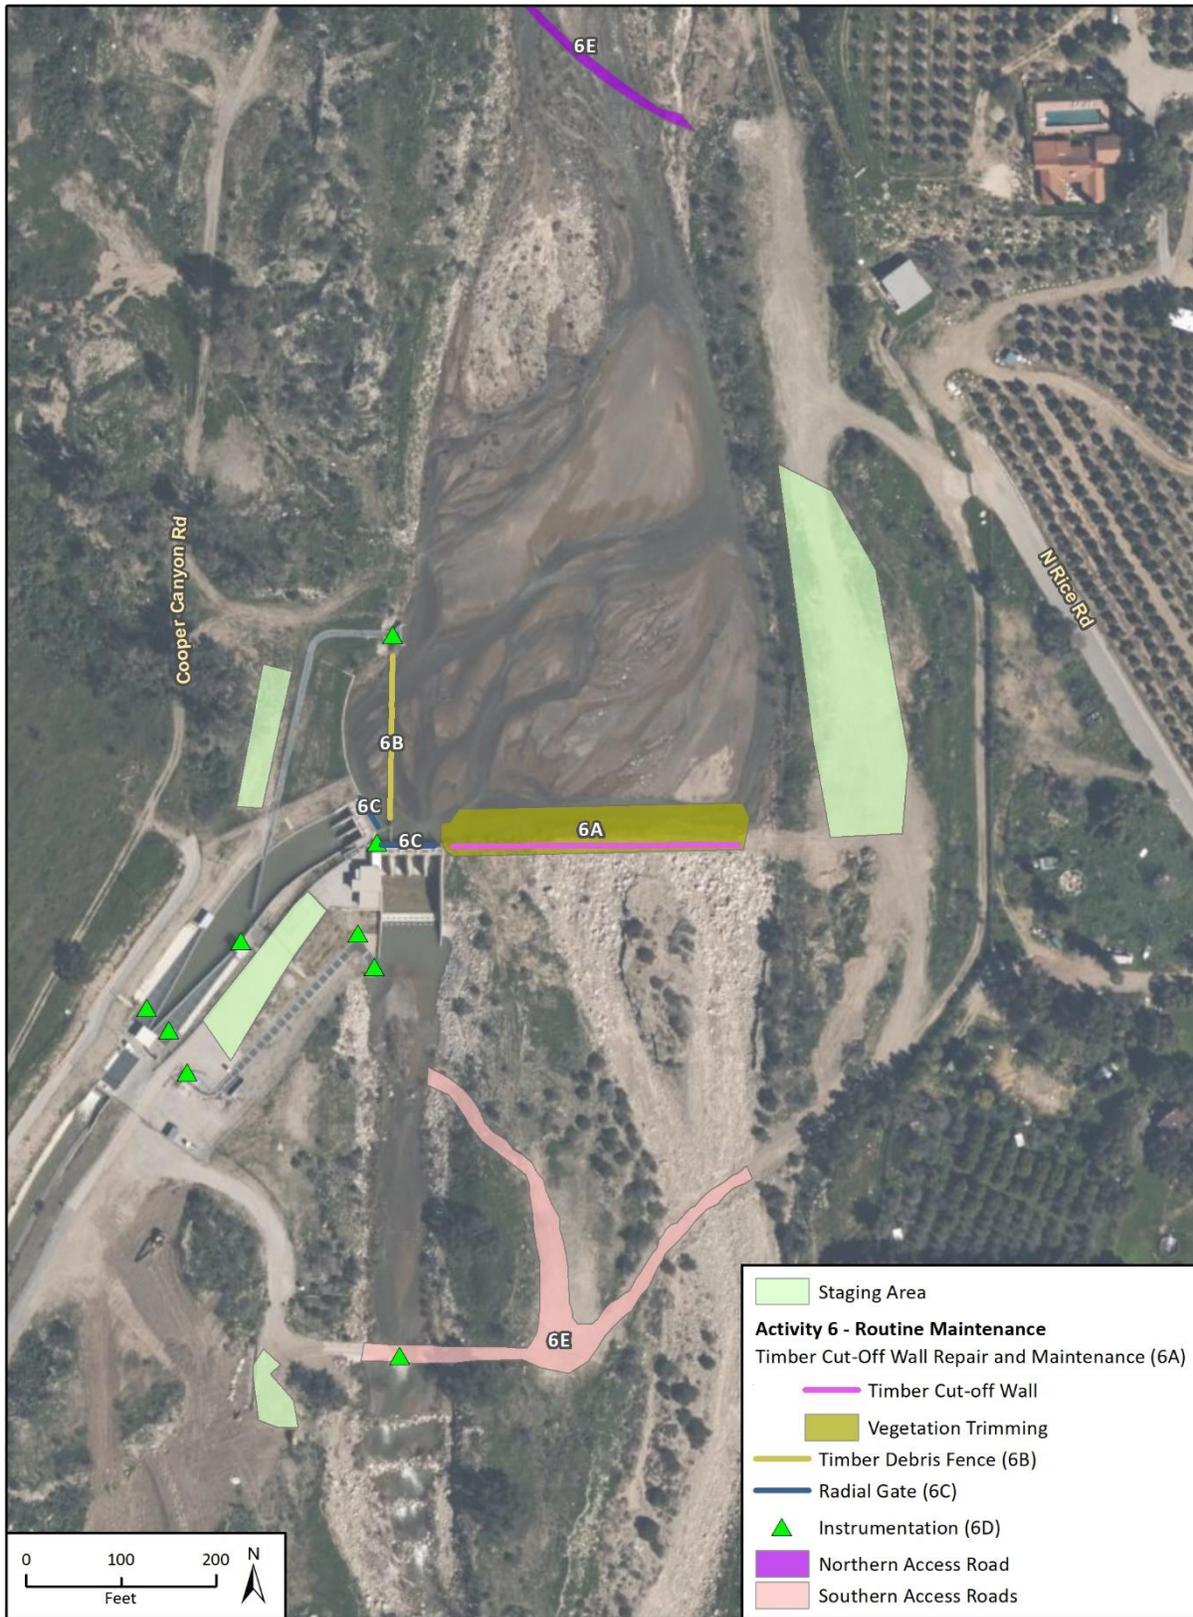
**Figure 8 Activity 6 Routine Maintenance**

Fig. 8 Activity 6 Routine Maintenance

Table 2 shows the extent of temporary impacts to potentially jurisdictional areas resulting from timber cut-off wall repair and vegetation maintenance activities. Vegetation removal would not involve excavation or backfill.

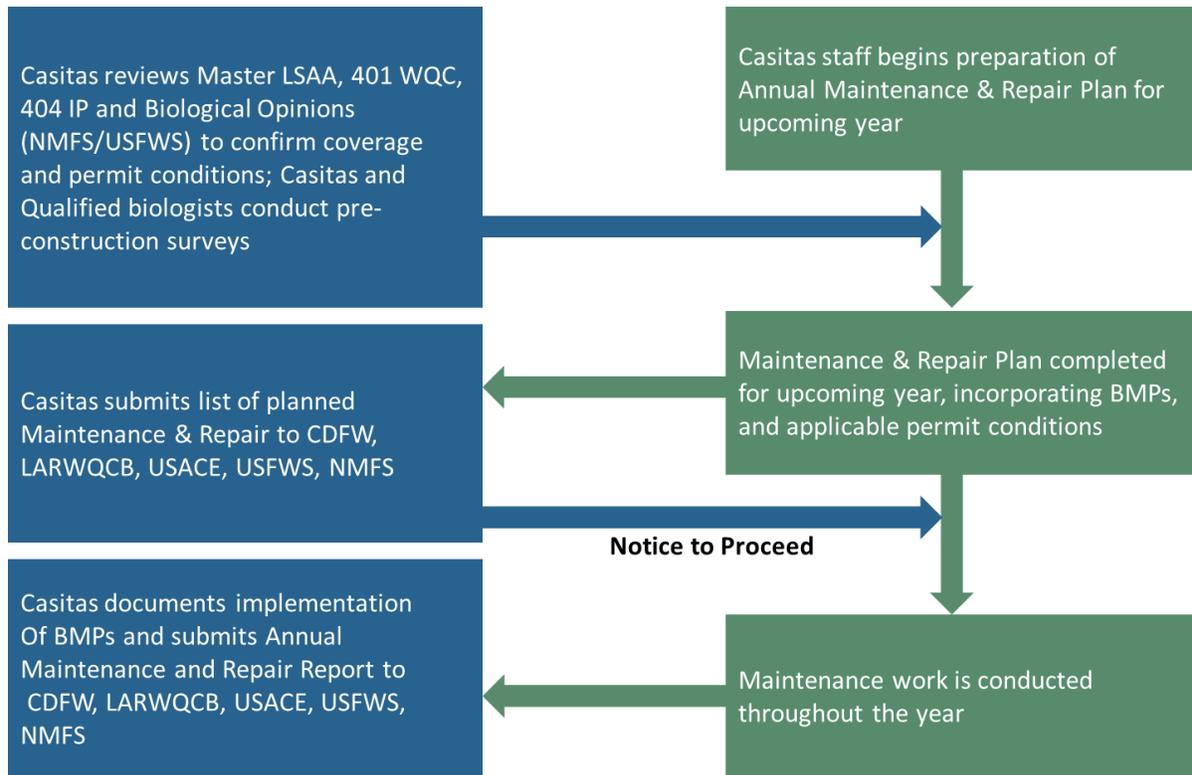
**Figure 9 Annual Monitoring and Reporting Flow Diagram**

Annual R&M Program Milestones	Timeframe
Pre-restoration/Post Winter Survey (Forebay)	April/May
Annual Maintenance and Repair Plan submitted to the resource agencies	May 30
Meeting to discuss Plan with Agencies/NTP	June
Perform Maintenance and Repair Work	July through November (dry conditions)
Post-Restoration Survey (Forebay)	October
Annual Monitoring Report submitted to resource agencies	May 30

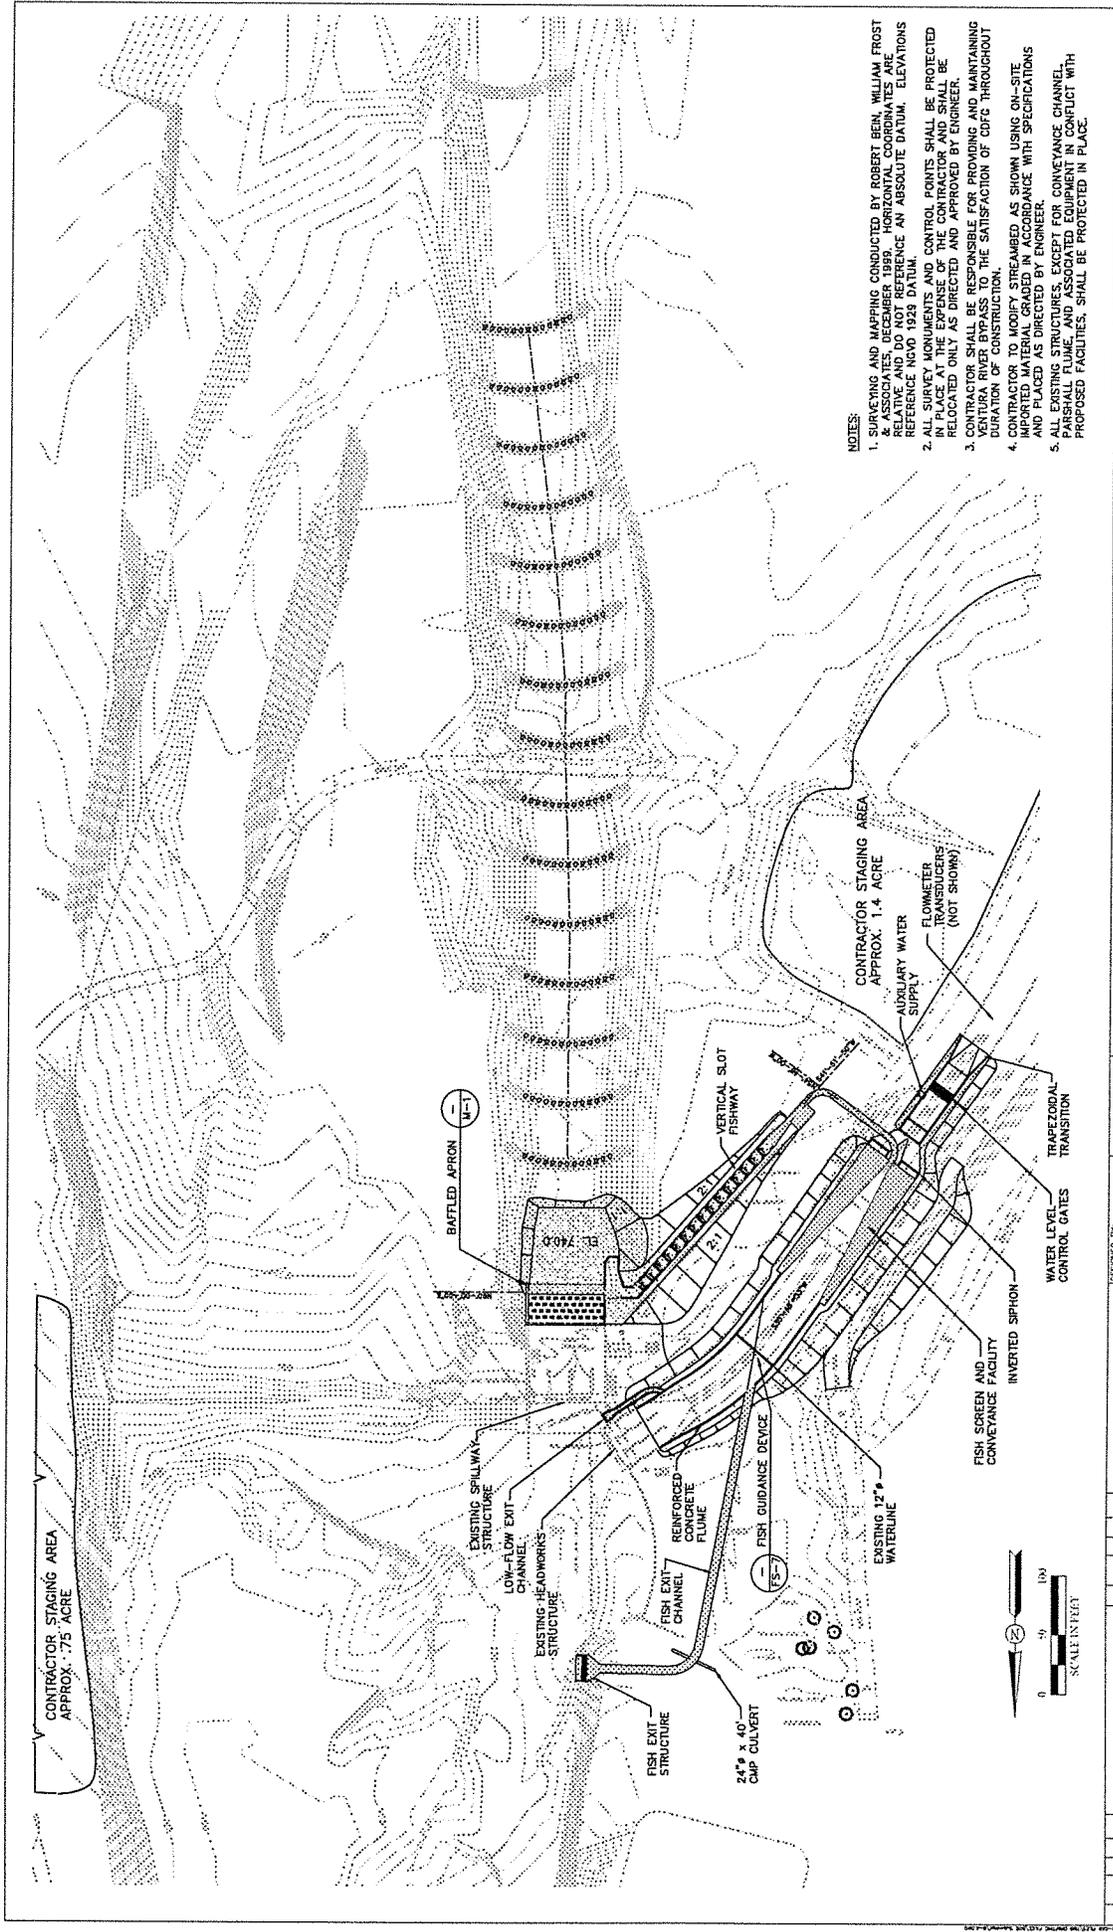
GASTRAN MUNICIPAL WATER DISTRICT FACILES DIVISION DAM FISH SCREEN AND FISHWAY PROJECT		SCALE OF ORIGINAL 1"=50'	
PROJECT NO. 1508 SHEET NO. 1		DRAWING NO. G-1	
<b>SITE PLAN</b>			
SUBMITTED _____ APPROVED _____		BORCALLI ENGINEERS 1500 S. 10TH AVE. DENVER, CO 80202	
DESIGNED BY: T. BULLER DRAWN BY: T. BULLER IN CHARGE: F. BORCALLI		CHECKED BY: F. BORCALLI DATE: 8/19/00	
NO. 1 DATE 8/19/00 BY F. BORCALLI DESCRIPTION:	NO. 2 DATE BY DESCRIPTION:	NO. 3 DATE BY DESCRIPTION:	NO. 4 DATE BY DESCRIPTION:

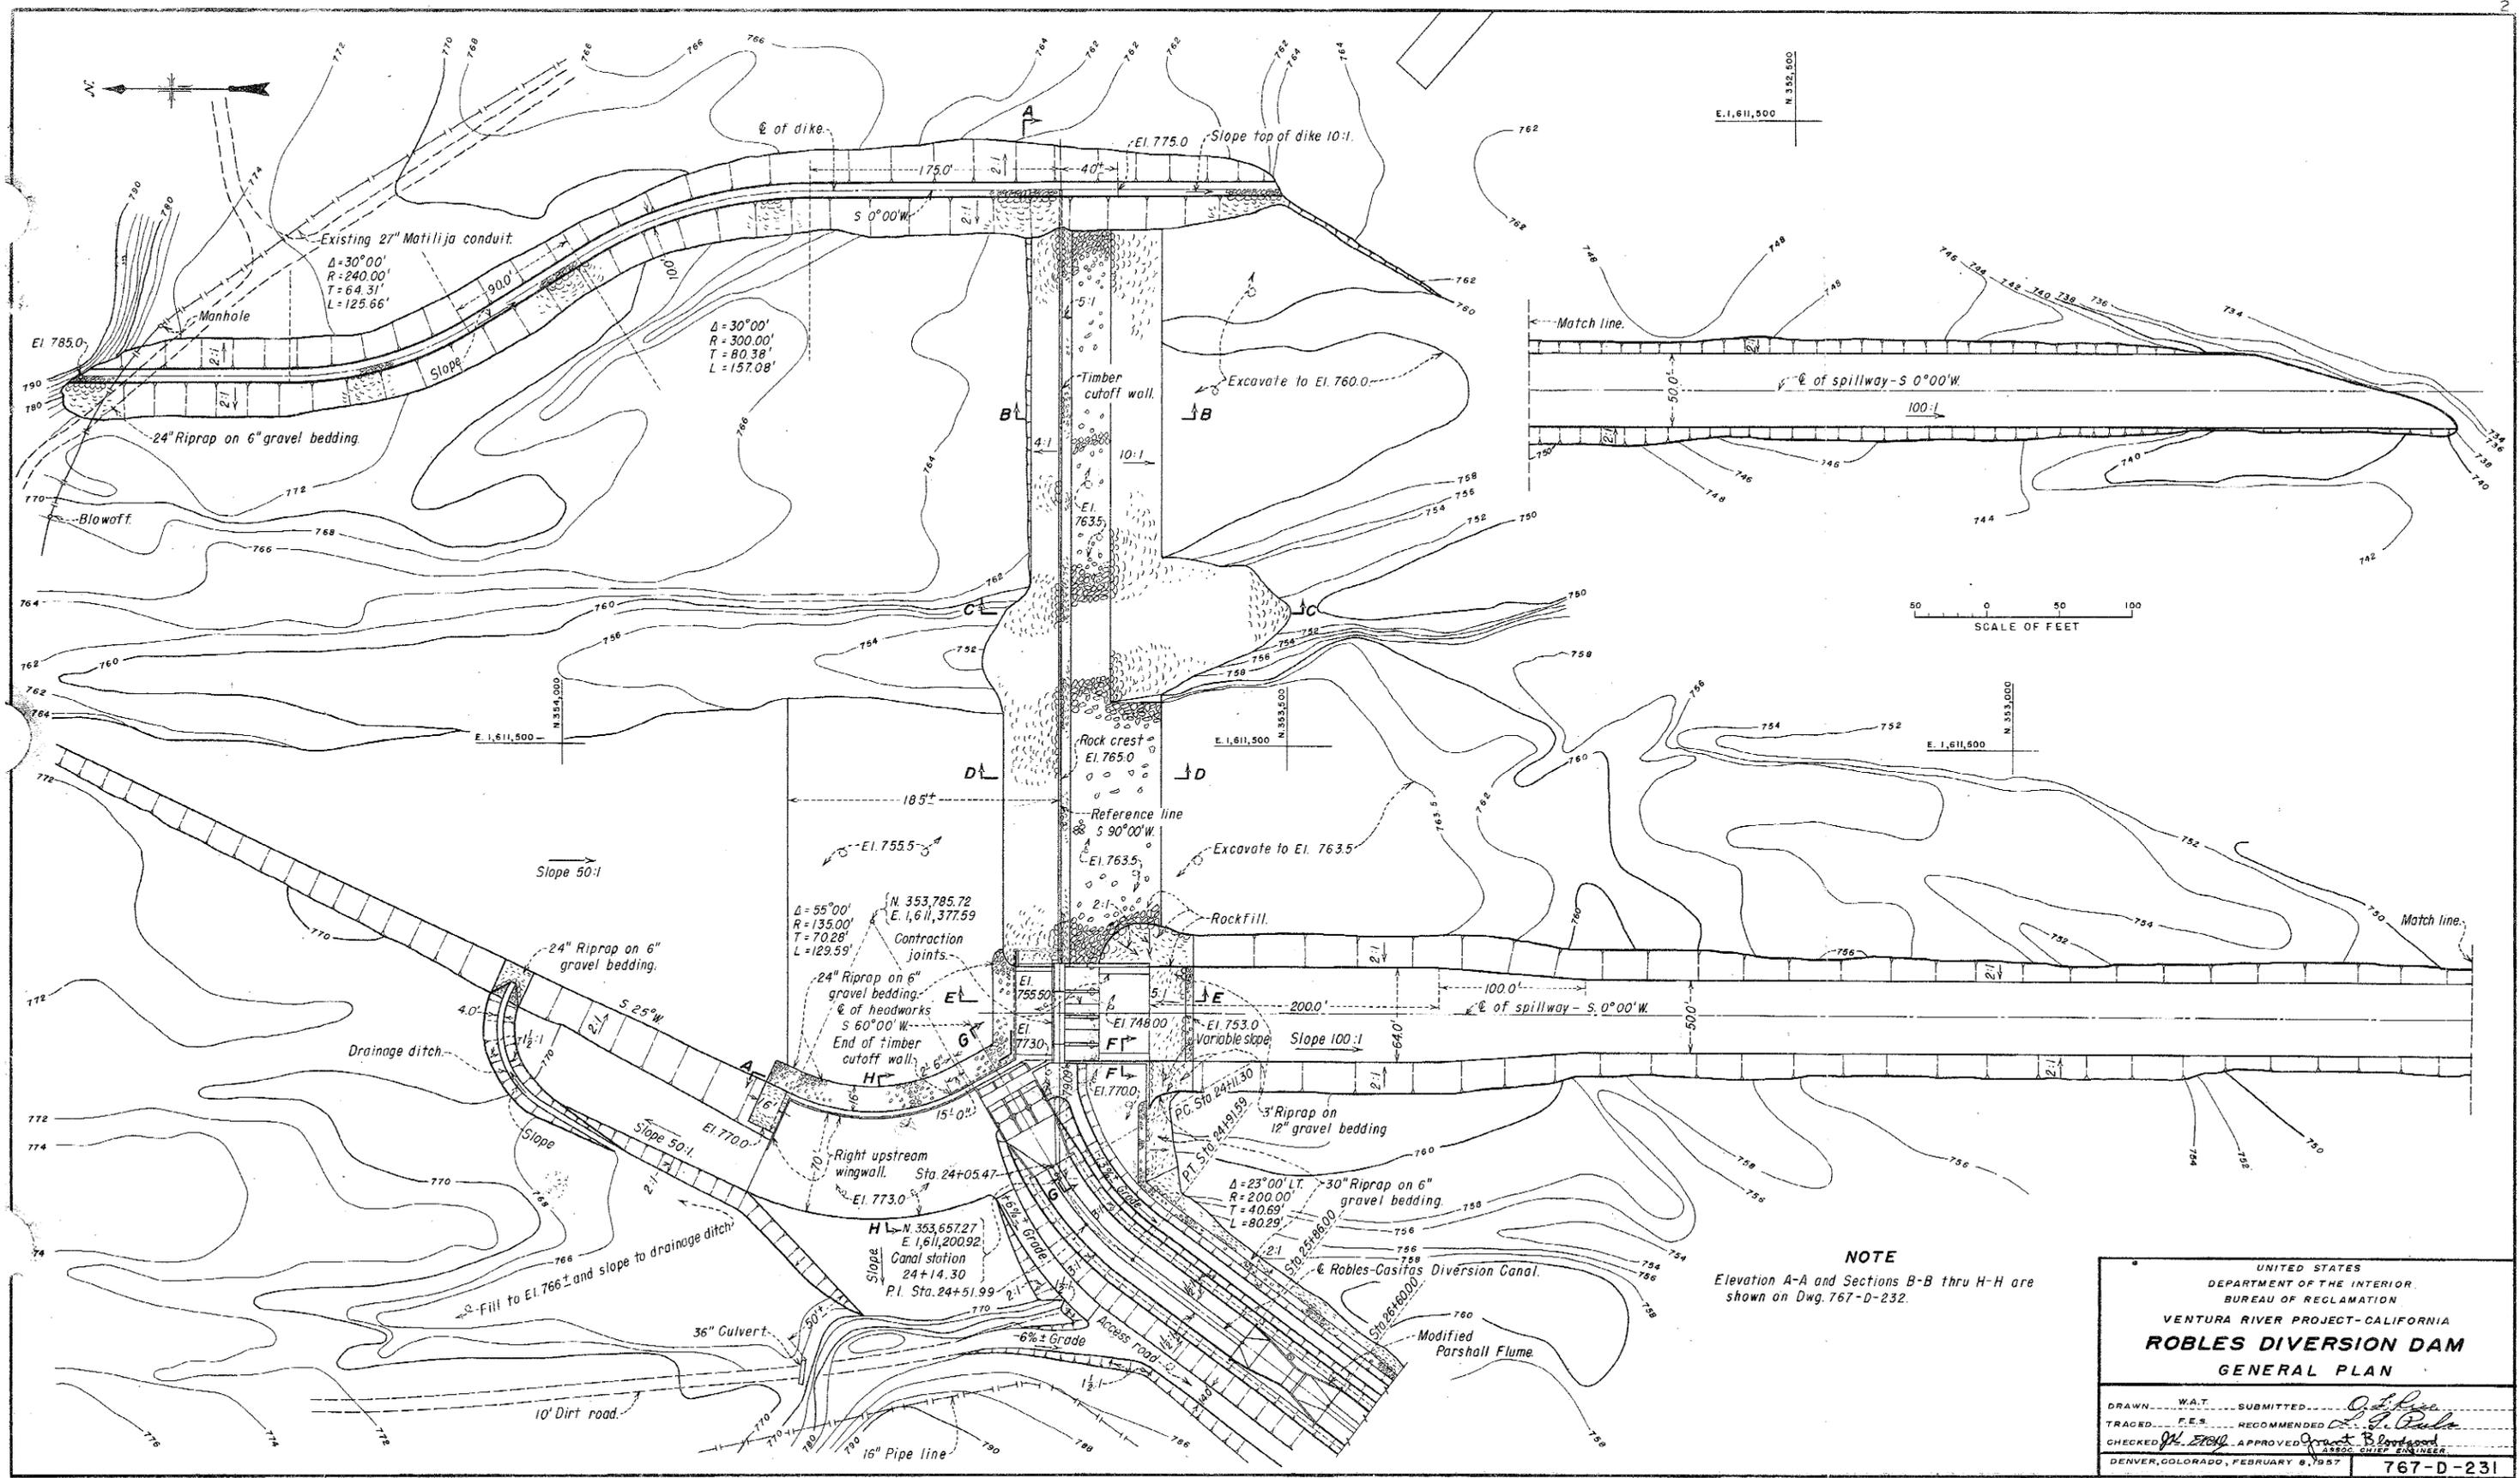
1957 Forebay Design

**NOTE**  
Elevation A-A and Sections B-B thru H-H are shown on Dwg. 767-D-232.

UNITED STATES DEPARTMENT OF THE INTERIOR BUREAU OF RECLAMATION	
VENTURA RIVER PROJECT-CALIFORNIA	
<b>ROBLES DIVERSION DAM</b>	
GENERAL PLAN	
DRAWN <i>W.A.T.</i>	SUBMITTED <i>Q.L. Rice</i>
TRACED <i>F.E.S.</i>	RECOMMENDED <i>Q.L. Rice</i>
CHECKED <i>W. E. ...</i>	APPROVED <i>Q.L. Rice</i>
DENVER, COLORADO, FEBRUARY 8, 1957	
767-D-231

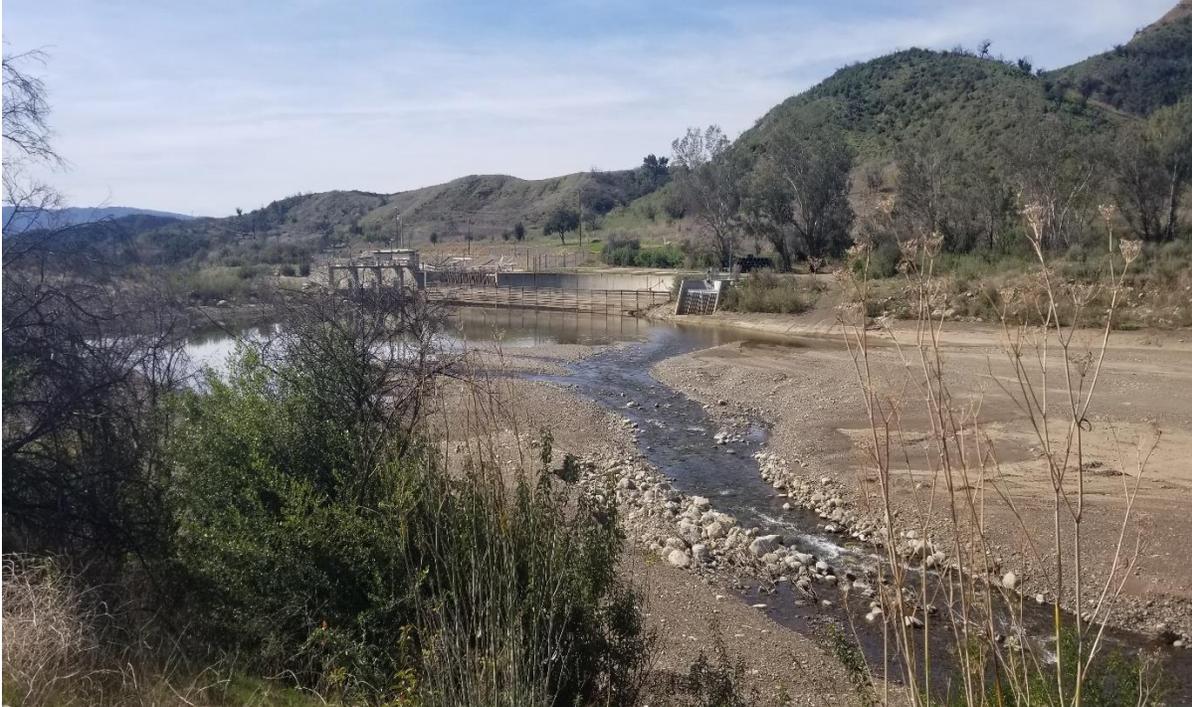
**Photograph 1.** View of the forebay (facing southwest) following the 2019 sediment removal project (February 4, 2020).

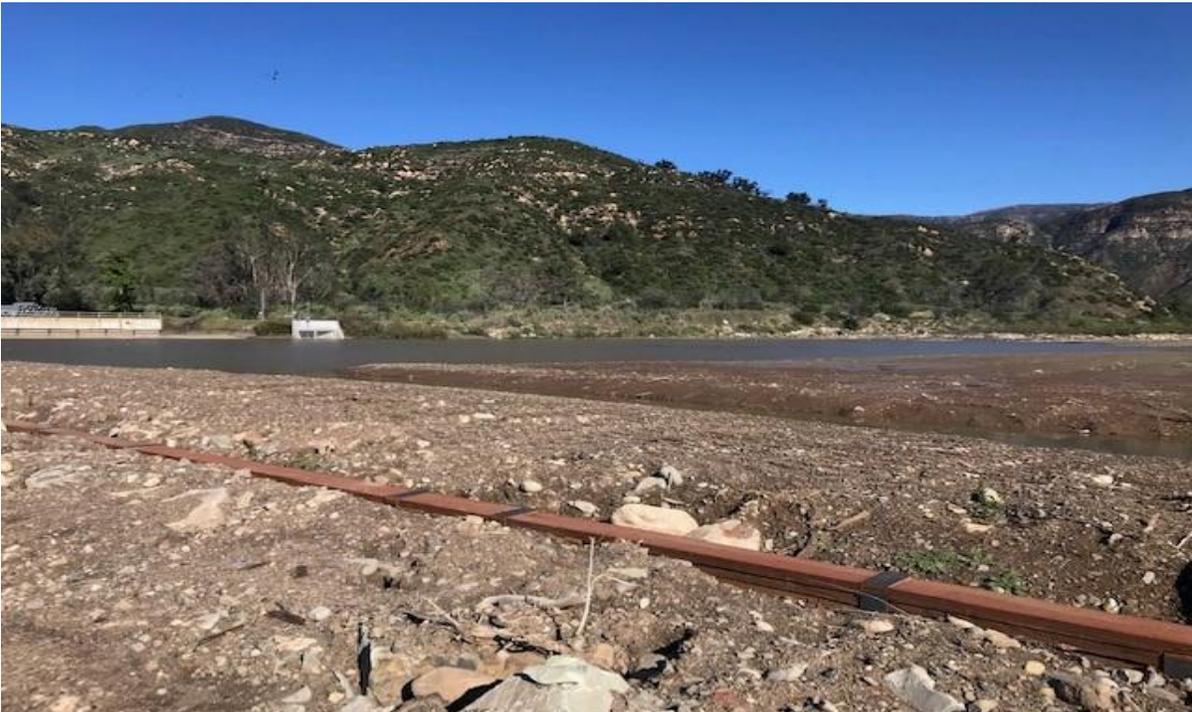
**Photograph 2.** View of the timber cut-off wall after repairs to the wall were made in November 2019. Light vehicles can drive over the timber cut-off wall to access the fish passage facility to the west, without driving through the active flowing channel (February 2, 2020).

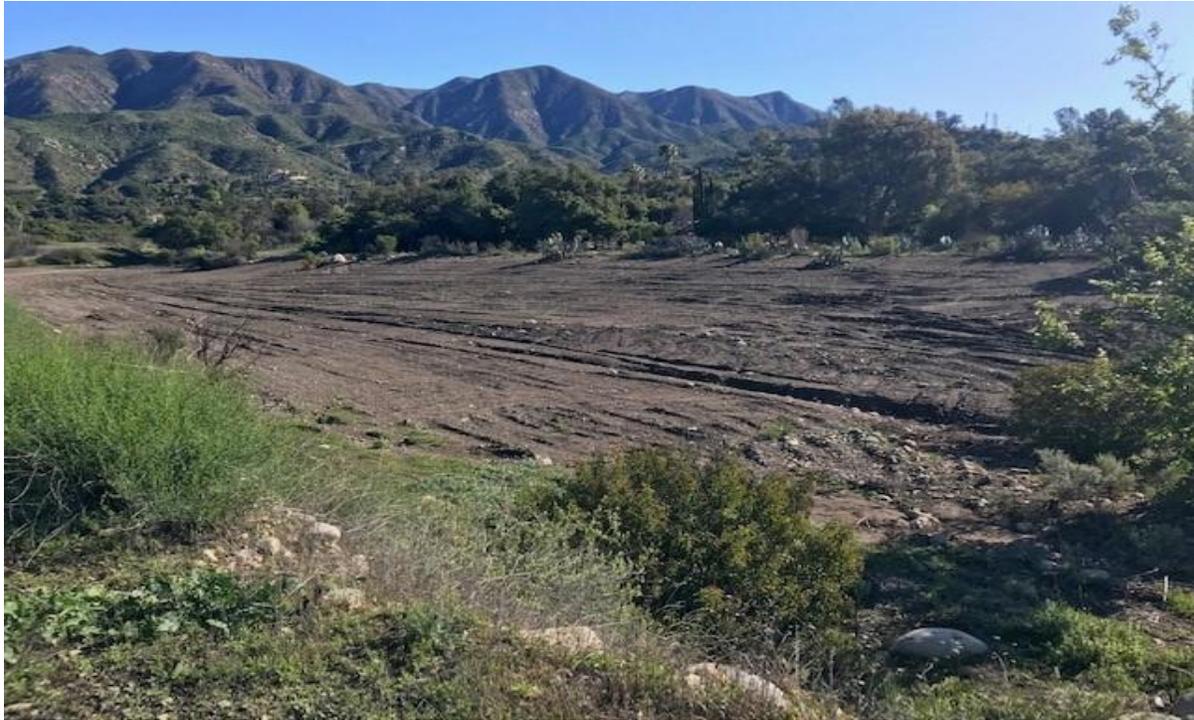
**Photograph 3.** View of the primary sediment placement area following the relocation of sediment from the forebay in November 2019 (March 17, 2020).
