Biological Resources Assessment (BRA) Report

# Robles Diversion and Fish Passage Facility Annual Maintenance and Repair Program

## Biological Resources Assessment

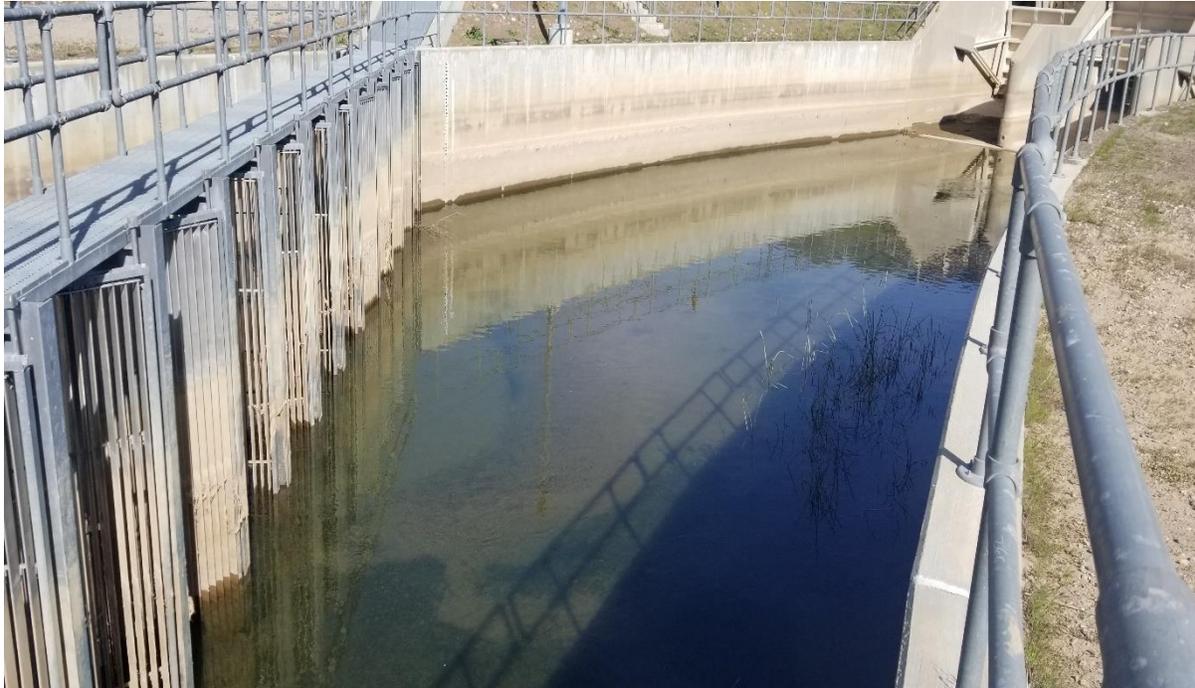
**Photograph 5.** View of the screenbay looking toward the headworks (February 4, 2020).

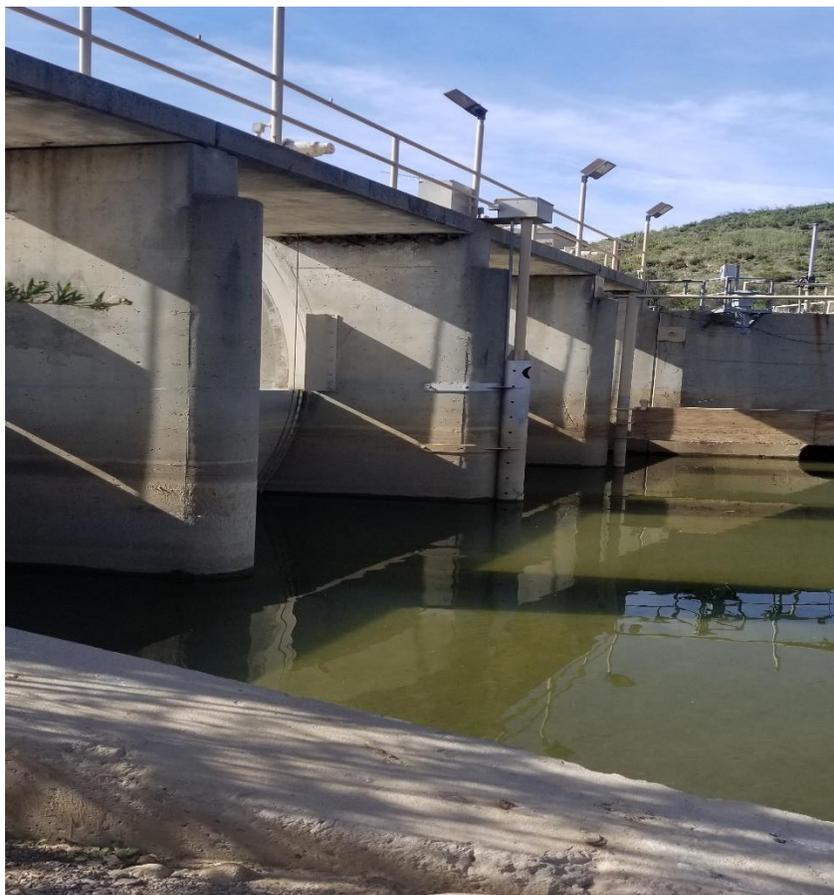
**Photograph 6.** View of the upstream side of the spillway (February 4, 2020).

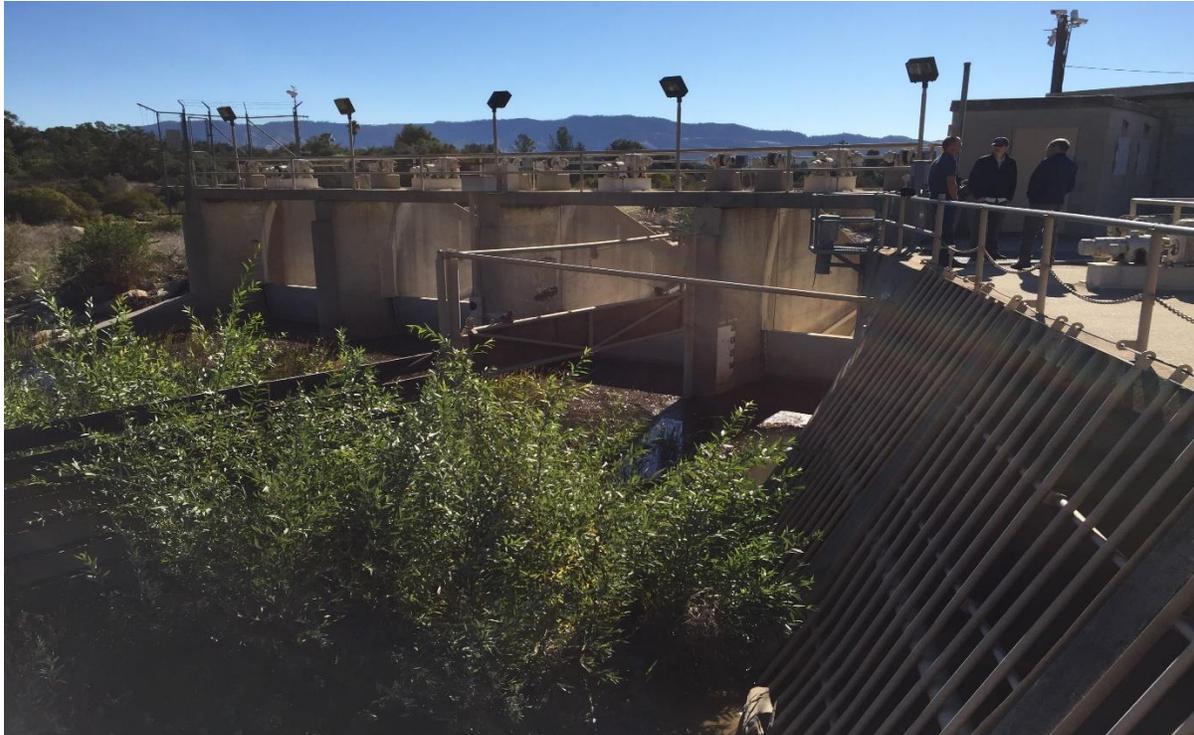
**Photograph 7.** View of upstream side of the spillway, radial gates and headworks (December 13, 2019).

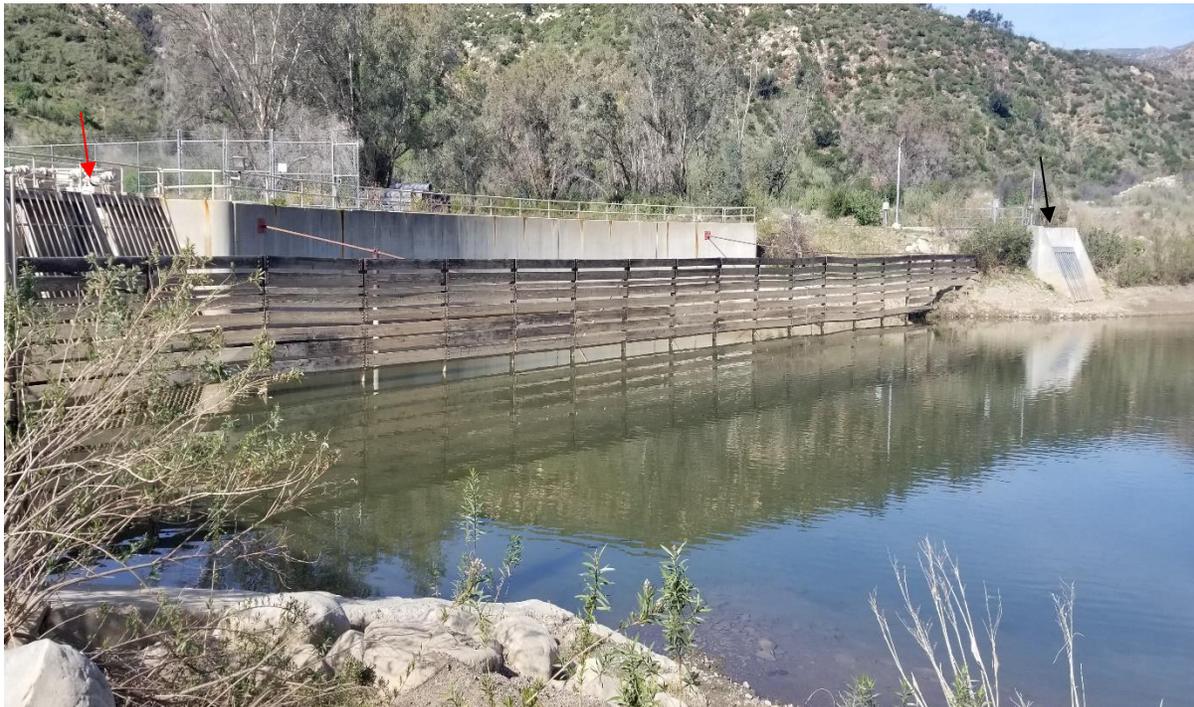
**Photograph 8.** View of the timber debris fence and high-flow fish exit (black arrow). The headworks is shown in back of the fence, denoted with a red arrow (February 4, 2020).

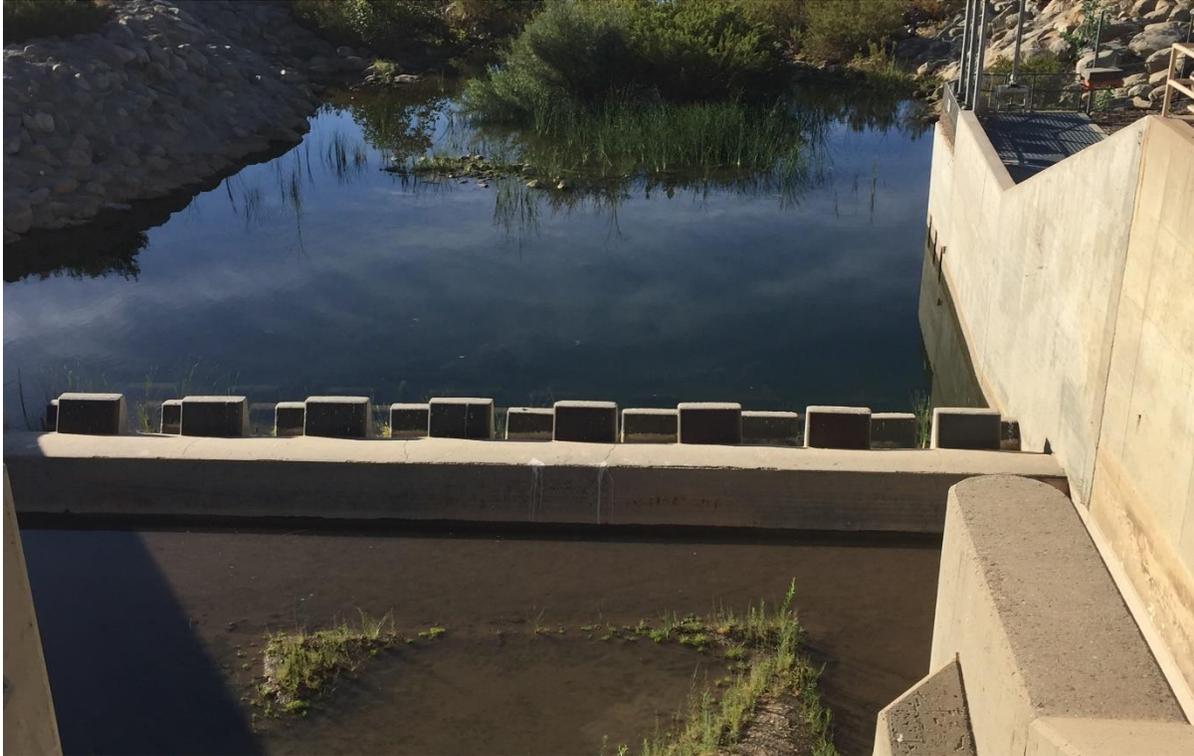
**Photograph 9.** View of the baffled apron downstream of the spillway, at the beginning of the entrance pool (December 13, 2019).

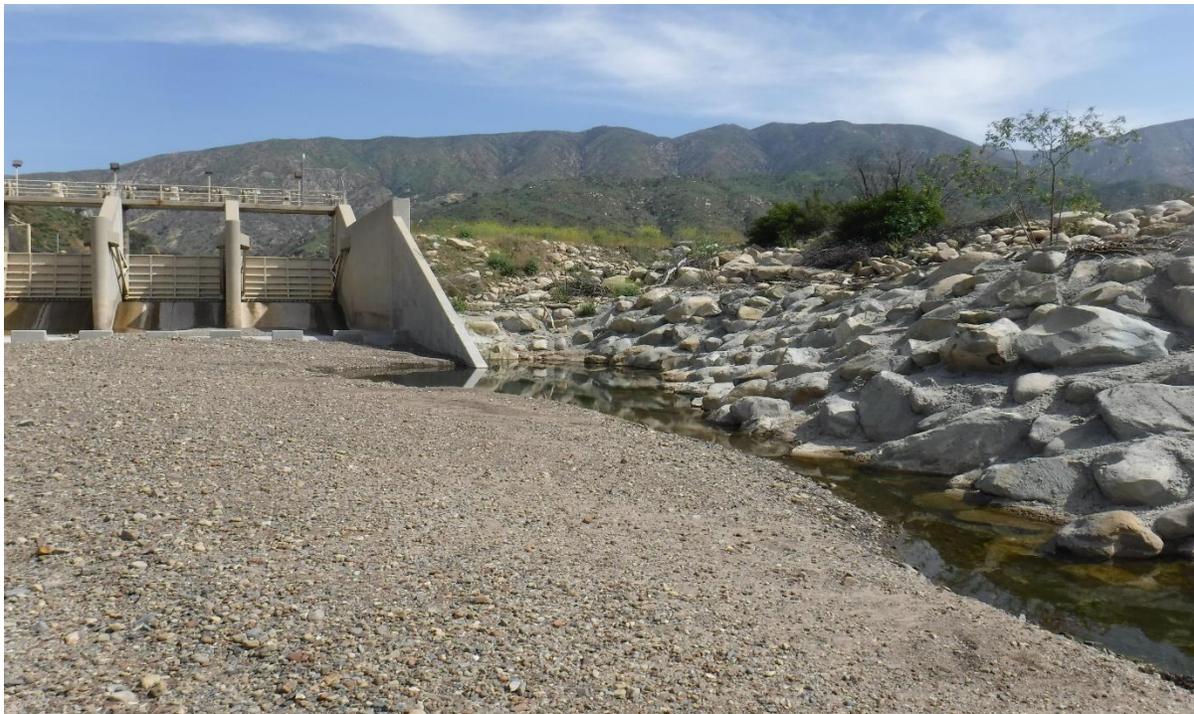
**Photograph 10.** View looking at the downstream side of the spillway, at the entrance pool which was completely filled in with sediment following storms post-Thomas Fire (May 2, 2019).

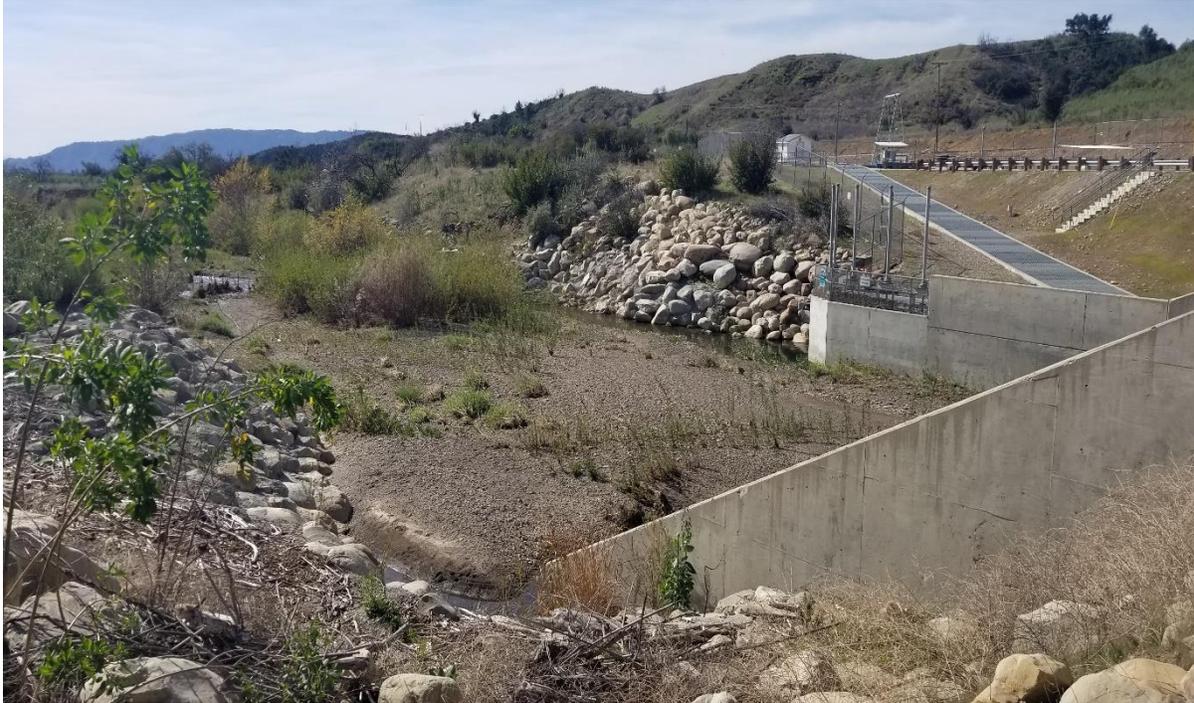
**Photograph 11.** View of the entrance pool area surrounded by grouted riprap (February 4, 2020).

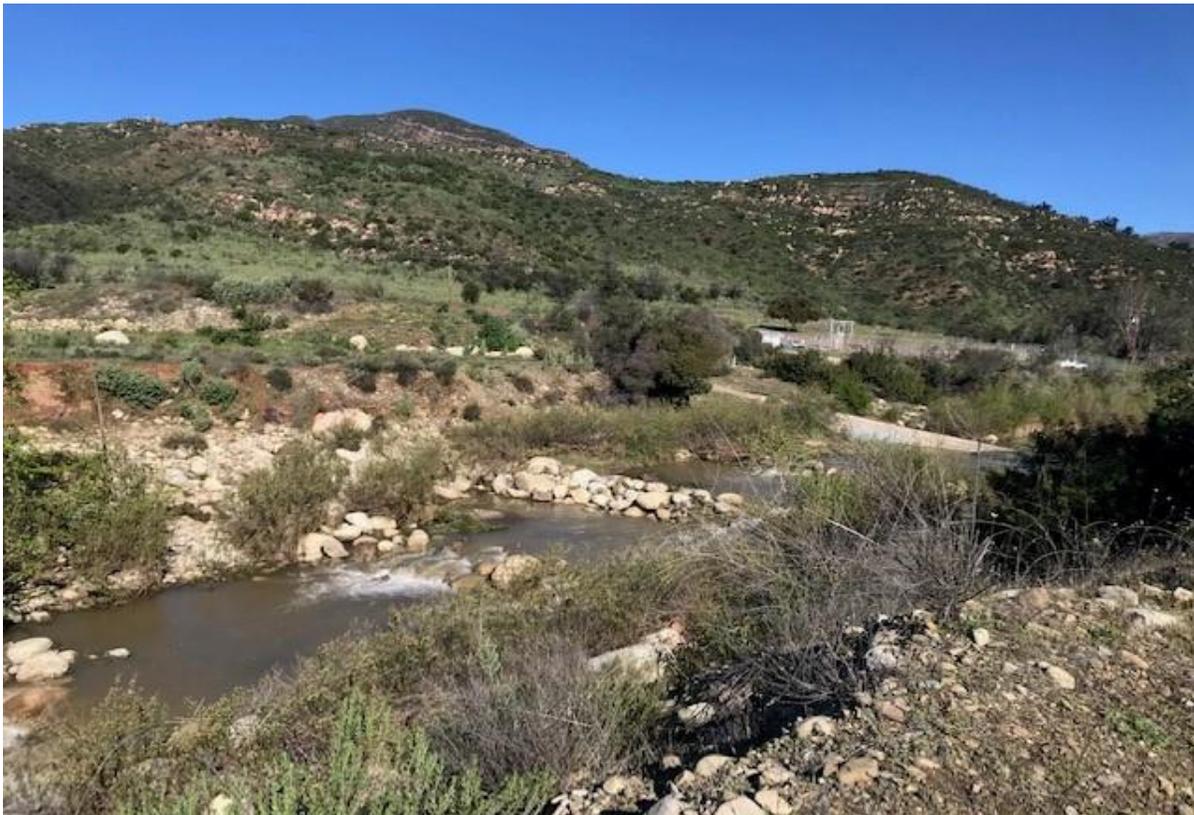
**Photograph 12.** View of the rock weirs downstream of the measurement weir, in the spillway channel (March 17, 2020).

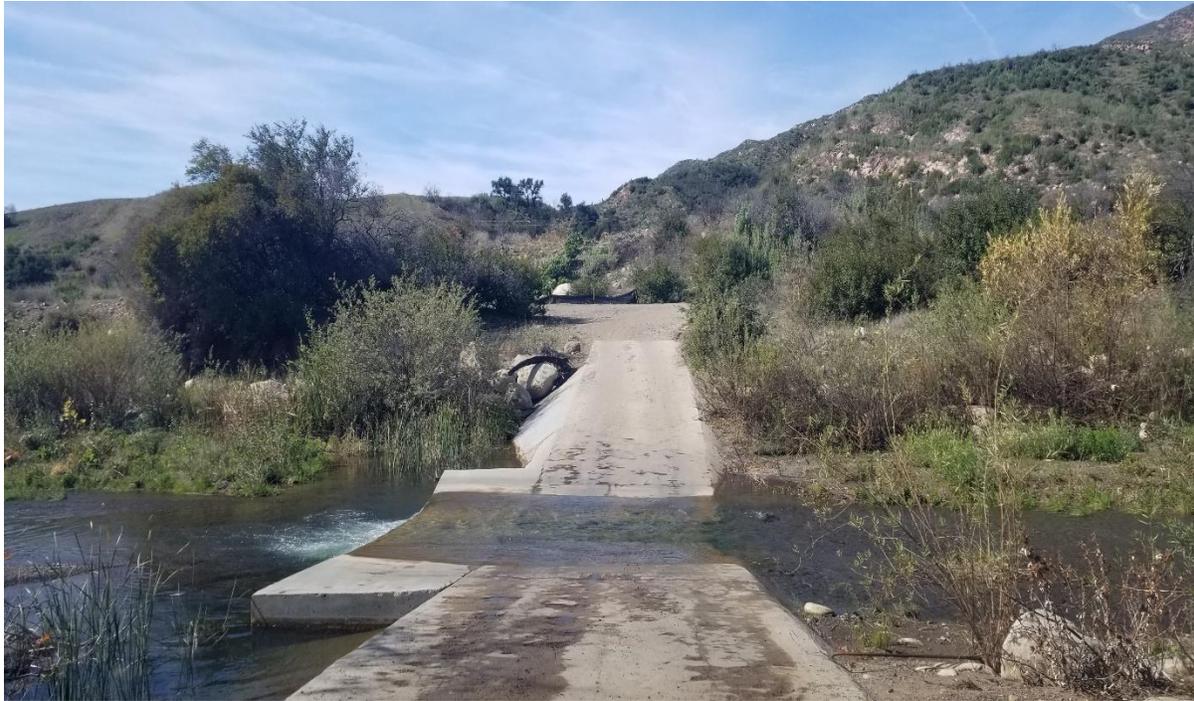
**Photograph 13.** View of the measurement weir and road crossing (February 4, 2020).

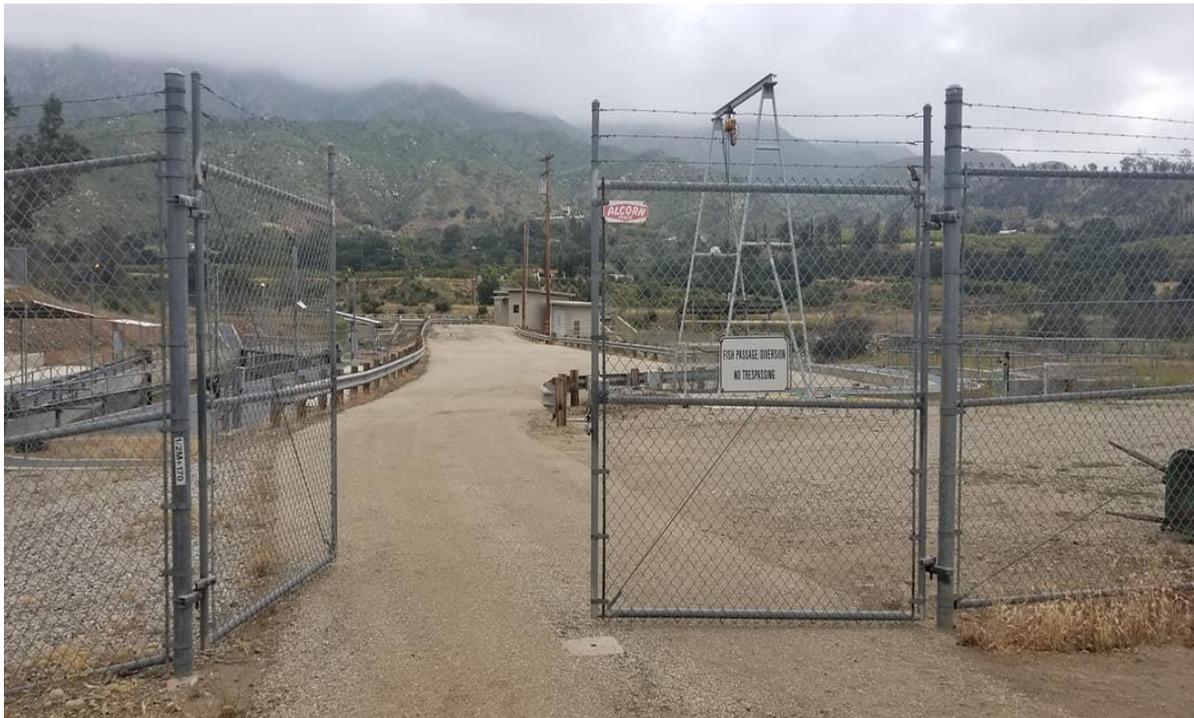
**Photograph 14.** View of the entrance to the fish passage facility (April 16, 2019).
