Robles Diversion and Fish Passage Facility Annual Maintenance and Repair Program

Cultural Resources Assessment Report

Casitas Municipal Water District

September 2021

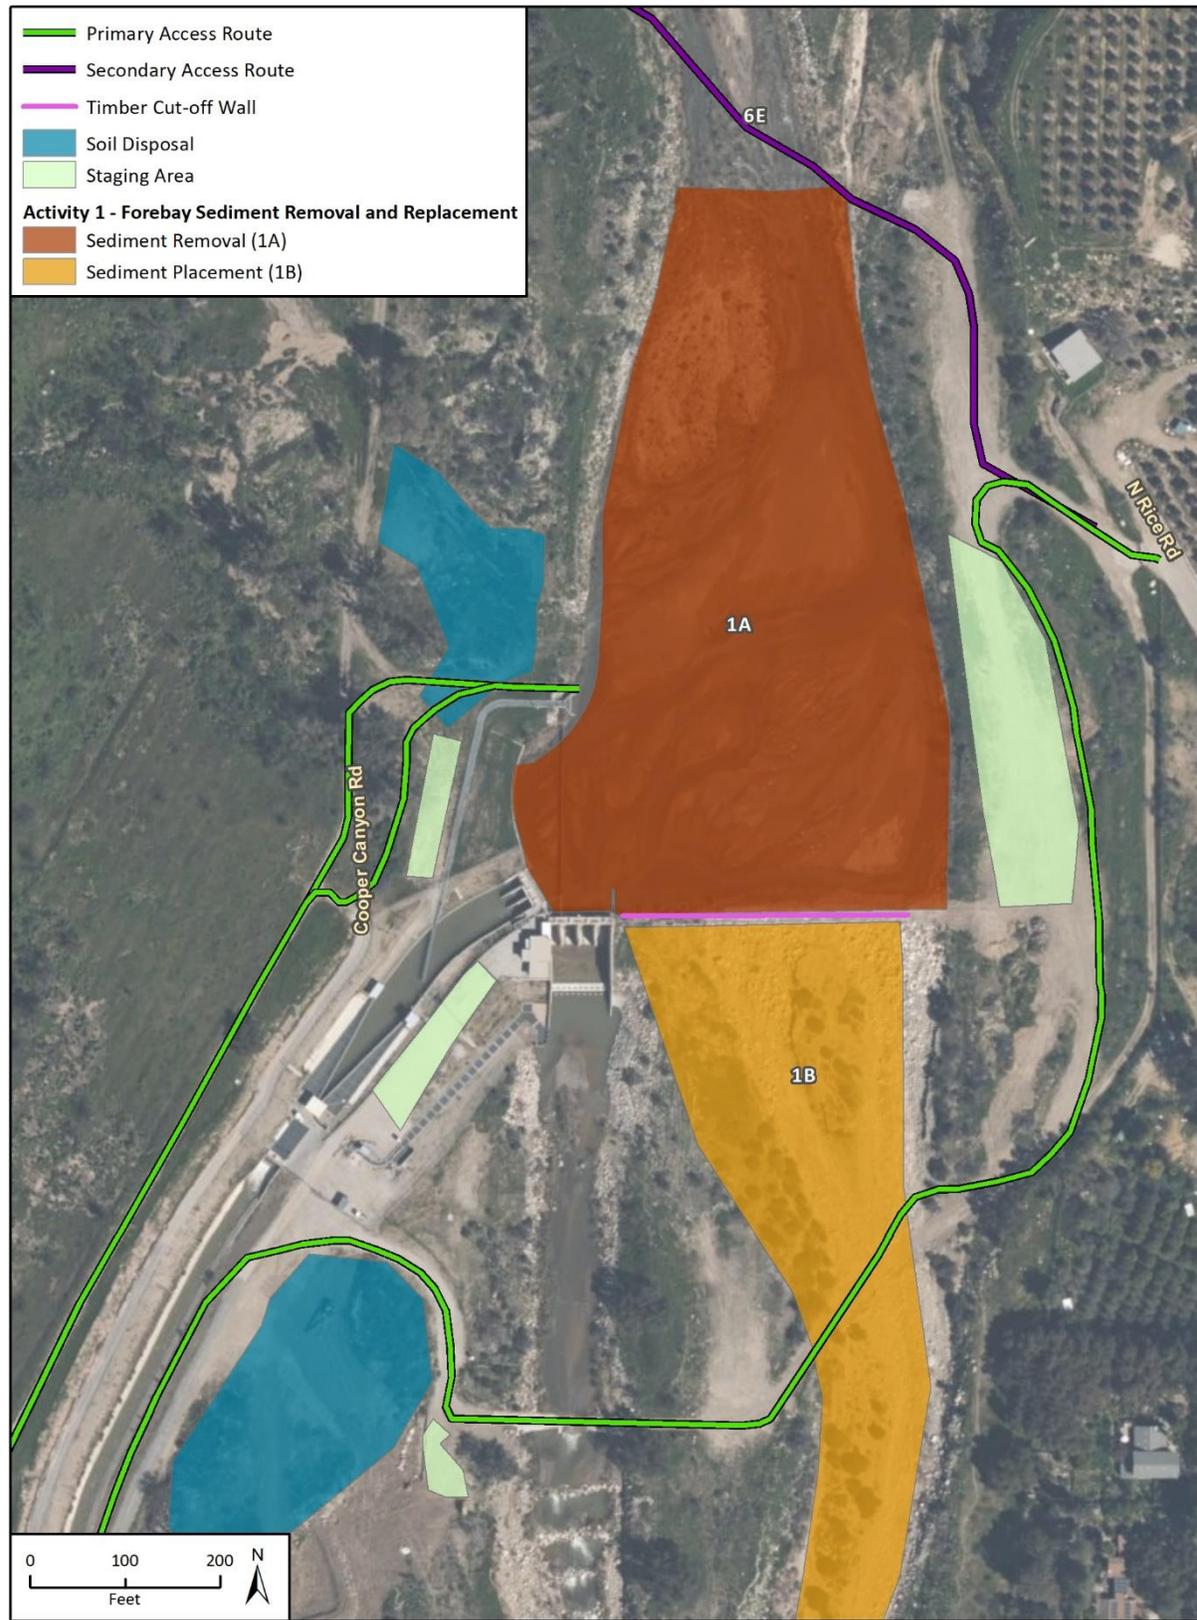
Figure 2 Activity 1 Forebay Sediment

When flows are sufficiently high to overtop the cut-off wall, erosion of the streambed and banks of the overflow channel downstream occurs. Sediment removed during forebay maintenance activities is first used to restore these storm-eroded areas. For the purpose of routine maintenance, Casitas proposes to restore the forebay area by removing the accumulated sediment annually, typically when 10 percent of basin capacity is occupied by sediment and debris, subject to flow and sediment conditions. The sediment removed will be used to restore storm-eroded areas within 1,100 linear feet downstream of the timber cut-off wall, in the designated primary placement area. The sediment would be deposited downstream of the timber cut-off wall over approximately 4.12 acres, where forebay sediment has been placed in the past, and where active flow within the channel would not be impeded (Figure 2).

Fig. 2 Activity 1 Forebay Sediment Removal and Placement Locations

sediment removal actions, Casitas will evaluate conditions of the sediment placement area at the end of the storm season (April/May) to determine how much sediment can be placed there. If the amount of sediment to be excavated exceeds the capacity of the placement area, the excess sediment that cannot be placed downstream will be stockpiled above the ordinary high-water mark of the Ventura River in designated soil disposal areas, or exported offsite. If sediment is stockpiled in designated disposal areas onsite, Casitas will evaluate whether stockpiled sediment can be placed back into the river each year, pending capacity established in the survey of the deposition area.

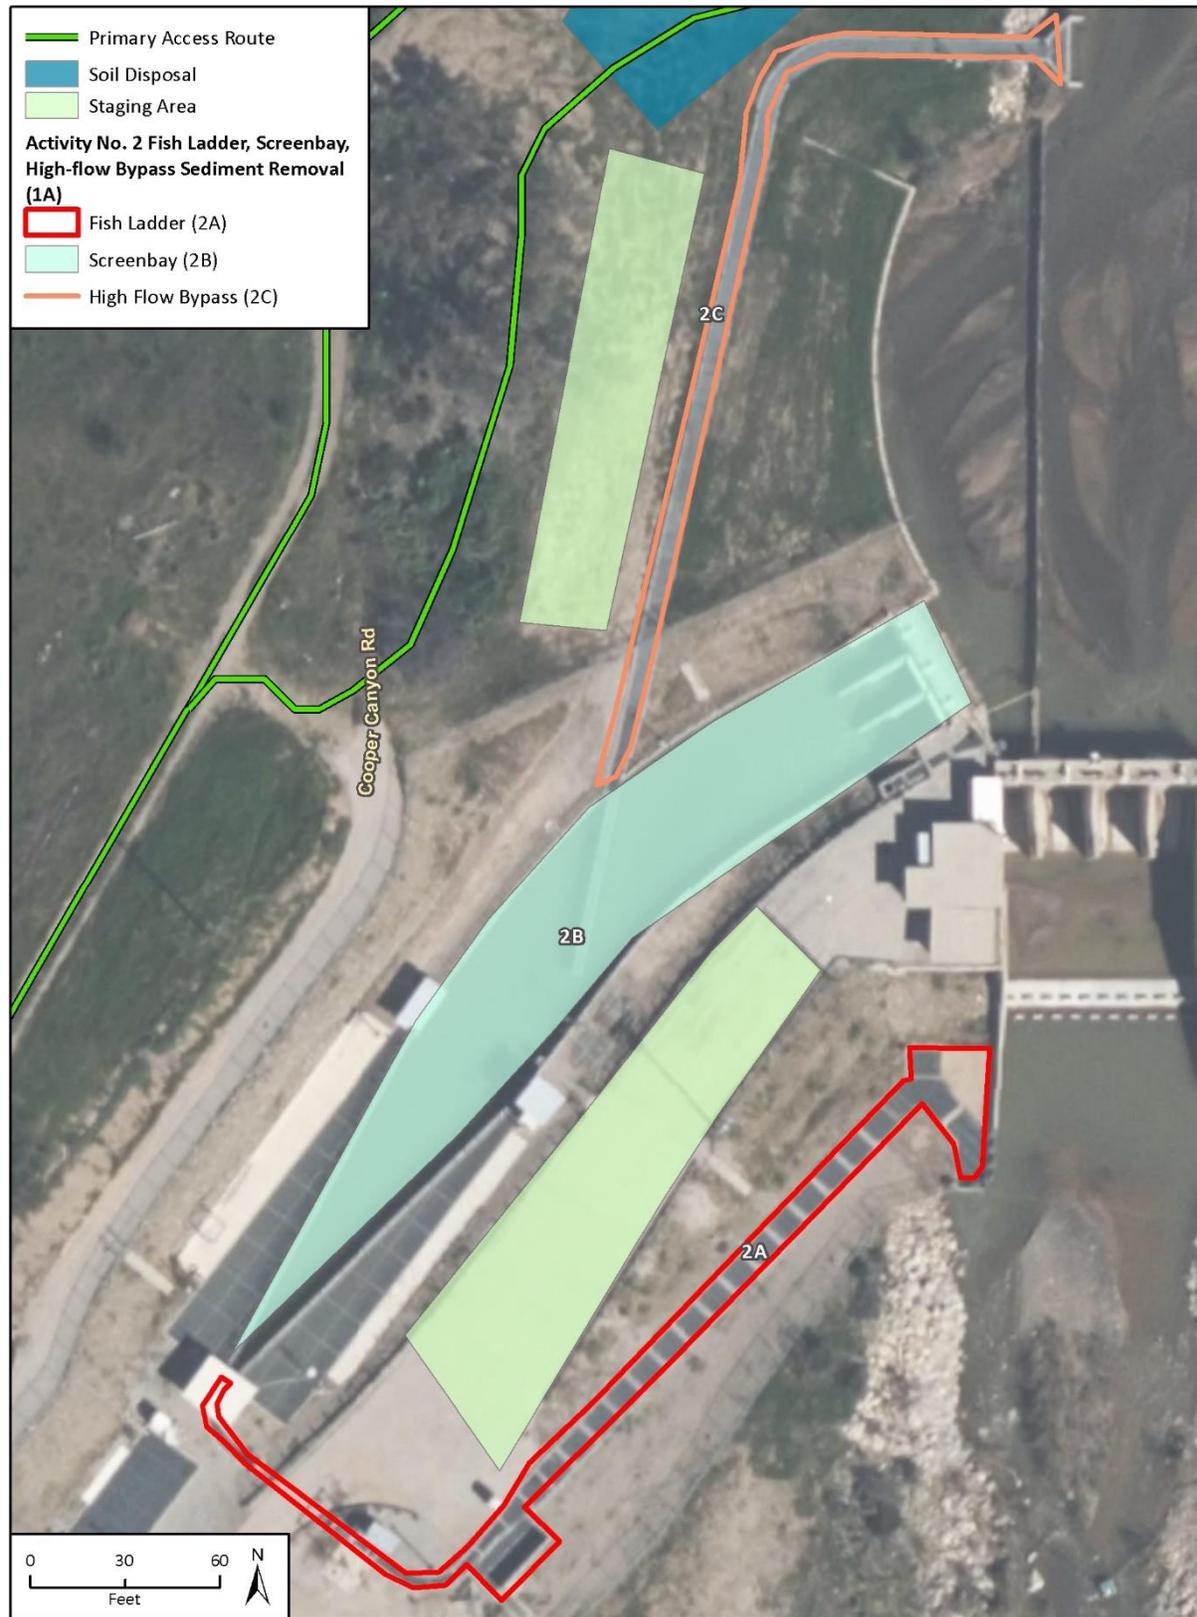
Figure 3 Activity 2 Fish Ladder, Screenbay, High-flow Bypass

Fig 4 Activity 2 Fish Ladder-Screenbay High Flow Bypass

Access to the fish ladder, screenbay, and high-flow bypass is from the north end of Rice Road located east of the forebay, from the northern access road at the upper limit of the forebay, and from the south along the canal road. Staging of heavy equipment occurs on the west of the forebay adjacent to the high-flow bypass, which is unpaved. It is anticipated the maintenance and repair activities would require up to 1 to 2 weeks to complete annually; and heavy equipment will be used for up to 6 days.

Small debris will be removed by hand via the access grate above the fish ladder, screenbay, and high-flow bypass. Removal of small debris by hand will occur throughout the year provided that it can be safely removed without shutting down the facilities. It is possible that removal of small debris may require a partial shutdown of facilities during wet conditions; in which case, the work would only be conducted if necessary to maintain operations of the diversion and fish passage.

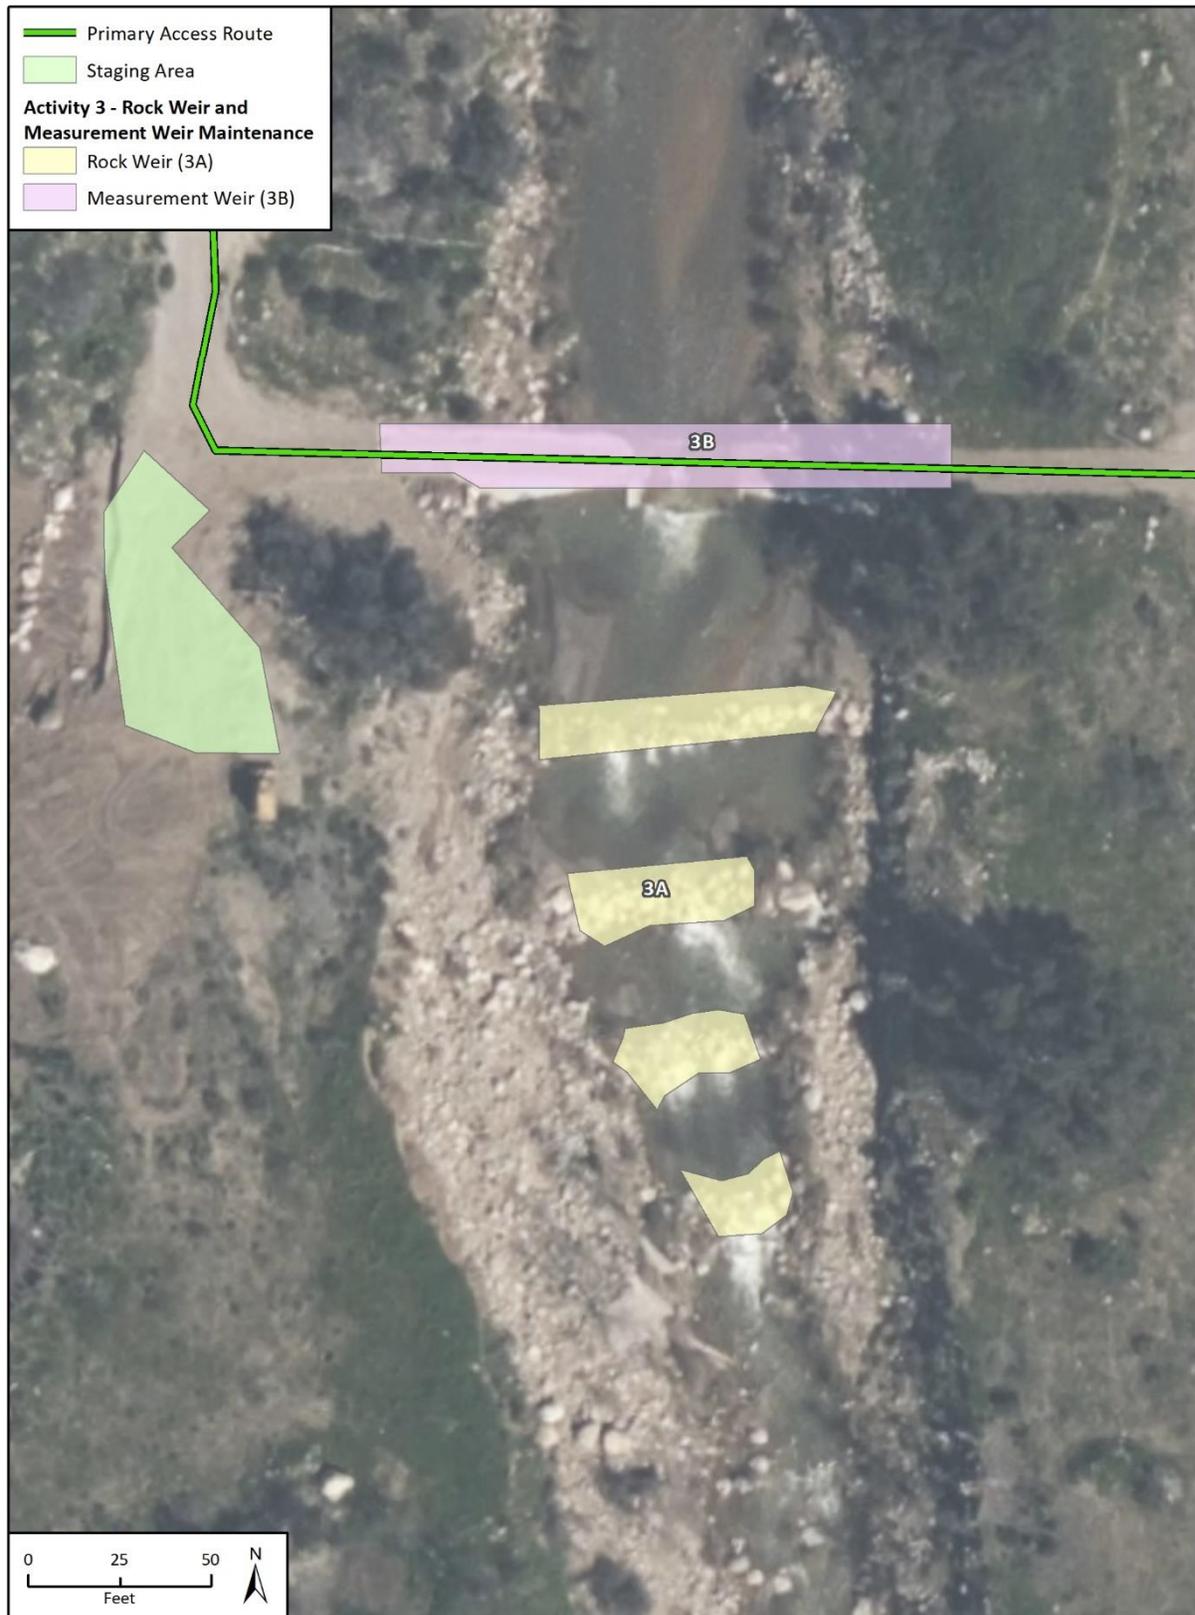
Figure 4 Activity 3 Rock Weir and Measurement Weir

Fig. 4 Activity 3 Rock and Measurement Weir

The proposed maintenance activity would occur during the dry season when surface water is absent. It is anticipated maintenance and repair activities associated with the weirs would require 1 to 2 weeks to complete, depending on level of activities. Staging of heavy equipment will occur in upland areas on bare ground west of the channel where the weirs are located (Figure 4). Access to the weirs will be from Rice Road located east of the forebay across the Ventura River via the southern access road.

The existing concrete measurement weir may need repair if damaged to accurately measure flow from Robles diversion, which is critical to operation of the water diversion and downstream BiOp-required releases (NMFS, 2003). Repair of the bubbler line which runs down the upstream face of the weir may be necessary. Maintenance associated with the measurement weir should be minimal and limited to removal of debris by hand, and will occur only during dry conditions.

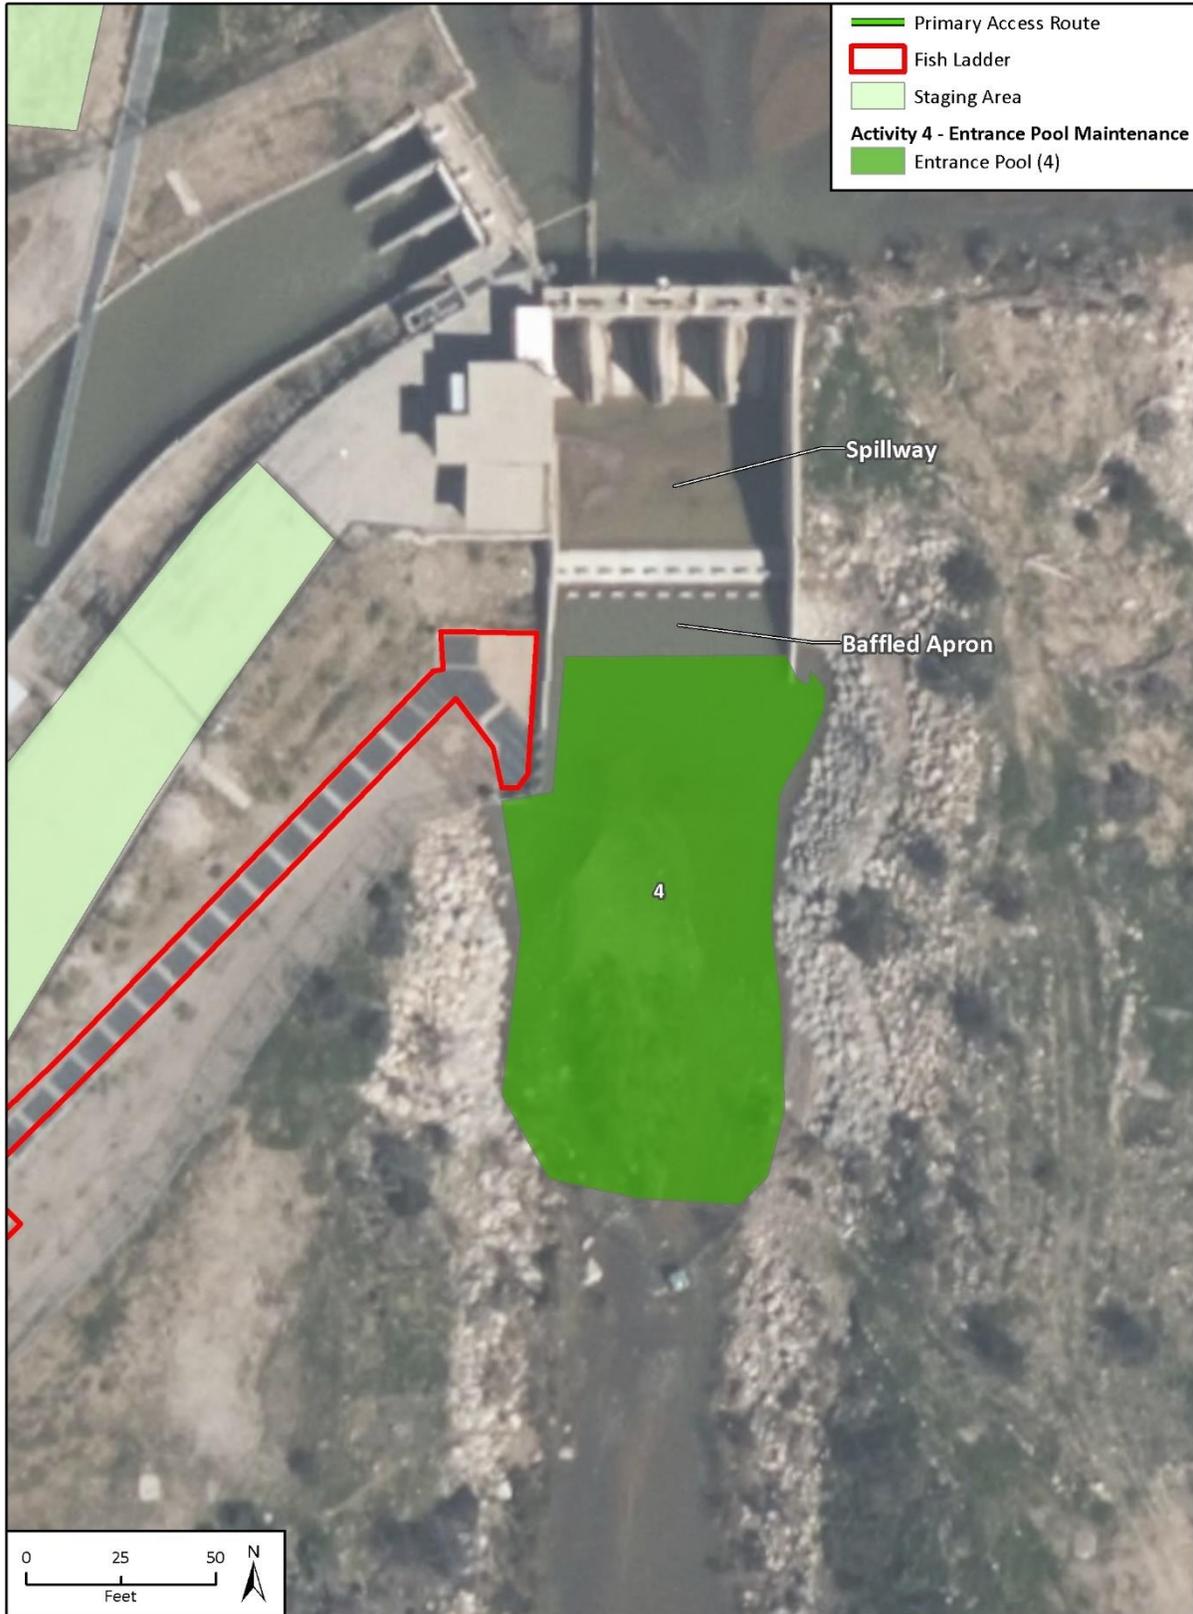
Figure 5 Activity 4 Entrance Pool

Fig. 6 Activity 4 Entrance Pool Maintenance

Sediment and vegetation removed would be stockpiled outside of jurisdictional areas in designated soil disposal sites (Figure 5). Re-contouring with boulder/cobbles/sediment will occur in the bottom of the entrance pool and adjacent areas to repair erosion along existing concrete abutments and riprap. The proposed maintenance activity would occur during times when surface water is absent.

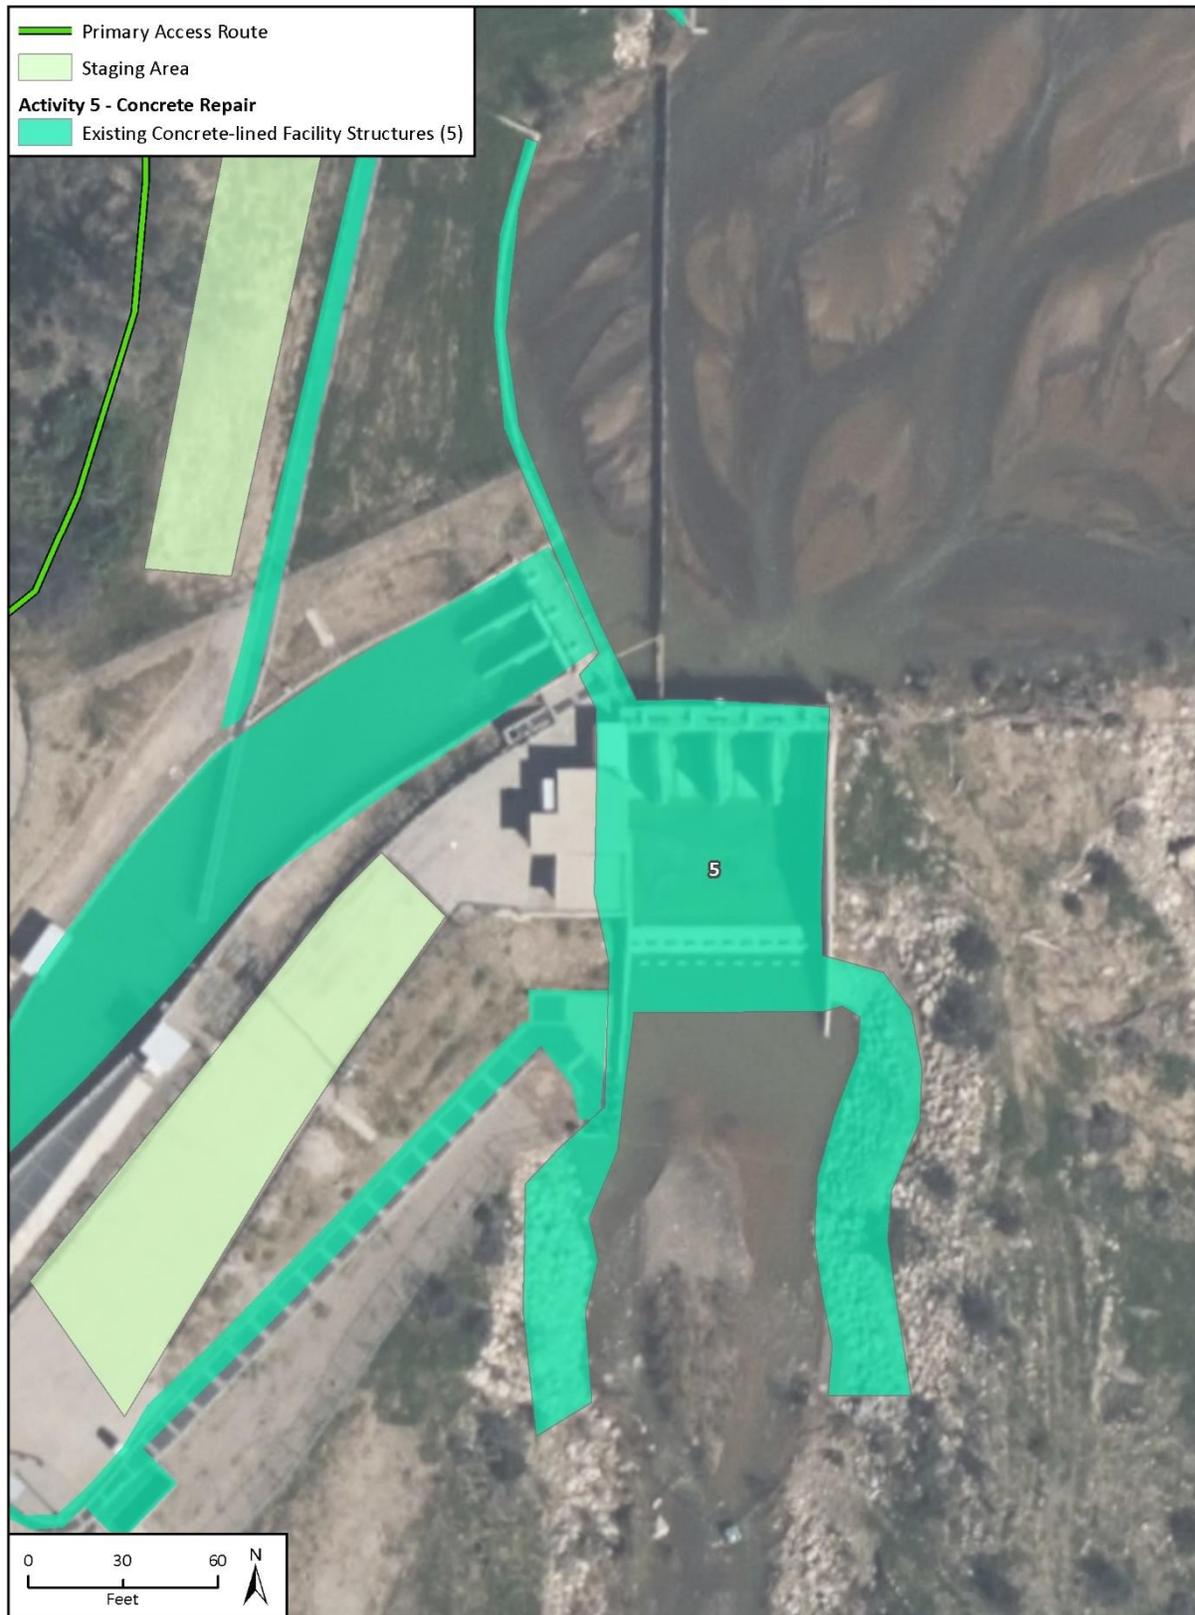
Figure 6 Activity 5 Concrete Structures

Fig. 7 Activity 5 Concrete Repair

Concrete repairs may be made to the spillway, concrete protective rip-rap, measurement weir, and baffled apron, as needed (Figure 6) during dry conditions. In addition, concrete repairs may be made to the existing concrete-lined screenbay and extended upstream across the canal gates, and include, the high-flow fish exit. Casitas staff or a contractor will clean and prepare the damaged area; build and place forms as necessary; place and finish concrete; remove forms and backfill area, as needed. All work will implement Best Management Practices for concrete repair.

Heavy equipment will be used to remove damage concrete and perform concrete repairs. Equipment may include a pick-up truck, flat-bed, dump truck, concrete mixer, excavator, or other similar equipment and concrete pump (if needed). It is anticipated concrete repairs would require 1 to 2 weeks to complete. Heavy equipment will be staged in upland areas on bare ground west or east of the channel adjacent to the entrance pool. Access to the spillway will be either from Rice Road located east of the forebay across the Ventura River via the southern access road; or from Cooper Canyon Road headed north toward the Facility.

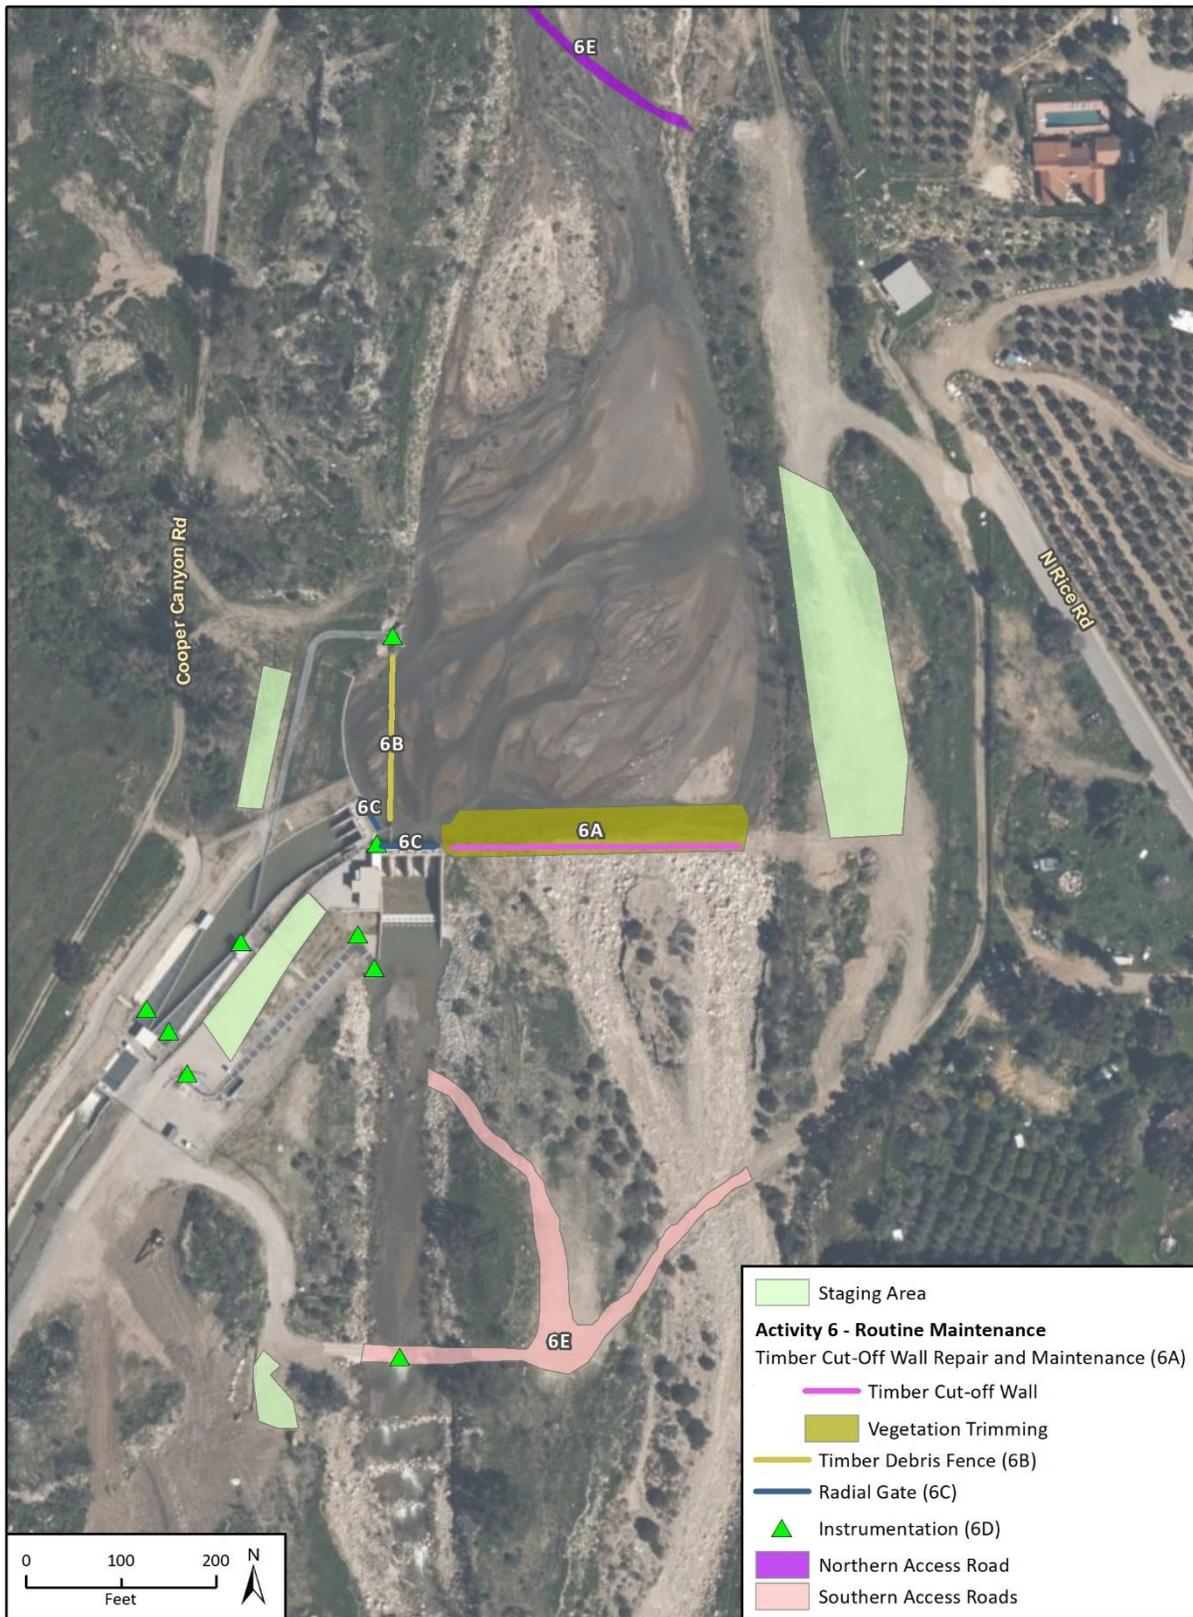
Figure 7 Activity 6 Routine Maintenance

Fig. 7 Activity 6 Routine Maintenance

The timber debris fence lies upstream of the diversion headworks in the forebay (Figure 7). The racks of the fence deflect debris away from the headwork gates and toward the spillway gates. Over time the fence collects woody debris, which can require removal. This maintenance activity will involve the removal of debris from the fence, and the repair or replacement of damaged wood timbers as needed to preserve the structural integrity and functionality of the fence.

Road maintenance and repair would occur as needed (estimated annually) on Reclamation property during dry river conditions (Figure 7). It is anticipated road maintenance will require 2 to 3 weeks to complete, annually. The southern access road begins at the entrance gate to the Facility at the terminus of North Rice Road and continues southwest across the Ventura River. This road is typically used by light trucks and passenger vehicles at flows under 15 cfs. The northern access road transverses the Ventura River upstream of the forebay. This road is generally used by contractors to complete the forebay restoration project (Activity 1), annually. The roads will be graded and shaped each year, if needed, during dry conditions. Road maintenance may involve use of heavy equipment to re-contour and re-compact access roads including an excavator, grader, bulldozer or backhoe.

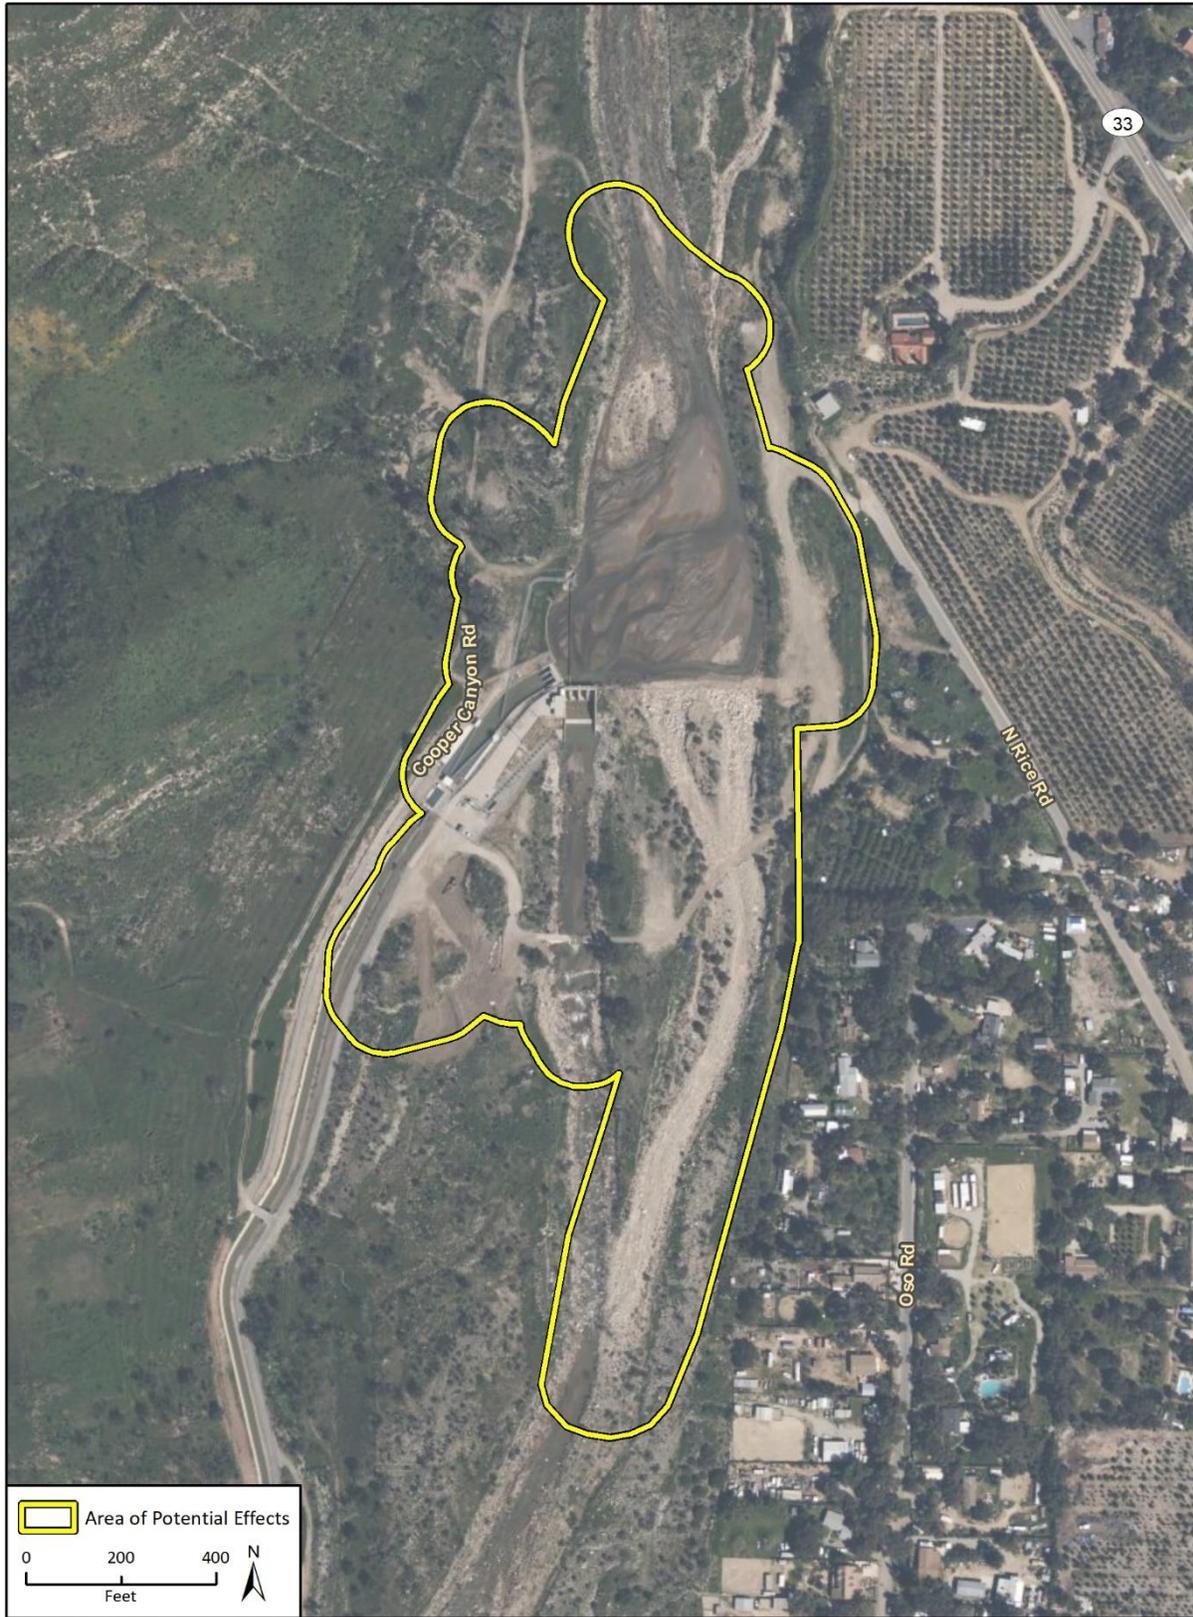
Figure 8 Area of Potential Effects

The area of potential effects (APE) of a project is defined in 36 Code of Federal Regulations (CFR) 800.16(d) as the “geographic area or areas within which an undertaking may directly or indirectly cause alterations in the character or use of historic properties, if any such property exists.” The APE generally depicts all areas expected to be affected by the project, including staging and construction areas (Figure 8). As defined for this project, the APE is comprised of 36.06 acres and encompasses the proposed project footprint described in Section 1.1.

The APE must also be considered as a three-dimensional space and include any ground disturbance associated with the project. The maximum depth of ground disturbance for the project is expected

to generally be approximately 10 feet in the forebay and 8 feet in the entrance pool located downstream of the spillway at the entrance to the fish ladder. Therefore, the vertical depth of the APE varies, but is not expected to exceed 10 feet in all areas.

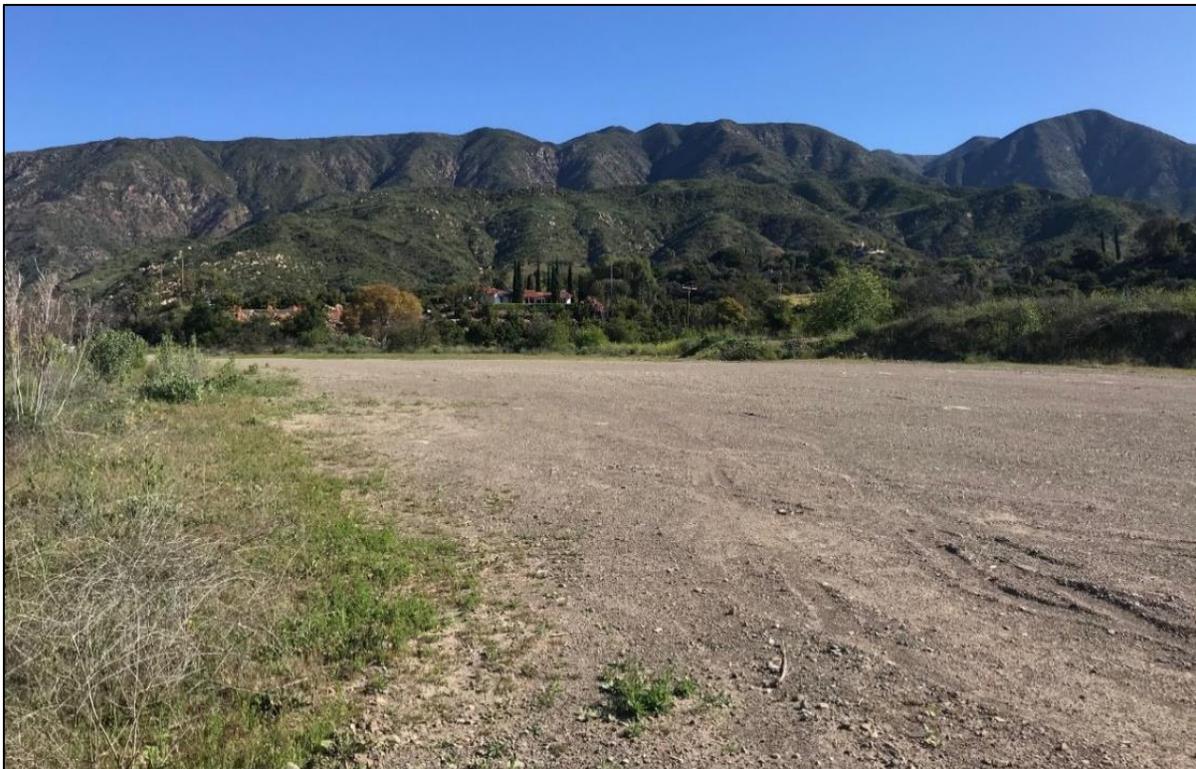
Figure 10 Portion of Eastern Extent of APE, View North

Ground visibility within the APE was approximately 25 percent, with gravel and vegetation inhibiting further visibility (Figure 10 through Figure 14). Portions of the APE are graded and leveled with fill made up of local and imported soils. Low-density deposits of modern freshwater clam shells are present throughout local fill areas along the eastern peripheries of the APE. Large granitic boulders associated with the river are also scattered throughout the APE. Two brown cryptocrystalline silicate tertiary flakes on the Robles Diversion Dam Facility were identified in an imported soil context. Casitas staff Steve Sharp confirmed the provenance of the soil where the artifacts were identified as imported fill during the survey (Sharp 2020). The isolated flakes were removed from their original context and stripped of any associations and/or data potential; thus, they were not formally recorded during the survey. No other archaeological resources were identified during the pedestrian survey.

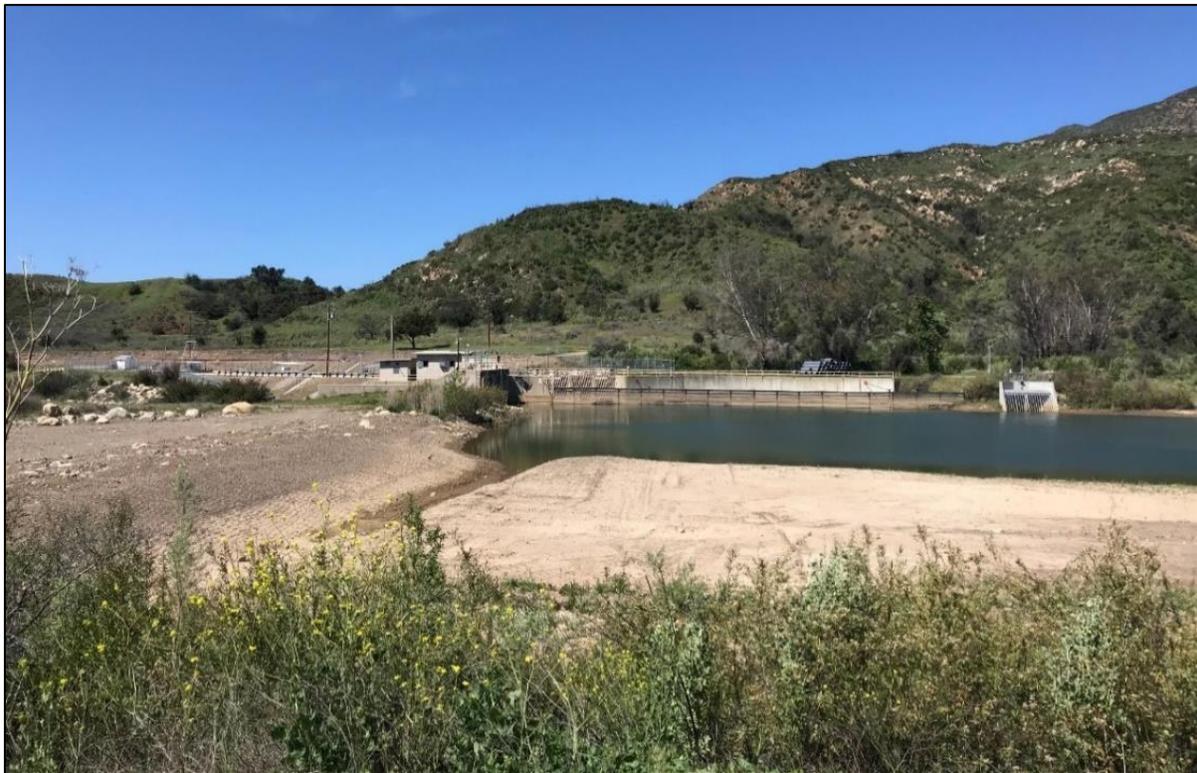
Figure 15 Overview of the Robles Diversion Dam Facility, View West

One previously recorded historic-era built environment resource, the Robles Diversion Dam Facility, was identified in the APE and recorded on Department of Parks and Recreation 523 Series Forms (Appendix C). No other built environment resources were identified during the survey.

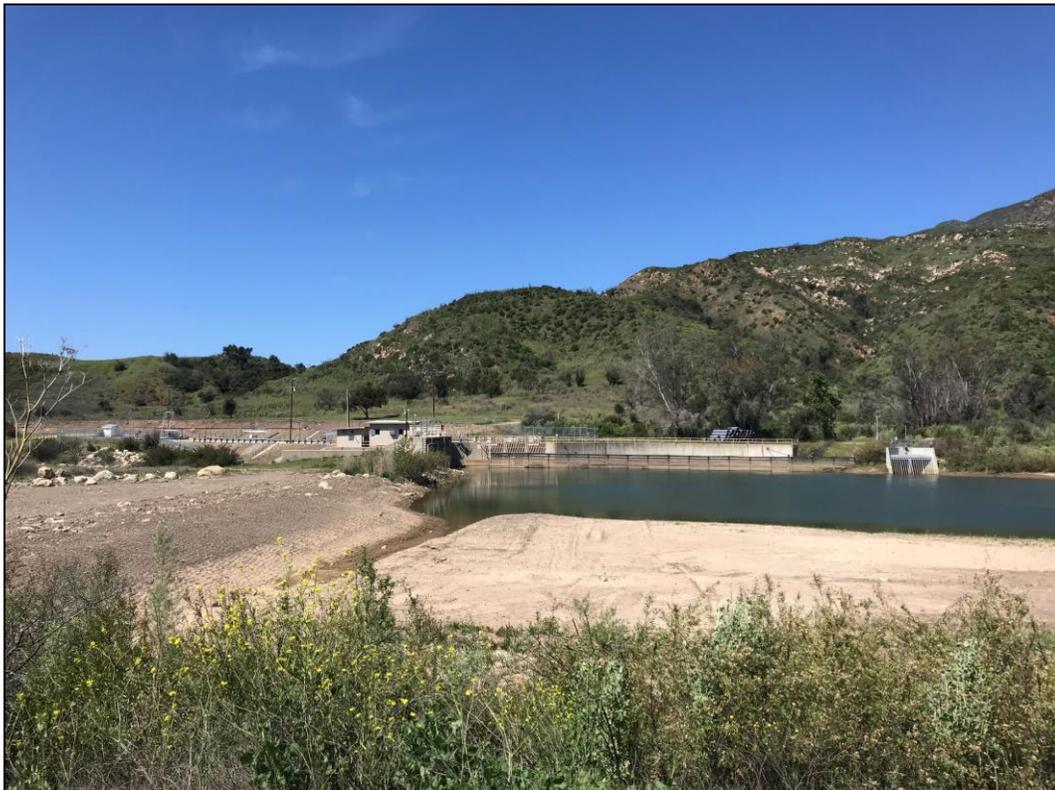
Photograph 1. Overview of Robles Diversion Dam Complex, view northwest. Photo taken April 3, 2020.

The Robles Division Dam Complex is recommended ineligible for listing in the CRHR pursuant to any applicable designation criteria. The subject property was developed in 1957-1959 during construction of the Ventura River Project. Research did not suggest the complex is associated with an event or series of events that made a significant contribution to the broad patterns of history in the city, region, state, or nation (Criterion 1). Research did not indicate that any persons associated with the complex can be considered significant to local, state, or national history (Criterion 2). The complex is utilitarian in design and materials and is a common example of a dam complex. It does not embody distinctive characteristics of a type, period, or method of construction (Criterion 3). A review of available evidence and records search results did not indicate the complex might yield information important to history or prehistory (Criterion 4).

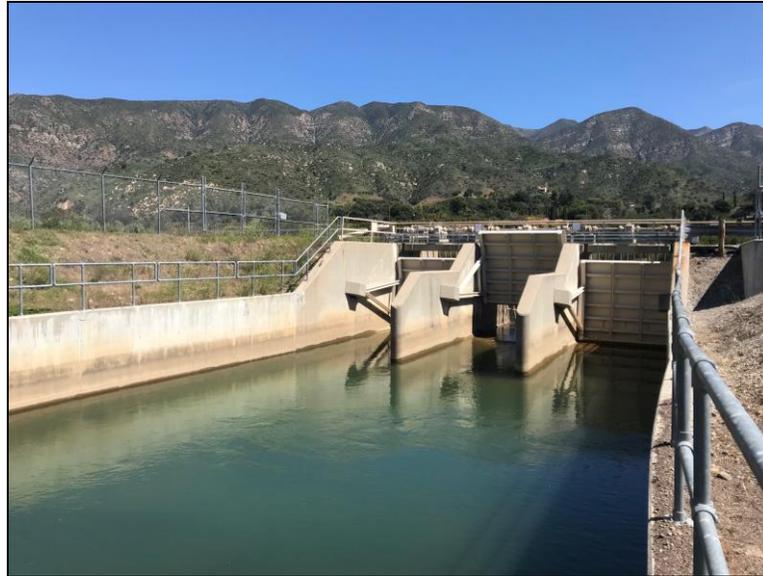
Photograph 2. Robles Diversion Dam Gates, view north. Photo taken April 3, 2020.
