Preliminary Delineation of Wetlands, Other Waters, and Jurisdictional Habitats

Permanent Fire Station 5 Rebuild Project

## Preliminary Delineation of Wetlands, Other Waters, and Jurisdictional Habitats

**March 2021**

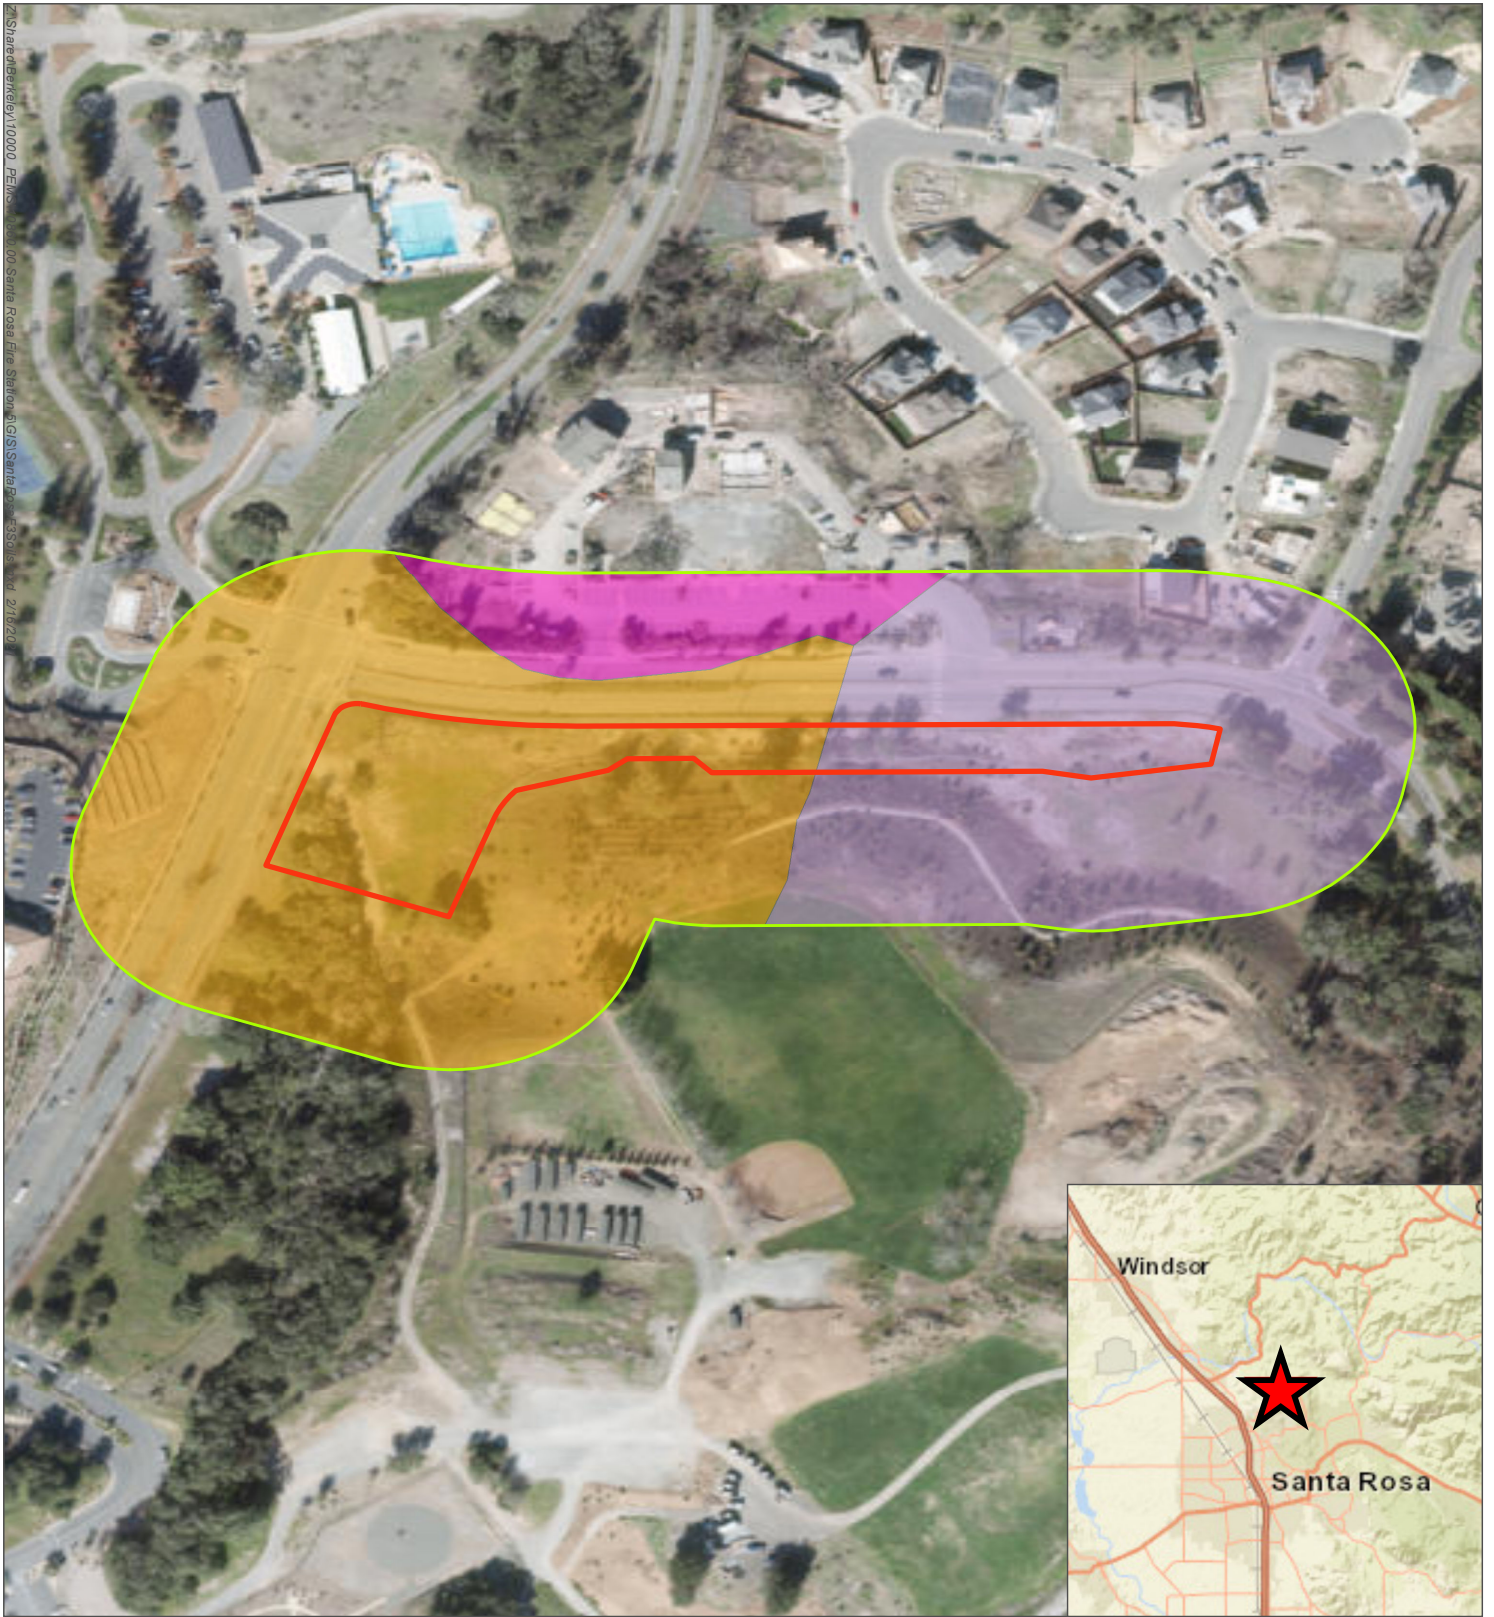
The western portion of the project site where the unnamed stream is located is mapped as GIE- Goulding cobbly clay loam, 15 to 30 percent slopes (NRCS 2020a). The eastern portion of the site where the storm drain outlet is located is mapped as SkE- Spreckles loam, 15 to 30 percent slopes (NRCS 2020a) (Figure 2).

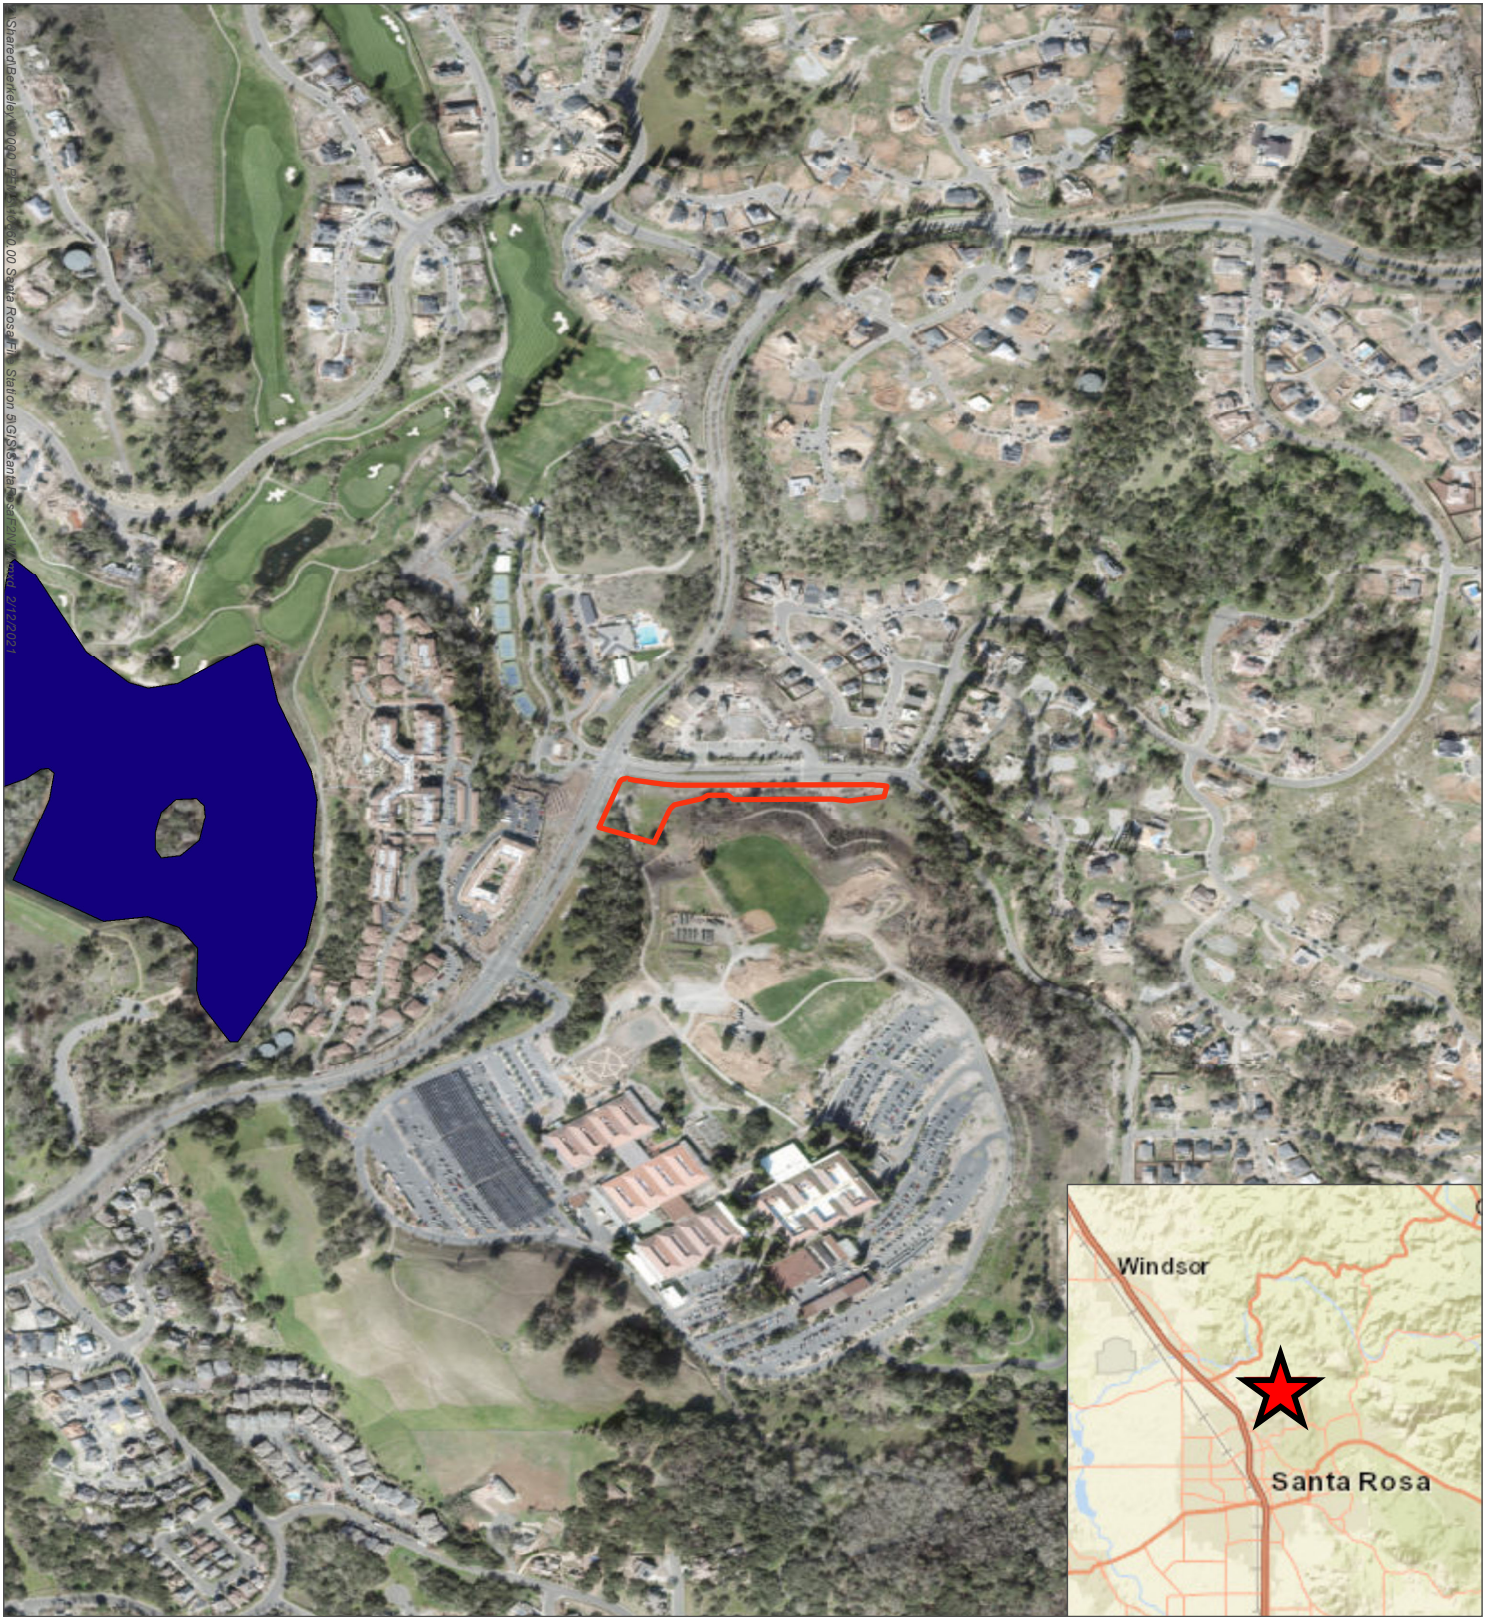
**Figure 3. USFWS National Wetlands Inventory Map**  
Preliminary Jurisdictional Delineation  
Santa Rosa Fire Station 5

The U.S. Fish and Wildlife Service's (USFWS) National Wetlands Inventory (NWI) map of the project area is depicted in Figure 3. The unnamed stream does not appear in the NWI (NWI 2020). NWI maps are based on interpretation of aerial photography, limited verification of mapped units, and/or classification of wetland types using the classification system developed by Cowardin et al. (1979). These data are available for general reference purposes and do not necessarily correspond to the presence or absence of jurisdictional waters.

The stream on the project site is unnamed and is not shown on the National Wetland Inventory (Figure 3) or on creek maps in the Santa Rosa Citywide Creek Master Plan (City of Santa Rosa et al. 2013). The unnamed stream flows from south to north across the northwest corner of the project site before flowing into a culvert under Stagecoach Road and connecting to the West Fork of Paulin Creek downstream of the site. The unnamed stream is approximately one to two feet wide and one foot deep. It appears to be perennial, based on a flowing condition observed in November and December 2020 after months with little rain and no recent rainstorms.

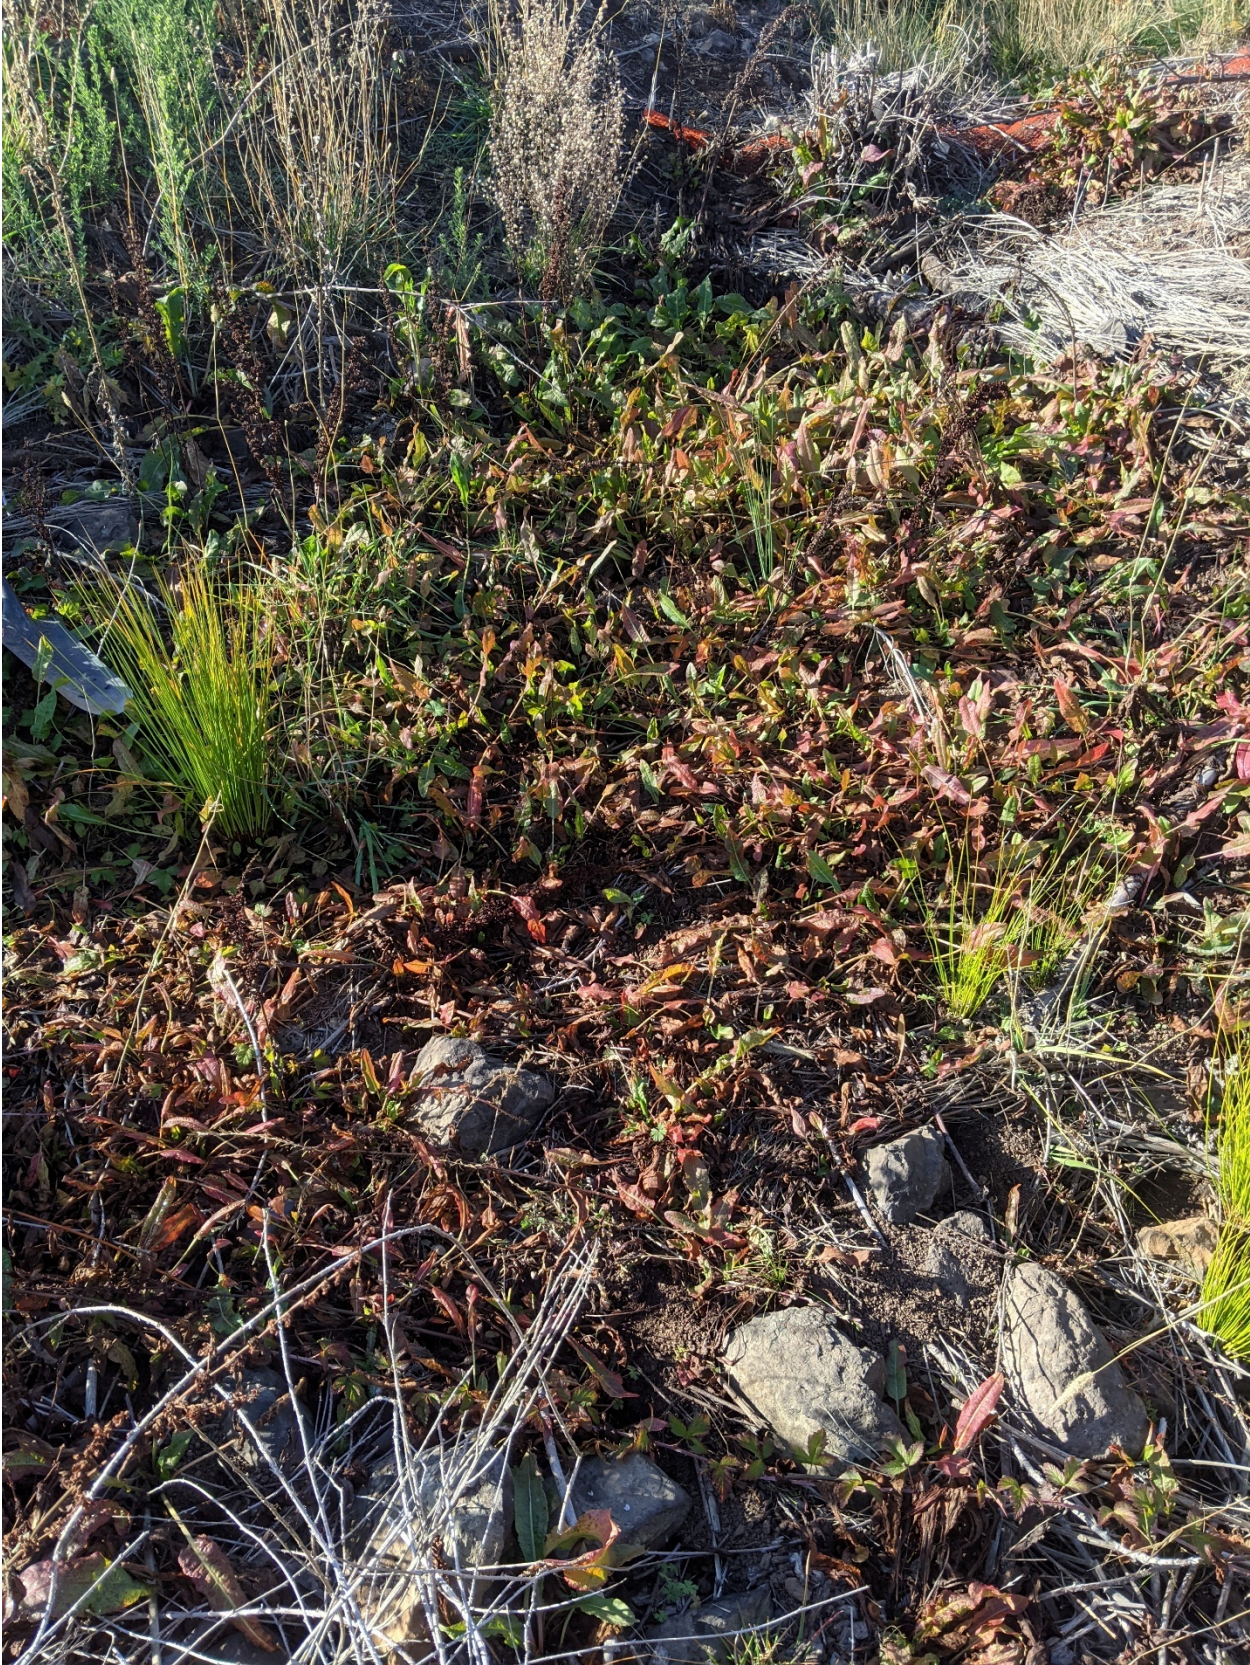
Photo 1: Wetland Sample Point 1 near storm drain outlet.

There is some indication that the area at WSP 1 may not be a wetland. The feature sampled with WSP 1 appears to be a storm drain outlet, whereas the other wetland sample points are in features associated with the perennial stream on site. WSP 1 had different dominant vegetation (curly dock, a FAC species, instead of tall flat sedge, a FACW species) as well as different hydric indicators (soils moist but not saturated, no surface water at or near sample point) than the other wetland sample points, indicating that it may be wet less frequently than the other sample points. Wetland Sample Point 1 also has a different soil type (SkE) according to the Web Soil Survey (NRCS, 2020) than the other sample points, which is not on the USDA Hydric Soils List whereas the soil type at wetland sample points 2 to 4 (GIE) is on the Hydric Soils List.

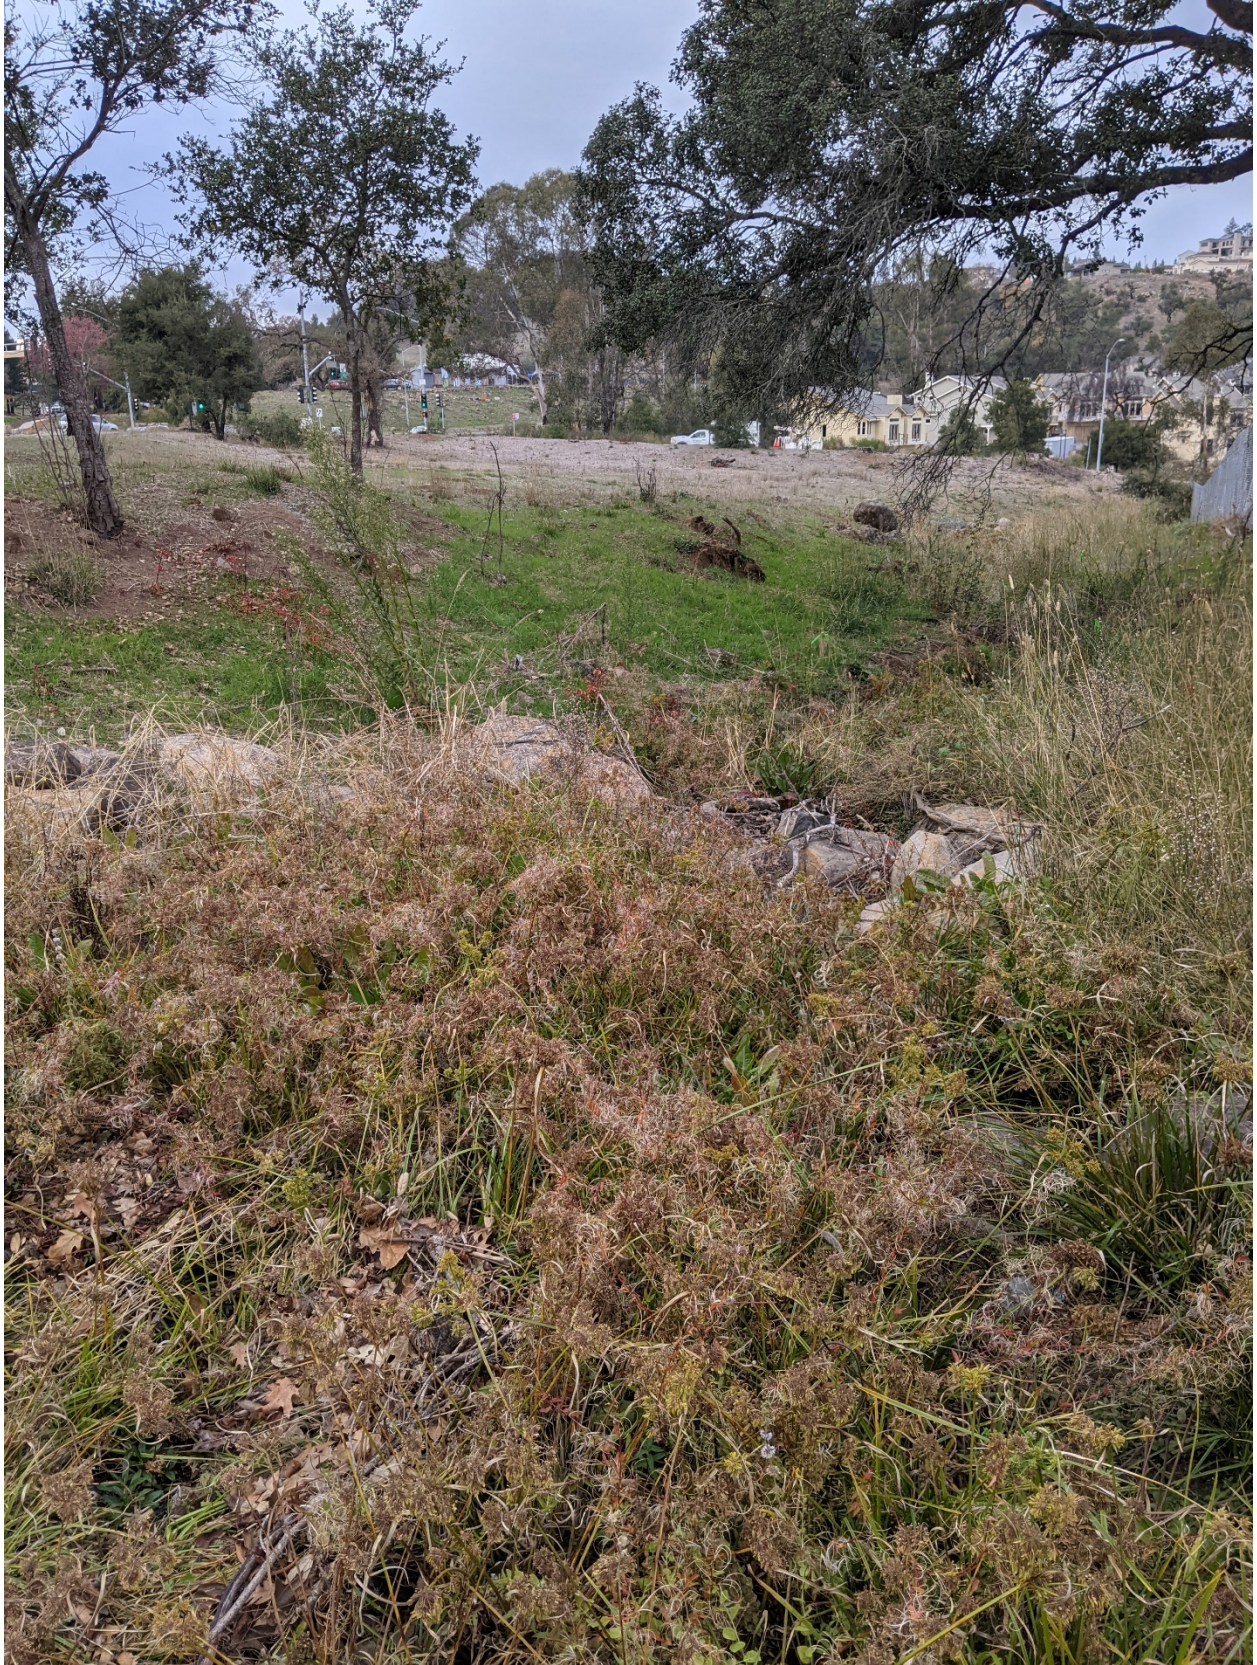
**WSP 2** was located next to the stream adjacent to where it flows under the existing chain link fence to the southern side of the fence (Appendix C, Appendix D Photo 2). This sample point had one dominant species in the shrub stratum and one dominant species in the herb stratum (and no tree or vine stratum), Himalayan blackberry (*Rubus armeniacus*, FAC) and tall flatsedge (*Cyperus eragrostis*, FACW), respectively. However, only tall flatsedge was dominant across all strata in terms of absolute cover (70% as opposed to 2% for Himalayan blackberry). This sample point had one hydric soil indicator at a depth of 6 to 18 inches, redox dark surface. The color of the soil was 100% 10YR 3/1 from 0 to 6 inches, and 90% 10YR 3/2 from 6 to 18 inches; the 10% redox features was 5YR 5/8 from 6 to 18 inches. The texture of the entire soil sample was clay. This sample point had primary hydrology indicators including a high water table, saturated soils, and water-stained leaves; and secondary hydrology indicators including drift deposits (riverine) and saturation visible on aerial imagery.

Photo 2: Wetland Sample Point 2: unnamed stream near chain link fence.

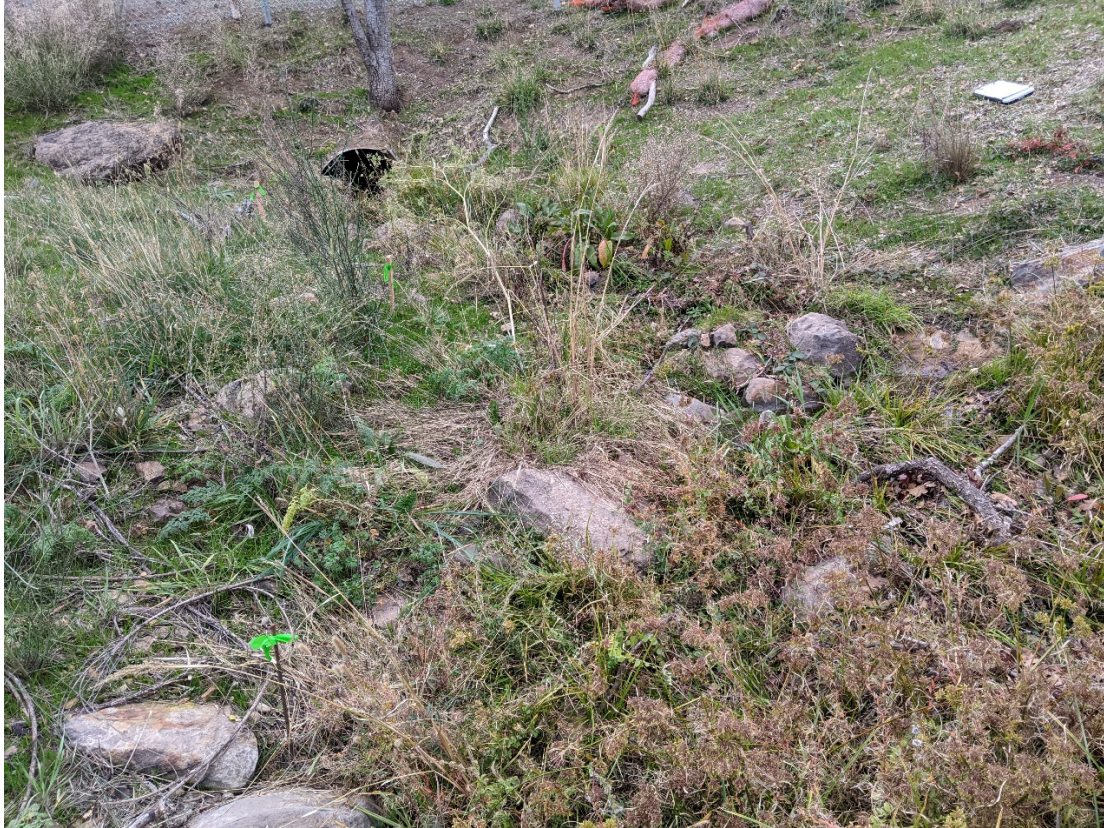
Photo 3: Wetland Sample Point 3 on east side of access road.

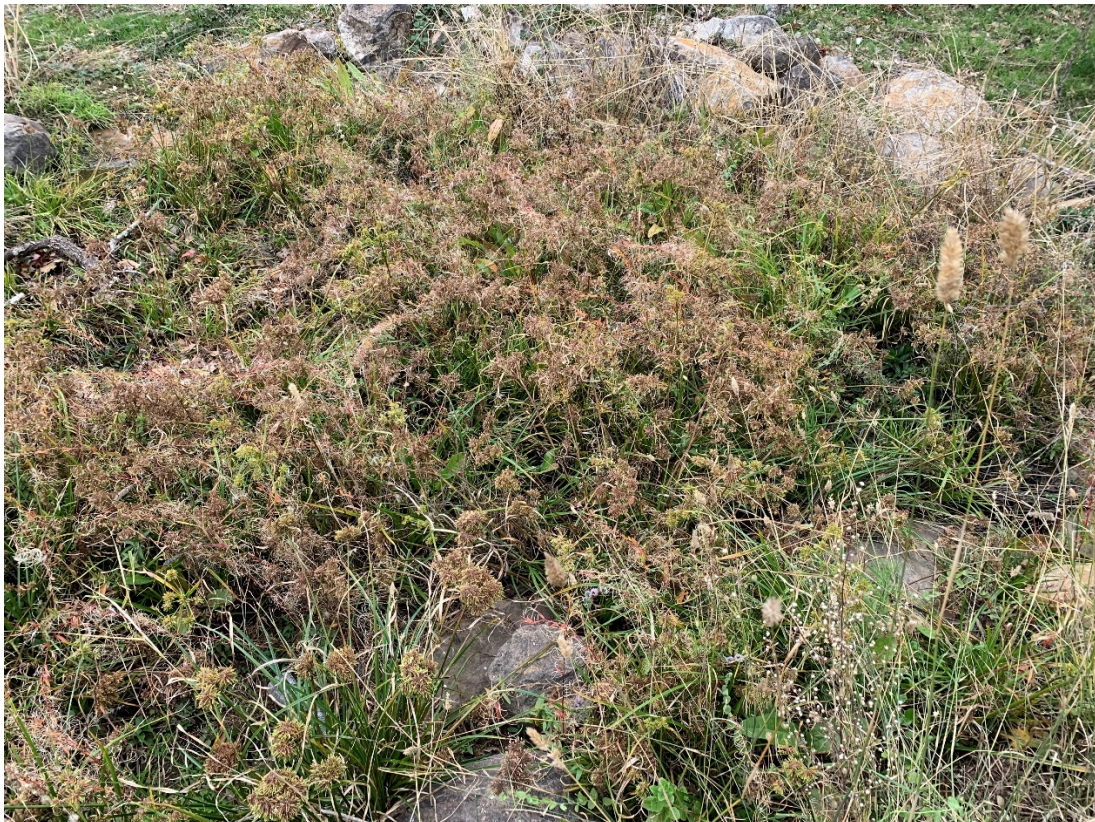
Photo 4: Wetland Sample Point 4 on west side of access road.

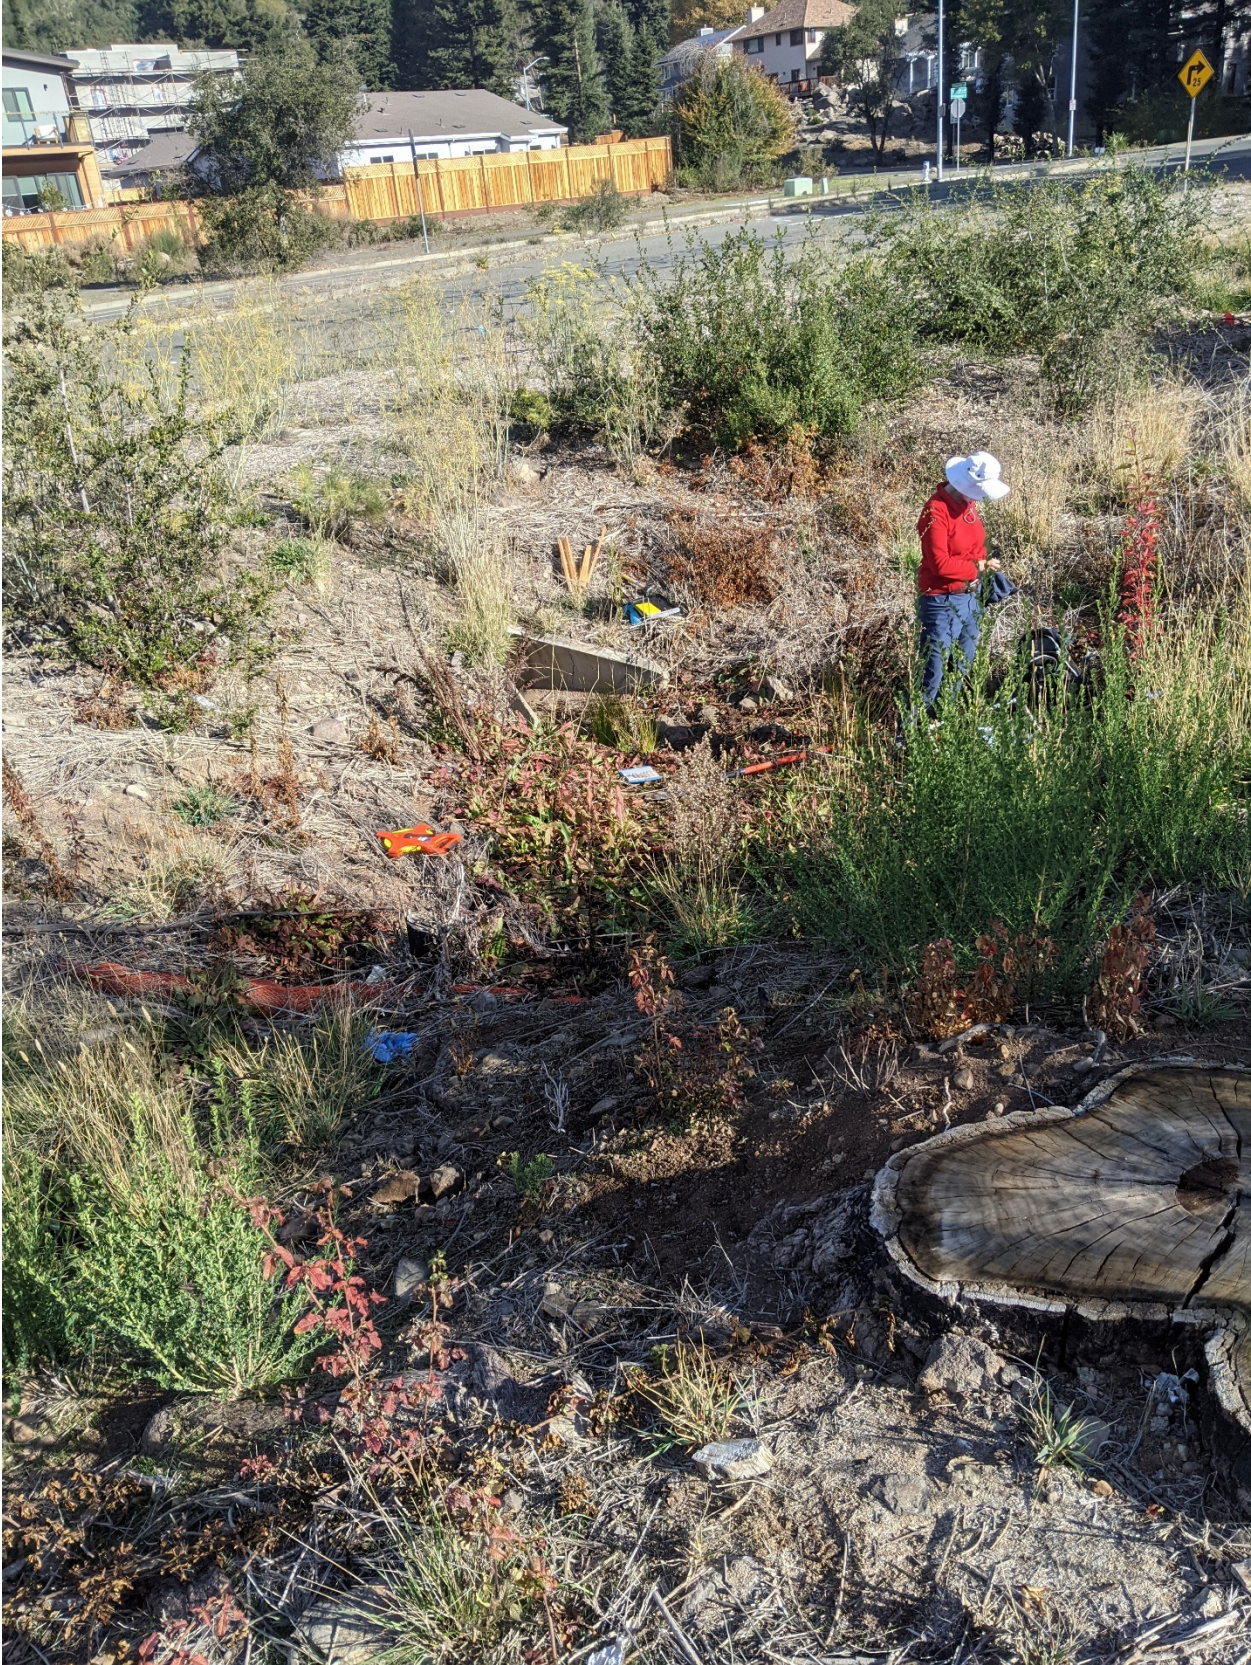
Photo 5: Cross Section 1 at storm drain outlet.

MIG biologists did three cross sections of aquatic features on the site (CS1 to CS3, Appendix C), one at the storm drain outlet, one on the portion of the stream northeast of the access road, and one on the portion of the stream southwest of the access road. Changes in vegetation and sediment were observed from the lowest part of the floodplain to the active flood plain boundary (Appendix C).

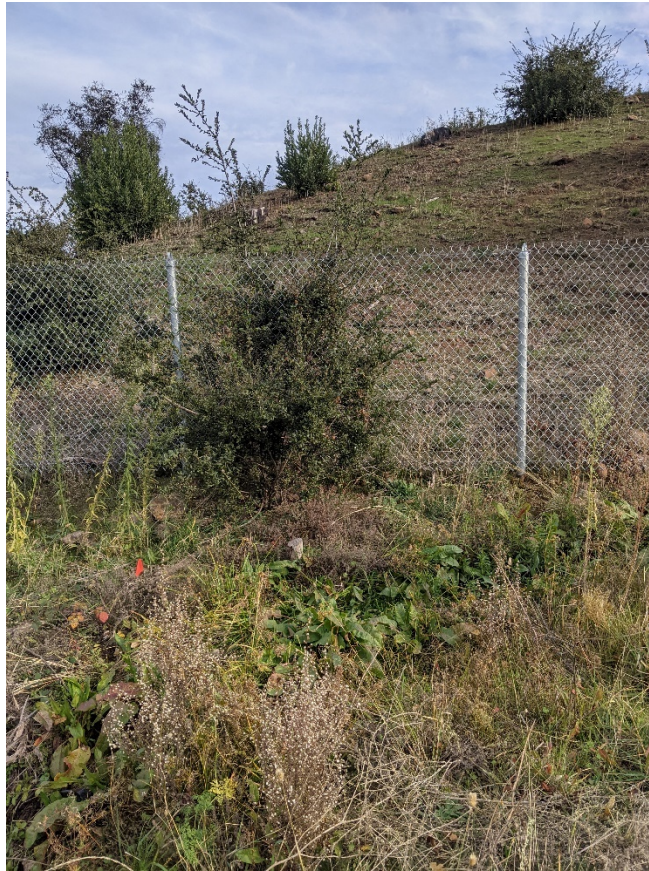
Photo 6: Cross Section 2 on unnamed stream east of access road.

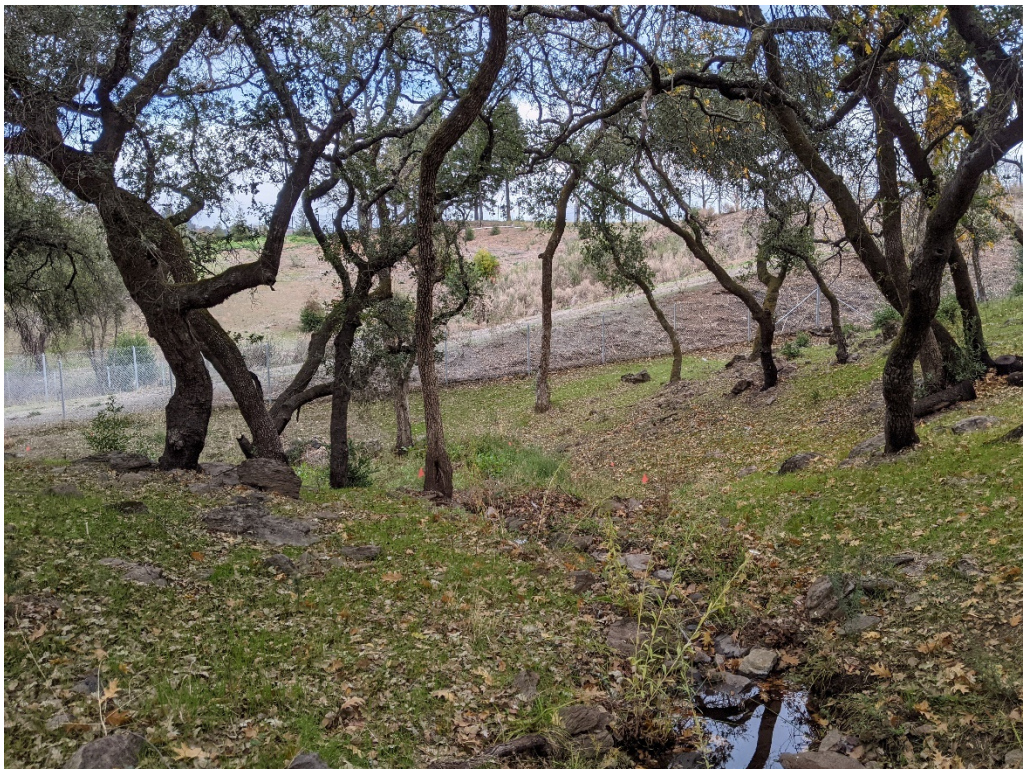
Photo 7: Cross Section 3 on unnamed stream west of access road.
