FARMLANDS IMPACT MEMORANDUM

SUBJECT: Farmlands Impact Memorandum – Gonzales River Road Bridge Replacement Project (BRLS-5944[098]) Caltrans Bridge No.44C0035, County Bridge No. 309 at the Salinas River.

*Gonzales River Road Bridge Replacement Project
 Monterey County, California
 Federal Project Number BRLS-5944(098)*

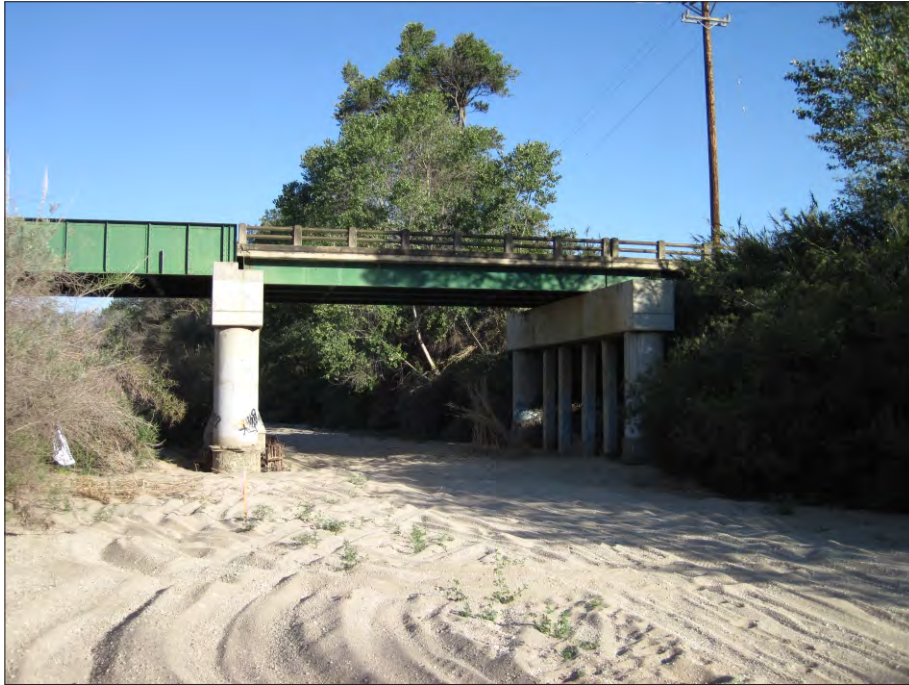
Figure 8a: Salinas River low flow channel, willows in foreground, Gonzales River Road Bridge in mid-ground, Fremont and black cottonwoods behind bridge, view from upstream of the bridge to the west. June 8, 2015.
