Redlands Boulevard and Hemlock Avenue Gas Station Project

MSHCP
Determination of Biologically Equivalent
or Superior Preservation

October 2021

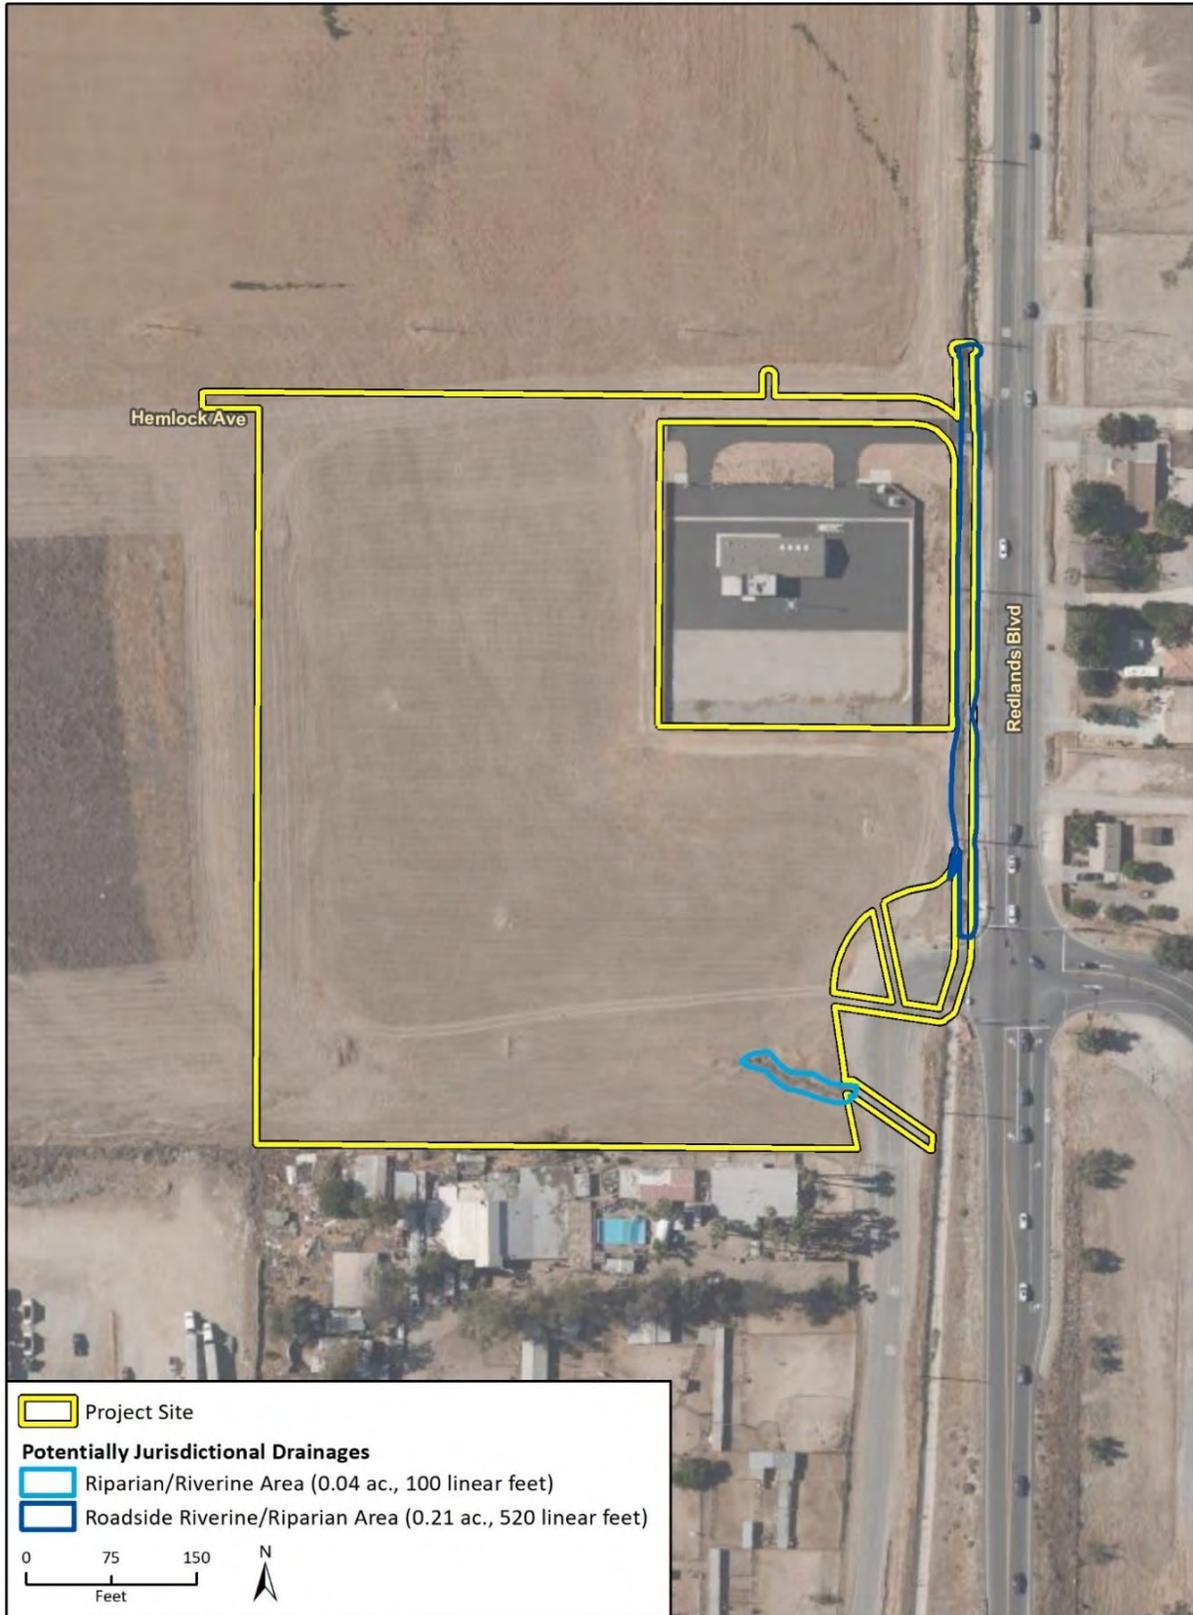
Figure 6 MSHCP 6.1.2 Riparian/Riverine Resources

This feature is regularly weed abated and contains an unlined substrate until Spruce Avenue, where the rest of the channel is concrete-lined running south until flows enter a culvert under State Route 60. Vegetative species associated with the unlined portion of the roadside drainage channel include riggut brome, slender wild oat (*Avena barbata*), wall barley, short-pod mustard, common sunflower (*Helianthus annuus*), arroyo lupine (*Lupinus succulentus*), red-stem filaree (*Erodium cicutarium*), sourclover (*Melilotus indicus*), brittlebush (*Encelia farinosa*), hairy vetch (*Vicia villosa*), and stinknet (*Oncosiphon pilulifer*).

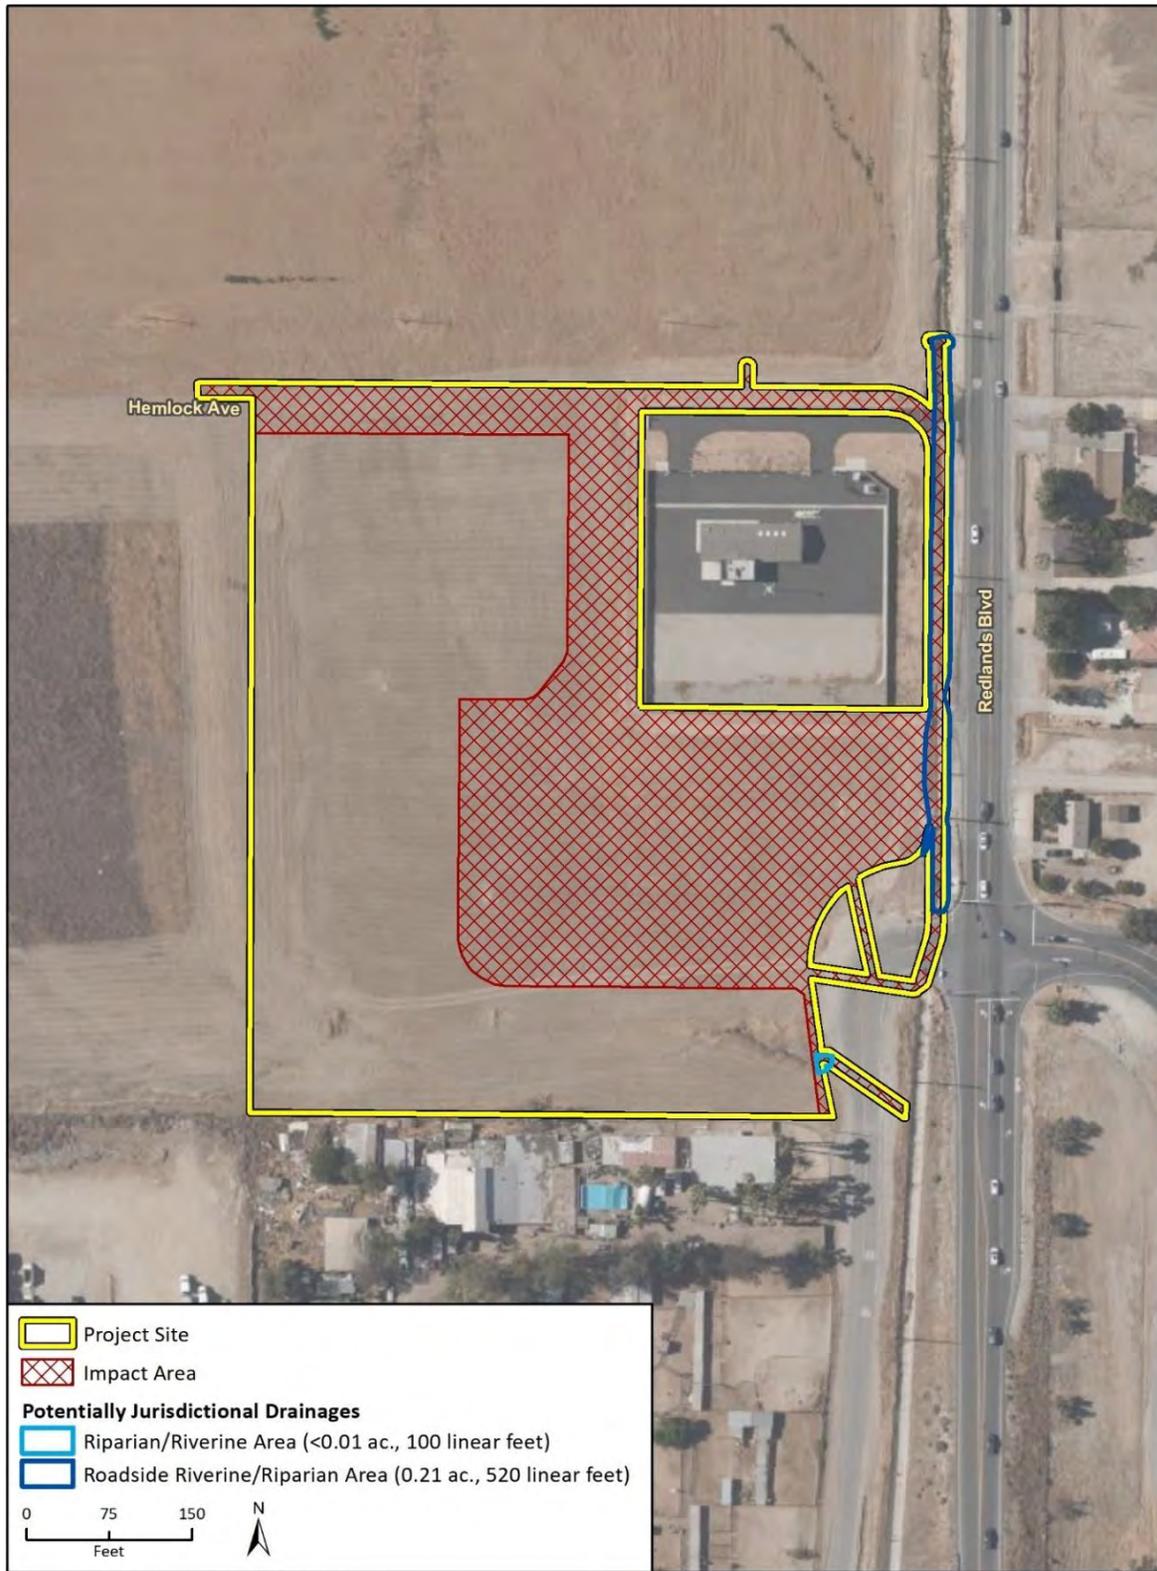
Figure 7 Impacts to Riparian/Riverine Resources

For unavoidable impacts to riparian/riverine systems, the MSHCP requires that a project establishes that it would be “biologically equivalent or superior” when compared to complete avoidance of the existing habitat. The purchase of mitigation credits will accomplish this goal, whereas the following avoidance and minimization measures will be utilized to avoid indirect impacts.

Impacts are limited to permanent changes to the 0.21 acre of roadside drainage ditch and erosional drainage ditch found in the project site. These impacts will be mitigated through the purchase of mitigation credits as a biologically superior alternative. Therefore, the mitigation strategy is considered biologically equivalent or superior to an avoidance alternative.

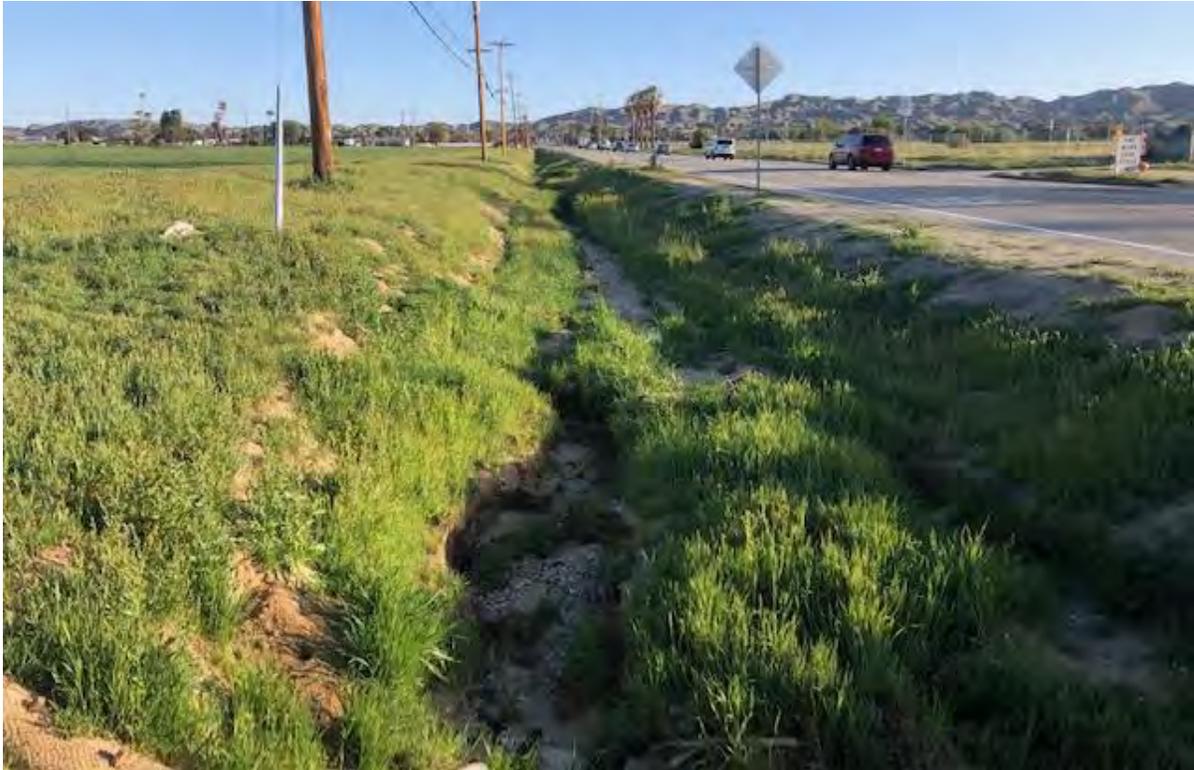
Photograph 1. Facing north west of Redlands Boulevard looking at the roadside drainage ditch.

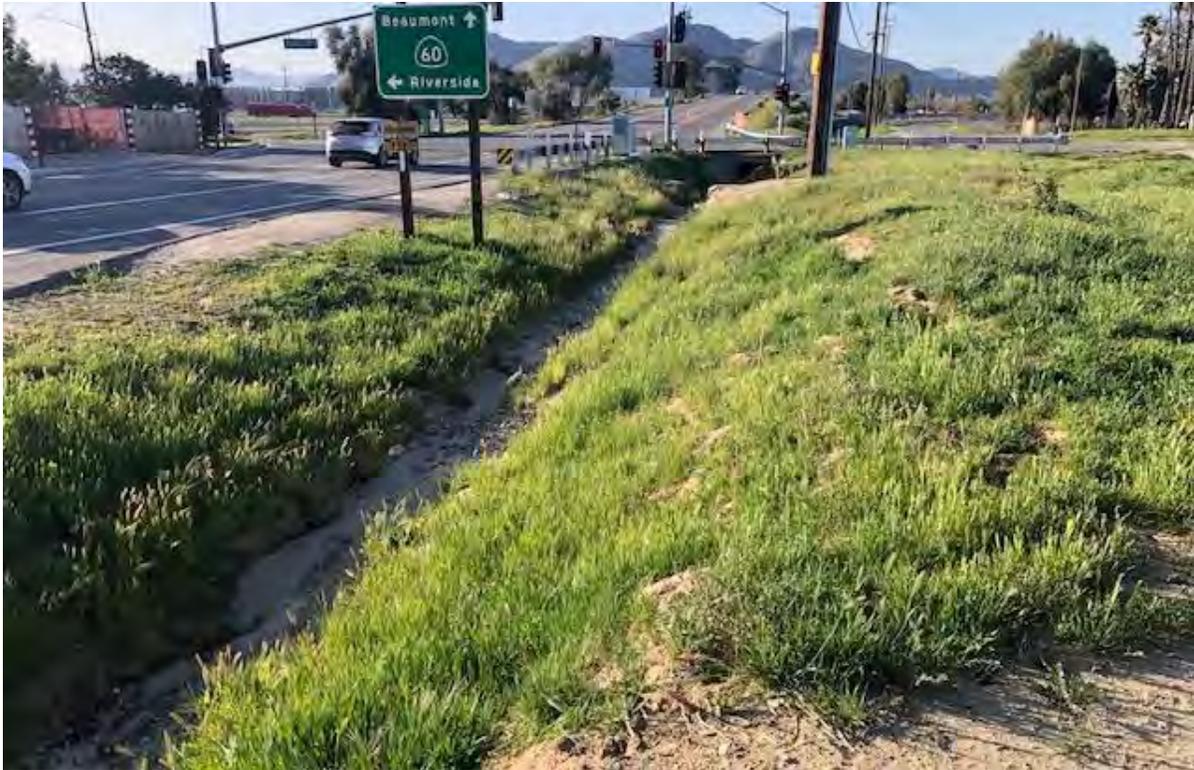
Photograph 5. Facing south and downstream at roadside drainage ditch.

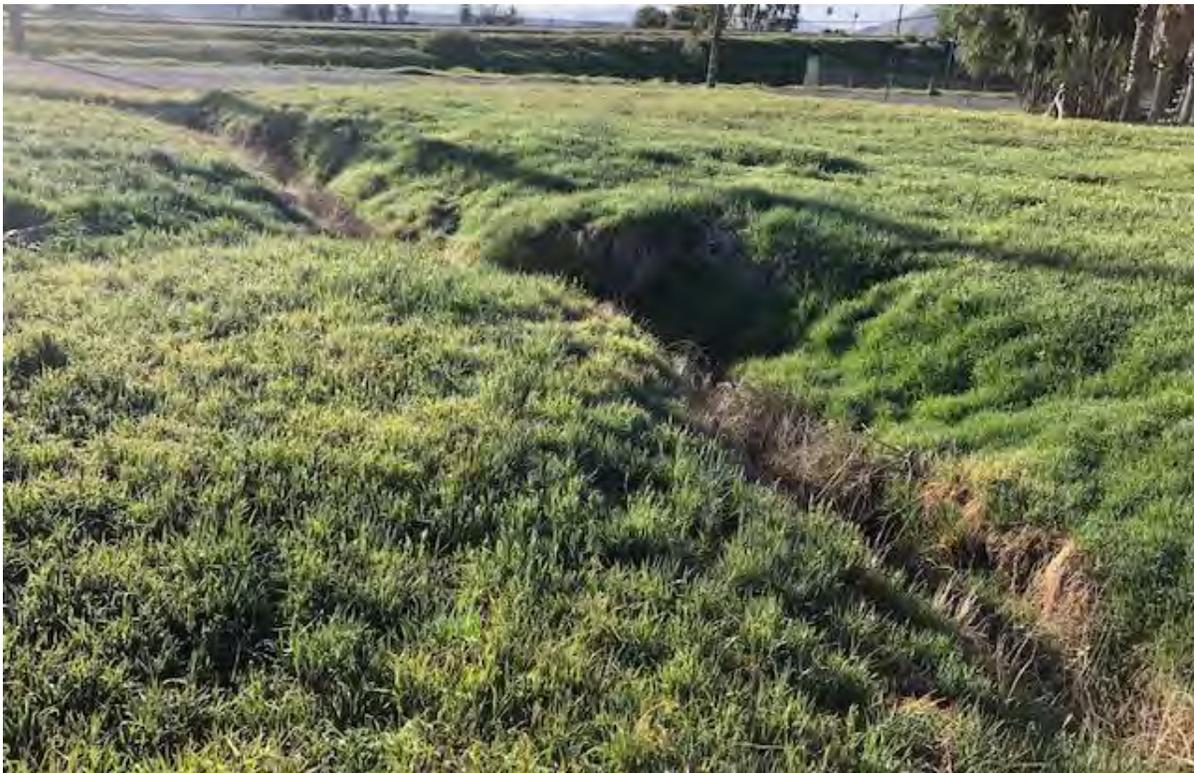
Photograph 6. Downstream, southeast-facing view of erosional feature toward Spruce Ave.

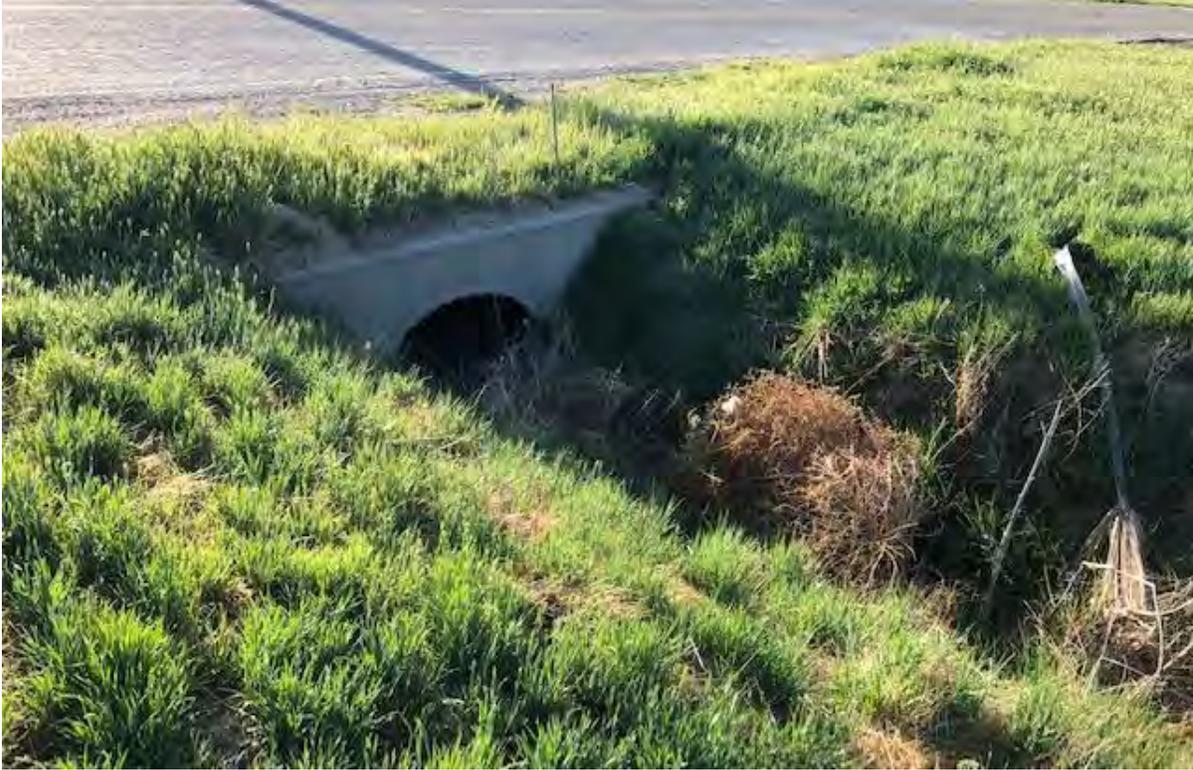
Photograph 7. Showing where the erosional drainage feature meets the culvert under Spruce Avenue.

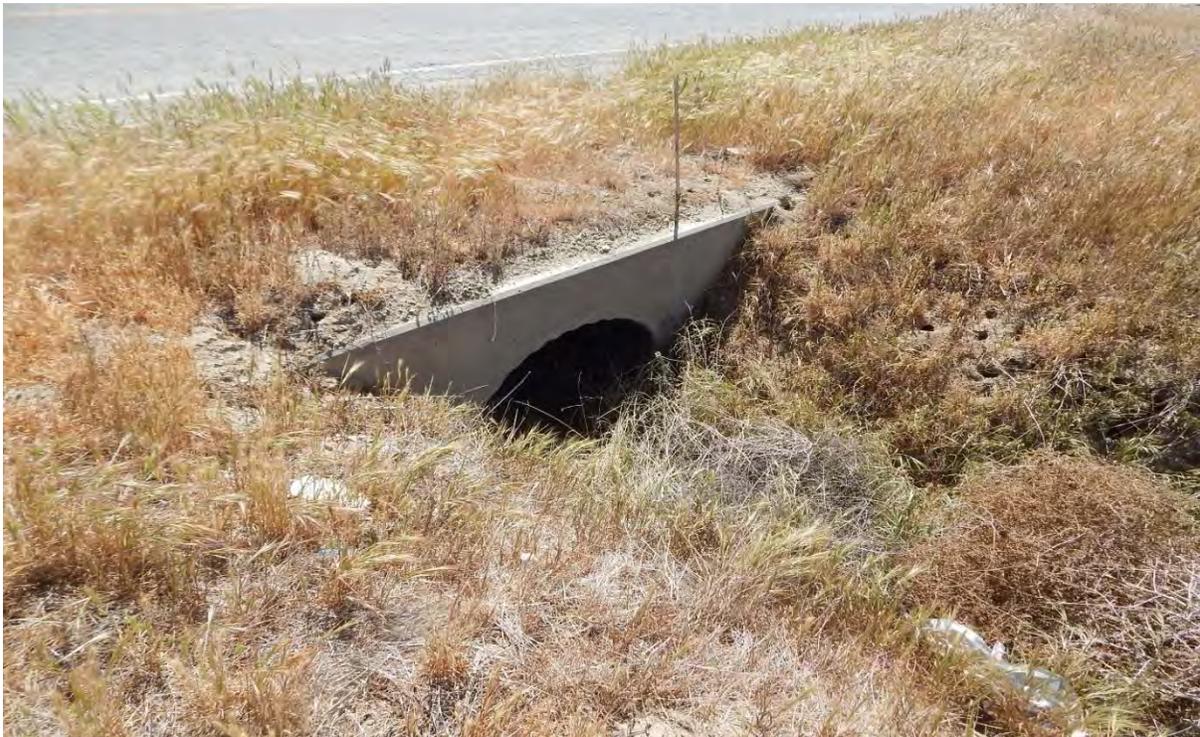
Photograph 8. Showing single storm drain intake under Spruce Avenue and Russian thistle in the channel bed at the downstream east end of the erosional drainage ditch.

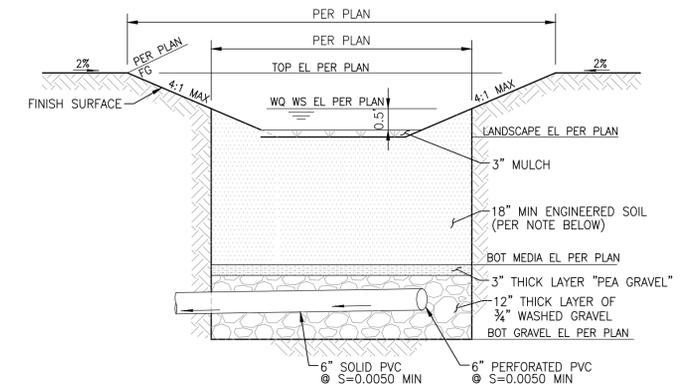
BIORETENTION FACILITY DETAIL (TYP)
NTS

BIORETENTION CLEAN-OUTS:
INSTALL 6" CLEAN-OUTS EVERY 50 FT OF UNDERDRAIN LATERAL, AT THE COLLECTOR DRAIN LINE CONNECTION, AND AT ANY BENDS.
EACH CLEAN-OUT SHALL BE EXTENDED 6" ABOVE THE MEDIA AND SHALL HAVE A LOCKABLE SCREW CAP.
INSPECT MONTHLY, OR AS NEEDED AFTER STORM EVENTS. MAINTAIN IF NEEDED.

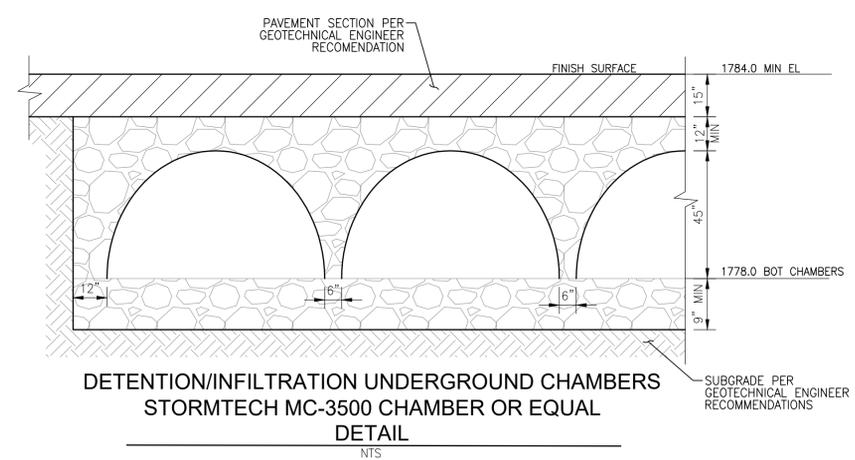
DETENTION/INFILTRATION UNDERGROUND CHAMBERS
STORMTECH MC-3500 CHAMBER OR EQUAL
DETAIL
NTS
