Redlands Boulevard and Hemlock Avenue Gas Station Project

Jurisdictional Waters and Wetlands Delineation

September 2021

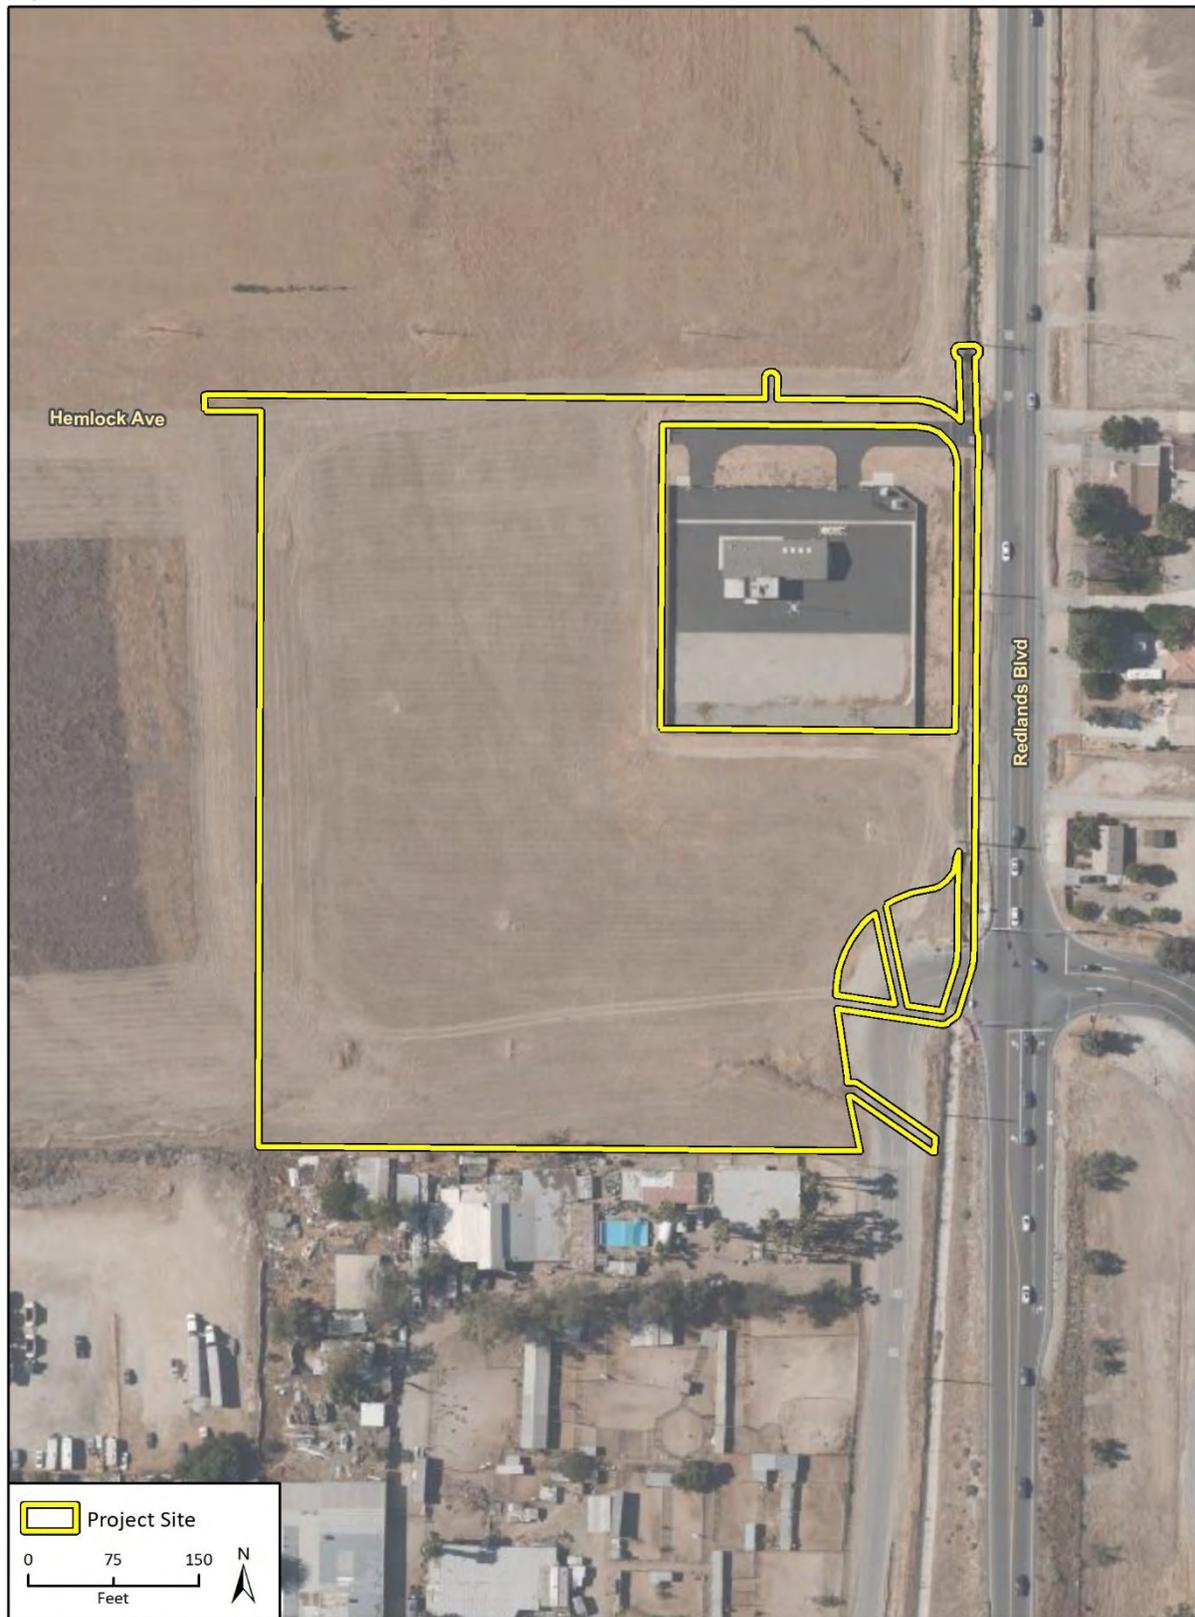
Figure 2 Project Location

The project site is generally located in Moreno Valley, south of the Badlands (Figure 1). The site is specifically located west of Redlands Boulevard and Spruce Avenue and south of Hemlock Avenue (Figure 2). It is depicted on the Sunnymead, California, U.S. Geological Survey (USGS) 7.5-minute topographic map, within Section 2, Township 3 South, Range 3 West, San Bernardino baseline and meridian (Figure 1). The center point latitude and longitude coordinates for the project site are 33.941664°N and -117.157976°W.

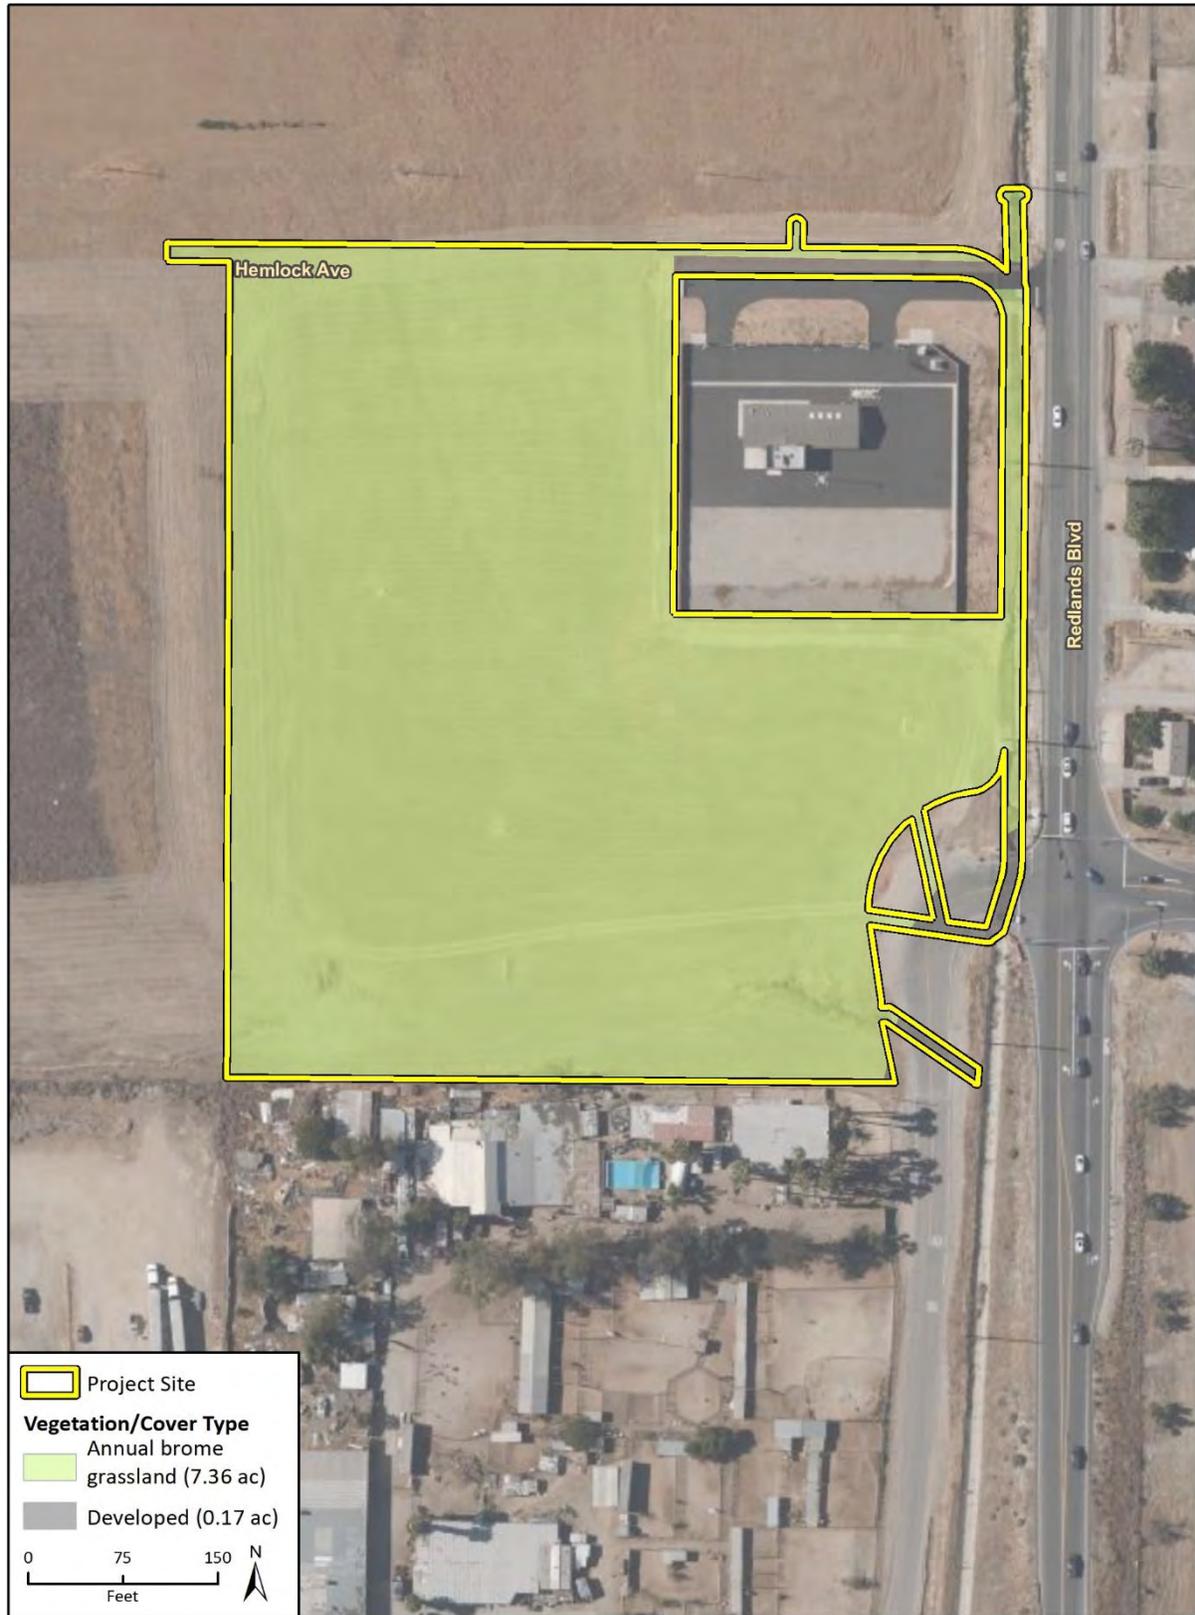
Figure 3 Vegetation Communities

Annual brome (*Bromus* spp.) grasslands are annual non-native grasslands with more than 60% of the herbaceous layer consisting of *Bromus* species. The entire project site consists of land that is regularly disturbed by tilling, resulting in annual brome grassland as the only habitat on site. Species diversity is limited, with only annual grassland species observed including, but not limited to, red brome (*Bromus rubens*), ripgut brome (*Bromus diandrus*), foxtail barley (*Hordeum murinum*), Rancher's fiddleneck (*Amsinckia menziesii*), and short-pod mustard (*Hirschfeldia incana*). Annual brome grassland comprises 7.36 acres in the project site and was observed in both drainage features. Hydrophytic vegetation was not present in either drainage feature.

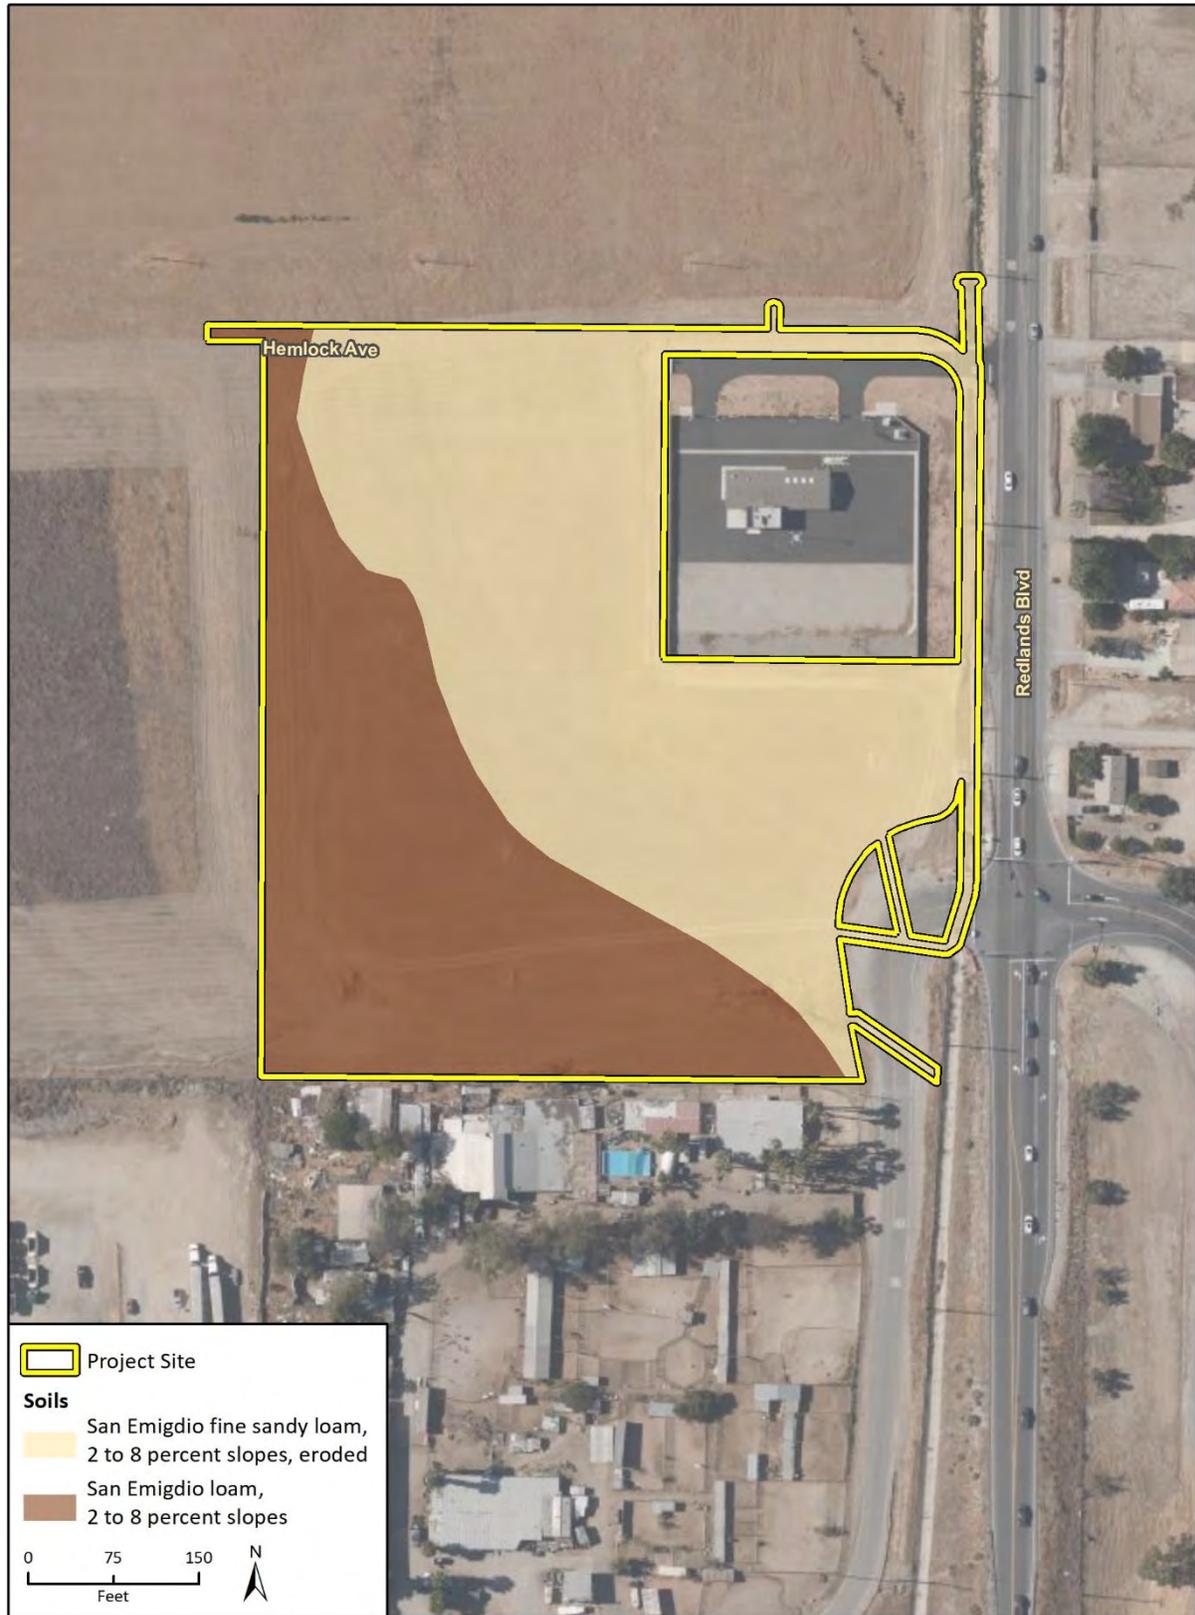
Figure 4 USDA Soils Map

Two soil types of the San Emigdio series occur on site: San Emigdio fine sandy loam, 2 to 8 percent slopes, eroded (SeC2) and San Emigdio loam, 2 to 8 percent slopes (SgC). The San Emigdio series consists of very deep, well drained soils that form in dominantly sedimentary alluvium. They are found on fans and floodplains and typically have low slopes. They are used for growing citrus fruit, alfalfa, and dryland grain and uncultivated areas are typically annual grasses and forbs (USDA NRCS 2021b). Soils on site have been tilled in the past for agricultural purposes.

Based on soil pit data (Appendix B) from the field survey, no hydric soils indicators are present within either the roadside drainage channel or the erosional drainage ditch. The roadside drainage channel bed is comprised of a mix of cobbles, gravel, and weirs and contains debris. This channel may drain water too rapidly for hydric soils indicators to develop within the soil profile. The channel bed of the erosional drainage ditch is comprised of sandy loam and is densely vegetated with rigput brome, wall barley, slender wild oat, and Russian thistle (*Salsola tragus*). The problematic hydric soils analysis of the Arid West Supplement is not applicable since sustained hydrology has not been observed.

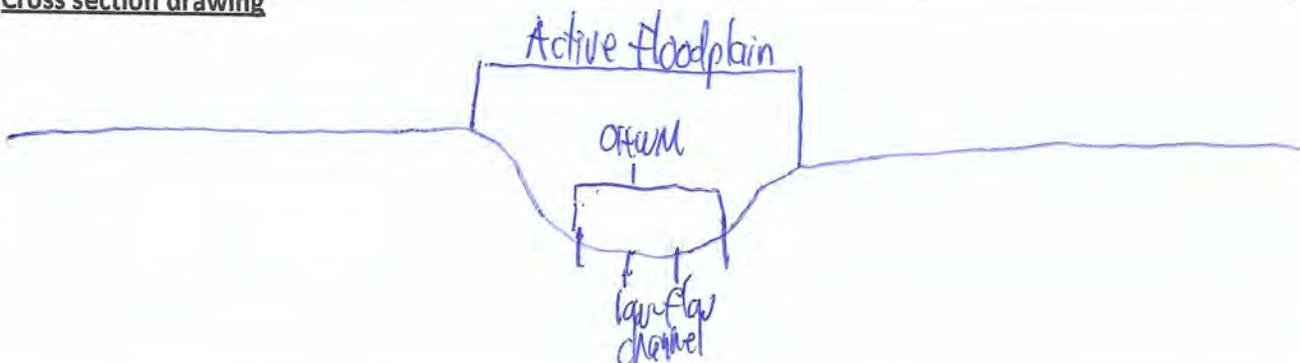
Cross section drawing

Arid West Ephemeral and Intermittent Streams OHWM Datasheet

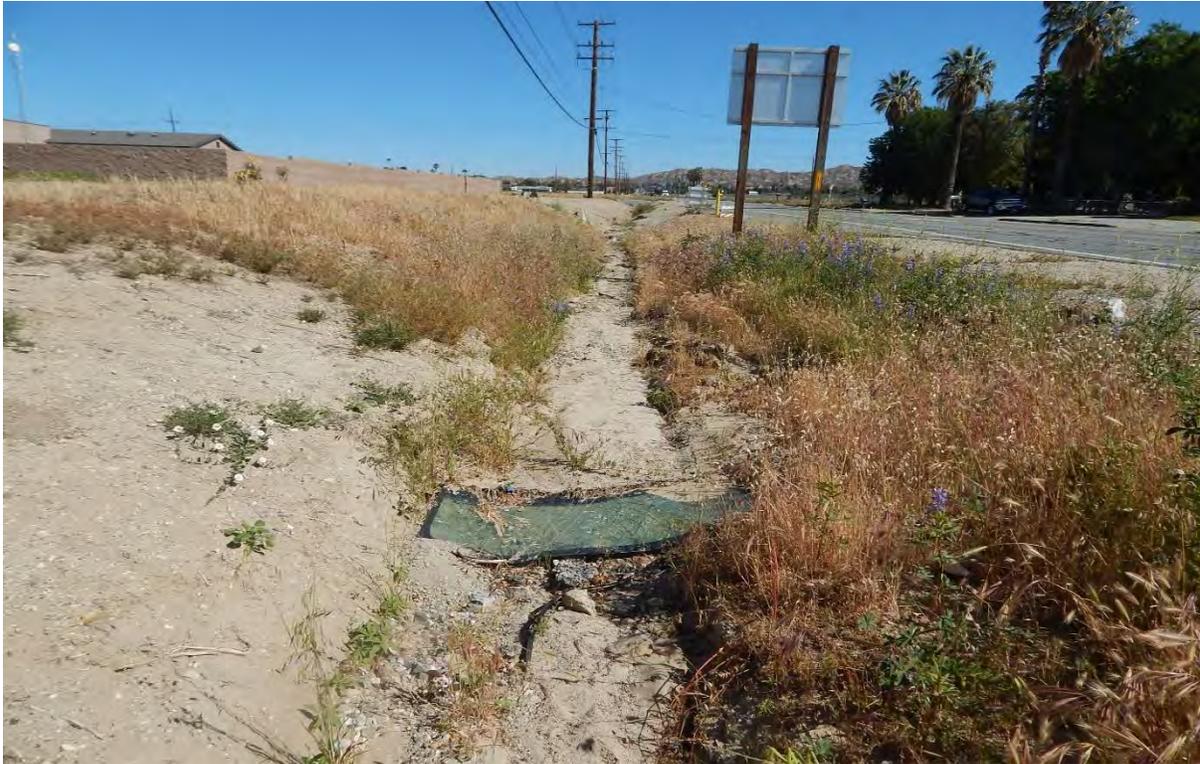
Photograph 1. View north and upstream of the roadside drainage channel showing dry channel bed and annual grassland vegetation with arroyo lupine (*Lupinus succulentus*).

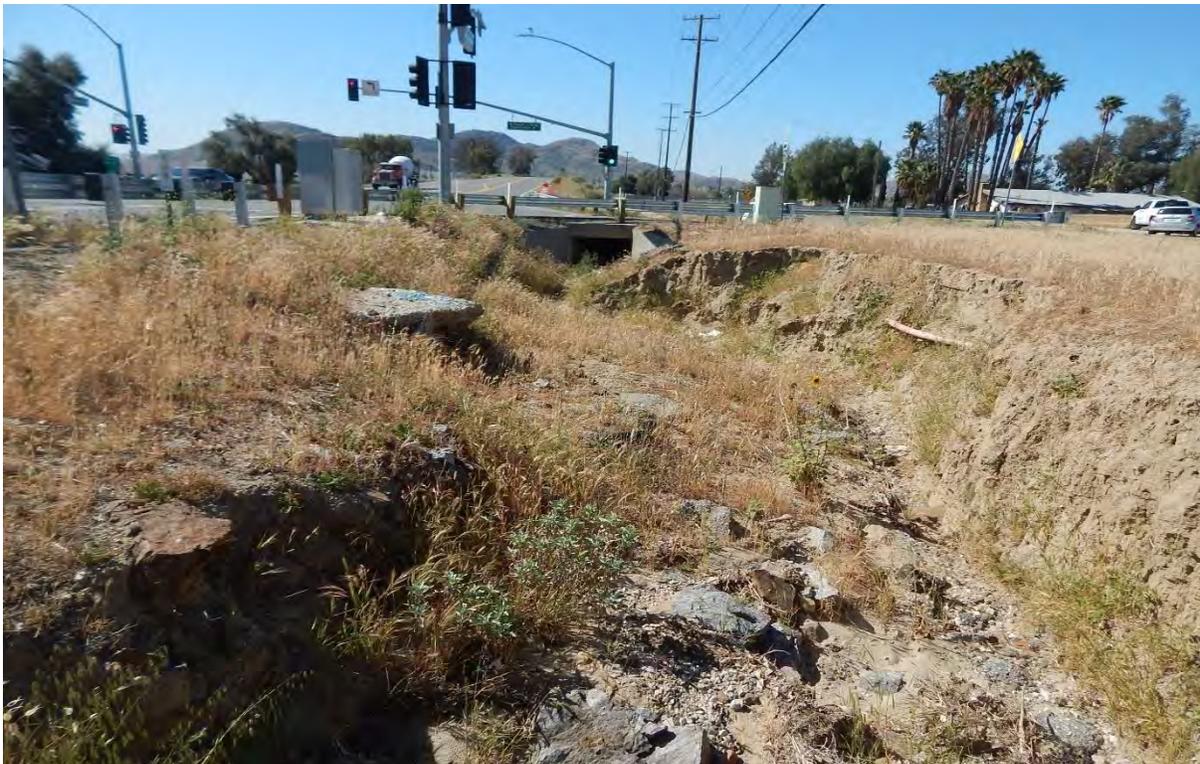
Photograph 2. View south and downstream of the roadside drainage channel toward Redlands Boulevard and Spruce Avenue intersection.

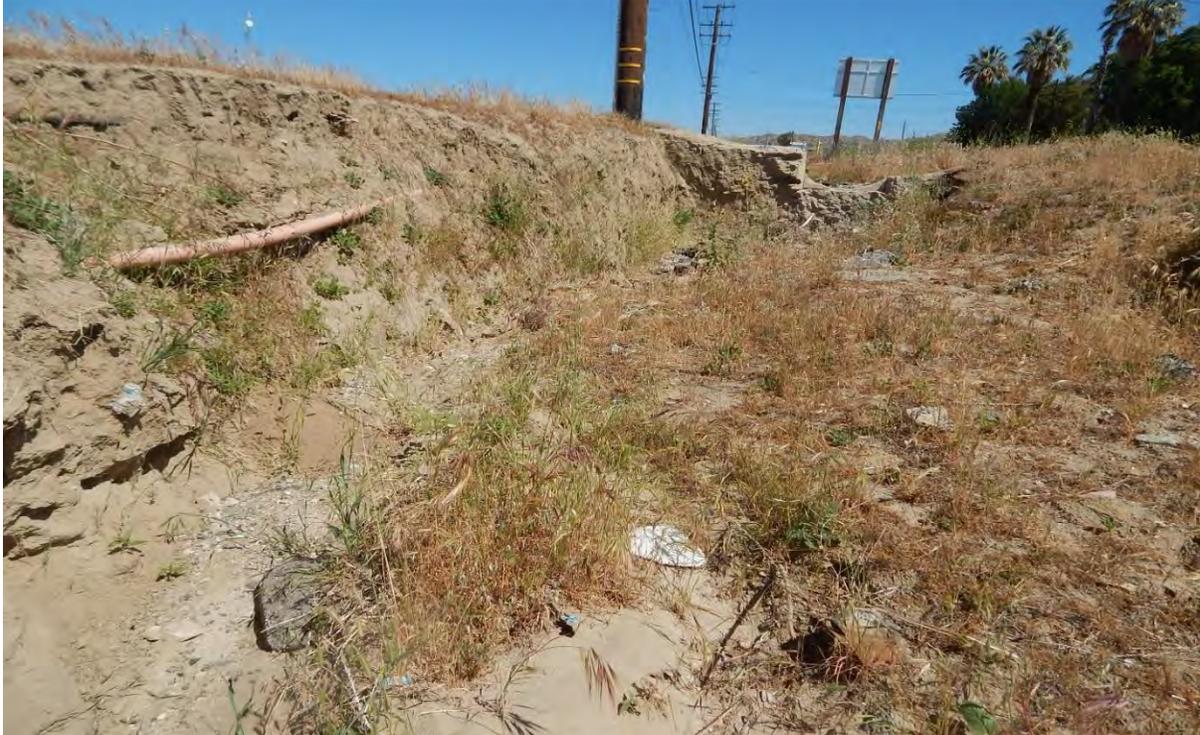
Photograph 3. View north and upstream of the roadside drainage channel showing the low-flow channel to the left of a terrace, steep banks, and a drop weir structure in the channel bed in the background.

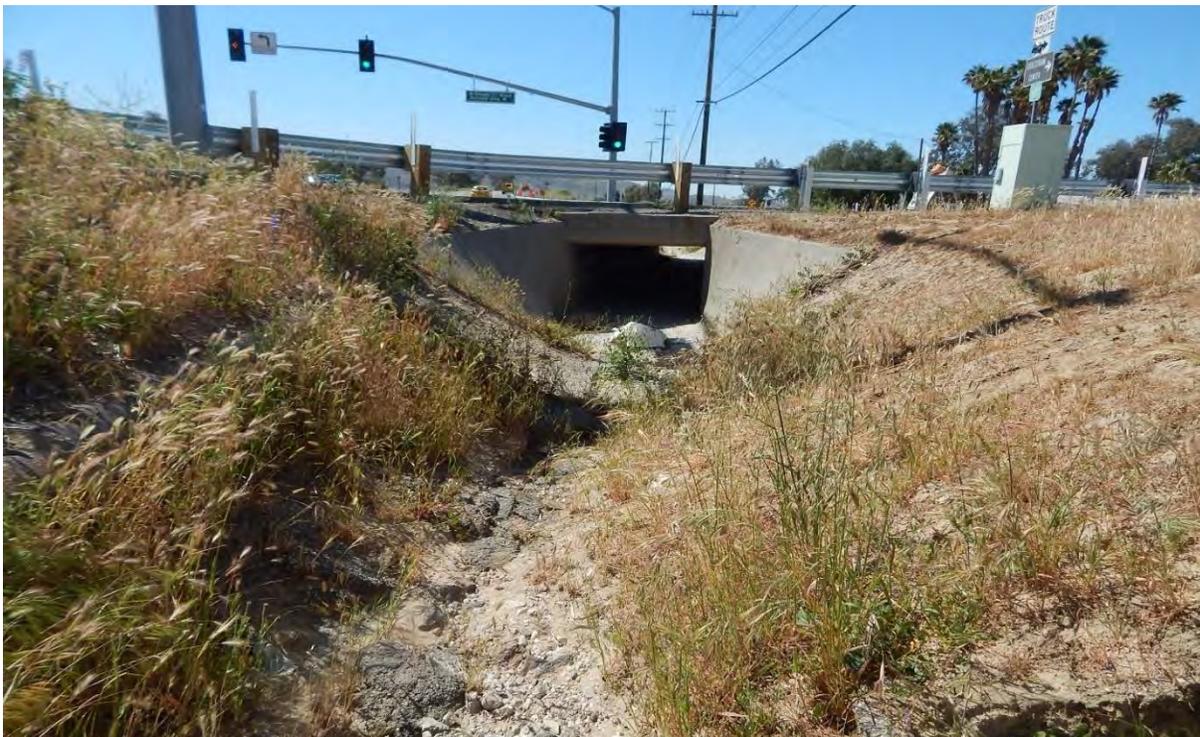
Photograph 4. View south and downstream of the roadside drainage channel showing the single box culvert under Spruce Avenue near the Redlands Boulevard and Spruce Avenue intersection.

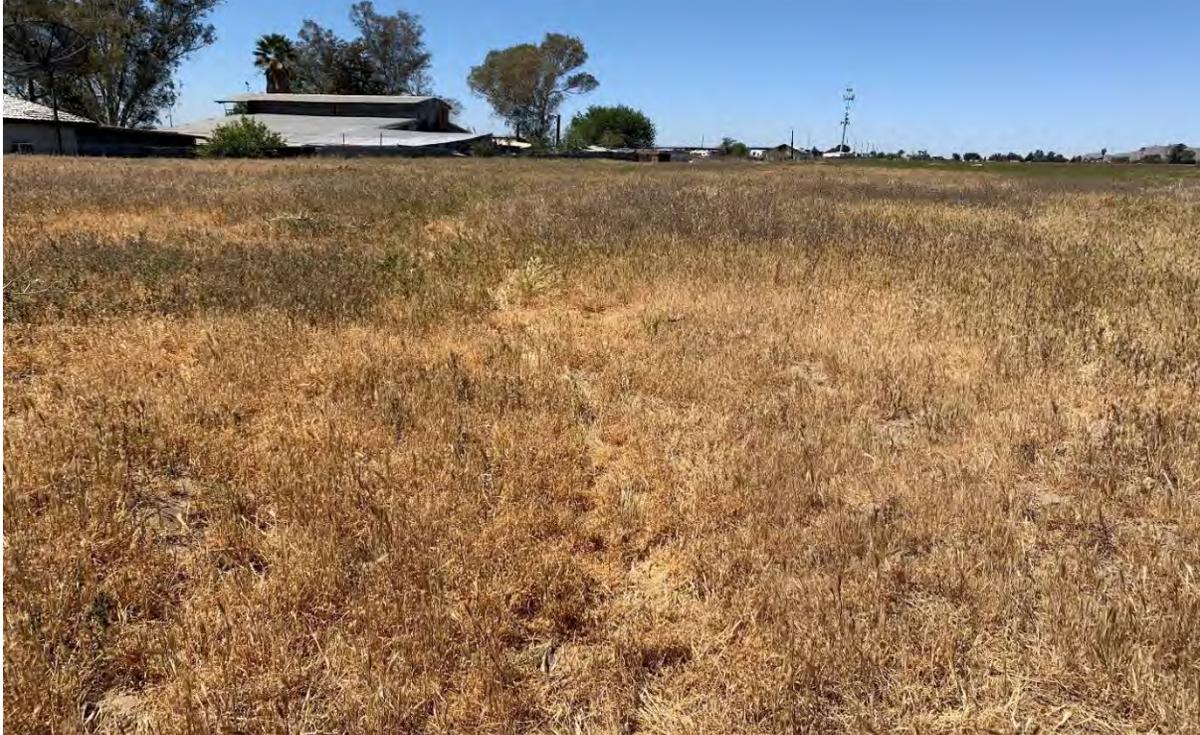
Photograph 5. Southwest-facing view showing lack of water flow evidence west of erosional drainage ditch and dense annual brome grassland.

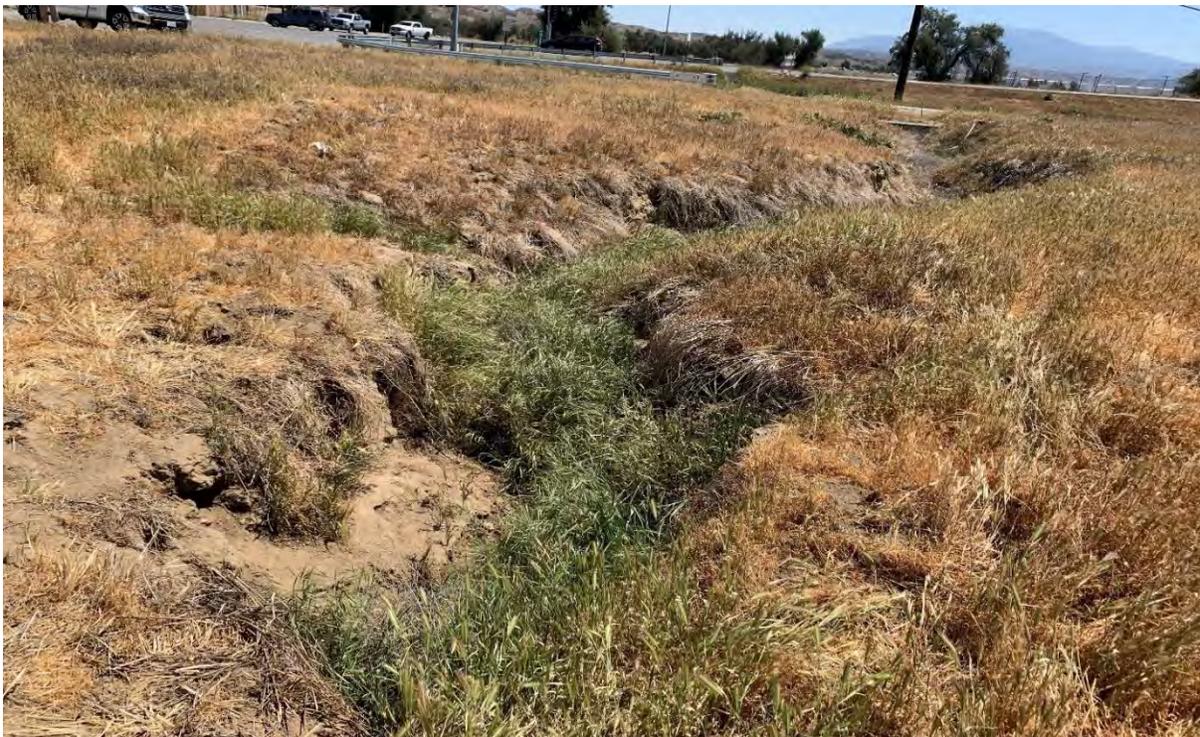
Photograph 6. East-facing view toward Spruce Avenue and Redlands Boulevard intersection showing weak water flow evidence and dense annual grasses in the erosional drainage ditch.

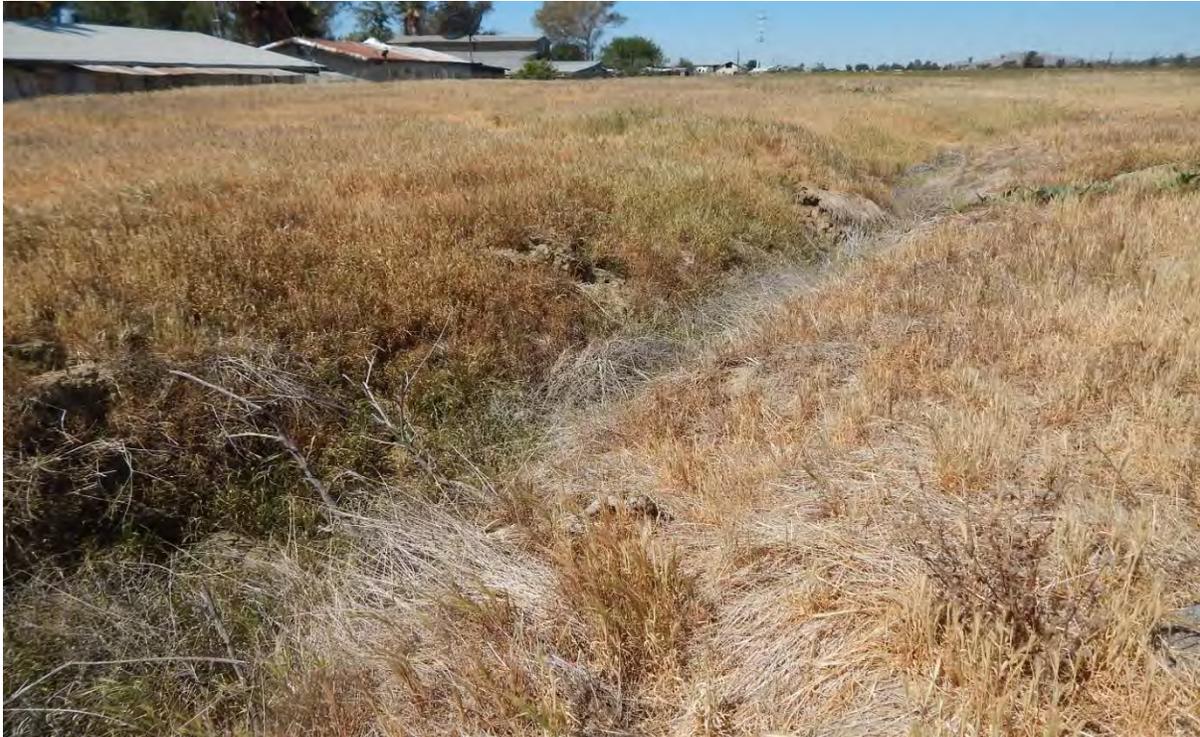
Photograph 7. Southwest-facing and upstream view of erosional drainage ditch in dense annual brome grassland.

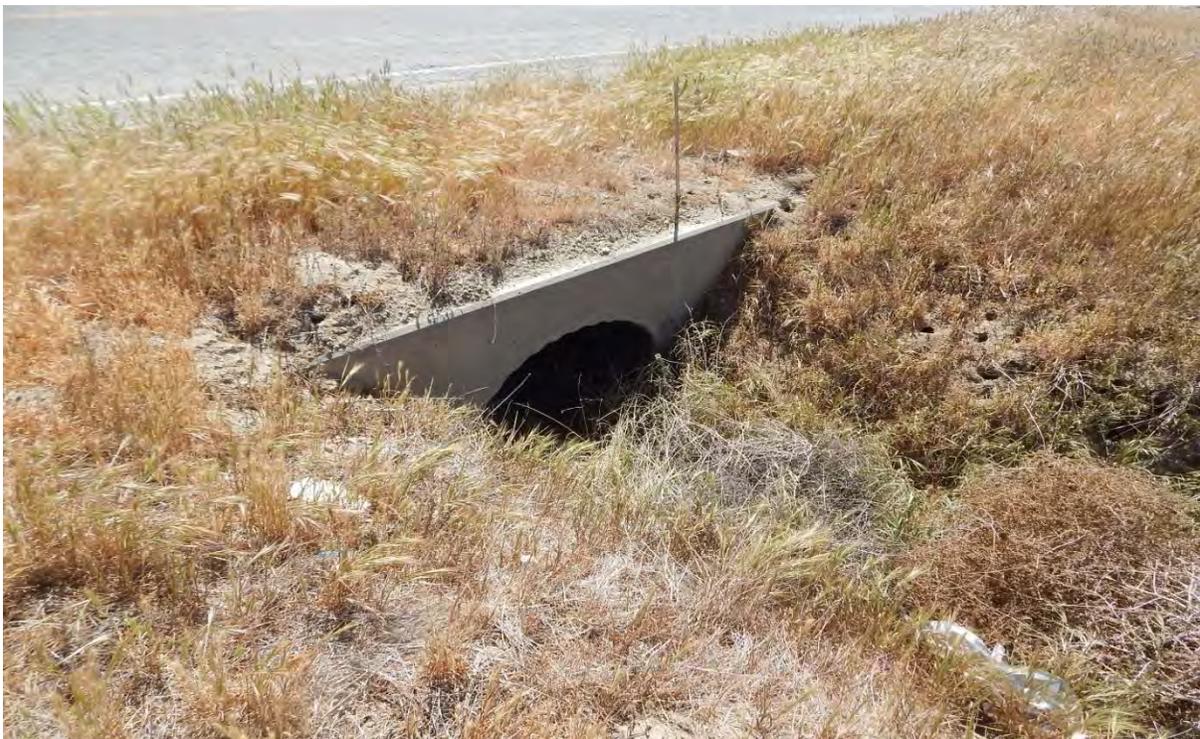
Photograph 8. Showing single storm drain intake under Spruce Avenue and Russian thistle in the channel bed at the downstream east end of the erosional drainage ditch.
