Hazardous Materials Reports

**Reference: Pre-Demolition Hazardous Materials Survey
325 – 391 Hampshire Road, Thousand Oaks, California 91361**

November 1, 2021
Pre-Demolition Hazardous Materials Survey
325 – 391 Hampshire Road, Thousand Oaks, California 91361

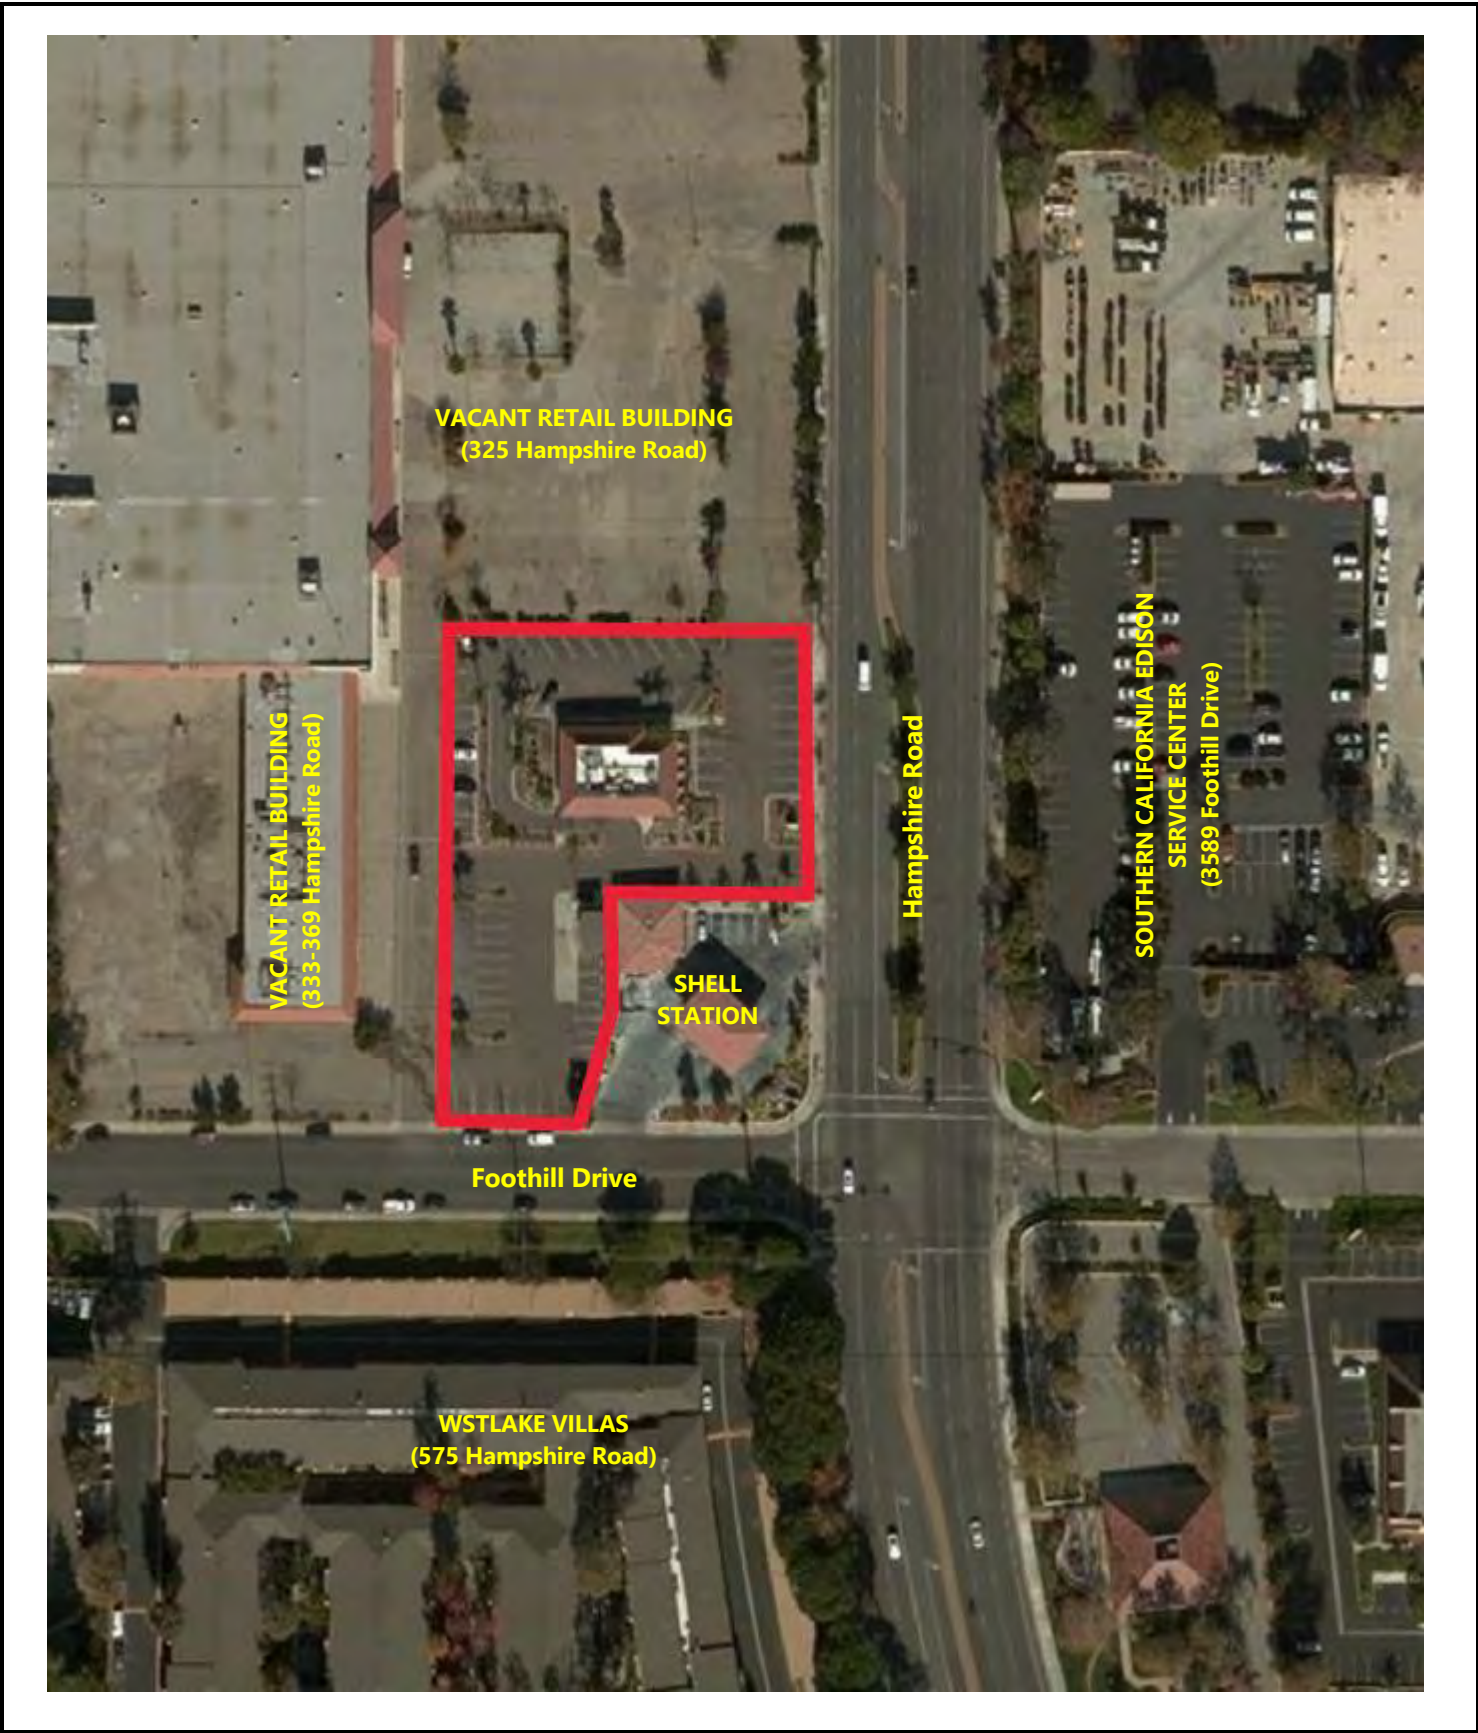
FIGURE 2: SITE PLAN
Project No. 19-252164.1

**GROUNDWATER
FLOW**
