December 18, 2020
Project No. 2329-CR

Subject: Additional Infiltration Evaluation
Proposed Single-Family Residential Development
Units 1 through 71, Tract No. 83138
Covina Area of Los Angeles County, California

GEOPHYSICAL INVESTIGATION

GeoTek, Inc.
PERCOLATION TESTING

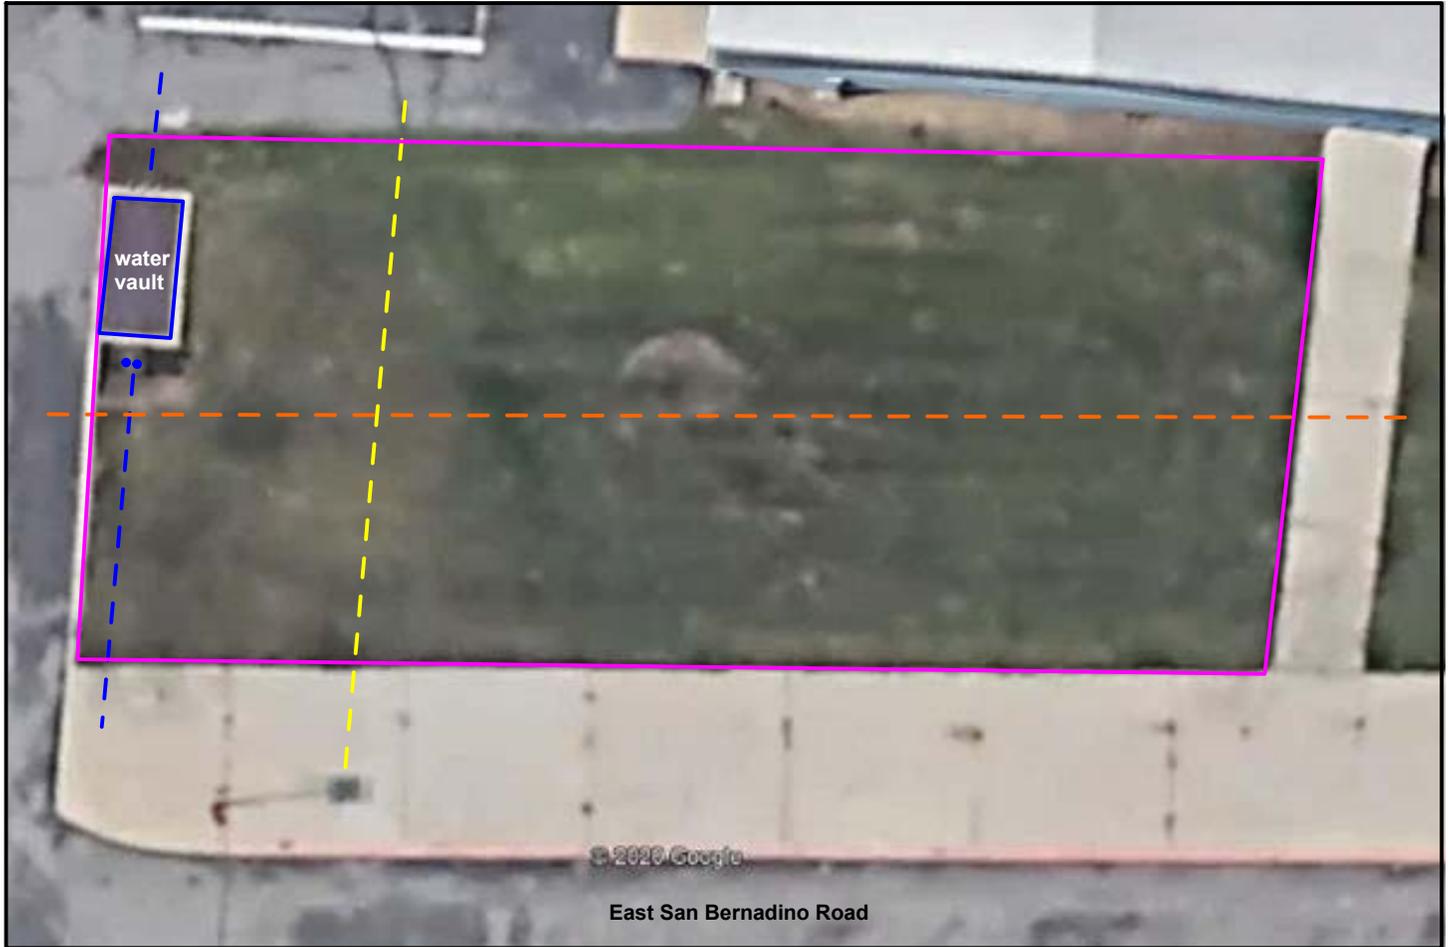
FIGURE 2

Utilities detected were marked out with feather chasers and in spray paint using blue for water, yellow for gas, and orange for unknown piping.

SITE: Adult Education Center 16209 East San Bernadino Road Covina, California	TITLE: Site Utility Map	SURVEY DATE: November 19, 2020
		PREPARED FOR: GeoTek, Inc.	SSS PROJECT NO.: 20-514
LEGEND: water line - - - - - gas line - - - - - unknown line - - - - - water riser • water vault □ survey boundary □

Interpretation and Conclusions - The interpretation took place in real time as the survey progressed, and accordingly, the findings of our investigation were telephonically relayed to the client, and further documented with a site map (Figure 2) and site photographs (Figures 3-7).
