December 18, 2020
Project No. 2329-CR

Subject: Additional Infiltration Evaluation
Proposed Single-Family Residential Development
Units 1 through 71, Tract No. 83138
Covina Area of Los Angeles County, California

MLC Holdings, Inc.
Tract No. 83138
Covina Area of Los Angeles County, California

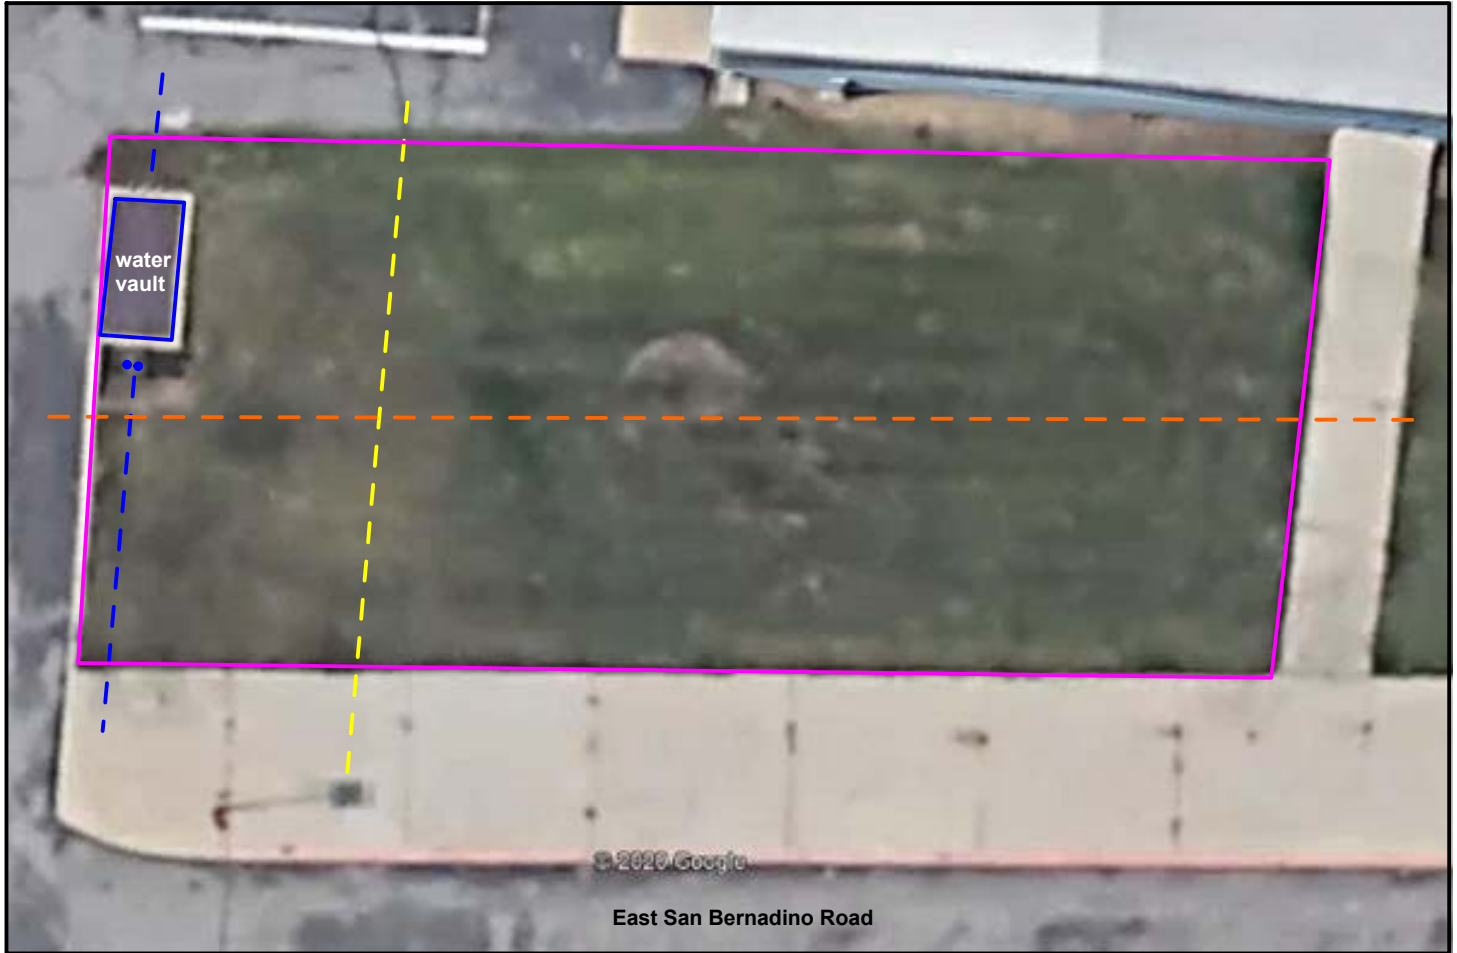
FIGURE 2

SITE: Adult Education Center 16209 East San Bernadino Road Covina, California	TITLE: Site Utility Map	SURVEY DATE: November 19, 2020
		PREPARED FOR: GeoTek, Inc.	SSS PROJECT NO.: 20-514
LEGEND: water line - - - - - gas line - - - - - unknown line - - - - -		water riser • water vault □ survey boundary □

Interpretation and Conclusions - The interpretation took place in real time as the survey progressed, and accordingly, the findings of our investigation were telephonically relayed to the client, and further documented with a site map (Figure 2) and site photographs (Figures 3-7).

Utilities detected were marked out with feather chasers and in spray paint using blue for water, yellow for gas, and orange for unknown piping.
