**Griswold School**  
**16209 E. San Bernardino Road**  
**Los Angeles County, California**

Historical Resource Evaluation Report

**Prepared by:**  
CONSULTING

March 2020

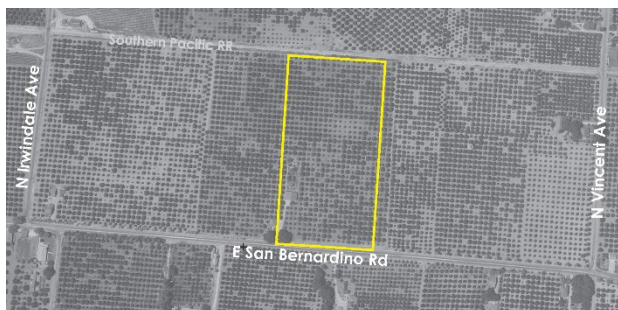
Figure 2: Historic aerial photograph showing project site outlined in yellow. 1934. Source: UCSB.

As depicted in historic aerials, the property and surrounding area were primarily cultivated with orchards in the 1920s and remained as such into the 1940s (see **Figure 2**). The adjacent cities began experiencing a housing boom in the late 1940s. Once residential development started, it boomed and quickly spread outside of established city boundaries. In the early 1950s, the hinterland was subdivided and developed with housing tracts (see **Figure 3**).

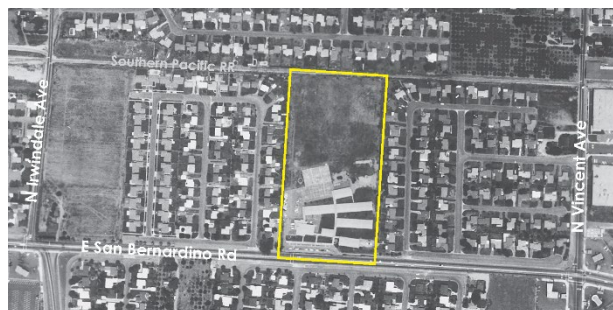
Figure 3: Historic aerial photograph showing project site outlined in yellow. 1960. Source: UCSB.

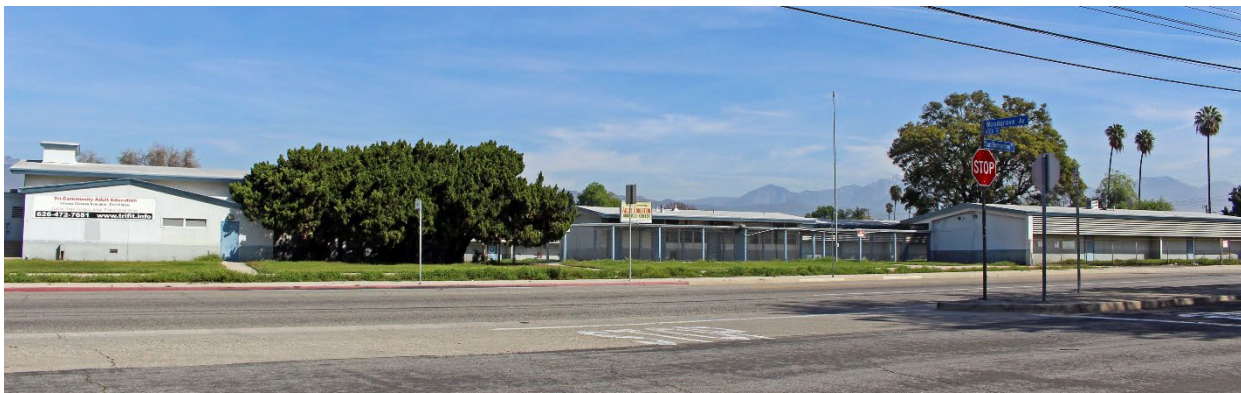
Figure 4: Griswold School campus, looking northeast from San Bernardino Road. March 2020. Source: GPA.

The property is located on the north side of E. San Bernardino Road on a rectangular parcel bound by the Southern Pacific Railroad tracks on the north and tract housing development to the east and west. The buildings on the school campus are all on the southern portion of the parcel such that the campus fronts E. San Bernardino Road. The campus is setback from the four-lane thoroughfare by a narrow front lawn and driveway. The long, east-west driveway has an entrance curb cut near the center of the south property line and exit curb cut at the southwest corner of the property. The asphalt driveway extends north, about half-way along the west property line before turning about 45-degrees to the west, wrapping the rear of the school campus with surface

parking. The northern half of the parcel is open field with chain-link fence batting cages at each corner the only remnants of baseball fields now overgrown. The parcel is partially enclosed on the east and west property lines by chain-link fence. A concrete wall is along the north property line.

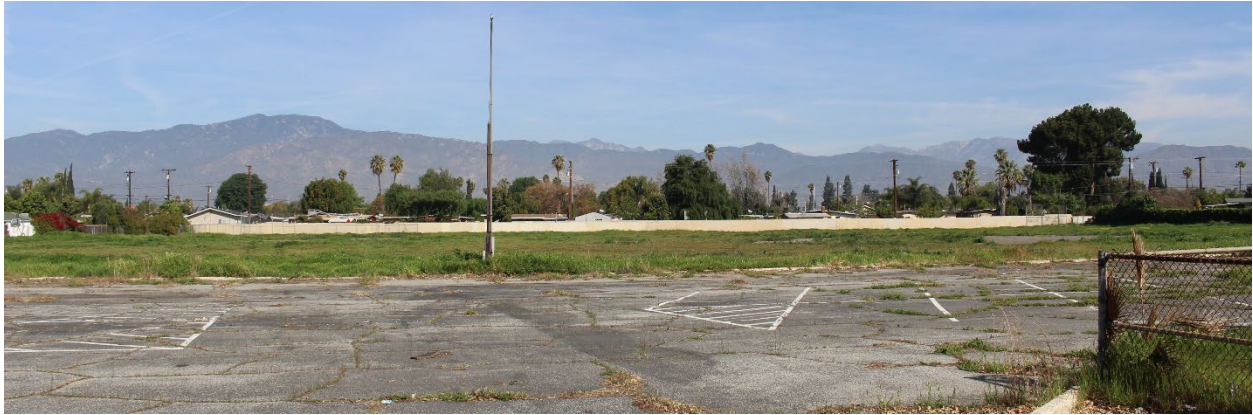
Figure 5: Griswold School campus, looking northeast from San Bernardino Road. March 2020. Source: GPA.

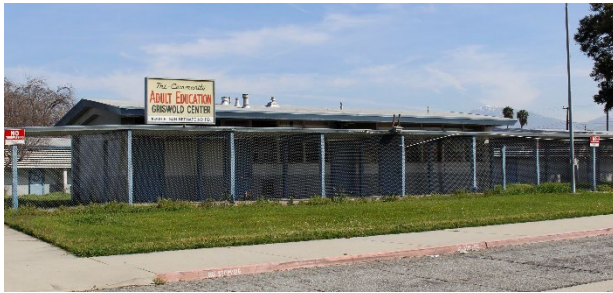
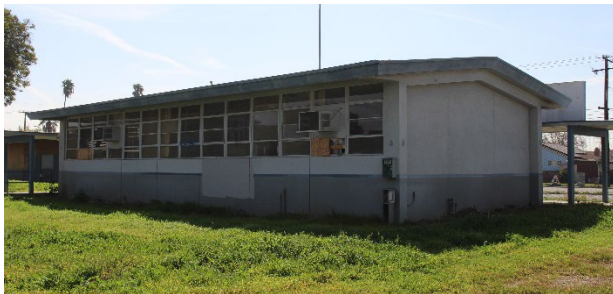
Figure 7: Building A. South elevation above and north and west elevation below. 2020. Source: GPA.

Building A is the main office building. It is located near the center of the campus, oriented to the south, facing E. San Bernardino Road. The building is one-story in height, with a low pitch gabled roof with shallow, boxed eaves. The roof appears to be clad in composition roofing and exterior walls are clad in stucco.

There are four entrances on the primary (south) elevation. Each door is hollow wood slab. Fenestration on the north and south elevations consists of rows of metal, multi-light window-walls. There is one opening on the east elevation where a partially glazed, single-light wood door is located off-center from the gable peak. There are no other openings on the side (east and west) elevations.

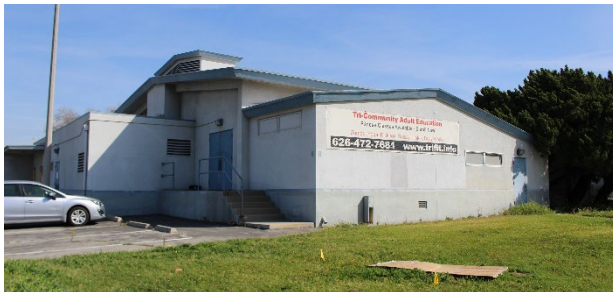
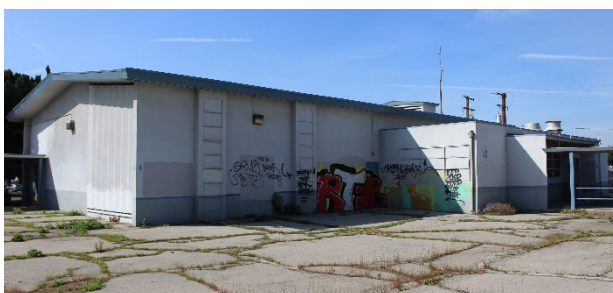
Figure 8: Building B. South and west elevation above and north and east elevation below. 2020. Source: GPA.

Building B houses the “cafetorium,” which is presumably the cafeteria and auditorium space. The building is located on the southwest corner of the campus, overlooking the east driveway. The building is one-and-a-half-stories in height, with multiple, low-pitch gabled roofs with shallow, boxed eaves. A cupola with a louvered metal vent is located on the west end of the roof. The roof appears to be clad in composition roofing and exterior walls are clad in stucco.

doors. A loading dock with metal double-doors is on the south end. Pairs of short windows and metal louvered vents are distributed across the elevation.

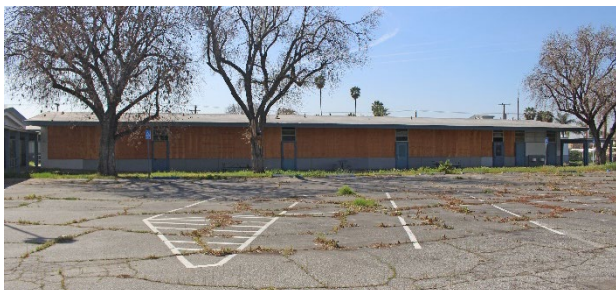
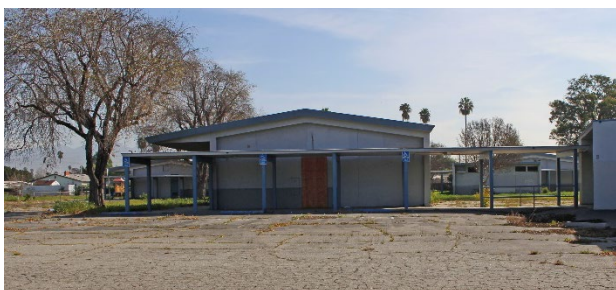
Figure 9: Building C. North elevation above and west elevation below. 2020. Source: GPA.

Building C is a classroom building. It is the northeastern most building on the campus. It is one-story in height with a low pitch gabled roof with shallow boxed eaves on the south, east, and west elevations, and a wide, overhanging eave with fascia board on the north elevation. The roof appears to be clad in composition roofing and exterior walls are clad in stucco. Sheltered beneath the overhanging eave on the north elevation are classroom entrances. There are four partially glazed doors and two hollow-slab doors are incorporated within a window-wall consisting of metal, multi-light windows.

There is an entrance centered on each of the side elevations.

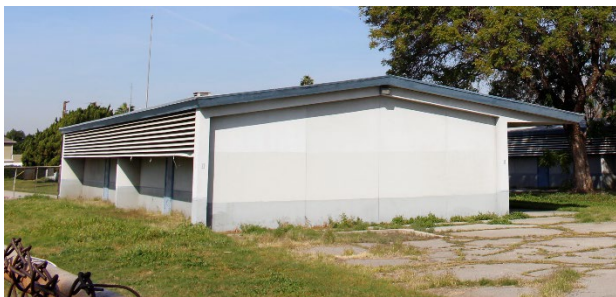
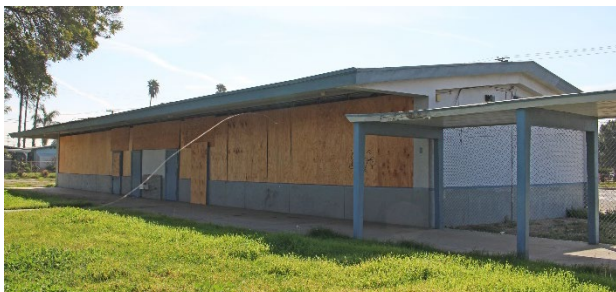
Figure 10: Building D. South and east elevation above and north and west elevation below. 2020. Source: GPA.

Building D is a classroom building. It is located at the southeast corner of the campus. The building is one-story in height with a low pitch gabled roof with shallow boxed eaves on the south, east, and west elevations, and a wide, overhanging eave with fascia board on the north elevation. The roof appears to be clad in composition roofing and exterior walls are clad in stucco. Sheltered beneath the overhanging eave on the north elevation are classroom entrances.

There are no openings on the side elevations.

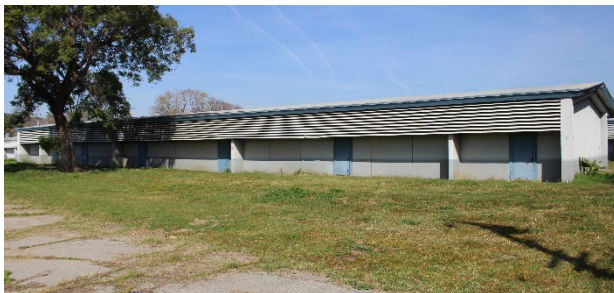
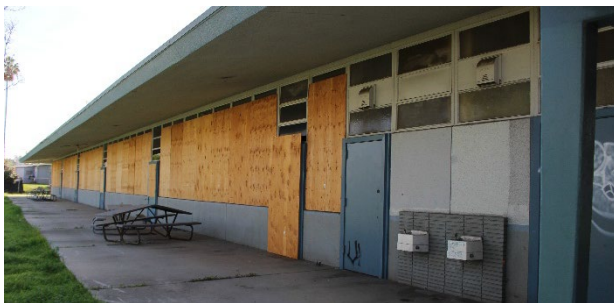
Figure 11: Building E. South and east elevation above and north elevation below. 2020. Source: GPA.

Building E is a classroom building. It is located on the east side of the campus, between Building D (south) and Building F (north). The building is one-story in height with a low pitch gabled roof with shallow boxed eaves on the south, east, and west elevations, and a wide, overhanging eave with fascia board on the north elevation. The roof appears to be clad in composition roofing and exterior walls are clad in stucco. Sheltered beneath the overhanging eave on the north elevation are classroom entrances.

roofline are partially concealed by a brise soleil that extends down from the perimeter of the roof consisting of louvered metal slats. There are no openings on the side elevations.

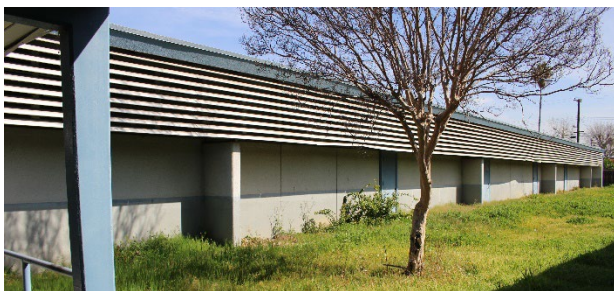
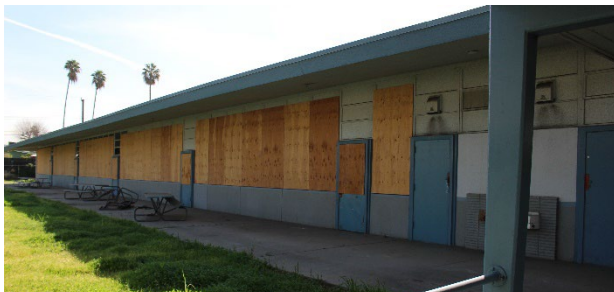
Figure 12: Building F. South elevation above and north elevation below. 2020. Source: GPA.

Building F is a classroom building. It is located on the east side of the campus, between Building E (south) and building G (north). The building is one-story in height with a low pitch gabled roof with shallow boxed eaves on the south, east, and west elevations, and a wide, overhanging eave with fascia board on the north elevation. The roof appears to be clad in composition roofing and exterior walls are clad in stucco. Sheltered beneath the overhanging eave on the north elevation are classroom entrances.

roofline windows are partially concealed by a brise soleil that extends down from the perimeter of the roof consisting of louvered metal slats. There are no openings on the side elevations.

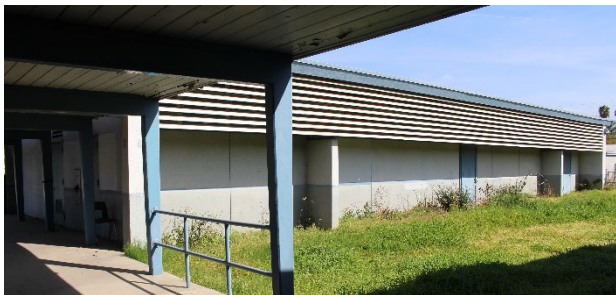
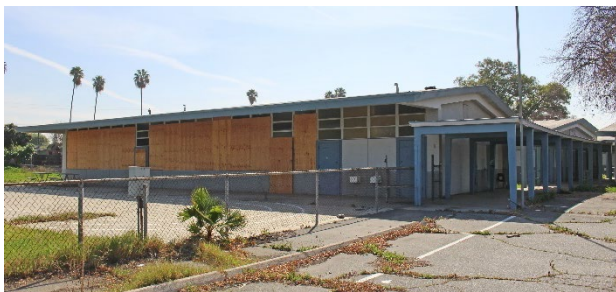
Figure 13: Building G. South elevation above and north and west elevation below. 2020. Source: GPA.

Building G is a classroom building. It is located north of the other buildings, overlooking a concrete slab with painted track adjacent to a playset. The building is one-story in height with a low pitch gabled roof with shallow boxed eaves on the gable ends and wide, overhanging eaves with fascia board on the gable sides. The roof appears to be clad in composition roofing and exterior walls are clad in stucco. Sheltered beneath the eaves on the north and south elevation are classroom entrances. There are four slab doors on the north elevation incorporated within a window-wall consisting of metal, multi-light windows.

On the south elevation, the classrooms are separated by projecting partition walls. Rows of short windows beneath the roofline are partially concealed by a brise soleil that extends down from the perimeter of the roof consisting of louvered metal slats.

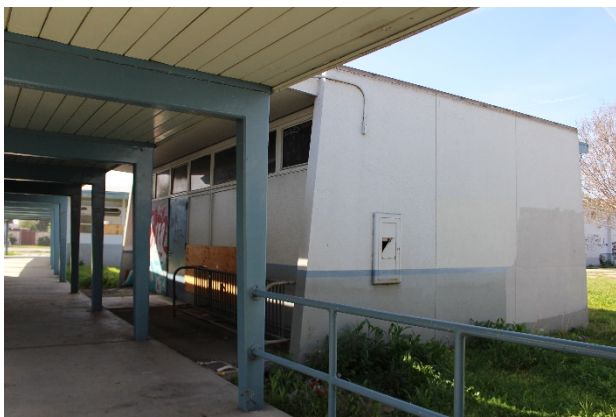
Figure 14: Library Building. East and north elevation. 2020. Source: GPA.

The Library building at the center of the cluster of buildings on the campus is trapezoidal in massing. It is oriented toward the east. It has a flat roof with flush eaves on the north and south. Overhanging eaves shelter a row of clerestory windows on the east and west. There is a single entrance on the east elevation consisting of a hollow metal slab door beneath a row of metal, multi-light transom windows that extend the length of the elevation. There are no openings on the side elevations.

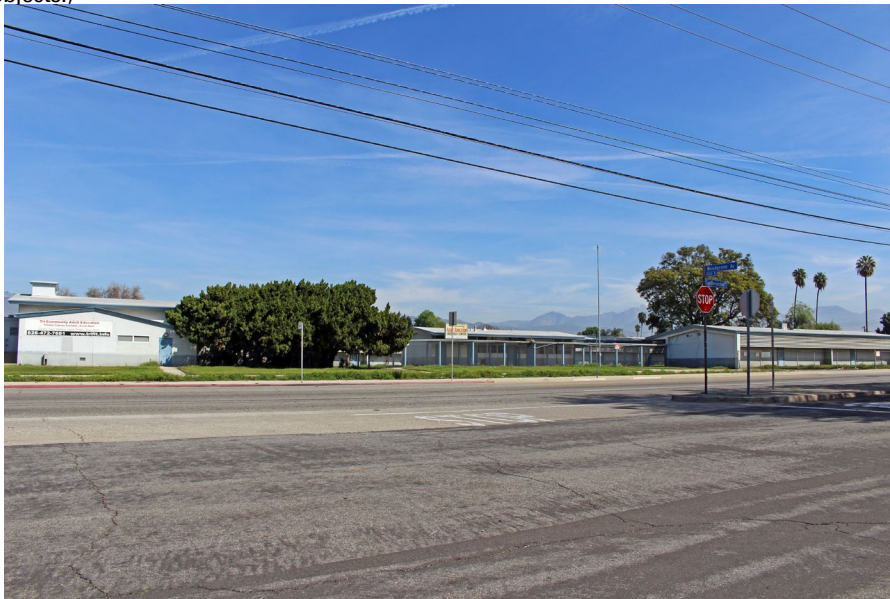
P5a. Photograph or Drawing (Photograph required for buildings, structures, and objects.)

P5b. Description of Photo: (view, date, accession #) View looking northeast, 02/05/2020

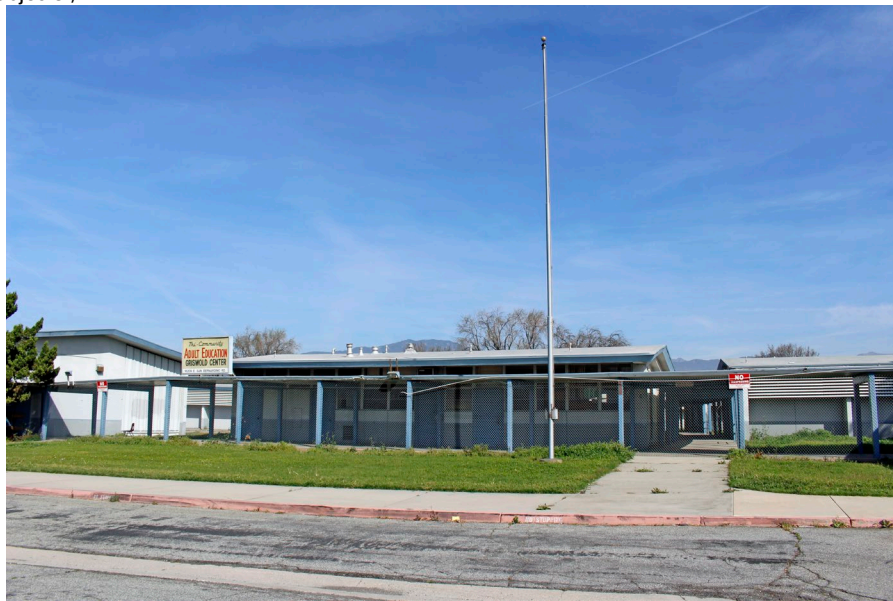
P5a. Photograph or Drawing (Photograph required for buildings, structures, and objects.)

P5b. Description of Photo: (view, date, accession #) View looking north, 02/05/2020

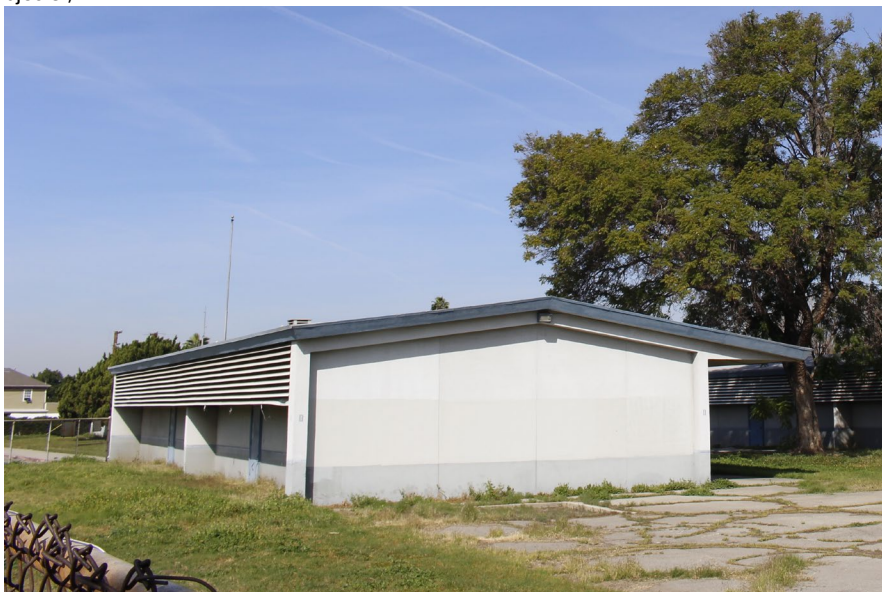
P5a. Photograph or Drawing (Photograph required for buildings, structures, and objects.)

P5b. Description of Photo: (view, date, accession #) View looking northwest, 02/05/2020

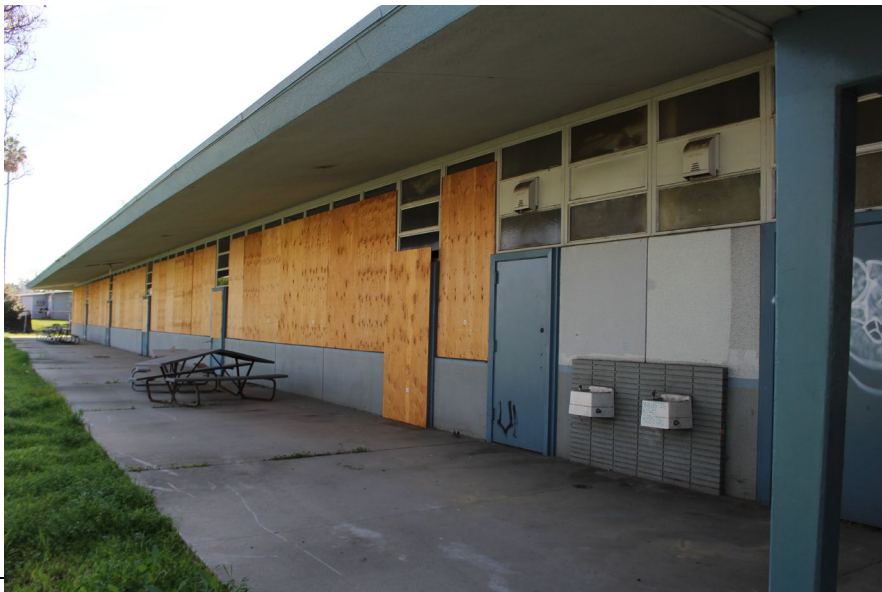
P5a. Photograph or Drawing (Photograph required for buildings, structures, and objects.)

P5b. Description of Photo: (view, date, accession #) View looking southeast, 02/05/2020

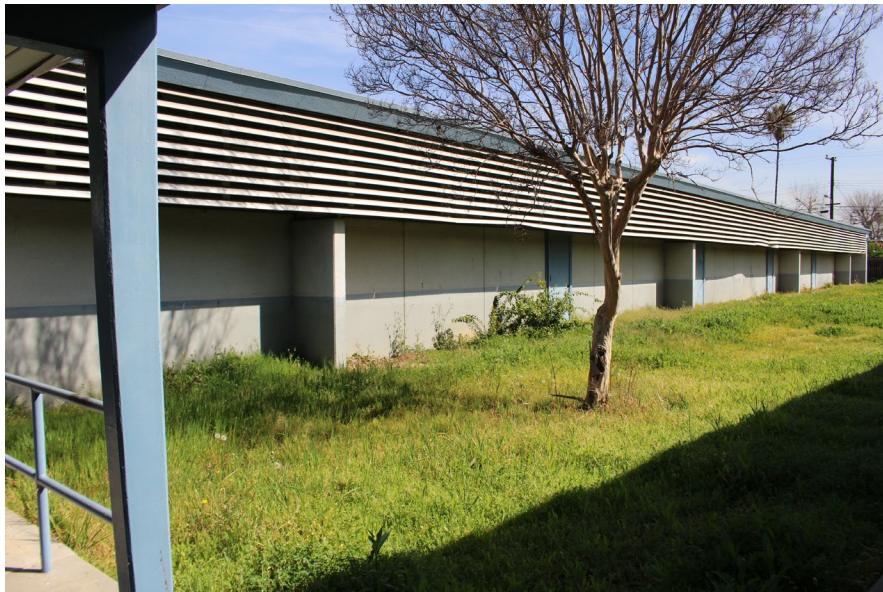
P5a. Photograph or Drawing (Photograph required for buildings, structures, and objects.)

P5b. Description of Photo: (view, date, accession #) View looking northeast, 02/05/2020

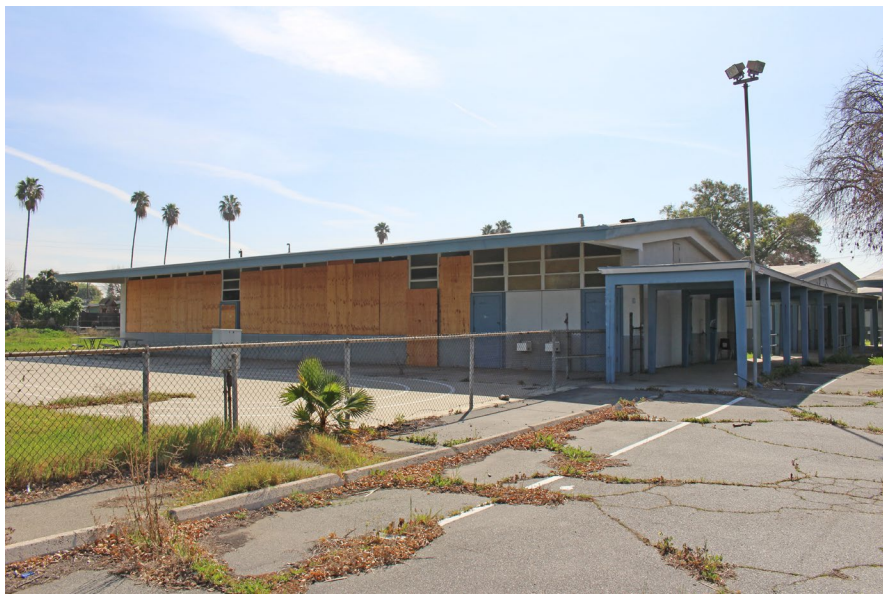
P5a. Photograph or Drawing (Photograph required for buildings, structures, and objects.)

P5b. Description of Photo: (view, date, accession #) View looking southeast, 02/05/2020

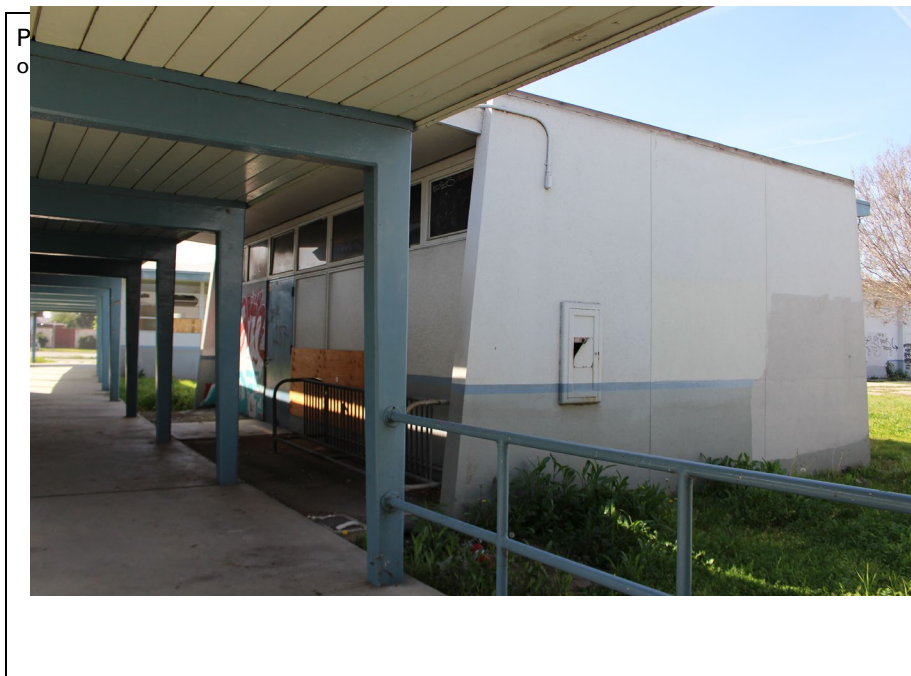
P5b. Description of Photo: (view, date, accession #) View looking southwest, 02/05/2020
