HISTORICAL/ARCHAEOLOGICAL RESOURCES SURVEY REPORT

BLEDSON CREEK SLOPE AND STORM DRAIN REPAIR PROJECT

**Line A Storm Drain Improvements on APN 0288-251-83
City of Highland, San Bernardino County, California**

June 3, 2020
CRM TECH Contract No. 3601A

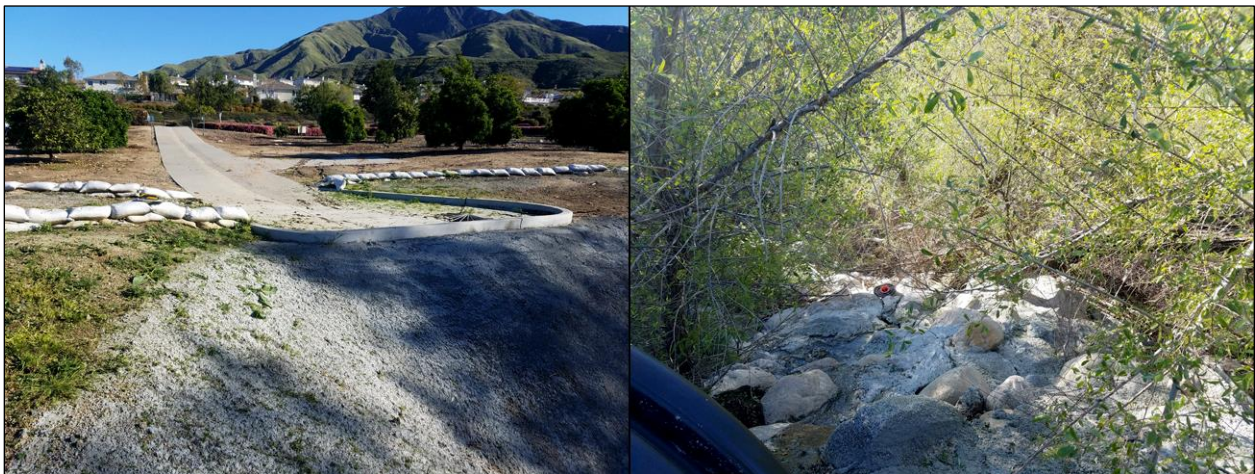
Figure 4. Current natural setting of the project area. *Left*: northern portion, view to the north; *right*: southern portion, view to the south. (Photographs taken on April 15, 2020)

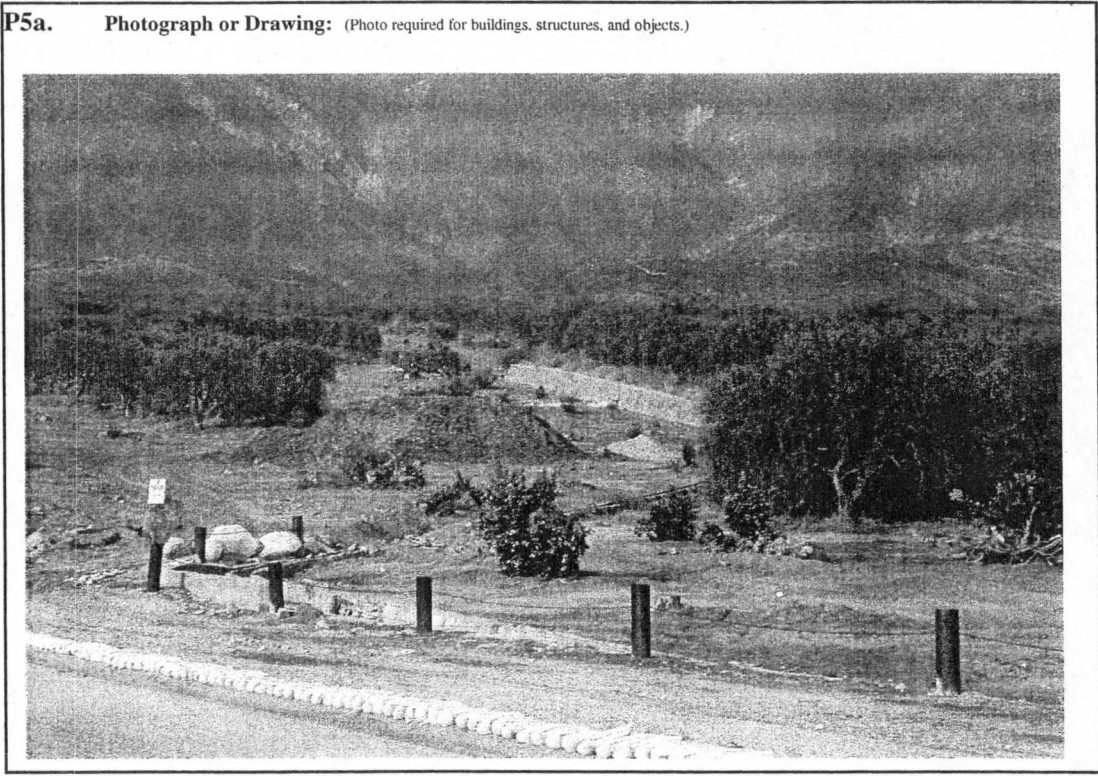
P5b. Description of Photo: (View, data, accession #) Overview of East Highlands Ranch orange grove from Church Street (1199.jpg) View to the north.

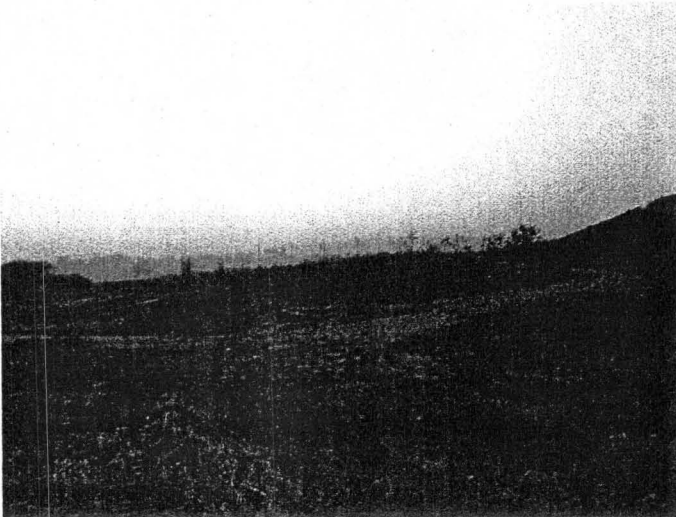
P5. Photograph or Drawing:

P5b. Description of Photo: Overview of Feature 77 reservoir (1195.jpg).
View to the west.

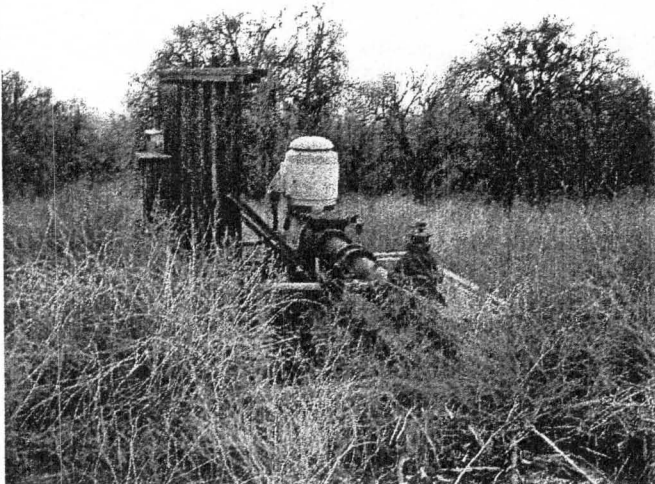
P5b. Description of Photo: Overview of Feature 78 water pump (1210.jpg).
View to the south.

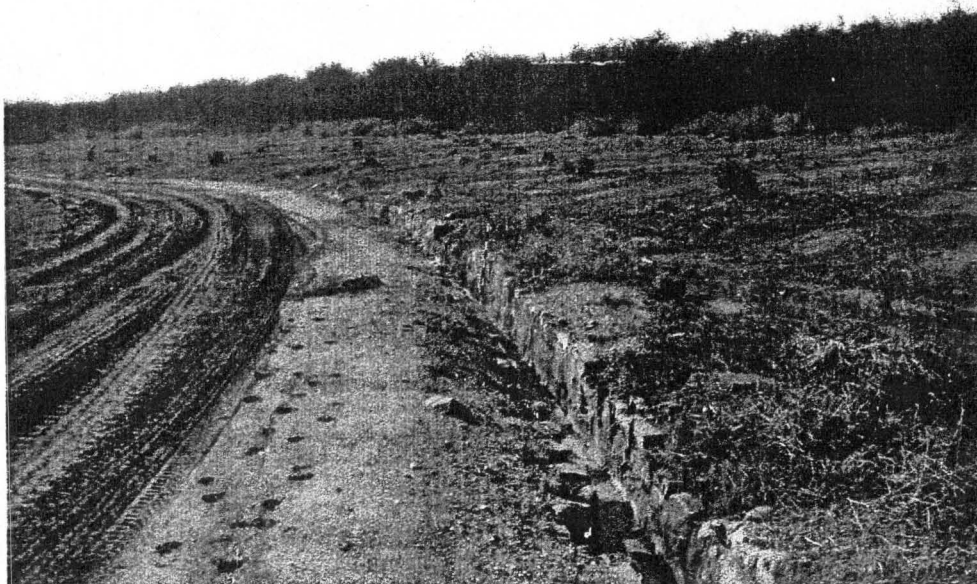
L8a. **Photograph, Map or Drawing**

L8b. **Description of Photo, Map, or Drawing** (view, scale, etc.)
 Overview of Feature 2 middle segment (1185.jpg). View to the south.

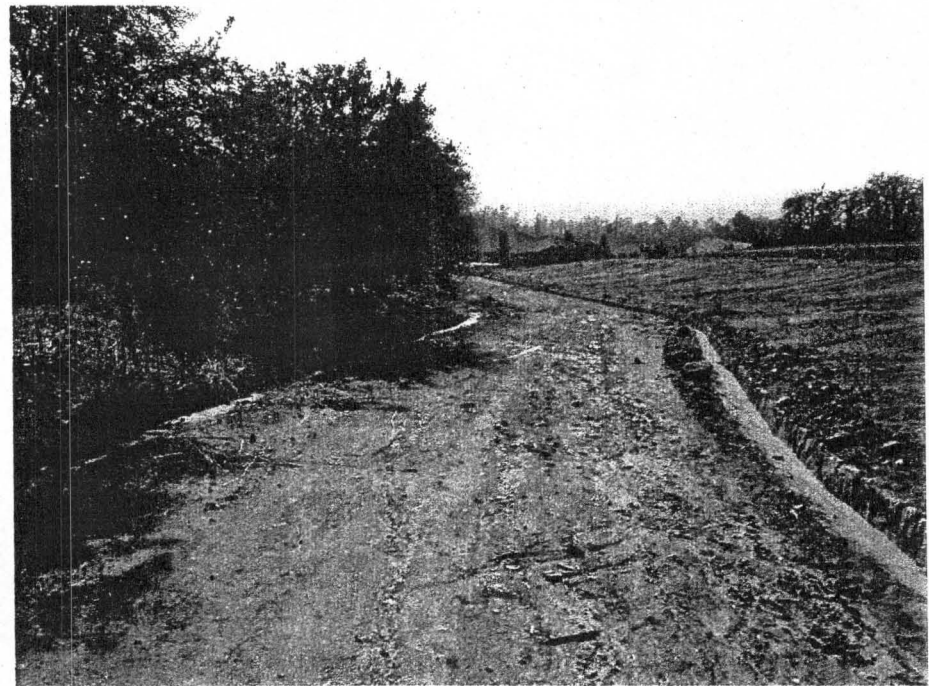
L8a. Photograph, Map or Drawing

Closeup of the middle segment of Feature 4 (1117.jpg). View to the southwest.

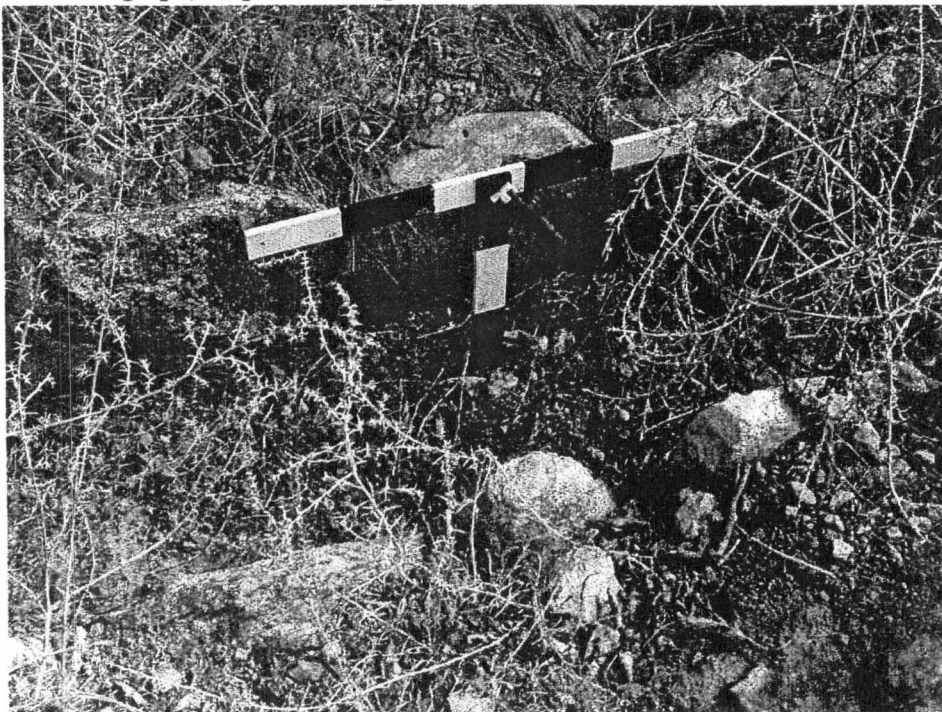
L8a. **Photograph, Map or Drawing**

L8b. **Description of Photo, Map, or Drawing**
Closeup of Feature 6 (1169.jpg). View to the east.

L9. **Remarks:**
 The scale is in 10 cm units.

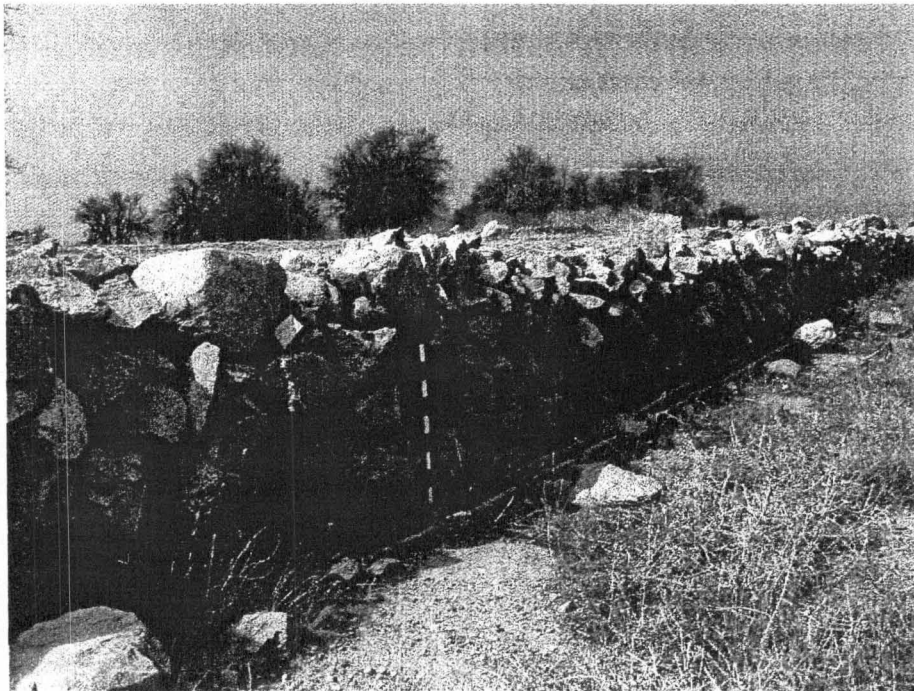
L8a. Photograph, Map or Drawing

L8b. Description of Photo, Map, or Drawing
Overview of Feature 8 (1168.jpg). View to the west.

L9. Remarks:
 The scale is in 10 cm units.

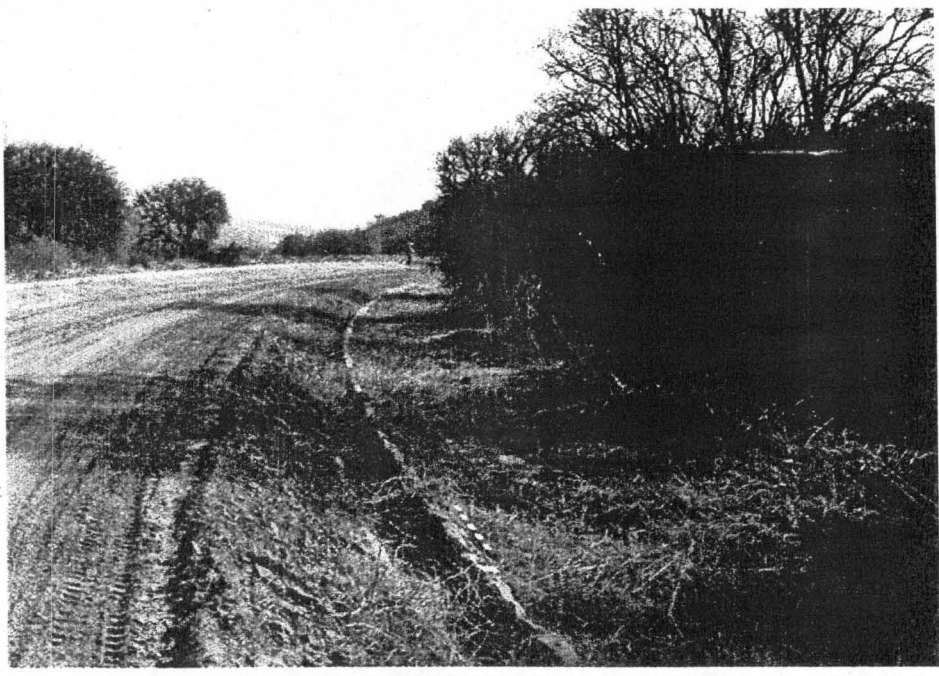
L8a. Photograph, Map or Drawing

L8b. Description of Photo, Map, or Drawing
 Overview of Feature 10 (1182.jpg). View to the east.

L9. Remarks:
 The scale is in 10 cm units.

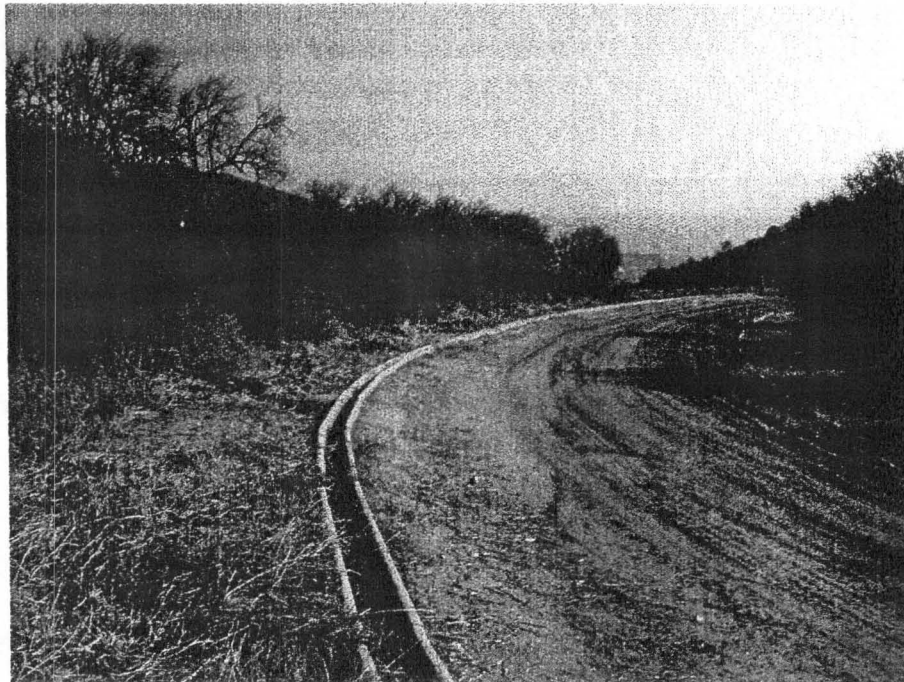
L8a. **Photograph, Map or Drawing**

L8b. **Description of Photo, Map, or Drawing**
Overview of Feature 12 (1181.jpg) View to the east.

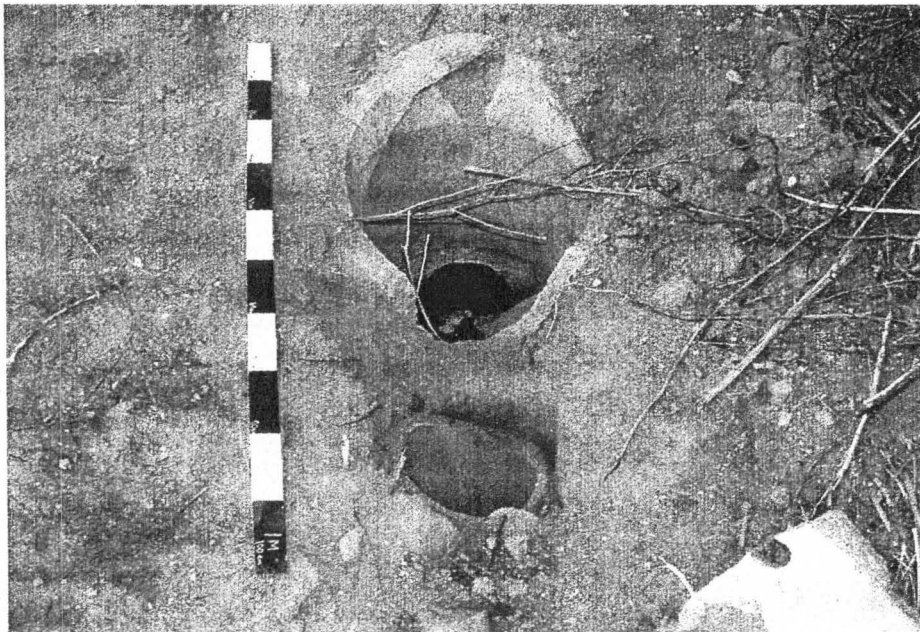
L8a. Photograph, Map or Drawing

L8b. Description of Photo, Map, or Drawing (view, scale, etc.)
Overview of Feature 13 to the south (1214.jpg)

L9. Remarks:
 The scale is in 10 cm units.

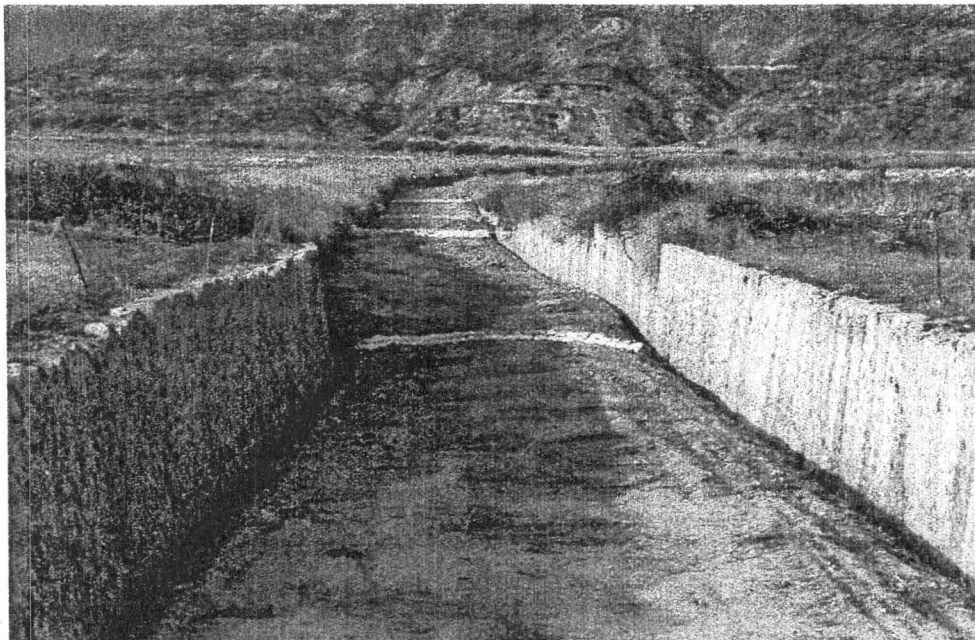
L8a. **Photograph, Map or Drawing**

L8b. **Description of Photo, Map, or Drawing**
Overview of Features 15 and 16 (Feature 16 is on the right). View to the North (1200.jpg)
