Gilpin Geosciences, Inc
Earthquake & Engineering Geology

September 22, 2020
91682.01

**Subject: Engineering Geological and Geotechnical Evaluation
 Project Pioneer
 APN 024-080-040, -044, -048, & -049
 1 Angwin Avenue
 Angwin, California**

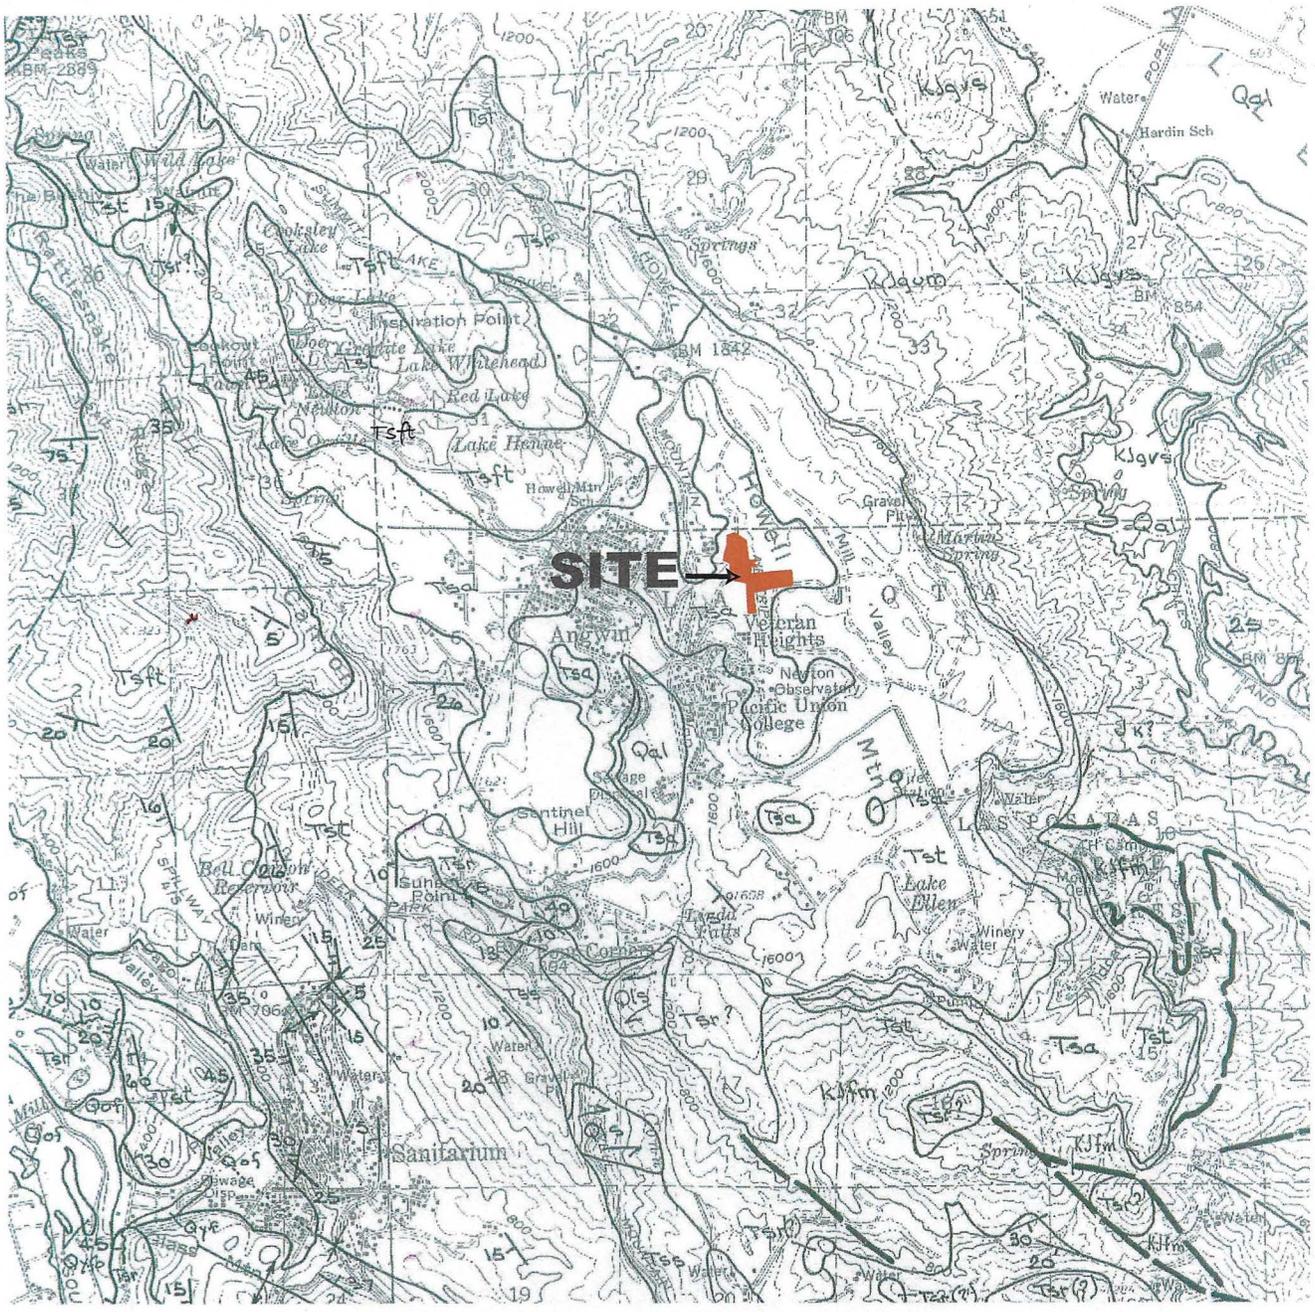
FIGURE
2

The site is located in the Coast Ranges geomorphic province, which is characterized by northwest-southeast trending valleys and ridges (Figure 2). These are controlled by folds and faults that resulted from the collision of the Farallon and North American plates and subsequent shearing along the San Andreas fault. The bedrock in the site vicinity is mapped as Sonoma Volcanics andesitic lava flow (Fox and others, 1973). This unit is characterized by andesite flows with associated assortment of volcanic deposits including tuff, breccias, and bedded tuff deposits.

Road. Block 3 lies on a gently west-sloping pasture adjacent, and south, of a treated wastewater reservoir. Andesitic volcanic lava is mapped capping this upland plateau. The gentle relief of the surface is probably the result of differential weathering of the associated ash flow and tuff units. (Figure 2). We noted few field stones (boulders) in areas not presently used for pasture.

REGIONAL GEOLOGY MAP
