RE: Arrow & Branch Winery (P21-00087)

This is in response to Napa County Planning, Building & Environmental Services' Application status letter dated May 19, 2021 for the Arrow & Branch Winery (Formerly Ideology) listed as P21-00087. The County was requesting clarification to: "Confirm that the proposed physical improvements will not impact nearby riparian woodland or sensitive biotic vegetation."

Arrow & Branch Winery General Information

Proposed Project: Building a Winery including structure, parking area, driveway, and landscaping within an existing vineyard.

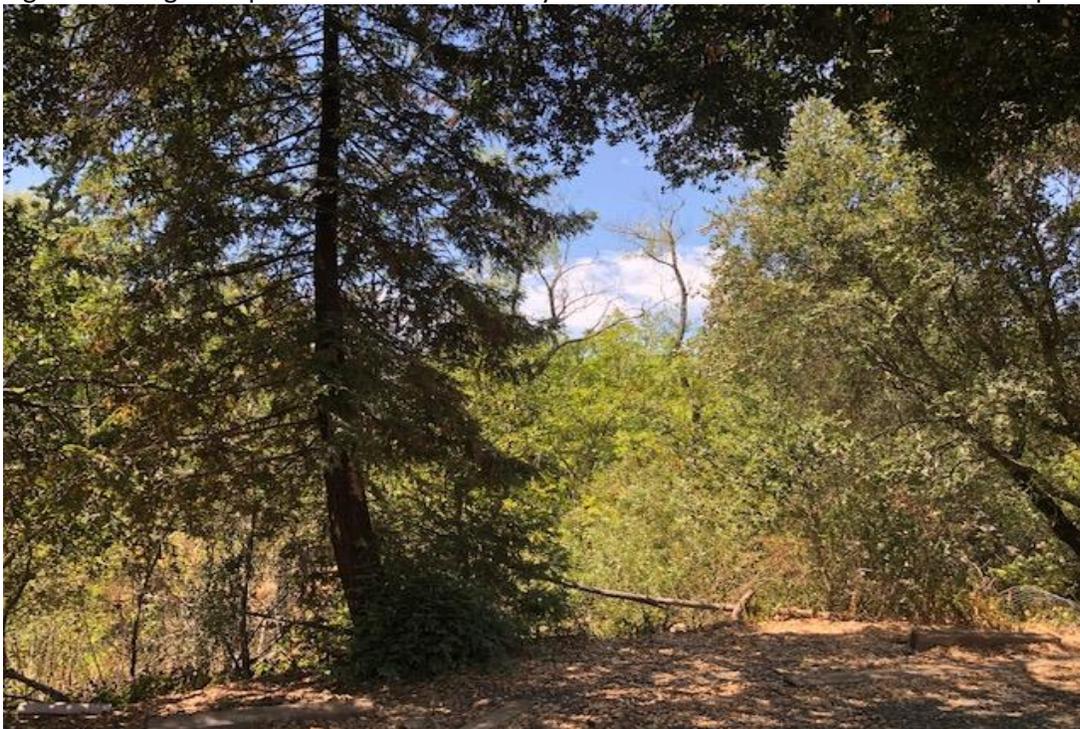
There is a lack of aquatic vegetation such as bulrush, alisma, or duckweed because of perpetually dry summers prohibiting the establishment and long-term survival of these species. Within the riparian area, the predominant tree species is dusky willow (*Salix melanopsis*) and Oregon ash (*Fraxinus latifolius*). Herbaceous species include torrent sedge (*Carex nudatum*), Smilo grass (*Stipa milliacea*), mugwort (*Artemisia douglasiana*) and tall flatsedge (*Cyperus eragrostis*). Within the transitional zone and upland area, common shrubs and herbaceous species include upright snowberry (*Symphoricarpos albus*) and wild grape (*Vitis californica*). Oaks, specifically coastal live oak (*Quercus agrifolia*) and valley oak (*Quercus lobata*) are found generally at the edge of the upland area and above the transitional zone which extends down into the main creek zone.

Figure #1: Edge of Upland Area – Immediately above the transitional zone down into riparian area.

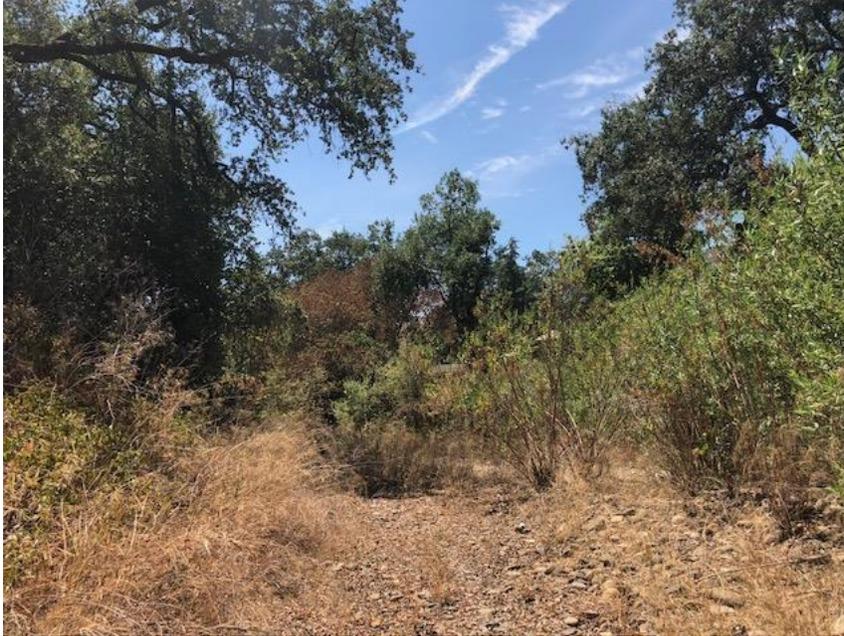
Figure #2: The main channel of Dry Creek (July 2021). Dusky willow can be seen in the immediate area of the channel. Larger, mature oaks are located at the top of the bank and adjacent to the vineyards.

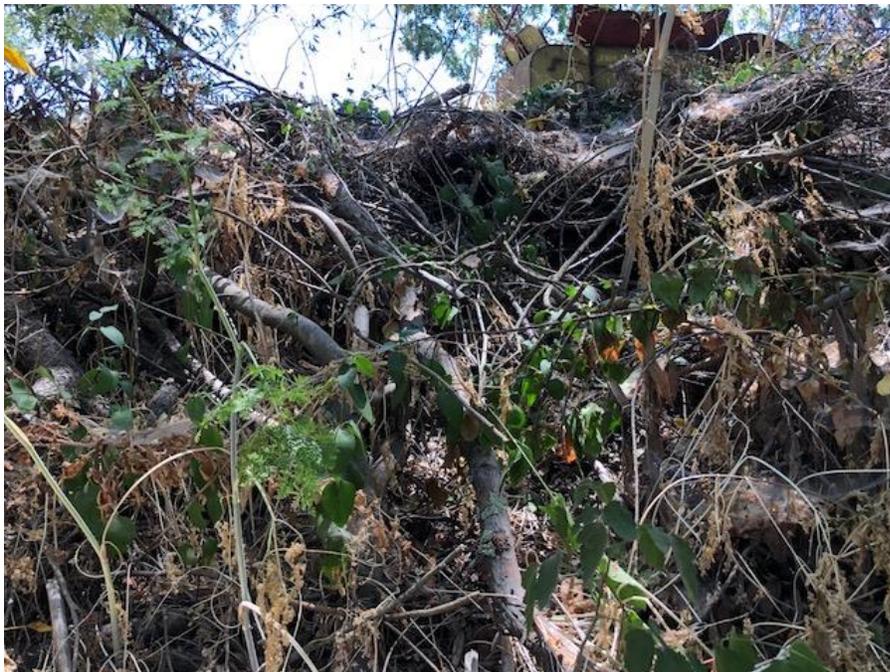
Evidence of dumping vegetation trimmings from vineyard maintenance can be found in various areas below the main bank.

Figure #3: Vegetative material thrown over the edge of the bank.

- Leftover material from vineyard/property maintenance has been thrown over the edge of the bank. This material can be a fire hazard and hinder growth of native vegetation. Non-organic material can also contribute to degradation of the watercourse.

- Existing non-organic material should be manually removed and disposed of property.
 - Existing organic material can be left and allowed to decomposed.

- Future organic vineyard material can be mulched, removed from the property, or piled outside the native vegetation zone.
 - Storage drums/containers should be stored within a way so potential spills can be property cleaned up, and located well away from the native vegetation zone.
