LIMITED PHASE II SUBSURFACE INVESTIGATION

13892 Old 215 Frontage Road
Moreno Valley, California 92553

AEI Project No. 425871

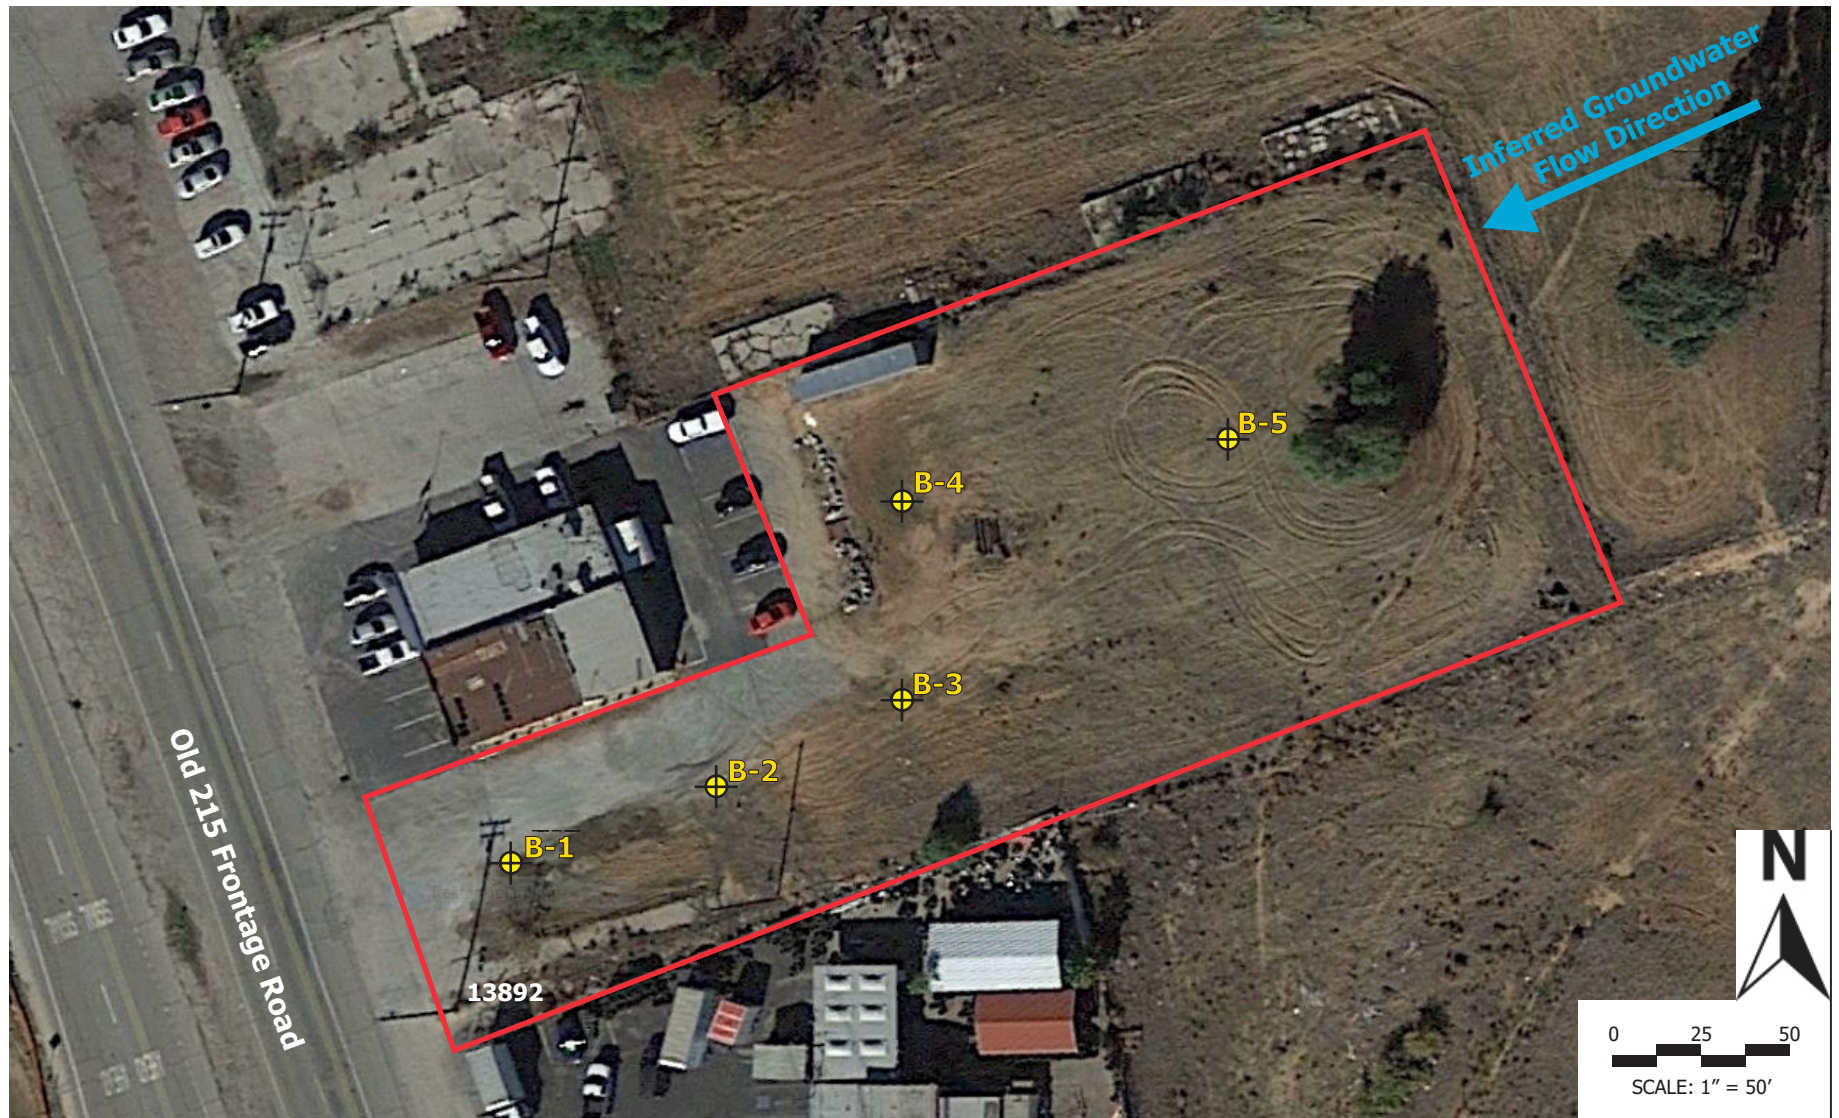
FIGURE 2
 Proposal No. 425871

- Approximate Site Boundary
- ⊕ B-5 Approximate Boring Location

AEI Consultants
 2207 West 190th Street, Torrance, California 90504
SITE MAP SHOWING APPROXIMATE BORING LOCATIONS

The boring locations were chosen in part based on a review of historic aerial photographs included in the Draft Phase I ESA report showing the previous Site usage, and the results of the utility clearance. These locations are shown on Figure 2.

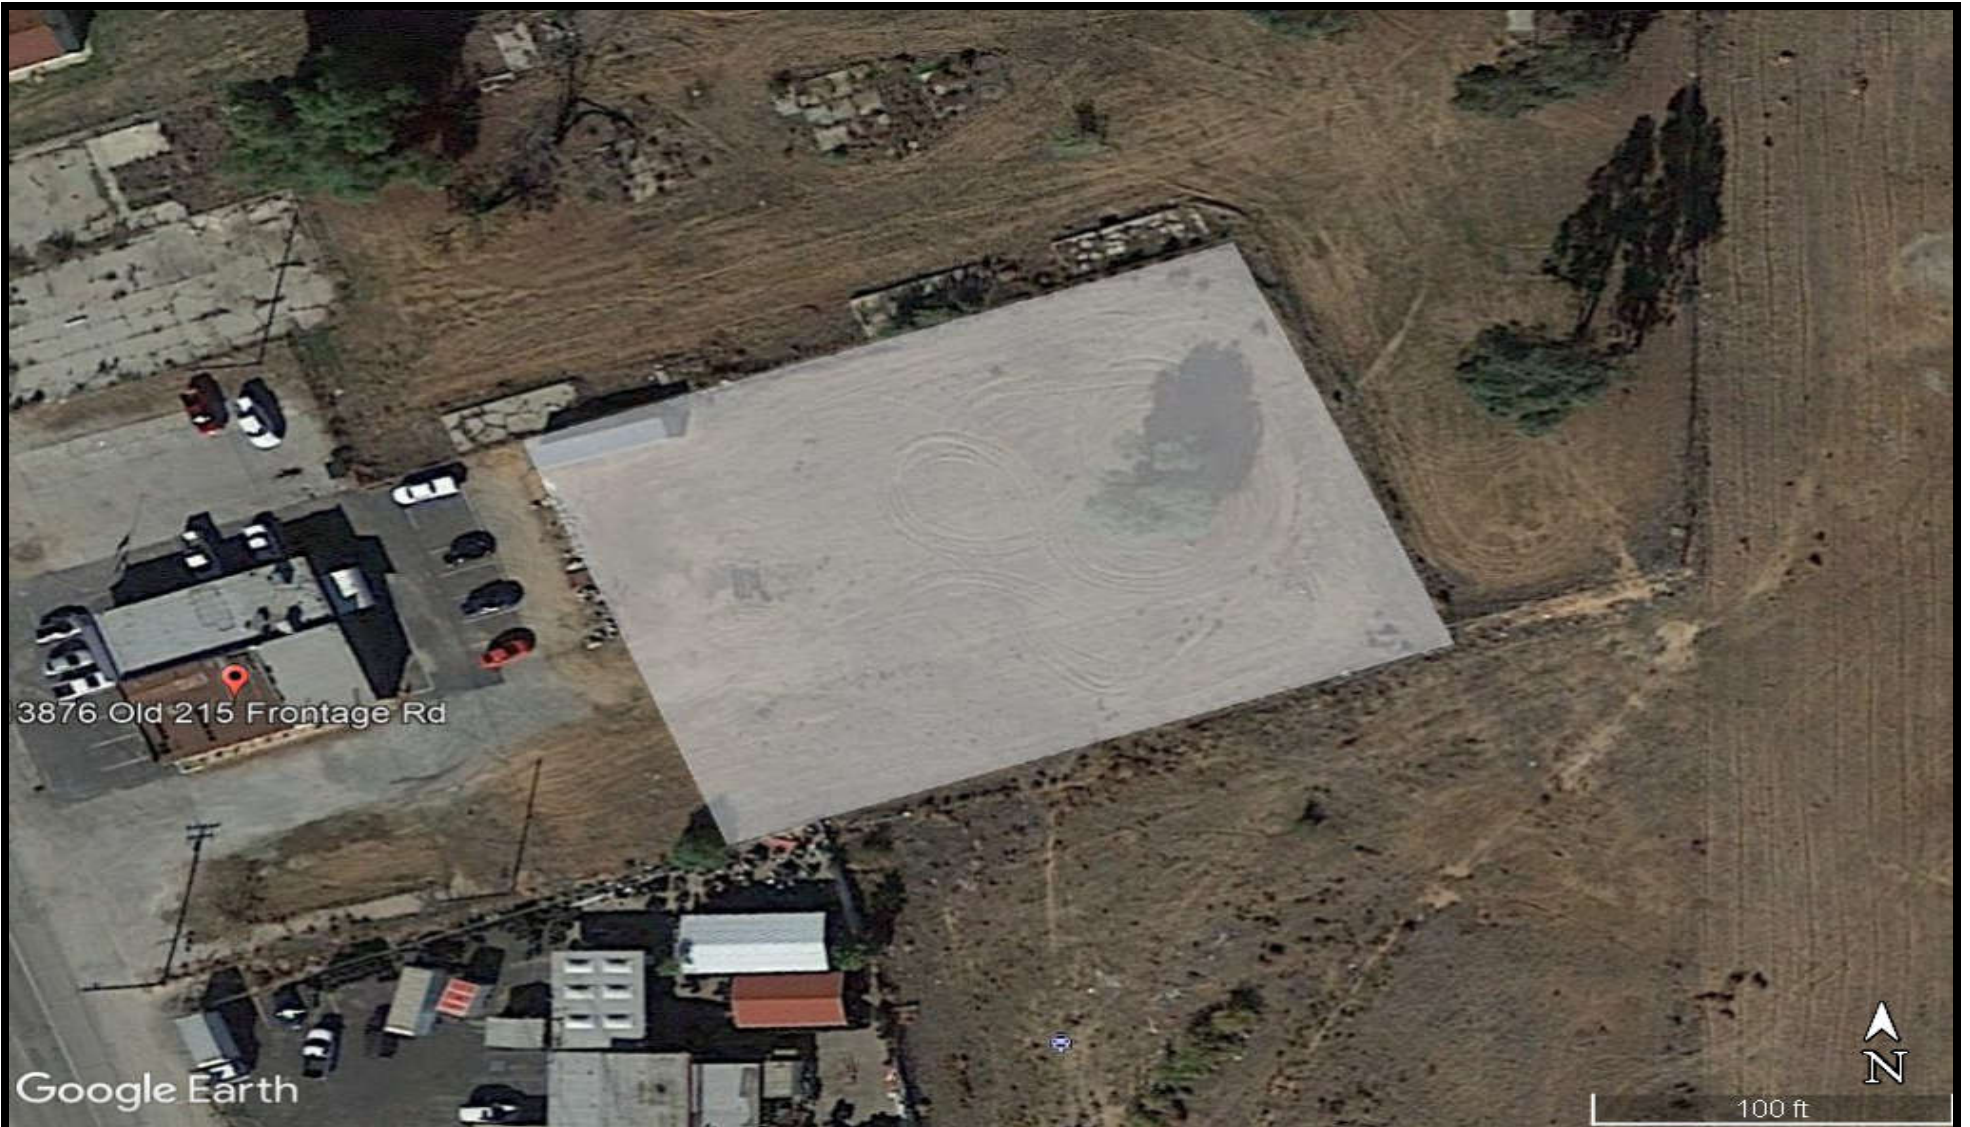
The subsurface conditions at the time of the scanning allowed for maximum GPR depth penetration of 3' in most areas. There were no visible indications of utilities within the vicinity. Additionally, there was also no observed reactions within the data to indicate the presence of utilities. The equipment and methods used did not detect reactions from a potential UST. The following pages will provide further explanation of the findings.

The subsurface conditions at the time of the scanning allowed a maximum GPR depth penetration of approximately 3 feet below the surface in most areas. The equipment and methods used did not detect reactions from potential UST's, or any subsurface disturbance or excavation in the area scanned. In addition, as the Site is a vacant lot, no evidence of former drains, or clarifiers were observed during this investigation.

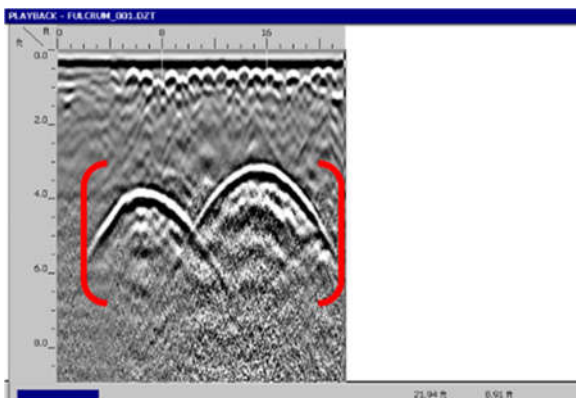
Sample GPR data screenshot showing two potential USTs. These reactions are larger than a typical utility but large utilities can look identical to a UST.

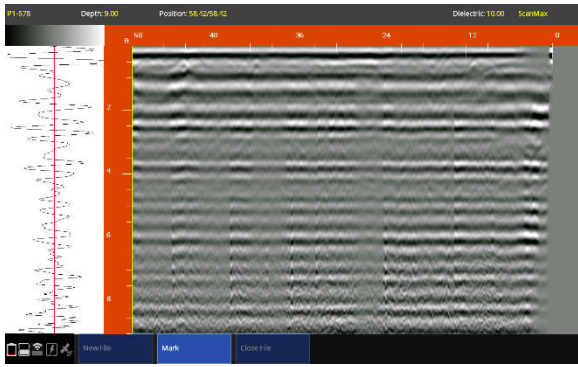
GPR data screenshot showing an absence of reactions indicating the presence of utilities or a UST.

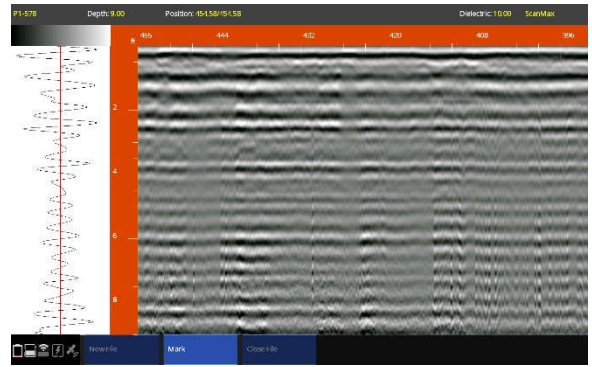
GPR data screenshot showing an absence of reactions indicating the presence of utilities or a UST.

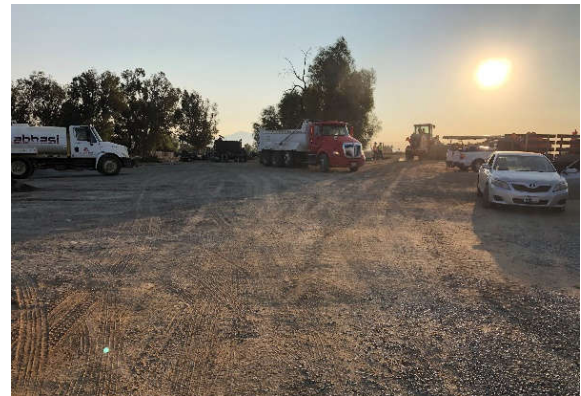
Photo showing empty lot where scanning was conducted.

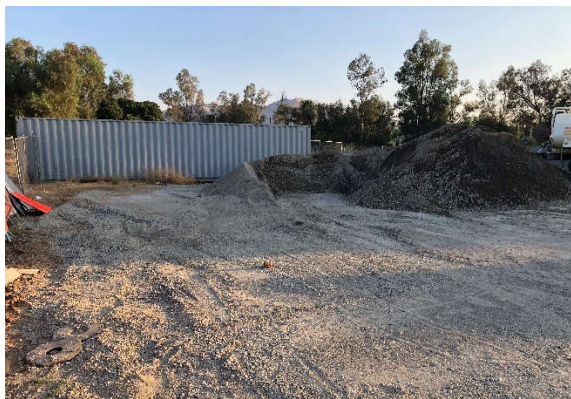
Additional photo showing where scanning was conducted.
