**Biological Resources Technical Report and
Western Riverside County Multiple Species
Habitat Conservation Plan Consistency Analysis
for the Camp Ronald McDonald for Good Times Project**

Camp Ronald McDonald for Good Times
56400 Apple Canyon Road
Mountain Center, California 92561
Contact: Brian Crater

DUDEK
27372 Calle Arroyo
San Juan Capistrano, California 92675
Contact: Ryan Henry

APRIL 2017

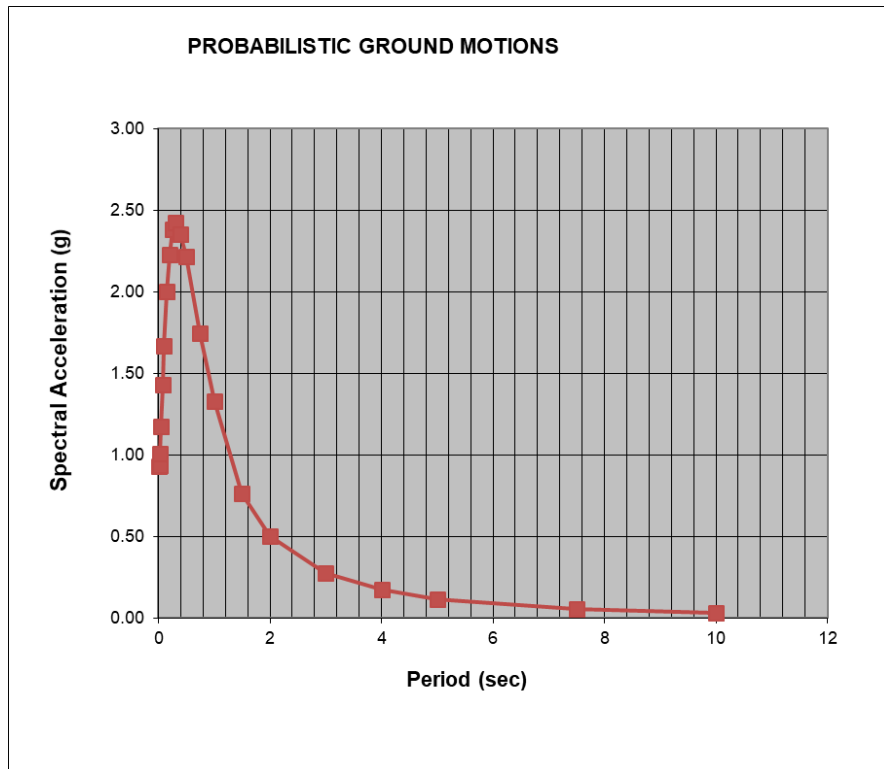
Next Generation Attenuation West-2 Relations (2014 NGA) were utilized to produce a response spectrum. These included Chiou & Youngs (2014), Abramson et al., (2014), Boore, et al., (2014) and Campbell & Borzignia (2014). The Probabilistic Risk Targeted Response Spectrum was determined as the product of the ordinates of the probabilistic response spectrum and the applicable risk coefficient (C_R). These values were then modified to produce a spectrum based on the maximum rotated components of ground motion. The resulting MCE_R Response Spectrum is indicated below:

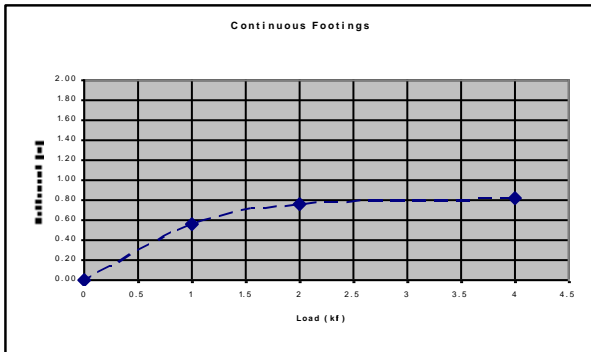
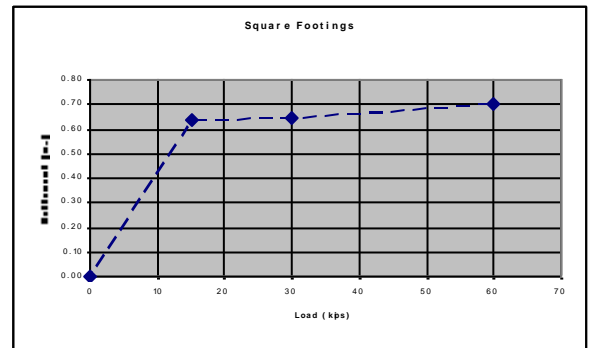
less than one-half inch vertical over 20 feet horizontal. Differential settlement will occur across structures with variable loads and footing configurations. These may be estimated on the basis of computed settlements for various loads and loading conditions as presented in the following graphs:

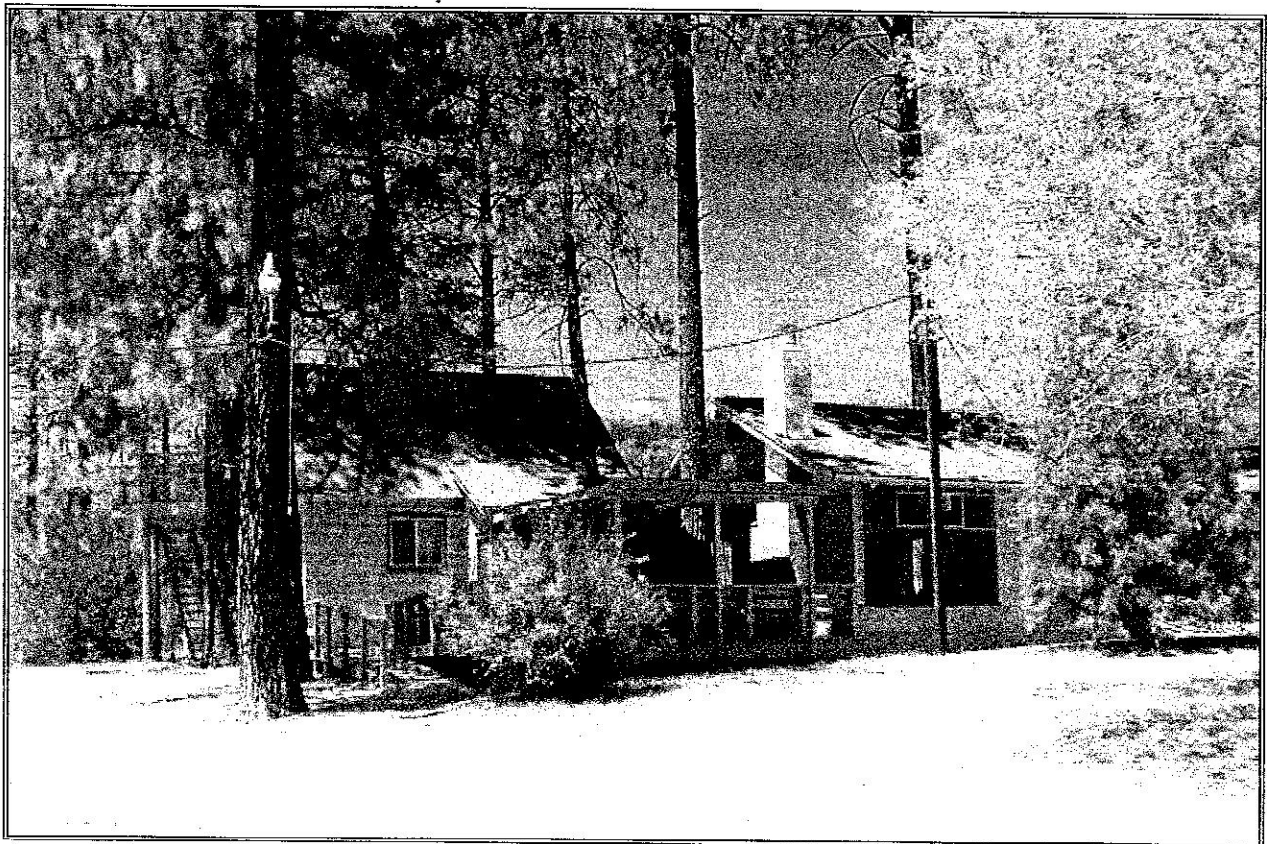
Figure 16: Frontal view of original and contemporary portions of Cabin 7.

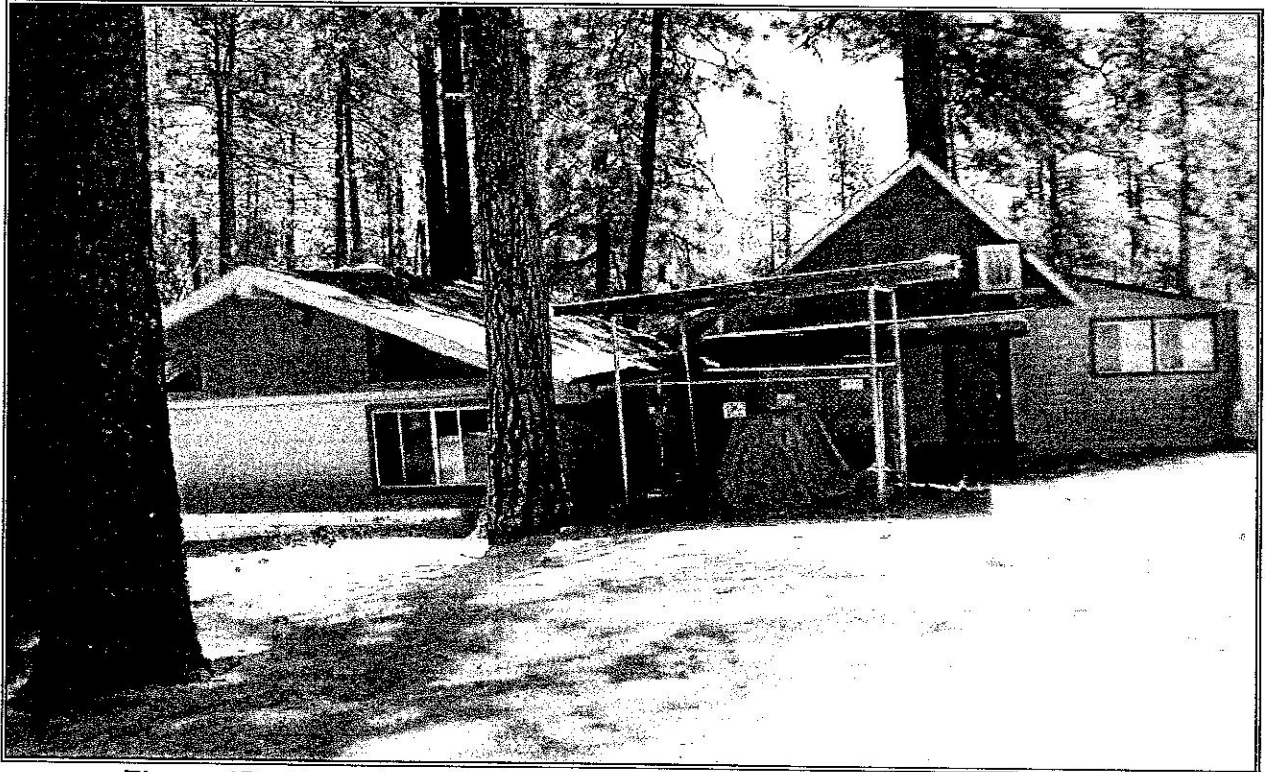
Figure 17: Rear view of original and contemporary portions of Cabin 7.

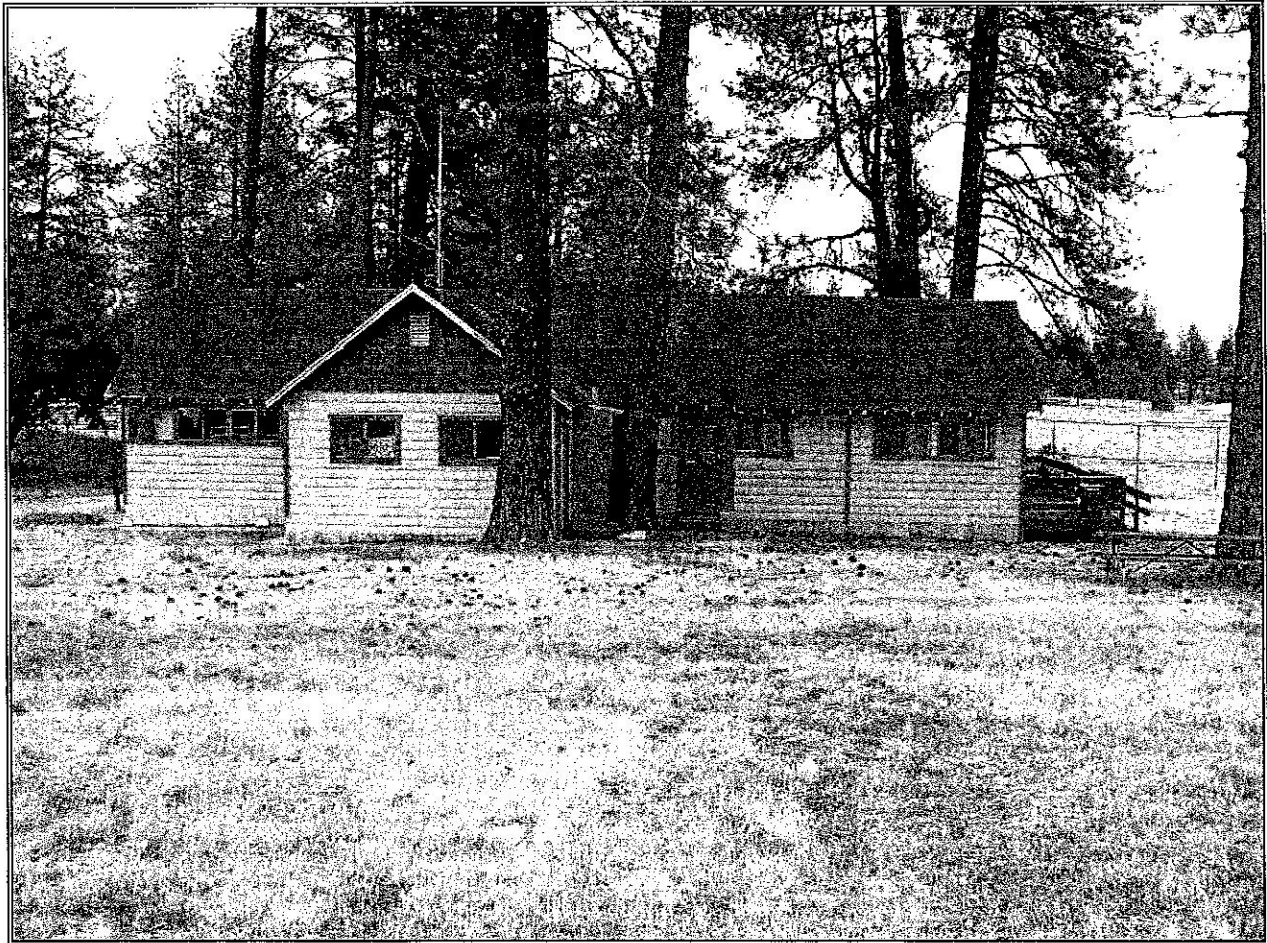
Figure 26: West side view of Cabin 18 showing room addition.
