January 12, 2022

Subject: Biological Resources Letter Report for the Live Oak Springs Water System Improvements Project

Summary

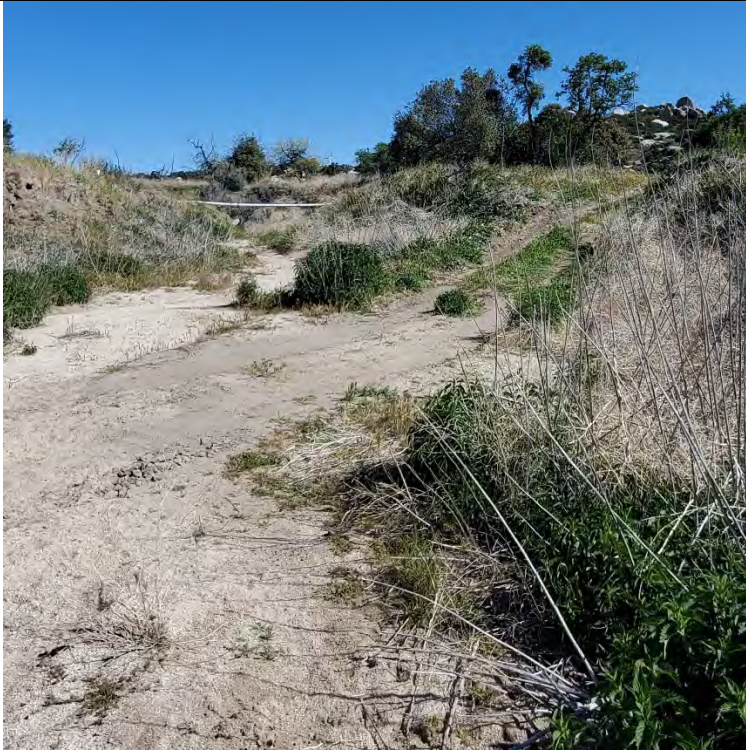
Photograph 2: North-facing view of the northern reach of Campo Creek that crosses the western portion of the project site. Evidence of vehicle tracks and ruts is shown in the center of the photograph and a water conveyance pipe spanning Campo Creek channel is shown in the background.

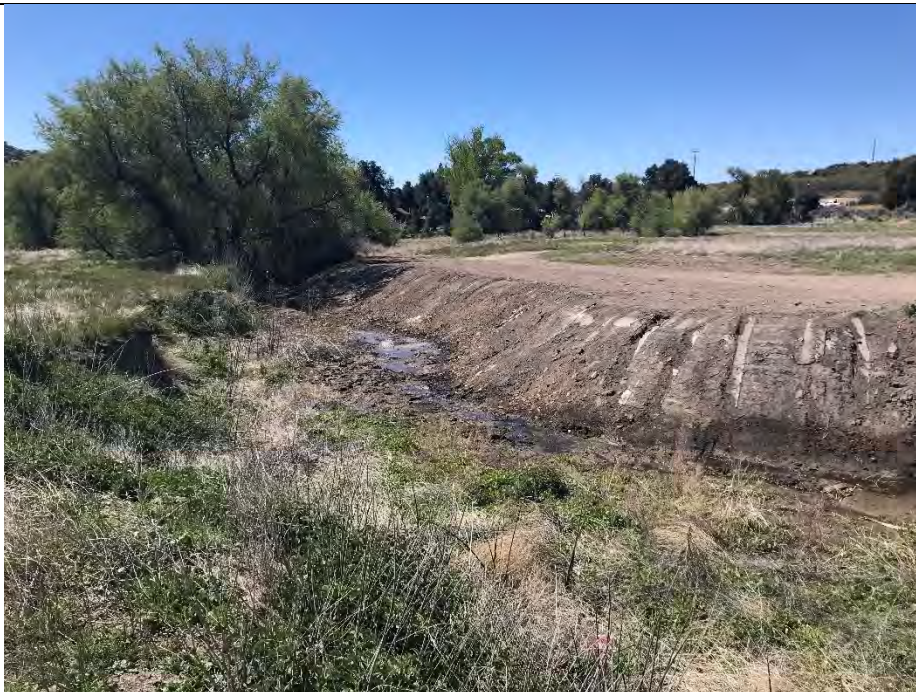
Photograph 6: Southwestern-facing view of a portion of the Campo Creek channel in the west-central portion of the project site. This photograph shows the evidence of mechanical disturbance on the western Campo Creek channel bank observed during the fieldwork on April 28, 2021.

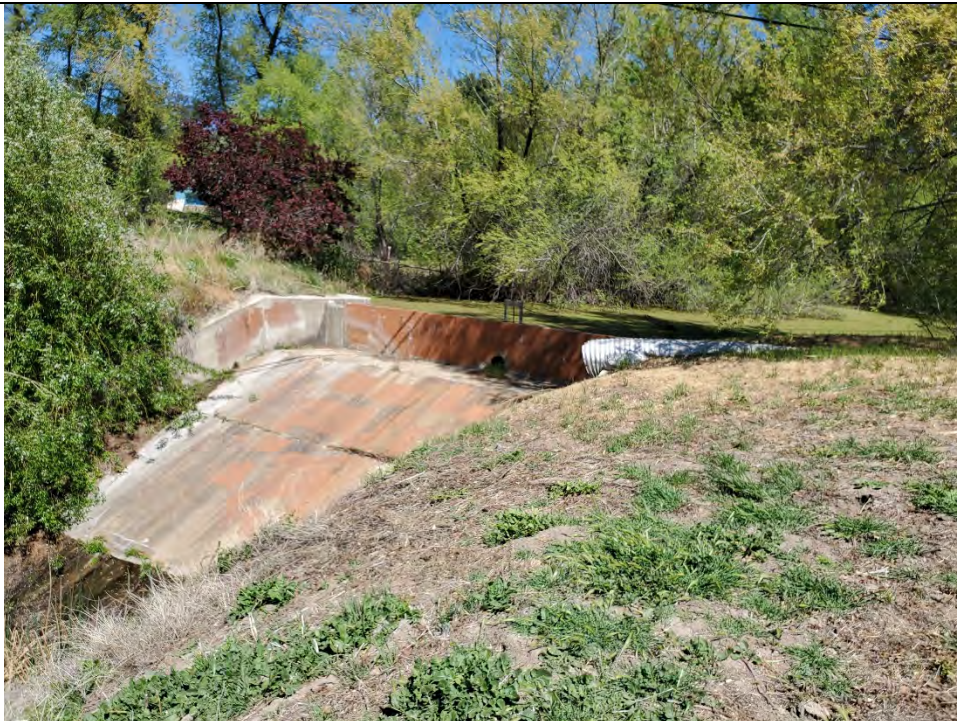
Photograph 10: Northwest-facing view of the concrete dam and spillway at the southern end of freshwater Pond 1 in the southern portion of the project site. The concrete dam has formed Pond 1 within Campo Creek and has contributed to the formation of the freshwater marsh within the southern extent of Campo Creek (due to the ponding of water).
