Arborist Report

Arborist Report for the
**SMUD Cordova Park Underground
Cable Replacement Project**

April 2022

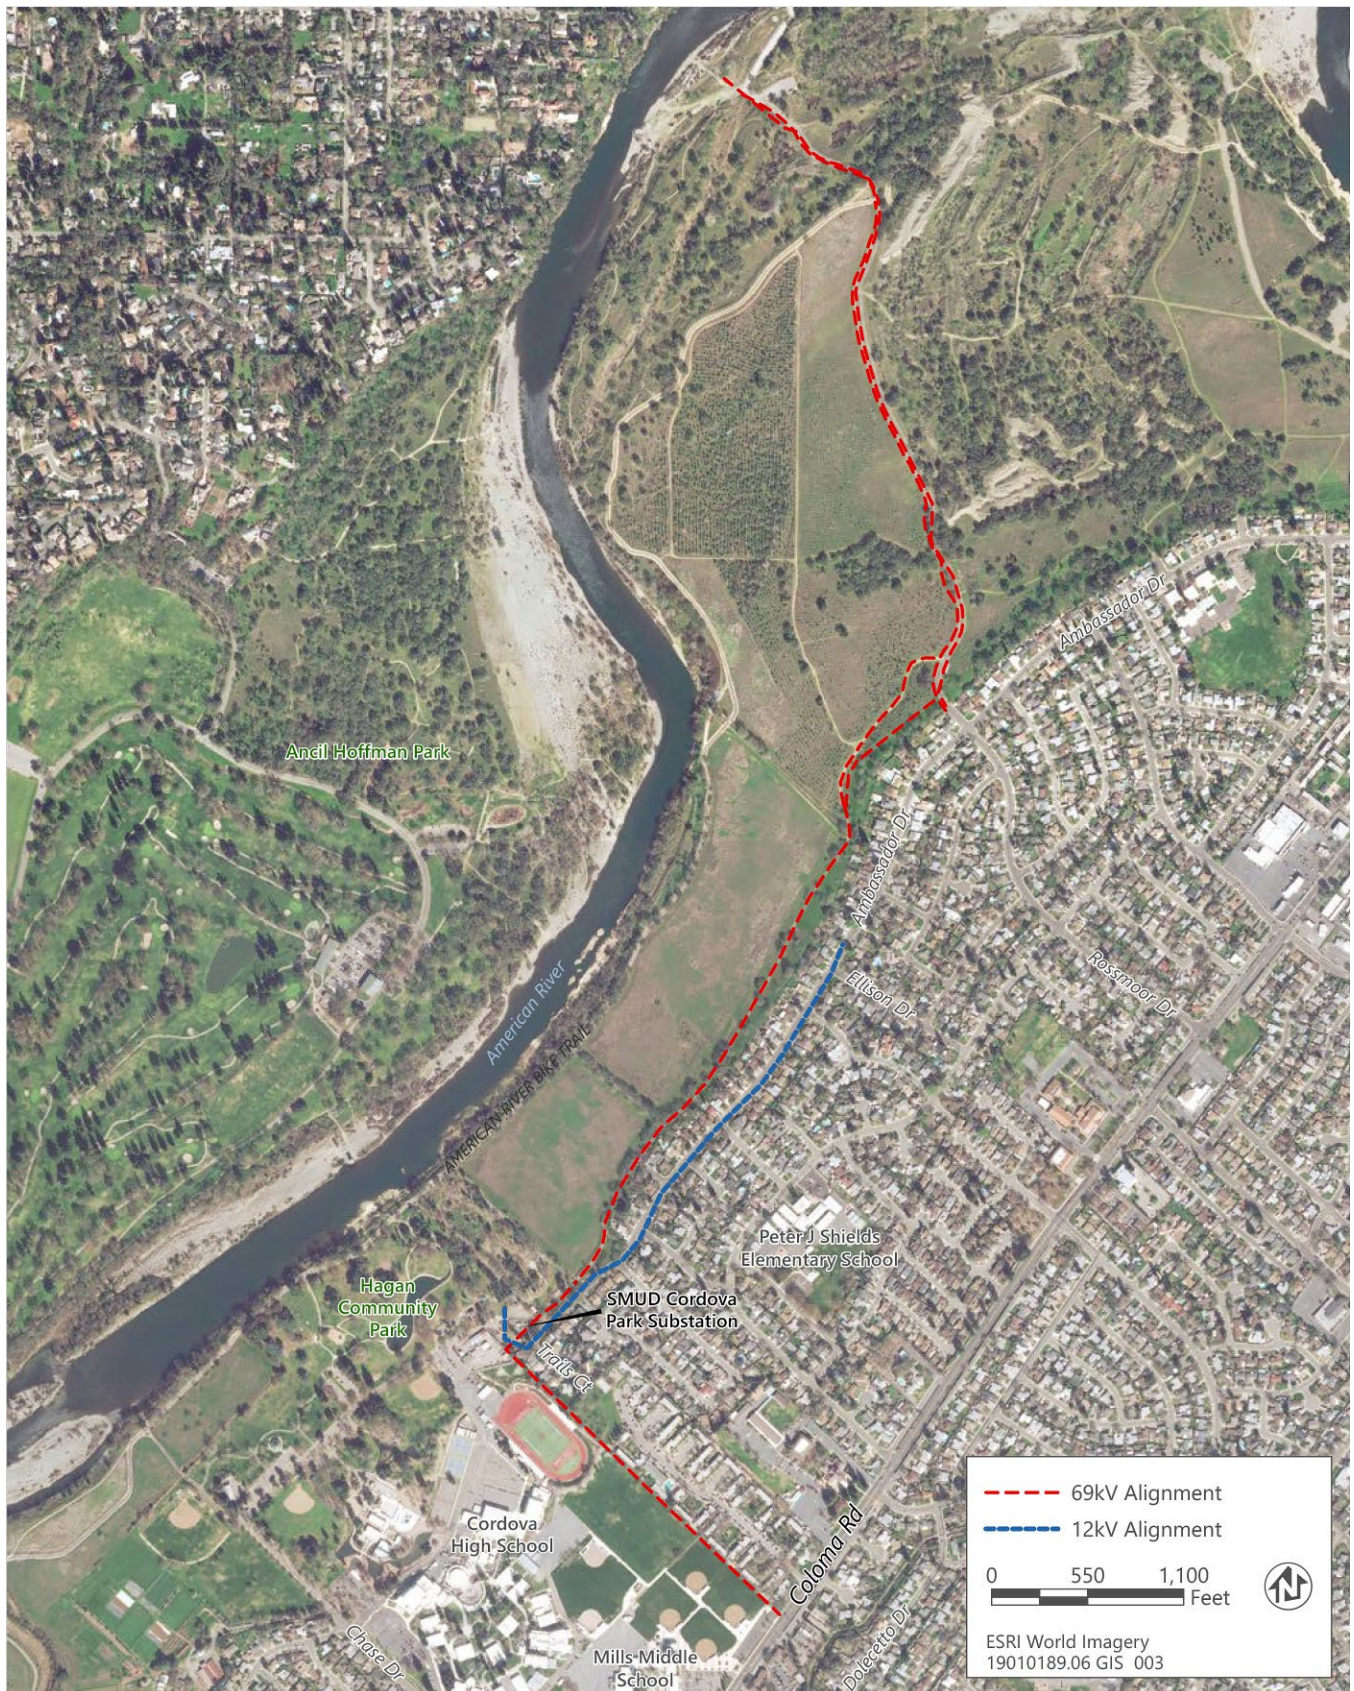
Figure 2 Project Alignment

SMUD replaces aging electrical infrastructure as part of its routine maintenance and upgrade protocols. Accordingly, SMUD proposes to install approximately 0.6 miles of 12 kilovolt (kV) underground cable, approximately 2.12 miles of 69kV underground cable and up to 13 new utility vaults in the City of Rancho Cordova, near the location of existing 12kV and 69kV underground cables that are approaching the end of their operational lives (see Figure 1). The proposed 69kV alignment begins on the northwest side of Coloma Road, approximately 200 feet southeast of Sierra Madre Court. The 69kV alignment heads northwest from Coloma Road, crossing through the property of Mills Middle School and Cordova High School, until it connects to SMUD's Cordova Park Substation located near the intersection of Ambassador Drive and Trails Court. From the substation, the 69kV alignment heads northeast along the backs of homes facing Ambassador Drive until it reaches Rossmoor Drive. At Rossmoor Drive, the alignment turns and heads north towards the American River. The 69kV alignment stays along Rossmoor Drive until its termination near the American River, when the alignment connects to existing riser poles located between the terminus of Rossmoor Drive and the American River. The existing 12kV and 69kV lines that run through the American River Parkway would be abandoned in place, and new conduit containing the new lines would be installed in separate trenches within the alignments described above. The proposed 12kV and 69kV alignments are highly disturbed due to vehicle traffic, including areas of pavement and dirt. There are residences adjacent to portions of the proposed 12kV and 69kV alignments. Along Ambassador Drive, the 12kV circuit would be installed beneath existing roadways, sidewalks, or curbs and gutters. Along Rossmoor Drive, the 69kV circuit would be installed beneath existing pavement or within an existing fuel break adjacent to the pavement. Installation of the new conduit and manholes would be done via open trenching. Figure 2 shows the project alignments.

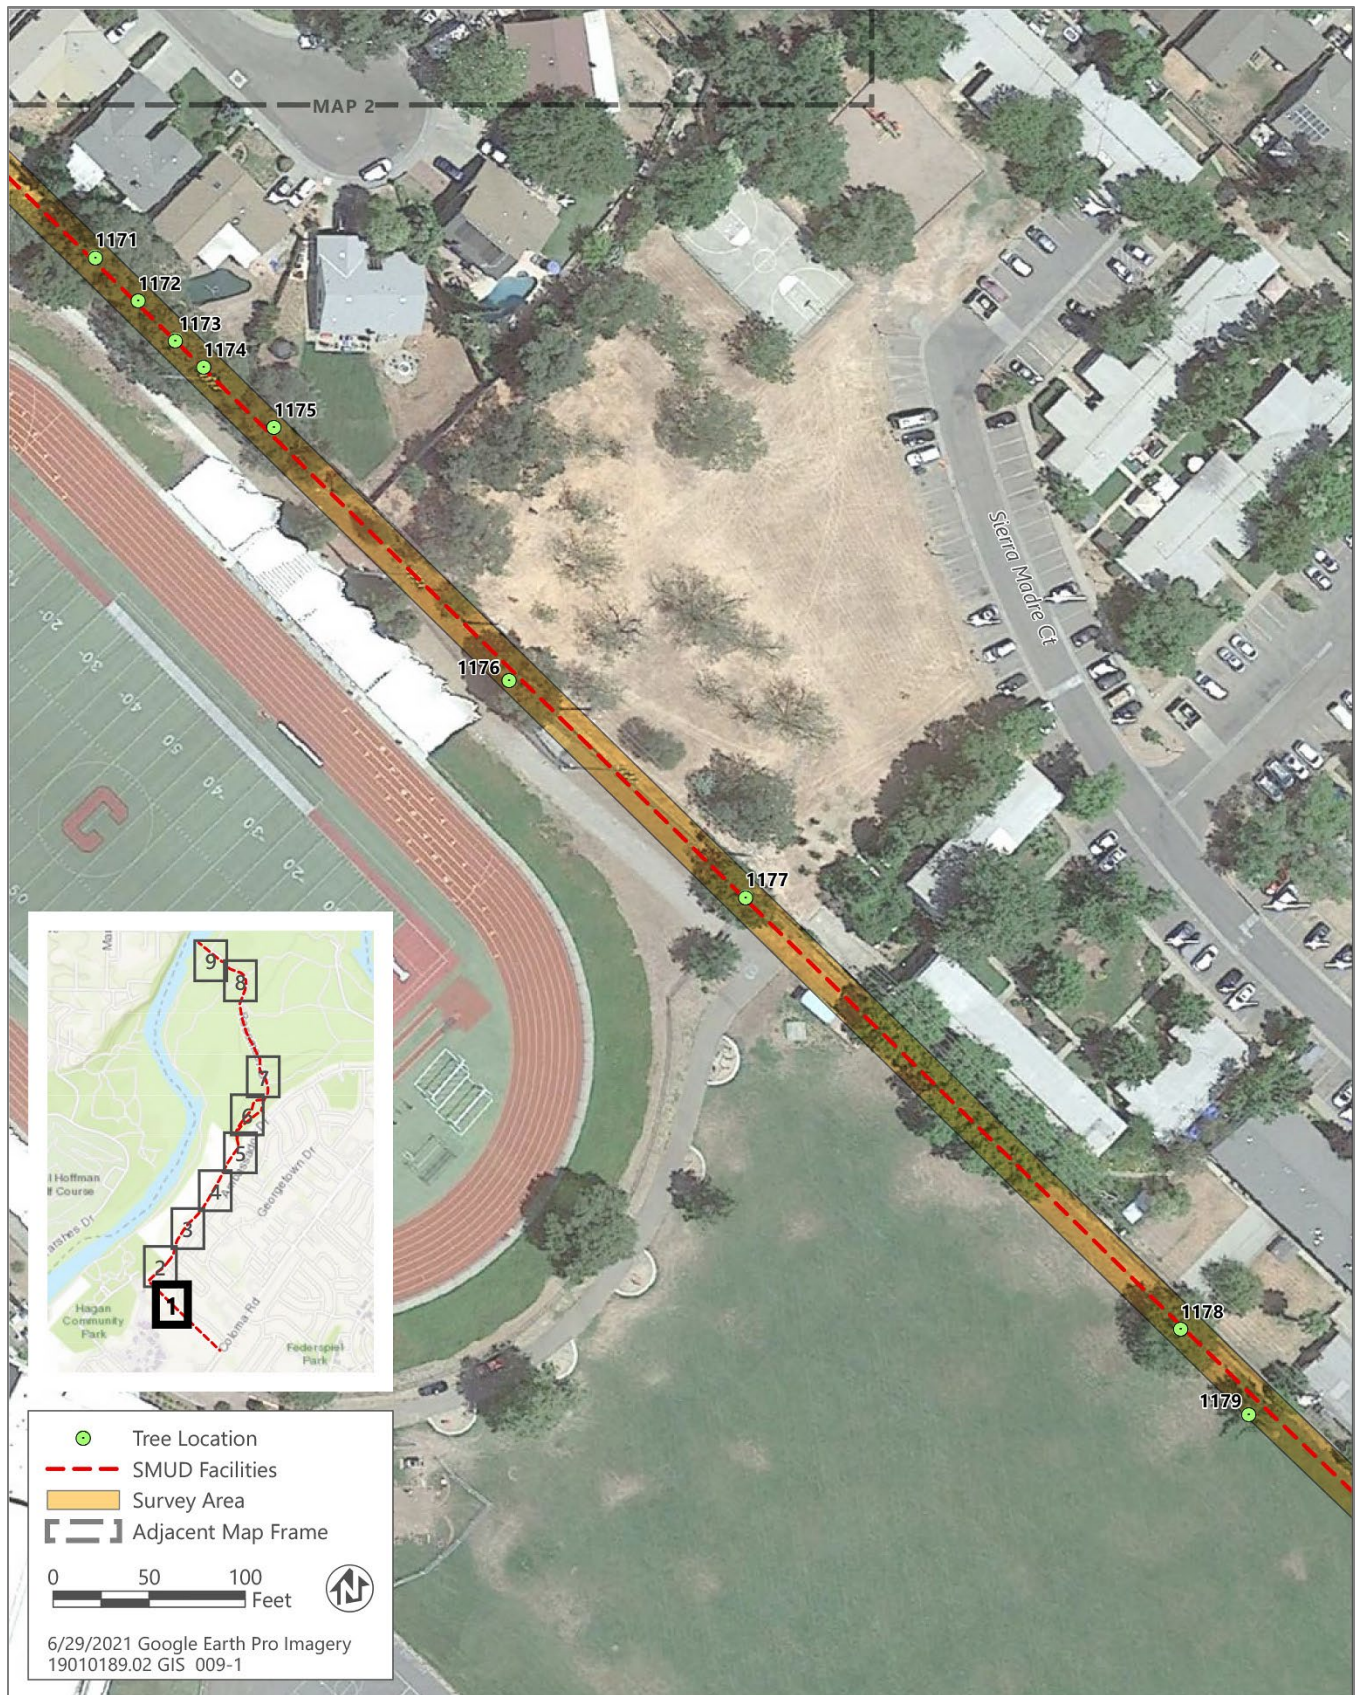
Figure 3a Tree Location (1 of 9)

The results of the data collected during the tree survey are presented in Figures 3a through 3i, Table 1, and Attachment A. Information provided in Table 1 includes a summary of the native and non-native tree species observed in the survey area. Figures 3a through 3i present all the trees identified and mapped during the field survey.
