### **Biological Resources Assessment Letter**

**Re: Biological Resource Assessment of North Coast County Water District Sheila Water Tank, Pacifica, San Mateo County, CA**

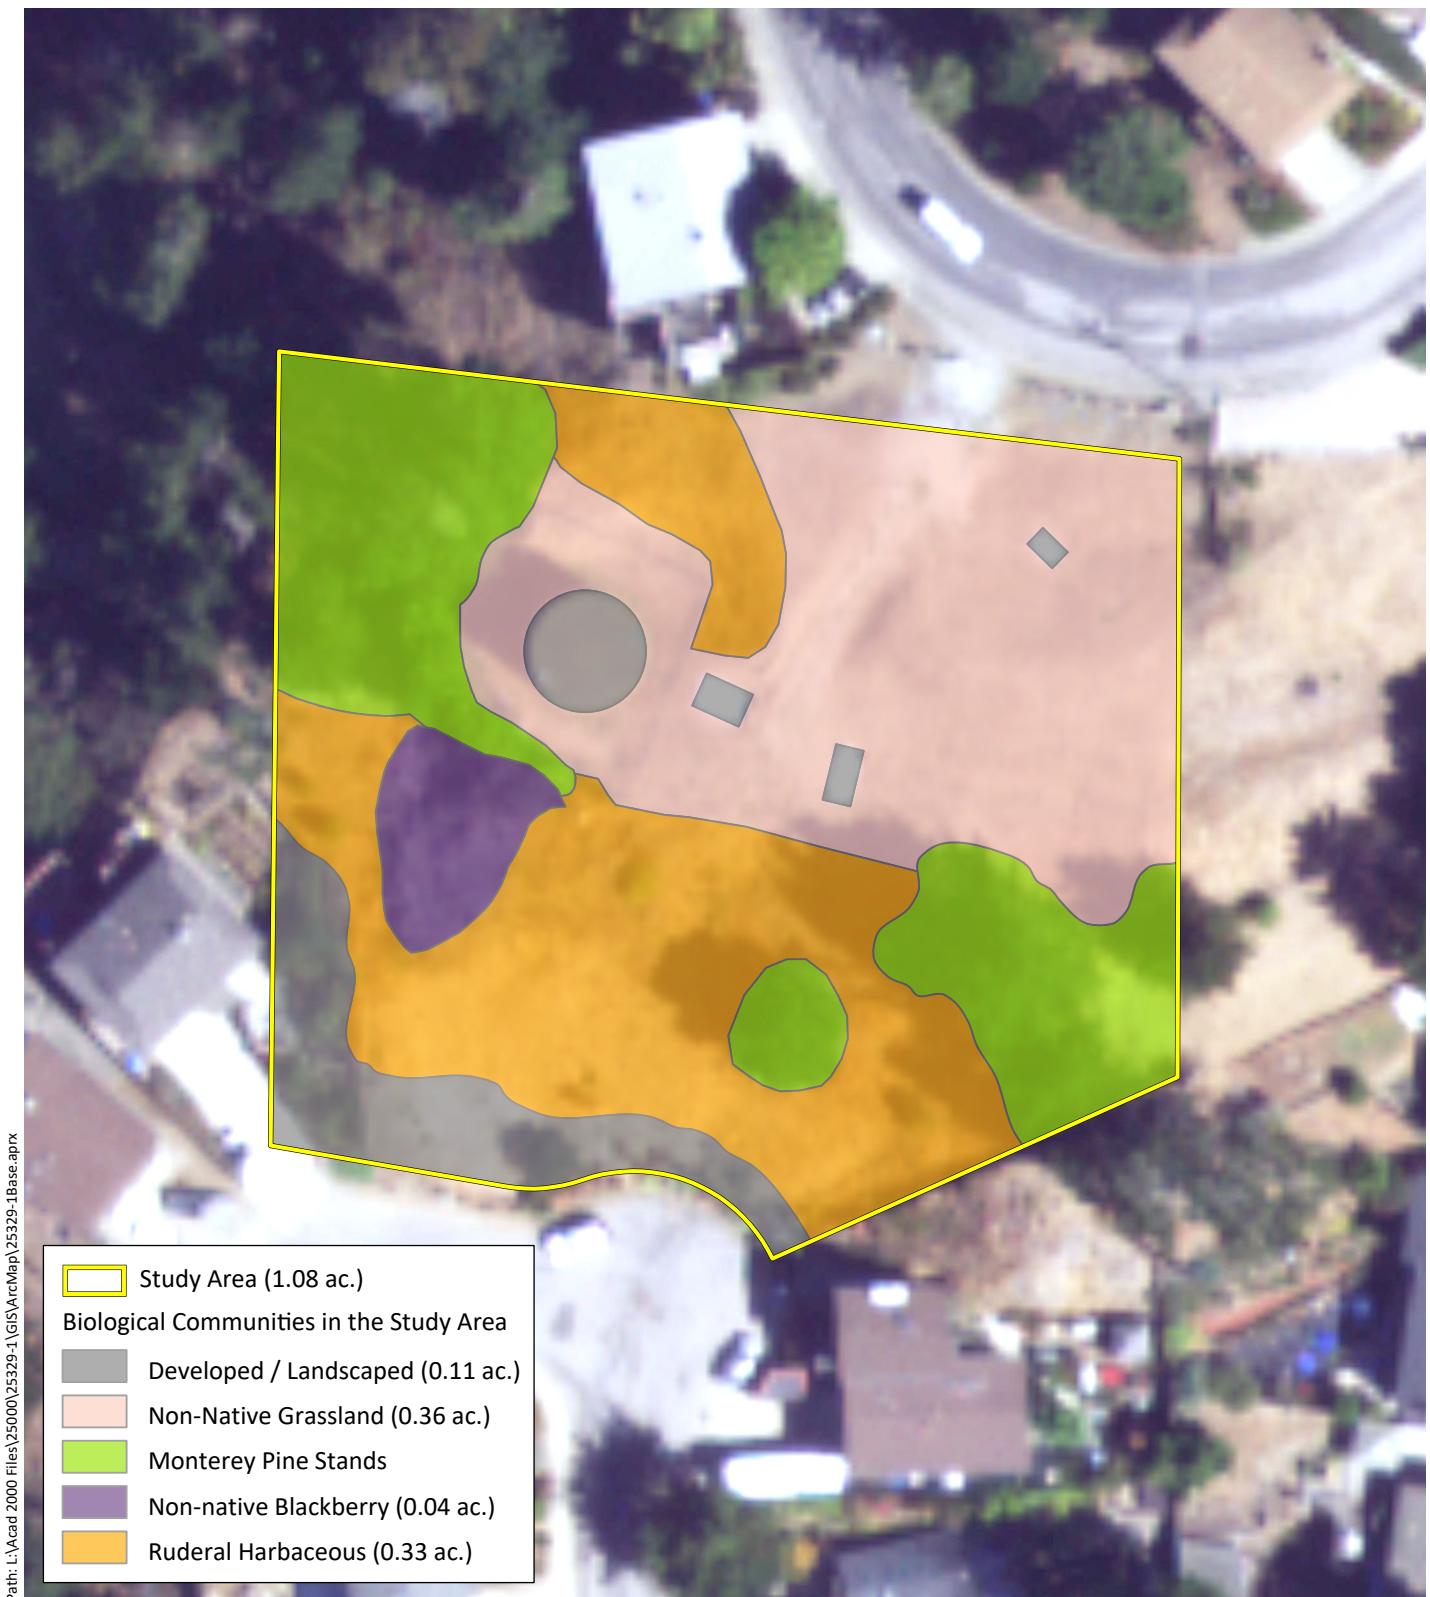
**Figure 2. Biological Communities in the Study Area**

The Study Area contains five non-sensitive land cover types including Monterey pine (*Pinus radiata*) stands, 0.36 acres of non-native annual grassland, 0.04 acres of non-native blackberry thicket, 0.33 acres of ruderal herbaceous forbs and grasses, and 0.11 acres of developed/landscaped terrain (Appendix A, Figure 2). Appendix B provides representative photographs of the Study Area.

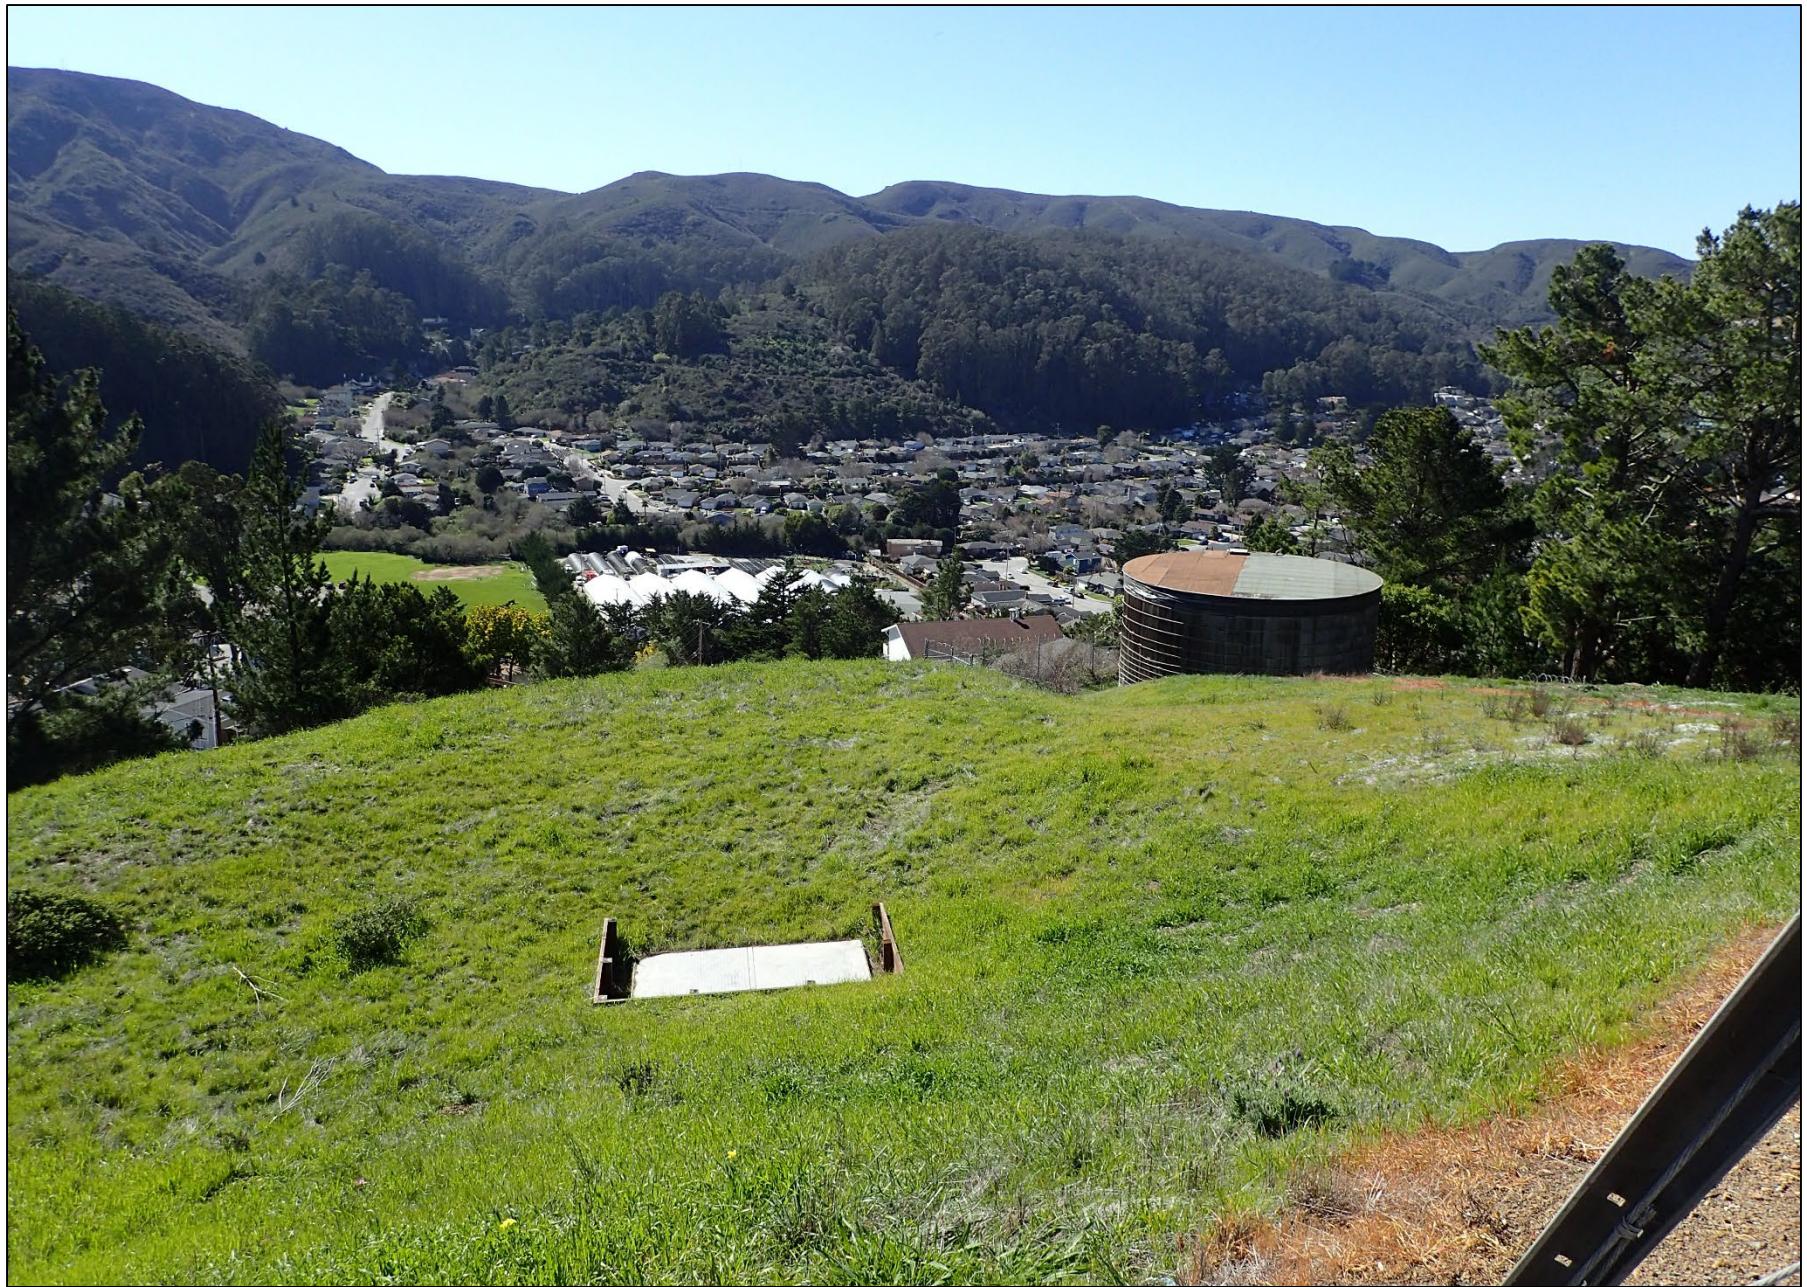
Photograph 1. Photograph showing non-native annual grasslands in the foreground and Sheila Tank in the background with Monterey pine stands on both western and eastern edges of the Study Area, facing south. Taken February 18, 2021.

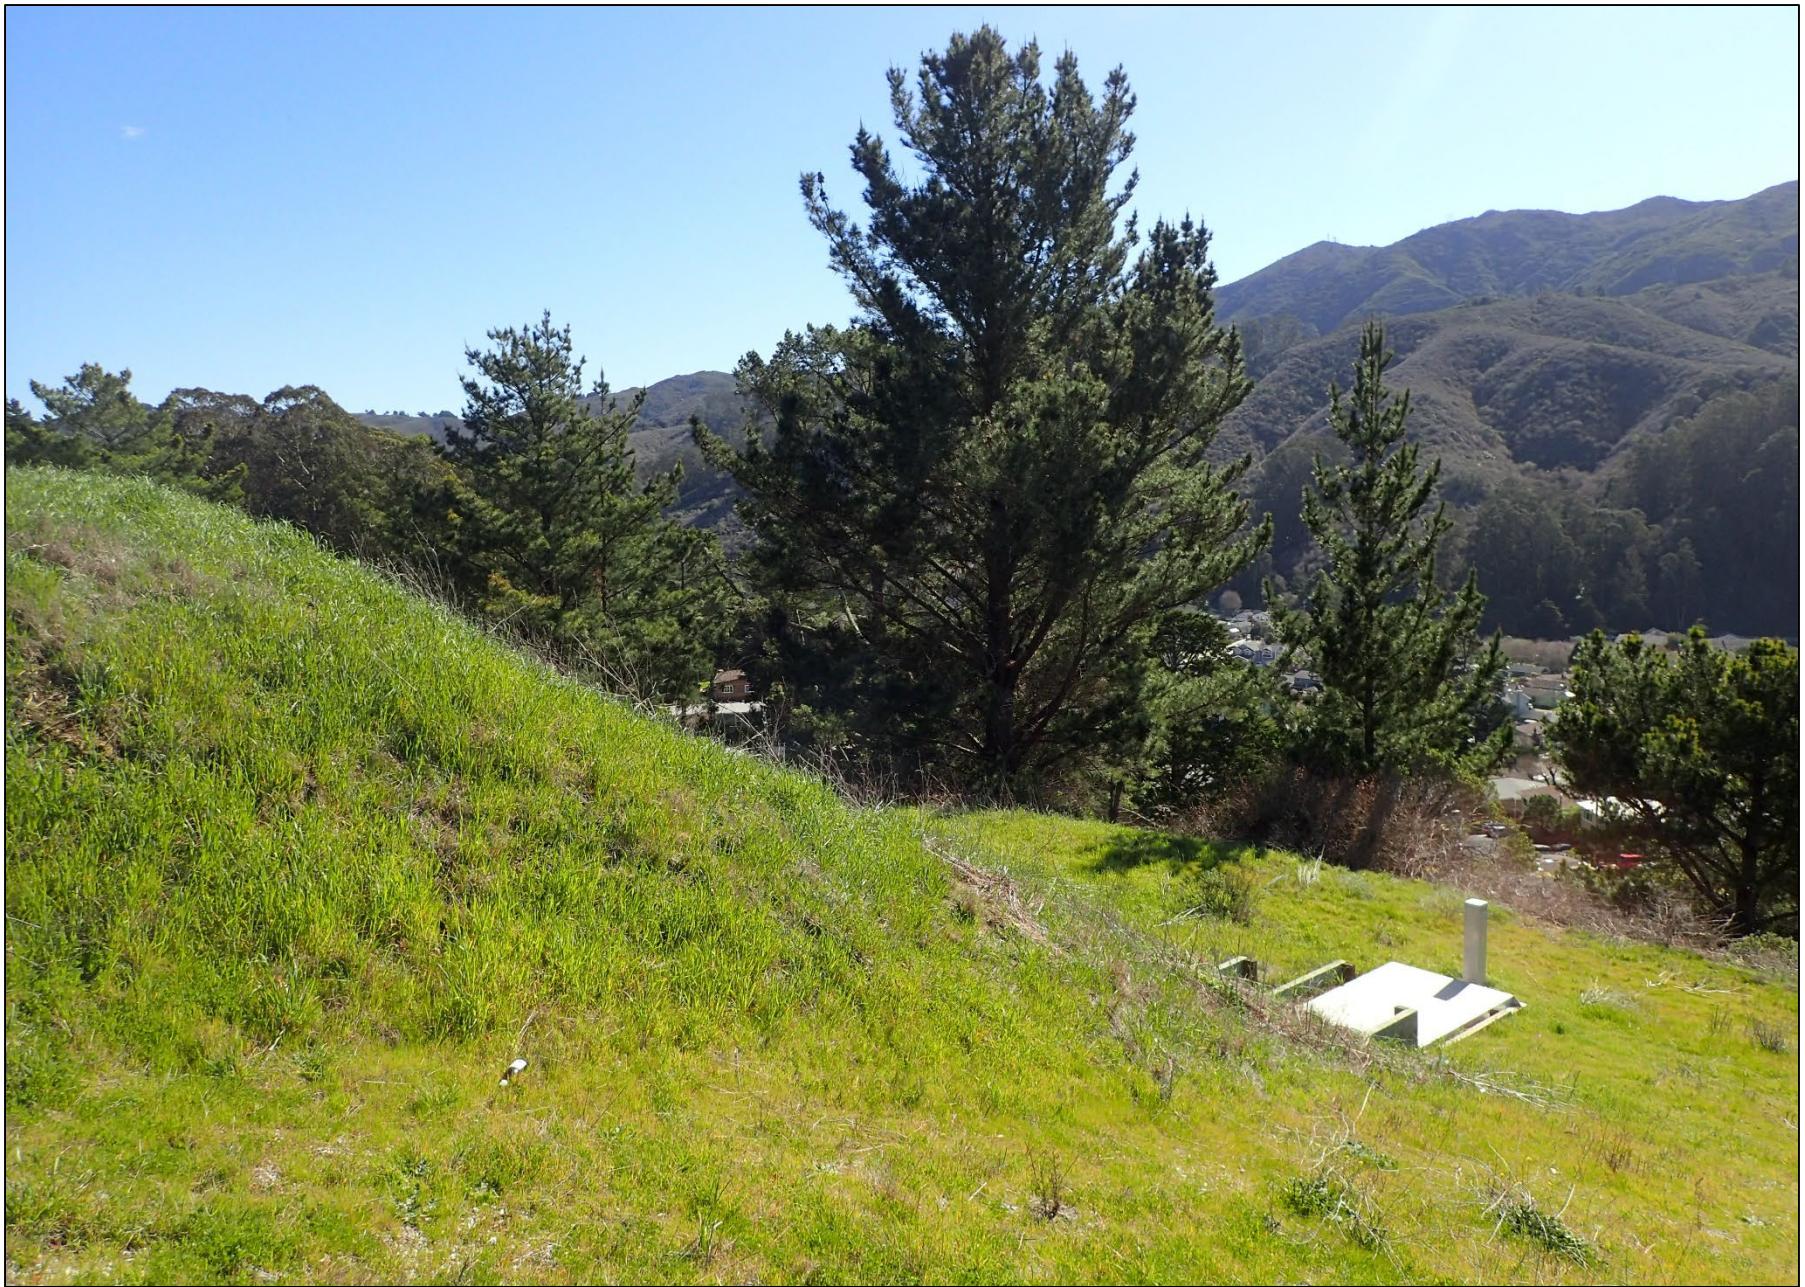
Photograph 2. Photograph showing Monterey pine stands in the Study Area, facing east. Taken February 18, 2021.

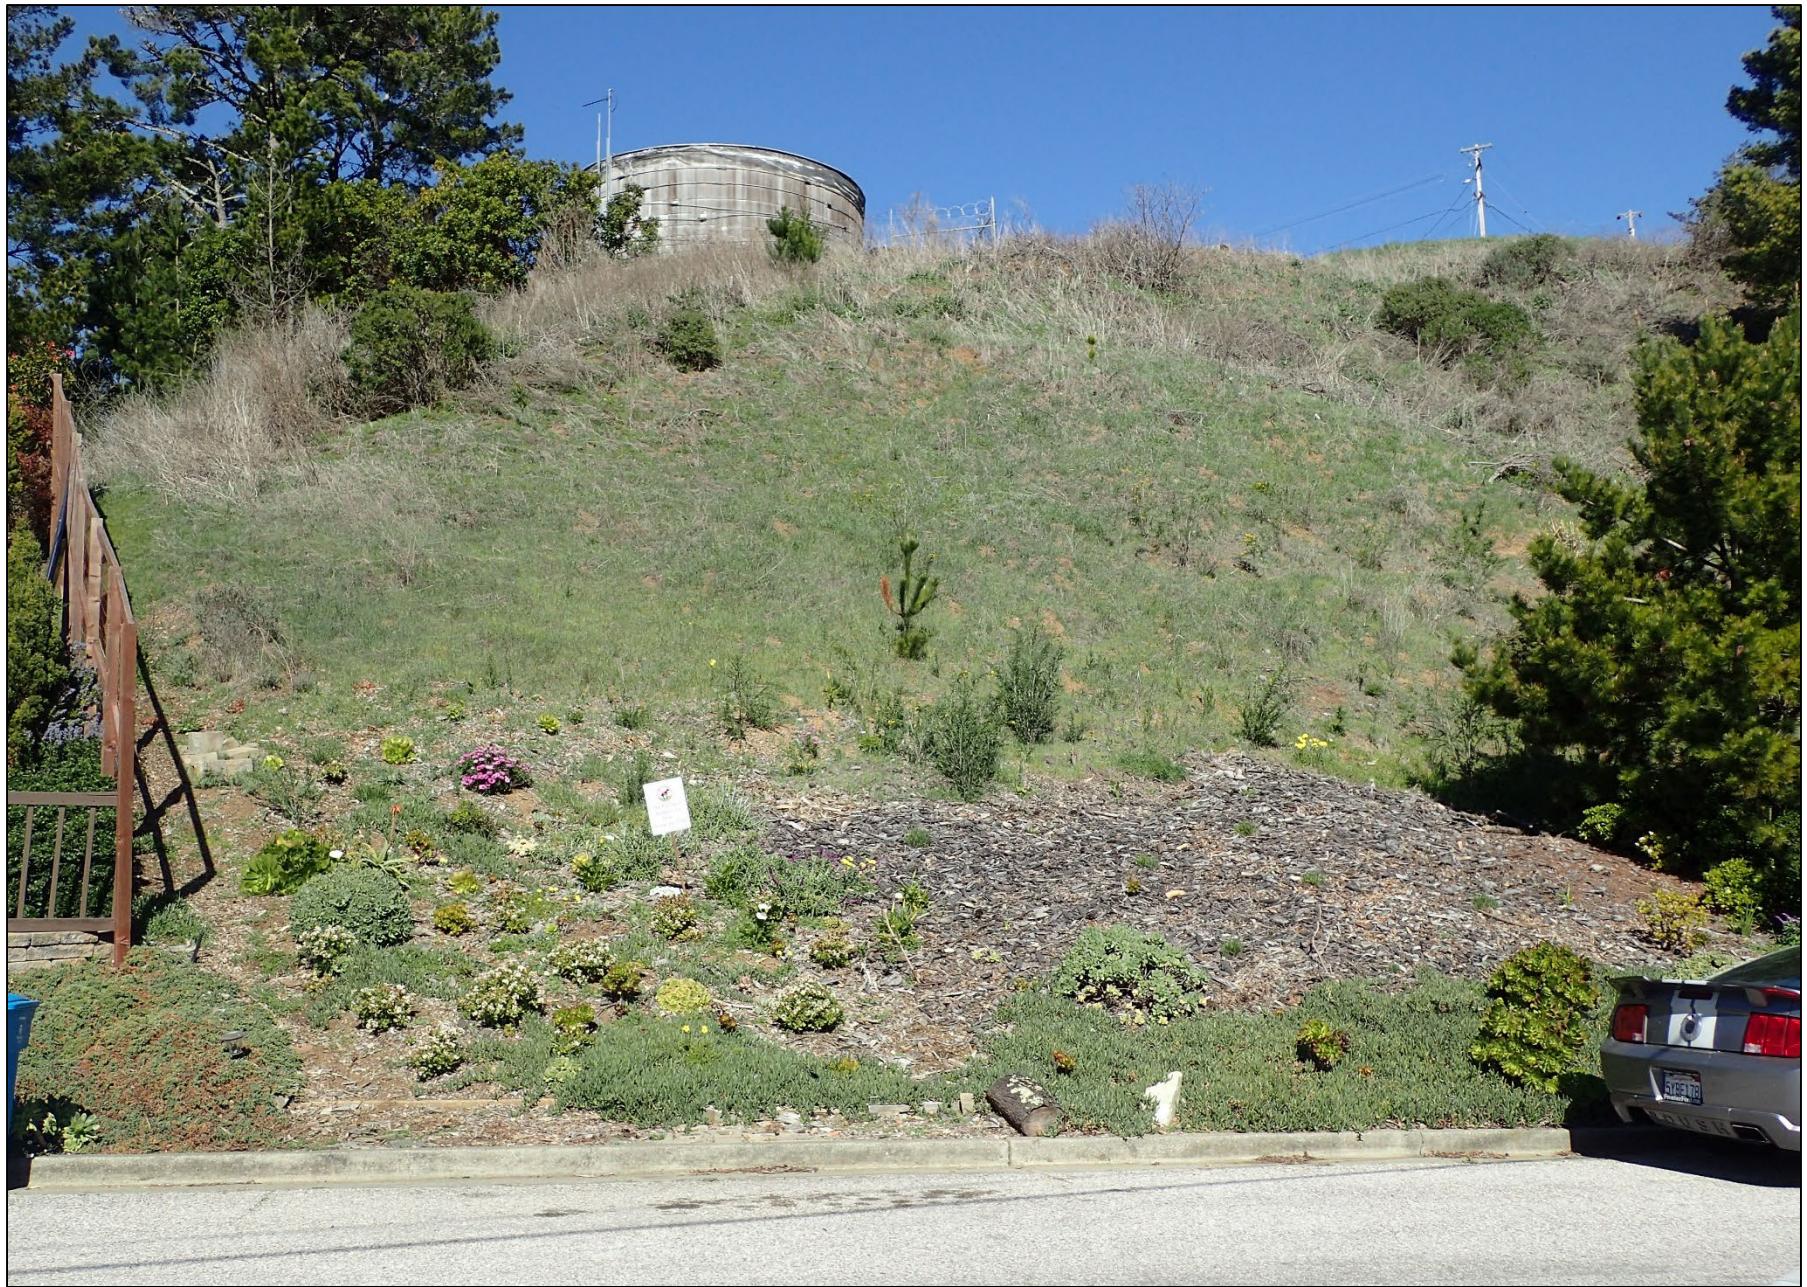
Photograph 3. Photograph showing several biological communities and steep slopes of the Study Area, facing north. Taken February 18, 2021.

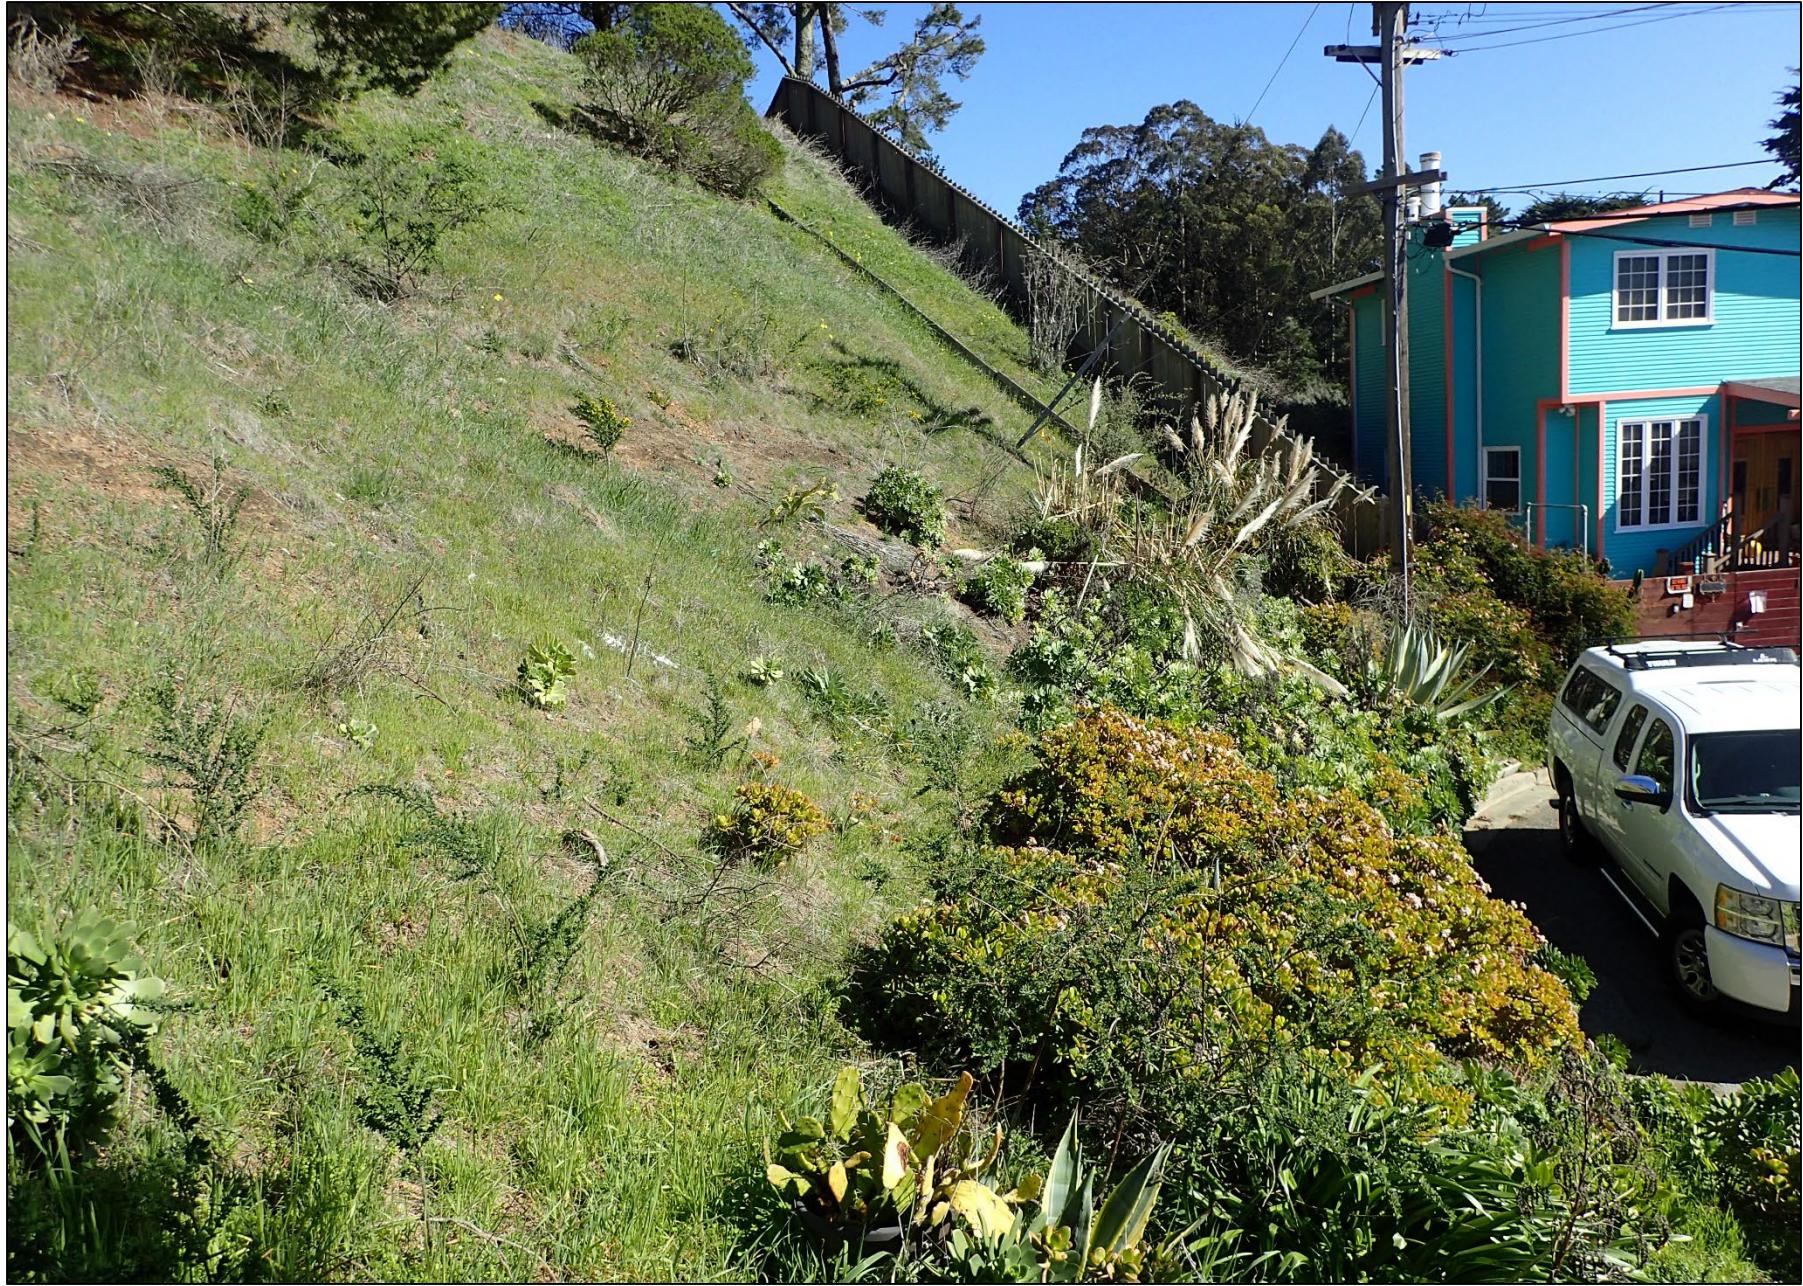
Photograph 4. Photograph showing ruderal herbaceous biological community in the Study Area, facing east. Taken February 18, 2021.

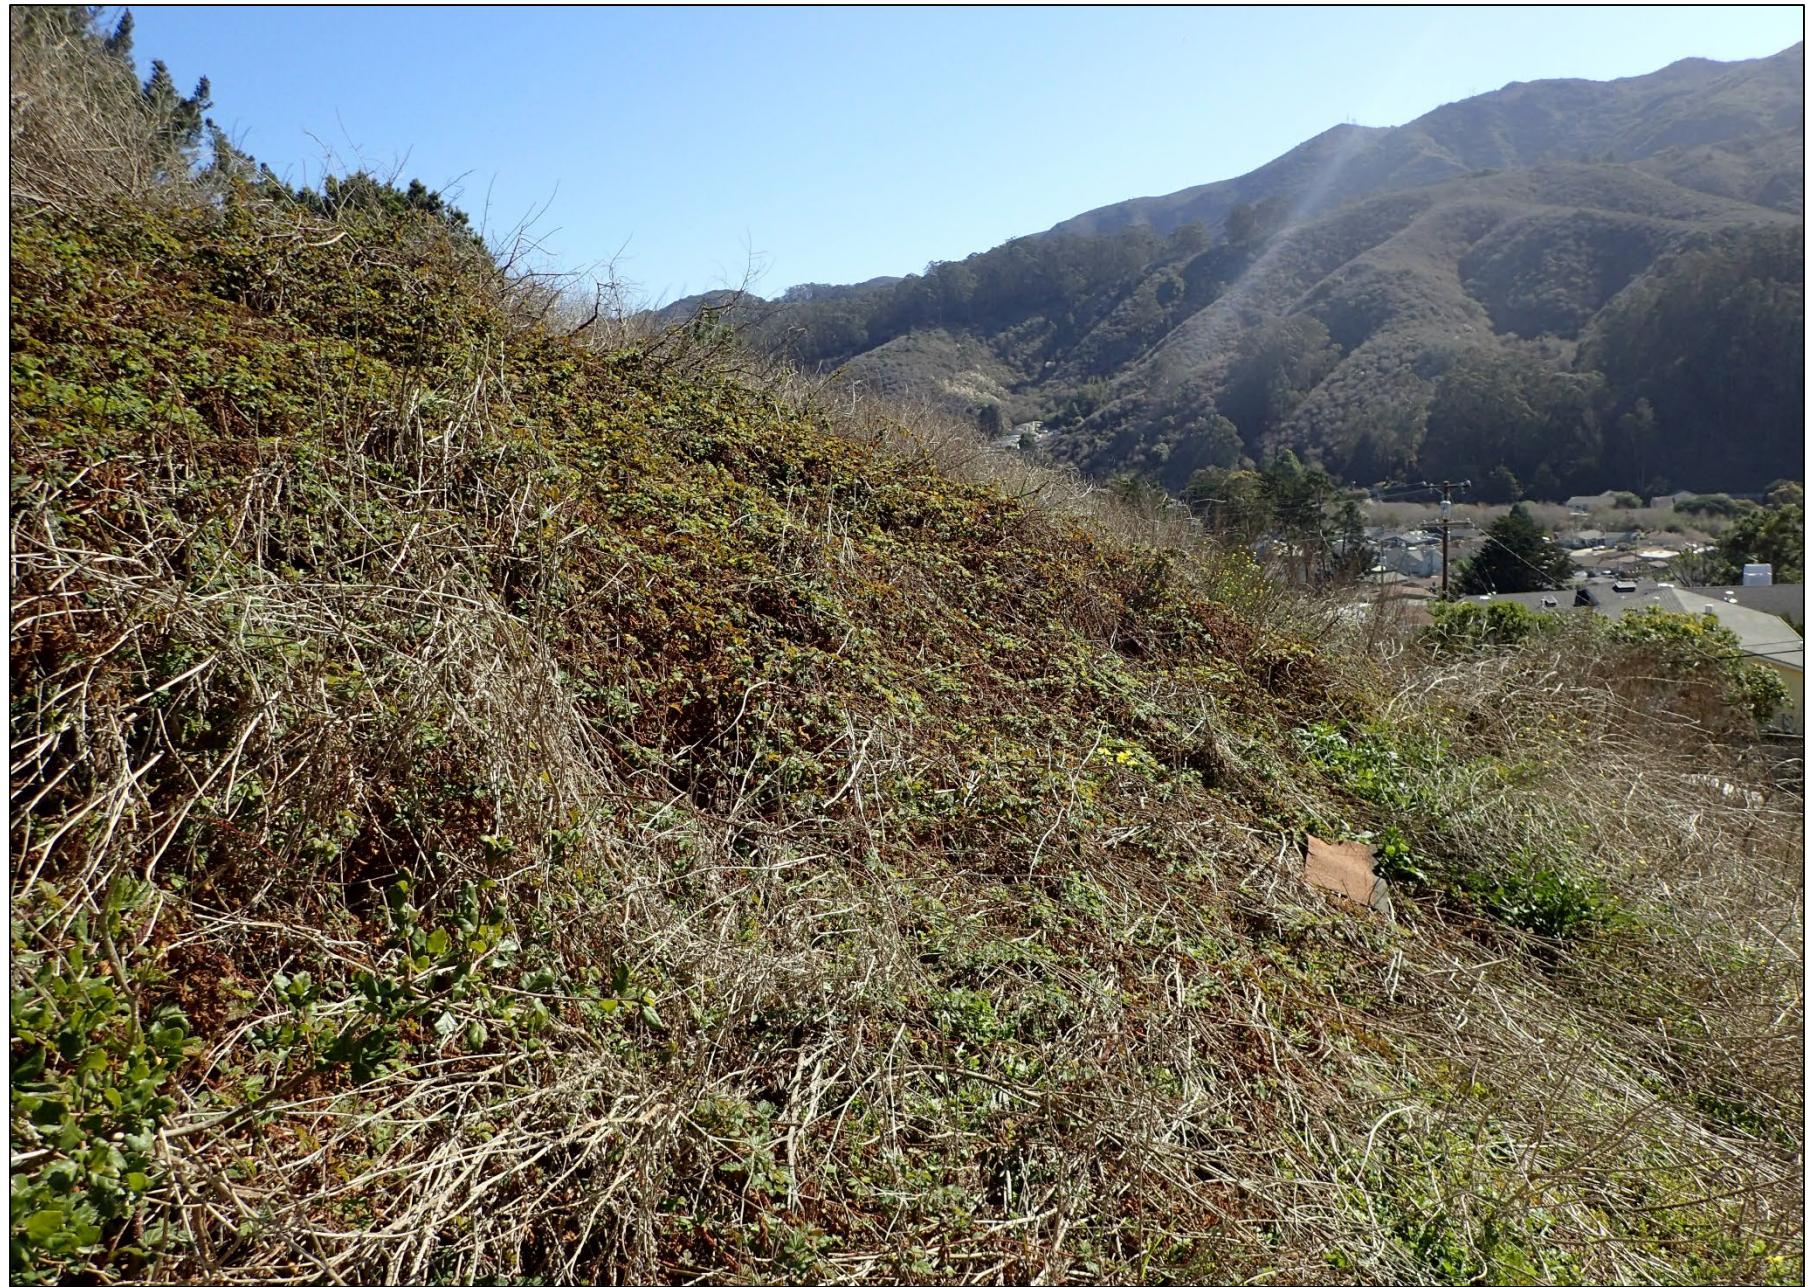
Photograph 5. Photograph showing *Rubus* shrublands in the Study Area, facing east. Taken February 18, 2021.
