# **BIOLOGICAL RESOURCES ASSESSMENT**

**1850 OGULIN CANYON ROAD [APN 010-053-03]  
LAKE COUNTY, CALIFORNIA**

PROJECT № LAK003

REVISED JUNE 24, 2021

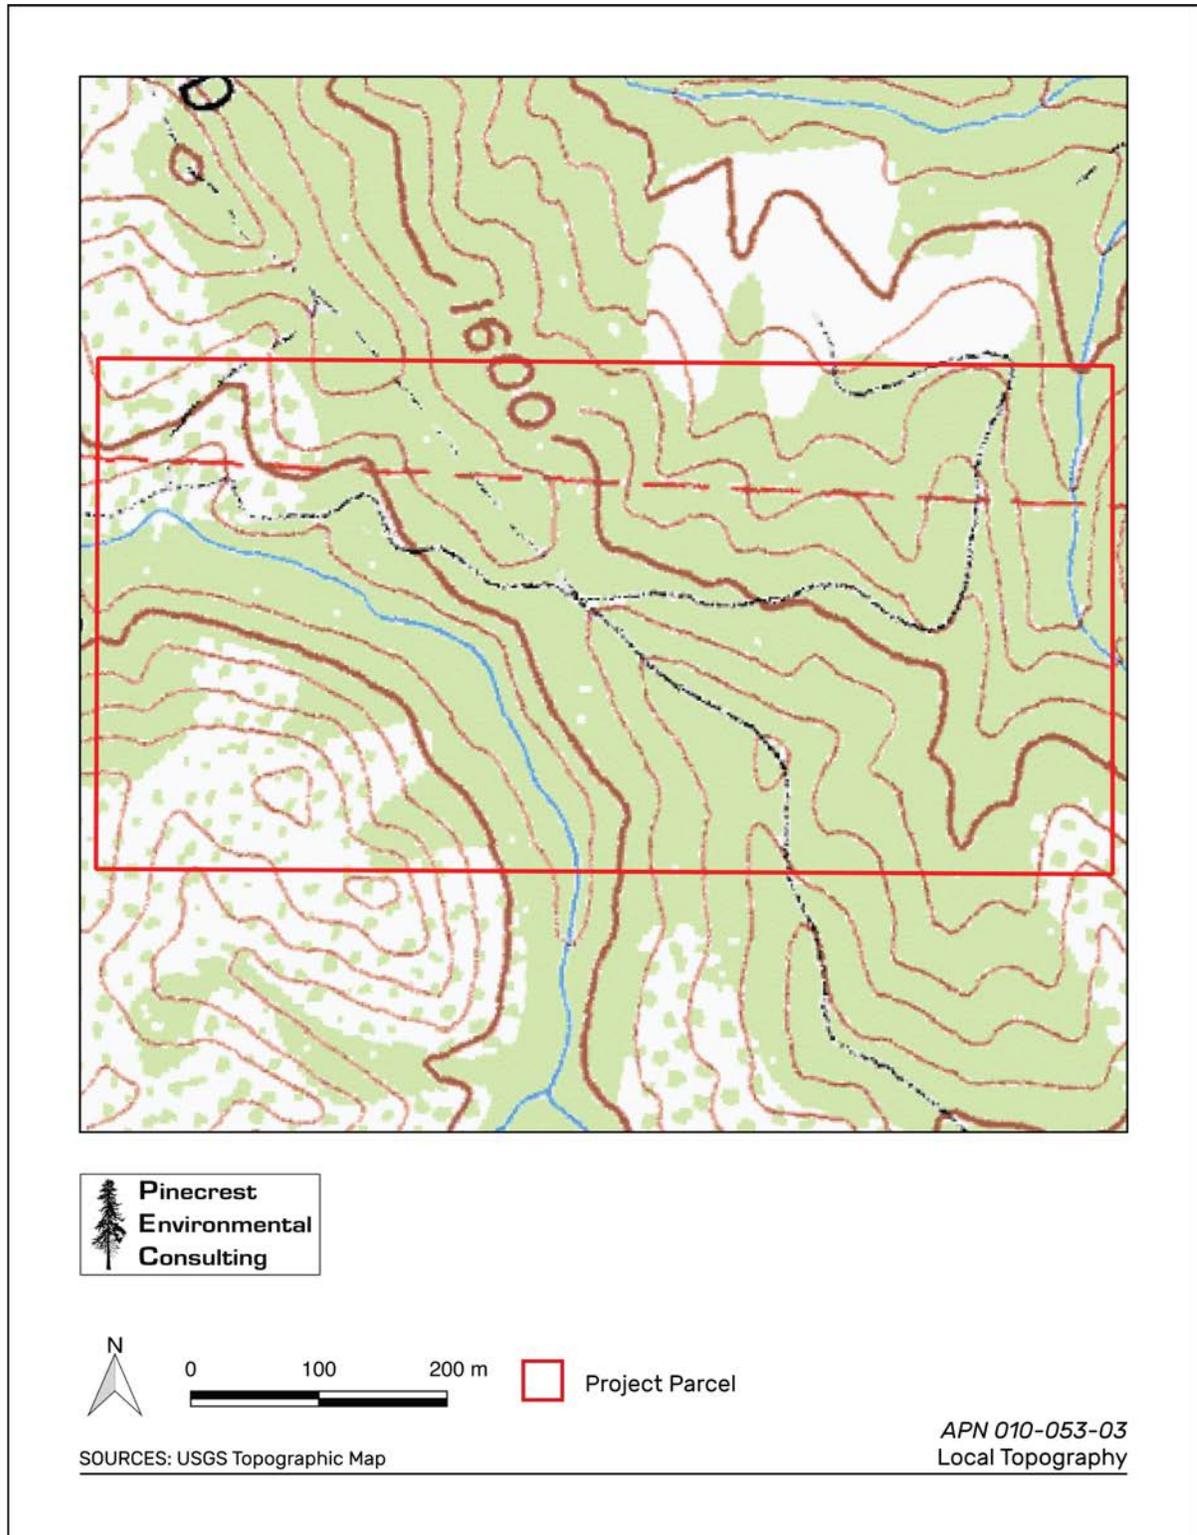
**FIGURE 2: 40 FOOT CONTOURS**

Precipitation mostly infiltrates locally due to the lack of a significant upslope watershed (Figure 2). During large storm events water may flow overland primarily as unconsolidated sheet flow into the series of ephemeral Class III watercourses. All water onsite eventually drains towards the center of the property into Blackeye Canyon, which flows west for 1.9 miles before entering the Burns Valley,

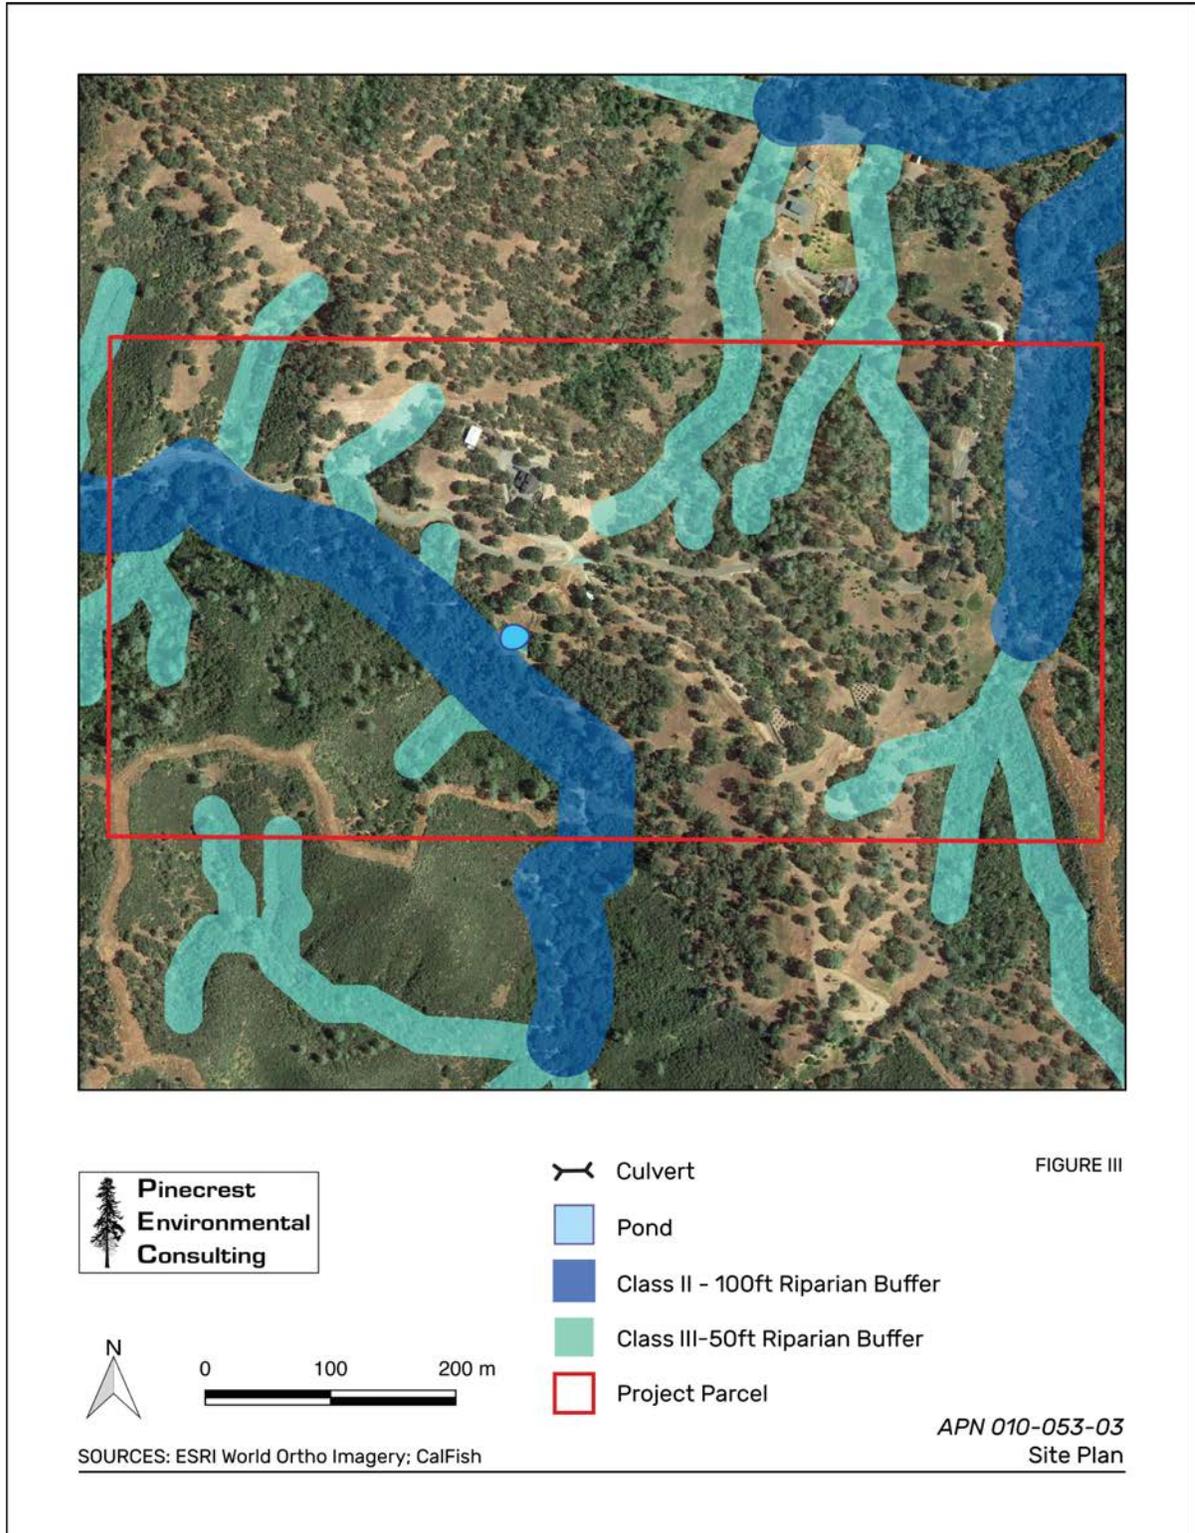
**FIGURE 3: WATER FEATURES**

There are several unnamed ephemeral Class III watercourses that flow towards an unnamed seasonal Class II watercourse that flows west through Blackeye Canyon (Figure 3). There is also an unnamed seasonal Class II watercourse with several Class III spurs that exists in the far northeast corner of the parcel and drains towards the northeast. Two culverts convey water beneath the access roads onsite (Figures 7 & 8) and are both in good condition and have rock protection installed up and downstream. There is additionally one stock pond that exists south of the main road (Figure 13) that does not appear to have a channelized inlet source. There are no areas onsite that appear to be potential wetlands.

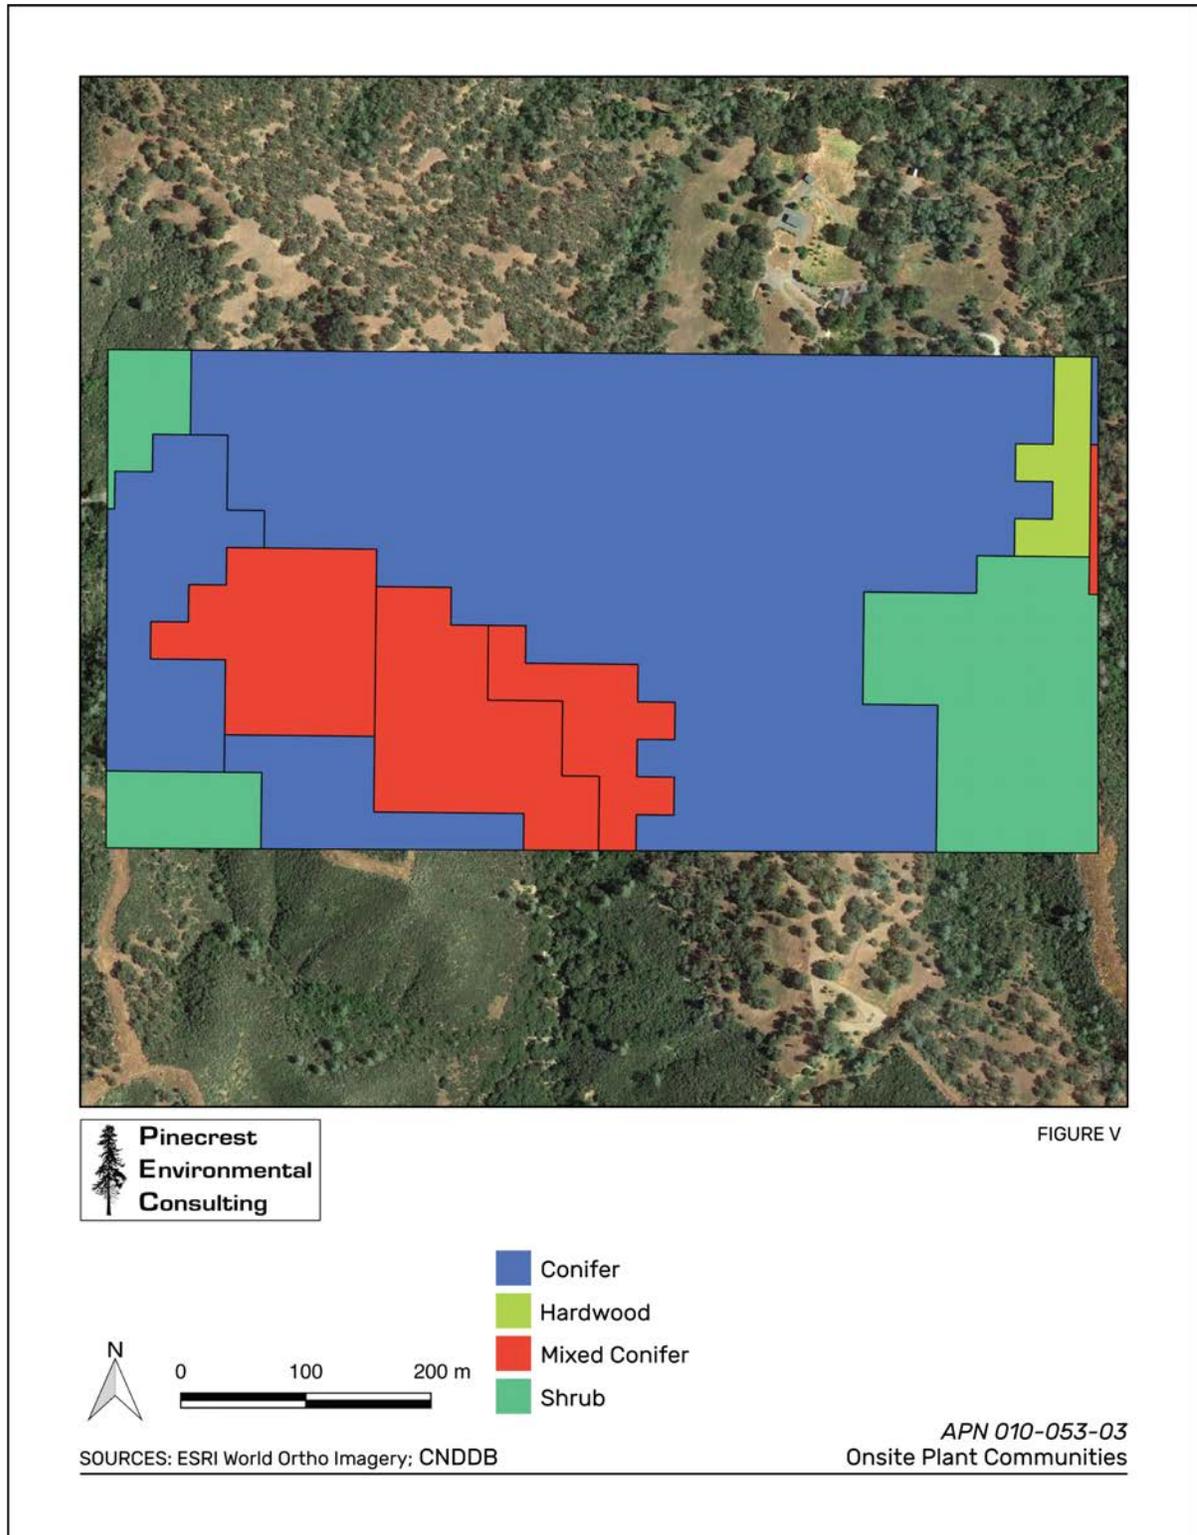
**FIGURE 5: ONSITE PLANT COMMUNITIES**

Overall, the parcel consists of approximately 70% Blue oak woodland, 20% *Chamise* chaparral, and 10% annual grassland and developed area (Figure 5). The bottom of Blackeye Canyon contains a slightly higher proportion of hardwood and riparian species and so is treated separately, below. The grassland and chaparral habitats are continuous with the oak woodland habitat and the entirety of the parcel is more or less homogenous in community composition. The specific community descriptions below are organized based on the zones that were surveyed, and the floristic results presented in Appendix B.

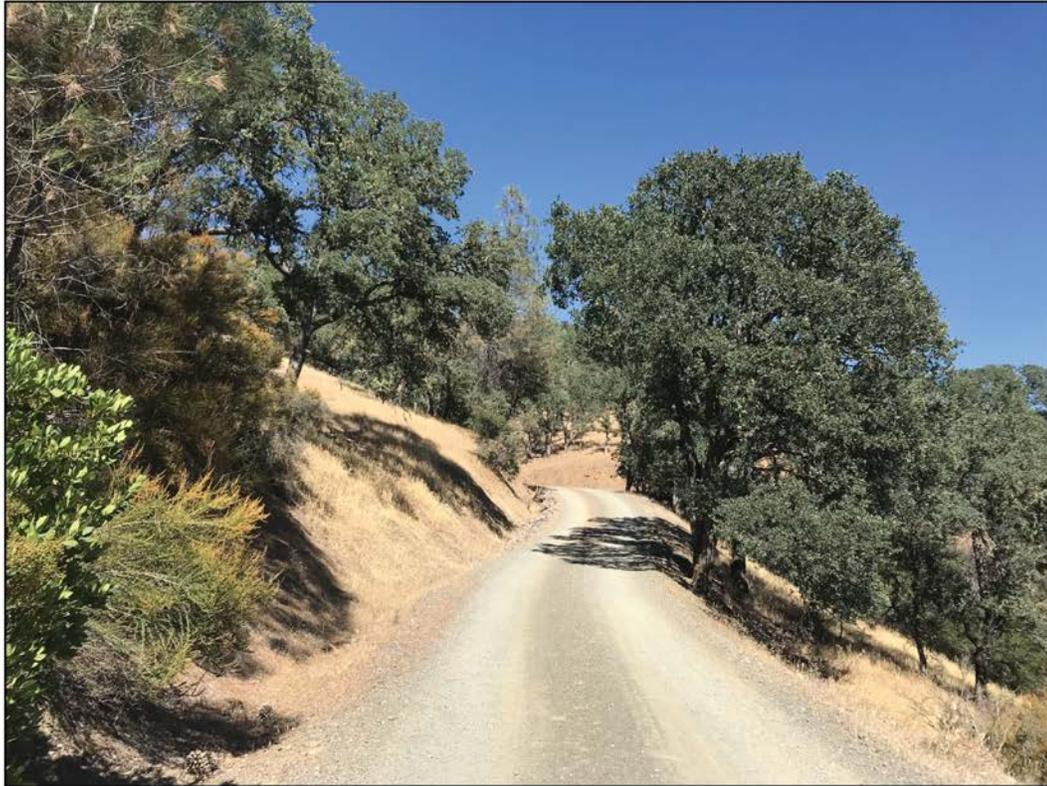
**FIGURE 6: PHOTOGRAPH OF ACCESS ROAD**

The driveway that passes through Blackeye Canyon is known as Ogulin Canyon Road and is in good condition, packed dirt and gravel (Figure 6). Access is controlled by a locking metal automatic entry gate equipped with emergency lock access box. The road is in good condition and exhibits rock protection in numerous locations. Culverts are well built and maintained free of debris and appear to be adequately sized. There is one occupied single family residence onsite that is located approximately 0.3 miles past the entrance to the parcel. An existing 1,500 gallon septic system exits downhill from the main residence to the southeast. The proposed cultivation areas are located approximately 0.15 miles further to the east on the top of the main ridge (Figure 9) in an area of annual grassland and blue oak trees. There is a solar powered well located near the residence and water is pumped into a series of HDPE water storage tanks located at the top of the ridge near the proposed cultivation areas. The cultivation areas are surrounded by chain link fencing with visibility screening. There is a vehicle garage and outbuilding onsite but no other permanent structures.

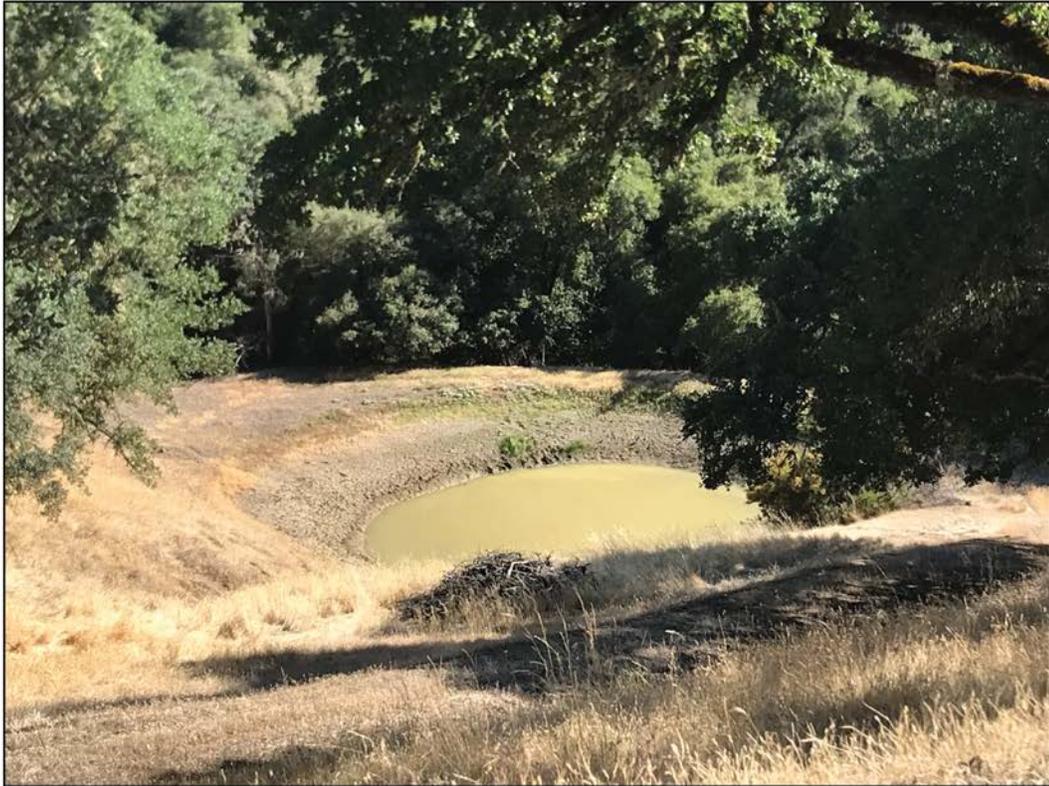
**FIGURE 13: PHOTOGRAPH OF STOCK POND**

The stock pond is not likely to be jurisdictional due to the lack of a defined inlet stream, and it is our recommendation that this feature is not an instream reservoir and instead collects subsurface flow locally. The stock pond is small and measures approximately 0.06 surface acres and has an outlet composed of a 24" corrugated metal pipe that is buried into the earthen fill dam and spills out into an area of intact vegetation to the west. There was no streamchannel observed associated with the outfall and it does not appear that the outfall spills every year.
