Appendix HAZ

Phase I Environmental Site Assessment and Phase II Subsurface Investigation

**PHASE I ENVIRONMENTAL SITE ASSESSMENT
730 Central Avenue
Mountain View, California 94043
ERAS Project Number 19128**

ERAS Environmental, Inc.
November 25, 2019

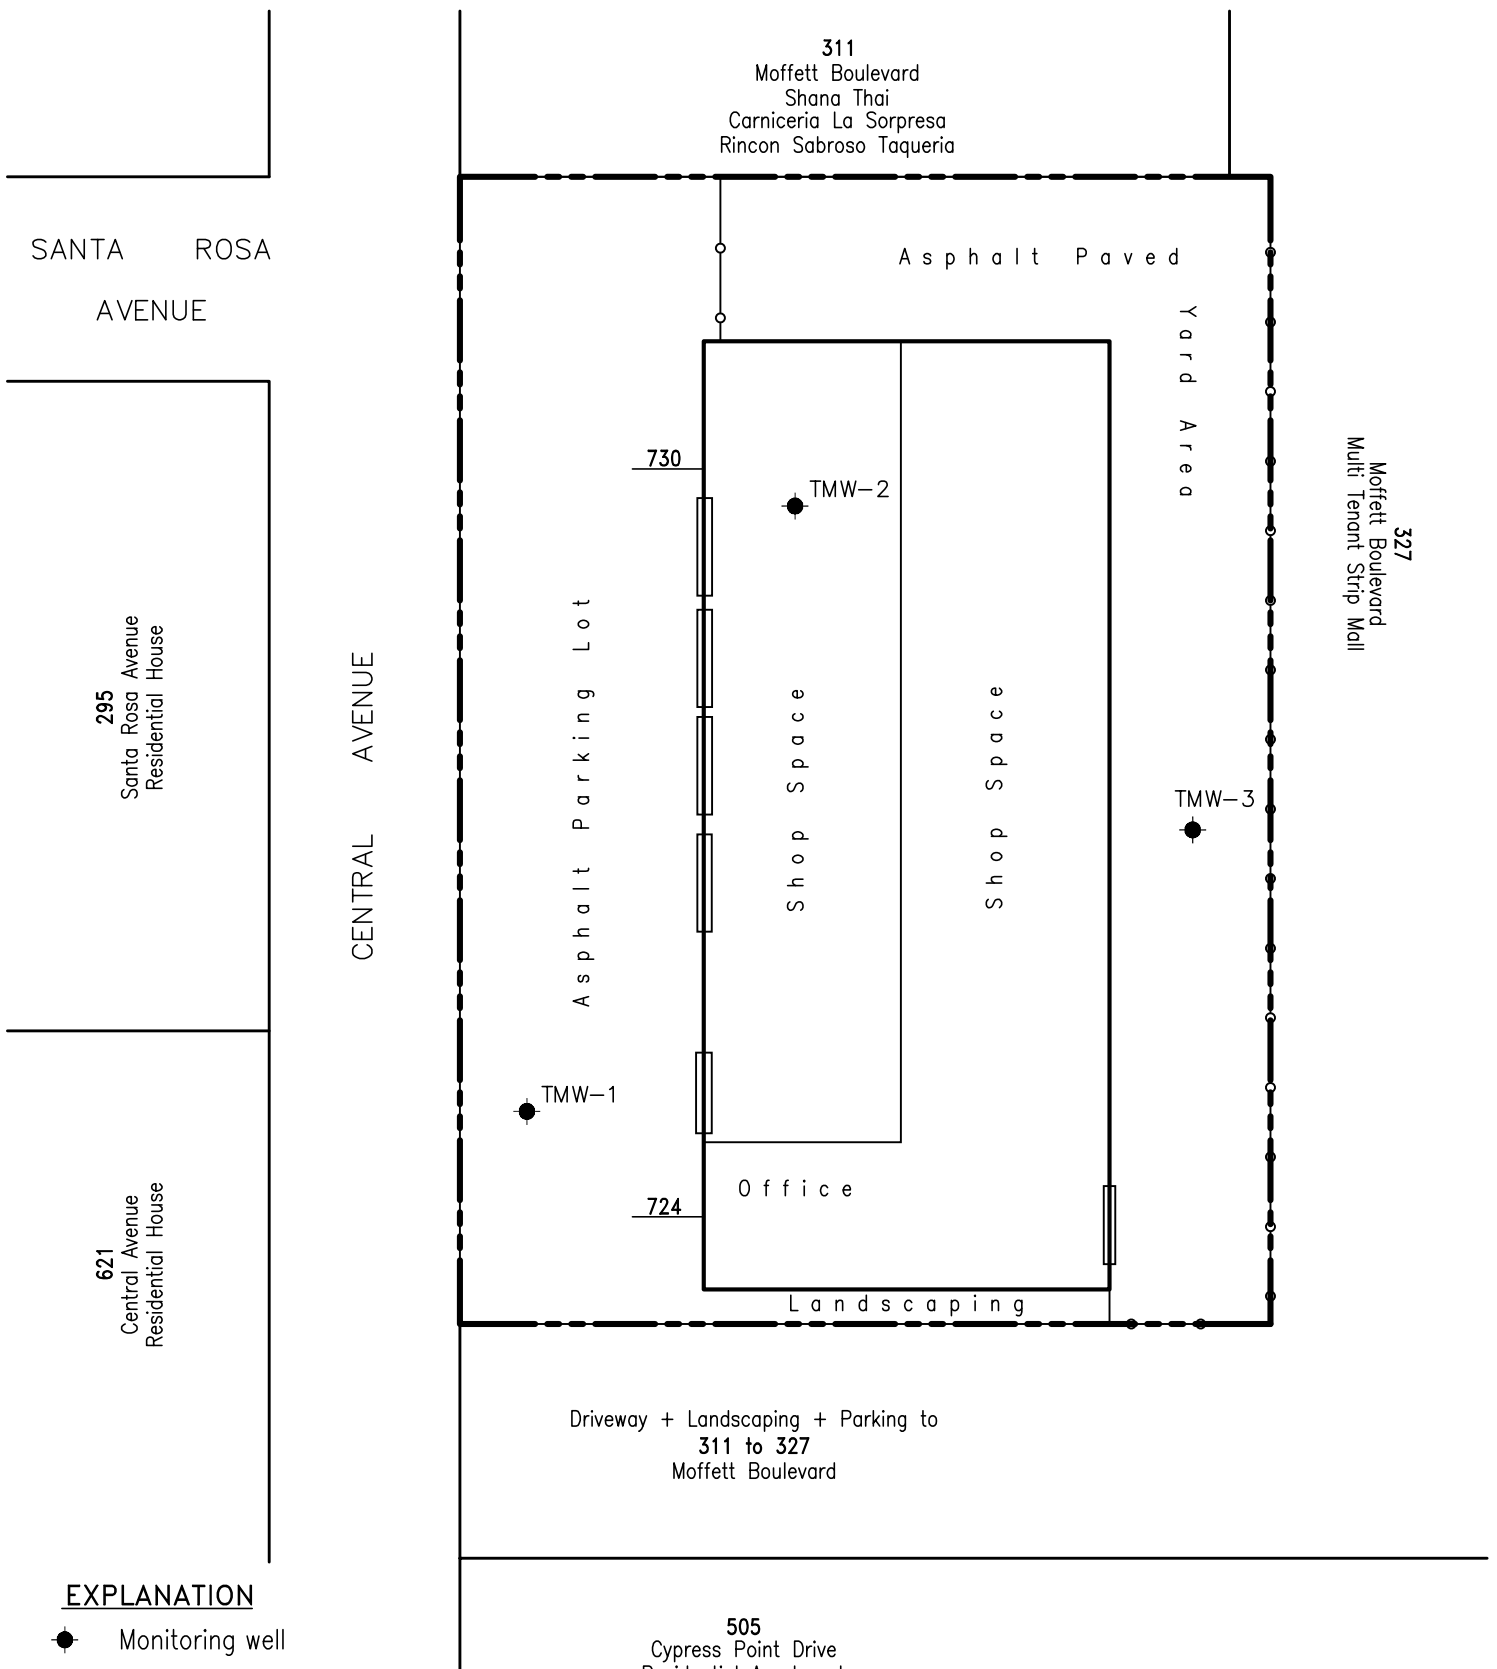
● Monitoring well

Three groundwater monitoring wells were observed on the Property. The well lids of all three monitoring wells were opened and the wells were observed to be constructed of 1-inch PVC casing.

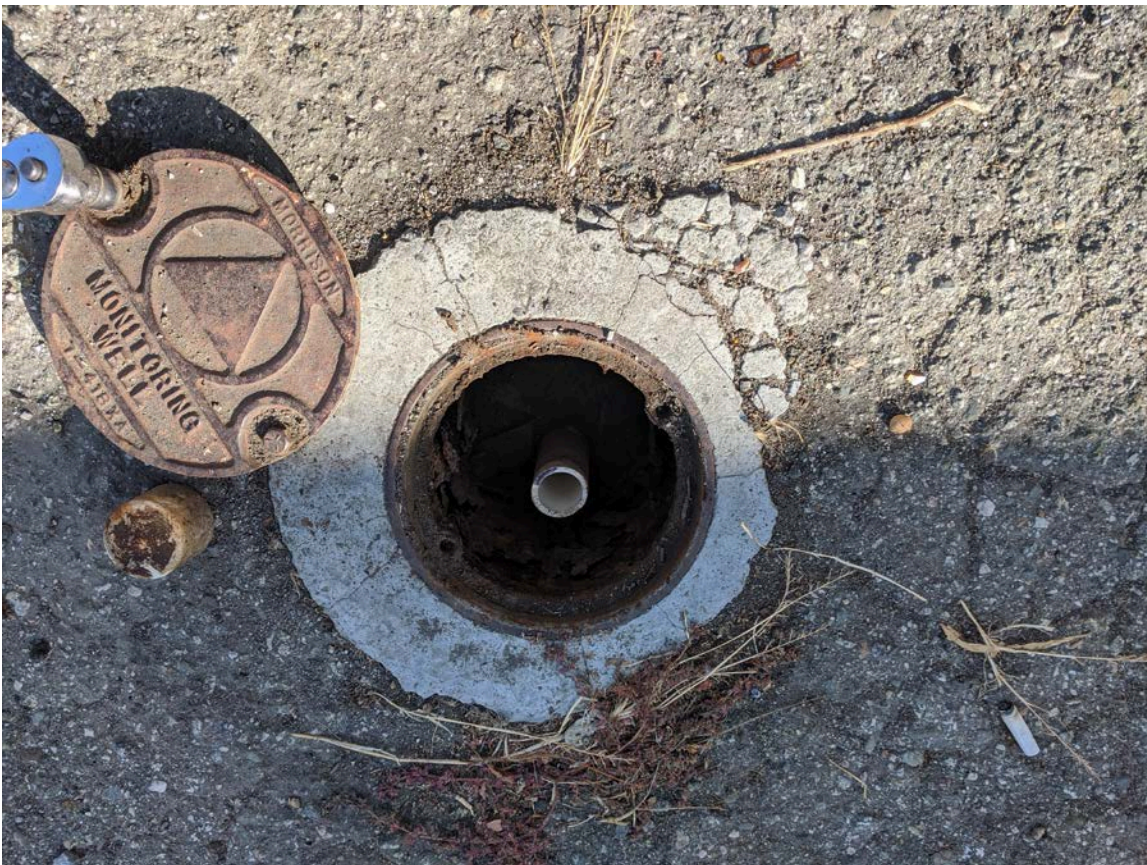
Photograph 8 - View of one of the three groundwater monitoring wells on the Property

ERAS contacted the RWQCB and was informed that the monitoring wells located on the Property should be properly abandoned under permit. The RWQCB also confirmed that the Property was not considered an open leak case.

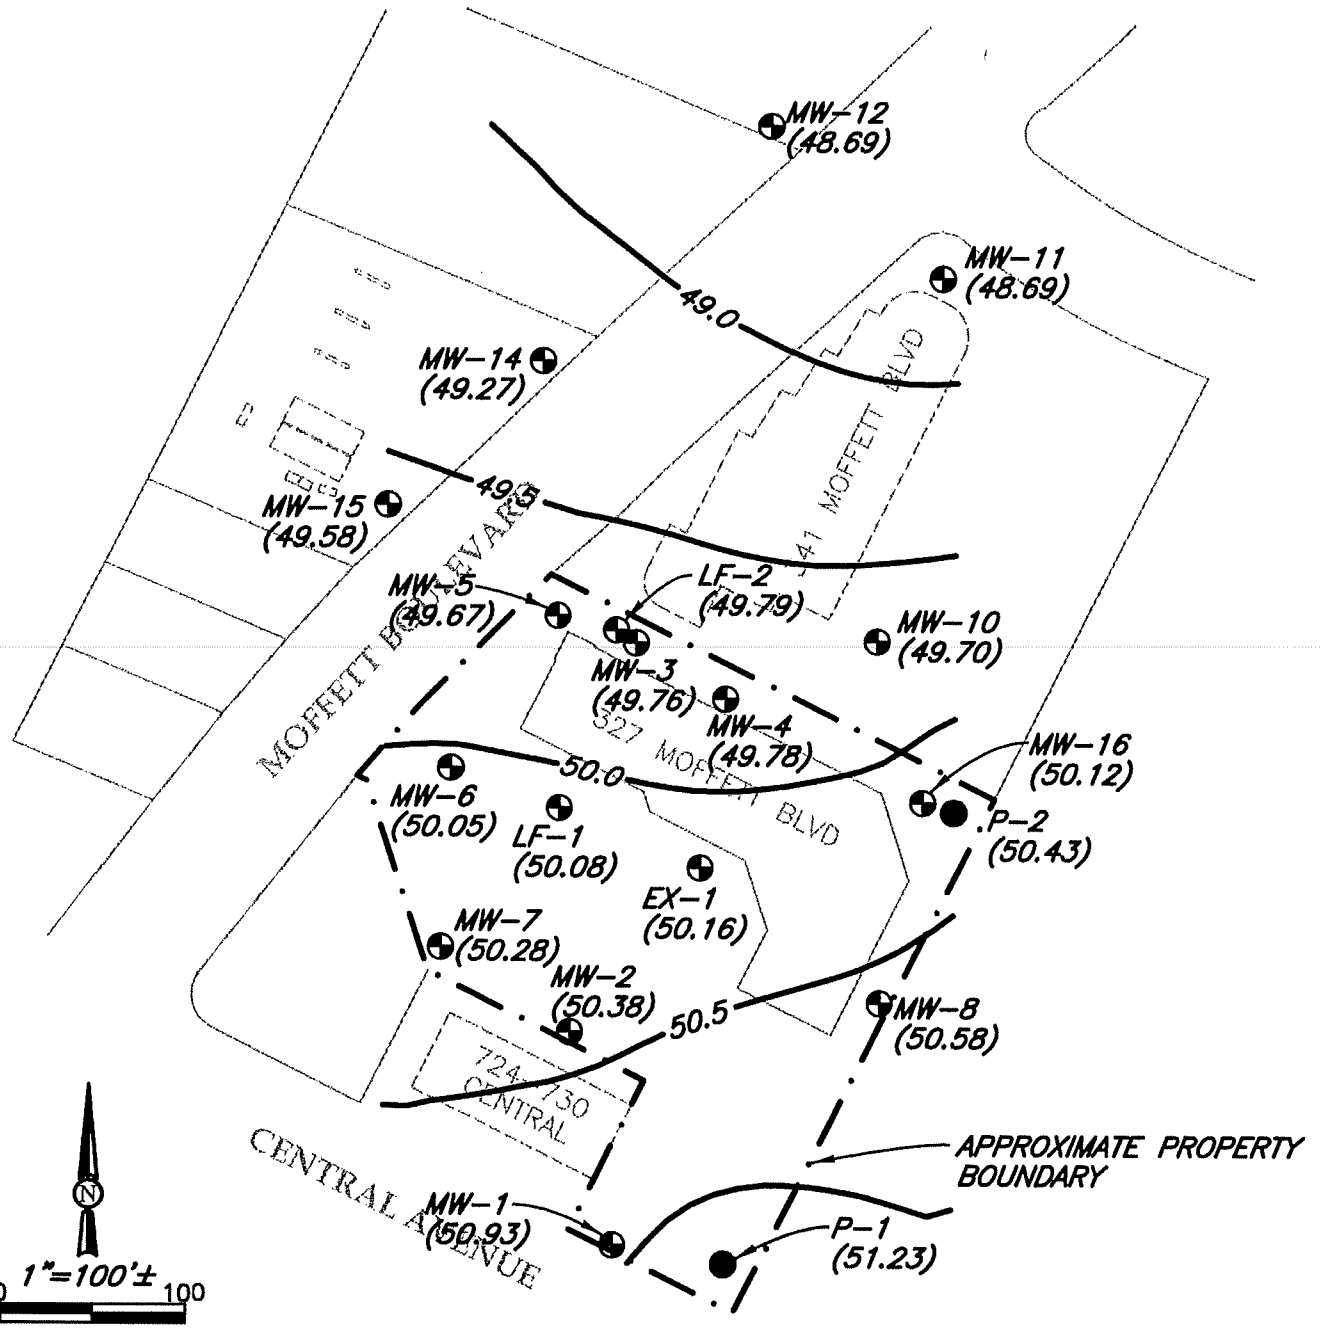
Figure 3

1. BASE MAP DEVELOPED FROM COUNTY OF SANTA CLARA COUNTY ASSESSORS MAPS, SURVEY DATA PROVIDED BY KEIR & WRIGHT, FIELD OBSERVATIONS, AND MAPS PRODUCED BY ENVIRON CORPORATION AND GEOPLEXUS, INC.
2. THIS FIGURE REPRESENTS ON INTERPRETATION OF THE DATA. OTHER INTERPRETATIONS OF THE SAME DATA MAY BE POSSIBLE.
3. ELEVATIONS REPORTED IN FEET ABOVE MEAN SEA LEVEL.
4. PIEZOMETRIC ELEVATIONS MEASURED ON OCTOBER 4, 2006.

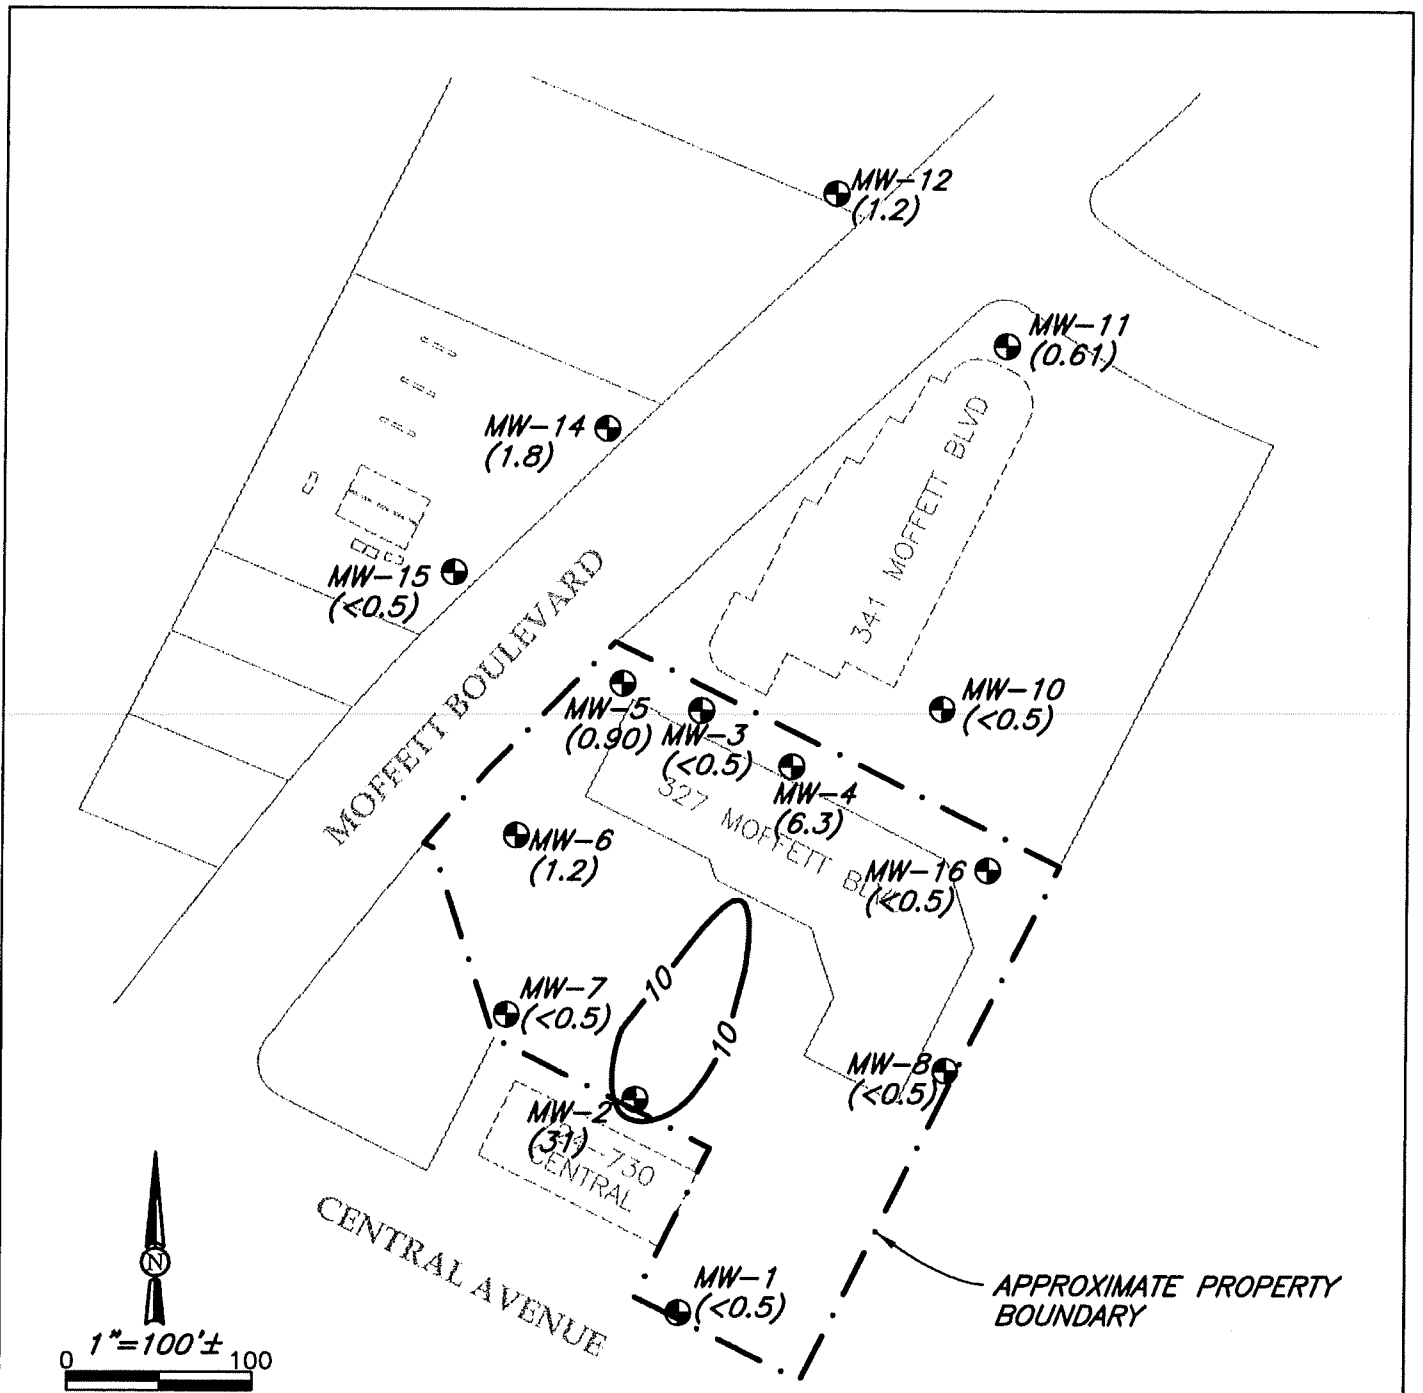
Figure 4

1. BASE MAP DEVELOPED FROM COUNTY OF SANTA CLARA COUNTY ASSESSORS MAPS, SURVEY DATA PROVIDED BY KEIR & WRIGHT, FIELD OBSERVATIONS, AND MAPS PRODUCED BY ENVIRON CORPORATION AND GEOPLEXUS, INC.
2. THIS FIGURE REPRESENTS AN INTERPRETATION OF THE DATA. OTHER INTERPRETATIONS OF THE SAME DATA MAY BE POSSIBLE.
3. GROUNDWATER SAMPLES COLLECTED ON OCTOBER 4 AND 5, 2006.

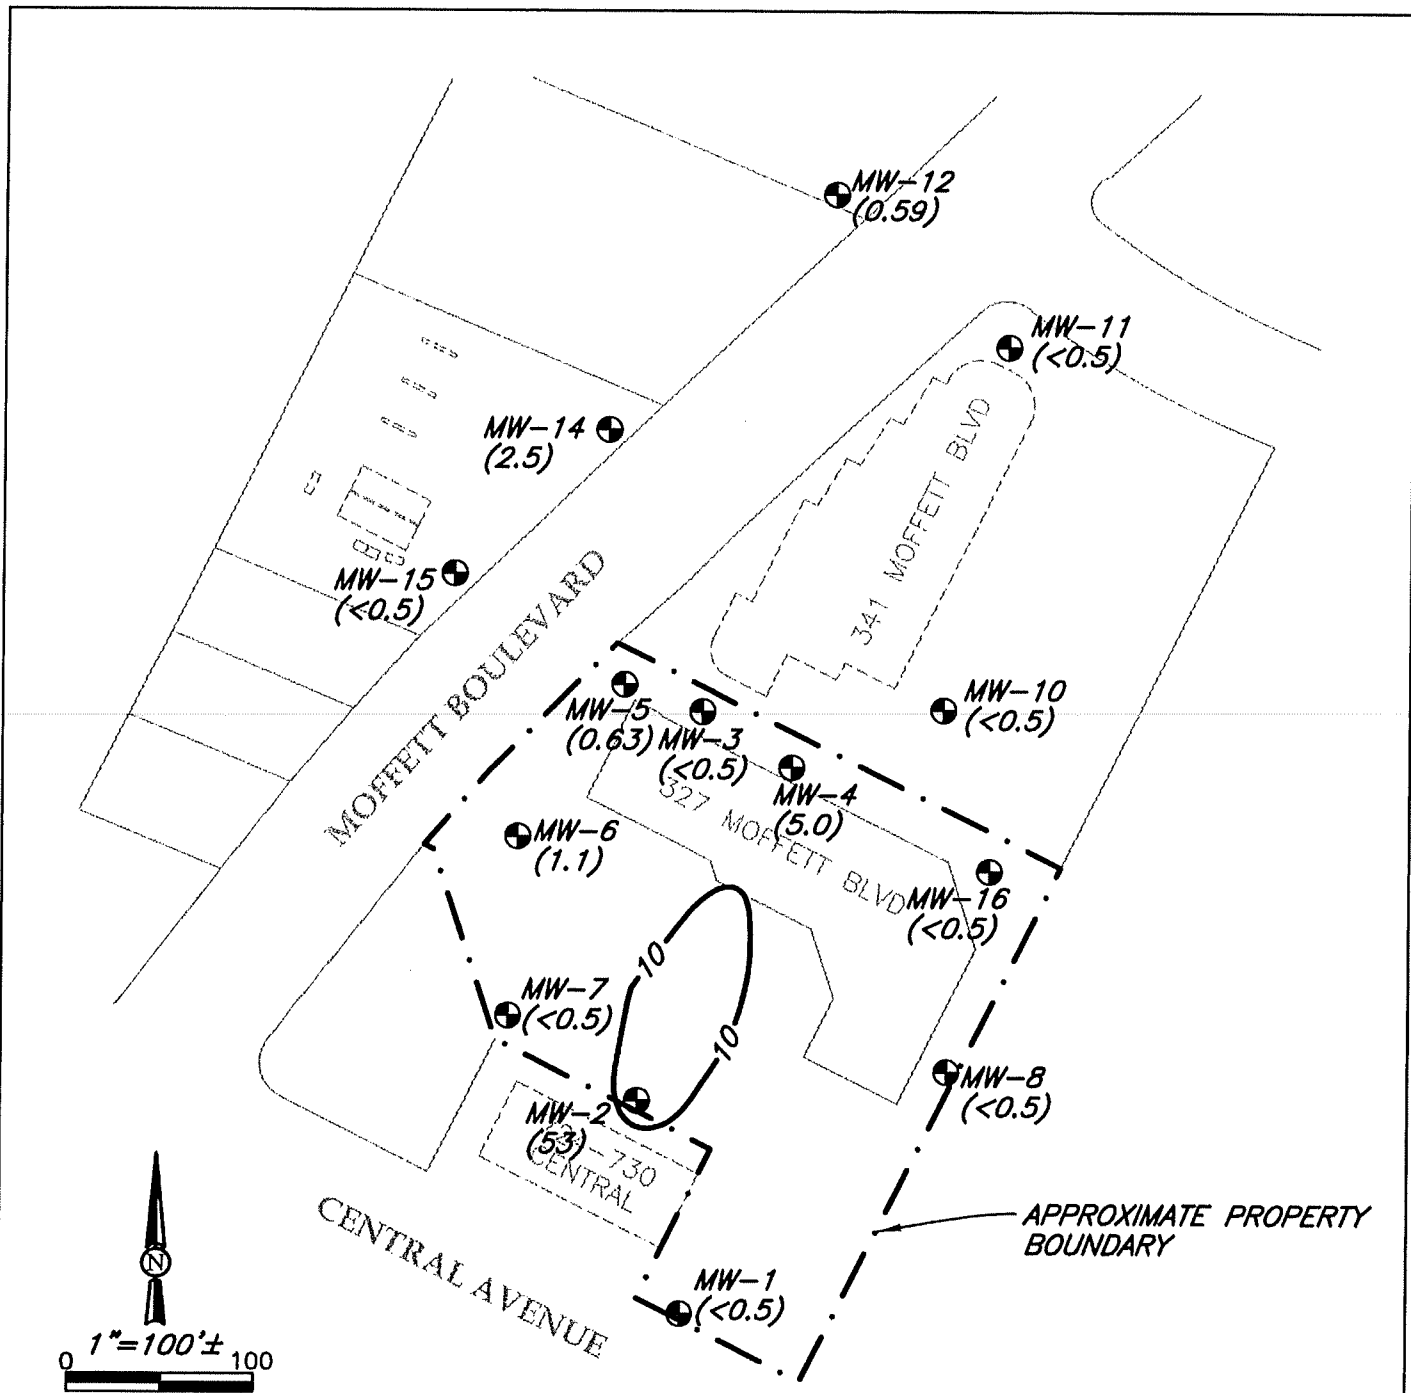
Figure 5

1. BASE MAP DEVELOPED FROM COUNTY OF SANTA CLARA COUNTY ASSESSORS MAPS, SURVEY DATA PROVIDED BY KEIR & WRIGHT, FIELD OBSERVATIONS, AND MAPS PRODUCED BY ENVIRON CORPORATION AND GEOPLEXUS, INC.
2. THIS FIGURE REPRESENTS ON INTERPRETATION OF THE DATA. OTHER INTERPRETATIONS OF THE SAME DATA MAY BE POSSIBLE.
3. GROUNDWATER SAMPLES COLLECTED ON OCTOBER 4 AND 5, 2006.

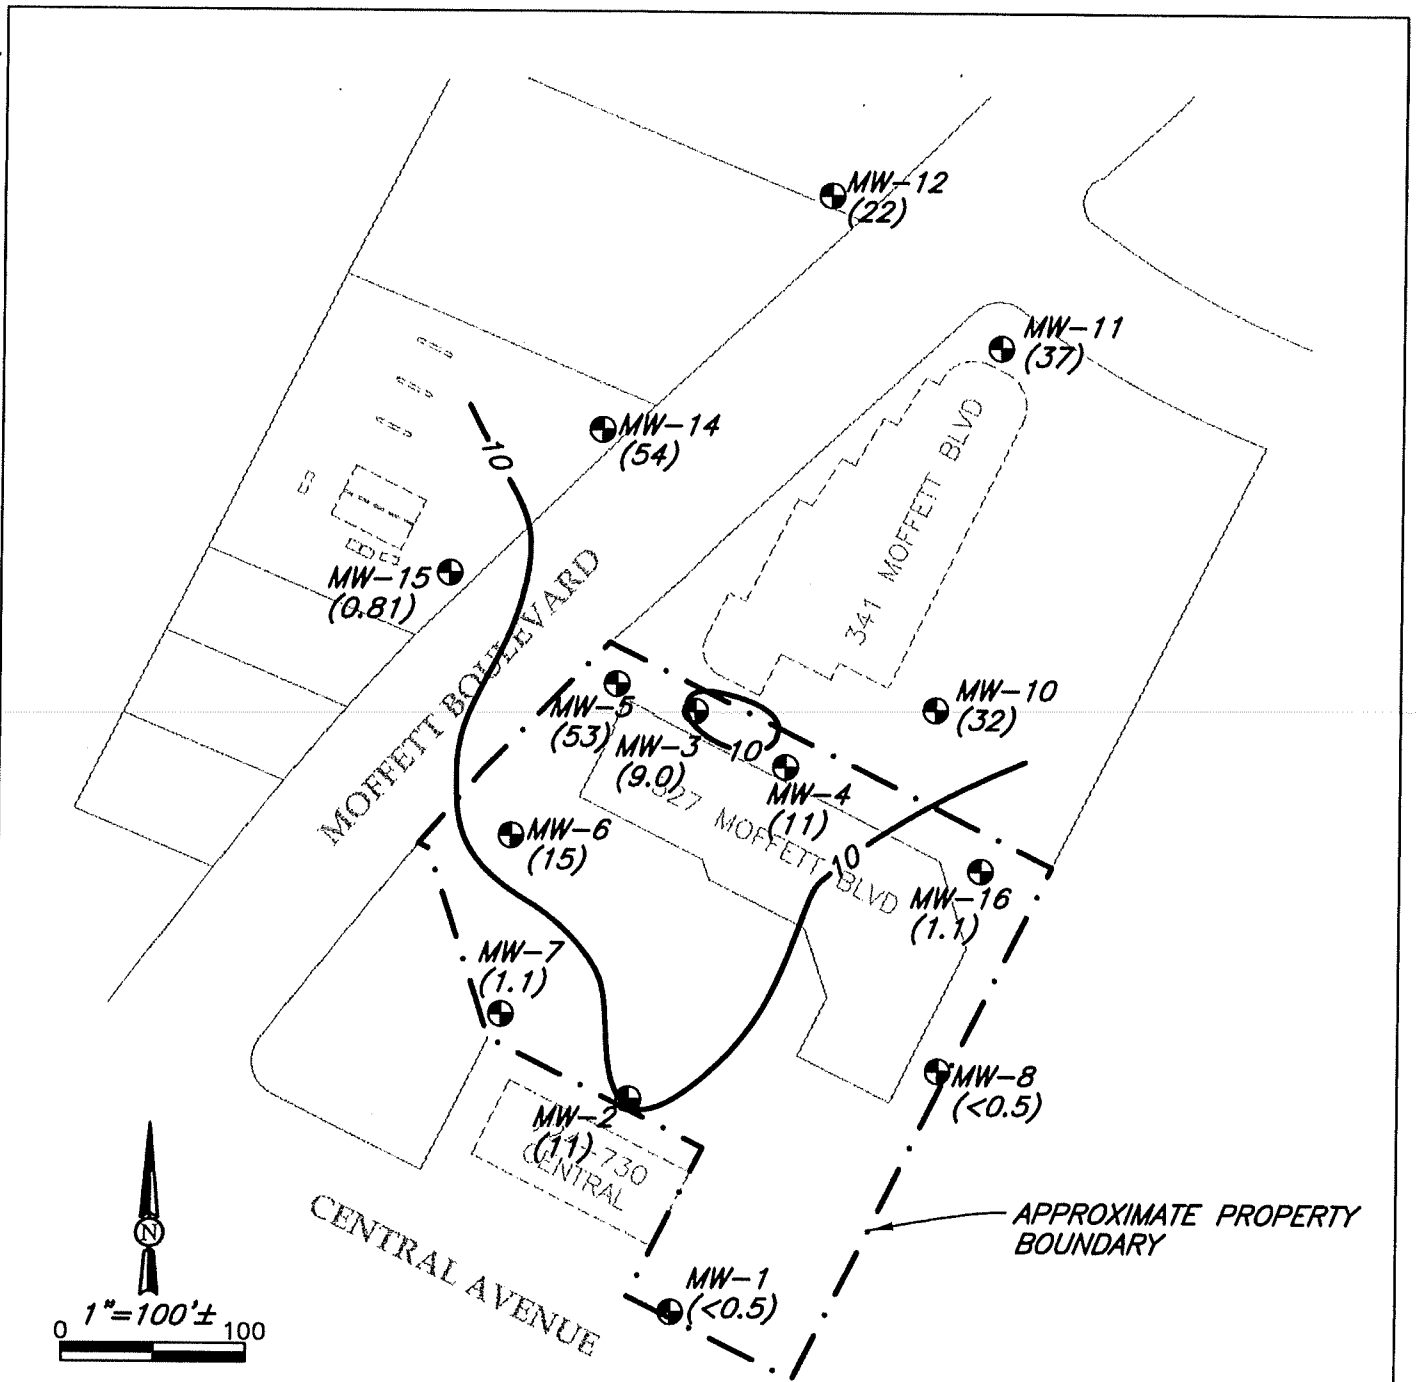
- 10- APPROXIMATE CONTOUR OF TCE CONCENTRATIONS IN SHALLOW AQUIFER ZONE GROUNDWATER
- MW-1 MONITORING WELL LOCATION AND DESIGNATION
- (54) REPORTED TCE CONCENTRATIONS IN SHALLOW AQUIFER ZONE GROUNDWATER SAMPLES (ug/l)

Union Bank of California 327 Moffett Boulevard Mountain View, California	Shallow Aquifer Zone TCE Concentration Contour Map October 2006 SHN 000289	
	November 2006	000289-TCE-OCT-2006	Figure 6

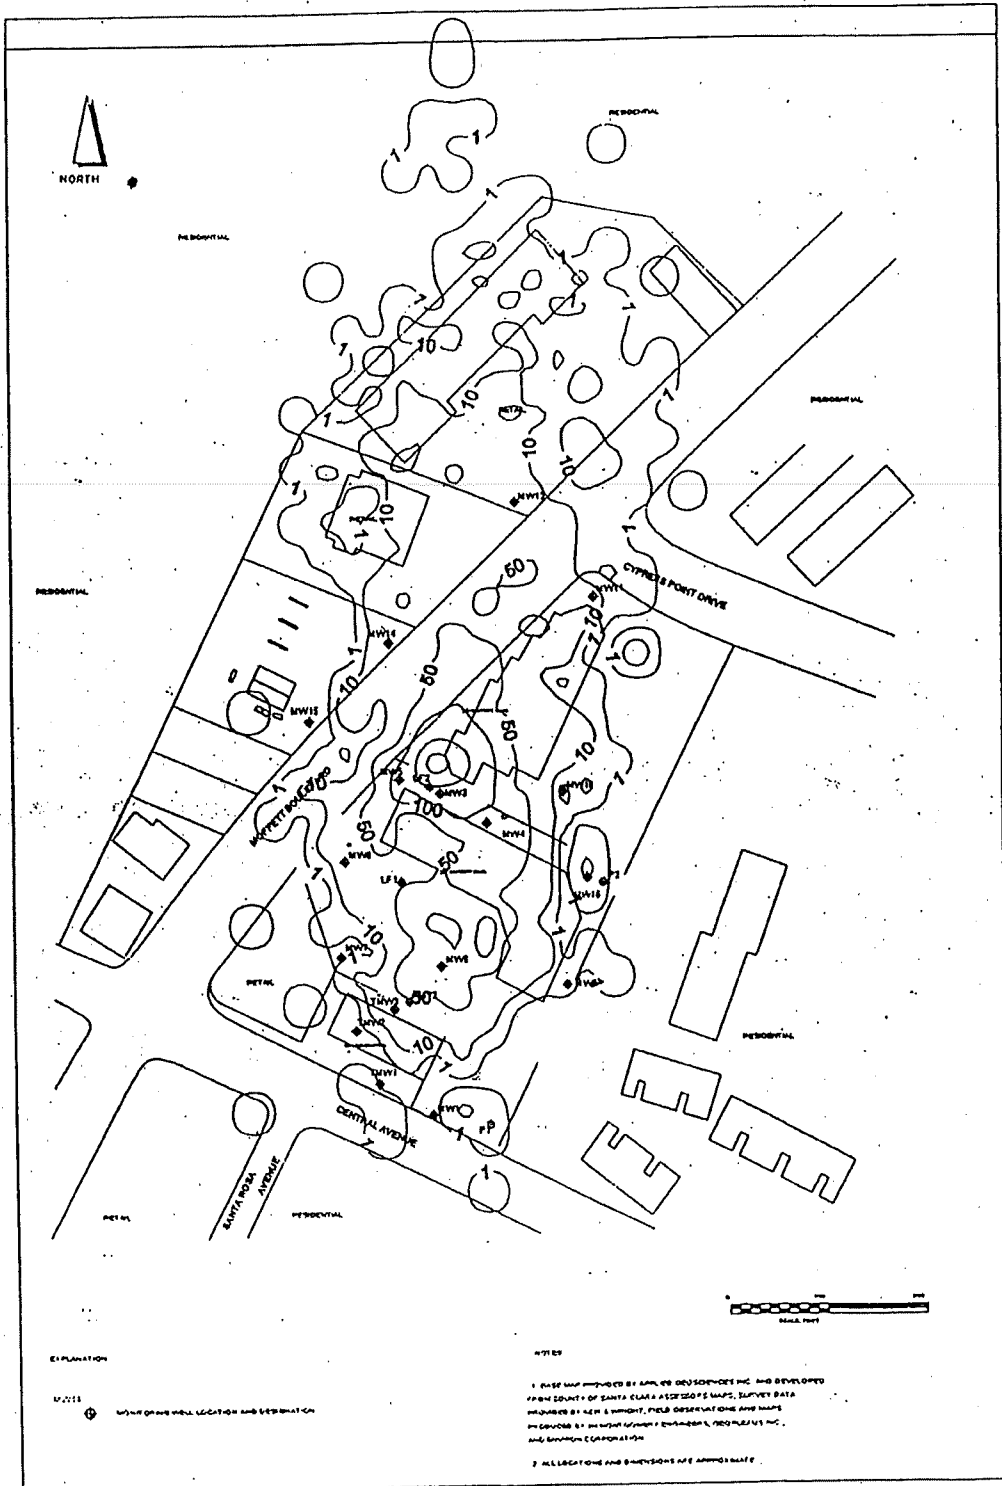
Figure 1. Simulated distribution of Trichloroethene, 1967 to 1995, for 327 MB only, at half-life of 10-years.

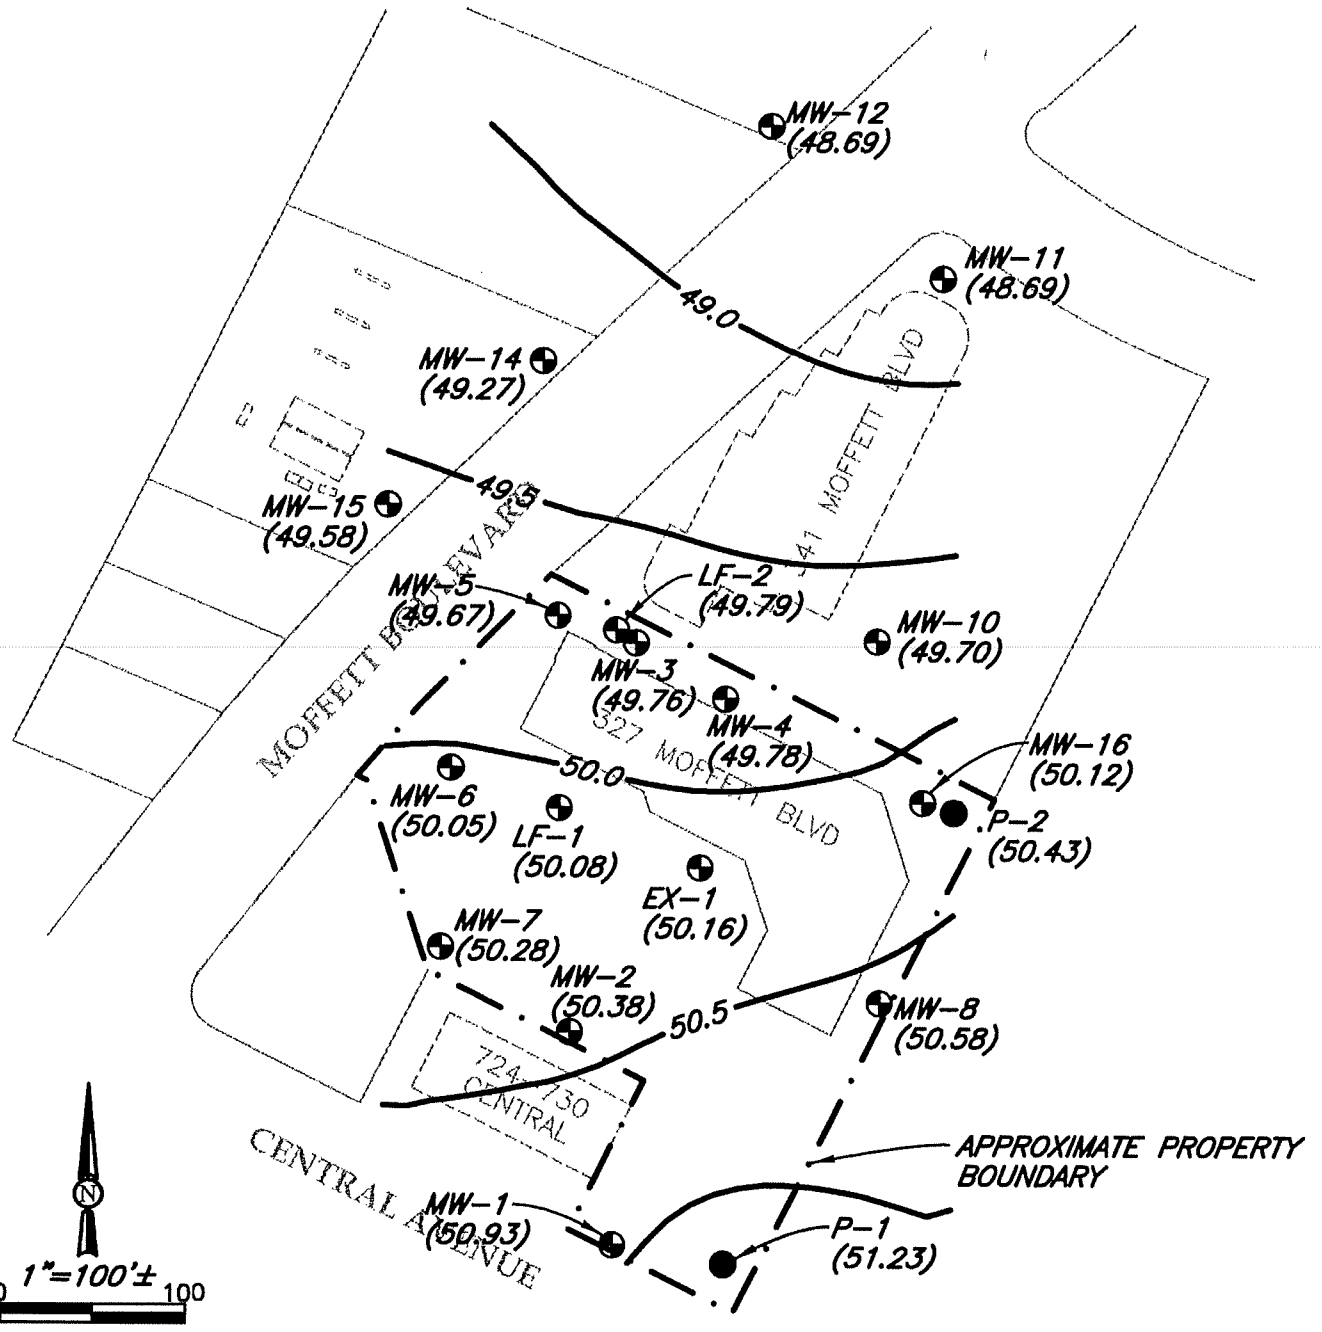
Figure 3

1. BASE MAP DEVELOPED FROM COUNTY OF SANTA CLARA COUNTY ASSESSORS MAPS, SURVEY DATA PROVIDED BY KEIR & WRIGHT, FIELD OBSERVATIONS, AND MAPS PRODUCED BY ENVIRON CORPORATION AND GEOPLEXUS, INC.
2. THIS FIGURE REPRESENTS ON INTERPRETATION OF THE DATA. OTHER INTERPRETATIONS OF THE SAME DATA MAY BE POSSIBLE.
3. ELEVATIONS REPORTED IN FEET ABOVE MEAN SEA LEVEL.
4. PIEZOMETRIC ELEVATIONS MEASURED ON OCTOBER 4, 2006.

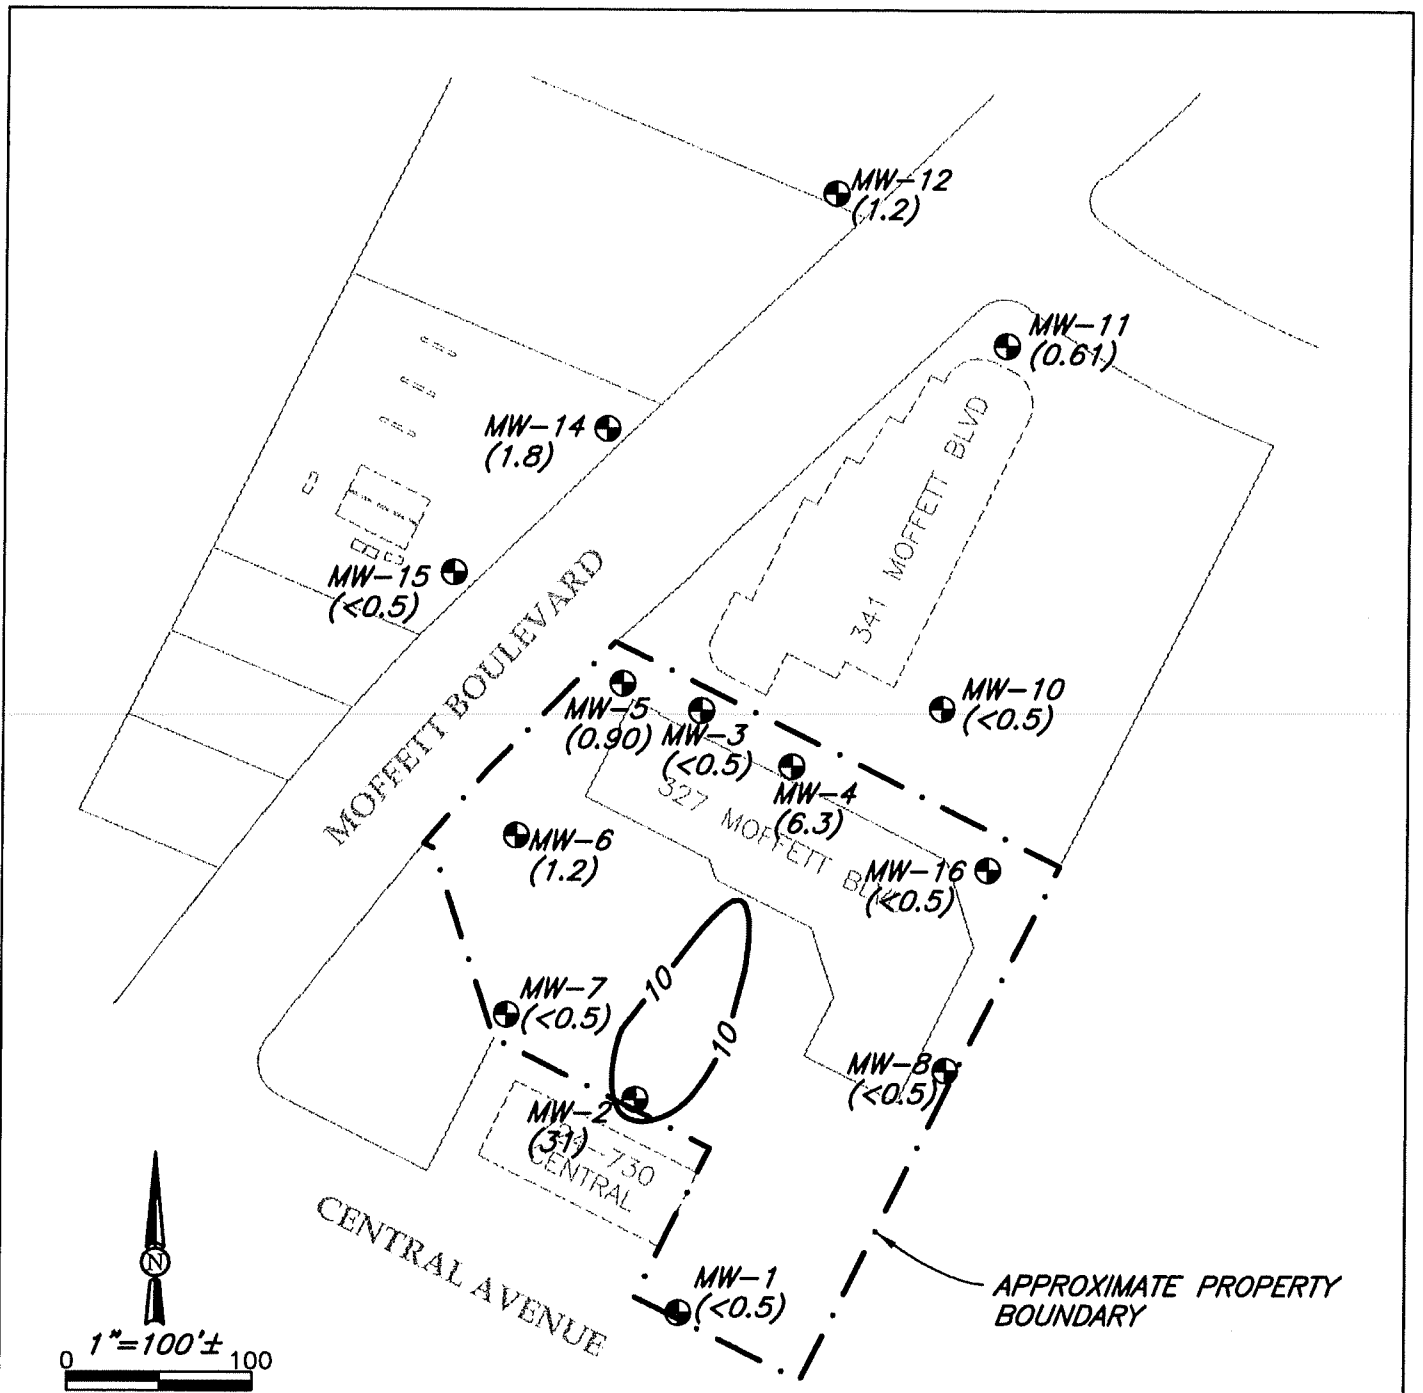
Figure 4

1. BASE MAP DEVELOPED FROM COUNTY OF SANTA CLARA COUNTY ASSESSORS MAPS, SURVEY DATA PROVIDED BY KEIR & WRIGHT, FIELD OBSERVATIONS, AND MAPS PRODUCED BY ENVIRON CORPORATION AND GEOPLEXUS, INC.
2. THIS FIGURE REPRESENTS AN INTERPRETATION OF THE DATA. OTHER INTERPRETATIONS OF THE SAME DATA MAY BE POSSIBLE.
3. GROUNDWATER SAMPLES COLLECTED ON OCTOBER 4 AND 5, 2006.

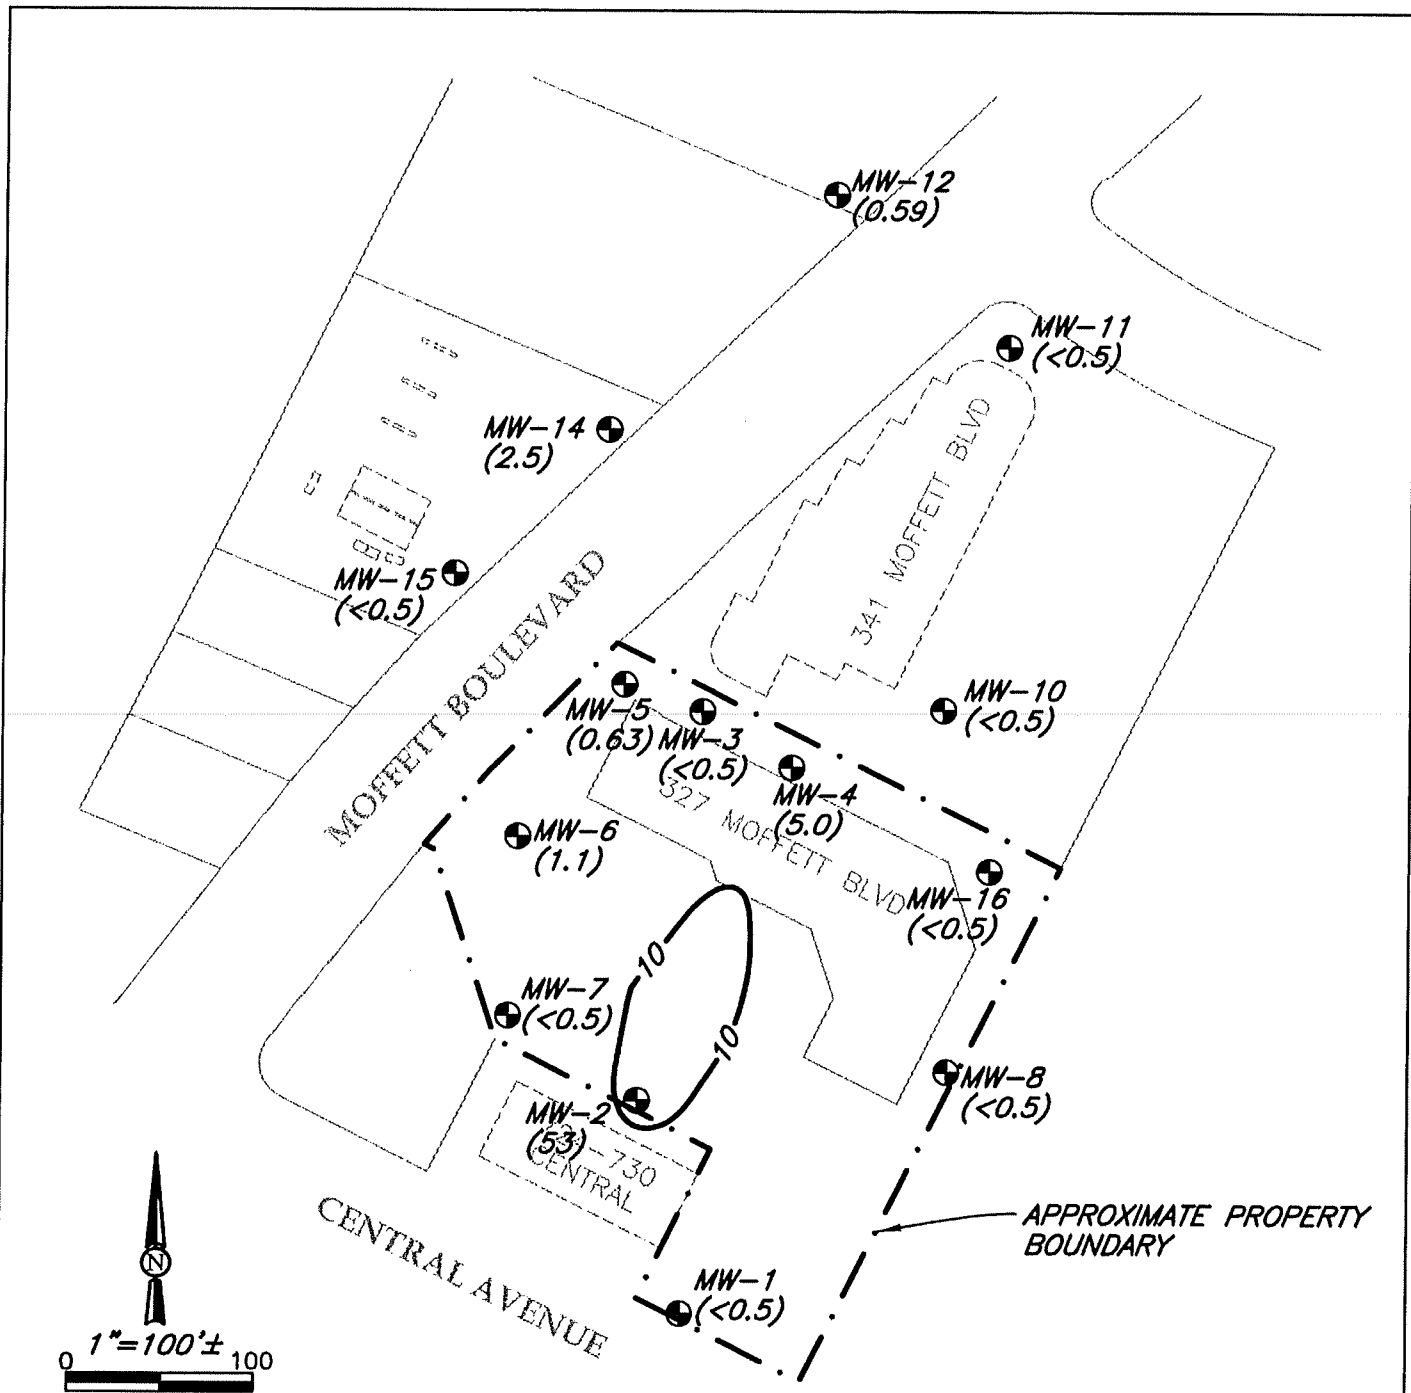
Figure 5

1. BASE MAP DEVELOPED FROM COUNTY OF SANTA CLARA COUNTY ASSESSORS MAPS, SURVEY DATA PROVIDED BY KEIR & WRIGHT, FIELD OBSERVATIONS, AND MAPS PRODUCED BY ENVIRON CORPORATION AND GEOPLEXUS, INC.
2. THIS FIGURE REPRESENTS ON INTERPRETATION OF THE DATA. OTHER INTERPRETATIONS OF THE SAME DATA MAY BE POSSIBLE.
3. GROUNDWATER SAMPLES COLLECTED ON OCTOBER 4 AND 5, 2006.

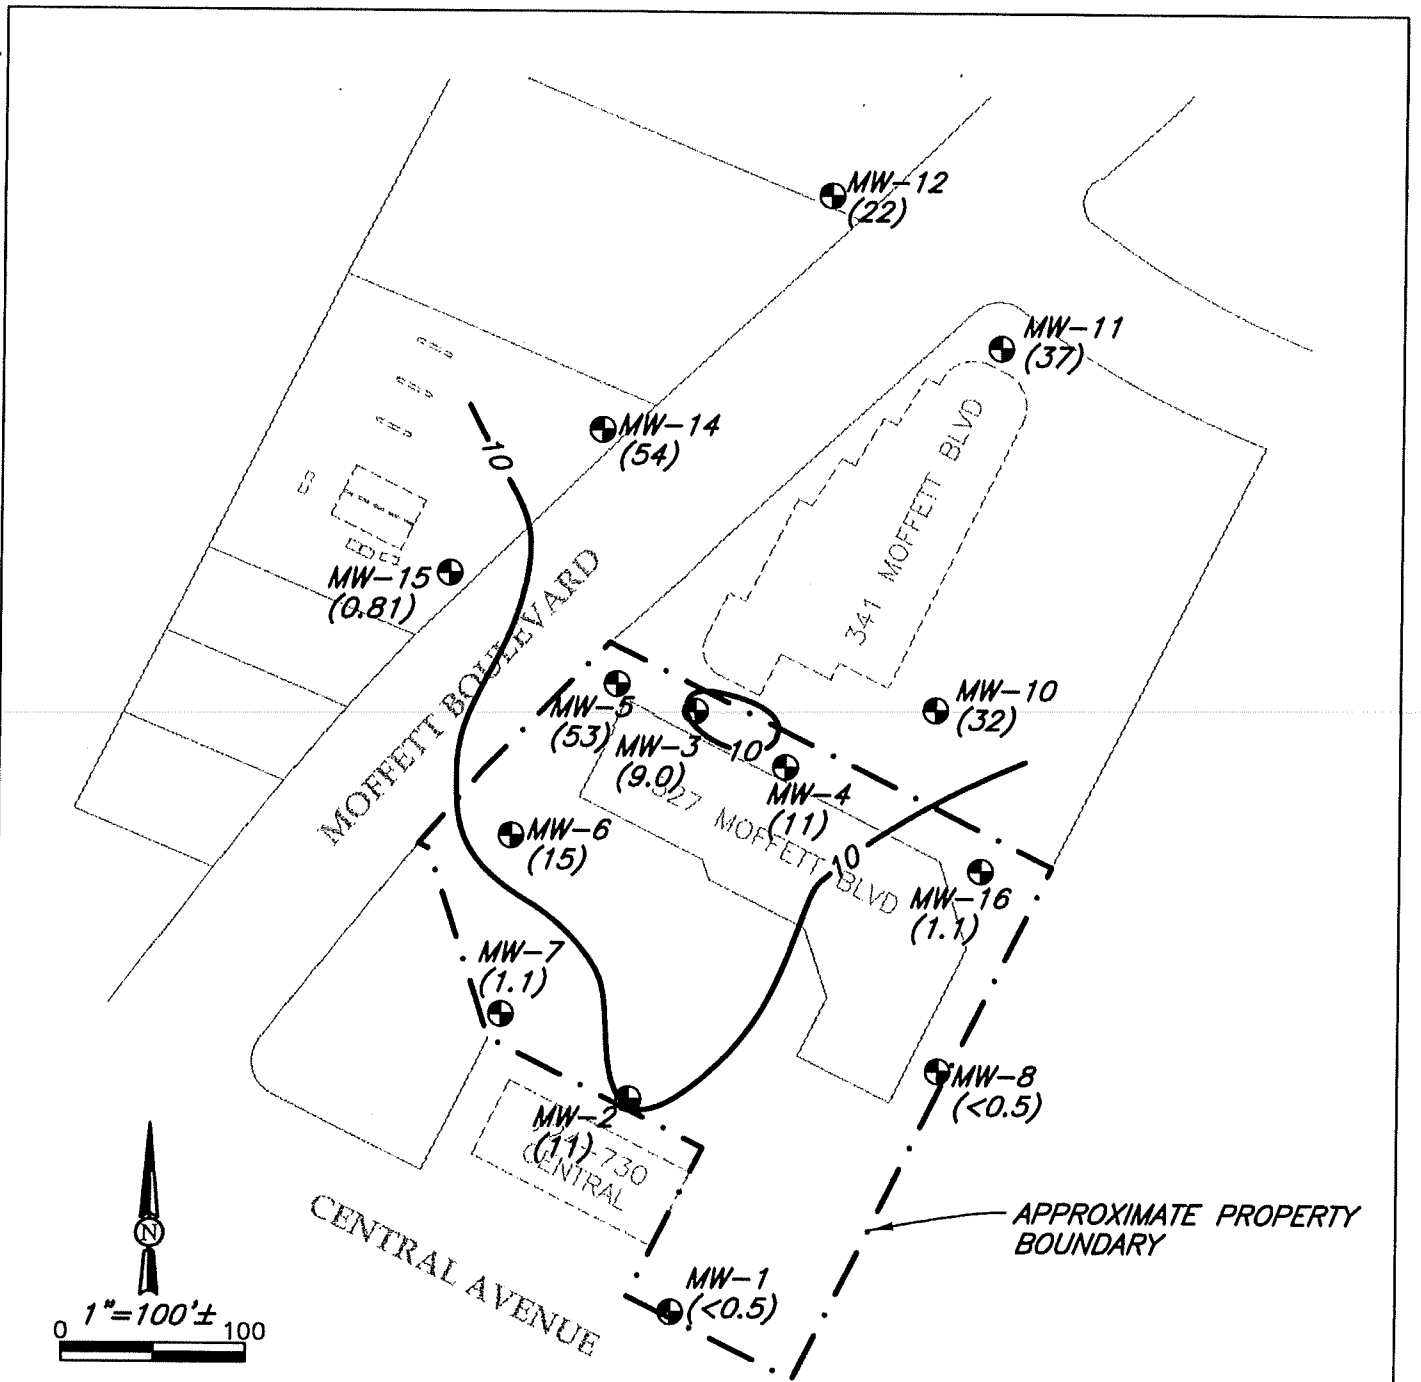
- 10- APPROXIMATE CONTOUR OF TCE CONCENTRATIONS IN SHALLOW AQUIFER ZONE GROUNDWATER
- MW-1 MONITORING WELL LOCATION AND DESIGNATION
- (54) REPORTED TCE CONCENTRATIONS IN SHALLOW AQUIFER ZONE GROUNDWATER SAMPLES (ug/l)

Union Bank of California 327 Moffett Boulevard Mountain View, California	Shallow Aquifer Zone TCE Concentration Contour Map October 2006 SHN 000289	
	November 2006	000289-TCE-OCT-2006	Figure 6

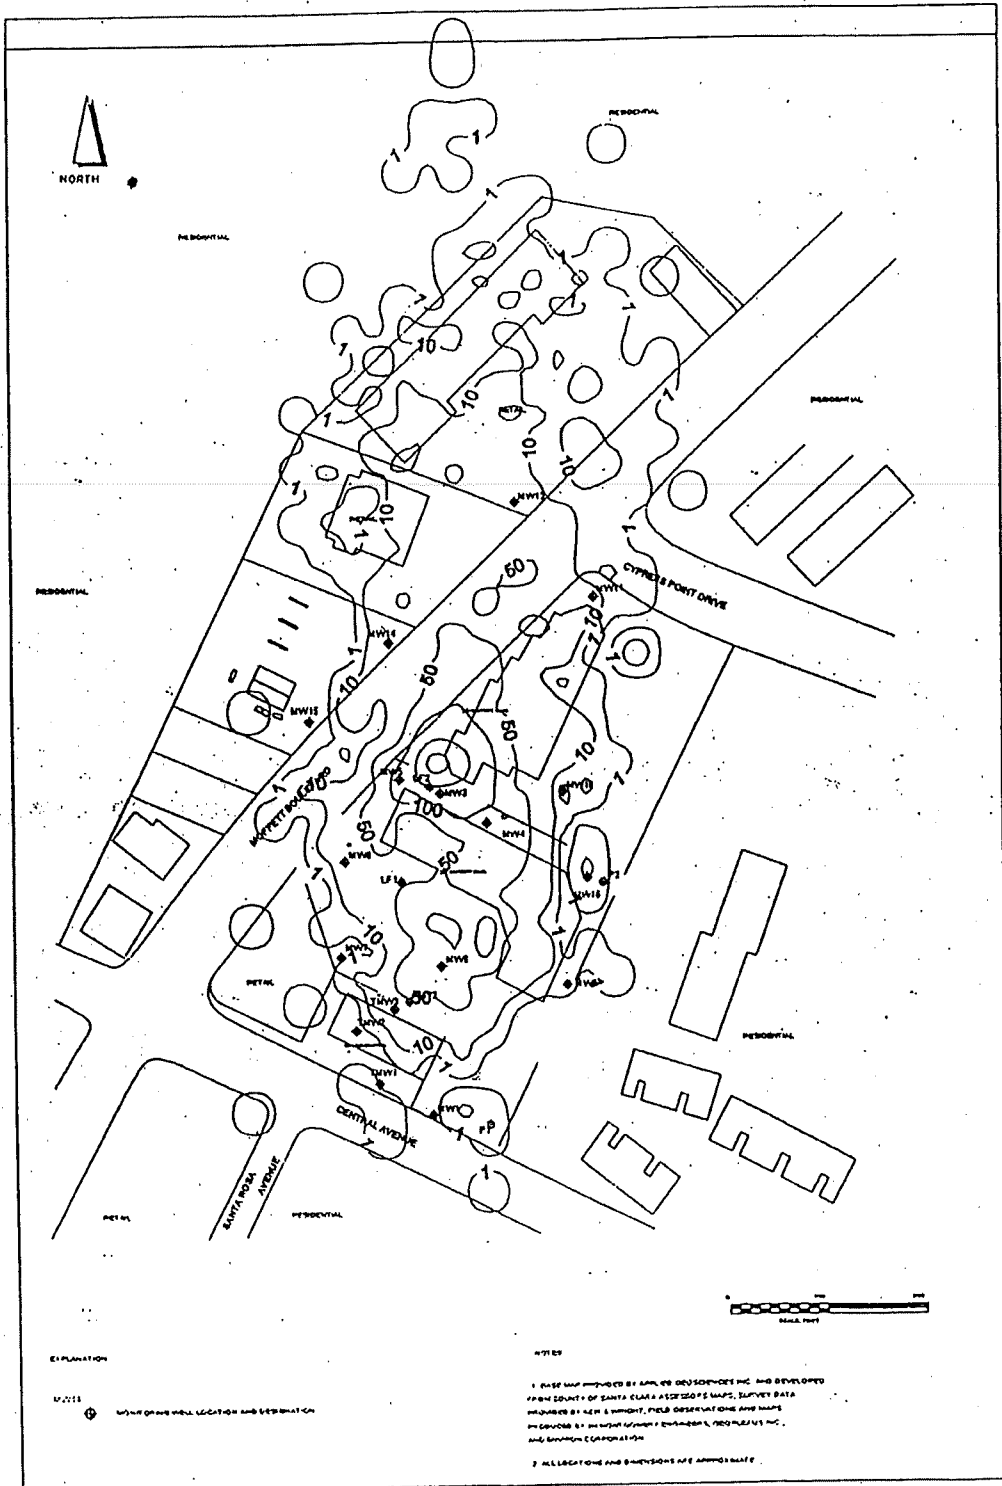
Figure 1. Simulated distribution of Trichloroethene, 1967 to 1995, for 327 MB only, at half-life of 10-years.
