Appendix HAZ

Phase I Environmental Site Assessment and Phase II Subsurface Investigation

**PHASE I ENVIRONMENTAL SITE ASSESSMENT
730 Central Avenue
Mountain View, California 94043
ERAS Project Number 19128**

ERAS Environmental, Inc.
November 25, 2019

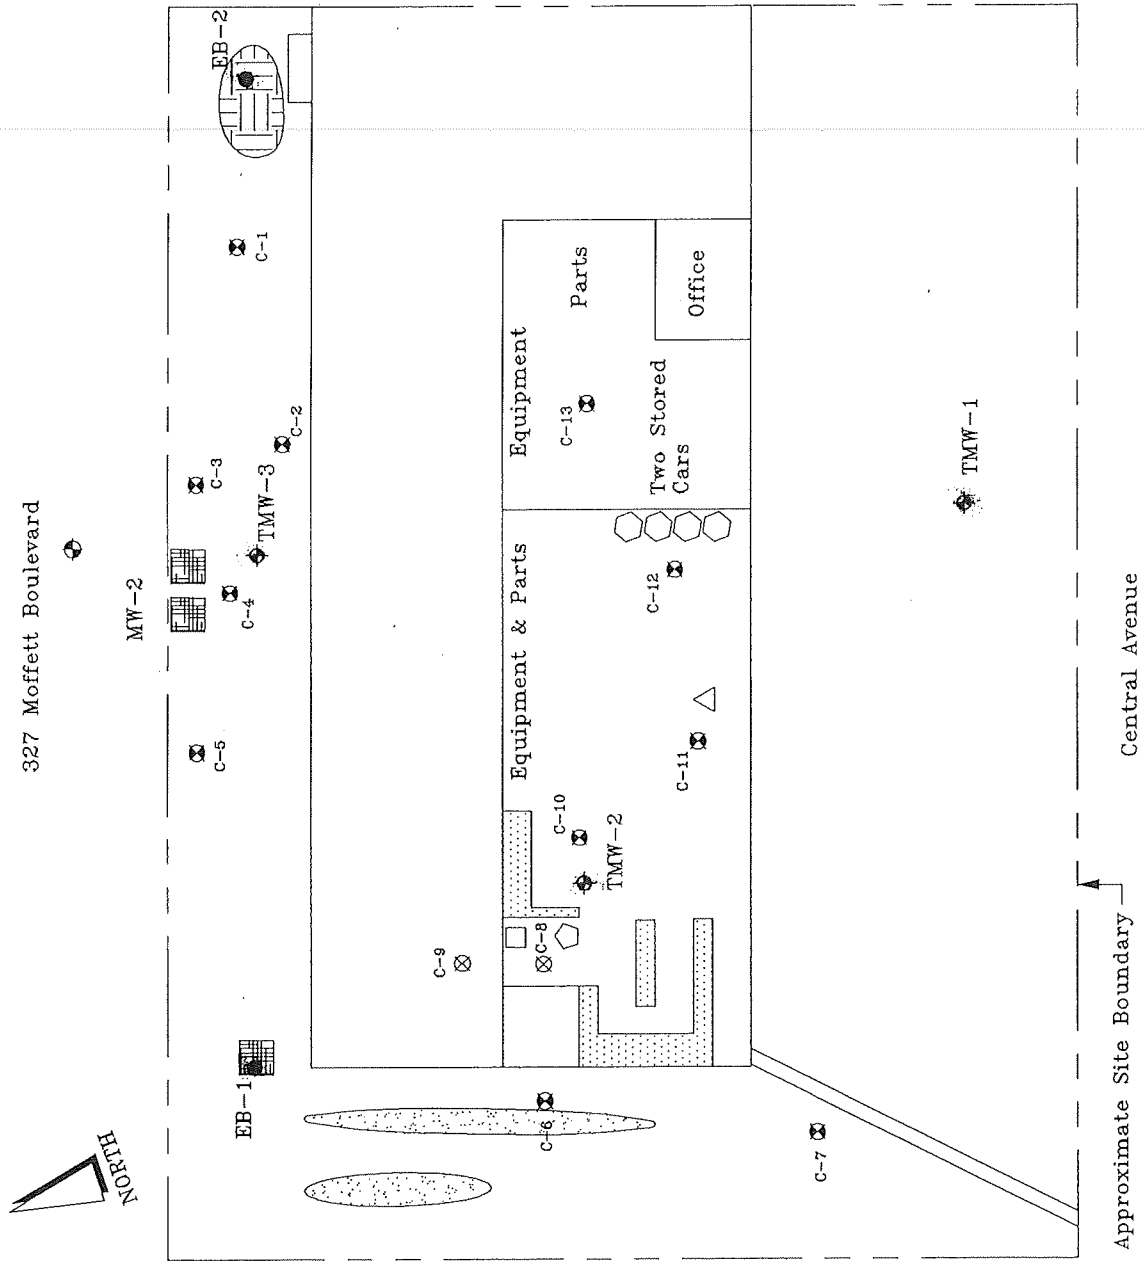
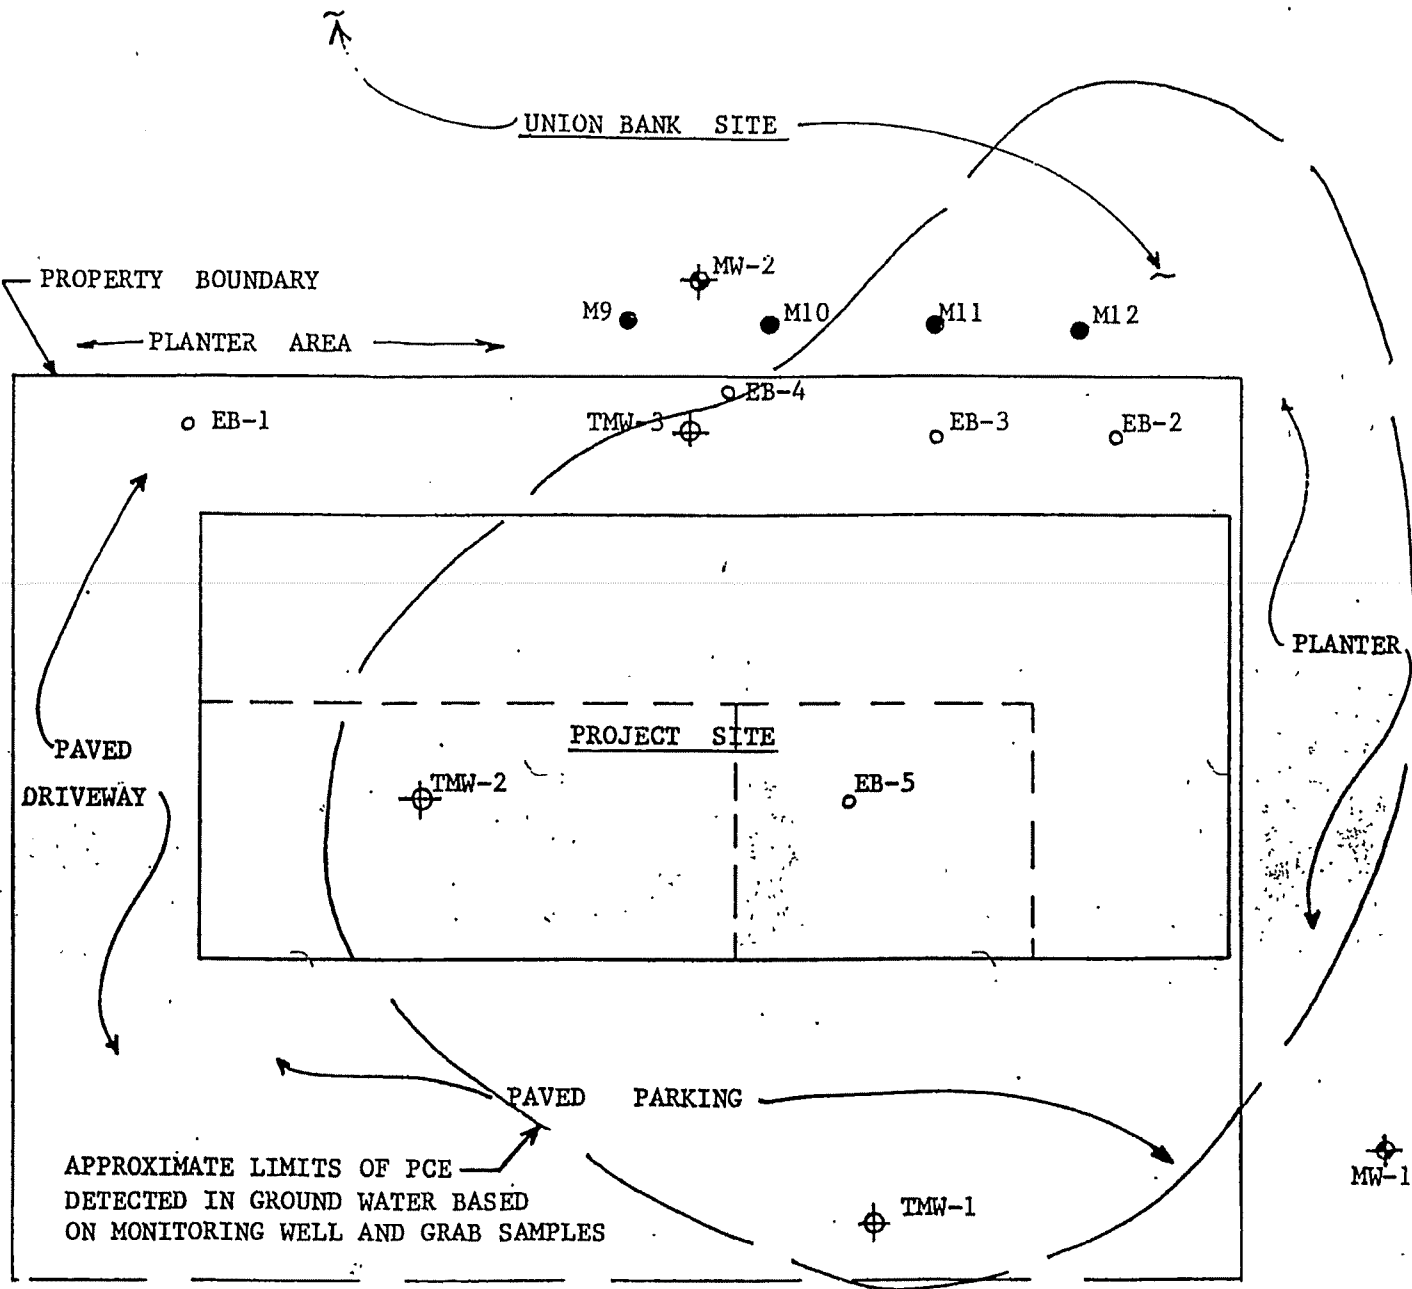
APPROXIMATE LIMITS OF PCE
 DETECTED IN GROUND WATER BASED
 ON MONITORING WELL AND GRAB SAMPLES
