Memorandum

From: R.J. Van Sant, ICF

Date: June 18, 2018; updated October 8, 2018

Re: **Otay River Mitigation Bank Jurisdictional Delineation Memorandum**

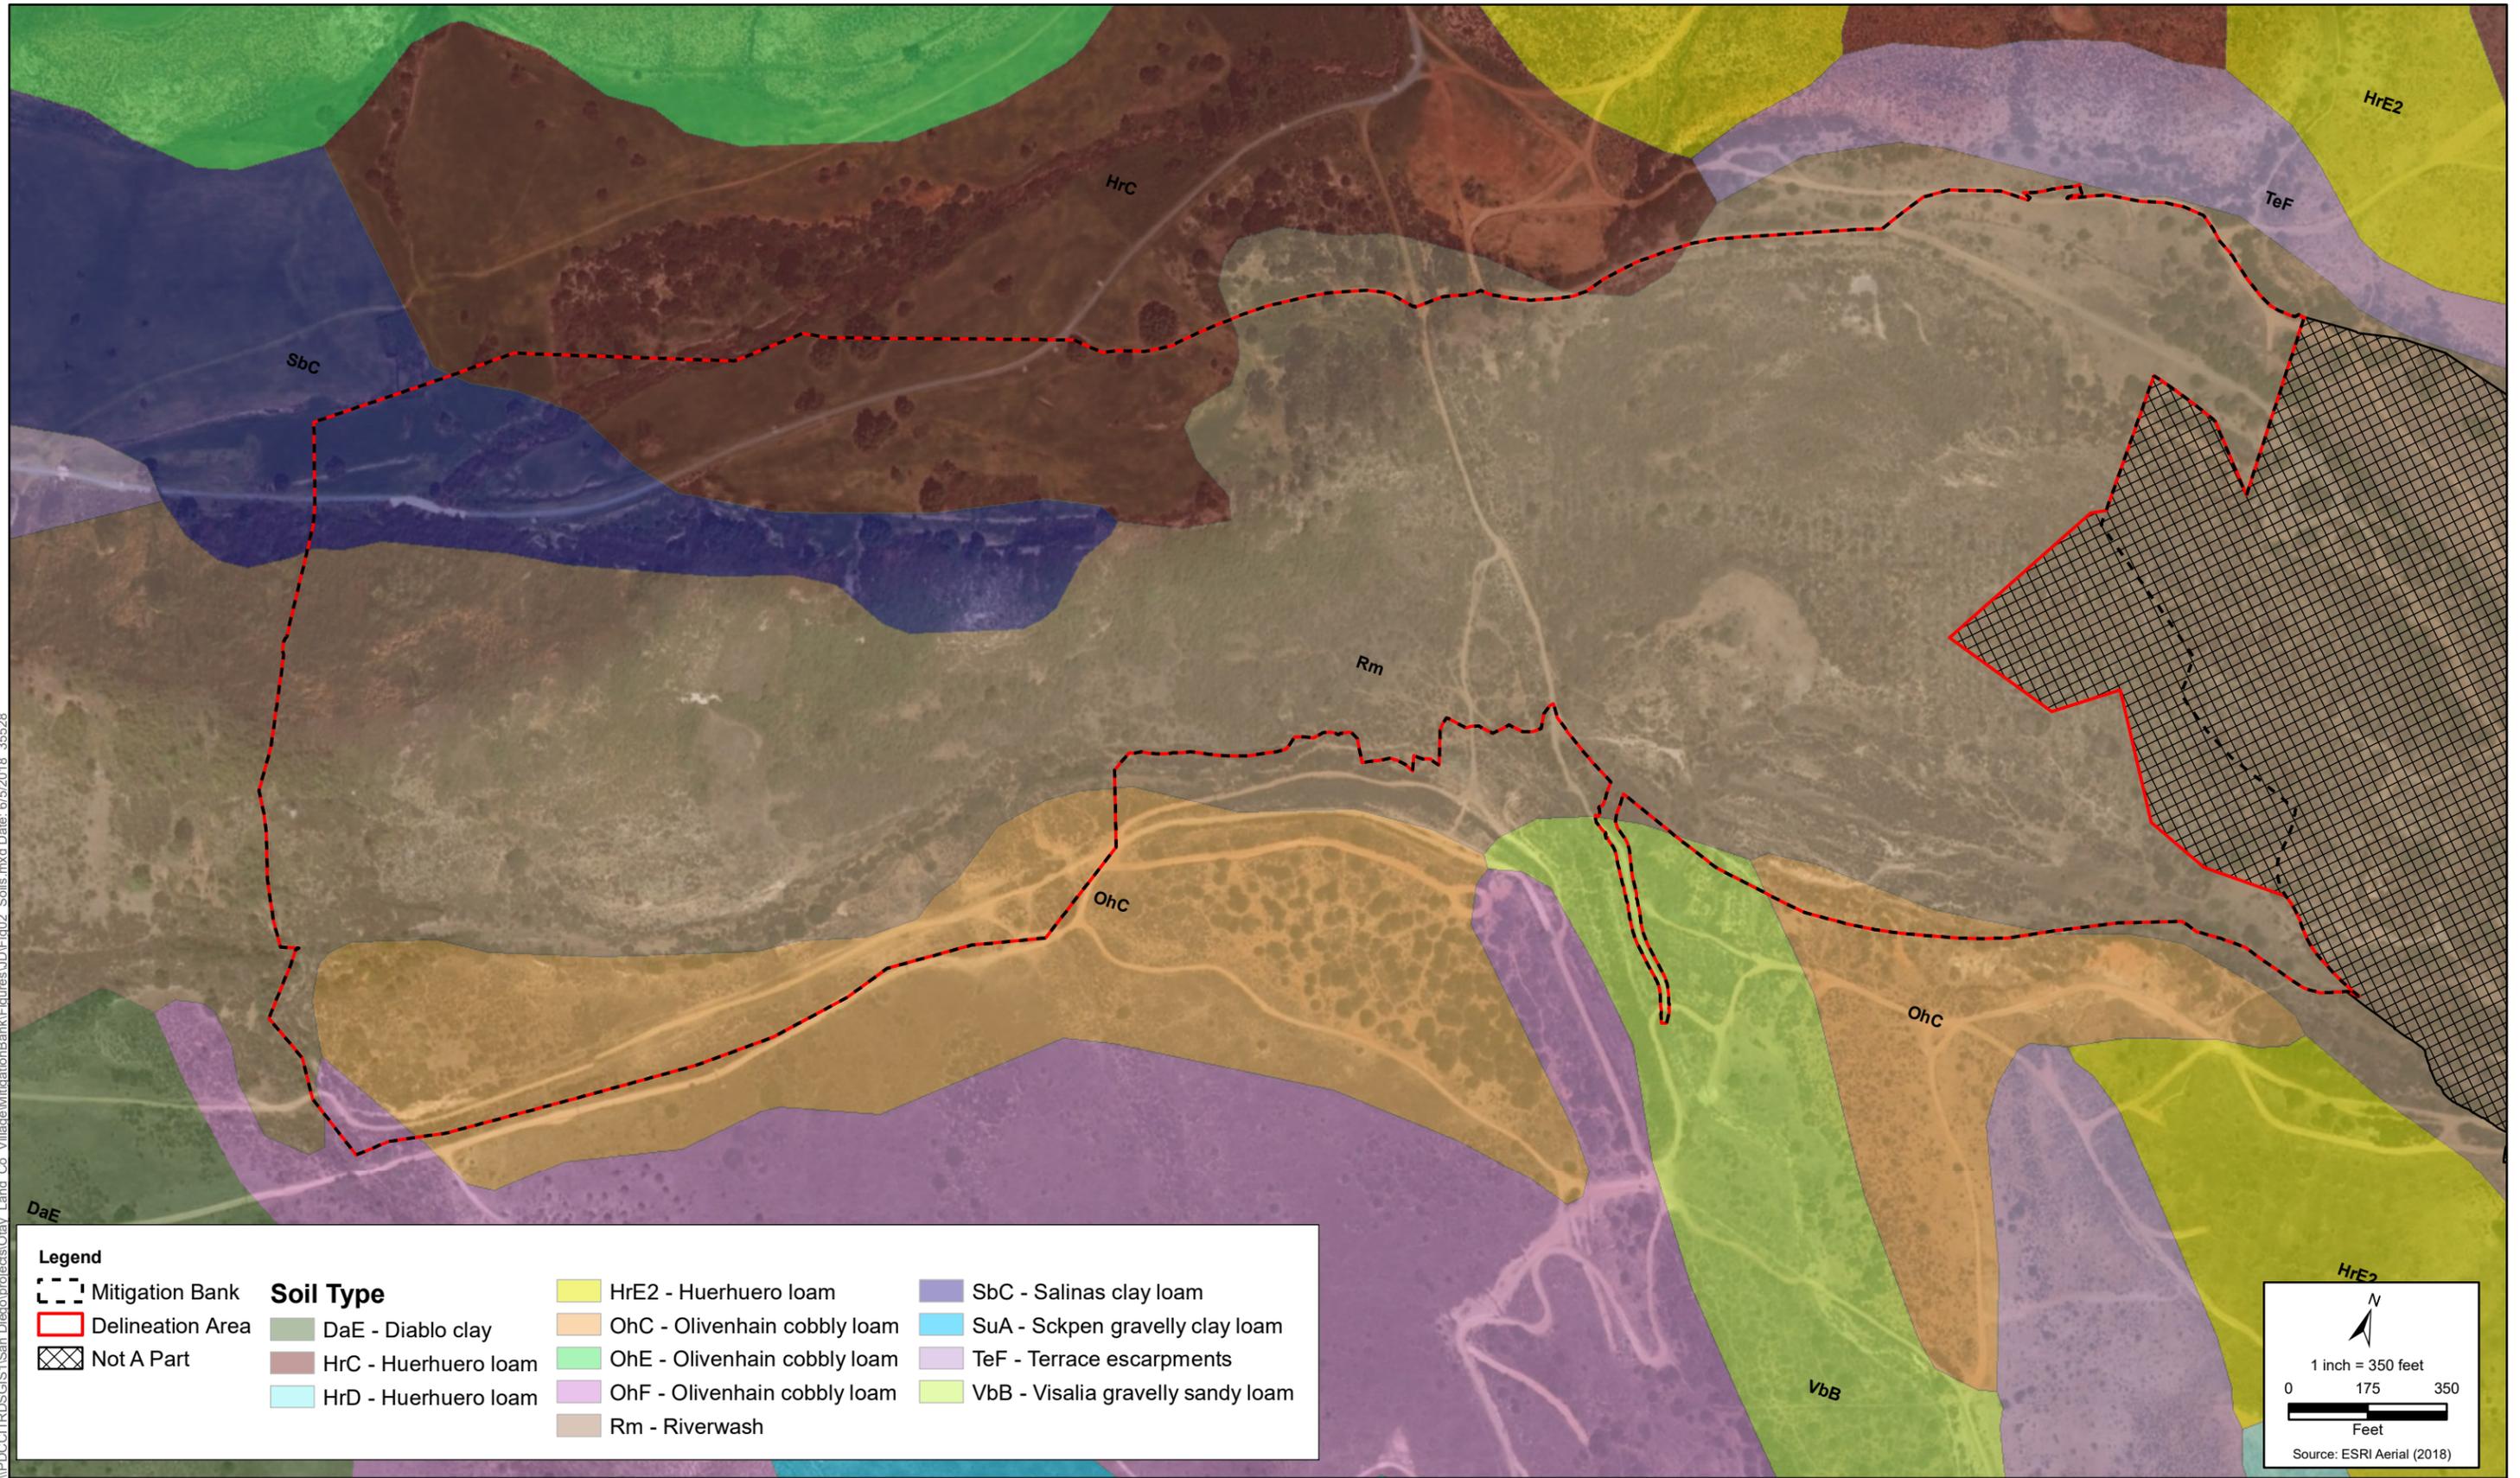
Figure 2
Soil Types
Otay River Mitigation Bank

Legend	
Mitigation Bank	Soil Type
Delineation Area	DaE - Diablo clay
Not A Part	HrC - Huerhuero loam
	HrD - Huerhuero loam
	HrE2 - Huerhuero loam
	OhC - Olivenhain cobbly loam
	OhE - Olivenhain cobbly loam
	OhF - Olivenhain cobbly loam
	Rm - Riverwash
	SbC - Salinas clay loam
	SuA - Sckpen gravelly clay loam
	TeF - Terrace escarpments
	VbB - Visalia gravelly sandy loam

Soils in the Otay East subbasin are predominantly clay, with some pockets of loam in O'Neal Canyon. The riparian areas and previously active floodplains of the Otay River lack distinct layers and are generally well drained and poorly developed (Aspen 2006). Soils in the floodplain area are characterized as having a high infiltration rate when thoroughly wetted, comprising primarily deep, well-drained sand and gravel. The water transmission rate is high, while runoff potential is low. The California Division of Mines and Geology has classified lands according to the presence or absence of significant sand and gravel deposits and crushed rock source areas in the form of Mineral Resource Zones (MRZs). The Otay River Valley in the Mitigation Bank area is classified as MRZ-2, which consists of Quaternary river channel and floodplain deposits, Tertiary and Quaternary conglomerate and alluvial fans, Cretaceous granitic rocks, and Jurassic meta-volcanic rocks (California Department of Conservation 1982).

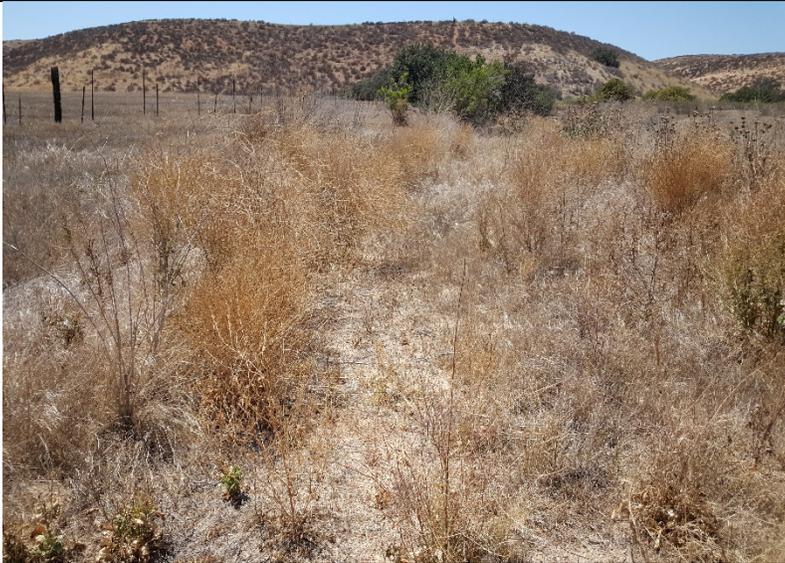
Photograph # 9

Comment: Looking upstream at Feature 24, near the end of a defined OHWM. After this area, the drainage begins to sheetflow and no longer has a defined OHWM. No swale feature was observed.

Feature 24 is a 1.5 foot wide ephemeral drainage on the eastern side of the site that is discernable as a channel for only a short distance. Flow upstream and downstream of this feature is not frequent enough to form a channel. OHWM indicators included sediment sorting and cracking.

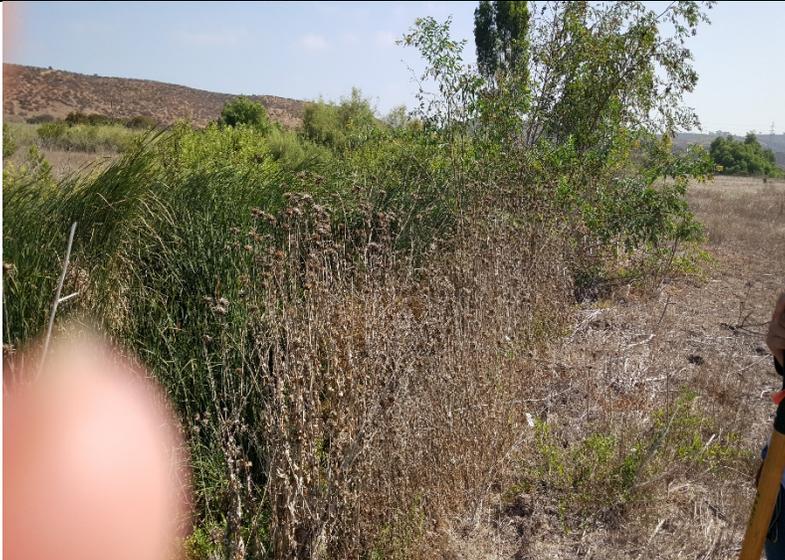
Photograph # 13

Comment: Looking upstream at Salt Creek (Feature 10). The center of the drainage is dominated by cattails with sparse patches of willows and tamarisk.

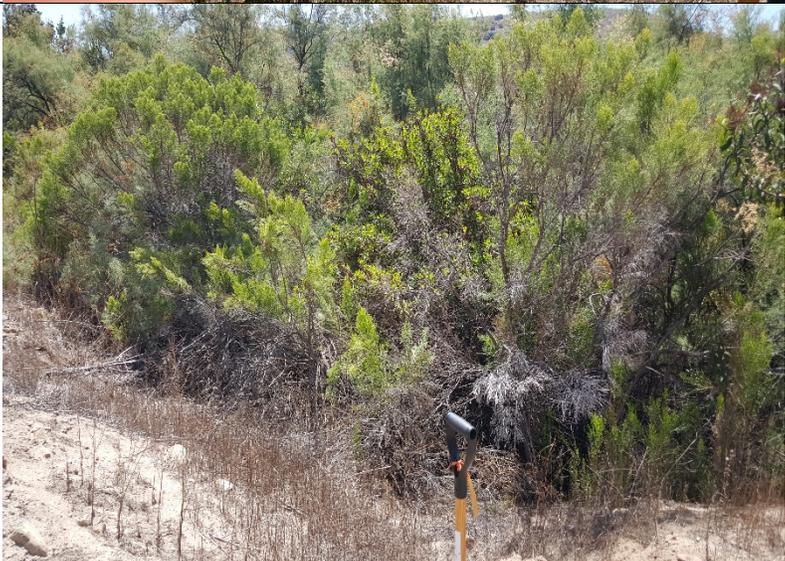
Photograph # 14

Comment: Looking at the wetlands/riparian habitat supported by the Otay River (Feature 1). A berm lines both the northern and southern edge of the larger Otay Floodplain.

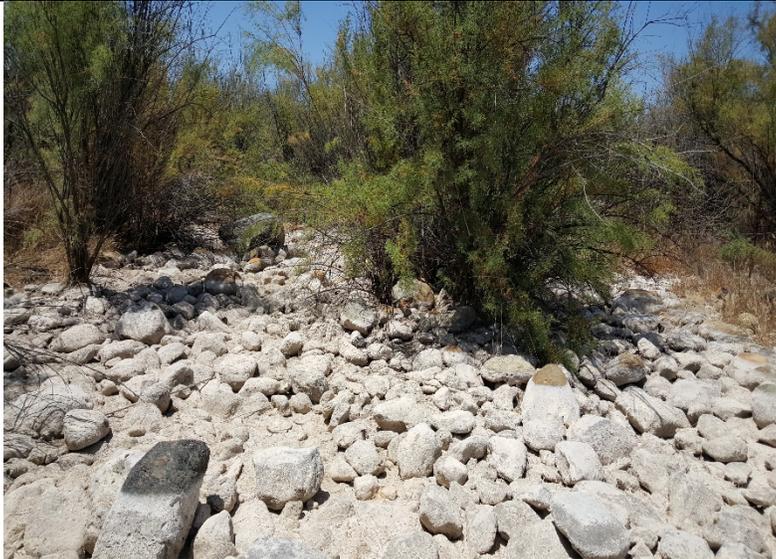
Photograph # 15

Comment: Looking downstream at the Otay River (Feature 1). The river is confined within this area due to two constructed berms on either side and is also unvegetated.

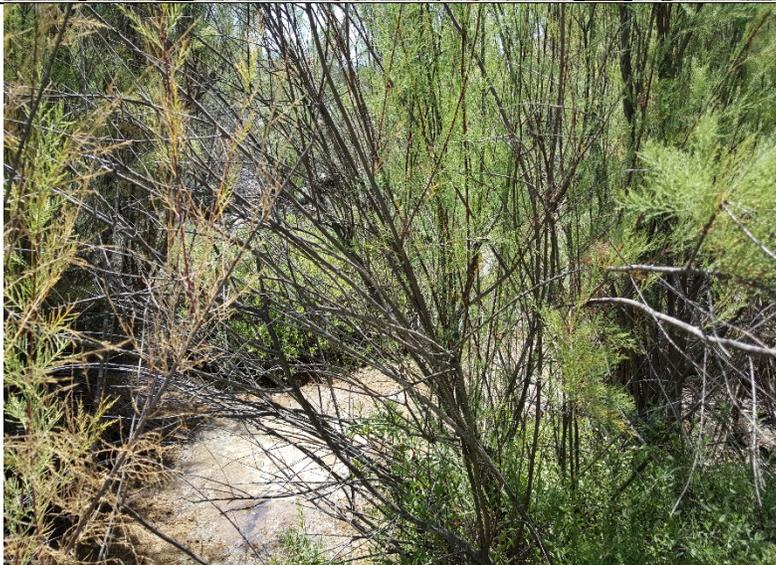
Photograph # 16

Comment: This is where groundwater resurfaces and the Otay River becomes defined again. Large areas of wetlands are supported by subsurface groundwater throughout the site.

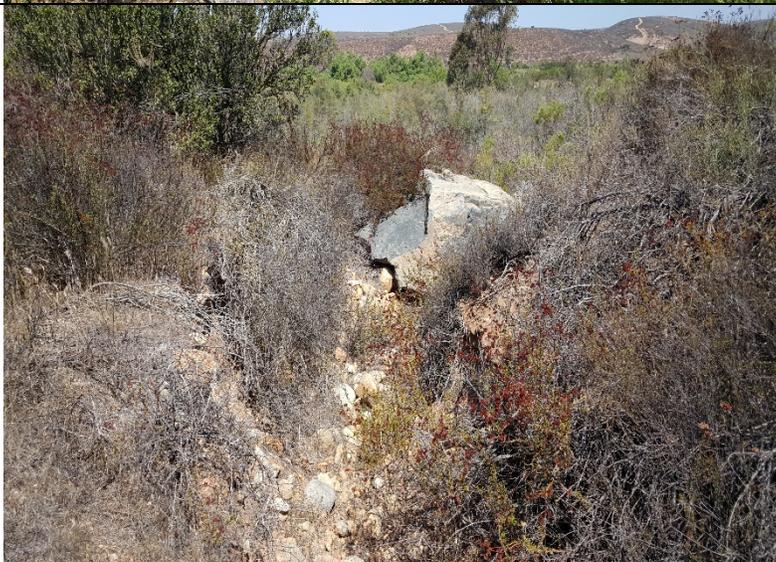
Photograph # 17

Comment: Looking downstream of Feature 8. A clearly defined OHWM and the bed and bank occur throughout this feature. Once the drainage hits the valley floor it dissipates into sheetflow.

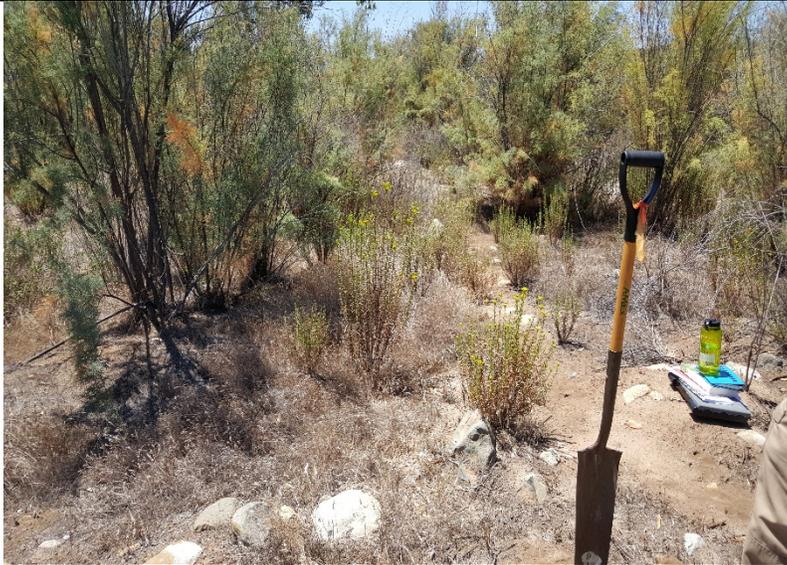
Photograph # 18

Comment: Looking at data point T7.1, near the edge of the wetland habitat. The area is dominated by rabbits foot grass, tamarisk, and goldenbush.

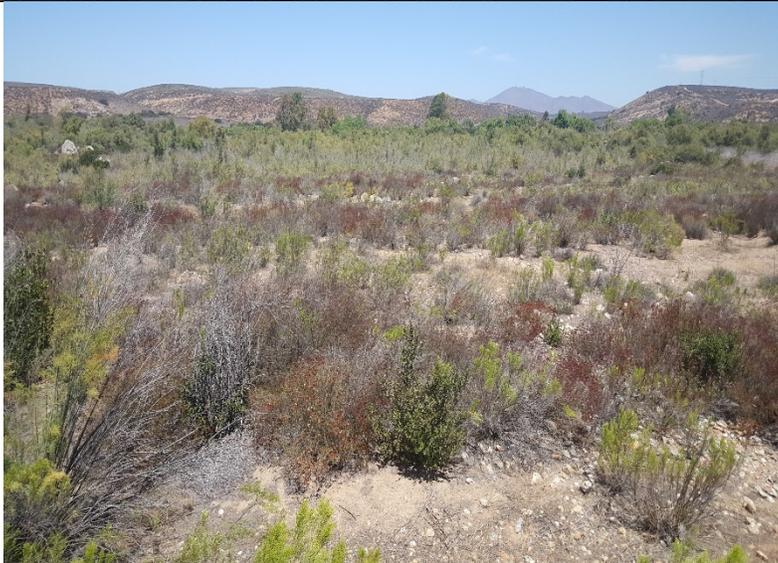
Photograph # 19

Comment: Looking north at the upland terrace of the Otay River within CDFW streambed jurisdiction. The limits were taken from berm to berm which includes the entire Otay floodplain. The row of tamarisk in the background is the approximate edge of USACE wetlands.

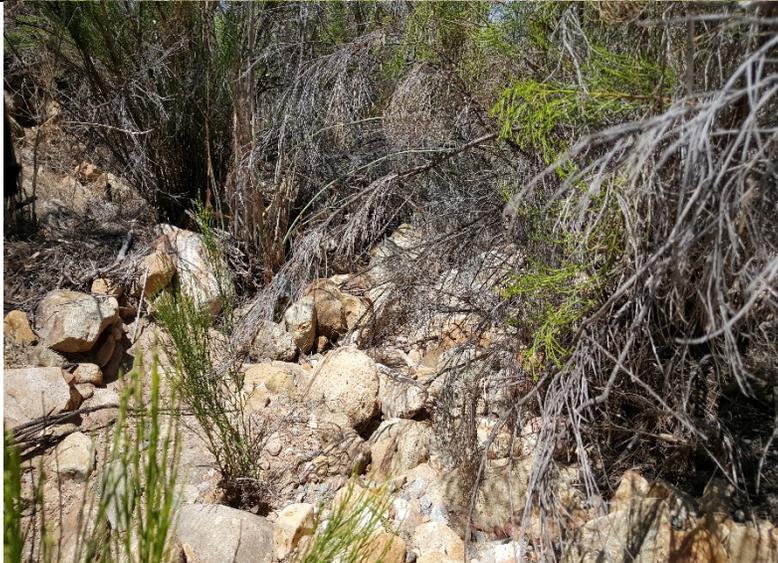
Photograph # 20

Comment: Looking downstream of Feature 7. A clearly defined OHWM and bed and bank was observed throughout the drainage.

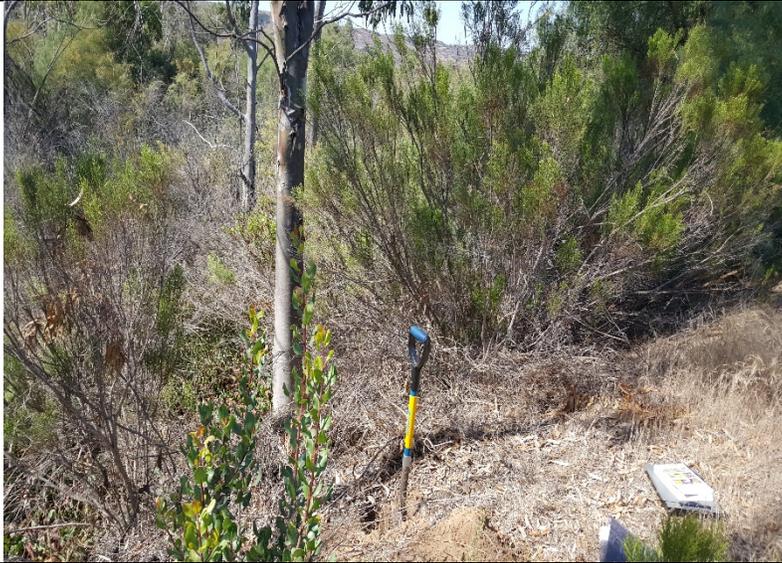
Photograph # 21

Comment: Looking at the upland data point 8.1 near the edge of the wetland habitat within Otay River.

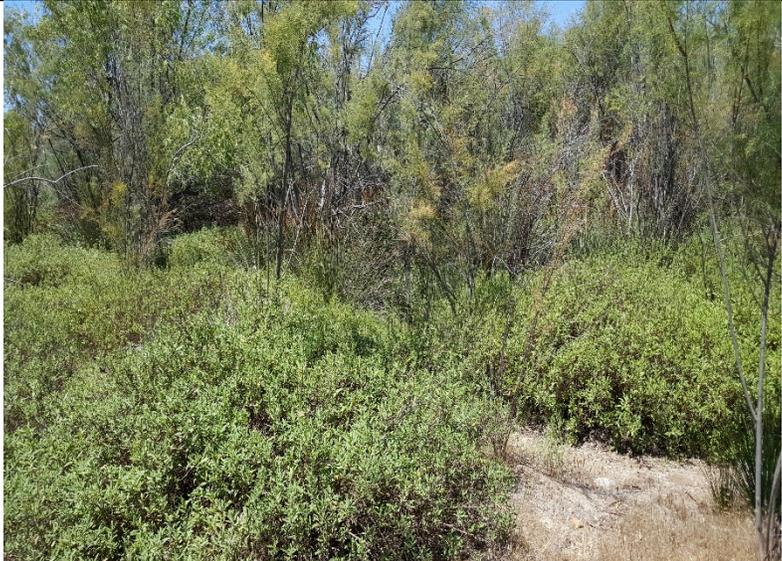
Photograph # 22

Comment: Looking north near the edge of the wetland habitat within Otay River where data point 8.2 was taken. The area is dominated by tamarisk and San Diego marsh-elder.

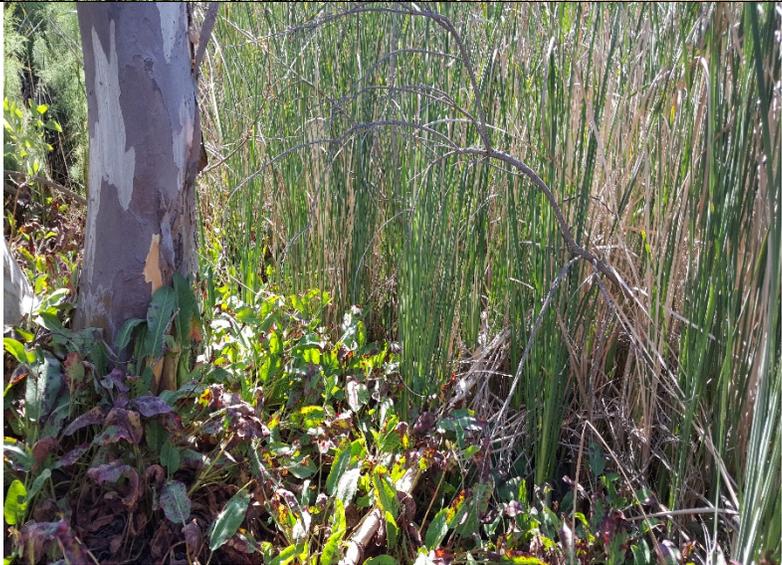
Photograph # 23

Comment: Looking south near the edge of the wetland habitat within Otay River dominated by the yerba mansa and cattails.

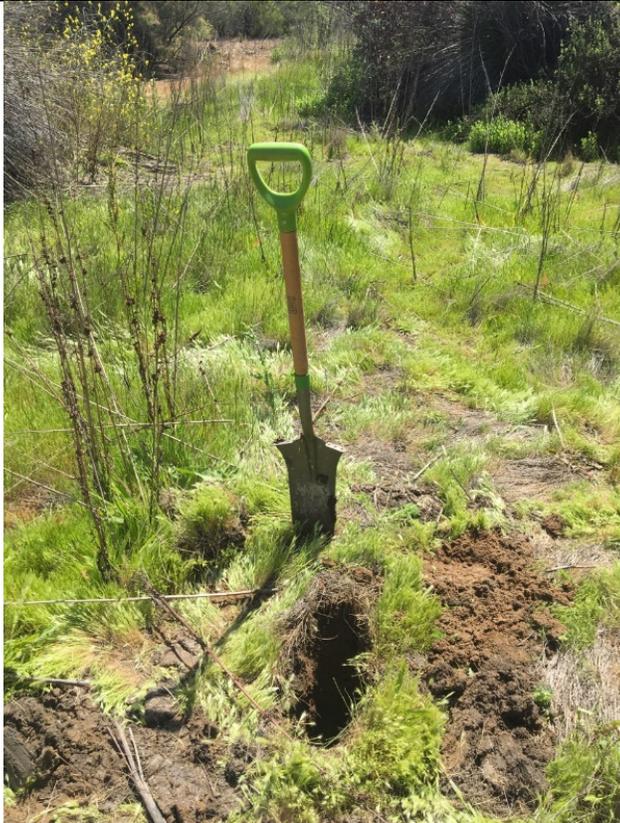
Photograph #ATT1

Comment: Looking east along a depression wetland (Feature 17) at the south side of the Otay River floodplain near the upstream end of the project.

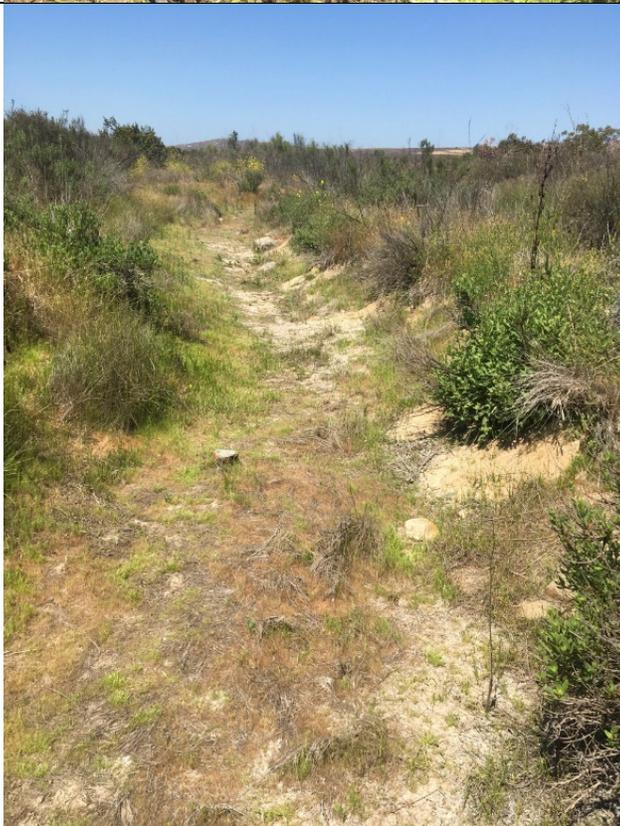
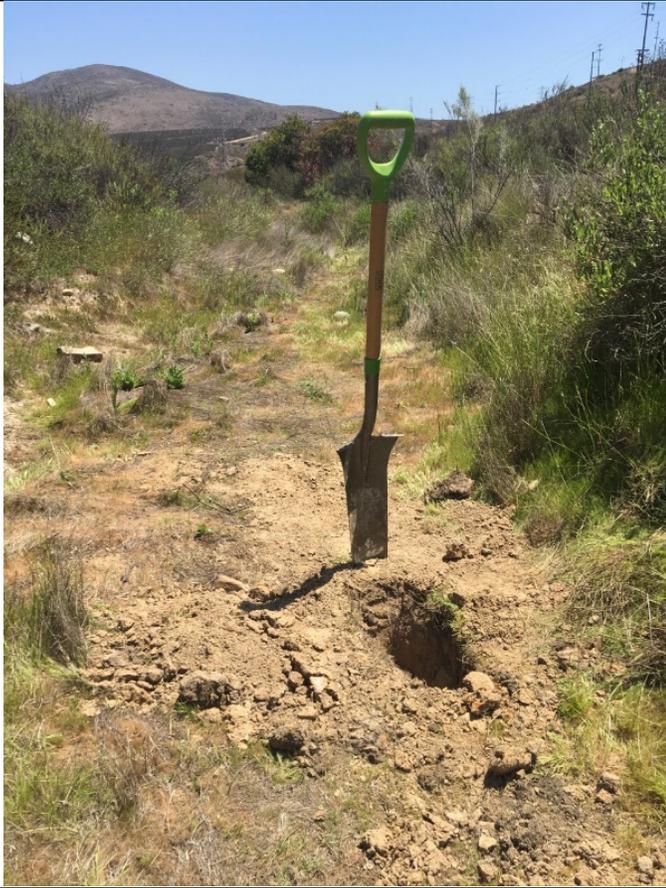
Photograph #ATT2

Comment: Looking west at Feature 18 at the south side of the Otay River floodplain near the upstream end of the project.

Comment: Looking east at Feature 18 at the south side of the Otay River floodplain near the upstream end of the project.

Feature 18 is a 4-6 foot wide channel on the southern side of the Otay River floodplain that appears to potentially be a relic primary or secondary channel of the Otay River but that still conveys minor surface flows and possibly is a point where groundwater reaches the surface and flows for a short period. The upstream portion of this feature is ephemeral and OHWM indicators included a bed and bank and sediment cracks. The downstream area is a wetland dominated by Rabbit's foot grass and spike rush.

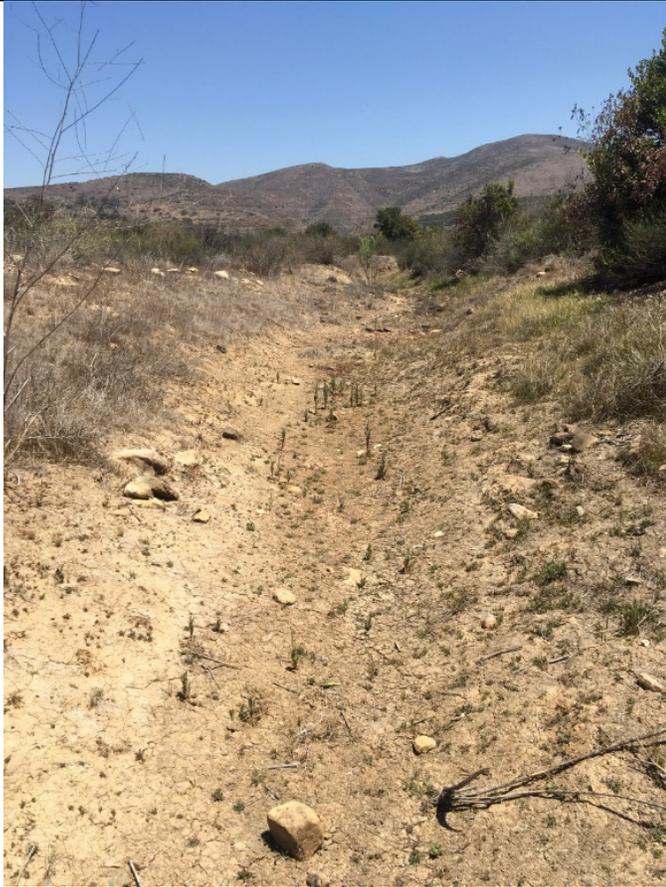
Photograph #ATT4

Comment: Looking east at Feature 19 at the south side of the Otay River floodplain near the upstream end of the project.

Feature 19 is a 10 foot wide ephemeral drainage on the southern side of the Otay River floodplain similar to Feature 18 in that it may be a relic channel but appears to still have some flow. OHWM indicators included a bed and bank and sediment cracks.

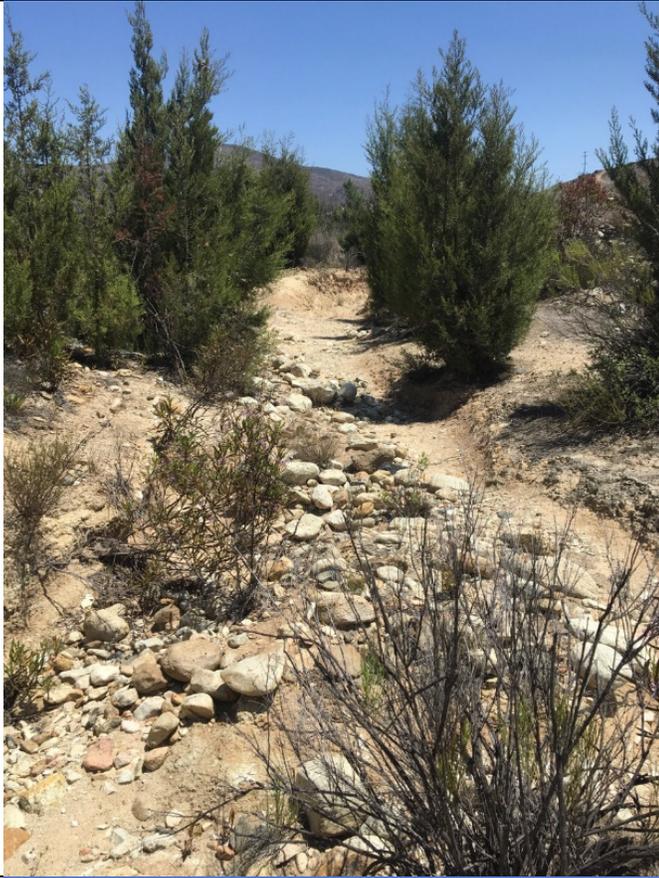
Photograph #ATT5

Comment: Looking east at Feature 21 at the south side of the Otay River floodplain near the upstream end of the project.

Feature 21 is a 5 foot wide ephemeral drainage on the southern side of the Otay River floodplain similar to Feature 18 in that it may be a relic channel but appears to still have some flow. OHWM indicators included a bed and bank, sediment sorting and sediment cracks.

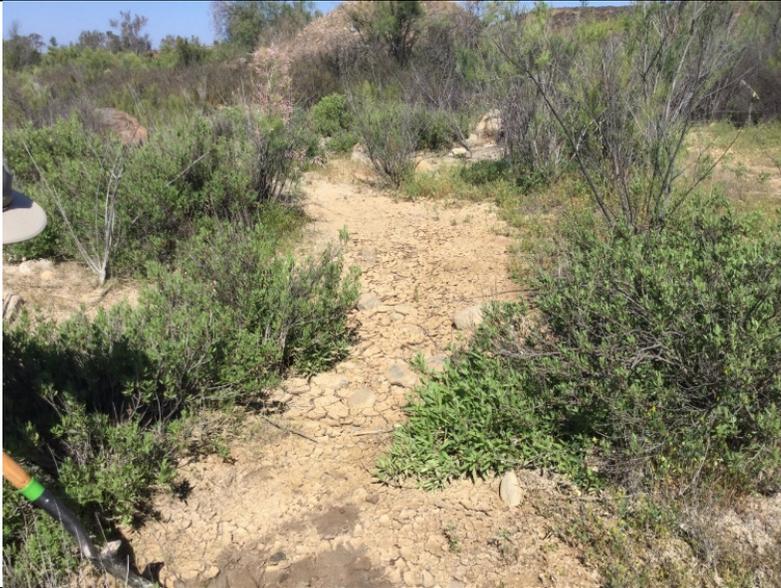
Photograph #ATT7

Comment: Looking east at a Feature 24 in the middle of the Otay River floodplain near the upstream end of the project.

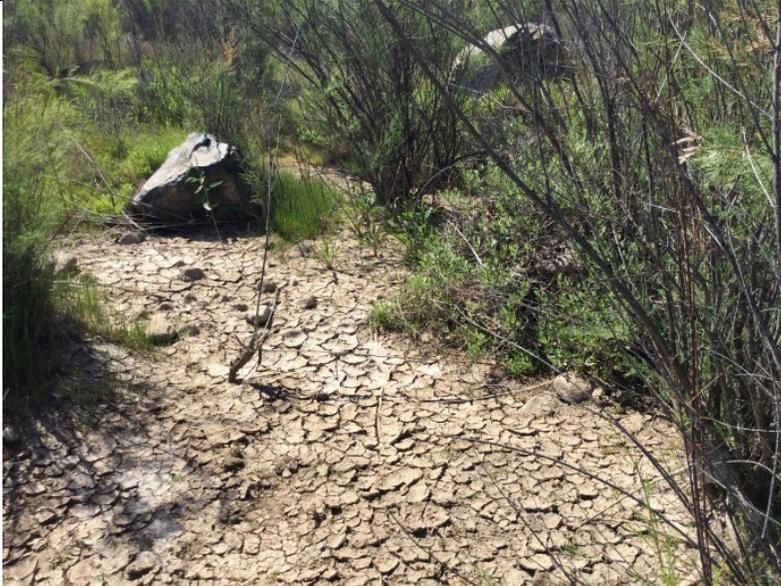
Photograph #ATT8

Comment: Looking at the ponded portion of Feature 25 where SP2.1 LC was dug. Hydrophytic vegetation and hydrology was seen but not hydric soils.

Feature 25 is a 2 foot wide ephemeral channel on the eastern side of the site that is dominated by annual grasses. Feature 25 also includes a ponded area just upstream of the channel segment. OHWM indicators included a break in slope in the channel portion and sediment cracks in the ponded portion.

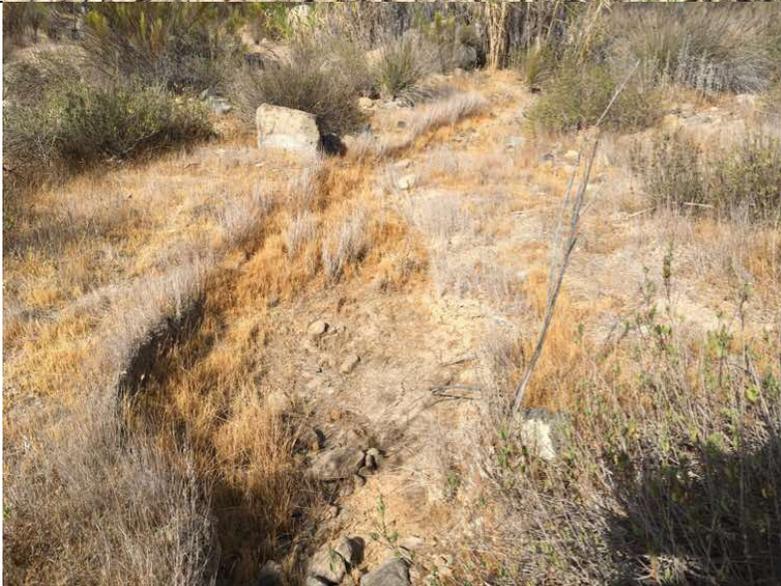
Photograph #ATT26

Comment: Looking at the channel portion of Feature 25.

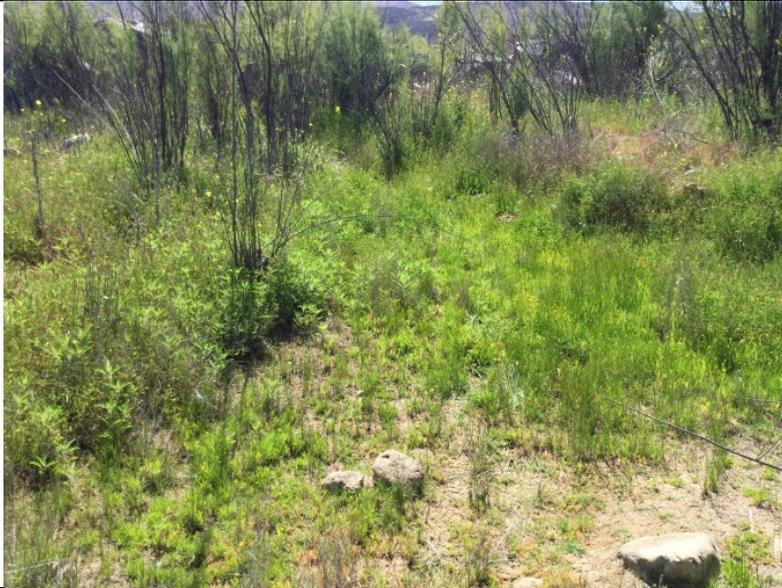
Photograph #ATT9

Comment: Looking upstream near where the Otay River loses definition of a channel and enters project site.

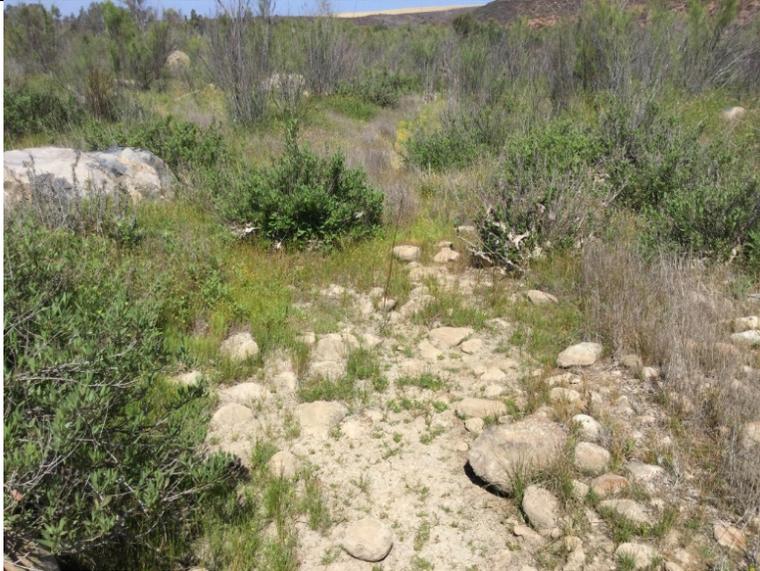
Photograph #ATT10

Comment: Looking downstream near where the Otay River loses definition of a channel and enters project site.

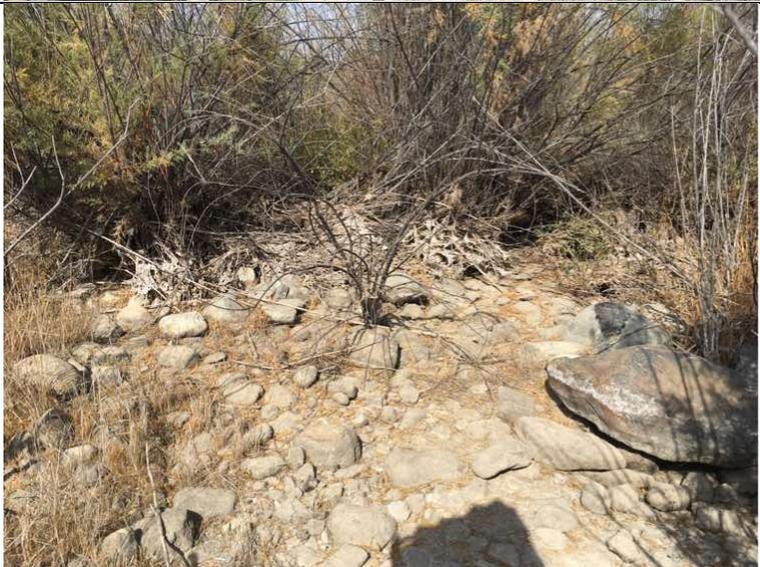
Photograph #ATT27

Comment: Looking downstream from within Feature 1 near the eastern end of the project. Feature 1 loses definition of a channel at this point.

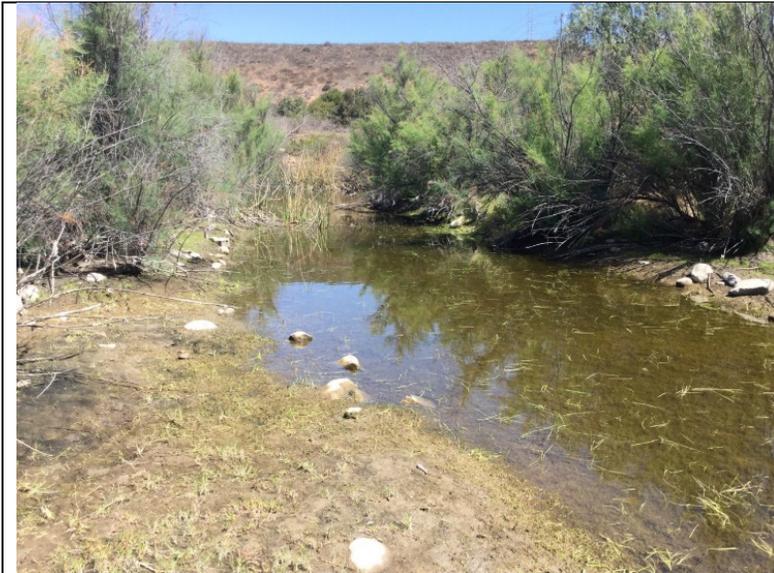
Photograph #ATT11

Comment: Looking north at Feature 11, a depression wetland, on the northern side of the Otay River floodplain near the upstream end of the project.

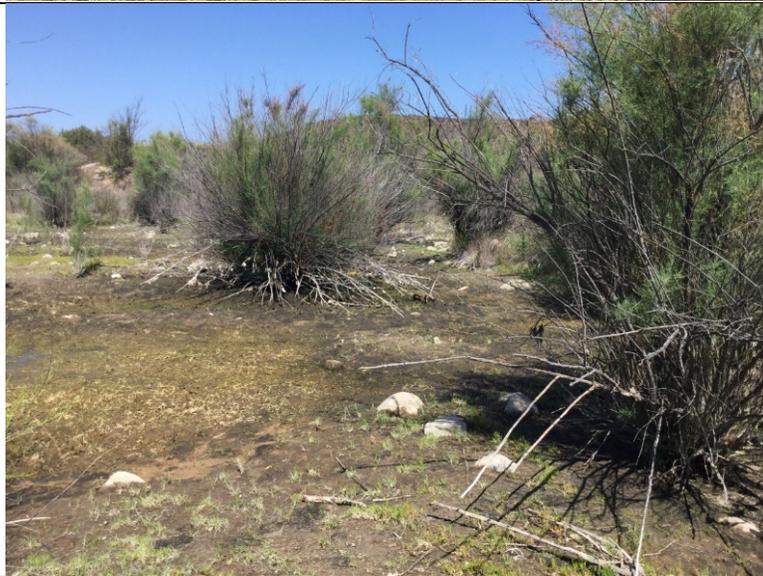
Photograph #ATT12

Comment: Looking north-west at Feature 11, a depression wetland, on the northern side of the Otay River floodplain near the upstream end of the project.

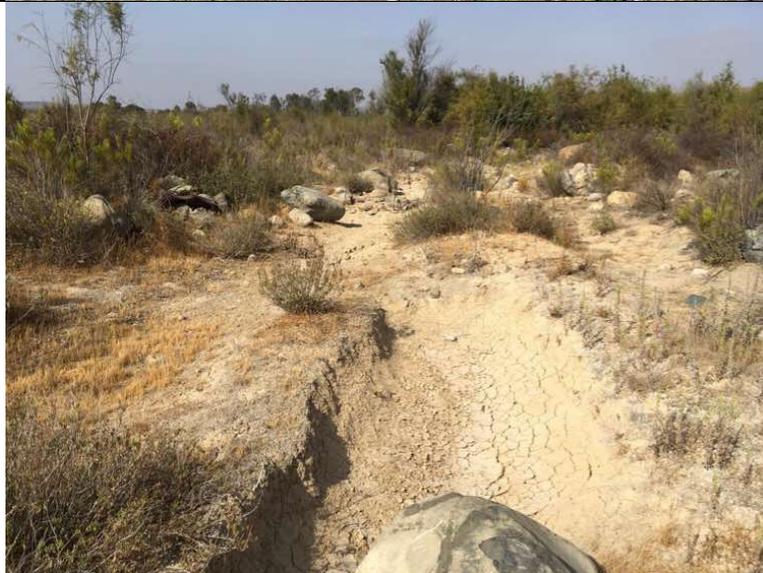
Photograph #ATT25

Comment: Looking at the non-wetland portion of Feature 11.

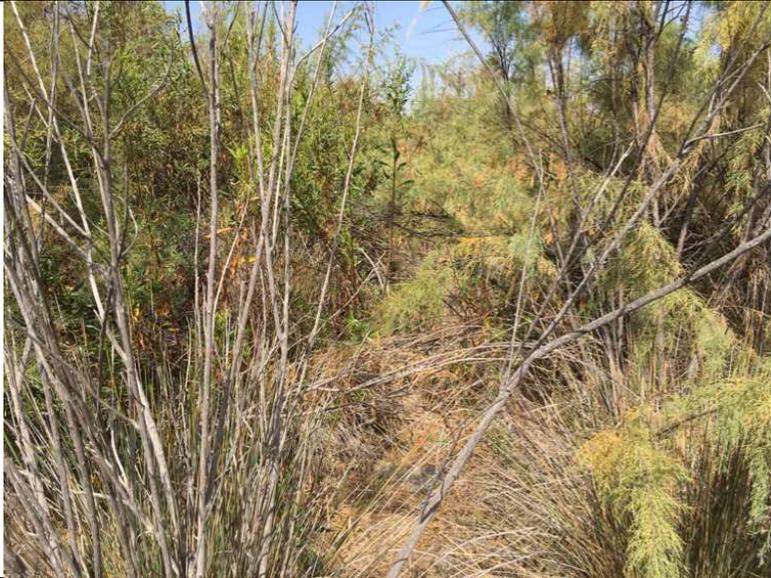
Photograph #ATT30

Comment: Wetland area of Feature 11 where SP A is located.

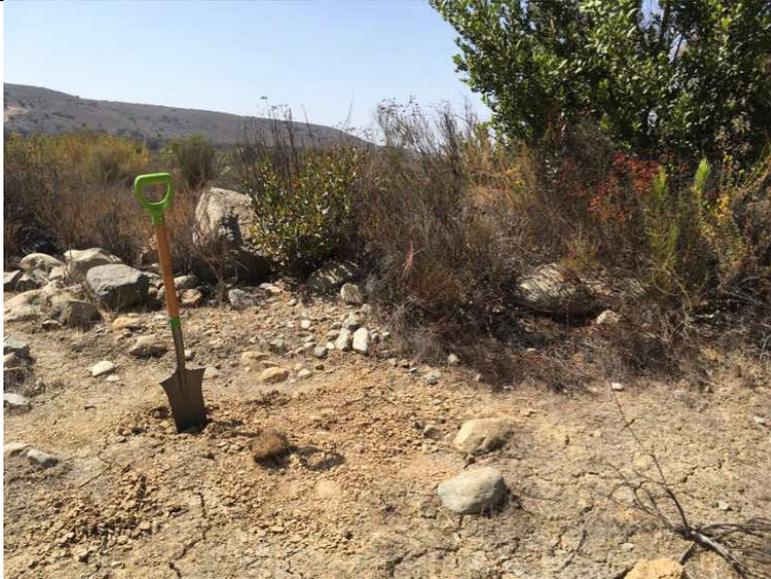
Photograph #ATT31

Comment: Upland data pit (SP B) located adjacent to Feature 11 and SP A.

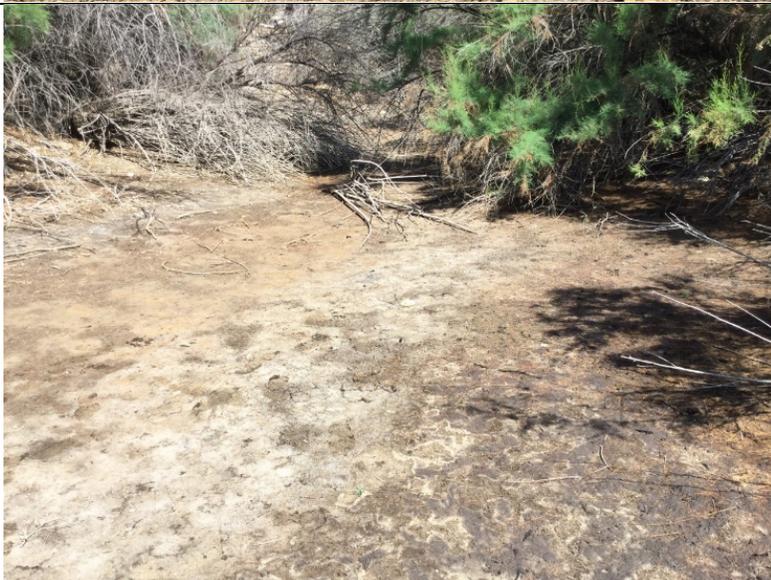
Photograph #ATT13

Comment: Looking north at Feature 12 wetland on the northern side of the Otay River floodplain.

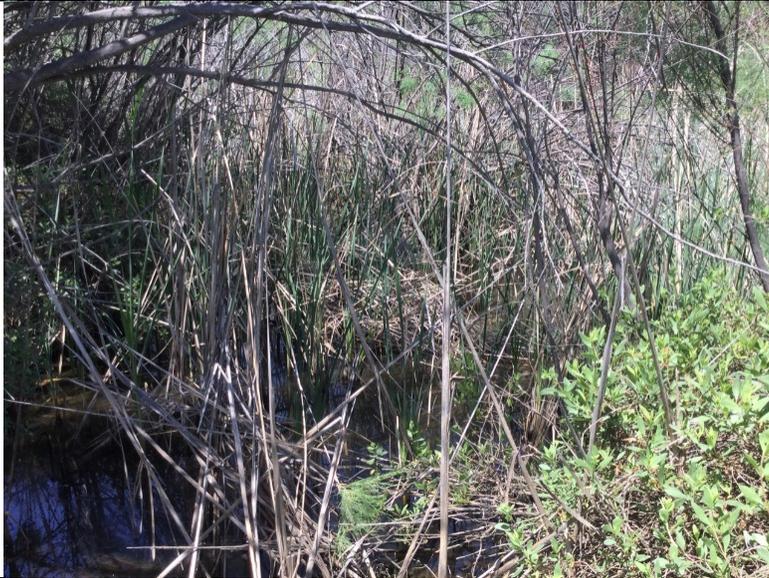
Photograph #ATT14

Comment: Looking north-west at Feature 23 wetland located in the Otay River floodplain near the center of the project.

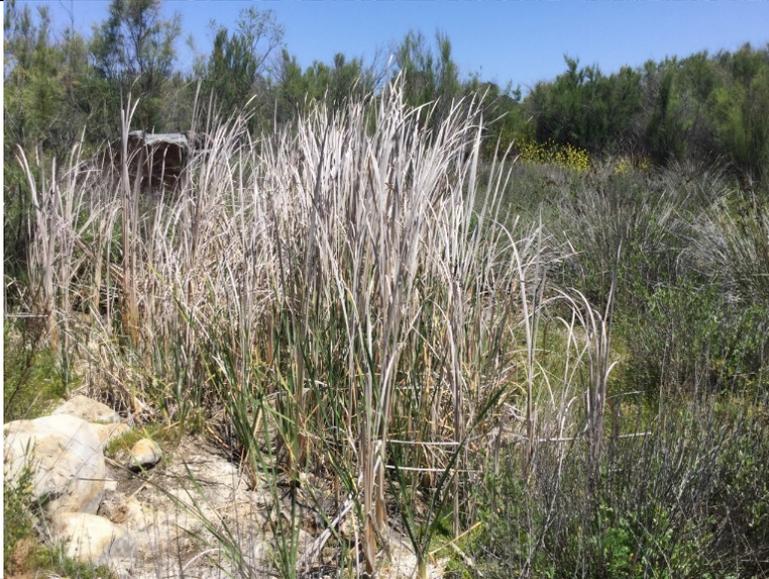
Photograph #ATT15

Comment: Looking north-east at Feature 23 wetland located in the Otay River floodplain near the center of the project.

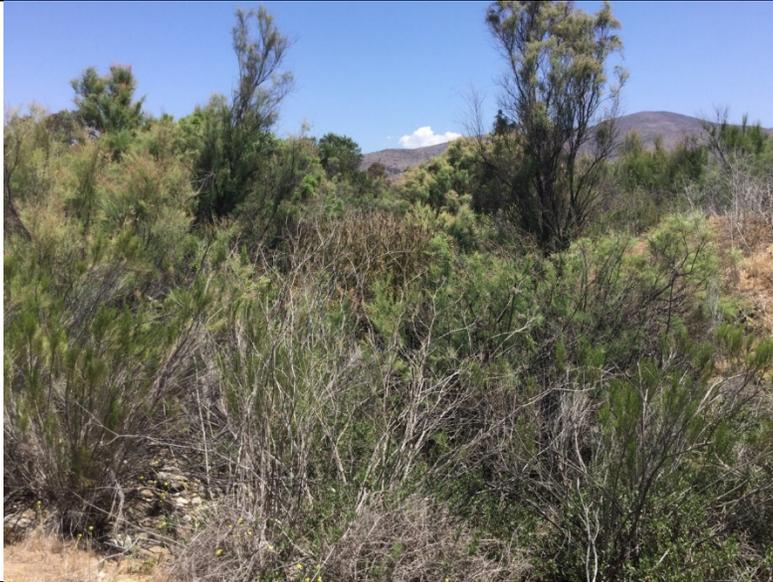
Photograph #ATT17

Comment: Looking east towards wetland Feature 2 located on the northern side of the Otay River floodplain.

Feature 2 is a linear wetland on the north side of the Otay River floodplain created by two berms on either side of the feature. This wetland appears to be primarily supported by subsurface groundwater and is dominated by cattails and arroyo willows (*Salix lasiolepis*). Standing water was observed during field visits.

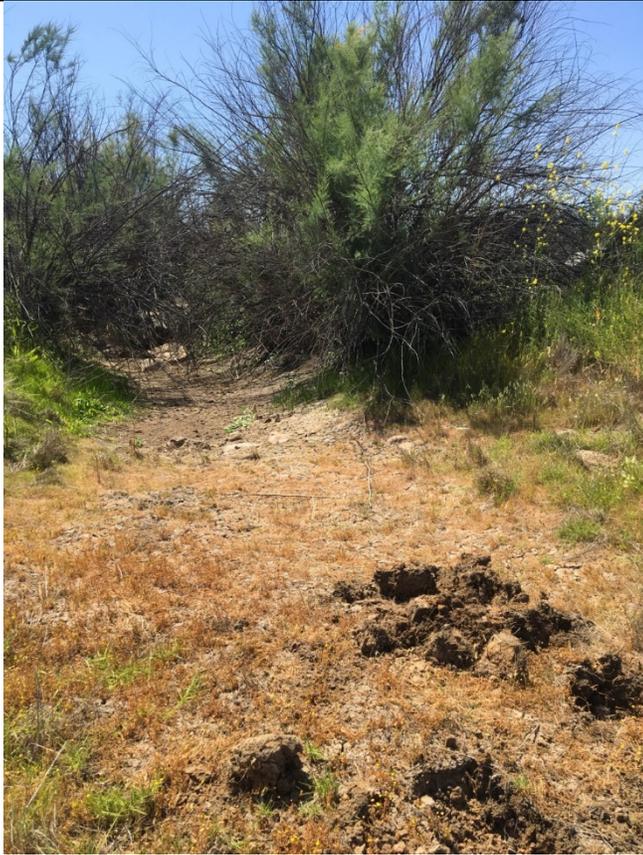
Photograph #ATT20

Comment: Looking west at sp3-rjv and a depressional wetland (Feature 21) on the southern side of the Otay River floodplain.

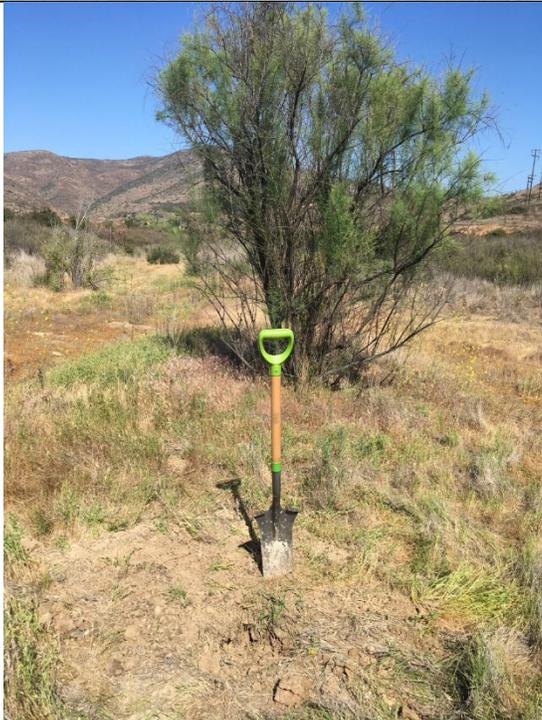
Photograph #ATT21

Comment: Looking east at upland data pit (sp4-rjv) just outside Feature 21.

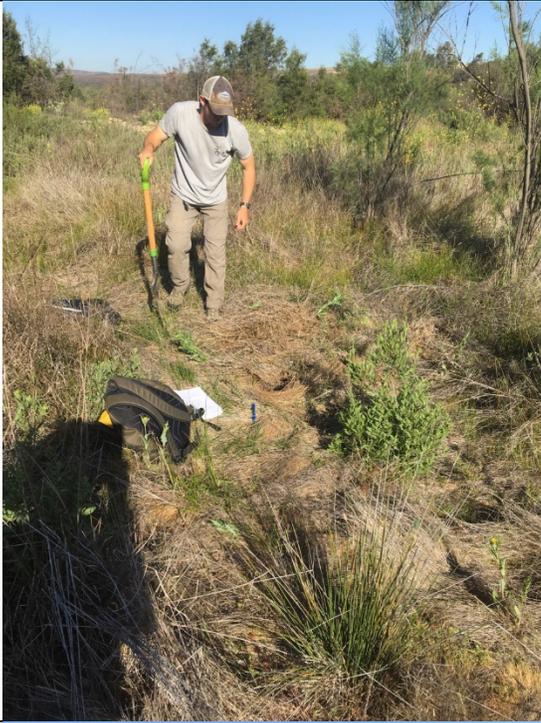
Photograph #ATT22

Comment: Looking west at sp5-rjv. The area had hydrophytic vegetation but lacked hydric soils and wetland hydrology.

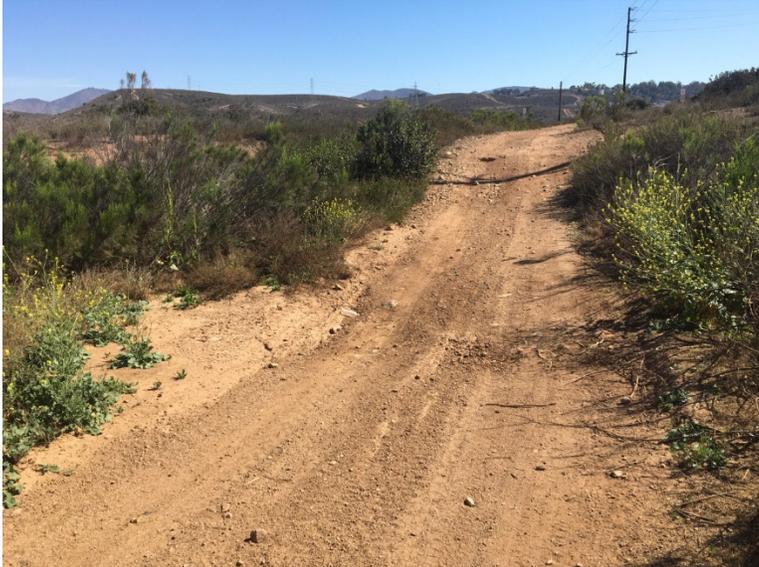
Photograph #ATT23

Comment: Looking east where a dirt access road crosses Feature 6 in the uplands on the southern side of the project.

Feature 6 is an ephemeral drainage on the south side of the Mitigation Bank that flows in a northwestern direction. An OHWM was observed throughout the length of the drainage and the drainage is dominated by upland coastal sage scrub species.
