Memorandum

From: R.J. Van Sant, ICF

Date: June 18, 2018; updated October 8, 2018

Re: **Otay River Mitigation Bank Jurisdictional Delineation Memorandum**

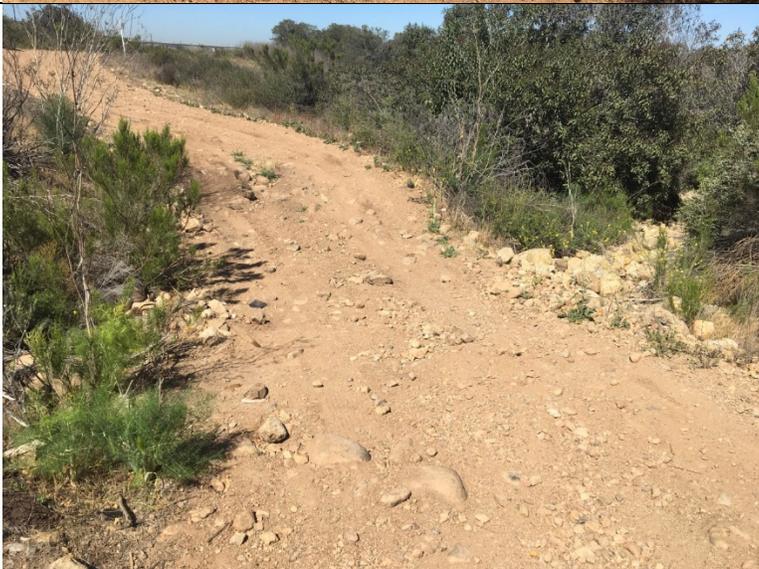
Photograph #ATT24

Comment: Looking west where a dirt access road crosses Feature 7 in the uplands on the southern side of the project.

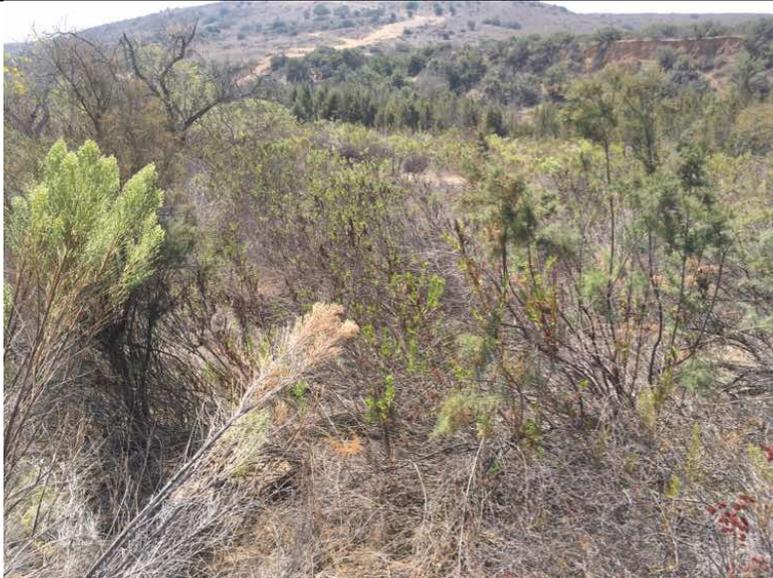
Photograph #ATT28

Comment: Mulefat area in foreground with Feature 5 in the background

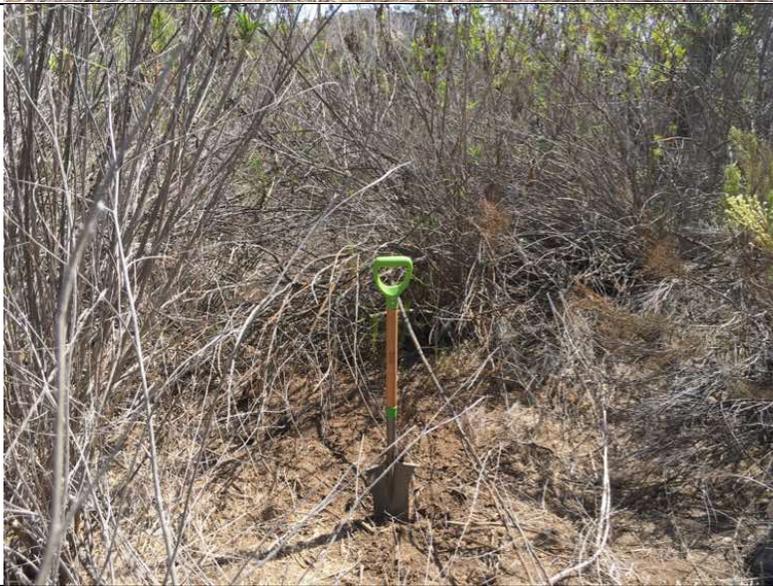
Photograph #ATT29

Comment: Location of SP C at the south end of the project site. No wetland hydrology, hydric soils or hydrophytic vegetation were found.
