Appendix G
**2020 Least Bell's Vireo and Yellow Billed Cuckoo
Survey Report**

Least Bell's Vireo (*Vireo bellii pusillus*) Surveys and Nest Monitoring at the Otay Ranch Preserve, City of Chula Vista, San Diego County

Appendix I
**GEOCON Infiltration Report for Vernal Pool
Creation Area**

Subject: INFILTRATION REPORT
OTAY VALLEY
CHULA VISTA, CALIFORNIA

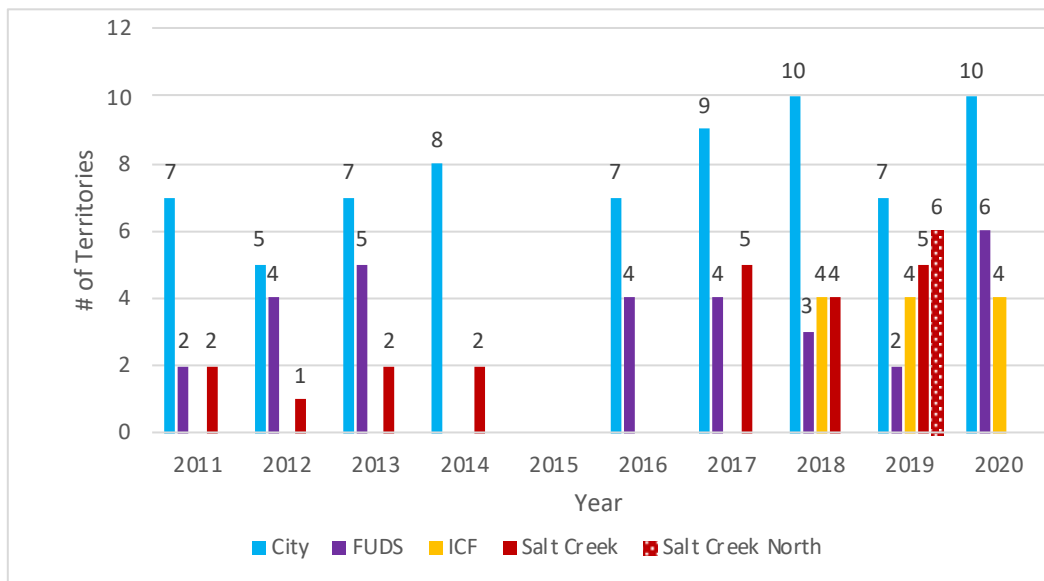
Figure 5. Number of territorial male Least Bell's Vireos by survey site at Otay Ranch Preserve, California, 2011-2019. Missing bar indicates no survey was conducted in that year (FUDS area incidentally monitored in 2011).

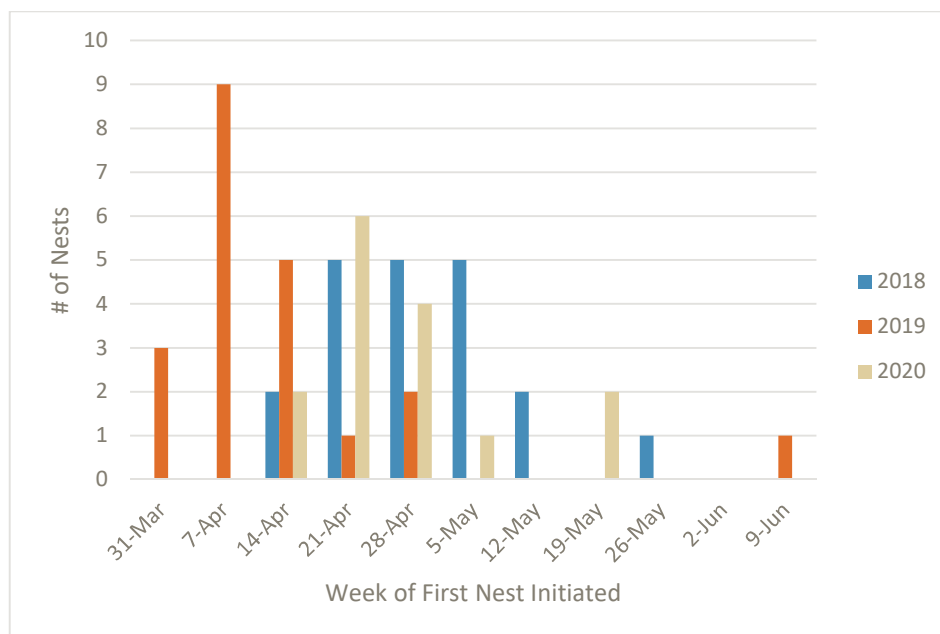
Figure 6. Number of first Least Bell's Vireo nests initiated by week at Otay Ranch Preserve, California, 2018-2020.

The average number of nesting attempts over the course of the 2020 breeding season was 1.9 ± 1.0 . Over one-half of all vireo pairs re-nested after their initial attempt (60%; 9/15). Three pairs initiated three nesting attempts and one pair initiated four nesting attempts. The majority of first nesting attempts occurred during the last two weeks of April (67%, 10/15). Least Bell's Vireos began building nests more than two weeks later in 2020 compared to 2019 (Figure 6). Patterns of nest initiation in 2020 were similar to 2018 when nest building peaked during the last two weeks of April.

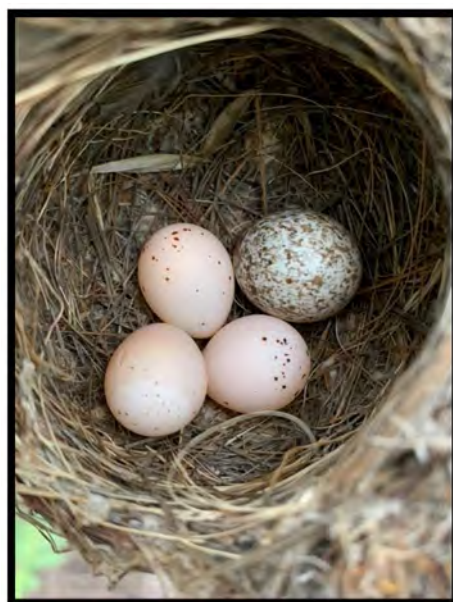
Photo 1. Least Bell's Vireo nest with three vireo eggs and one Brown-headed Cowbird egg at Otay River (OTY19 nest 1). Photo taken on 17 May 2020 by Kimberly Ferree.

In total, twelve nests were parasitized at the Project Area during the 2020 breeding season (Table 5; 43%, 12/28). Two nests failed directly as a result of cowbird parasitism. Of the remaining ten nests, five nests were parasitized and successful, and five nests were parasitized and subsequently depredated. We removed ten cowbird eggs from ten nests. Cowbird parasitism occurred between 17 May and 12 June. Parasitism was widespread across the Project Area (Appendix E, Figure 10). The highest concentration of cowbird parasitism occurred at the FUDS survey site where four pairs were parasitized (six nests total), of which two had two nests parasitized.

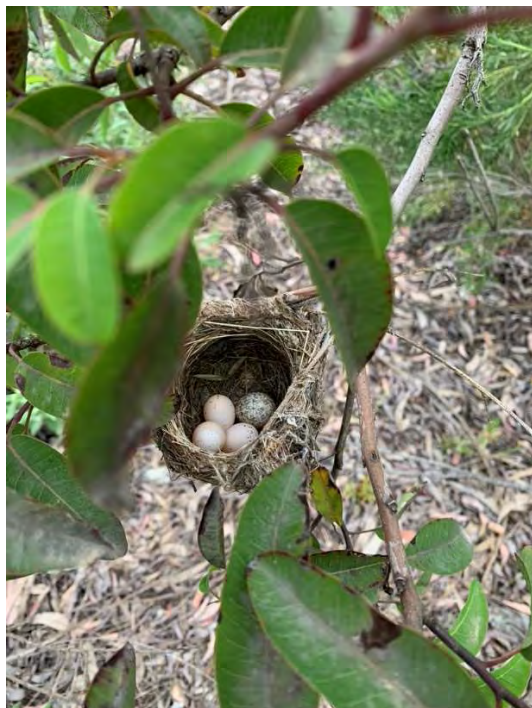
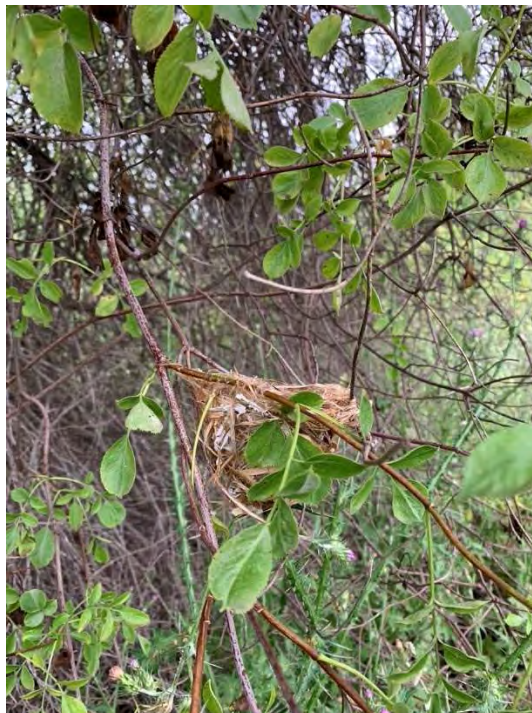
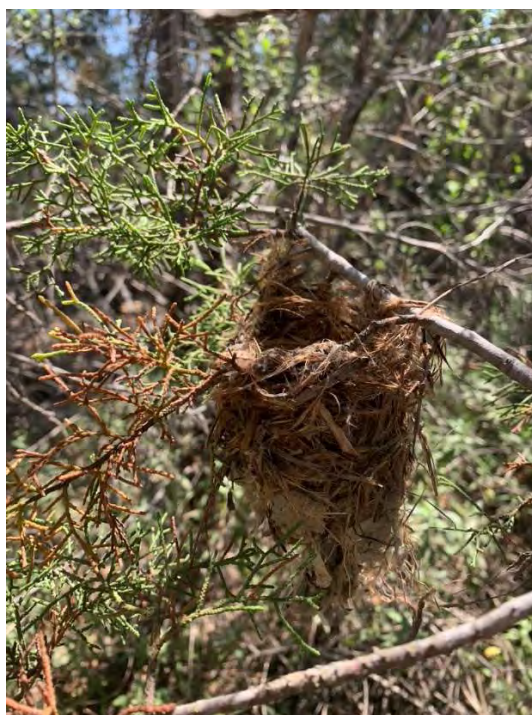
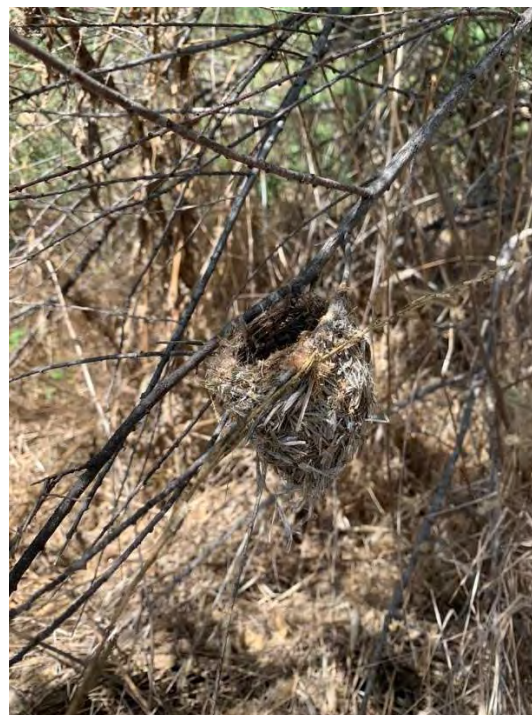
Photos 2-5. Least Bell's Vireo nests placed in laurel sumac (*Malosma laurina*, top left), Mexican elderberry (*Sambucus nigra* subsp. *Caerulea*, top right), Tecate cypress (*Hesperocyparis forbesii*, bottom left), and Mule fat (*Baccharis salicifolia*, bottom right) at Otay River. Photos taken in May-July 2020 by Kimberly Ferree.

Least Bell's Vireos used seven different host plant species at Otay River in 2020 (Table 7, Photos 2-5). Half of all nests were placed in laurel sumac (13/26). Mule fat and elderberry were the next most commonly used substrates representing 31%. Tamarisk, fennel, tecate cypress, and toyon were used once or twice.
