PRELIMINARY SITE RESTORATION PLAN

PG&E L-130 SACRAMENTO RIVER CROSSING PIPELINE REPLACEMENT PROJECT SOLANO AND SACRAMENTO COUNTIES, CALIFORNIA

Project No. 2002-5361

MARCH 2022

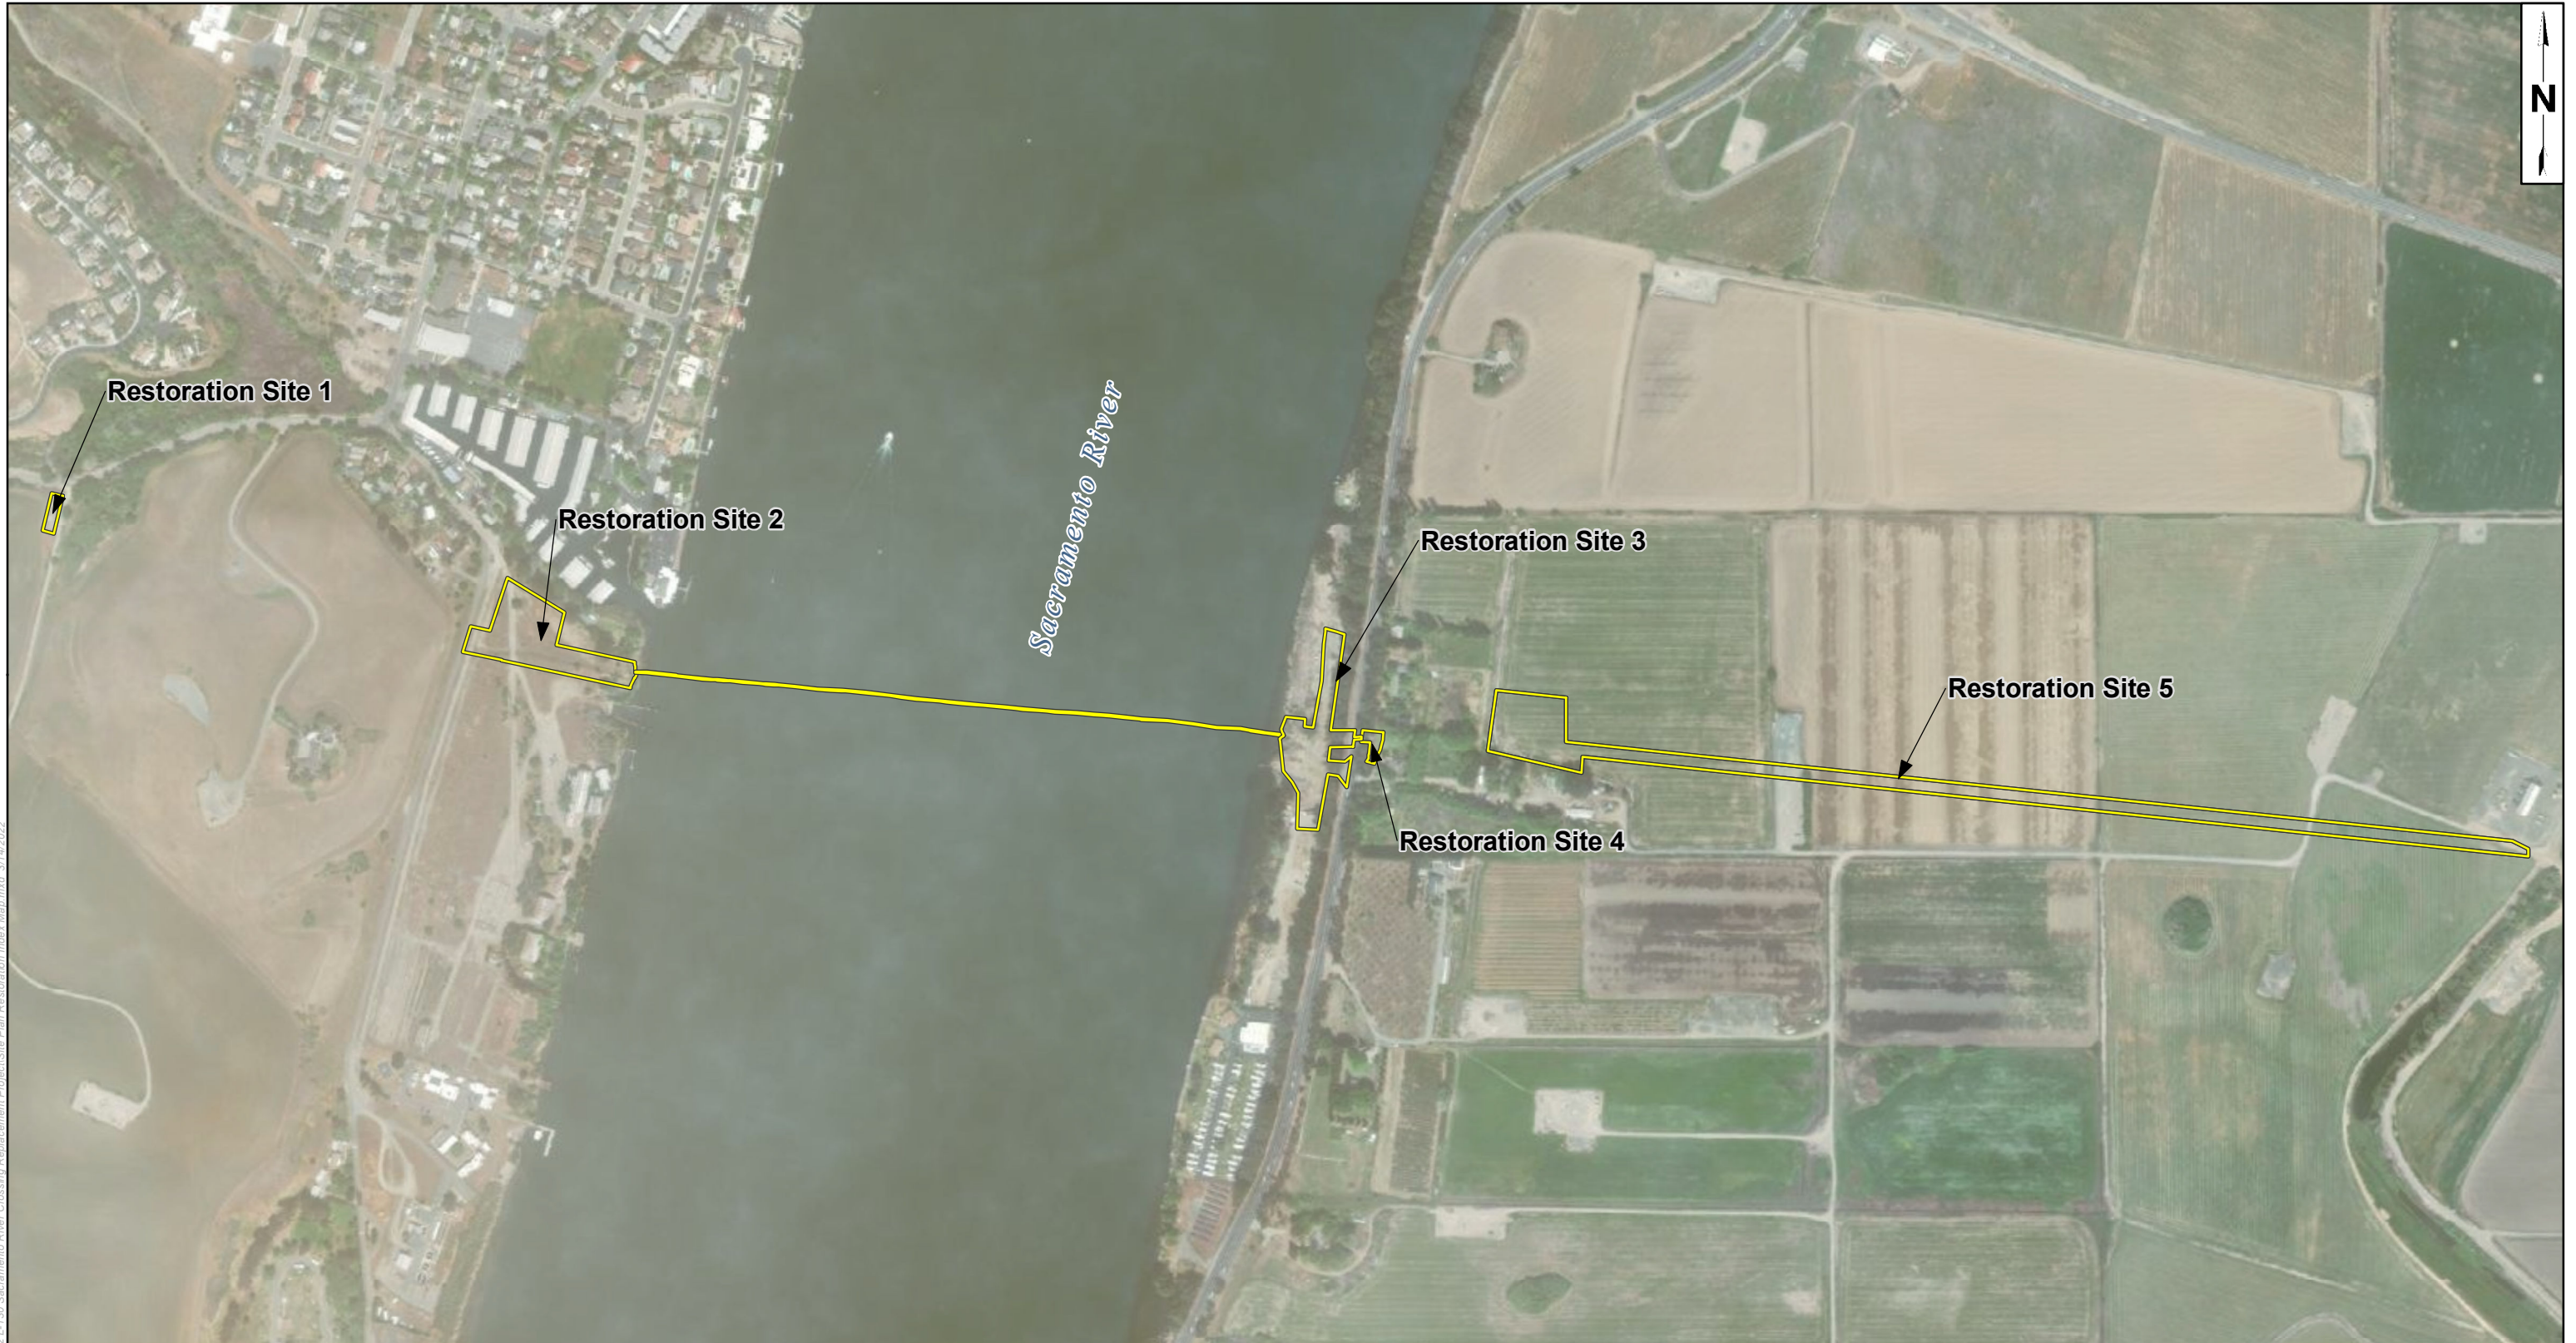
**FIGURE
2A**

Restoration Site 1

Restoration Site 2

The restoration area encompasses a total of 19.55 acres and is comprised of five distinct restoration sites based on impact area boundaries within the overall Project area. Each restoration site will be restored to the pre-disturbance condition or better. Active and/or passive restoration methods will be used based on the pre-disturbance conditions of mapped vegetation communities. Table 2 outlines the size, impact type, pre-disturbance vegetation community and acres, impact/restored acres, general restoration method, and revegetation methods for each restoration site. The restoration sites and the specific planting areas are depicted on Figures 2A-2E.

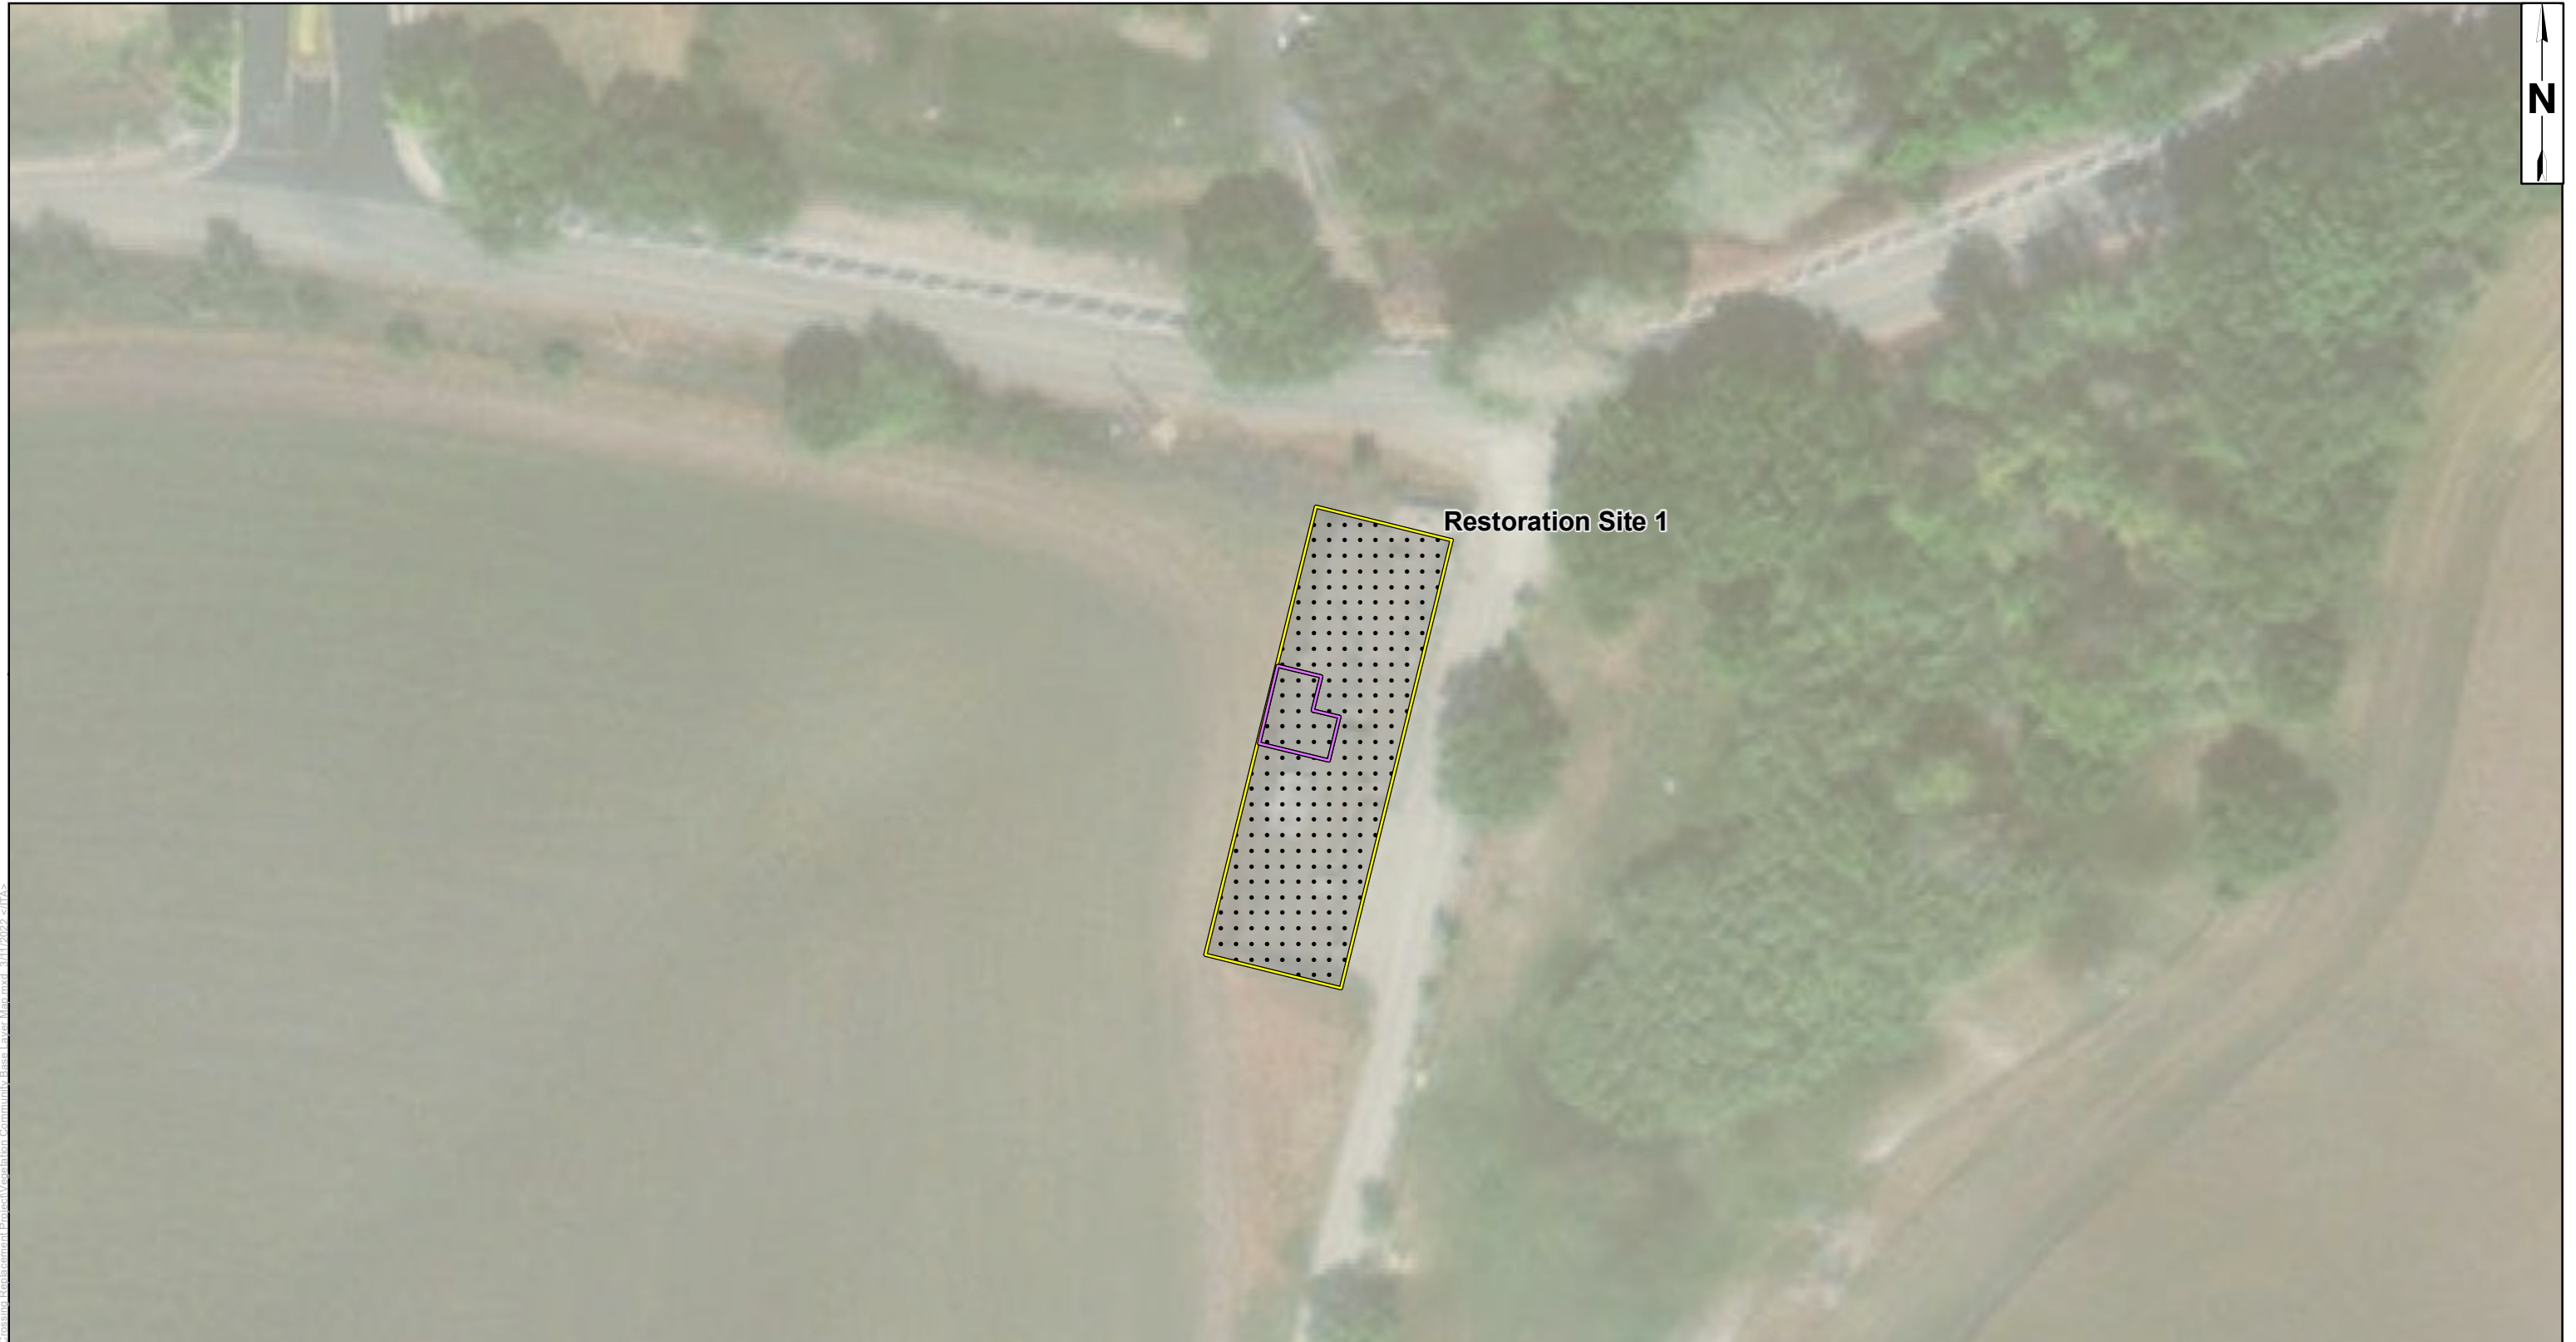
FIGURE 2B

Restoration Site 1

- Restoration Site 1 (0.15 ac)
- Excavation Area - L-130 Replacement Activities (0.01 ac)

Restoration Site 1 (RS-1) is surrounded by agricultural land and paved roads. The pre-disturbance conditions of RS-1 consists of unvegetated developed lands consisting of pavement and gravel, and pre-construction photos will be taken to document baseline condition of RS-1. Following completion of Project activities, the excavation area will be backfilled, and the site will be recontoured to original grade. No revegetation is proposed for this developed area because the pre-construction condition is unvegetated

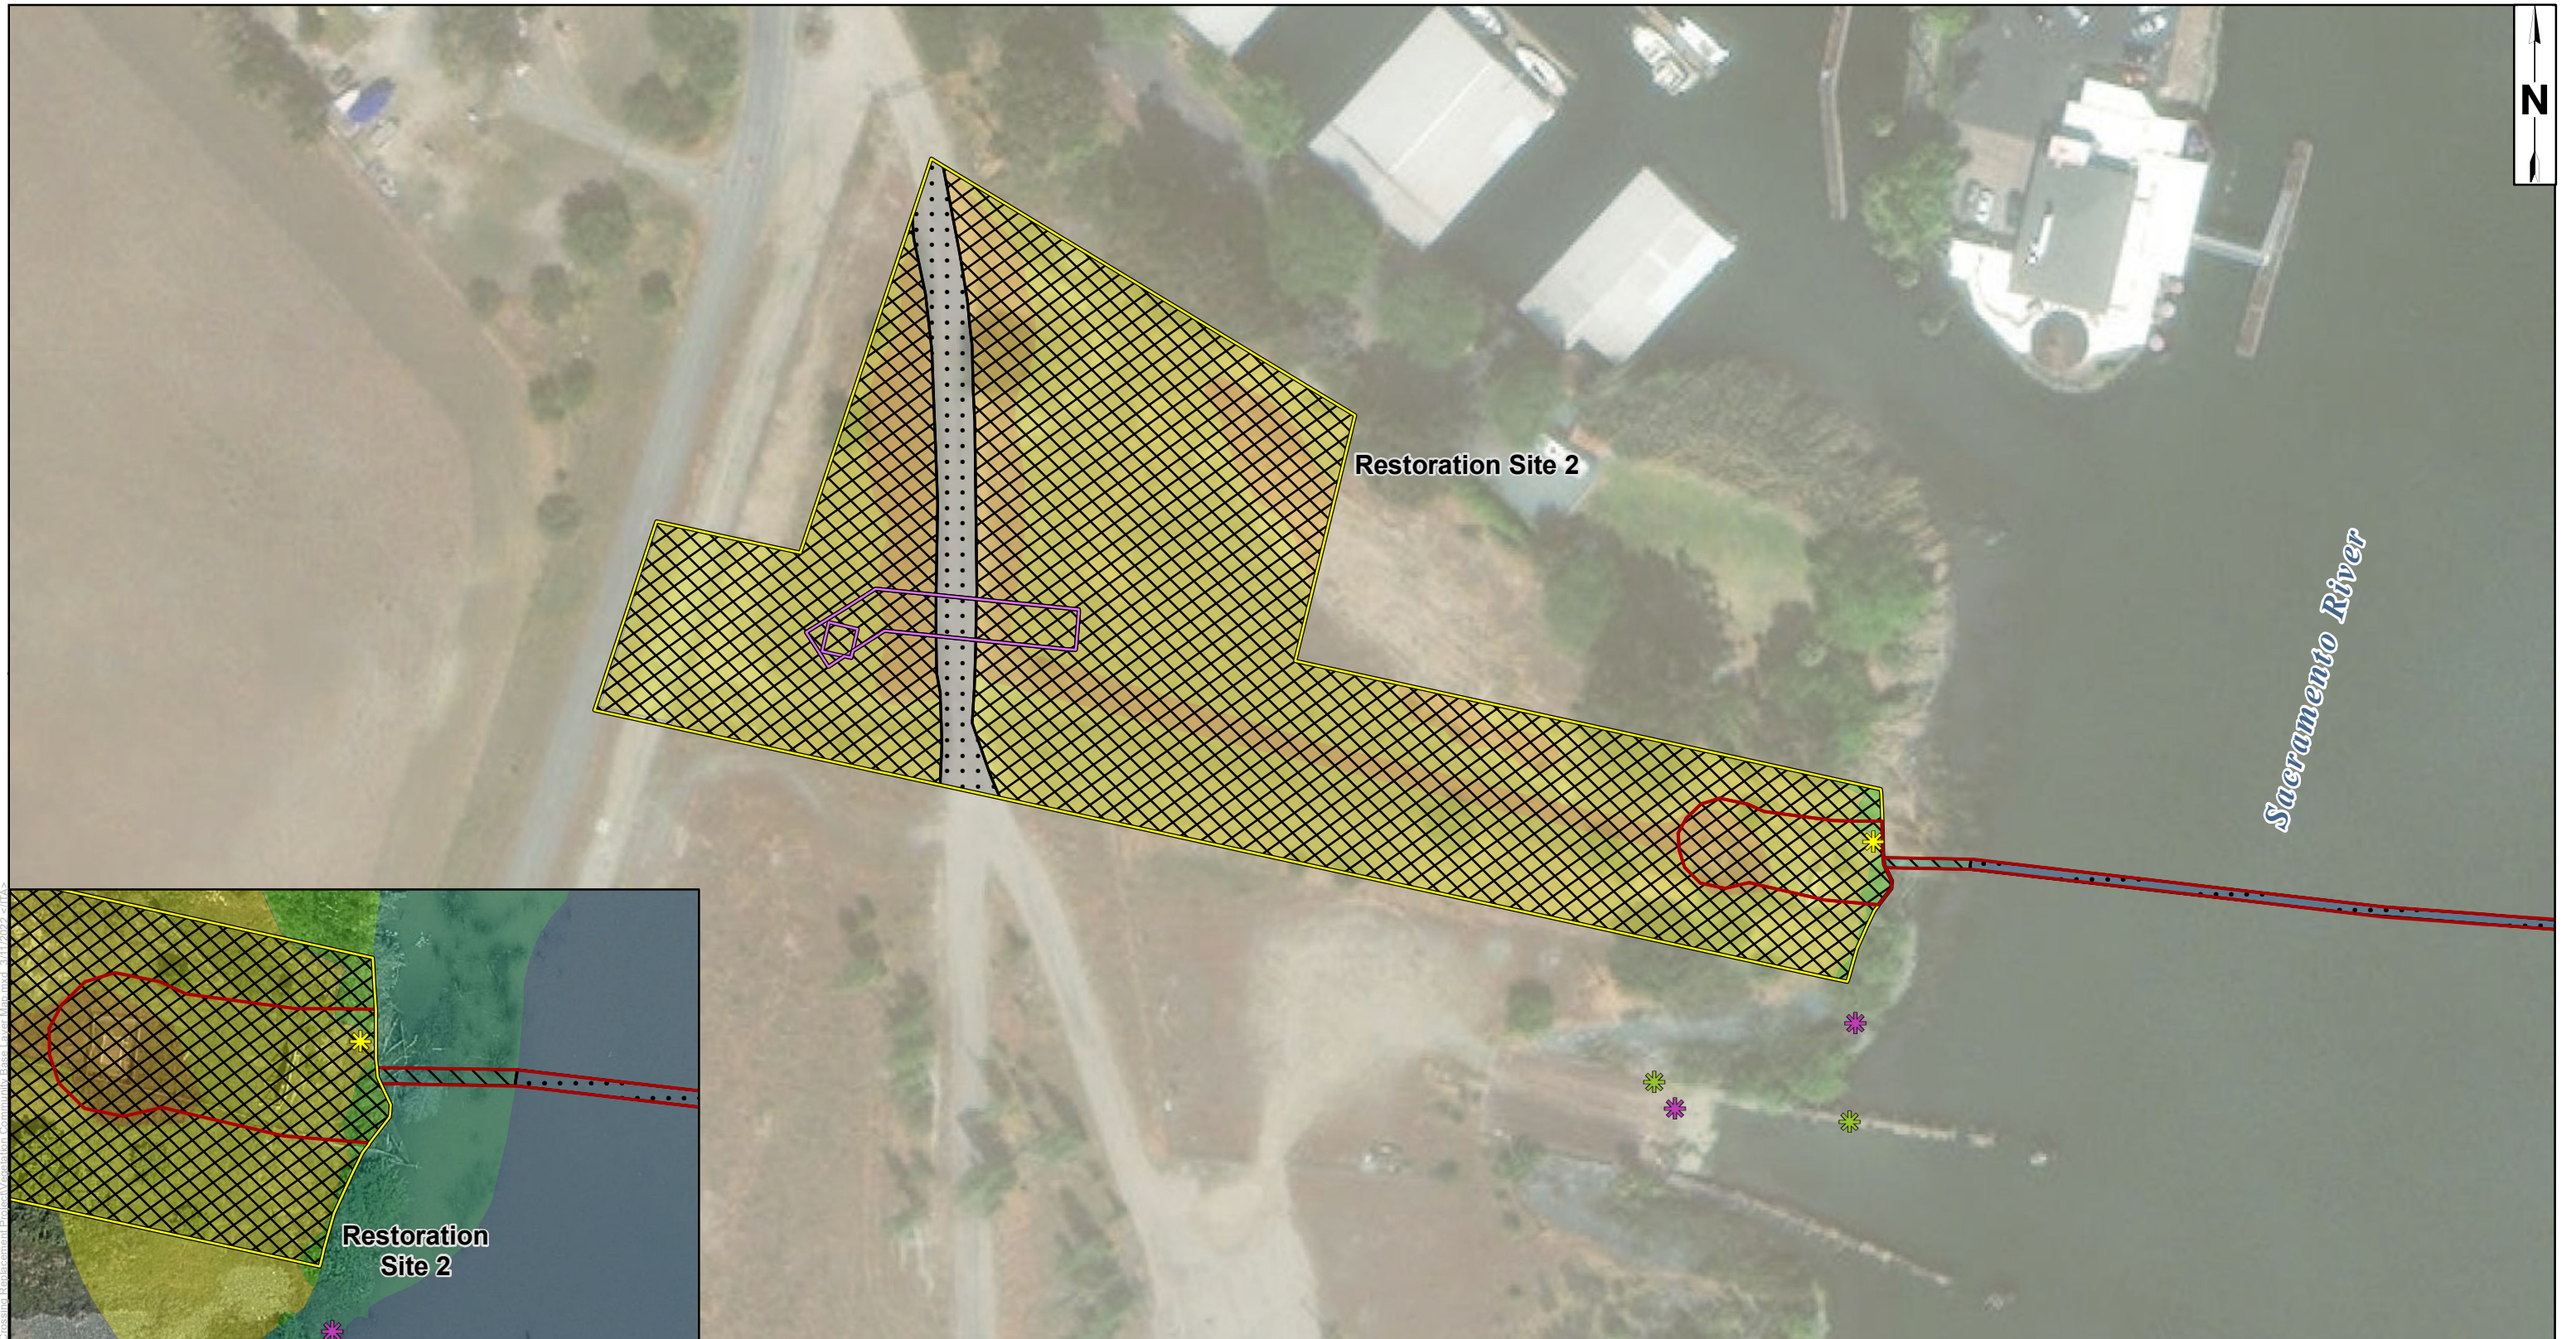
- LEGEND:**
- Restoration Site 2 (2.41 ac)
 - Excavation Area - L-130 Decommissioning Activities (0.09 ac)
 - Excavation Area - L-130 Replacement Activities (0.06 ac)

- Restoration Method**
- Restoration Active (2.41 ac)
 - Restoration Passive (0.01 ac)
 - Unvegetated/Agricultural Uses (No Restoration) (8.55 ac)

Restoration Site 2 (RS-2) extends from a paved road (Beach Drive) to the west bank of the Sacramento River and is surrounded primarily by urban development and vacant lots. The pre-disturbance conditions of RS-2 consists of jurisdictional waters / wetlands, riparian and upland

habitats supporting Non-native Grassland, Ruderal, Central Coast Riparian Scrub, and Coastal and Valley Freshwater Marsh vegetation communities. This site also includes some unvegetated developed lands (roadway). Pre-construction photos will be taken to document baseline condition of RS-2. Following completion of Project activities, the excavation areas will be backfilled, and the site will be recontoured to original grade. Based on pre-disturbance vegetation communities, the vegetated upland areas (ruderal and non-native grassland vegetation communities) will be actively restored by application of hydroseed using a native erosion control seed mix.

The riparian area (Central Coast riparian scrub vegetation community) on the west bank of the Sacramento River will be planted with native riparian species occurring in this location prior to Project implementation and adapted to frequently flooded conditions. Woody vegetation consisting predominantly of shrubs will be actively restored by planting arroyo willow and California button willow cuttings sourced from the Project site and surrounding area. Hydroseed application using a seed mix of native herbaceous species will provide understory habitat and reduce erosion.

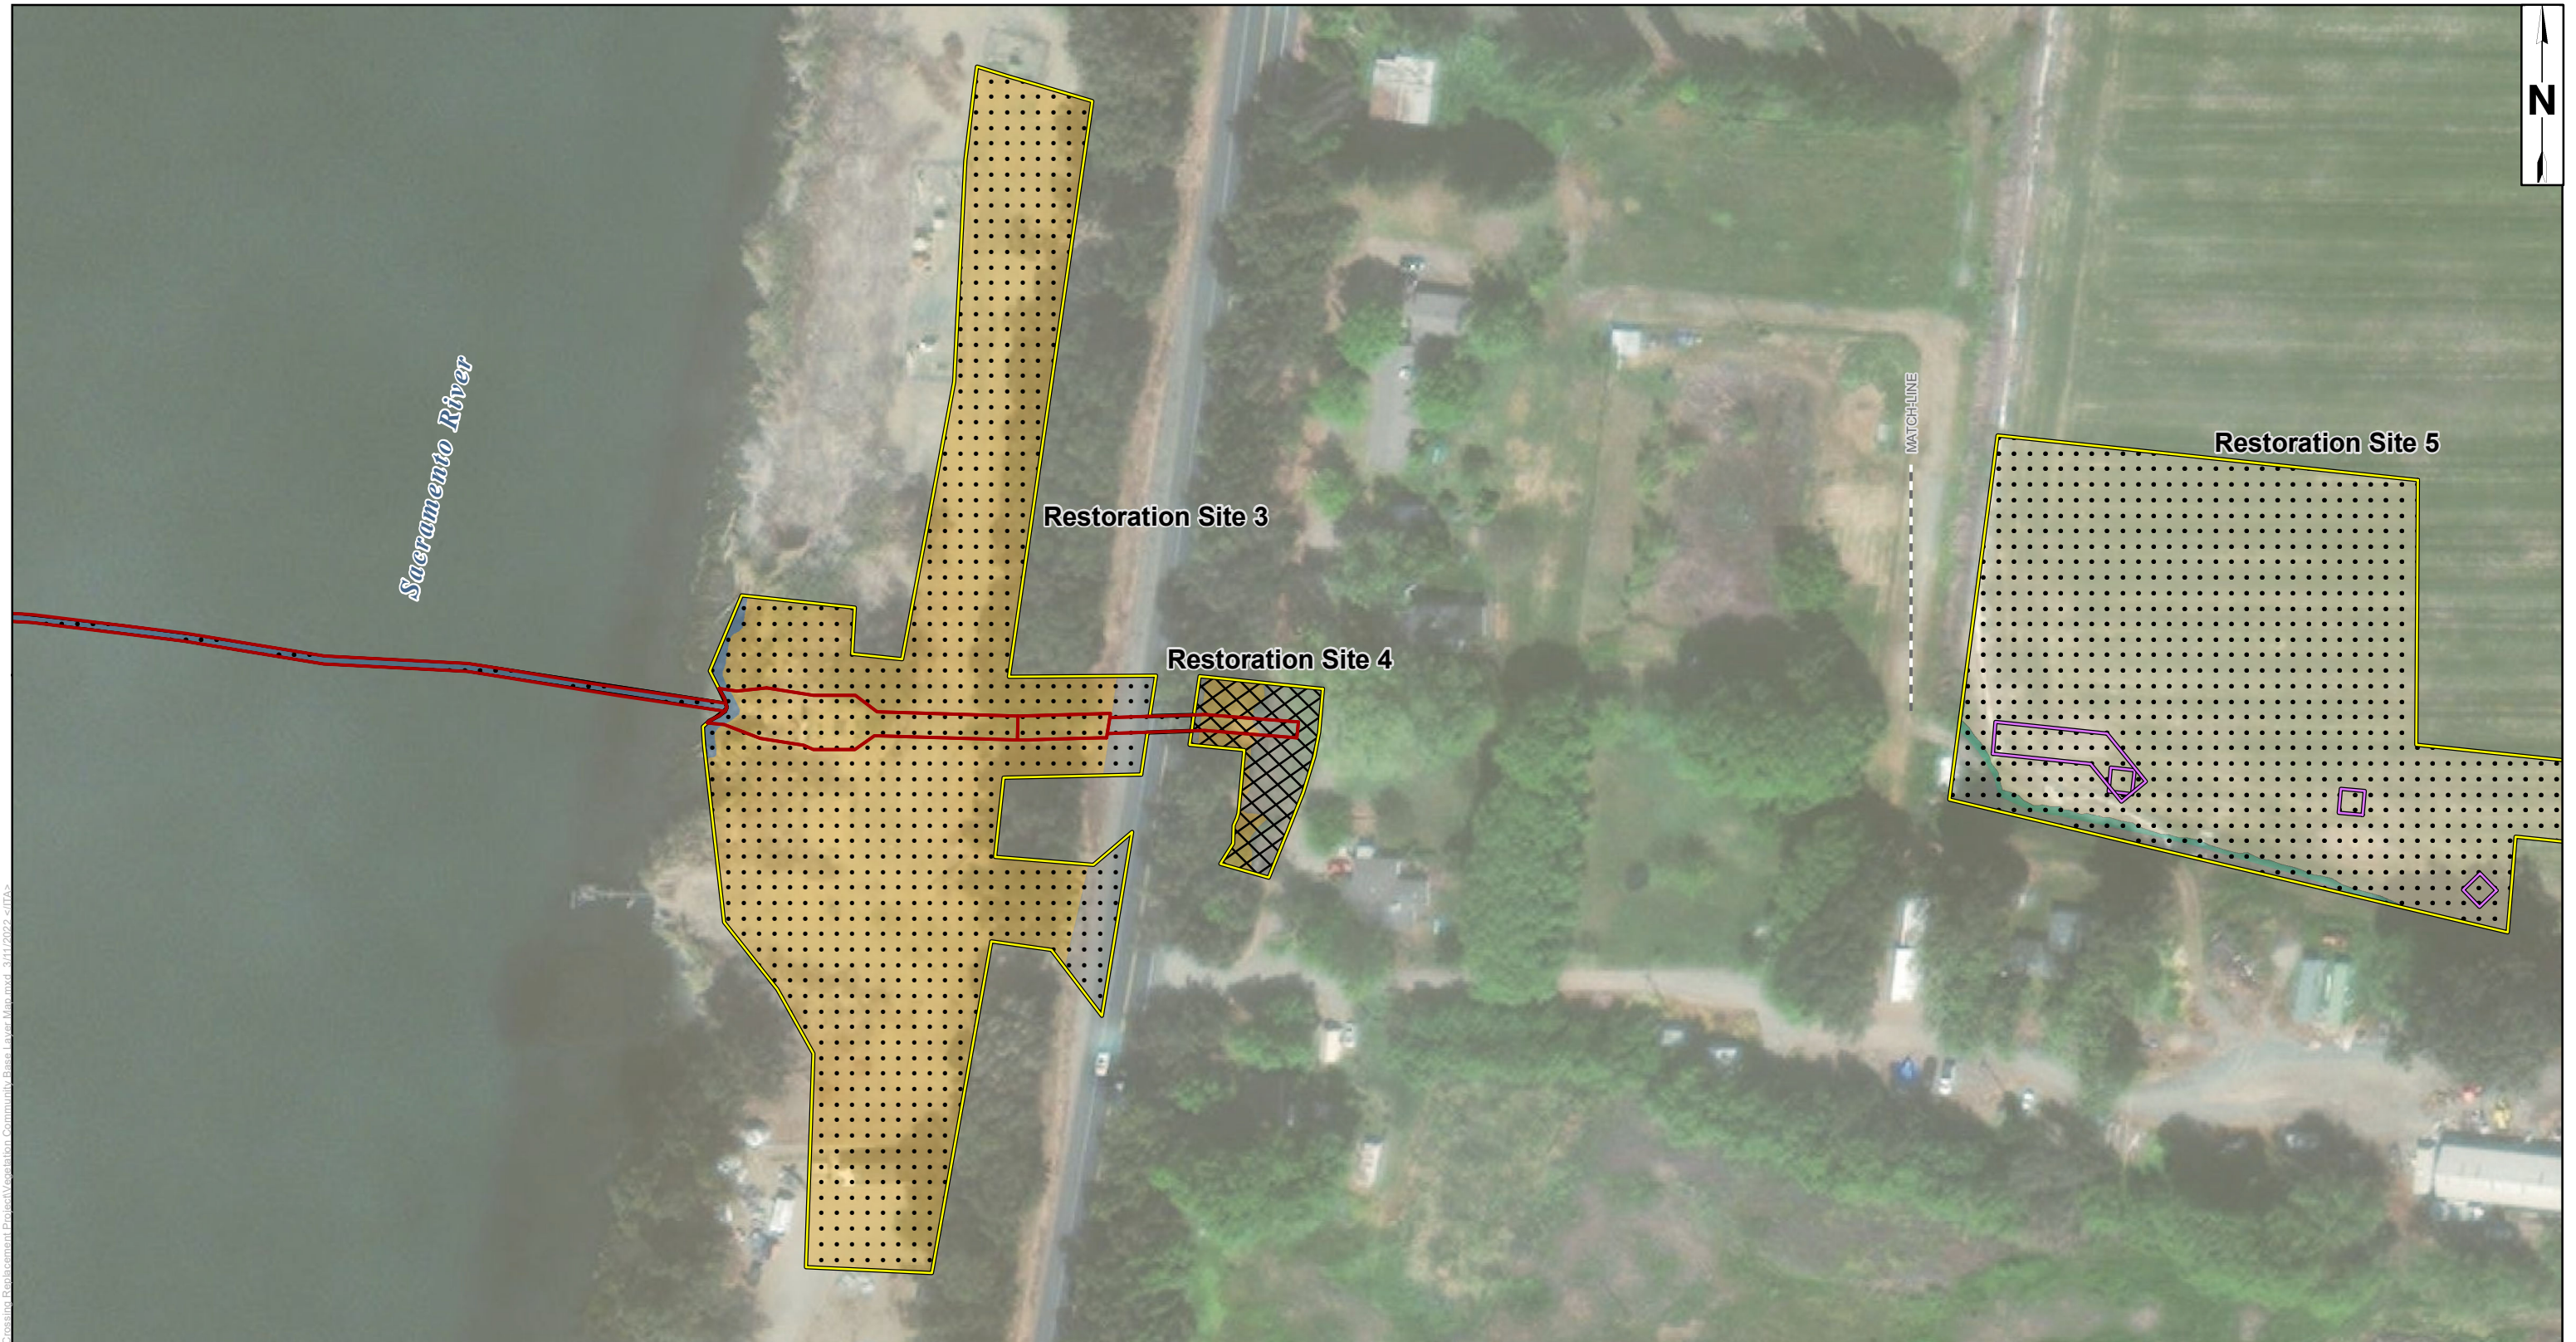
SITE RESTORATION PLAN FIGURE 2D

- LEGEND:**
- Restoration Site 3 (2.09 ac)
 - Restoration Site 4 (0.14 ac)
 - Restoration Site 5 (5.88 ac)
 - Excavation Area - L-130 Decommissioning Activities (0.14 ac)

Restoration Site 3 (RS-3) extends east from the east bank of the Sacramento River to the east side of a paved road (Highway 160). The pre-disturbance conditions of RS-3 consists of upland habitat that is mostly unvegetated but supports sparse Ruderal and Urban Mix vegetation communities in the form of giant reed stands. The riverbank at this location consists of rock riprap at the surface and does not support emergent wetland or riparian vegetation. Pre-construction photos will be taken to document baseline condition of RS-3. Following completion of Project activities, the excavation area will be backfilled and the site will be recontoured to original grade. The majority of RS-3 is a developed area that is unvegetated and is used by the current owner for parking and staging of materials and equipment. No revegetation is proposed for this developed area because the pre-construction condition is predominantly unvegetated and weedy. Application of hydroseed using a native erosion control seed mix may occur in some portions of this restoration site, if appropriate or required for compliance with the Stormwater Pollution Prevention Plan.

Restoration Site 4 (RS-4) is surrounded by paved road and vegetated open space. The pre-disturbance conditions of RS-4 consists of upland habitat supporting ruderal and urban mix vegetation and pre-construction photos will be taken to document baseline condition of RS-4. Following completion of Project activities, the excavation area will be backfilled, and the site will be recontoured to original grade. Active restoration will be employed and will consist of hydroseeding with a native erosion control seed mix in the previously vegetated areas (e.g., the landward slope of the levee).

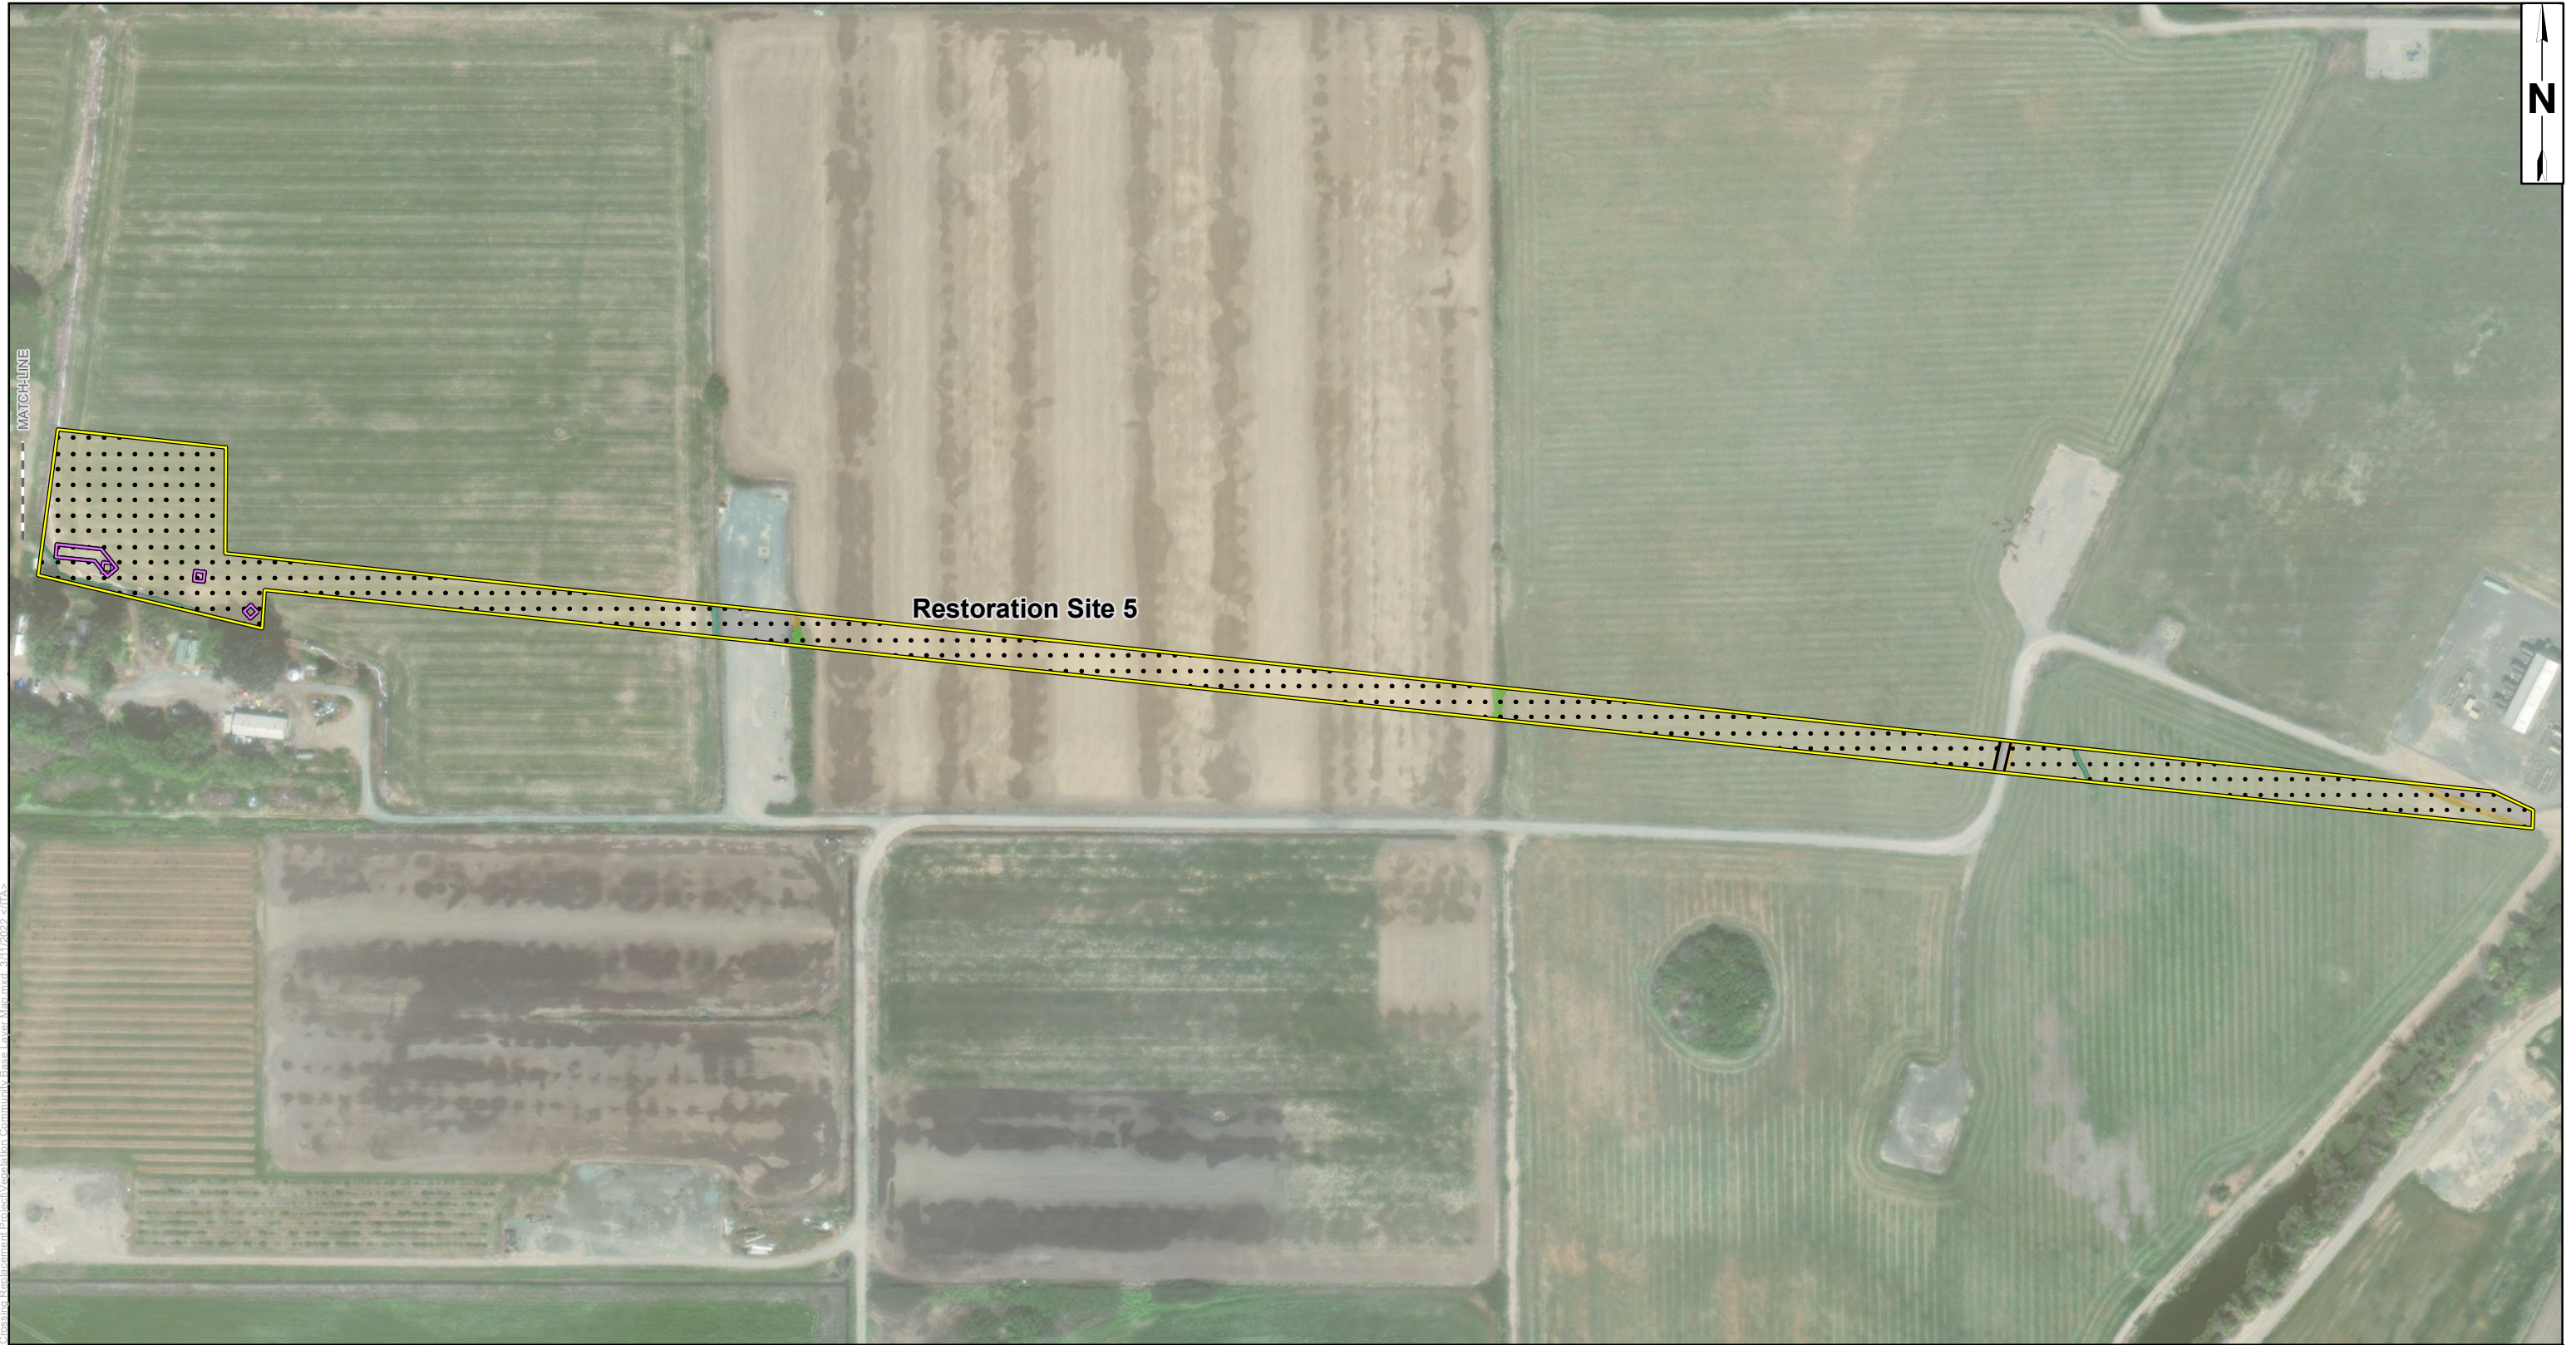
Restoration Site 5

- Restoration Site 5 (5.88 ac)
- Excavation Area - L-130 Replacement Activities (0.06 ac)

Restoration Site 5 (RS-5) consists of agricultural lands, with four transecting agricultural ditches. The pre-disturbance conditions of RS-5 consists of cultivated agricultural lands with patches of Ruderal and Urban Mix vegetation occurring in uncultivated locations. Central Coast Riparian Scrub, and Coastal and Valley Freshwater Marsh vegetation communities occur in agricultural ditches that transect this restoration site and pre-construction photos will be taken to document baseline condition of RS-5. Following completion of Project activities, the excavation area will be backfilled, and the site will be recontoured to original grade with the upper six inches of topsoil preserved and spread evenly over the excavation footprint. Topsoil consists of seeds, nutrients, and microorganisms that will assist in the rapid recovery of the vegetative community. Since these lands are privately owned and used in agricultural production, this restoration site will be returned to cultivated agricultural lands in accordance with landowner agreements. Temporary disturbance to agricultural ditches at the crossing locations will be returned to pre-project contours and passively restored to pre-project condition in accordance with landowner agreements.
