**Biological Survey Report for the
El Capitan Dam Spillway
Vegetation Removal Project
San Diego, California**

Prepared for
City of San Diego
Public Utilities Department
9192 Topaz Way
San Diego, CA 92123
Contact: Ms. Megan Hickey

Prepared by
RECON Environmental, Inc.
3111 Camino del Rio North, Suite 600
San Diego, CA 92108
P 619.308.9333

RECON Number 8863
April 9, 2021

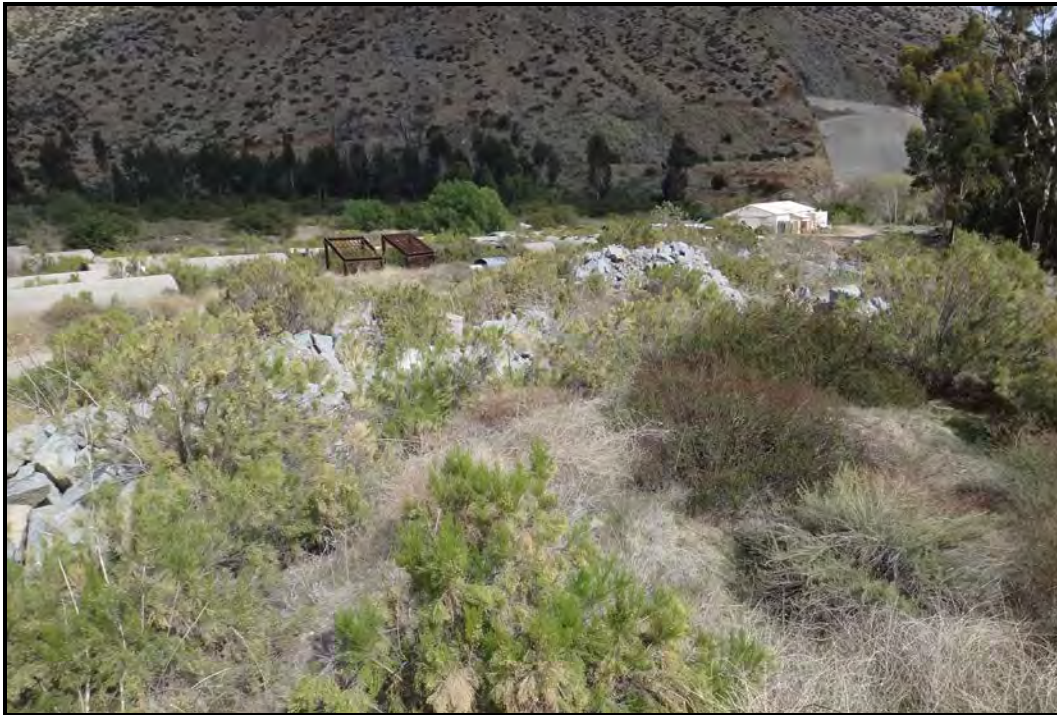
PHOTOGRAPH 13
Disturbed Diegan Coastal Sage Scrub in the Northwest Portion of the Survey Area, Facing East, Taken November 14, 2017

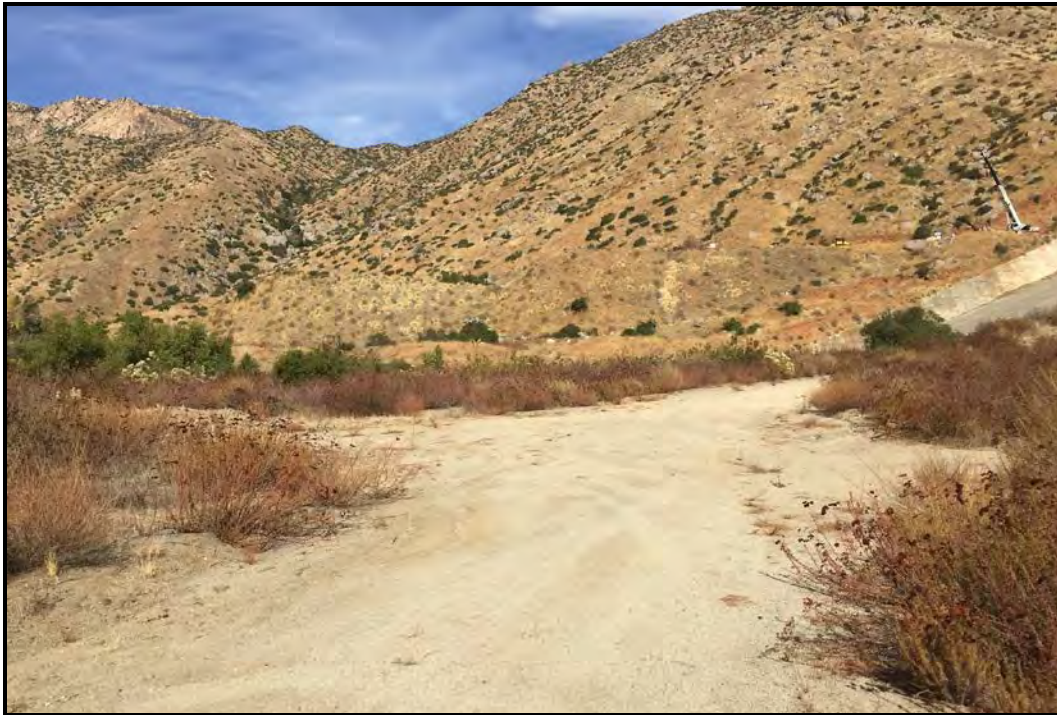
PHOTOGRAPH 17
Disturbed Land within an Access Road in the Central Portion of the Survey Area, Facing North, Taken November 14, 2017

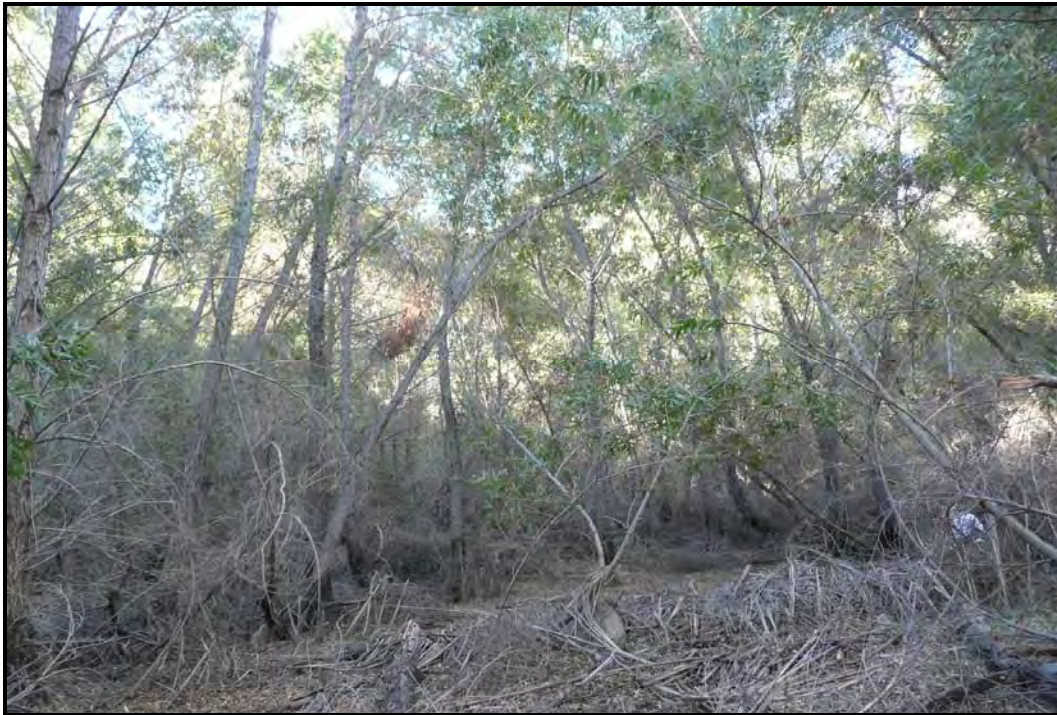
PHOTOGRAPH 1
Riparian Vegetation along Spillway Channel, Facing South

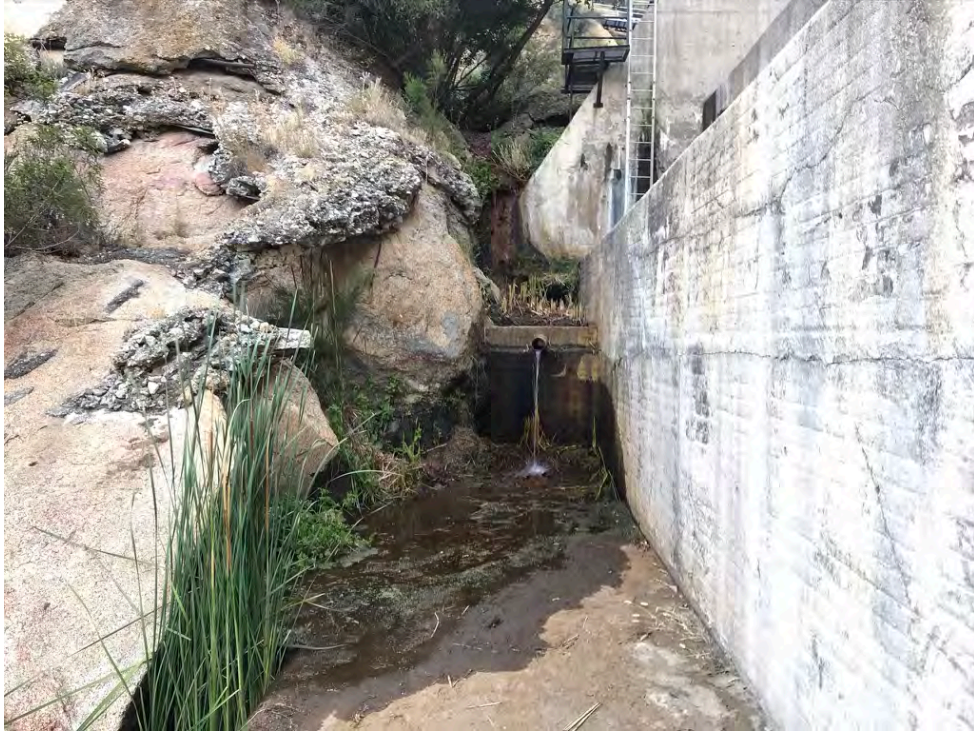
Photo 5. Barrett Dam – Seep near the bottom of the dam. Both species of treefrog often observed here. June 22, 2020.

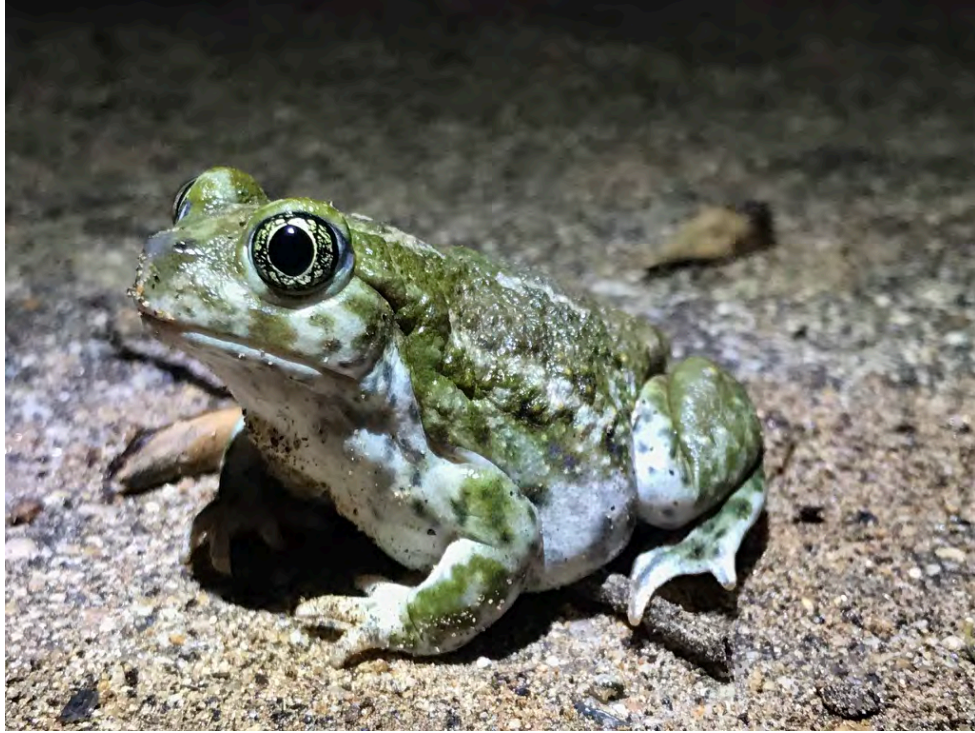
Photo 9. El Capitan Dam – Photo of western spadefoot (*Spea hammondi*), a CDFW Species of Special Concern, observed in upland habitat within the survey area. April 24, 2020.

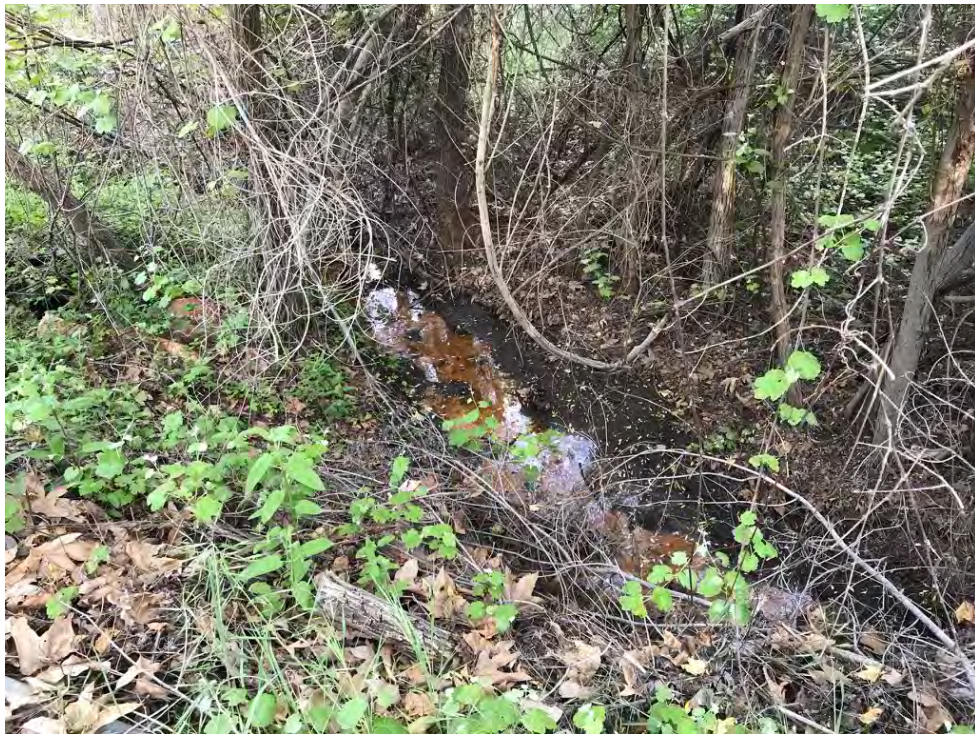
Photo 10. El Capitan Dam – Surface water present in the San Diego River channel within the survey area but not suitable conditions for ARTO breeding. April 24, 2020.

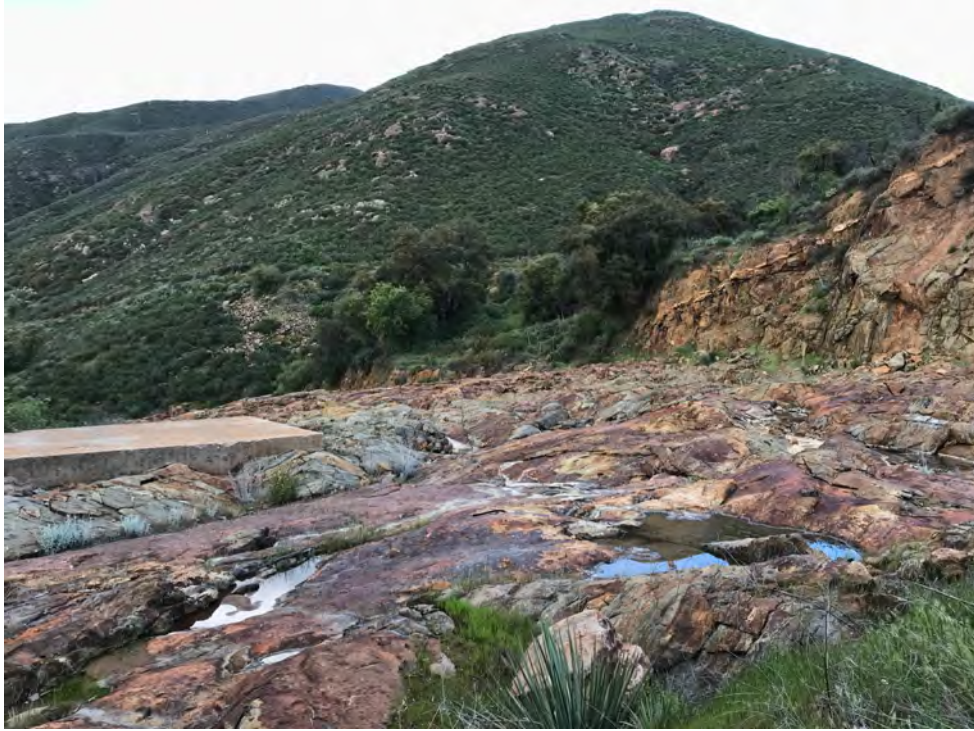
Photo 15. Sutherland Dam – Daytime view of the rocky area on top of the Sutherland Dam spillway where arroyo toad was observed. April 30, 2020.

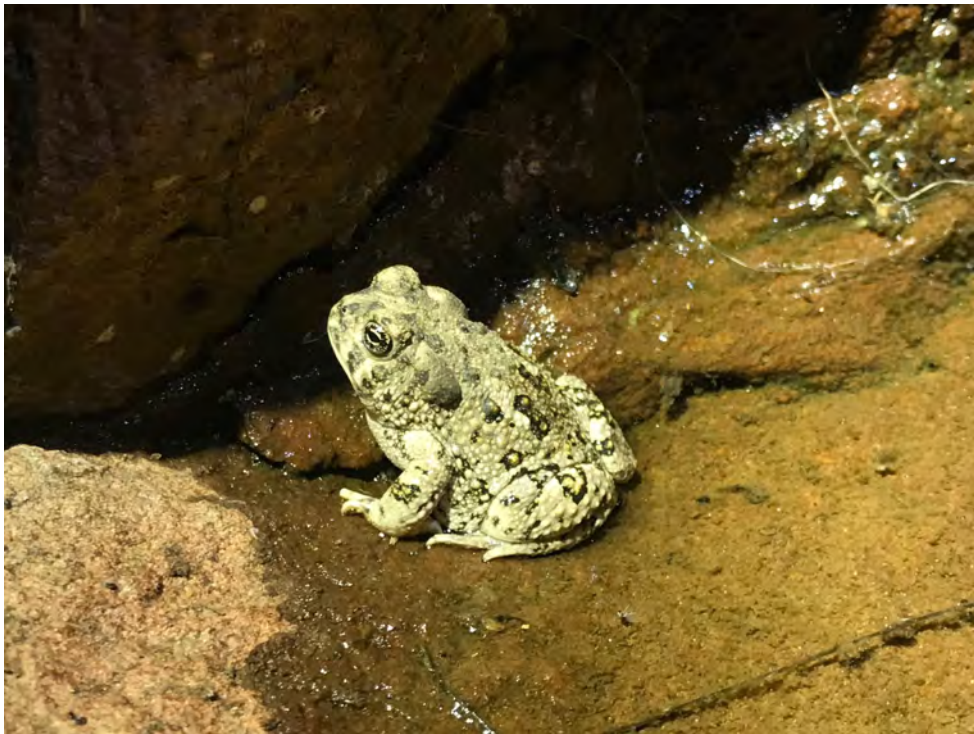
Photo 16. Sutherland Dam – Adult arroyo toad in a small, spring-fed basin on the rock-lined portion of the dam spillway on the eastern side of the dam. April 30, 2020.

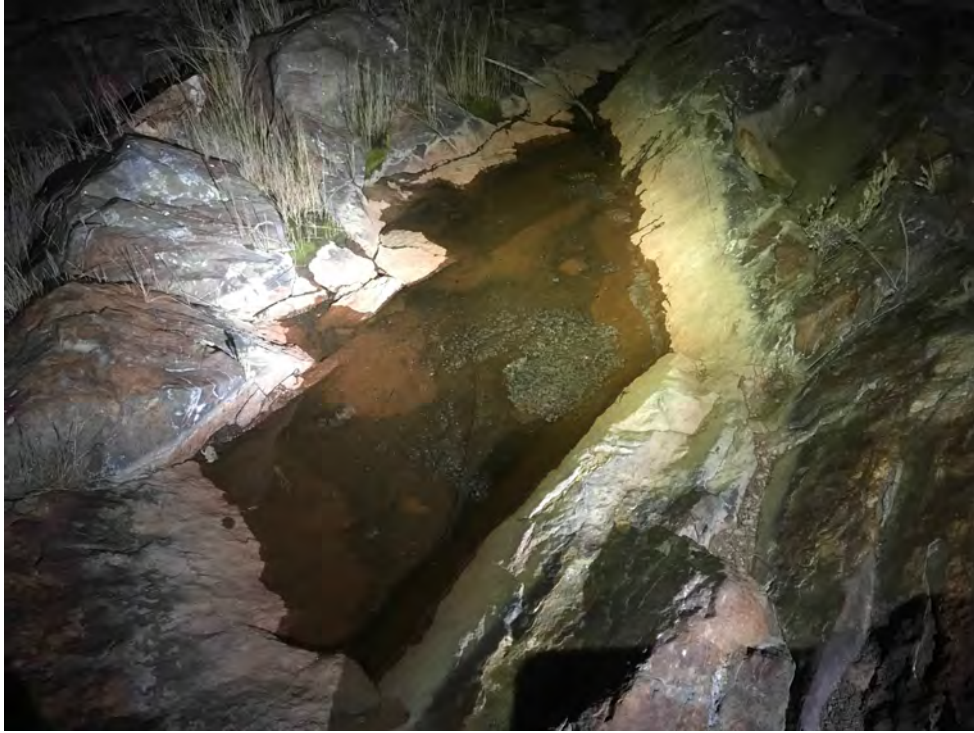
Photo 17. Sutherland Dam – Overview of the basin in which the adult arroyo toad was observed. April 30, 2020.

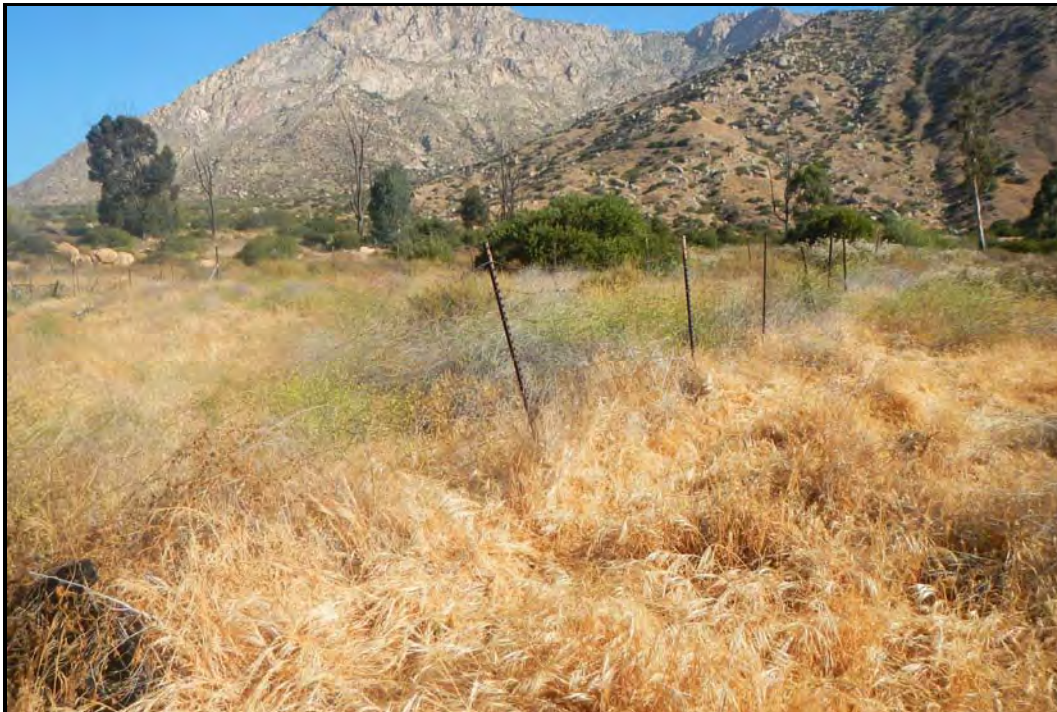
PHOTOGRAPH 18
El Capitan Spillway AA, View of Degraded Fence Included in Buffer
June 6, 2018

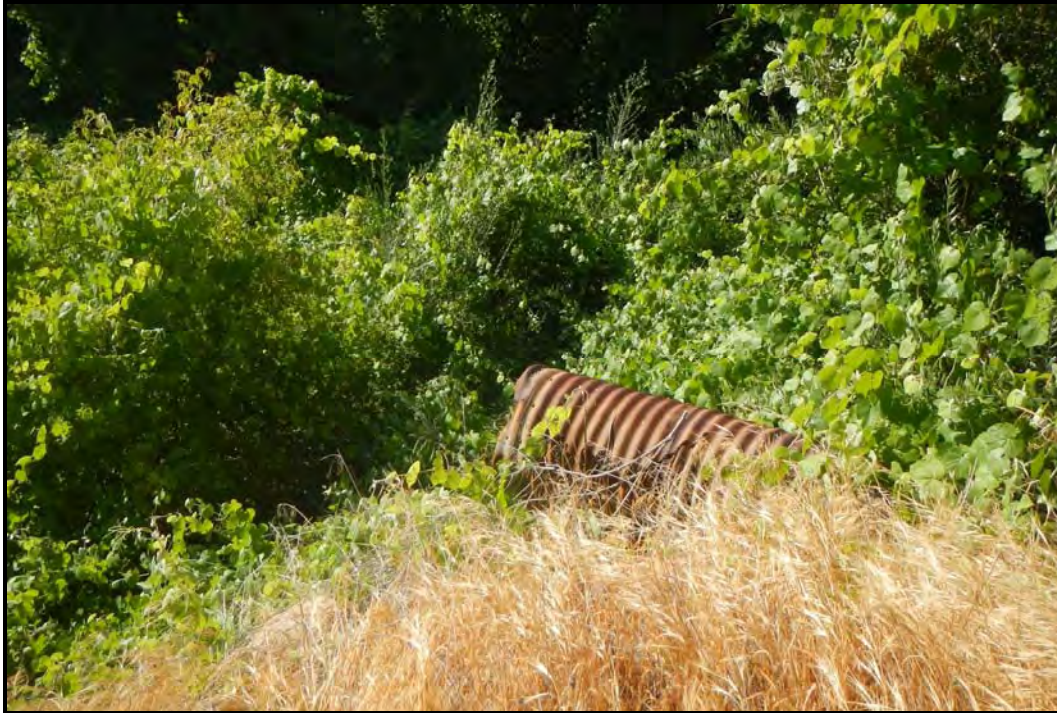
PHOTOGRAPH 19
El Capitan Spillway AA, View of Runoff Culvert that was Used to
Establish the Upstream End of the AA
June 6, 2018
